DEPARTMENT OF THE INTERIOR
U.S. GEOLOGICAL SURVEY

The Intensity of the July 21, 1986, Chalfant Valley,
California, Earthquake

Open-File Report 89-135

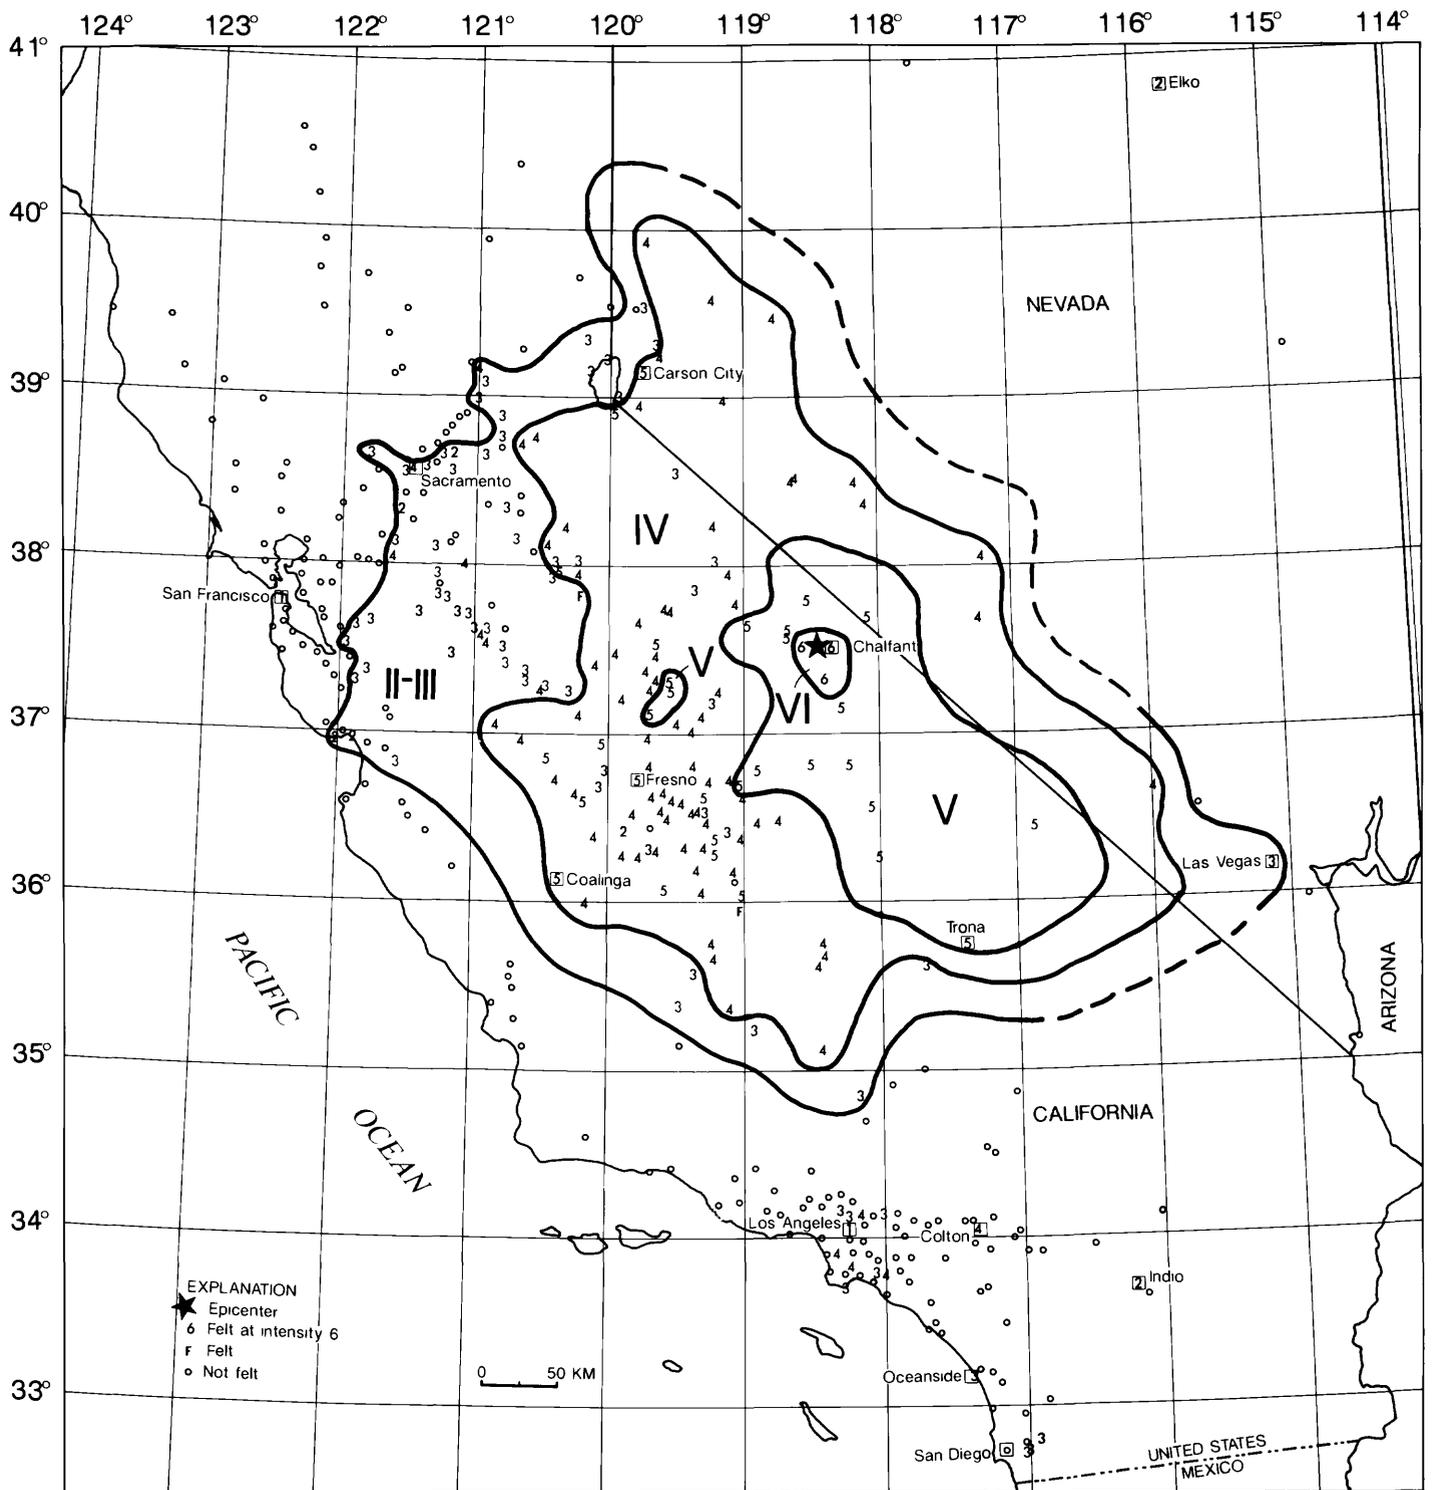
Three intensity MM VI values were assigned (see fig. 1) at: Chalfant, Bishop, and the Owens River Gorge plant system.

Figure 1. Isoseismal map for the Chalfant Valley earthquake of 21 July 1986, 14 42 26.6 UTC. Roman numerals represent Modified Mercalli intensities between isoseismals; arabic numerals are used to represent these intensities at specific sites. Felt indicates, felt only, at specific sites.

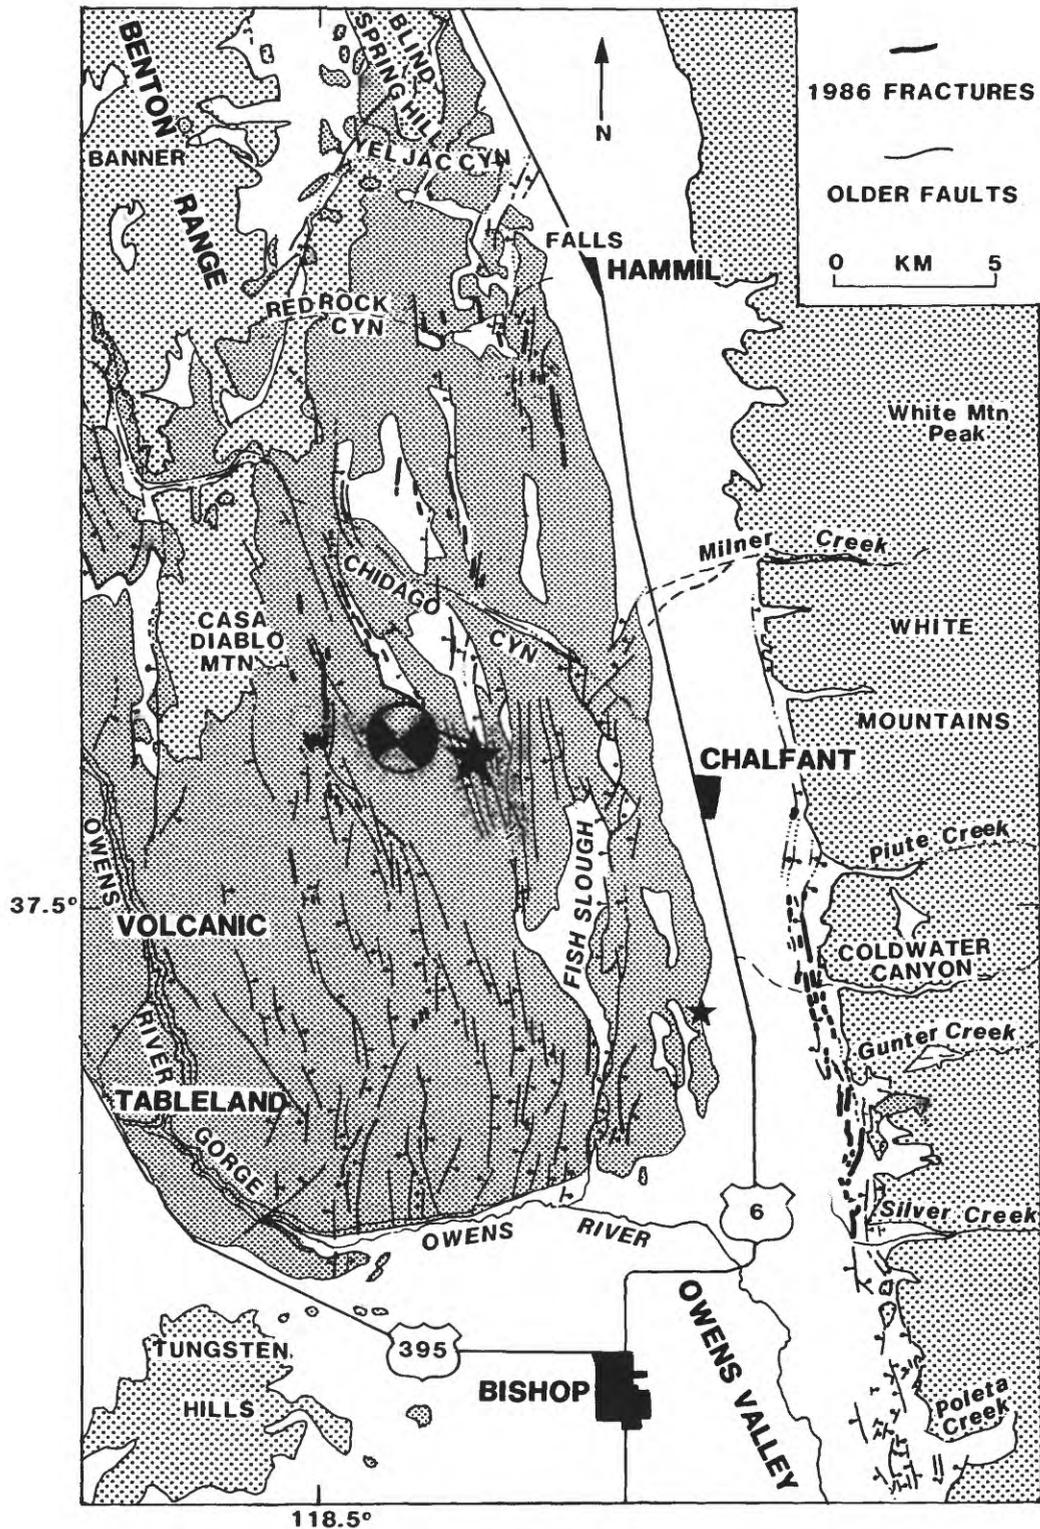
is located on valley fill deposits. The epicenter of the 21 July 1986 earthquake is located about 8 km northwest of Chalfant in the Volcanic Tableland (see fig. 2). This Volcanic Tableland was formed by the eruption of the Long Valley caldera (Cockerham and Corbett, 1987).

The preferred focal mechanism solution determined from first-motion readings at University of California, Berkeley, University of Nevada, and the National Earthquake Information Center (NEIC fault plane, see fig. 2) has a fault plane striking N28°W with a dip of 72° to the west and a rake (slip angle) of 168°. The fault plane solution corresponds to right-lateral, strike-slip faulting with a small normal component (east side up) (Bryant and others, 1986).

Figure 2. Geologic map of the Chalfant Valley area. Smaller stippling indicates Bishop Tuff (Volcanic Tableland); larger stippling is older bedrock; unshaded areas indicate Quaternary alluvium, including fan gravels. Large star is the epicenter of the, 21 July 1986, main shock and small star is largest aftershock (31 July 1986). The map is from Lienkaemper and others (1987). The main shock focal mechanism is from NEIC (Preliminary Determination of Epicenters, Monthly Listing, 1986).

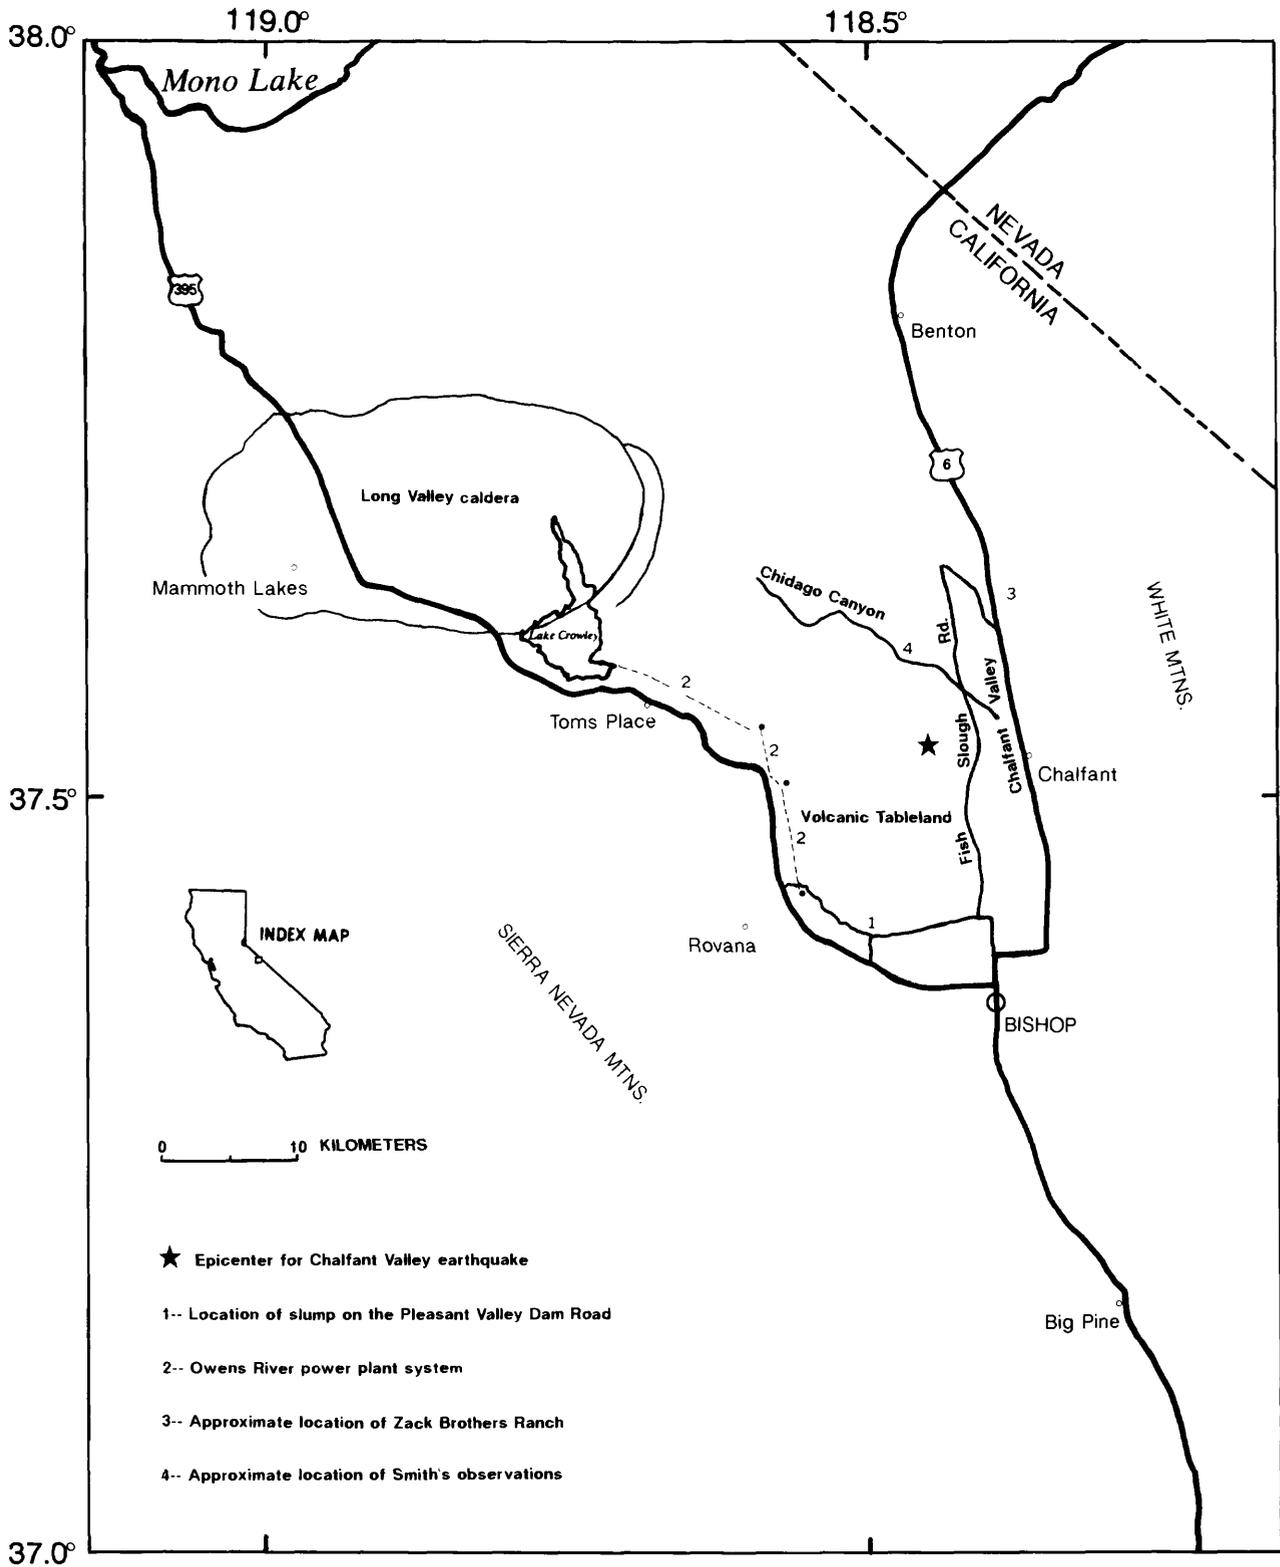
Numerous rockfalls were reported in Chidago Canyon and the canyons of the White Mountains; spectacular dust clouds were associated with these rockfalls. Rockfalls were also observed, during our NEIC survey, all along Fishslough Road (see fig. 3) Some roads were temporarily blocked by boulders; however, no thoroughfares were blocked.

The highest horizontal and vertical peak accelerations of .46 g and .35 g, respectively, were recorded at the Zack Brothers Ranch (see fig. 3) (Bryant and others, 1986). For a complete list of acceleration data obtained (in the epicentral area) from the earthquake see Appendix A (p. 24)

Figure 3. Schematic diagram showing points where there were shaking effects of special interest. Numbers correspond to those in the lower left-hand corner.
