**GEOLOGIC EVIDENCE FOR TRIGGERED SLIP ON THE
CALAVERAS FAULT DURING THE MAGNITUDE 7.1 LOMA PRIETA
EARTHQUAKE OF OCTOBER 17, 1989**

P.H. McClellan¹ and E.A. Hay²

OPEN-FILE REPORT
89-641

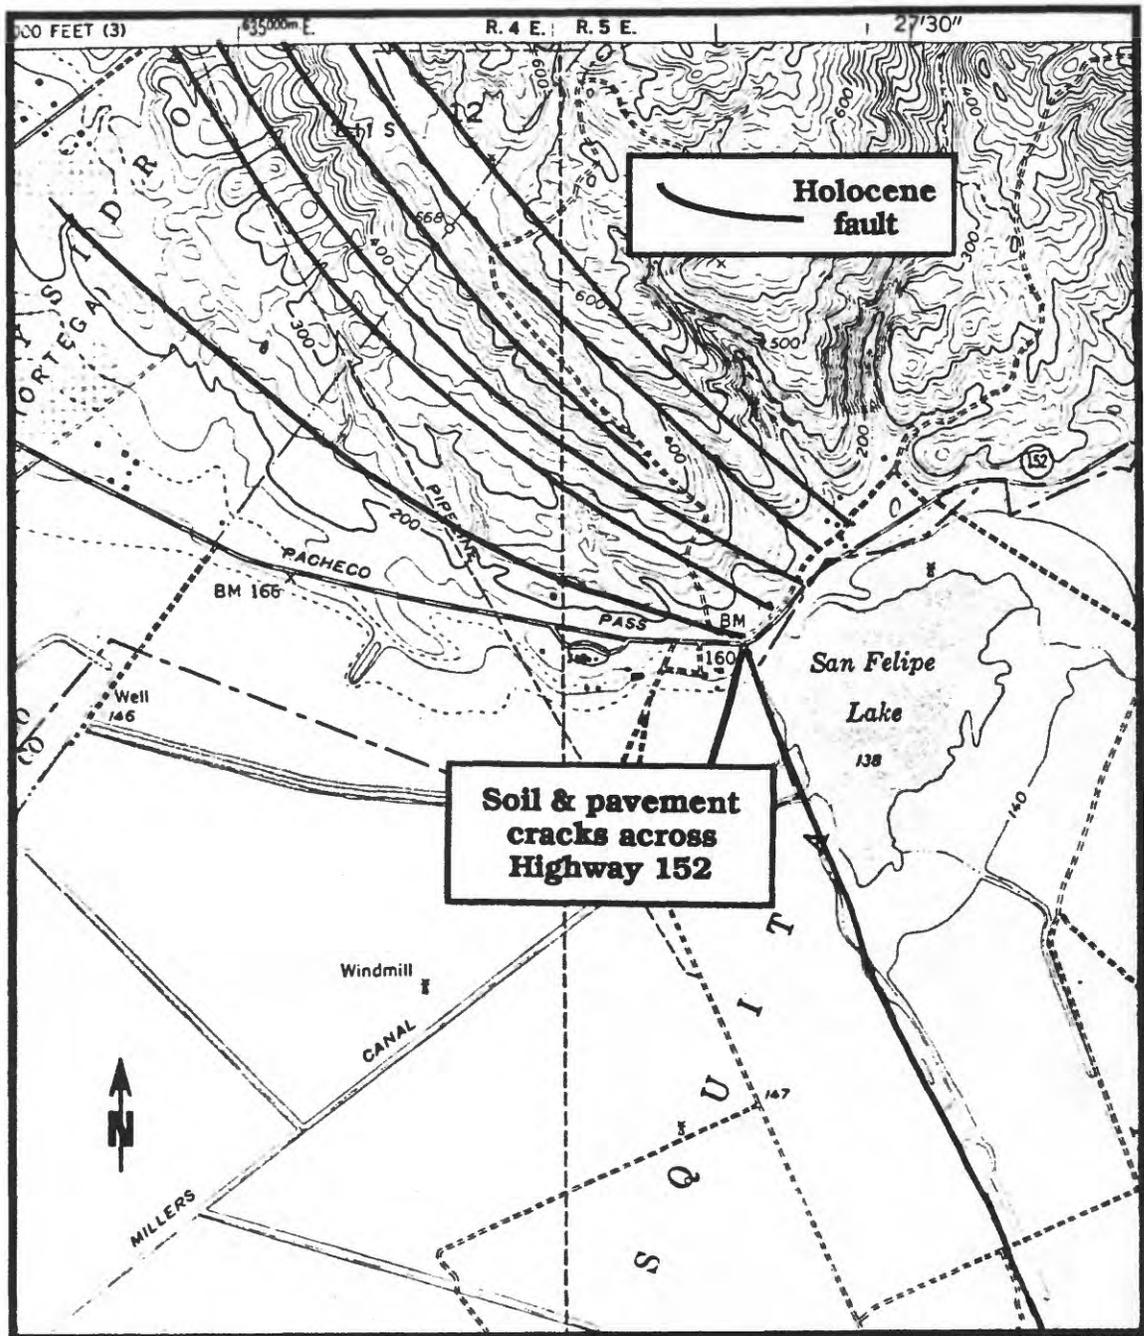
Fifteen km northwest of central Hollister the Calaveras fault passes along the western edge of San Felipe Lake and intersects State Highway 152 (Fig. 10). For the northernmost 9 km of this distance the fault is a single trace that strikes N20W. Immediately north of Highway 152 it enters the foothills of the Diablo Range where it abruptly bends 5-10 degrees more westerly, and becomes a broad zone encompassing at least six Holocene traces, four of which show historical creep where they offset fence lines (Armstrong, and others, 1980).

FIGURE 10. Map of vicinity of San Felipe Lake, 15 km northwest of Hollister, showing Holocene traces of the Calaveras fault zone (after Armstrong, and others, 1980), and site of right-lateral fault slip across Highway 152 apparently triggered by the Loma Prieta earthquake of October 17, 1989. (Base map is San Felipe 7.5-minute topographic quadrangle, USGS, scale 1:24,000.)

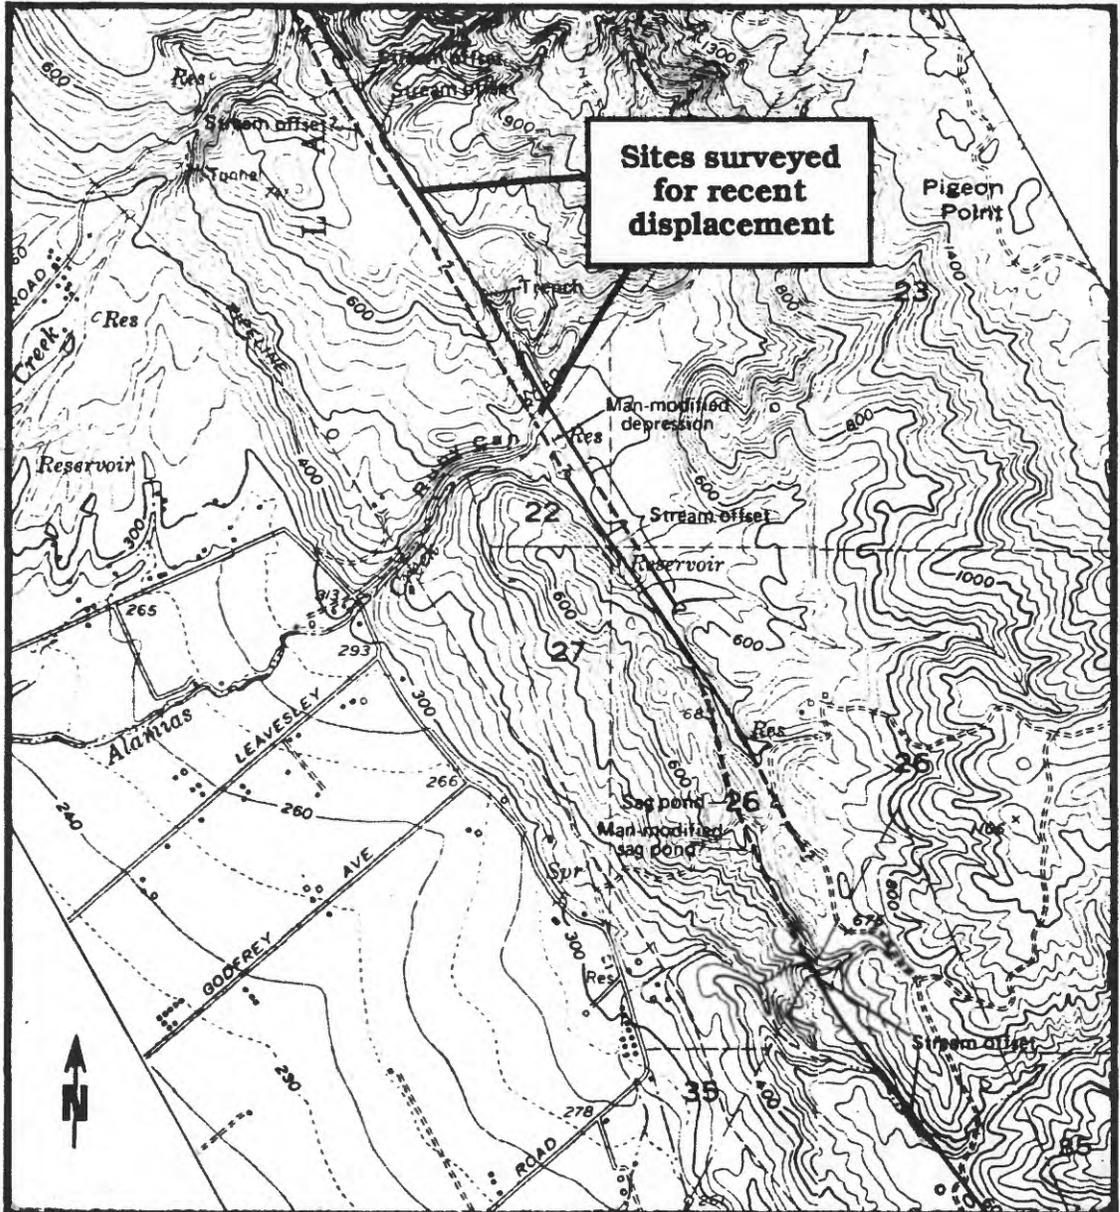
Leavesley Road crosses the Calaveras fault 8.5 km northwest of San Felipe Lake, 0.8 km inside the mouth of Ruby Canyon (Fig. 18). Here a zone of established en echelon shear cracks clearly marks the path of the fault across the old asphalt roadway. On October 21, no fresh parting or evidence of recent propagation of the shear cracks was apparent. However, in the absence of young cultural features athwart the fault trace here, recent displacements would be difficult to discern, especially if they were on the order of a few mm.

FIGURE 18. Location map of Ruby Canyon vicinity southeast of Coyote Reservoir (8.5 km northwest of San Felipe Lake) showing sites along the Calaveras fault zone we investigated for evidence of recent fault slip. (from Radbruch-Hall, 1974; base map is Gilroy 7.5-minute topographic quadrangle, USGS, scale 1:24,000.)

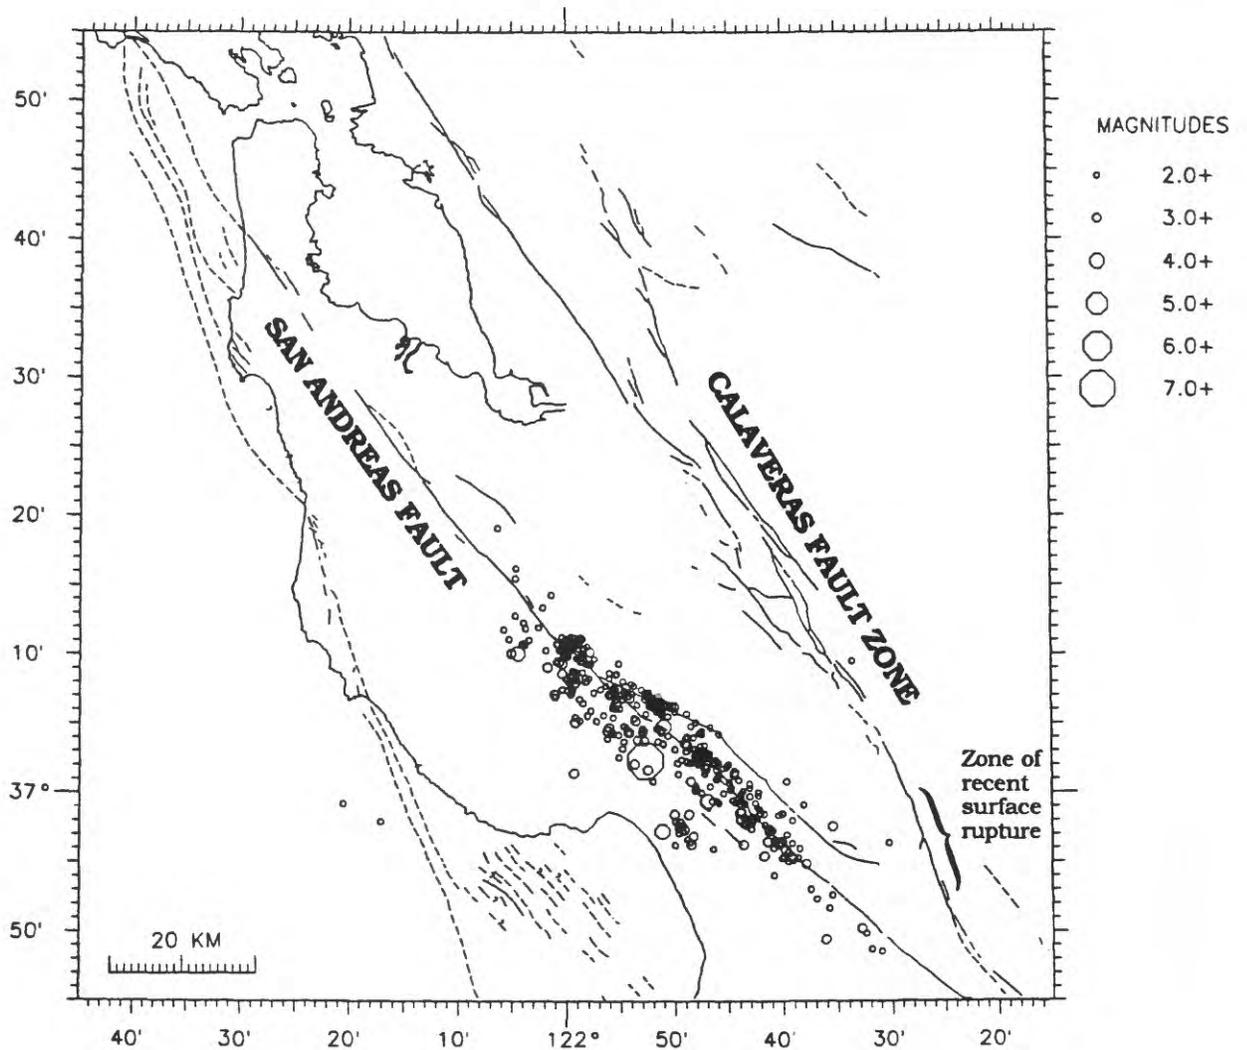
OCTOBER 17-20 1989 M>2.0

It is possible that the displacements we observed resulted from coseismic slip during earthquakes on the Calaveras fault around the time of the Loma Prieta earthquake (*Question 4*). A plot of seismicity from the time of the earthquake on October 17 through October 20 (Fig. 19), however, reveals only one earthquake on the southern section of the Calaveras fault. This event, of M 2.2 on October 20, 1989, about 15 km northeast of San Felipe Lake and 1.7 km deep (Lynn Dietz, USGS, unpublished data), we regard to be too small and too distant from our sites to be significant. Likewise, no earthquakes larger than M 3.0 occurred along the Calaveras fault during the 21 rain-free days ending with the time of our observations (*ibid.*), which

FIGURE 19. Seismicity map of the southern San Francisco Bay region showing M 2 and larger earthquakes from October 17 through October 20, 1989.

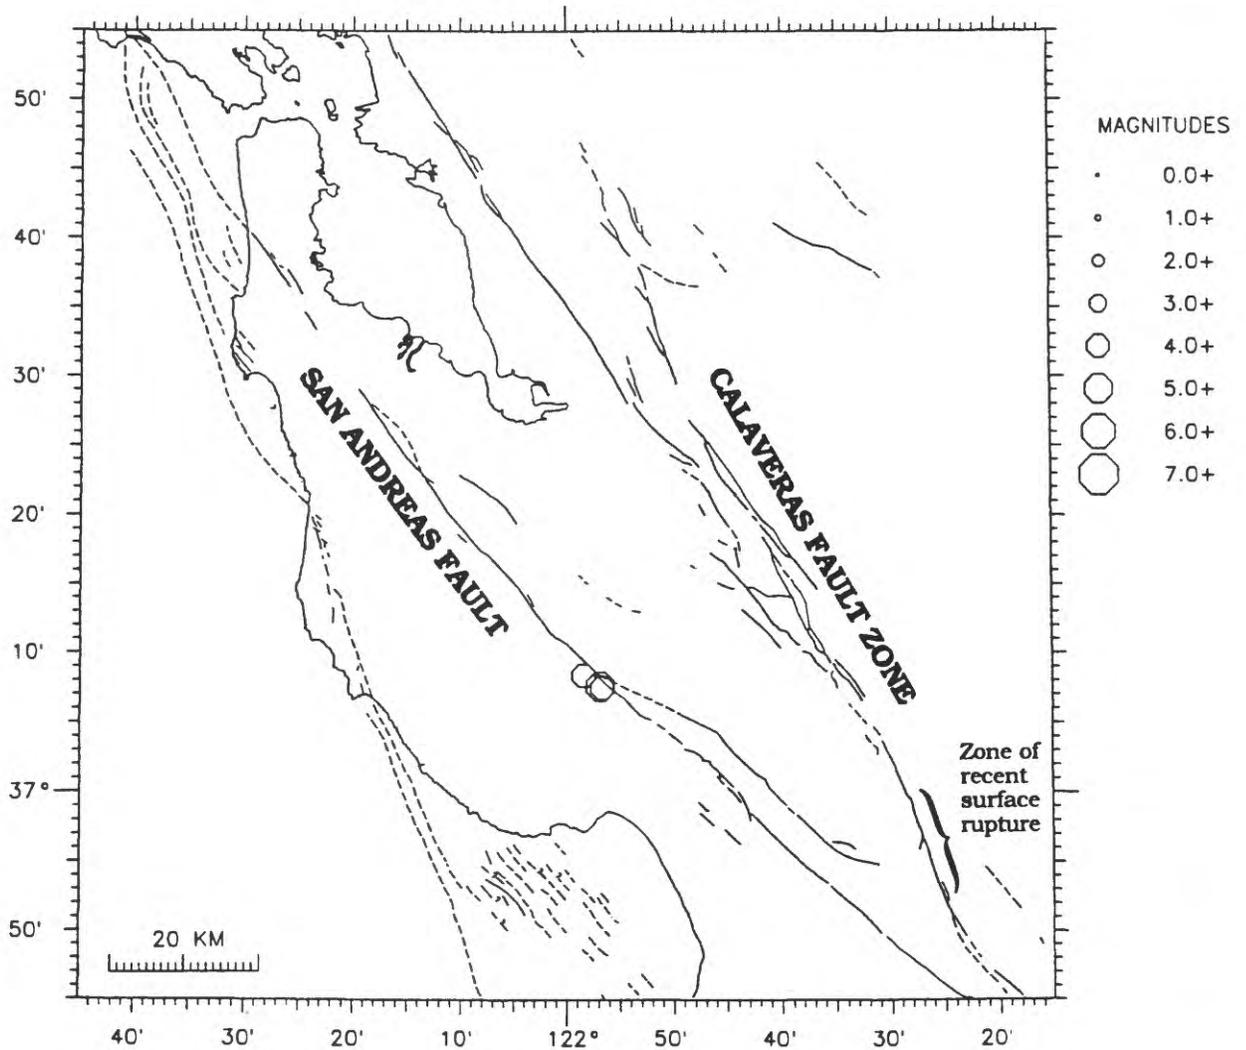
APRIL 4 1989 - OCTOBER 16 1989 M>4.0

FIGURE 20. Seismicity map of the southern San Francisco Bay region showing M 4 and larger earthquakes during the 6 months prior to the Loma Prieta earthquake.
