**DEPARTMENT OF THE INTERIOR
U.S. GEOLOGICAL SURVEY**

**Preliminary isoseismal map for the Santa Cruz (Loma Prieta), California, earthquake of
October 18, 1989 UTC**

Open-File Report 90-18

**National Earthquake Information Center
U.S. Geological Survey
Denver, Colorado**

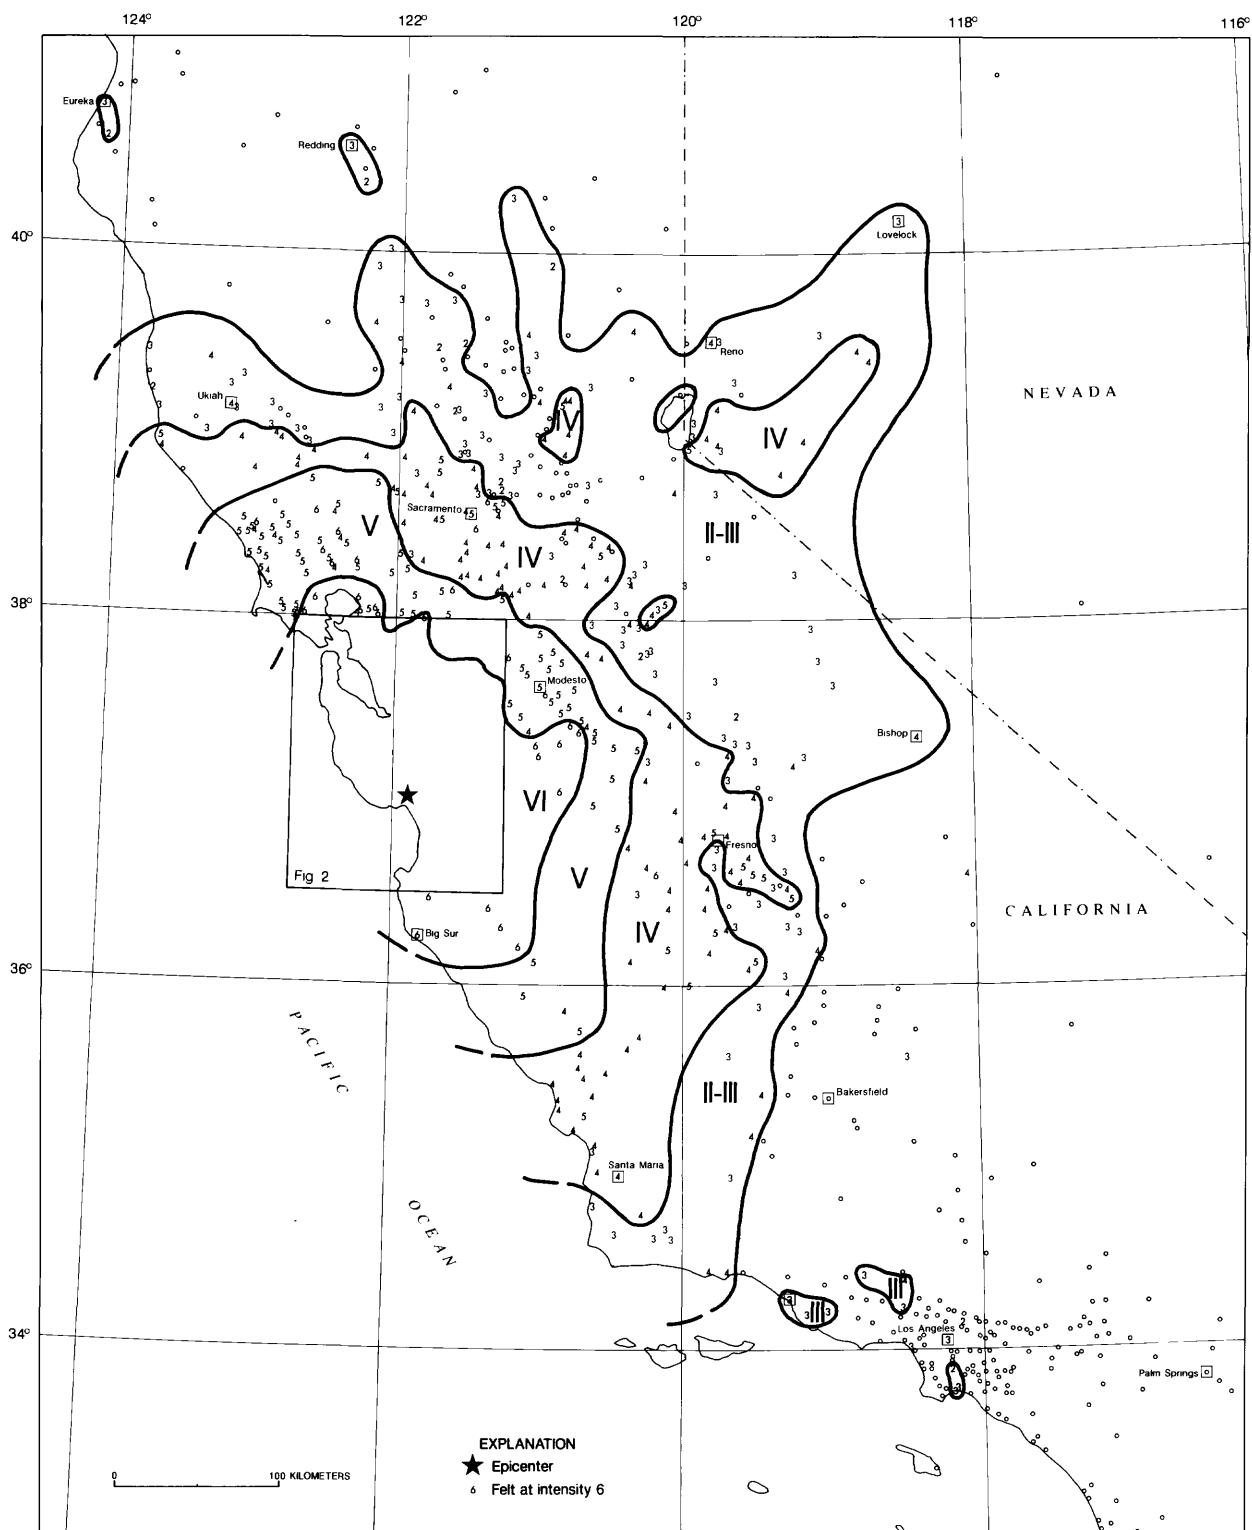
Figure 1 shows the areal distribution of intensities for the 1989 Santa Cruz earthquake. The intensities are based on data from field notes by the authors of this report; mail questionnaires from postmasters, fire and police departments; newspaper accounts; and a damage report provided by the Scotts Valley, California fire district. A final version of the isoseismal map that includes the data used here and the data from many studies that are presently being done will be published in the USGS Bulletin "United States Earthquakes, 1989".

The MMI II-III isoseismal that defines the limit of perceptibility in figure 1 is drawn to enclose contiguous localities that felt the earthquake. The contiguous felt area extends northward from Santa Barbara along the California coast to Fort Bragg and eastward to Lovelock, Nevada. This felt area, approximates 170,000 km² on land, is less than one third the size of the land felt area of the 1906 earthquake, which was about 550,000 km². On figure 1, isoseismals have been drawn around outlying areas near Eureka and Redding to the north and in the Los Angeles-Ventura region to the south.

On Figure 1, the MMI VI isoseismal outlines 22,000 km² of land area in California which encompasses the region associated with damage to structures. This damage ranges from minor (broken windows, cracked chimneys, cracked plaster, etc.) to severe (collapsed freeways, destroyed buildings, buildings rendered uninhabitable, buildings thrown off foundations, etc.). The dollar damage estimated by the State of California, Governor's Office of Emergency Services as of November 21, 1989 for the Santa Cruz earthquake is in excess of \$6 billion in property damage (Plafker and Galloway, 1989).

Figure 1. Iseismal map for the Santa Cruz (Loma Prieta), California, earthquake of October 18, 1989 UTC.

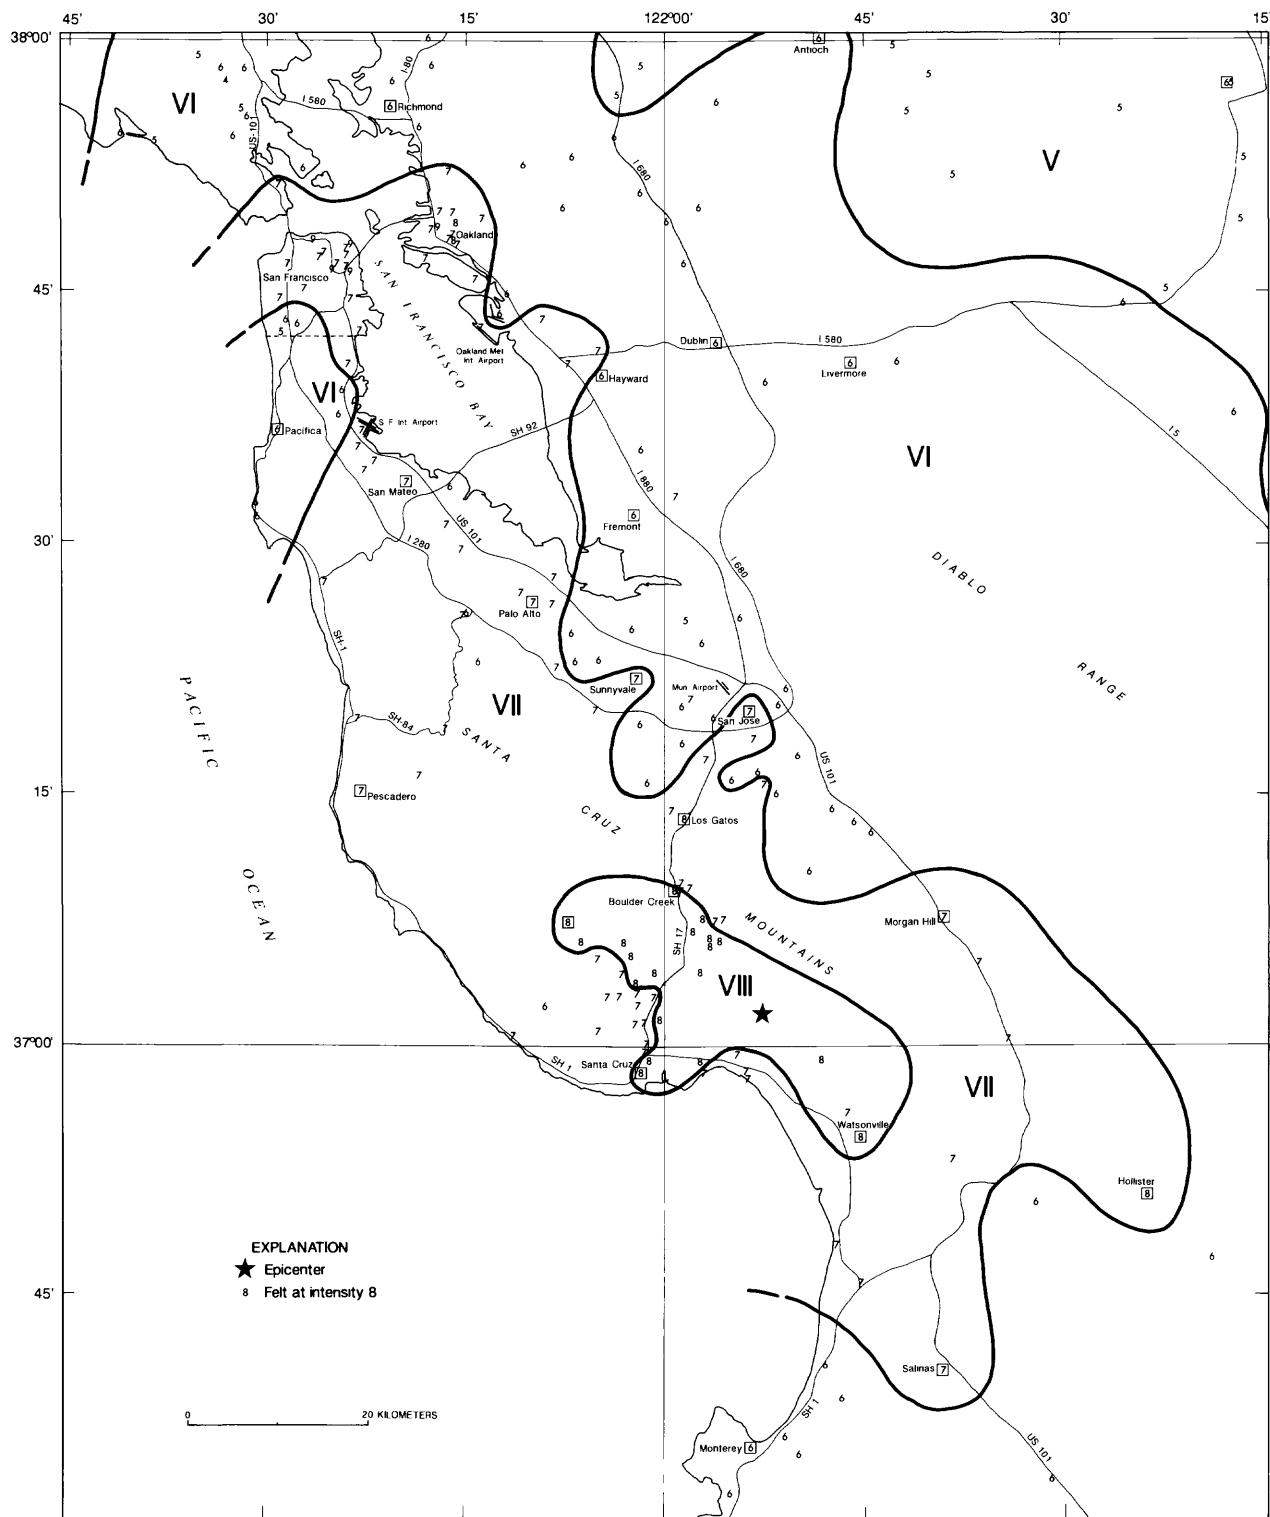
Figure 2 shows the distribution of intensities from the San Francisco Bay area south to Monterey. The maximum intensity shown on the map is MMI IX in parts of San Francisco and in Oakland, as mentioned in the introduction. The MMI IX and MMI VIII values are anomalous and represent small areas of damage; no MMI IX or MMI VIII isoseismals are drawn.

The maximum intensity in the epicentral area is MMI VIII as shown in figure 2. The area enclosed by the MMI VIII isoseismal is in close alignment with the fault-plane orientation of N.50°W. $\pm 8^\circ$. The NW-SE elongation of the MMI VIII isoseismal includes the length of the inferred fault

rupture that extends from State Highway 17 southeastward to the vicinity of Watsonville (Plafker and Galloway, 1989).

The general configuration of the MMI VII (fig. 2) isoseismal encompasses most of the region west and south of San Francisco Bay southward to Monterey Bay. The southwestern part of San Francisco County and the northern area of San Mateo County, that lies west of the San Francisco International Airport, is outlined by the MMI VI isoseismal.

Figure 2. Isoseismal map for the San Francisco Bay region for the Santa Cruz (Loma Prieta), California, earthquake of October 18, 1989 UTC.
