Department of the Interior  
U.S. Geological Survey

EFFECTS OF THE LOMA PRIETA EARTHQUAKE  
ON THE MARINA DISTRICT  
SAN FRANCISCO, CALIFORNIA

OPEN-FILE REPORT 90-253

April 20, 1990

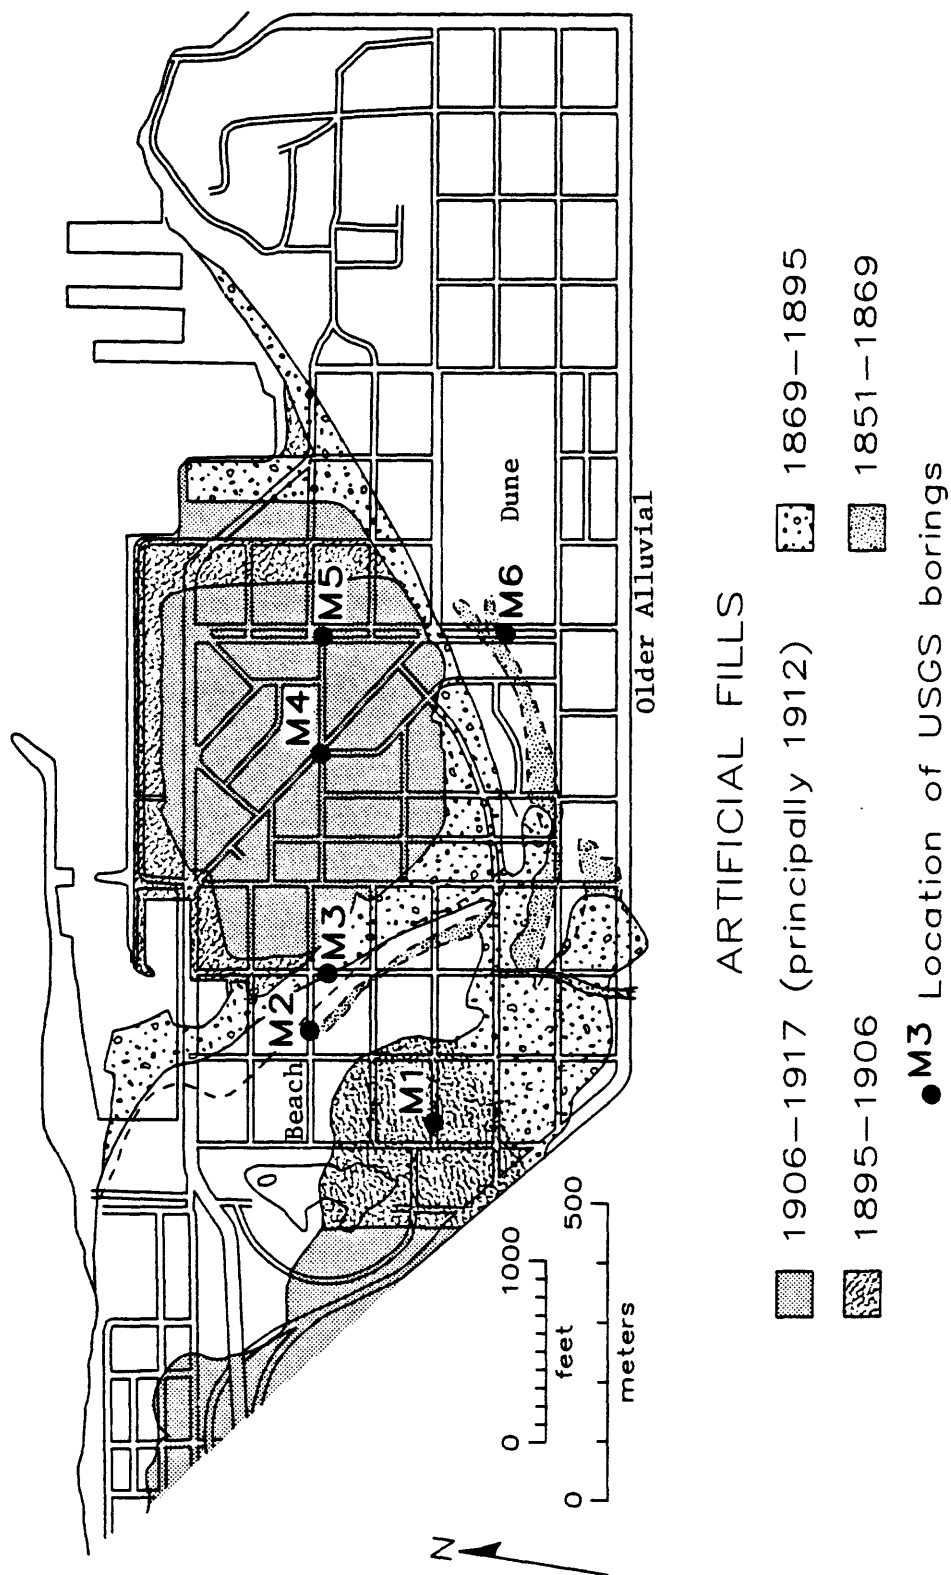
Figure 1. Map shows the general locations of the geologic units (the older alluvial deposits are generally south of Lombard St) and the location of the different fills used to reclaim the Marina district. The central fill area is referred to as Marina Cove.

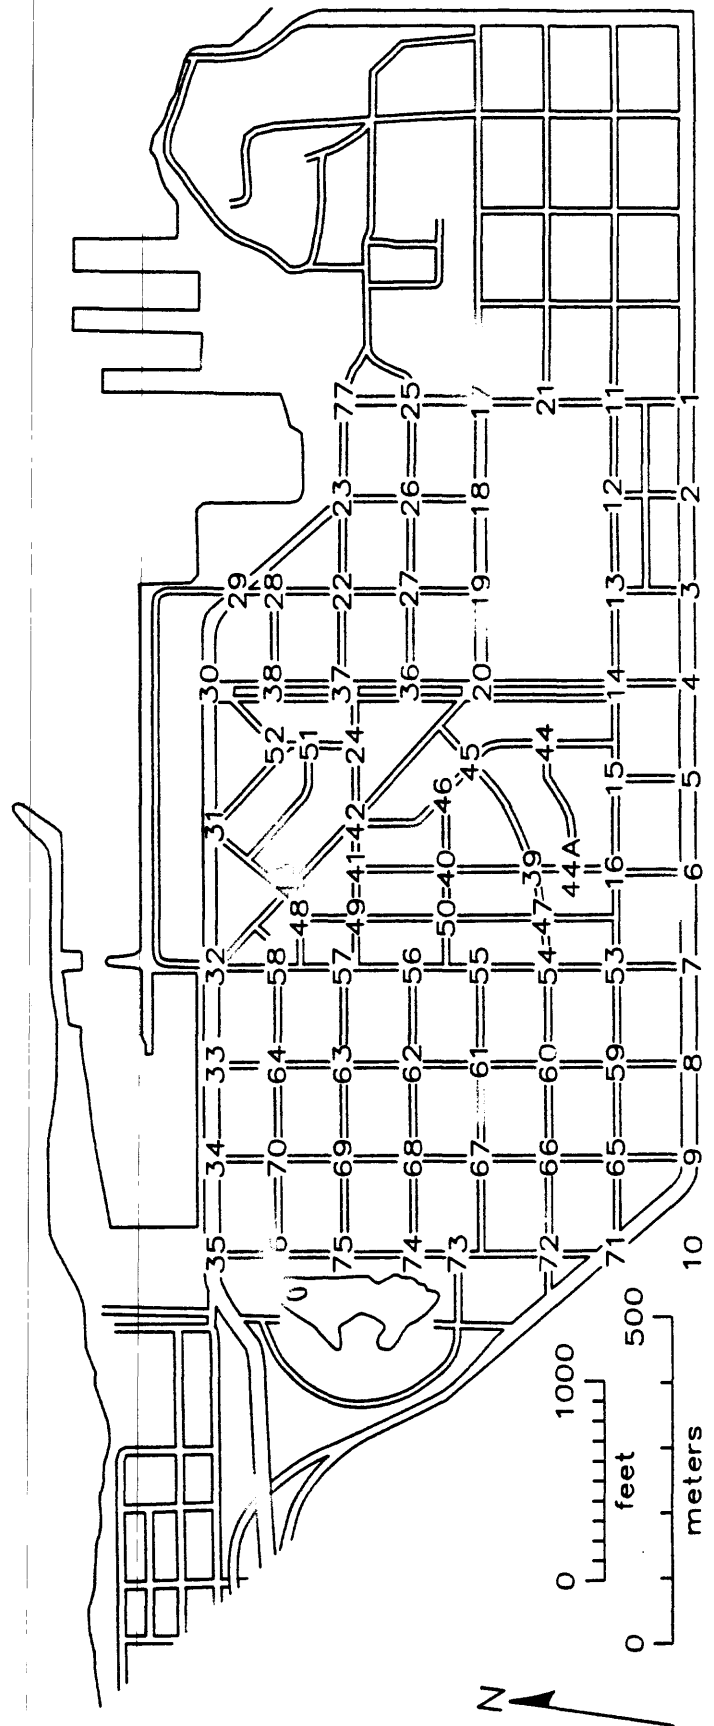
# LOCATION OF SURVEY STATIONS

A second order, class 1 leveling survey was conducted, by a US Geological Survey team, in the Marina to measure the vertical settlements caused by the earthquake. The location of the leveling stations is shown in figure 9. The intersection of Lombard and Laguna was assumed to be stable for computational purposes. Vertical settlement is the difference in elevation from a survey conducted in 1974 and the present survey. For the purpose of this report the settlement that occurred during 1974-1989 is referred to as "post-earthquake" settlement, the settlement that occurred during this time interval is not solely a result of the Loma Prieta earthquake. Settlement may be caused by consolidation of the fill and/or secondary compression of the bay mud.

Figure 9. Location of survey stations. A description of settlement at the stations is given in Appendix C.

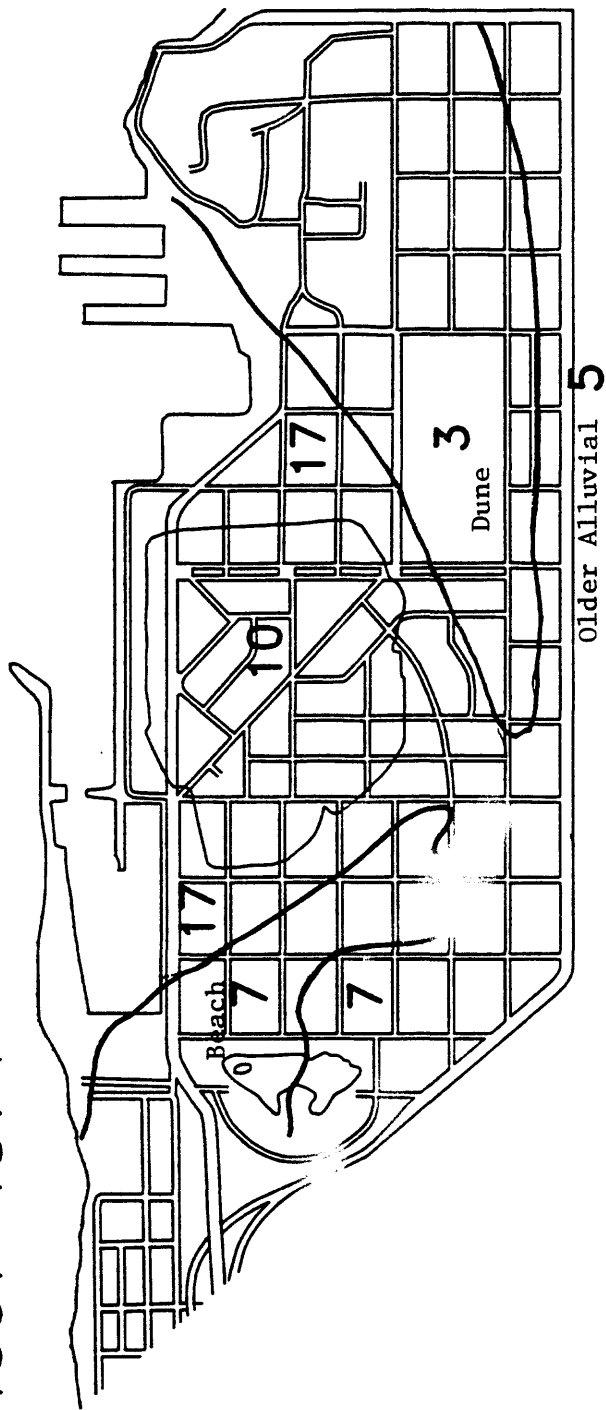
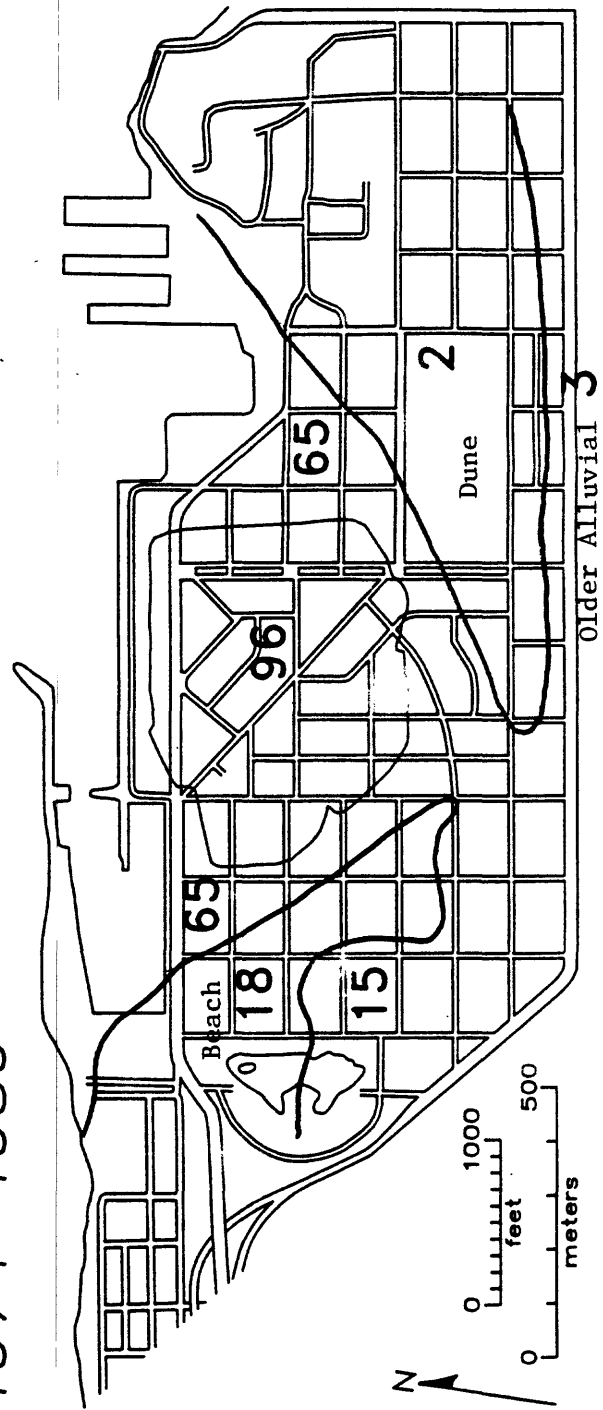
Magnitudes of settlement within the district correlate well with the geologic units (fig. 11). The average settlement for the different deposits before and after 1974 is shown in figure 11. The ratio between settlement in 1974-1989 and 1961-1974 is shown in figure 12 and Table 3. The natural deposits (dune, beach, and older alluvium) typically settled between 3 and 7 mm prior to 1974. After 1974 the range in average settlement of the natural deposits was 2 to 18 mm. In terms of settlement the fill is divided into three groups; a central fill (1869-1895), a southwestern fill (1895-1906), and the post-1906 Marina Cove fill. Except for the dune and older alluvial deposits all units showed greater settlement in the period 1974-1989 than the period 1961-1974. The difference as shown by the ratio of post 1974 settlement to pre 1974 settlement indicates that the increase of settlement was not uniform. The post-1906 fill showed almost 9 times more settlement after 1974 than before 1974 whereas the western fill showed less than twice as much settlement. Profiles along Divisadero (fig. 13) and Beach Streets (fig. 14) show that different magnitudes of settlement are associated with different geologic units. The hydraulic fill of the Marina cove is associated with the greatest magnitude of settlement.

Figure 11. Average Settlement between the years 1961-1974 and 1974-1989.

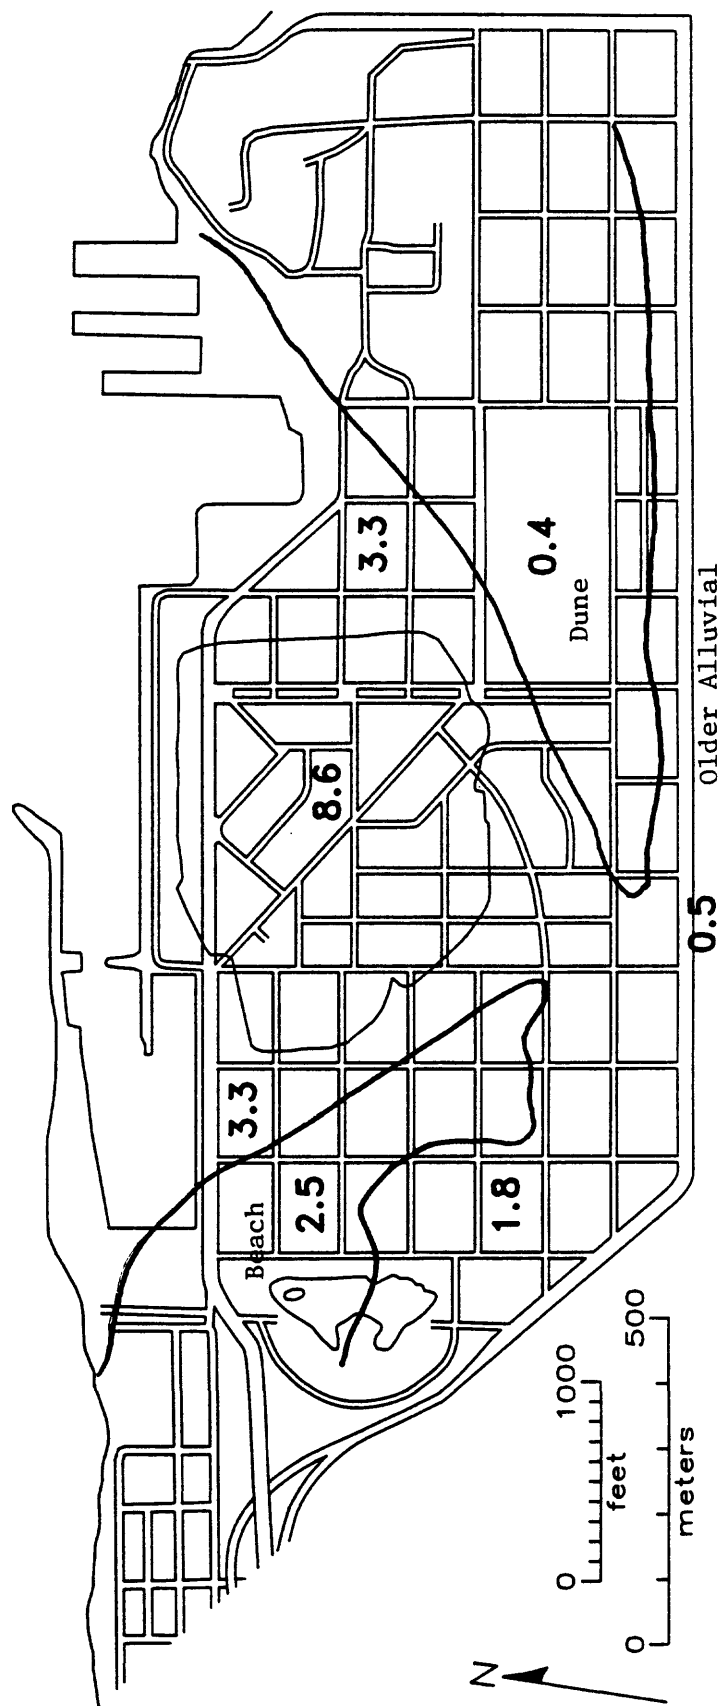
Figure 12. Ratio of 1974-1989 settlement to 1961-1974 settlement. Ratios less than one indicate more settlement took place before 1974 than after 1974.

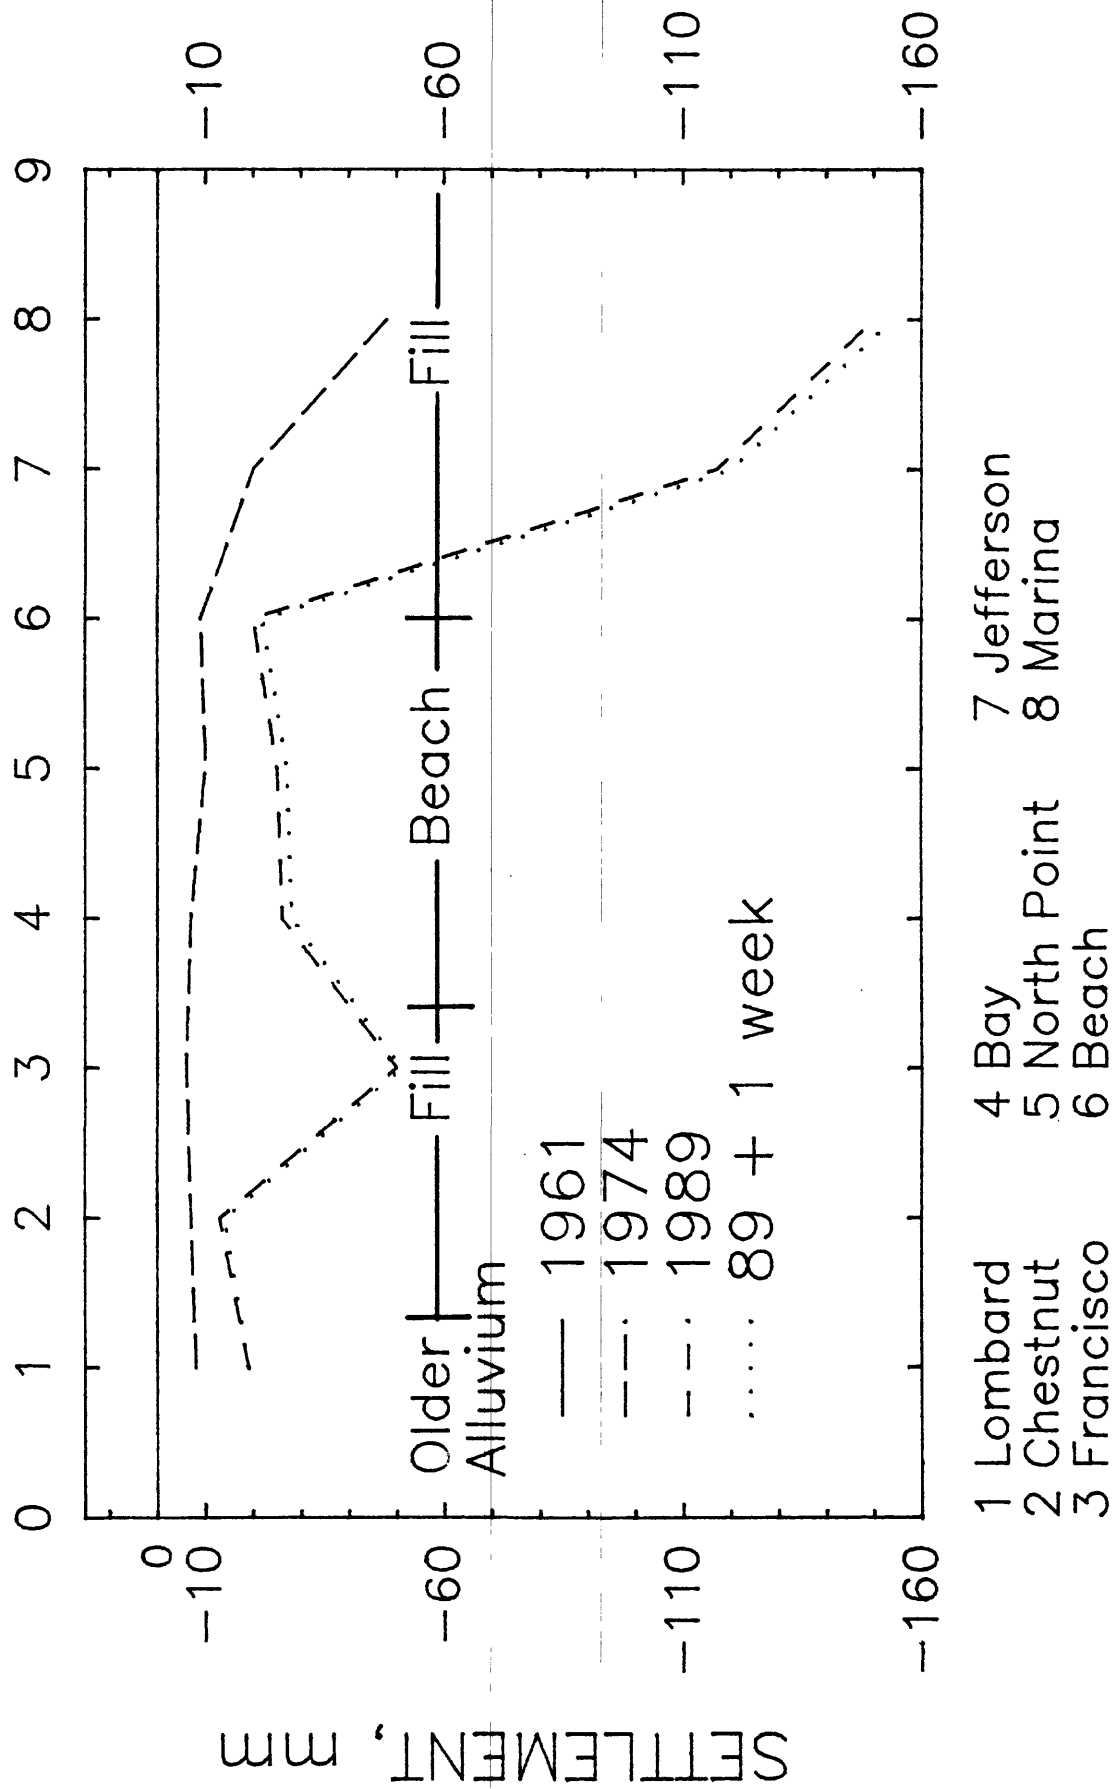
# Settlement along Divisadero

Figure 13. Settlement along Divisadero for three time intervals, 1961-1974, 1974-1989, and a one week period in November 1989.

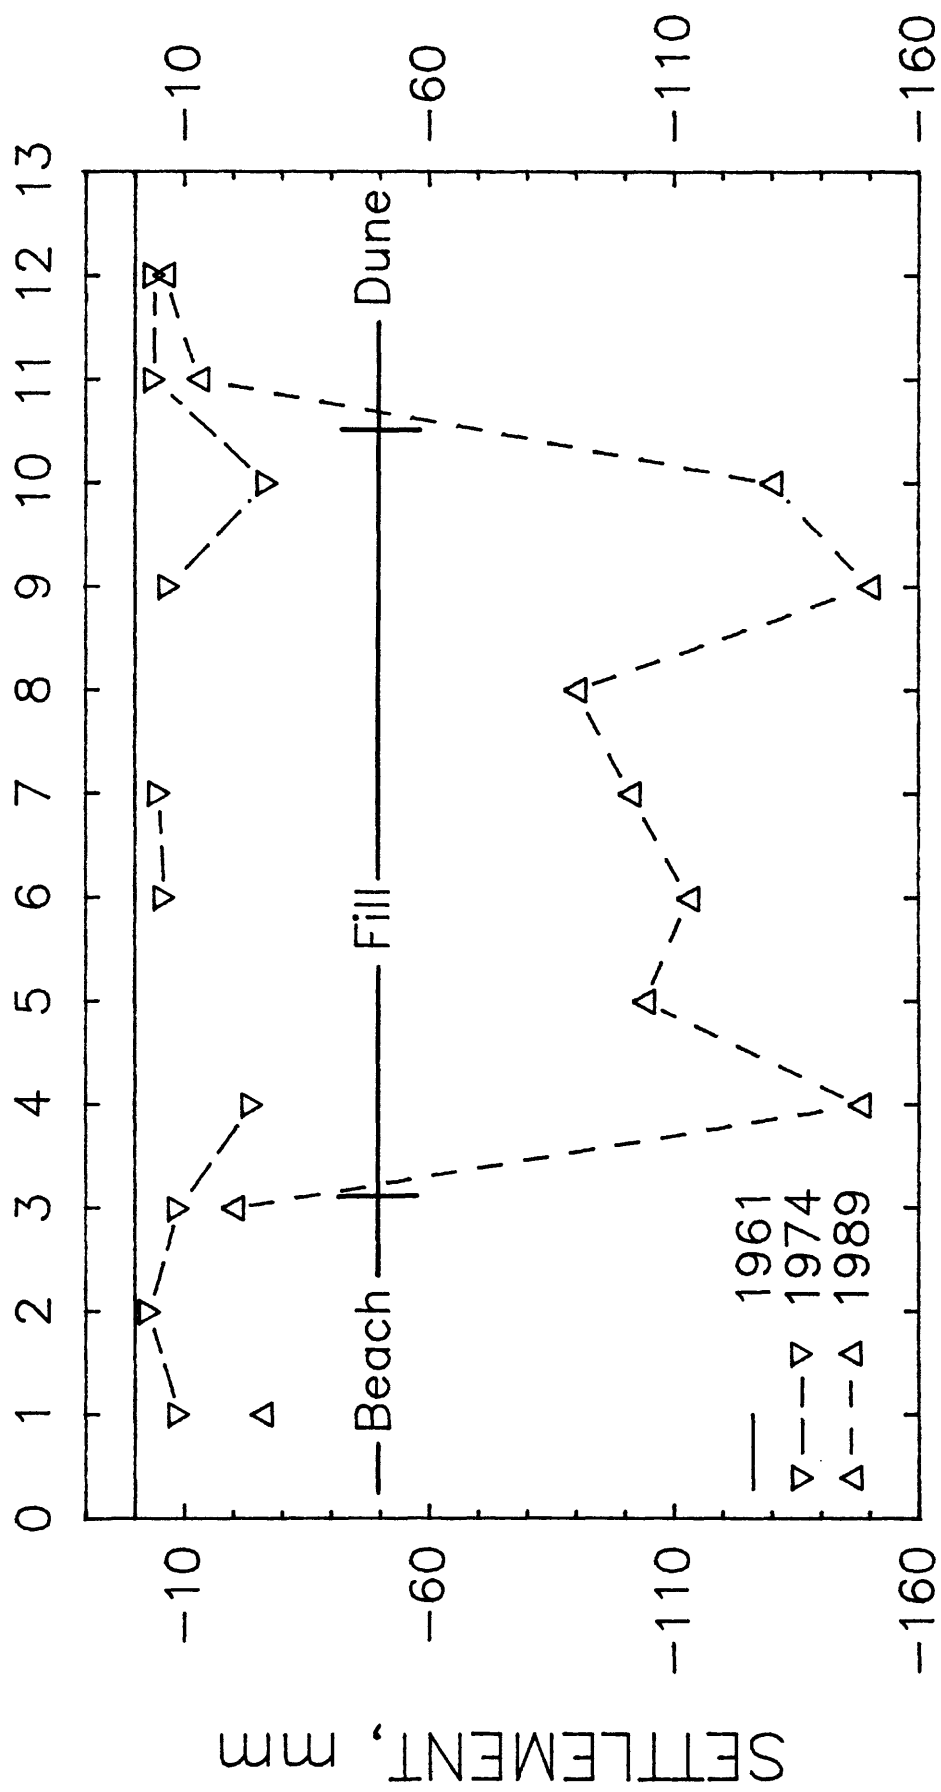
# Settlement along Beach St.

Figure 14. Settlement along Beach St. for the time intervals, 1961-1974, and 1974-1989. Avila and Retiro were not surveyed in 1961.

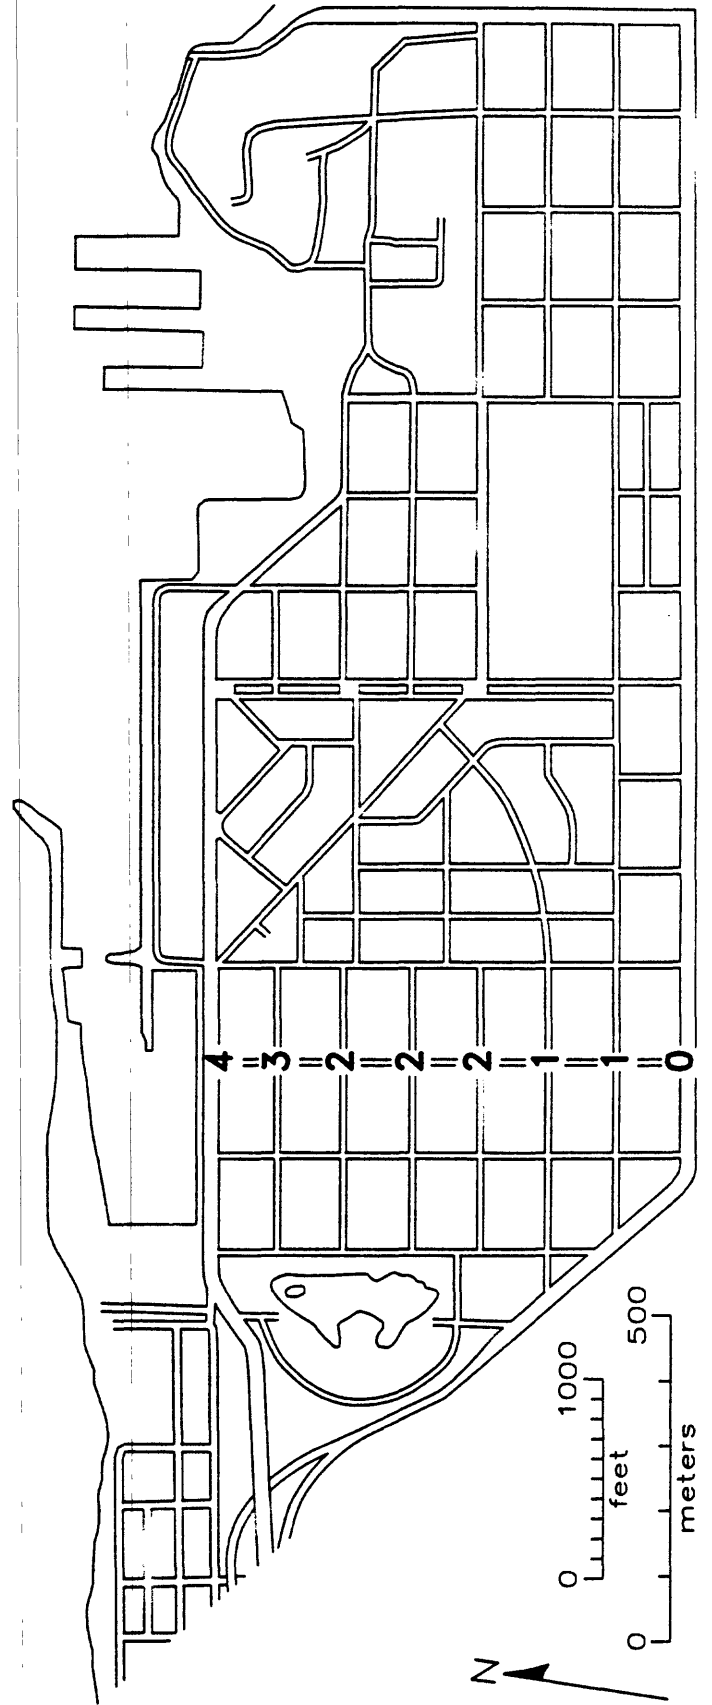
Two leveling surveys along Divisadero were made one week apart (November, 10-17). Holding the Lombard station as constant, settlement increases uniformly northward, at Marina Blvd the one week difference is 4 mm (fig. 15). Although the changes are small they are not random (written communication, A. Okamura, 1989).

Figure 15. Difference in elevation along Divisadero between November 10-17, 1989.

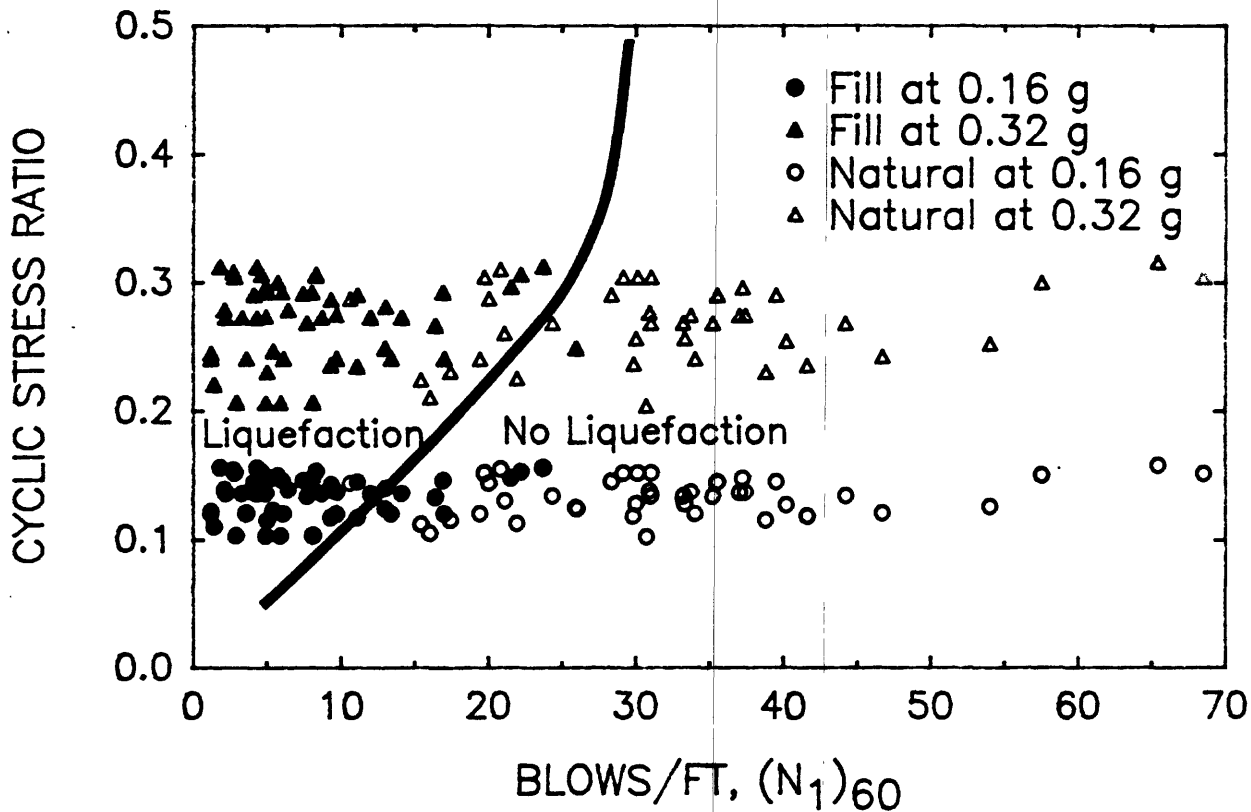
Figure 17. Liquefaction resistance chart using data from Dames and Moore (1976 and 1977) and USGS (this report). The fill, mostly hydraulic fill from Marina Cove, has a very low resistance to liquefaction at accelerations between 0.16 and 0.32 g. The natural deposits have a high resistance to liquefaction at an acceleration of 0.16 g, at the higher acceleration of 0.32 g the liquefaction resistance of some of the natural deposits is low. The line represents the boundary between liquefaction and no liquefaction for a M 7.1 earthquake.

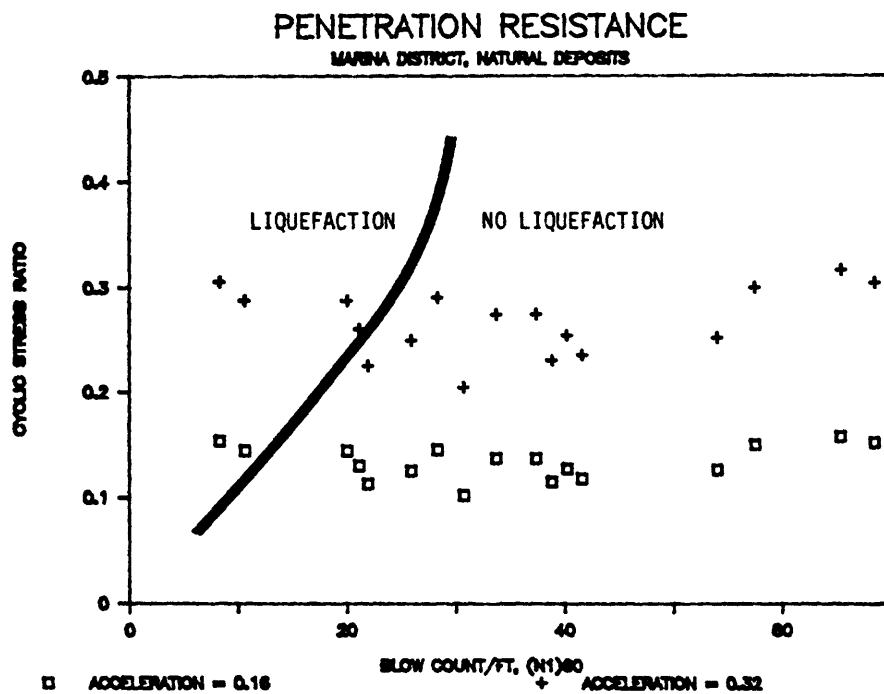
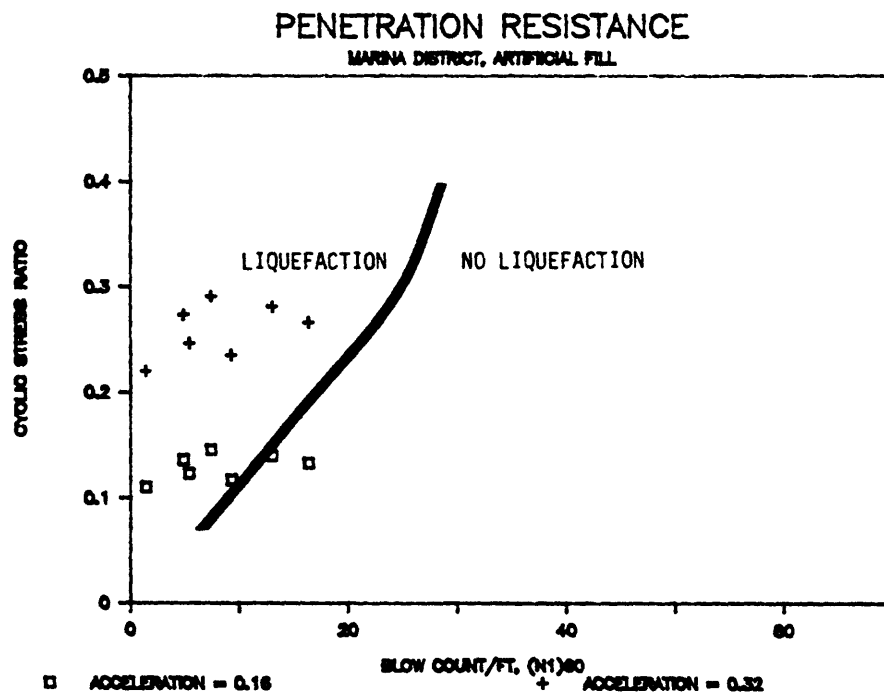
Figure 18. Liquefaction resistance chart using data from the USGS. This data confirms the Dames and Moore (1976 and 1977) data that show the fill has a very low resistance to liquefaction, whereas the natural deposits have a moderate to high resistance to liquefaction.

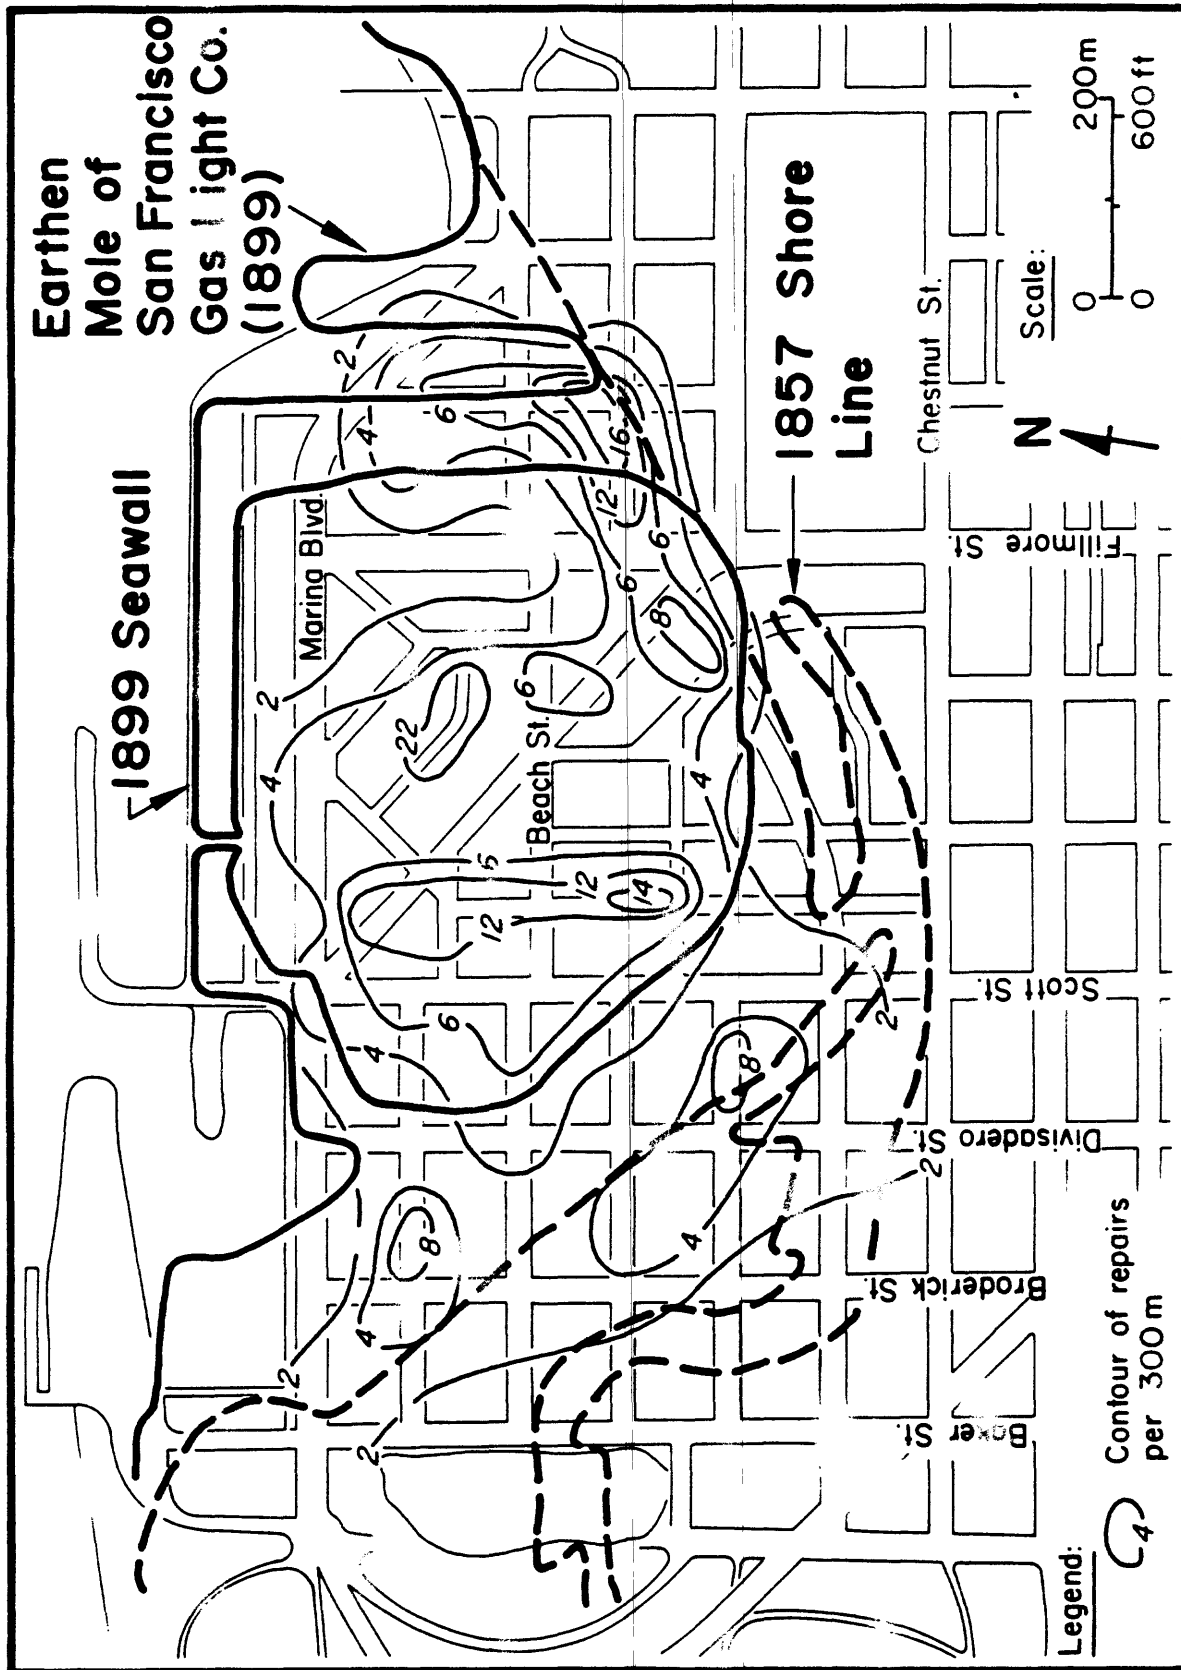
The inferred area of liquefaction is supported by a study of pipeline breakage within the Municipal Water Supply System by T.D. O'Rourke and B. L. Roth, "Performance of Pipeline Systems in the Marina." Most of the repairs were concentrated within the area of hydraulic fill (O'Rourke and Roth, Fig. 1), the area where most liquefaction-induced ground deformation occurred.

Figure 2. Contours of repairs to the Municipal Water Supply System per 300 m of pipeline.

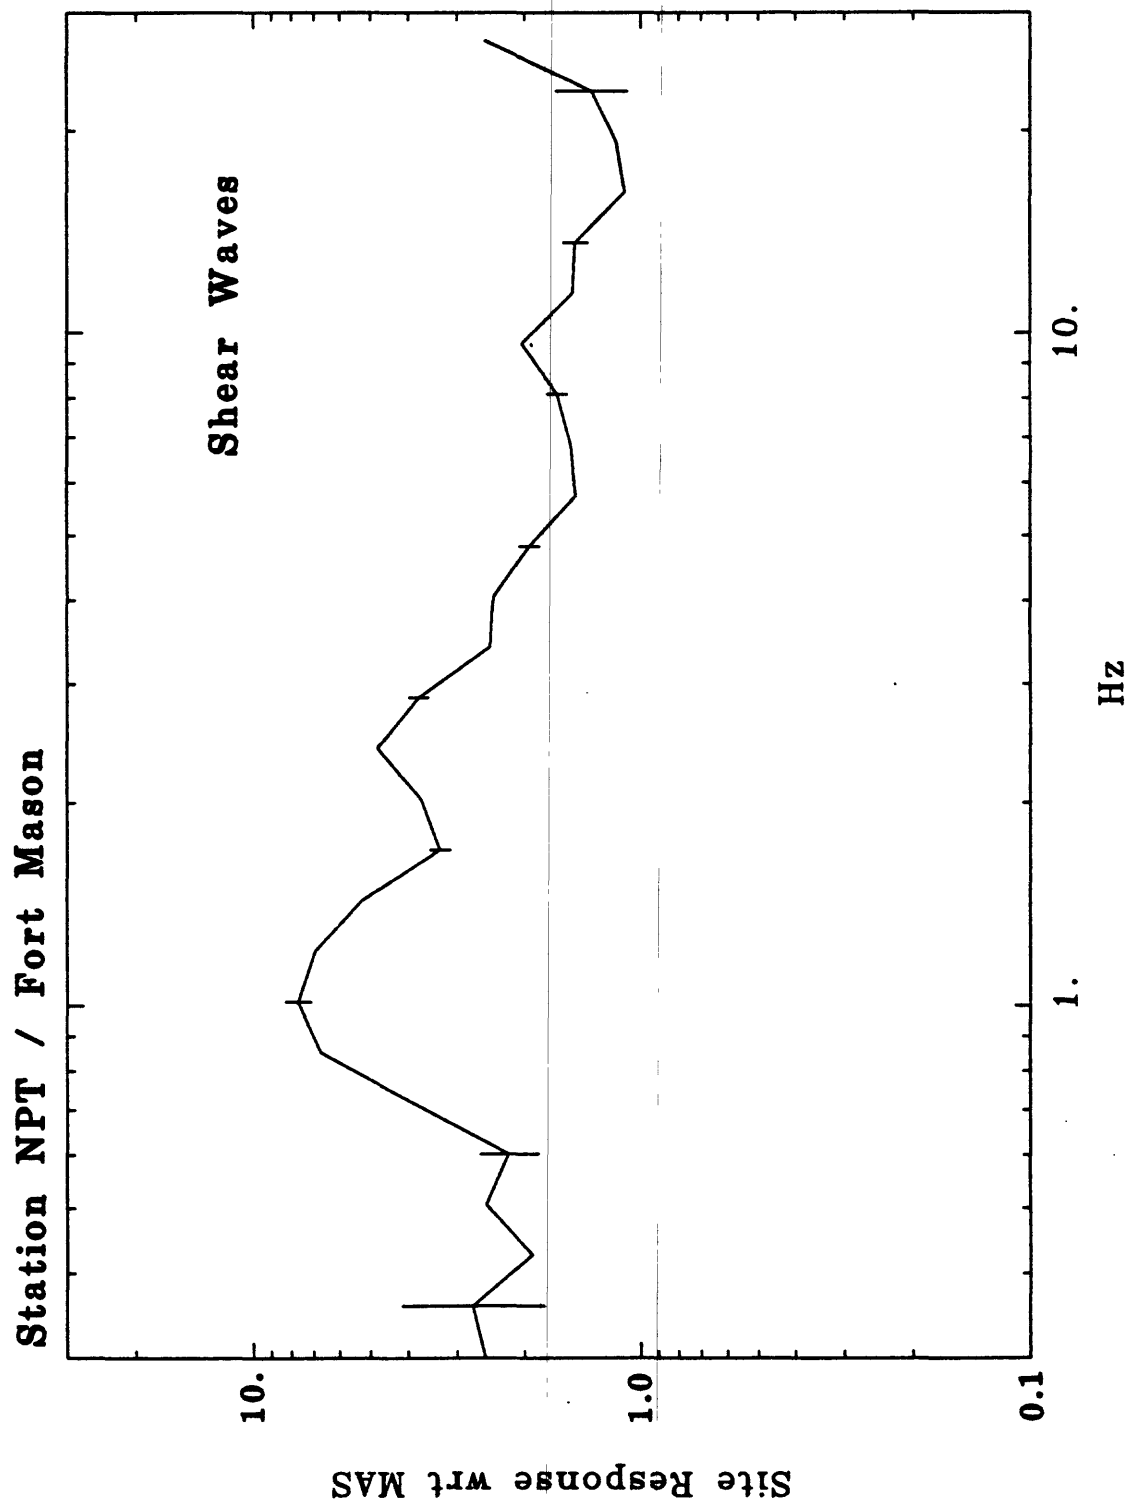
Figure 5 shows the site response of station NPT relative to station MAS; station NPT is located near the corner of North Point and Divisadero in an area which suffered significant damage during the main shock. The relative site response is well determined within the frequency band from 0.6 Hz (1.6 s) to 15 Hz. The site response is amplified by a factor of 7 near 1 Hz and decreases gradually with increasing frequency up to 15 Hz. At the lowest frequencies, the amplification is approximately a factor of 2.

Figure 5. Site response spectrum for station NPT, relative to station MAS. The vertical bars show the 85% confidence interval for the spectral estimates. The relative site response is well determined from 0.7 to 15 Hz. At low frequencies, the relative amplification is slightly larger than a factor of 2. The amplification peaks around 1 Hz and decreases gradually with increasing frequency until 15 Hz, where the amplification  $\approx 1$ .

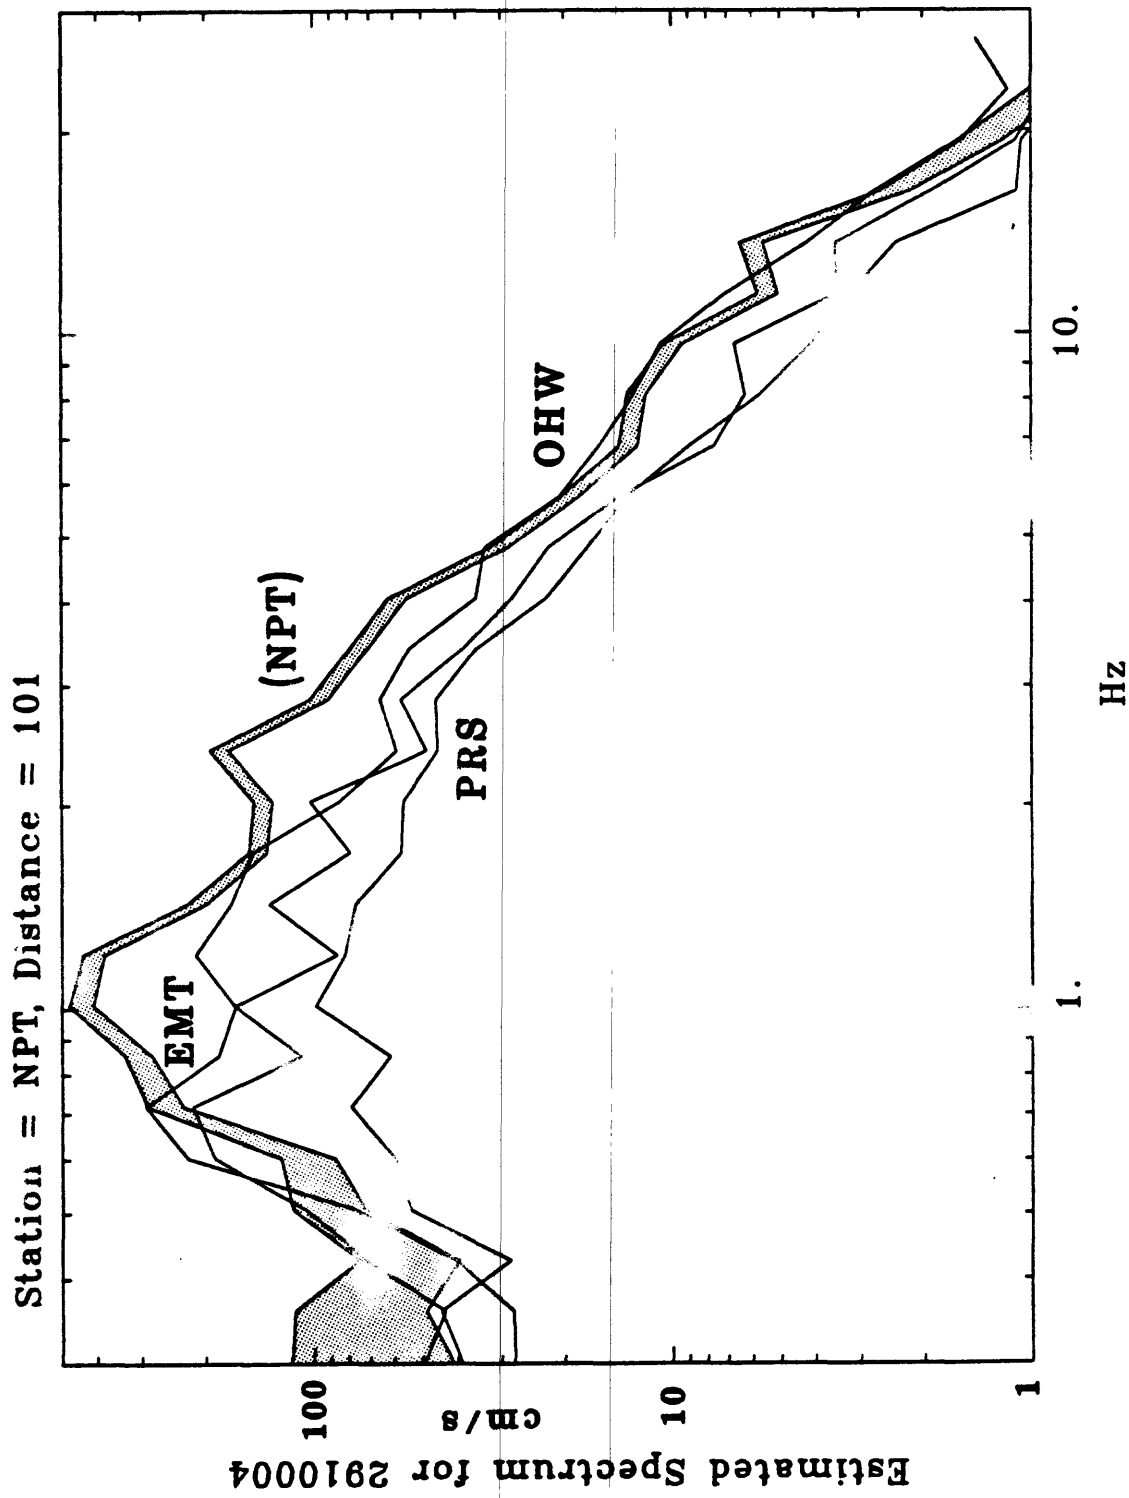
The extrapolated acceleration spectrum for station NPT is plotted in Figure 9 using 85% confidence limits. As plotted in Figure 5, the amplification for station NPT has a broad peak at 1 Hz and a "side lobe" at 2.3 Hz; these peaks are clearly evident in the extrapolated acceleration spectrum. The acceleration spectra from three accelerographs which recorded the main shock are also plotted in Figure 9. The spectrum labelled PRS was obtained from an accelerogram recorded  $\approx 1.5$  km to the southwest of the Marina in a small building on the Presidio Golf Course. The spectrum labelled EMT was obtained from free-field accelerograph in Emeryville. Finally, the spectrum labelled OHW was obtained from an accelerograph at the Outer Harbor Wharf in Oakland which recorded the largest accelerations of any site located north of the San Francisco Airport.

Figure 9. Comparison of the extrapolated acceleration spectrum for the main shock at station NPT with the recorded acceleration spectra from three accelerograph sites. The extrapolated spectrum is plotted as a shaded region. Station PRS is located on the Presidio Golf Course, Station EMT is in Emeryville, and station OHW is at the Outer Harbor Wharf in Oakland. These three accelerographs recorded peak accelerations of 21%, 25% and 29% g, respectively.

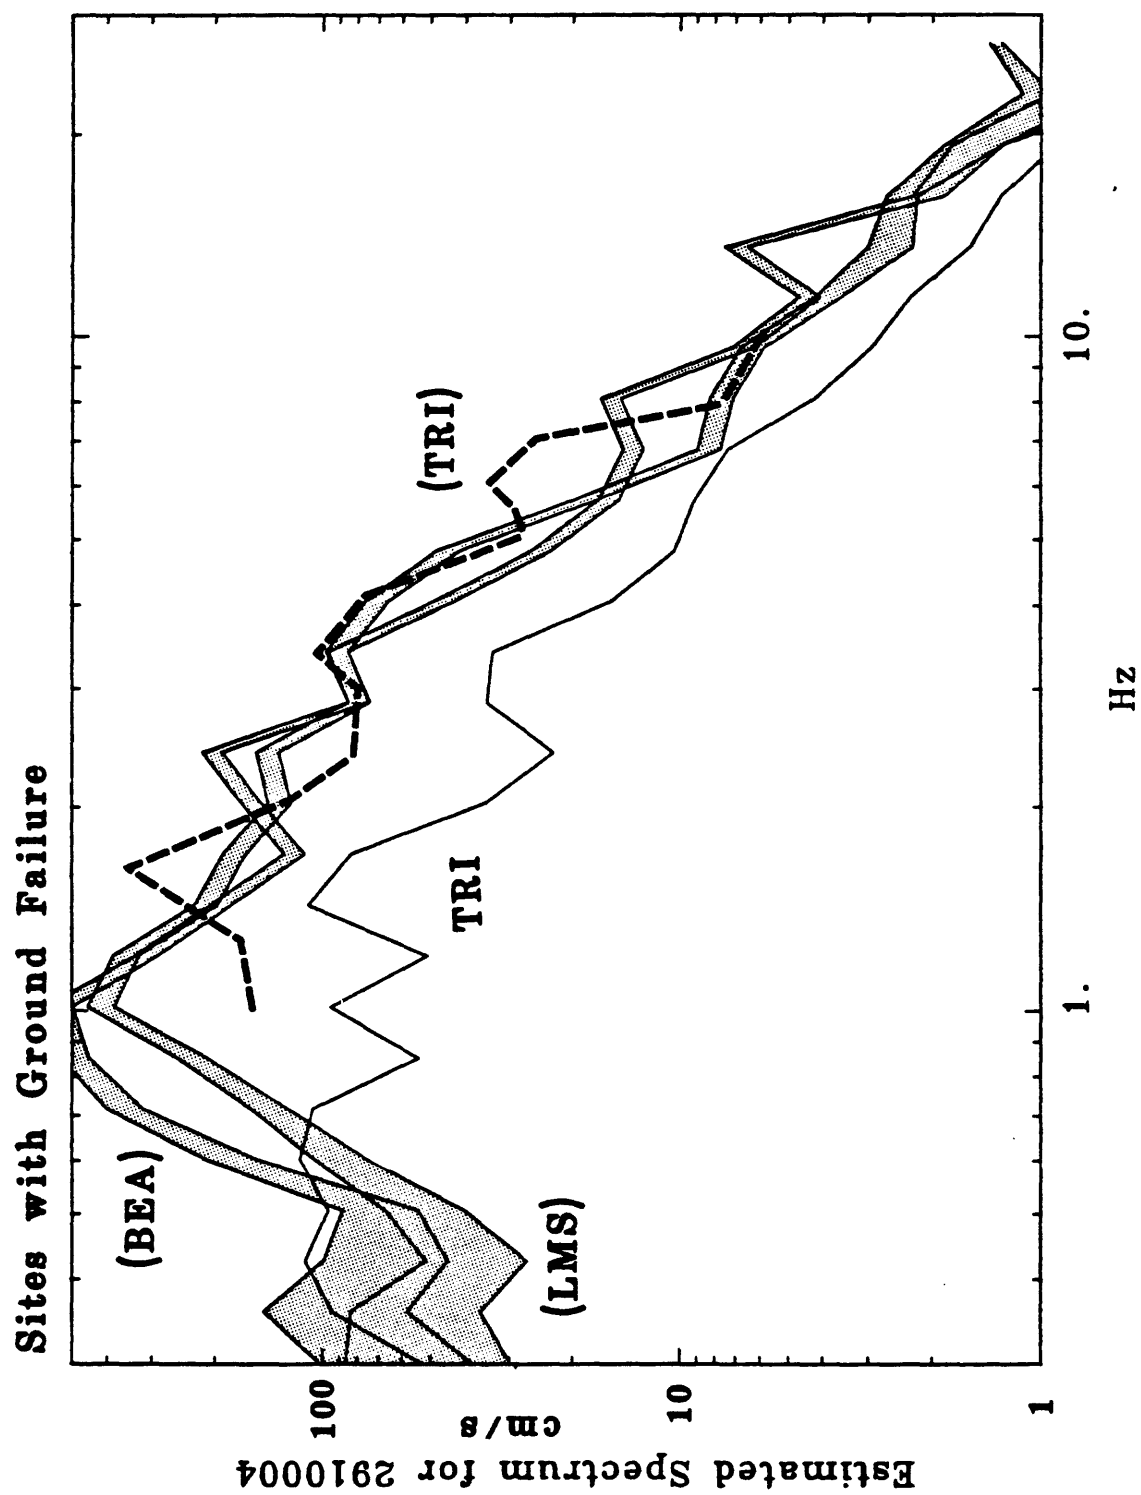
Figure 10 shows the extrapolated spectra for the main shock at two sites located on the 1912 hydraulic fill in the Marina, stations BEA and LMS. As in Figures 8 and 9, these extrapolations are plotted using 85% confidence intervals. The spectrum labelled TRI was obtained from the accelerogram recorded on Treasure Island which had a peak ground acceleration of 16% g. Hanks (oral communication, 1990) has suggested using this accelerogram as an analog for the ground motion in the Marina. The thick dashed line is an extrapolation for the main shock ground motions at Treasure Island, obtained from the relative amplification of the station TRI to the Yerba Buena Island site (station YBI) determined from recordings of seven aftershocks by Jarpe et al. (1990) and the spectrum of the main shock recorded at station YBI.

Figure 10. Comparison of the extrapolated acceleration spectra for two sites within the 1912 hydraulic fill with an extrapolated acceleration spectrum for station TRI (heavy dashed line), located on Treasure Island, as determined from the relative amplification of the NS component of motion for seven aftershocks, and the main shock recording at station YBI on Yerba Buena Island. The recorded acceleration spectrum for station TRI is about a factor of three less than the extrapolated spectra.
