Department of the Interior  
U.S. Geological Survey

EFFECTS OF THE LOMA PRIETA EARTHQUAKE  
ON THE MARINA DISTRICT  
SAN FRANCISCO, CALIFORNIA

OPEN-FILE REPORT 90-253

April 20, 1990

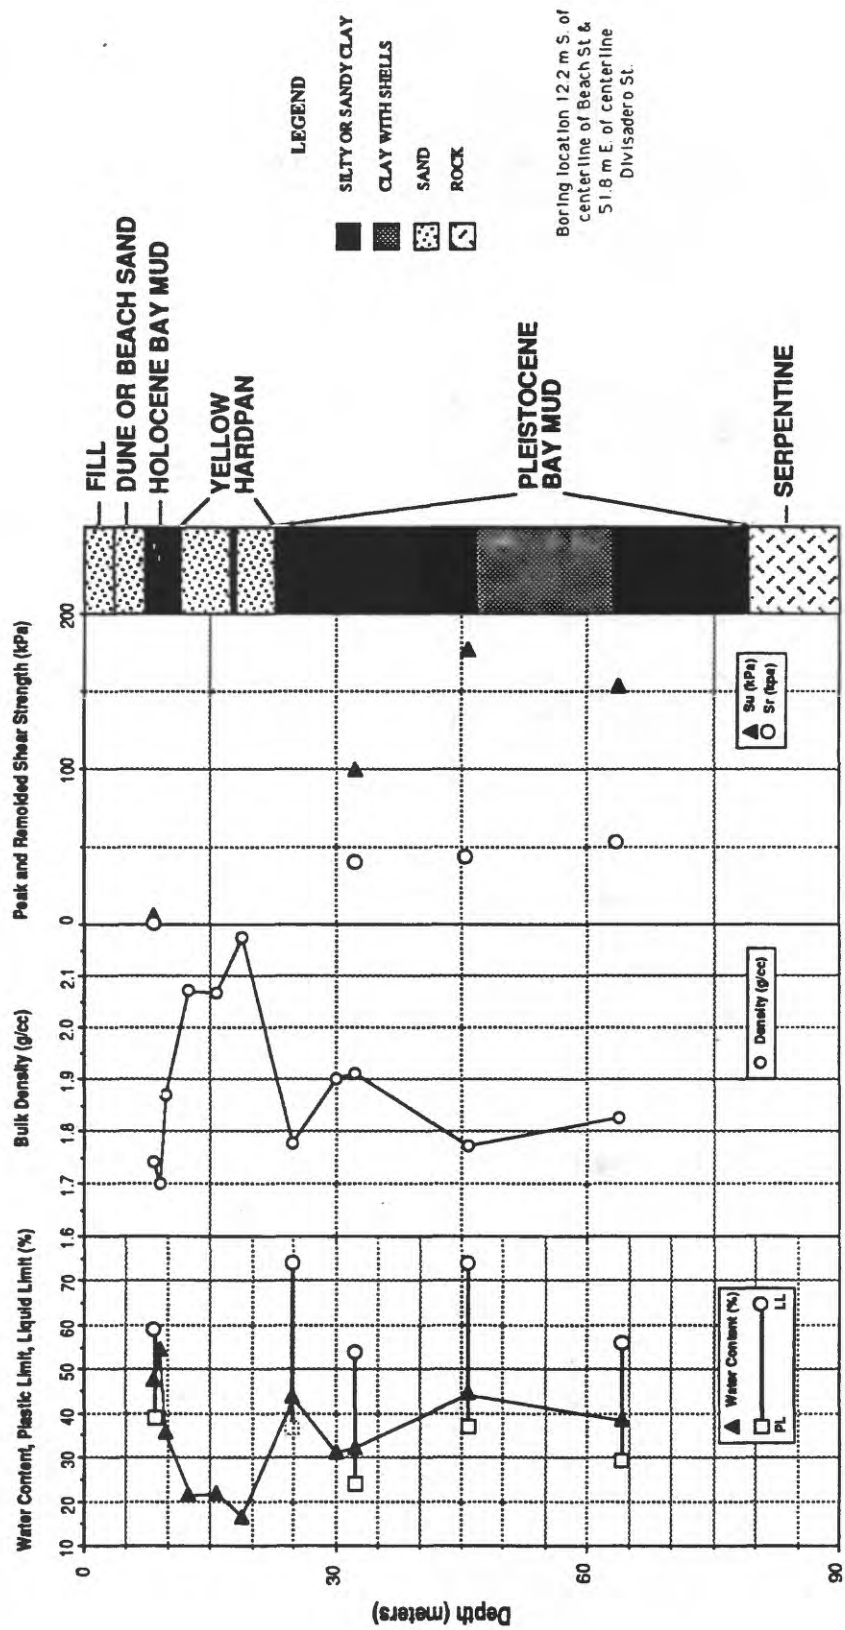
The stratigraphic sequence found at the Winfield Scott School site is presented as Figure 2; descriptive detail is given in Table 1. Stratigraphic units were defined from field observations of soil cuttings combined with samples listed in Table 1.

The soil column at the USGS boring site consists of 4.3 meters of filled sand overlying another 3.5 meters of (natural?) sand deposits. Below is an interbedded sequence of clayey-sand and clay to a depth of 11.6 meters interpreted to be the base of Holocene Bay Mud. The "Yellow hardpan", noted in the 1912 boring logs, is actually a layer of dense sand lying between 11.6 and 22.9 meters and is characterized by a distinct yellow-brown color and high penetration resistance. The lower 57.9 meters of the soil column consists of stiff dark greenish gray to olive-gray Pleistocene Bay Mud which overlies sheared serpentine at 79.5 meters.

Water content was determined for samples below the fill and underlying sand deposits (7.6m) and are assumed to be 100% saturated (below water table) (Figure 2, Table 2). Water content,  $w$ , is the weight of water divided by the weight of the soil particles.

Figure 2. Stratigraphy, and physical- and engineering-properties of the soil column at Winfield Scott School.

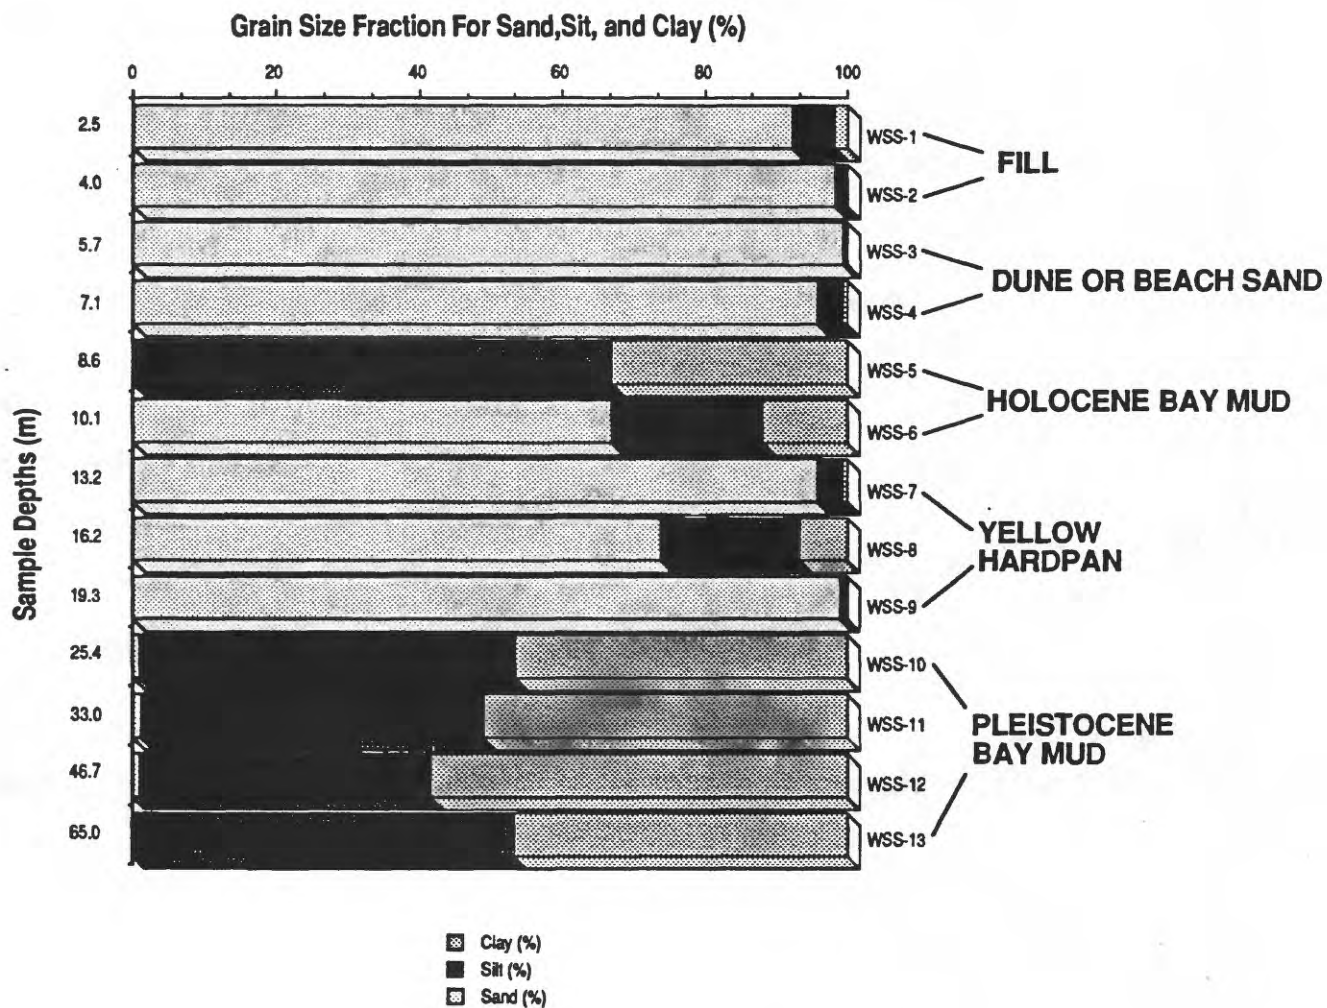
Figure 3. Grain size distribution at sampled intervals

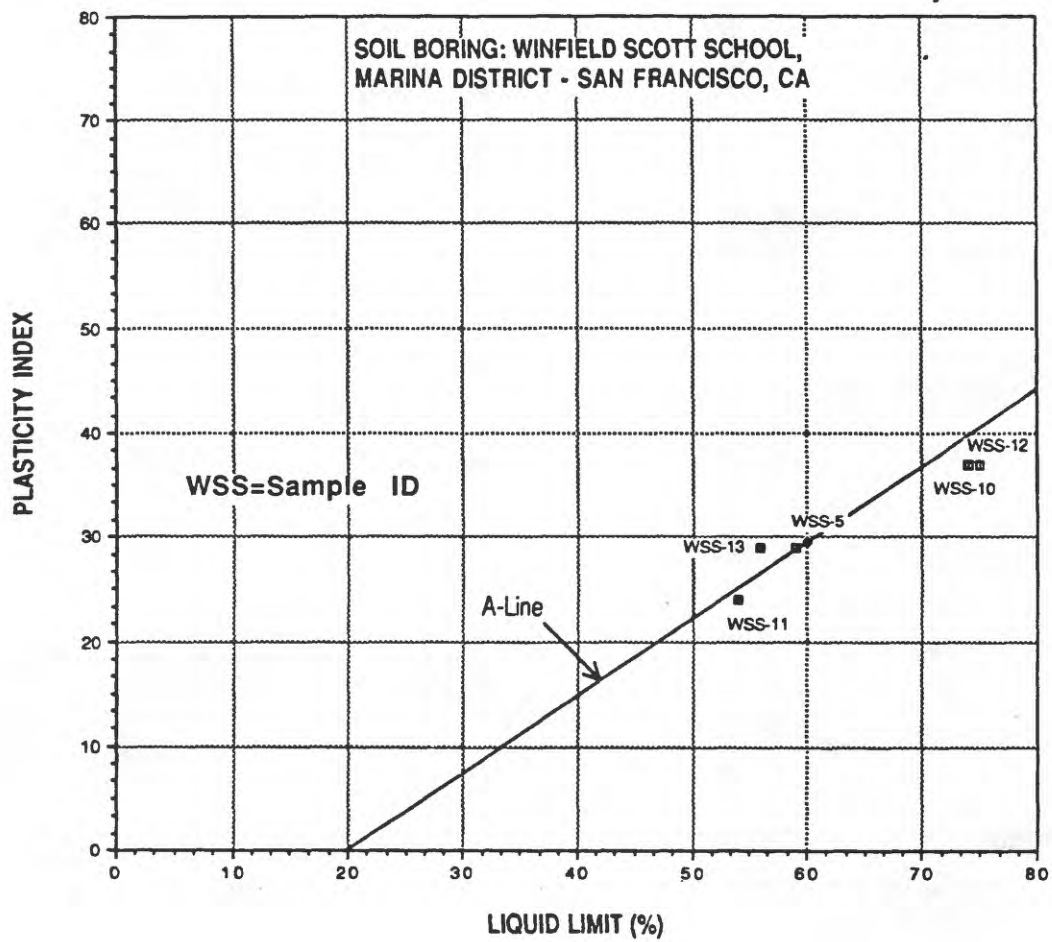
Dividing the peak shear strength by the effective overburden pressure gives normalized strength values of approximately 0.4 to 0.6 for the Pleistocene Bay Mud. Such low normalized values indicate that these muds are normally-consolidated to slightly over-consolidated. Sensitivities for both Pleistocene and Holocene Bay Mud are moderate, and are typical of San Francisco Bay Mud.

Figure 4. Atterberg Limits determination for cohesive samples.

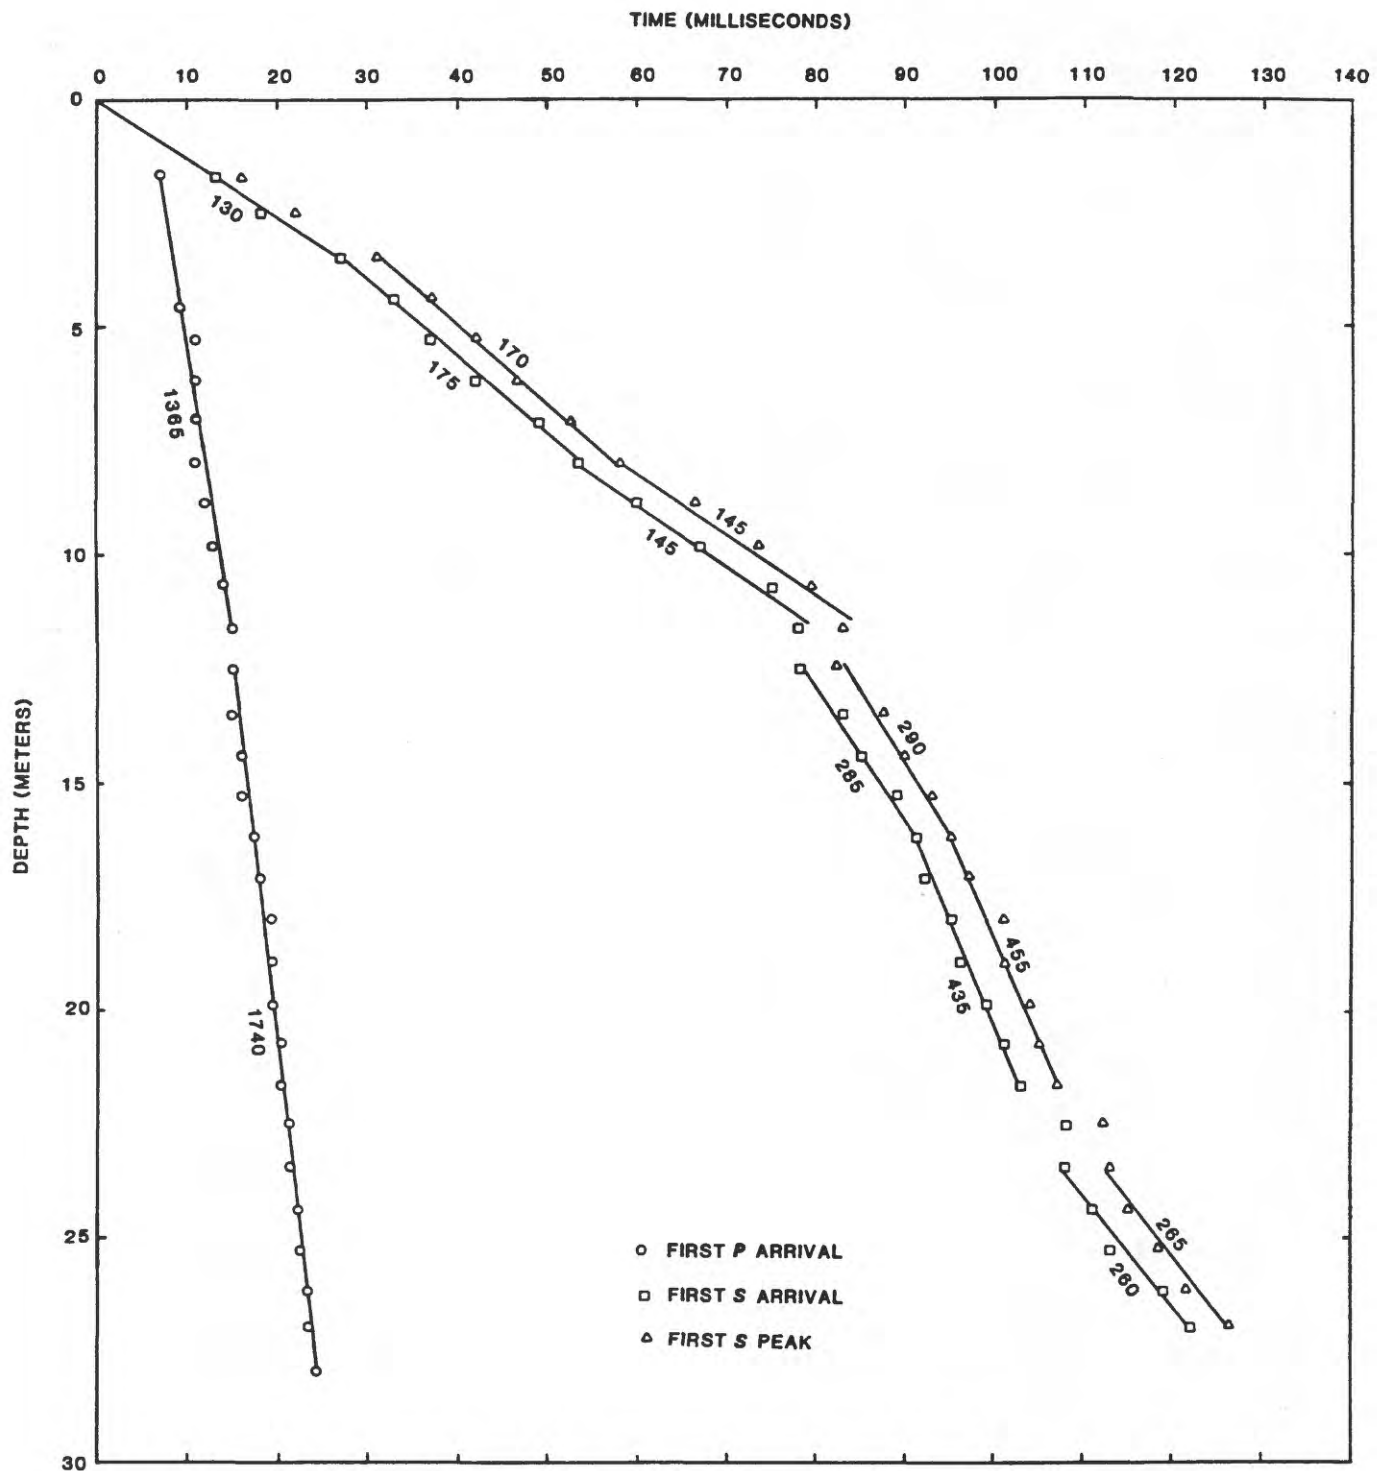
Data were taken starting at a depth of 1.66 m and then at 0.91 m intervals to a maximum depth of 28.18 m. An ES&G ES-1200 digital seismograph, triggered by an impact switch, was used to record the waveforms at a sampling rate of 1024 samples/channel/s. Travel times were determined for the first arrival and the first downward velocity maximum of the compressional waveforms; travel times were determined for the first S-wave arrival and the following two extrema in the recorded horizontal-component motions. The results are shown in Figure 5. The velocities, inferred from the travel time data, are shown in Figure 6.

Figure 5. Seismic shear wave and compression wave travel times versus depth.

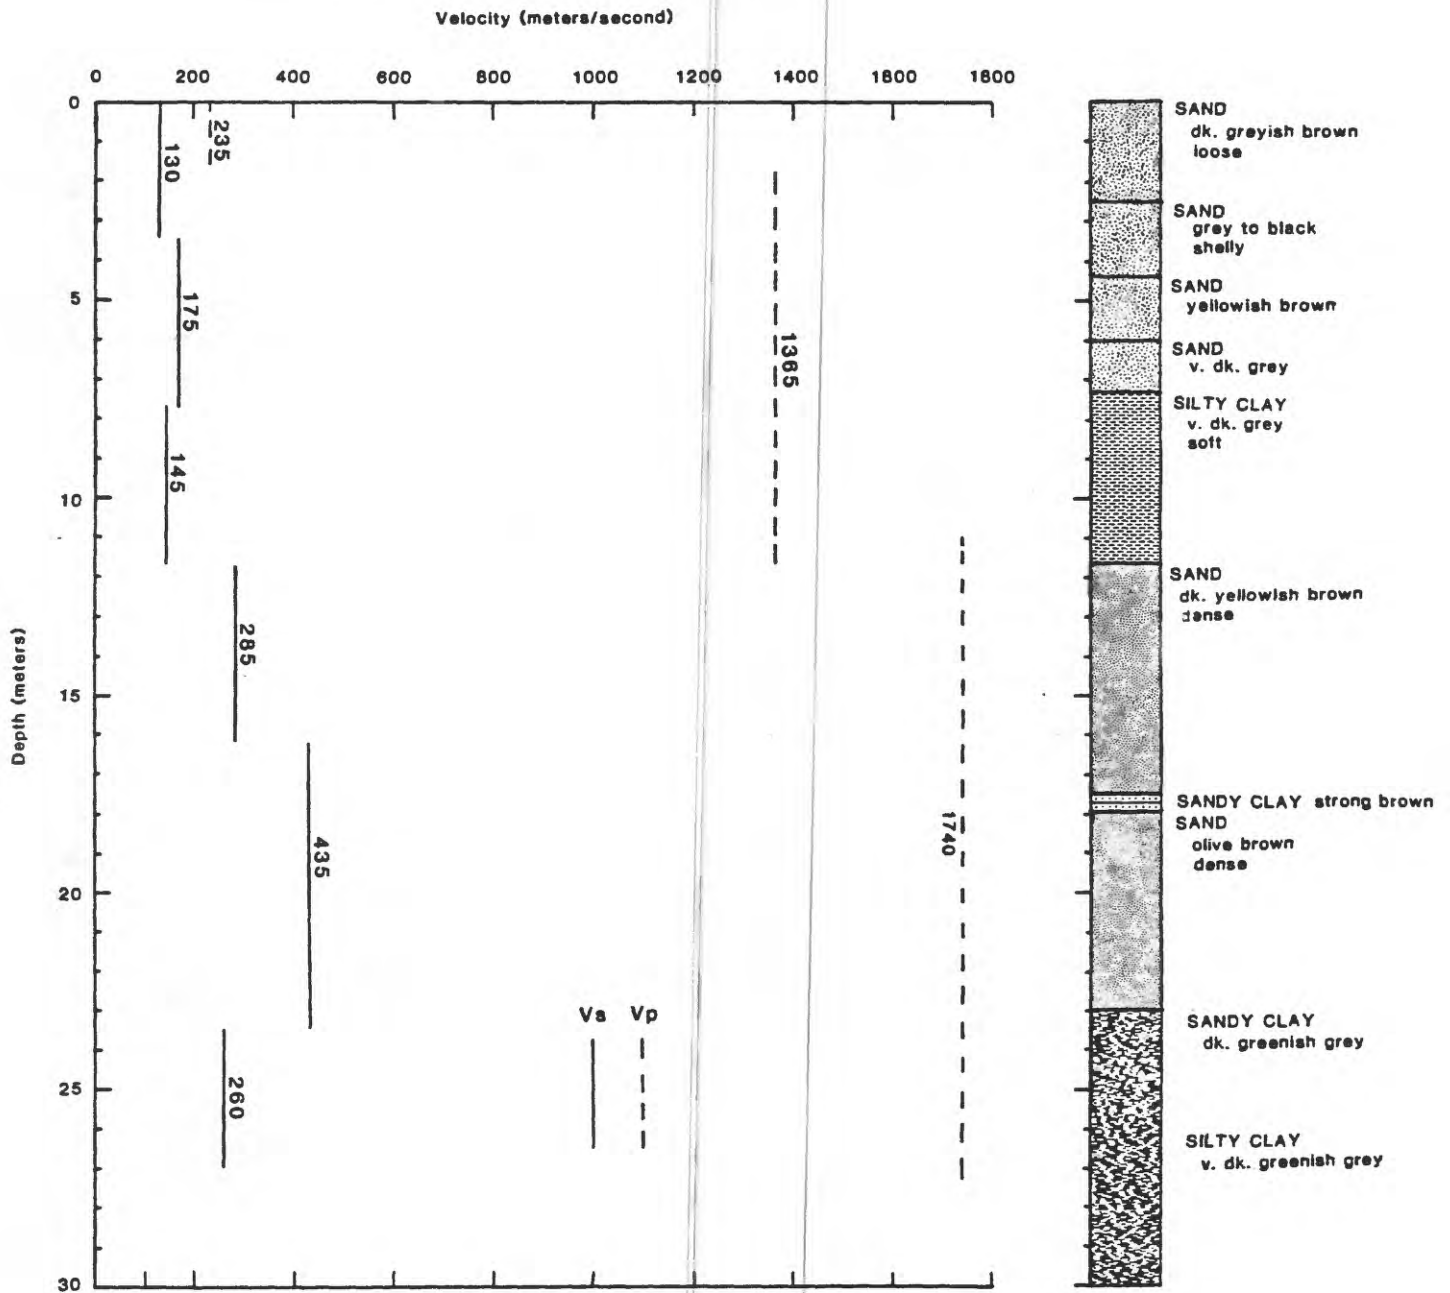
Figure 6. Shear wave and compression wave velocity versus depth (meters/sec).

Exhibition soil logs (Schlocker, 1974). Unfortunately, the 1912 soil logs led to the mistaken belief that the depth to bedrock ("Yellow hardpan") in the Marina District west of Fillmore St. was typically less than 12 meters. In contrast, this post-earthquake USGS soil boring identified a 57.6 meter-thick section of Pleistocene Bay Mud beneath the "Hardpan" layer.

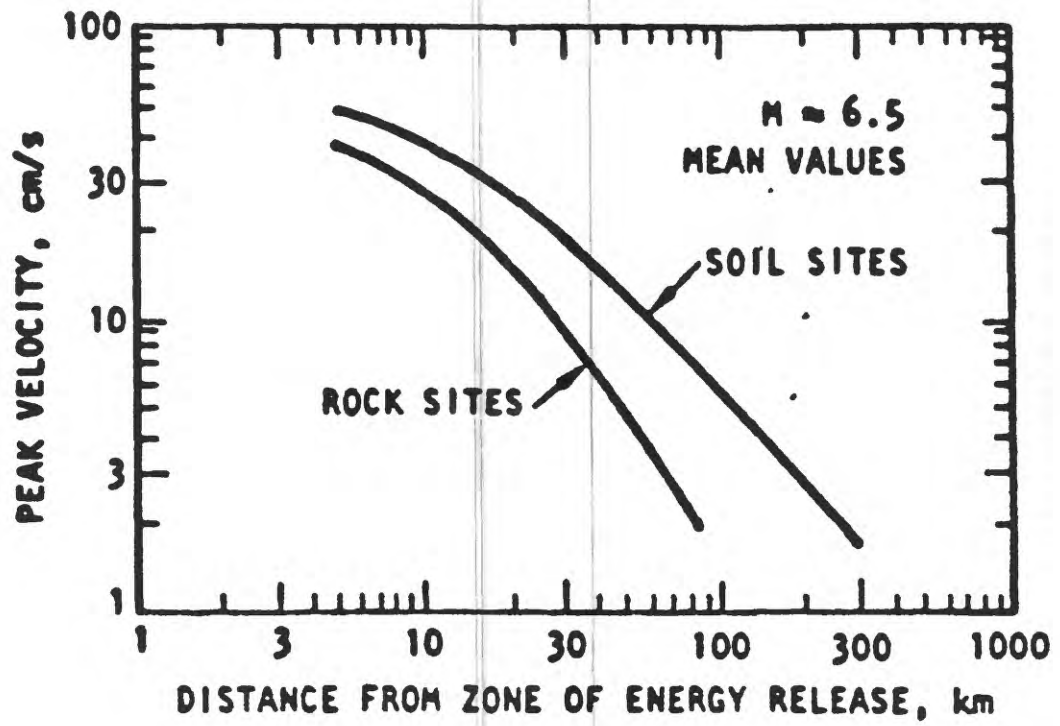
Figure 7. Peak velocity versus distance from zone of energy release (from Seed and Idriss, 1982).

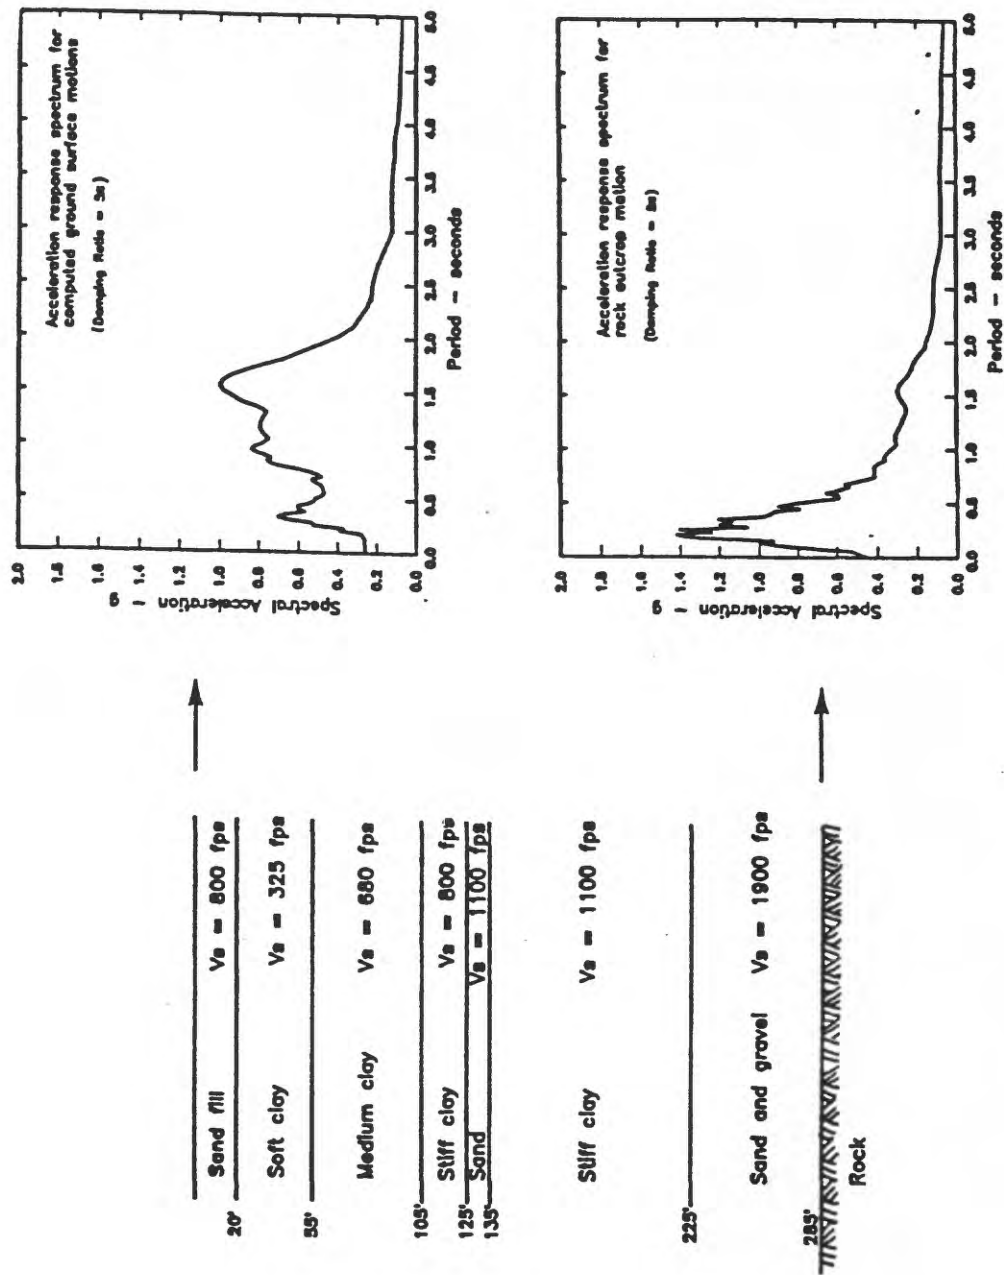
Figure 8. Predicted acceleration response spectra for the Southern Pacific Building (foot of Market Street) for a magnitude 7-1/4 earthquake with soil depth similar to the Marina District (from Seed and Sun, 1989). The incident rock motion entering at the base is filtered and amplified through the soil for natural periods of vibration in excess of 0.3 seconds. As a consequence of amplification through soil, structures with dominant periods in excess of 0.3 seconds will likely experience greater accelerations during earthquakes than nearby structures of similar design founded on rock.
