U.S. Geological Survey

Summary of Geotechnical and Hydrologic Data
Collected Through April 30, 1990,
for the Alani-Paty Landslide,
Manoa Valley, Honolulu, Hawaii

Open-File Report 90-531

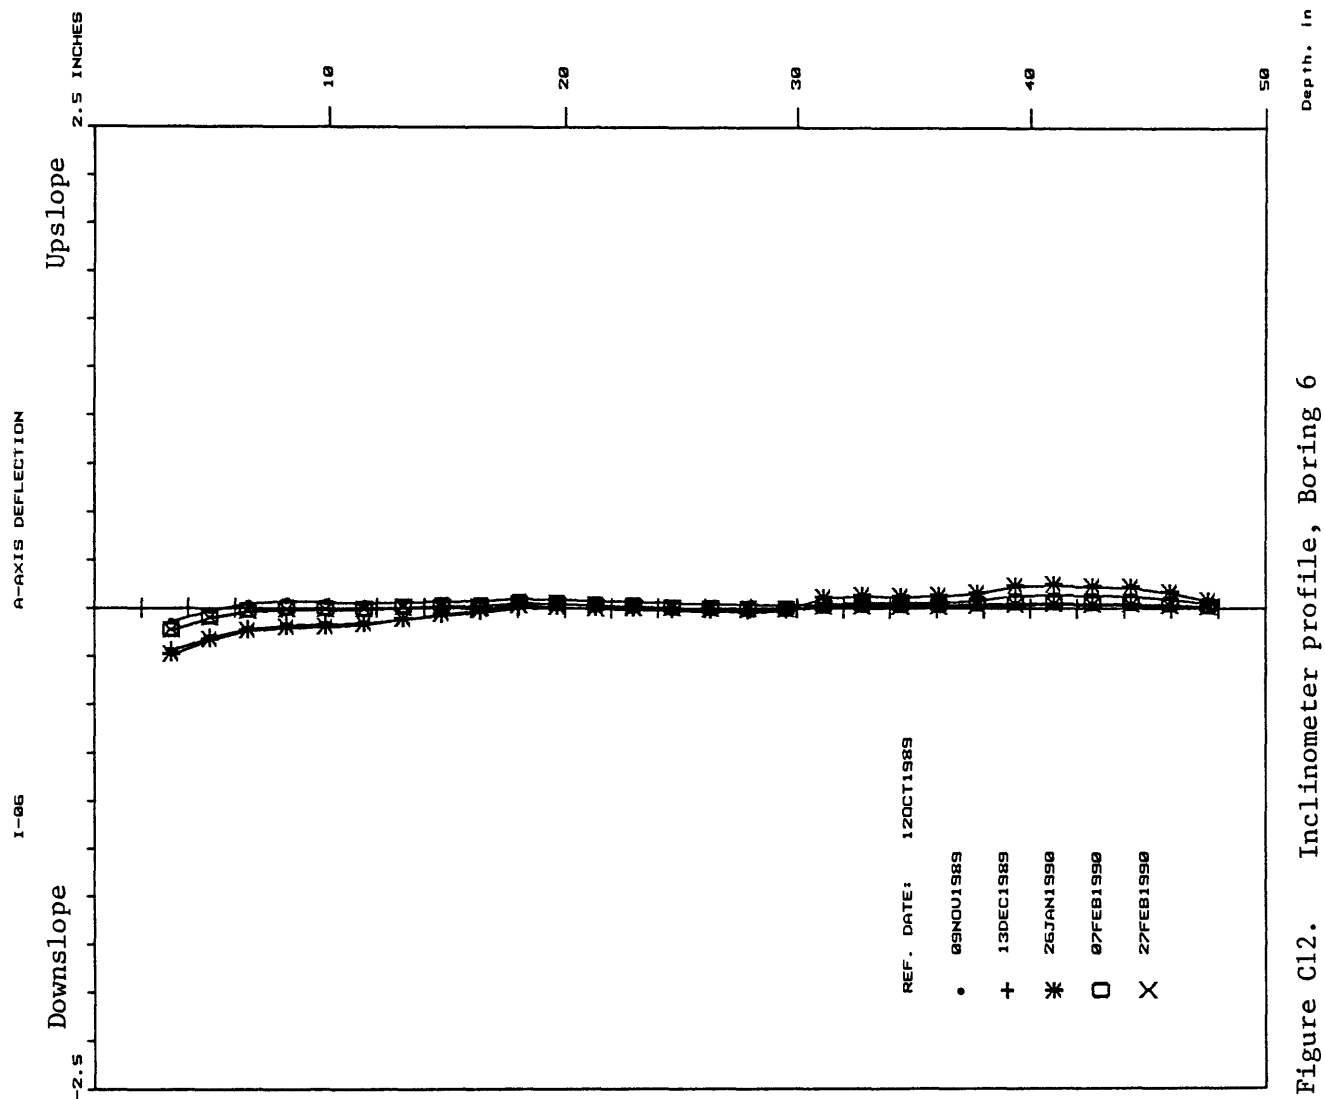
Figure C12. Inclinometer profile, Boring 6

Inclinometer measurements were made in two locations (borings 10 and 15, see fig. 2 and Appendix C) where incipient movement was suspected (Baum and others, 1989) and in one place (boring 6) that appears to be stable ground between the Hulu-Woolsey and Alani-Paty landslides. The inclinometer in Boring 15 indicates sliding occurred at a depth of 26 ft during January 1990. Thus far, borings 6 and 10 have shown only small random deflections but no unequivocal evidence of sliding.

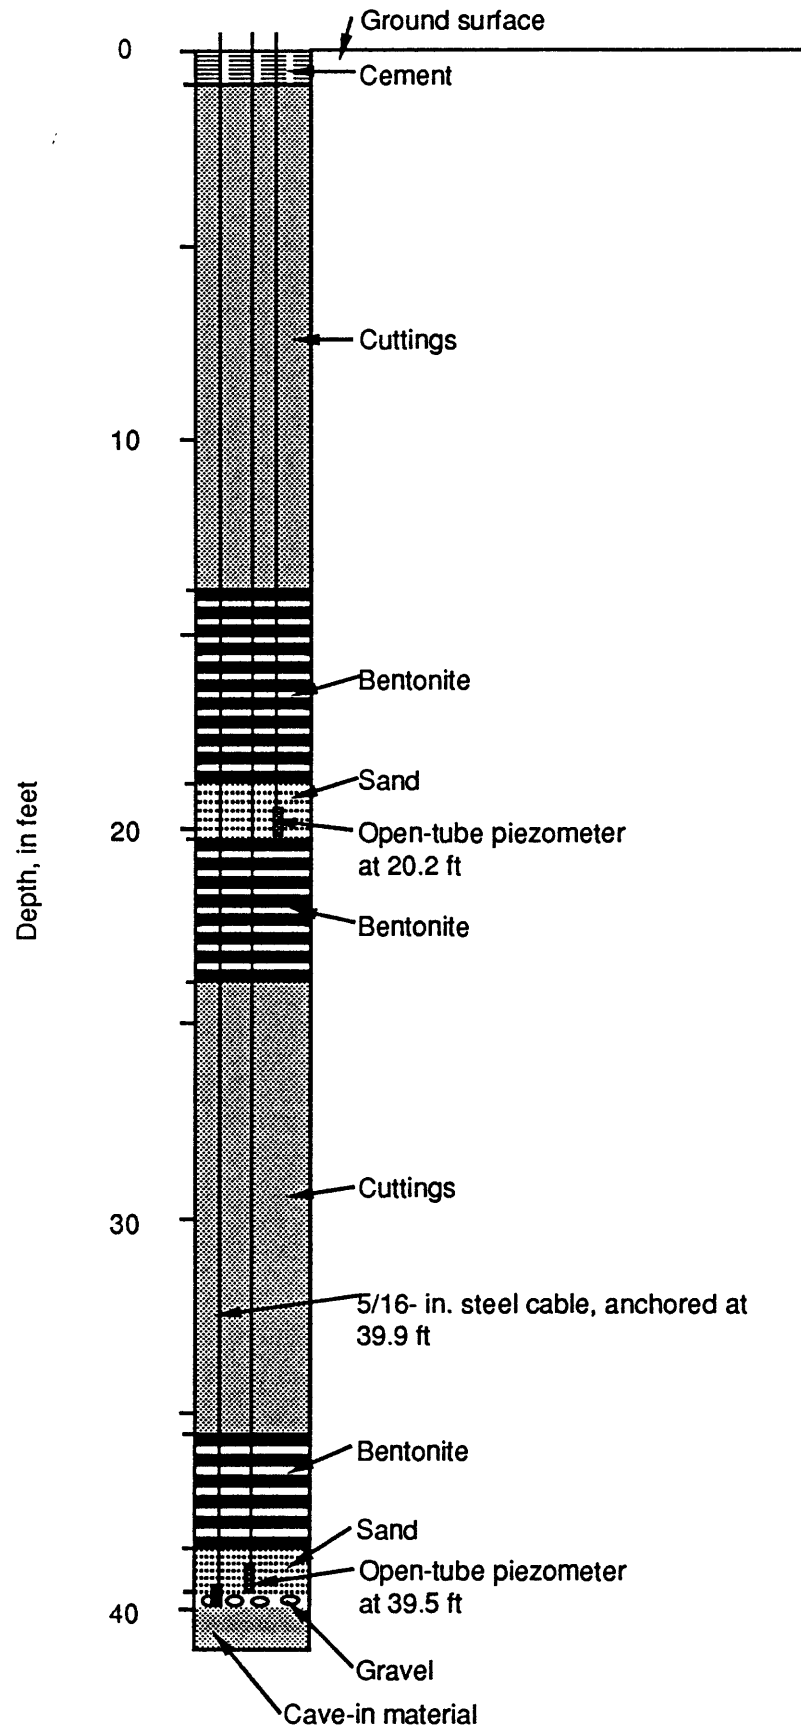
Figure C18. Sketch showing installation of instruments in boring 4
