U.S. DEPARTMENT OF THE INTERIOR  
U.S. GEOLOGICAL SURVEY

Preliminary Evaluation of the Fire-Related Debris Flows  
on Storm King Mountain,  
Glenwood Springs, Colorado

Open File Report 95-508

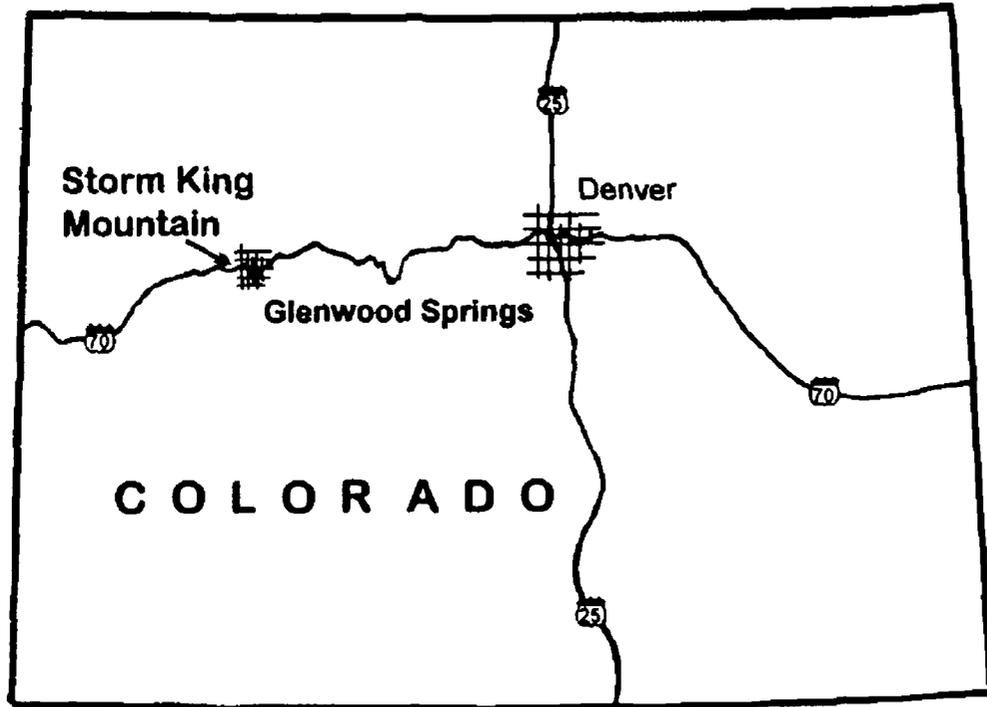
The South Canyon fire burned approximately 2000 acres of pinyon-juniper and mountain shrub vegetative communities (Plate 1 and Figure 2). The most intensely burned area extends from roughly 0.5 mile up the mountain side to near the summit of the mountain, and is characterized by the complete burning of large branches and many major tree trunks, completely burned brush and grass, and the presence of both dark and white ash (Figure 4). Some sandstone outcrops were fractured by the intense thermal stresses. The burnt soil is loose and friable, and approximately 2 to 4 inches in depth (Figure 5). Two samples of burnt soil (taken from the same location but at depths of 0-1 inch and 1-4 inches) were classified as silty sand (Table 1). The grain-size distribution of the burned soil is essentially the same as that for unburned soil (Figure 3A), indicating no discernable alteration in grain-size distribution occurs with burning. The average dry density of three samples of burned soil is 0.026 lb/in<sup>3</sup>.

Wells, W.G., 1987, The effects of fire on the generation of debris flows in southern California: in, Costa, J.E., and Wieczorek, G.F., eds, Geological Society of America, Reviews in Engineering Geology, vol.7, pp.105-114. Figure 2. Storm King Mountain after the burn. View is from west to east. Photograph by Pat Rogers, Colorado Geological Survey.

**Figure 2.** Storm King Mountain after the burn. View is from west to east. Photograph by Pat Rogers, Colorado Geological Survey.
