LEVEL II SCOUR ANALYSIS FOR BRIDGE 45B (BRIDTH0004045B) on TOWN HIGHWAY 4, crossing an unnamed DAILEY HOLLOW BRANCH TRIBUTARY, BRIDGEWATER, VERMONT

U.S. Geological Survey
Open-File Report 96-568

By ERICK M. BOEHMLER

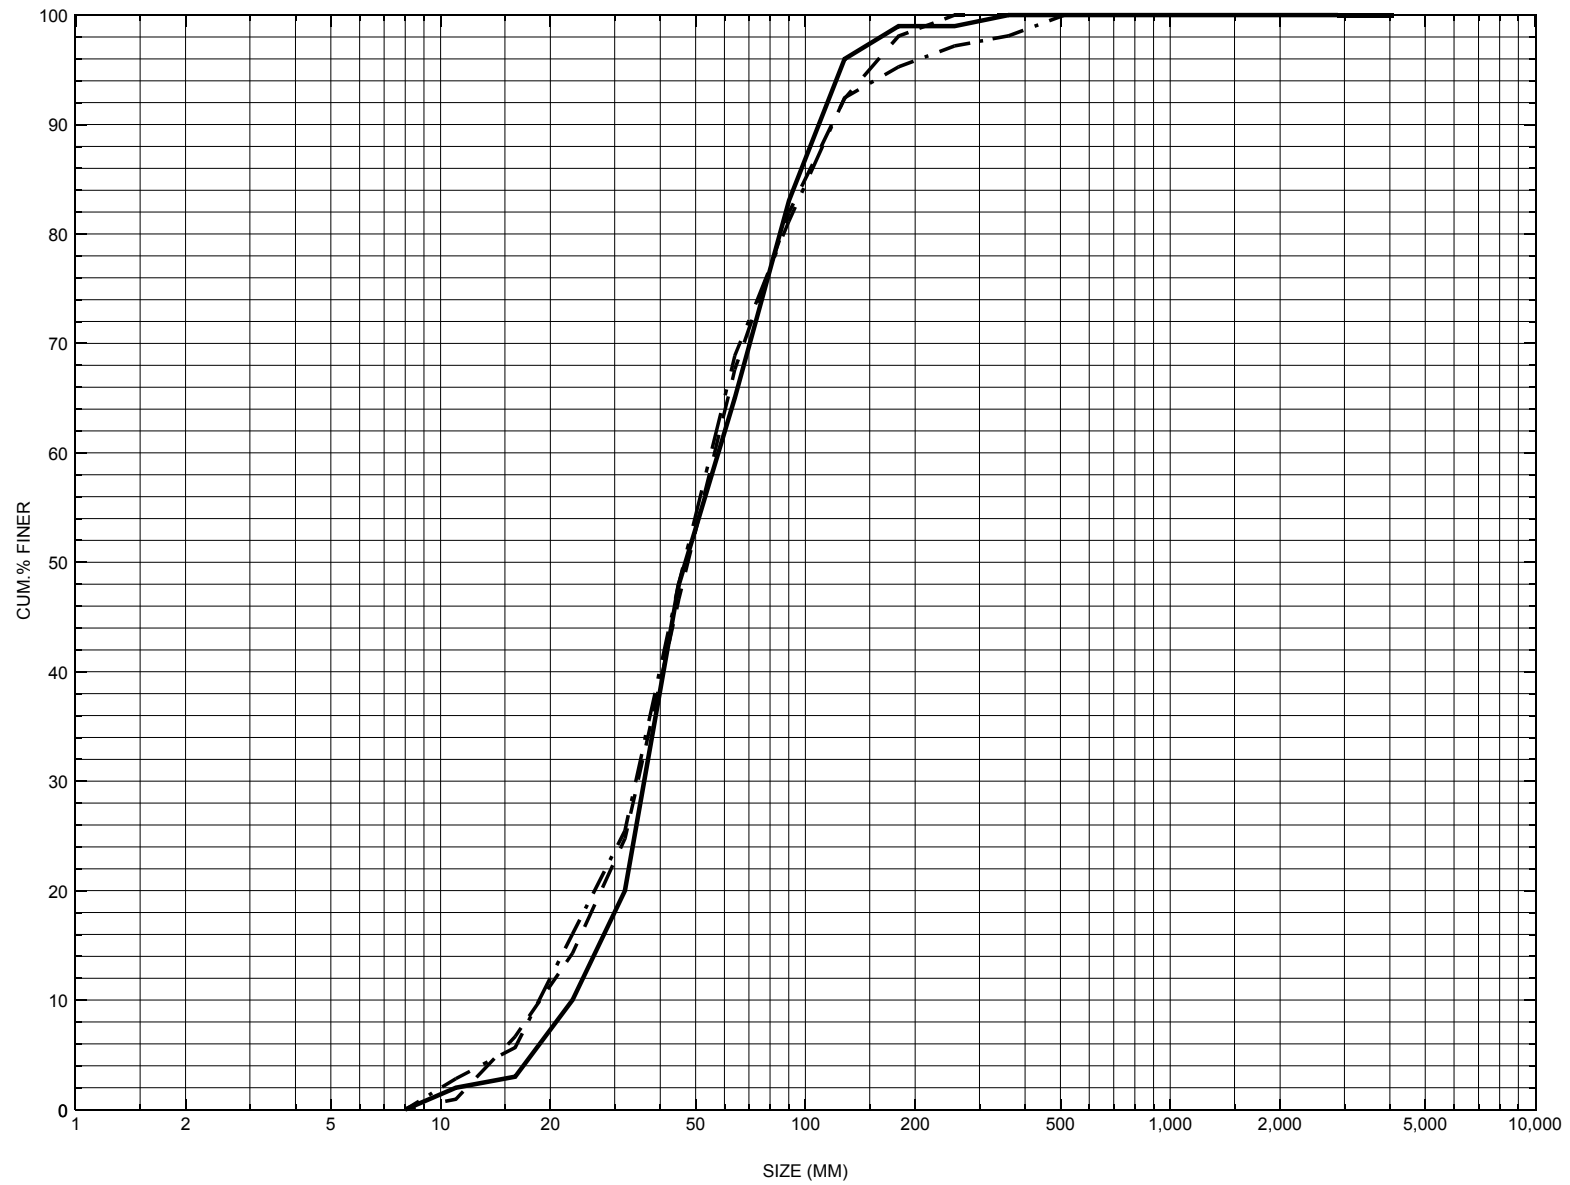
Appendix C. Bed material particle-size distributions for three pebble count transects at the approach cross-section for structure BRIDTH0004045B, in Bridgewater, Vermont.
