# LEVEL II SCOUR ANALYSIS FOR BRIDGE 28 (HARDTH00300028) on TOWN HIGHWAY 30, crossing the LAMOILLE RIVER, HARDWICK, VERMONT

U.S. Geological Survey  
Open-File Report 96-569

Prepared in cooperation with  
VERMONT AGENCY OF TRANSPORTATION  
and  
FEDERAL HIGHWAY ADMINISTRATION

By SCOTT A. OLSON and JAMES R. DEGNAN

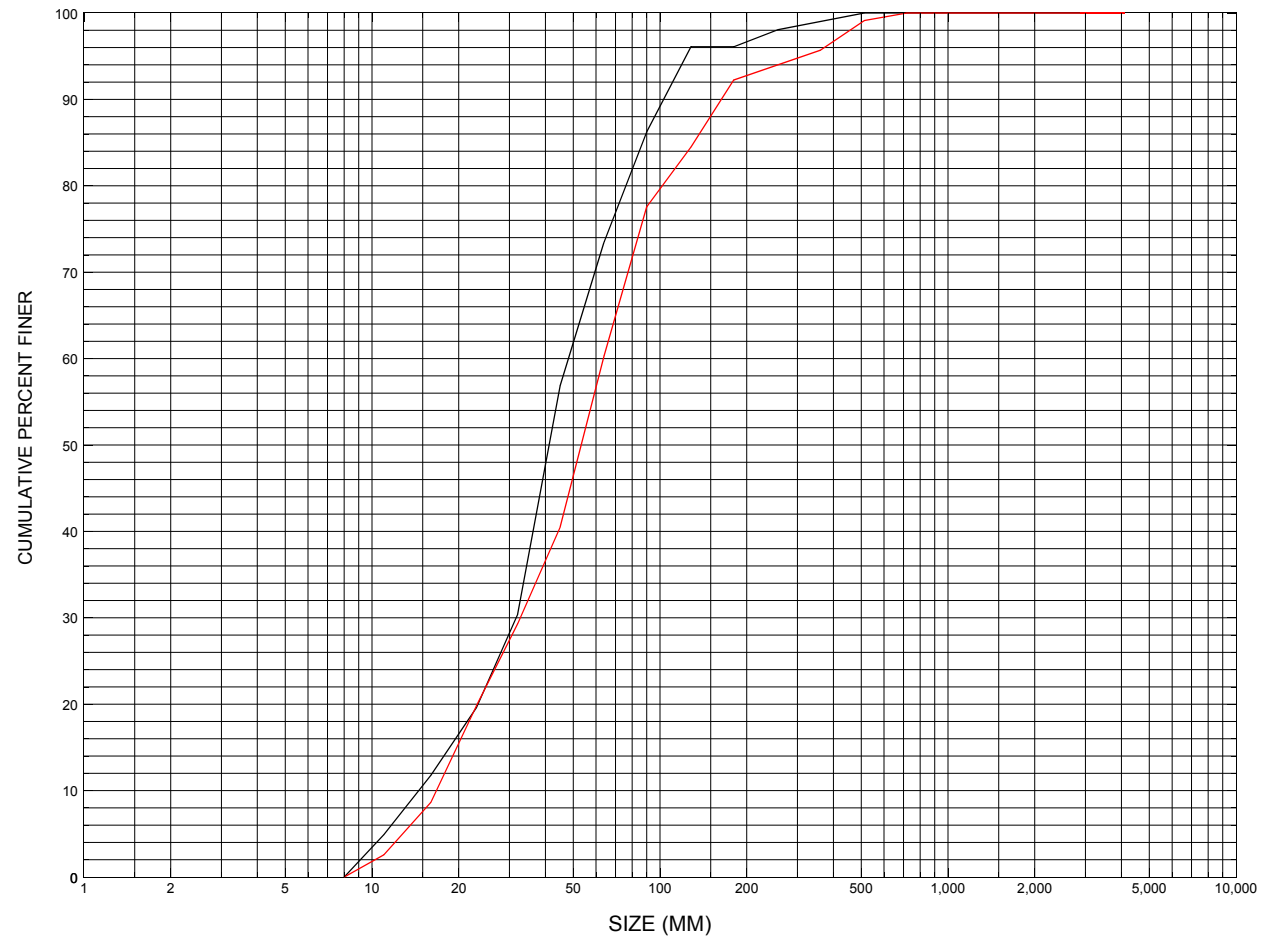
Appendix C. Bed material particle-size distributions for two pebble count transects at the approach cross-section for structure [HARDTH00300028](#), in [Hardwick](#), Vermont.
