# LEVEL II SCOUR ANALYSIS FOR BRIDGE 22 (REDSVT01000022) on STATE ROUTE 100, crossing the WEST BRANCH DEERFIELD RIVER, READSBORO, VERMONT

U.S. Geological Survey  
Open-File Report 97-191

Prepared in cooperation with  
VERMONT AGENCY OF TRANSPORTATION  
and  
FEDERAL HIGHWAY ADMINISTRATION

By Erick M. Boehmler and Ronda L. Burns

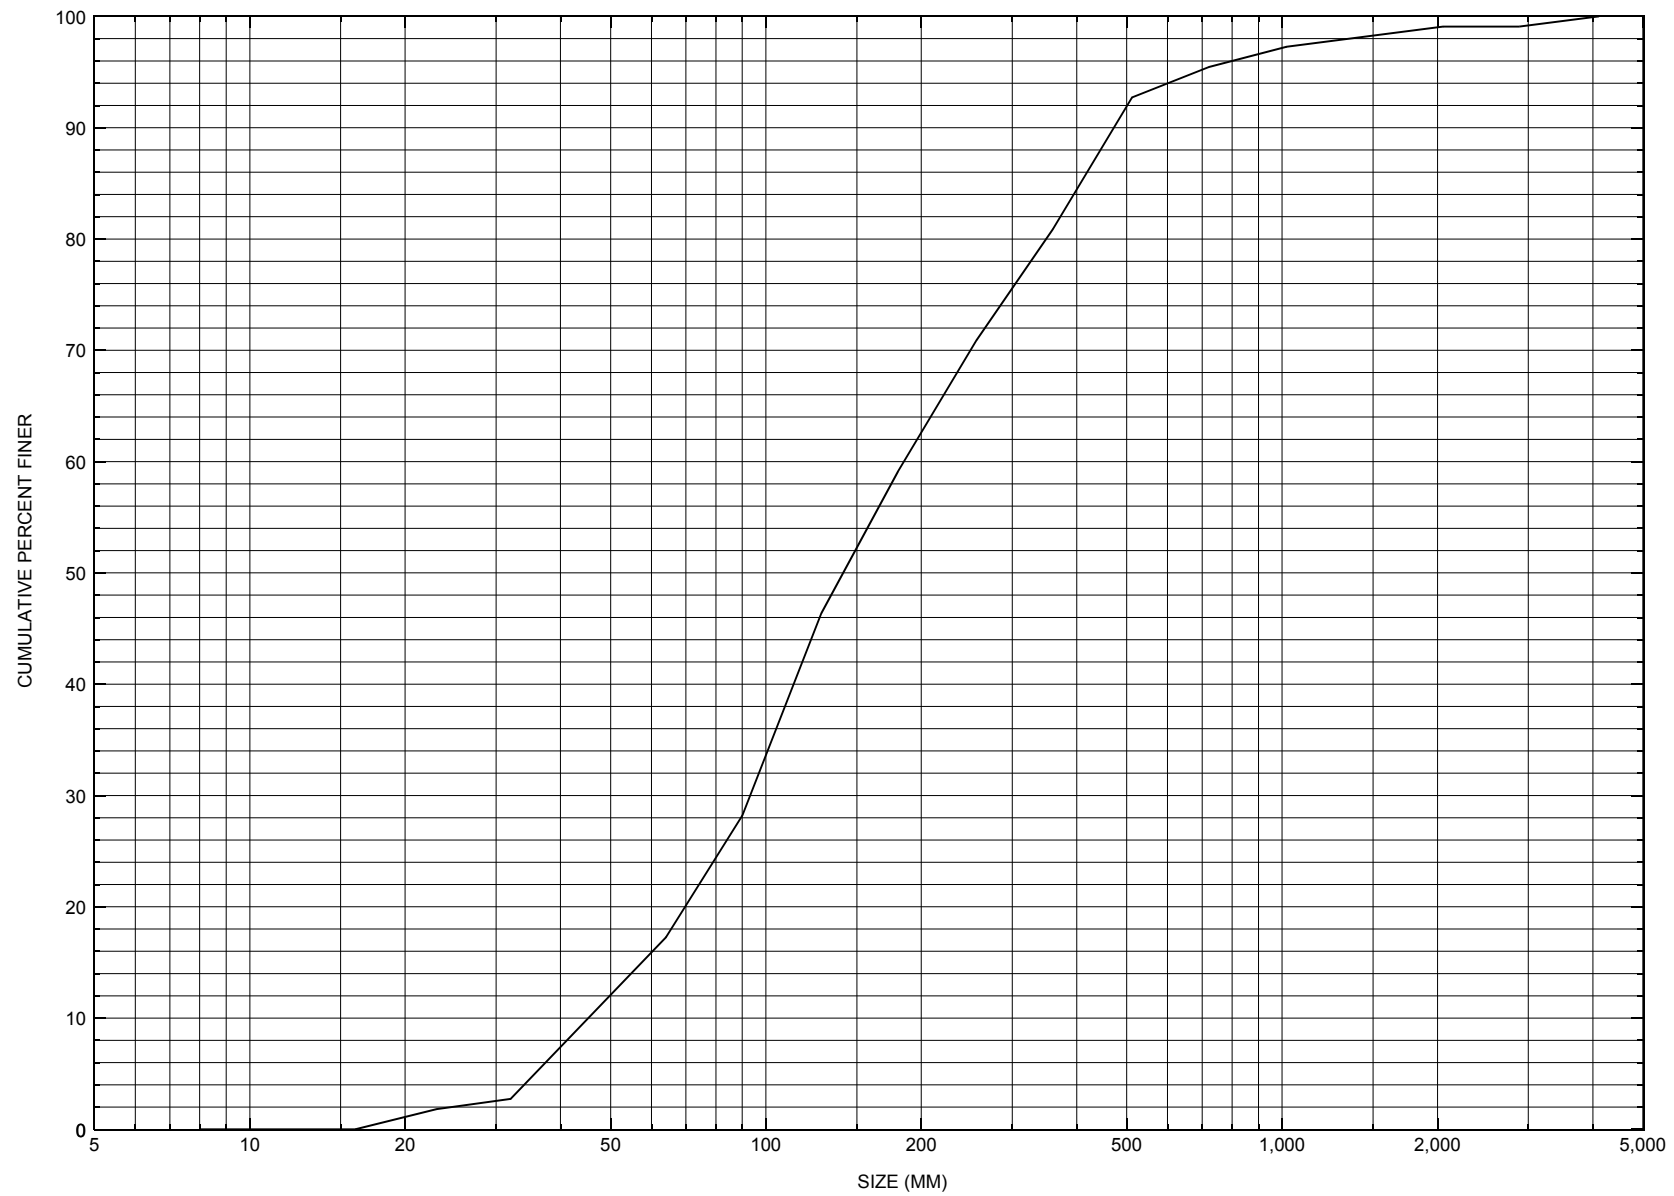
Appendix C. Bed material particle-size distribution [for a pebble count](#) in the channel approach of structure [REDSVT01000022](#), in [Readsboro](#), Vermont.
