EVALUATION OF THE LANDSLIDE POTENTIAL IN CAPULIN CANYON FOLLOWING THE DOME FIRE, BANDELIER NATIONAL MONUMENT, NEW MEXICO

Open-File Report 98-42

U.S. Geological Survey
Denver, CO 80225

1998

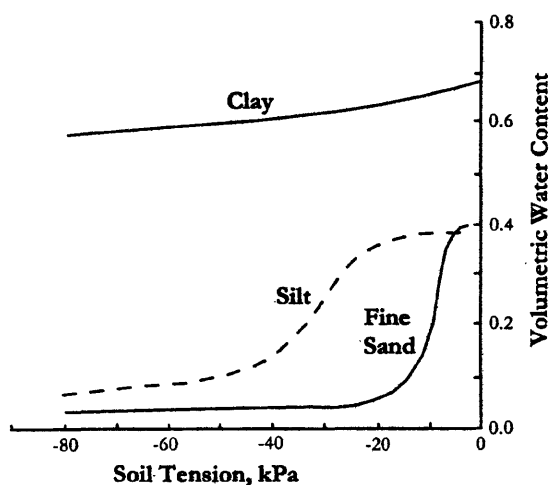
Note that although the Watermark sensors can respond to soil tensions well beyond the range of the data used in the calibration (between 0 and -80 kPa), it would not be appropriate to extrapolate the curves to these higher tension values. For this reason, only data in the range of 0 to -80 kPa are considered in this study. This constraint poses no serious limitations as soil tensions in excess of -50 kPa are measured in soils that can experience very little changes in water content (fig. 3).

Figure 3. Soil water retention curves for clay, silt, and fine sand.

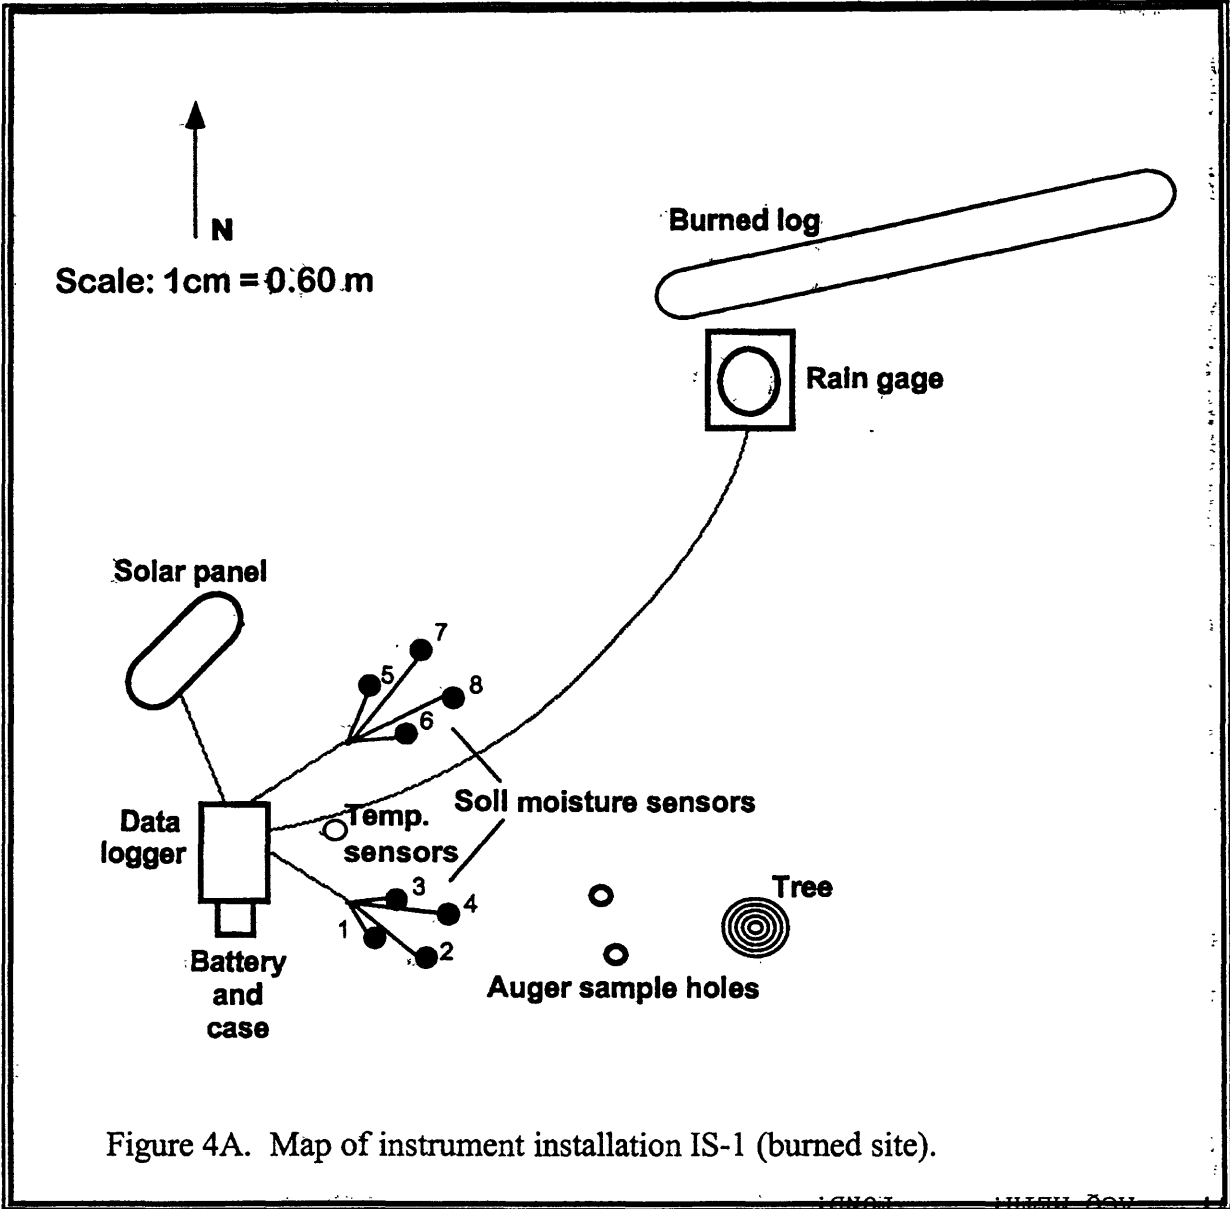
Figures 4A and 4B are sketch maps showing the location of the soil-moisture sensor emplacement holes, temperature sensor emplacement holes, rain gages, dataloggers, and solar panels at each instrumentation site. The depths of installation of the soil-moisture sensors at each site are listed in table 1. The depth to which the deepest sen-

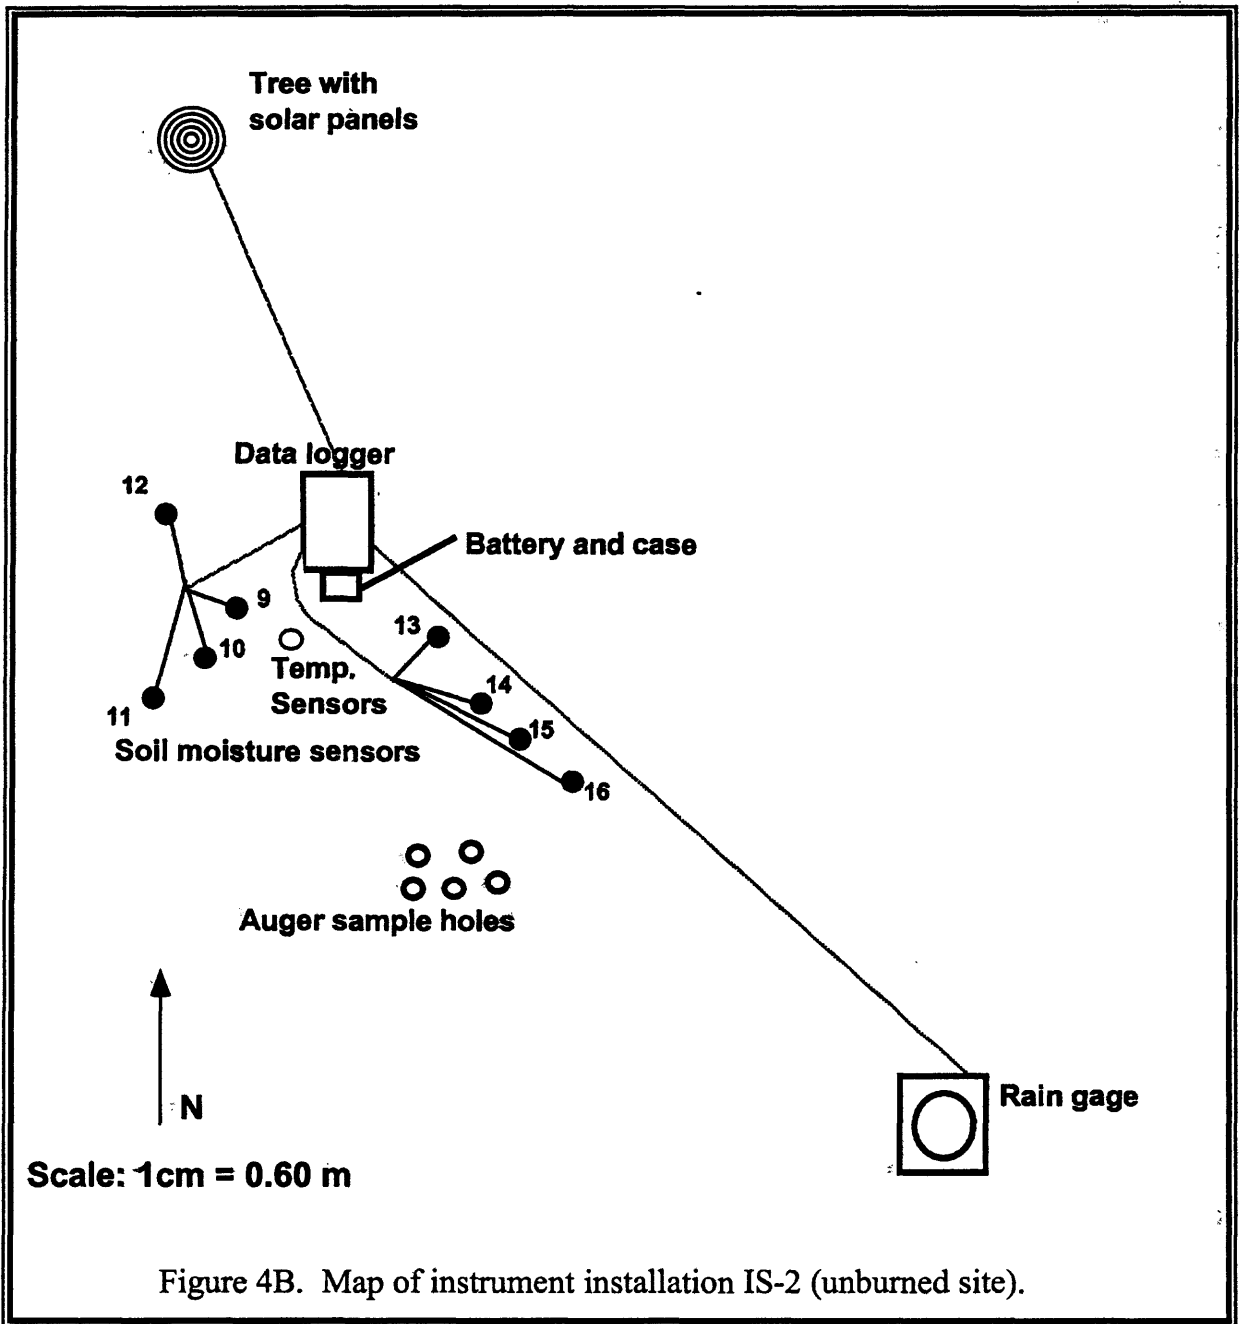
Figure 4B. Map of instrument installation IS-2 (unburned site).
