LEVEL II SCOUR ANALYSIS FOR BRIDGE 29 (JAMATH00300029) on TOWN HIGHWAY 30, crossing BALL MOUNTAIN BROOK, JAMAICA, VERMONT

Open-File Report 98-88

Prepared in cooperation with
VERMONT AGENCY OF TRANSPORTATION
and
FEDERAL HIGHWAY ADMINISTRATION

U.S. Geological Survey
Open-File Report 98-88

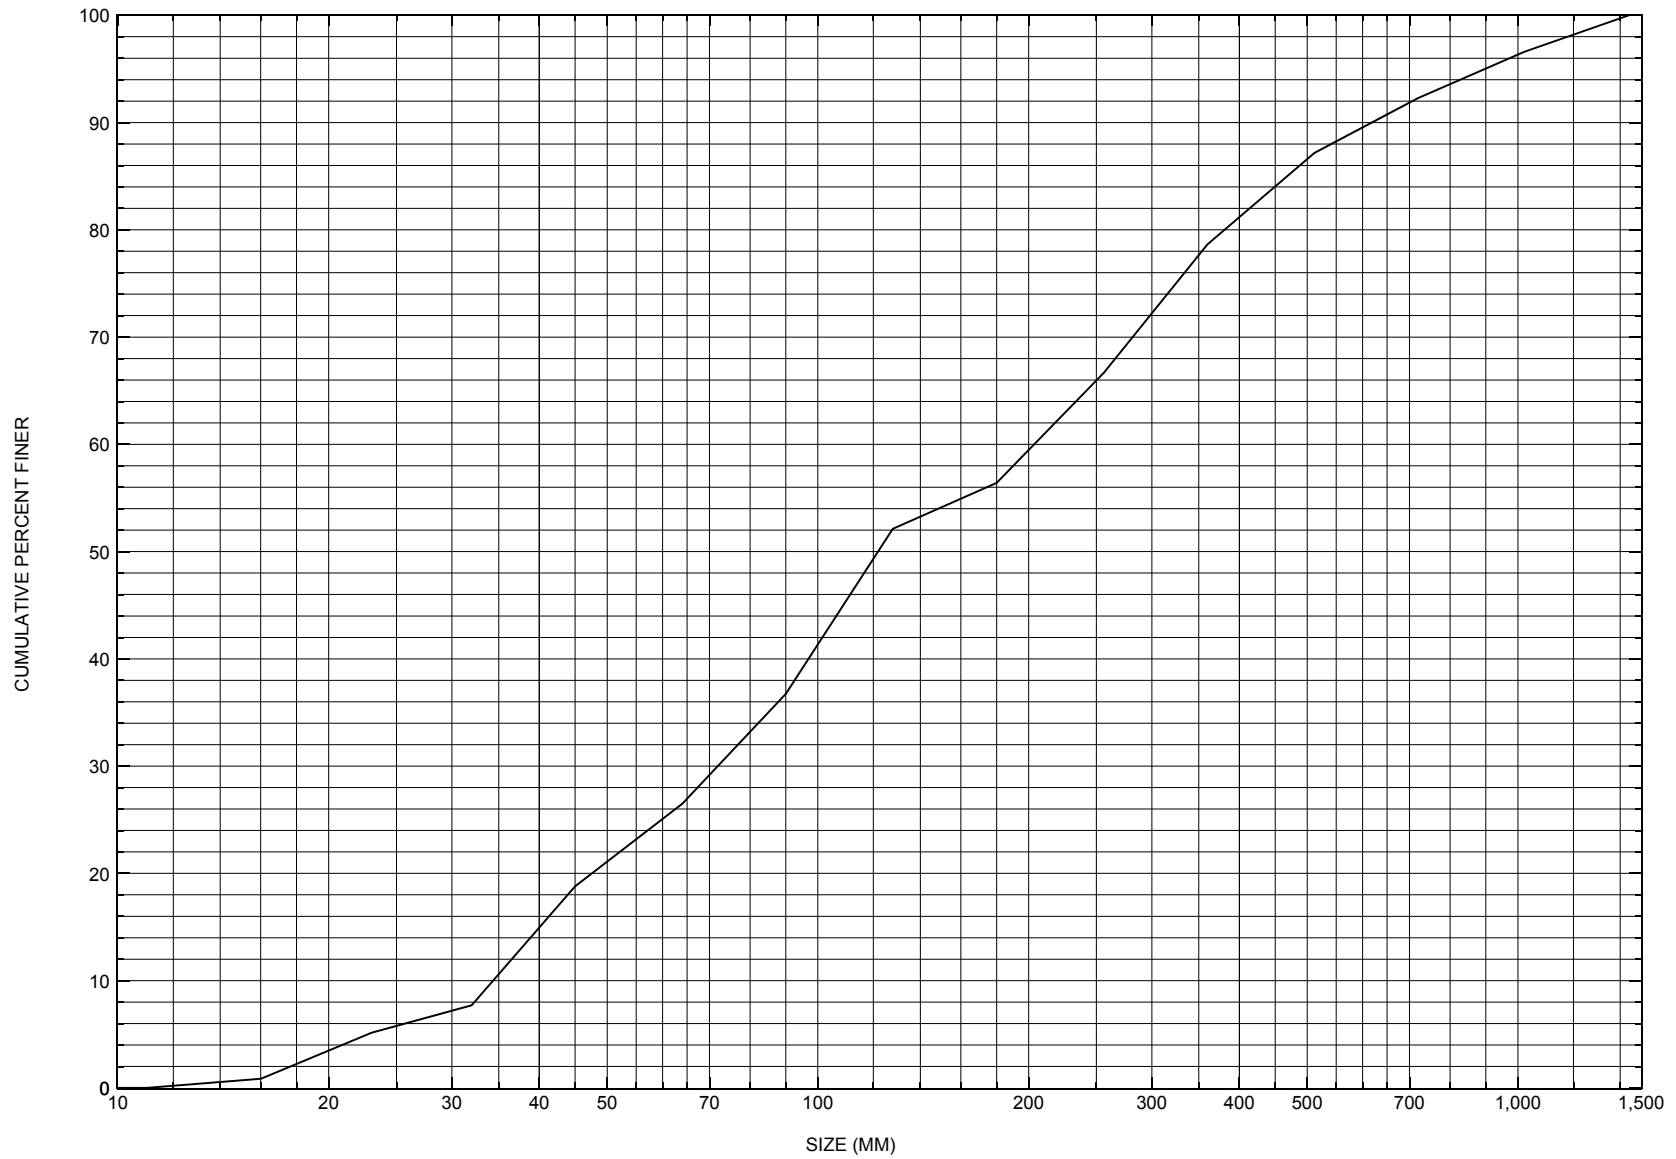
Appendix C. Bed material particle-size distribution for a pebble count in the channel approach of structure JAMATH00300029, in Jamaica, Vermont.
