# LEVEL II SCOUR ANALYSIS FOR BRIDGE 47 (LYNDTH00360047) on TOWN HIGHWAY 36, crossing the EAST BRANCH PASSUMPSIC RIVER, LYNDON, VERMONT

Open-File Report 98-406

By LORA K. STRIKER AND TIMOTHY A. SEVERANCE

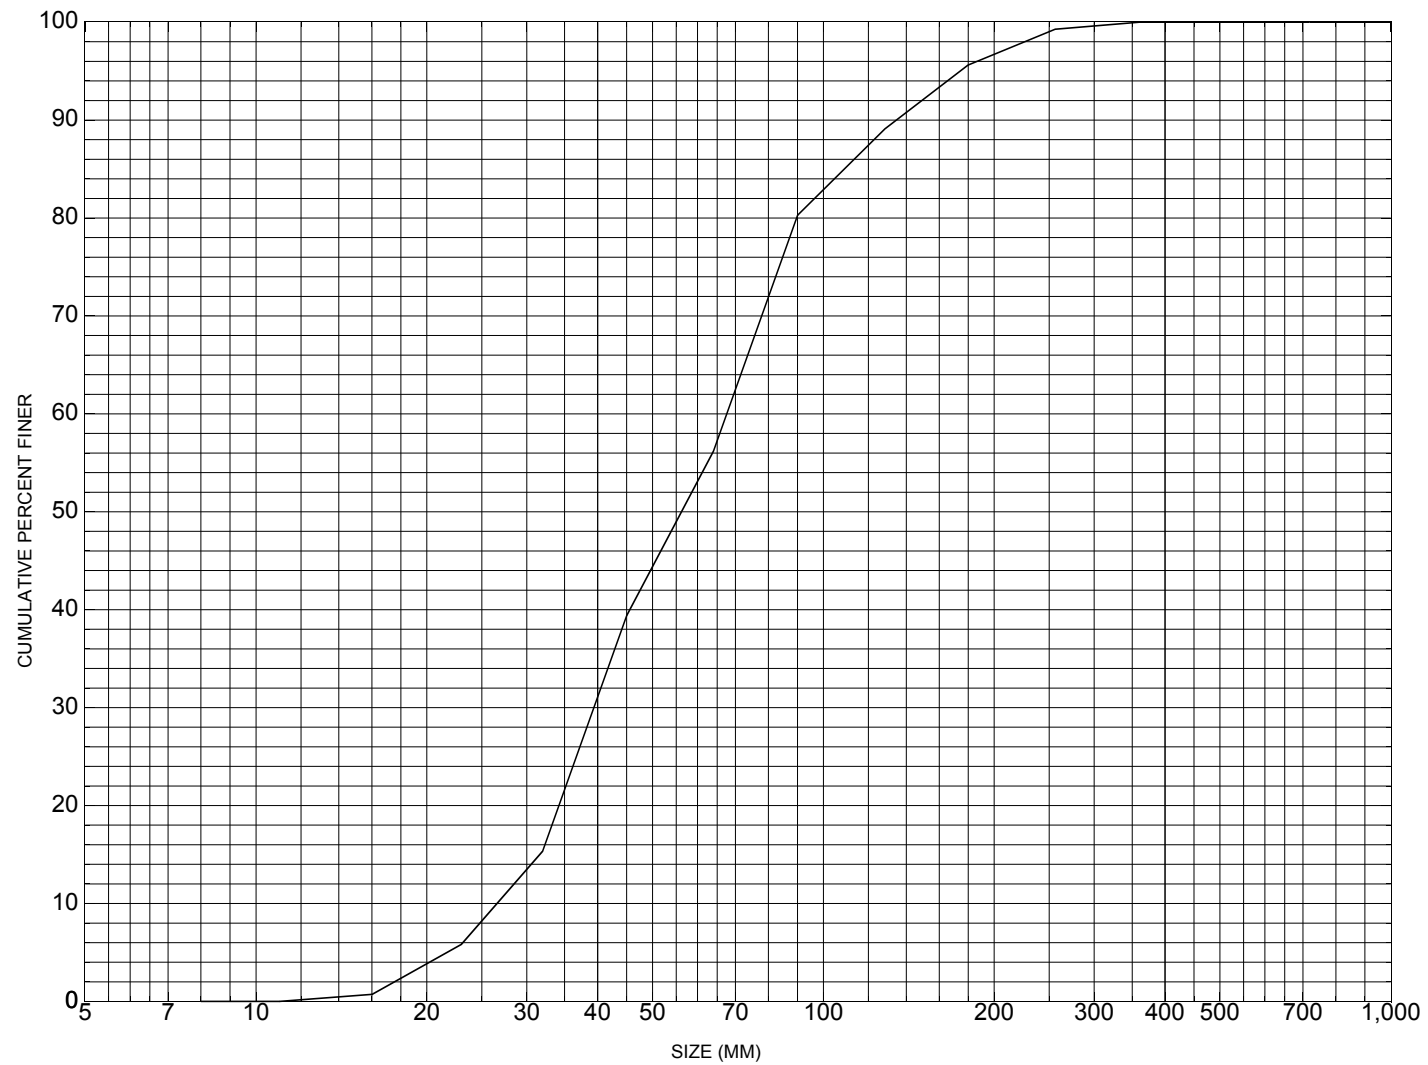
Appendix C. Bed material particle-size distribution for a pebble count in the channel approach of structure LYNDTH00360047, in Lyndon, Vermont.
