Assessment of Landslide Hazards in Kaluanui and Maakua Gulches, Oahu, Hawaii, following the 9 May 1999 Sacred Falls Landslide

By Randall W. Jibson *and* Rex L. Baum

Open-File Report 99-364

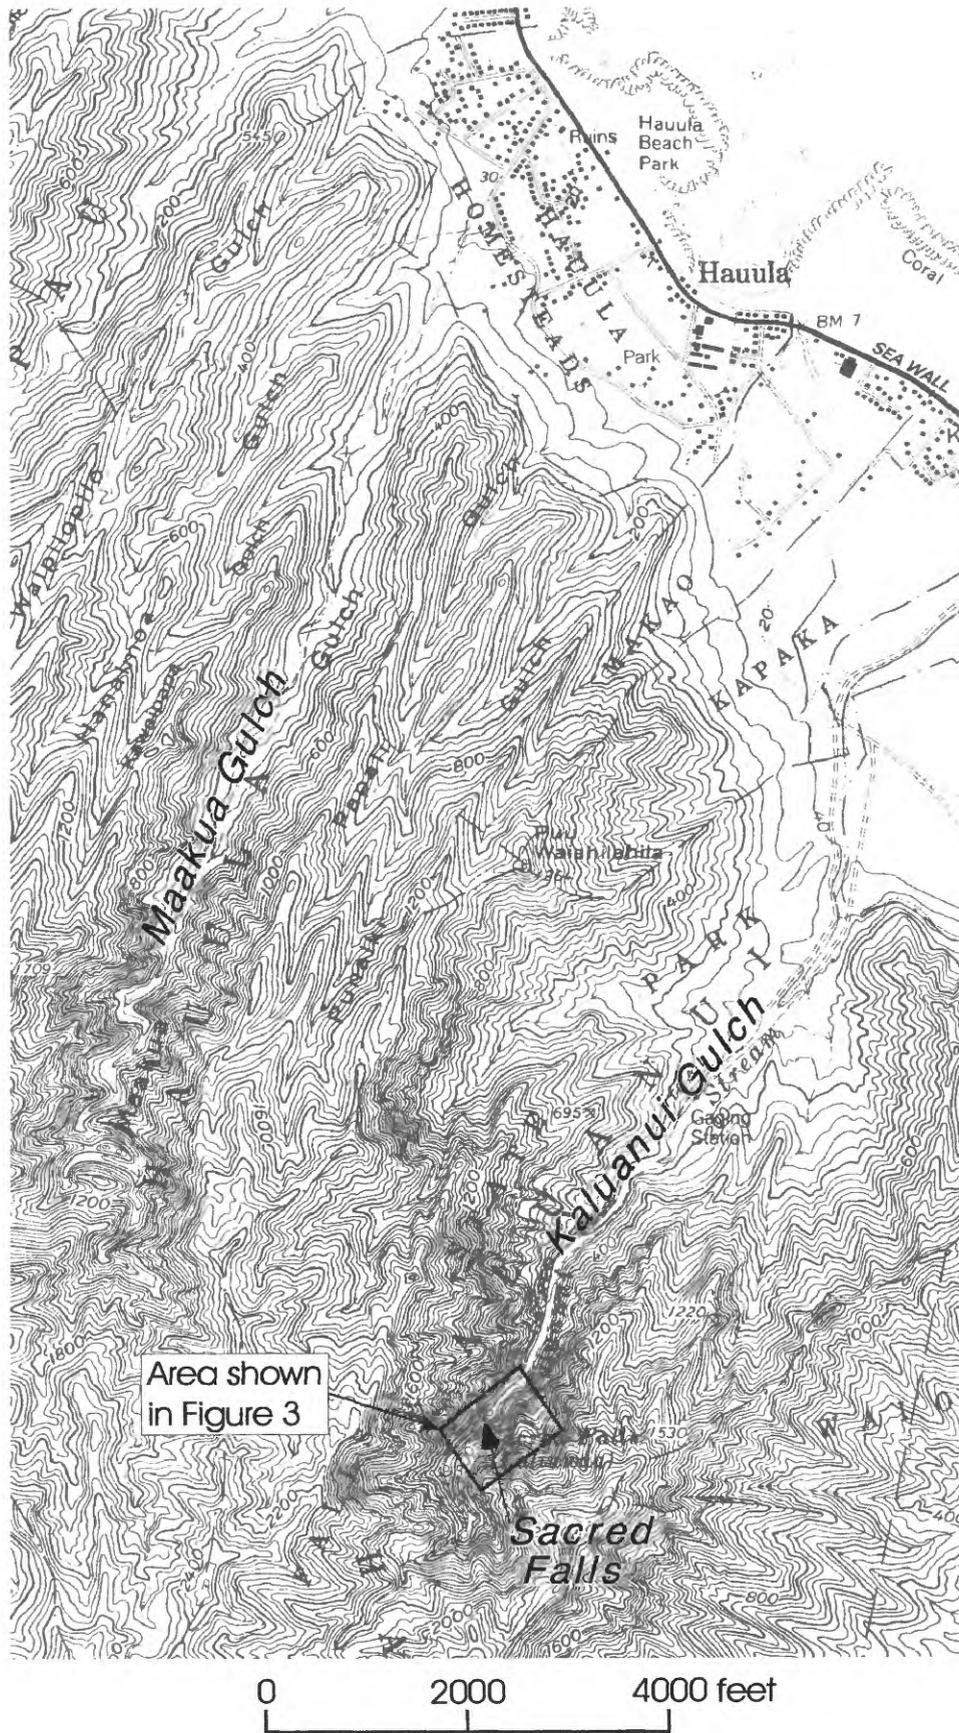
Figure 1. Topographic map showing Kaluanui gulch, Maakua gulch, and Sacred Falls (from USGS Hauula 1:24,000 quadrangle, contour interval 40 feet, north up). Area of Figure 3 shown.
