A Debris Avalanche at Forest Falls, San Bernardino County, California, July 11, 1999

By Douglas M. Morton¹ and Rachel M. Hauser¹

Open-File Report 01-146

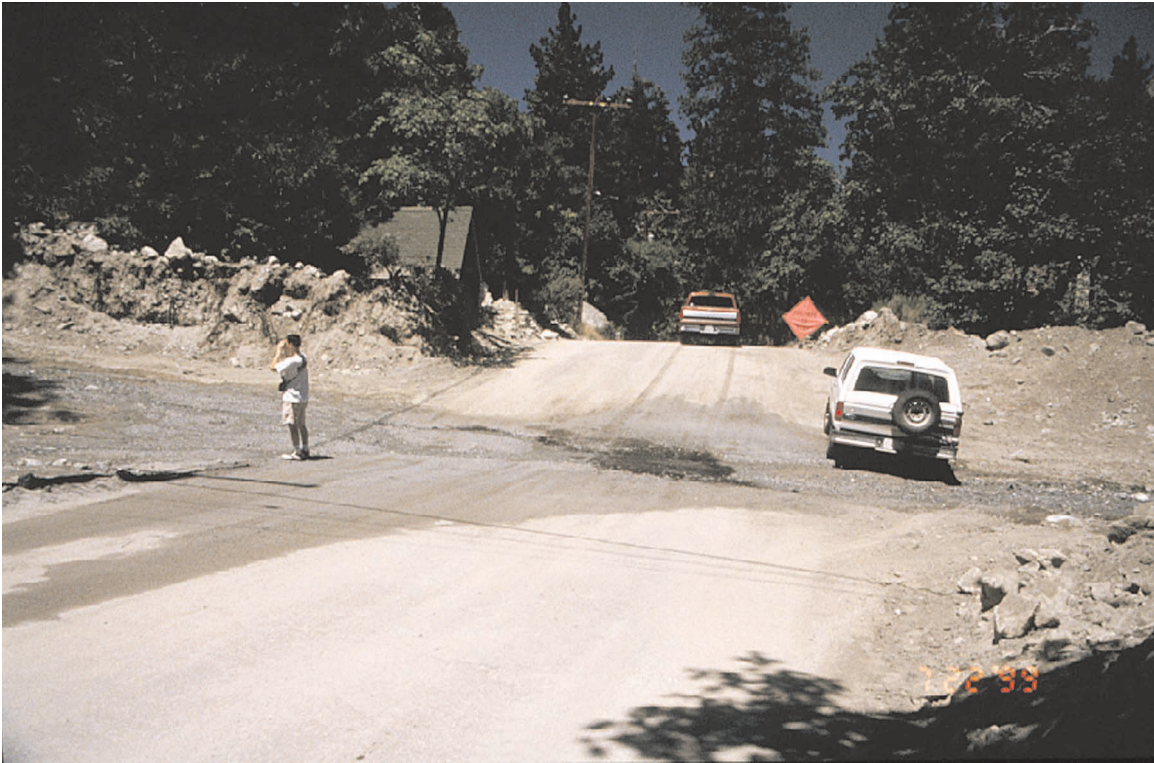
Figure 4. Broad debris flow levee on the lower part of Snow Creek fan where the Valley of Falls Road crosses Snow Creek. View is to the west. Here the levee is several hundred feet in width. Photograph was taken at the crest on the east side of the levee; the near car is at the center of the channel and the far car is on the crest of the west levee. These broad debris flow levees give rise to the rather anomalous setting of a channel occupying the crest of the topographic high.

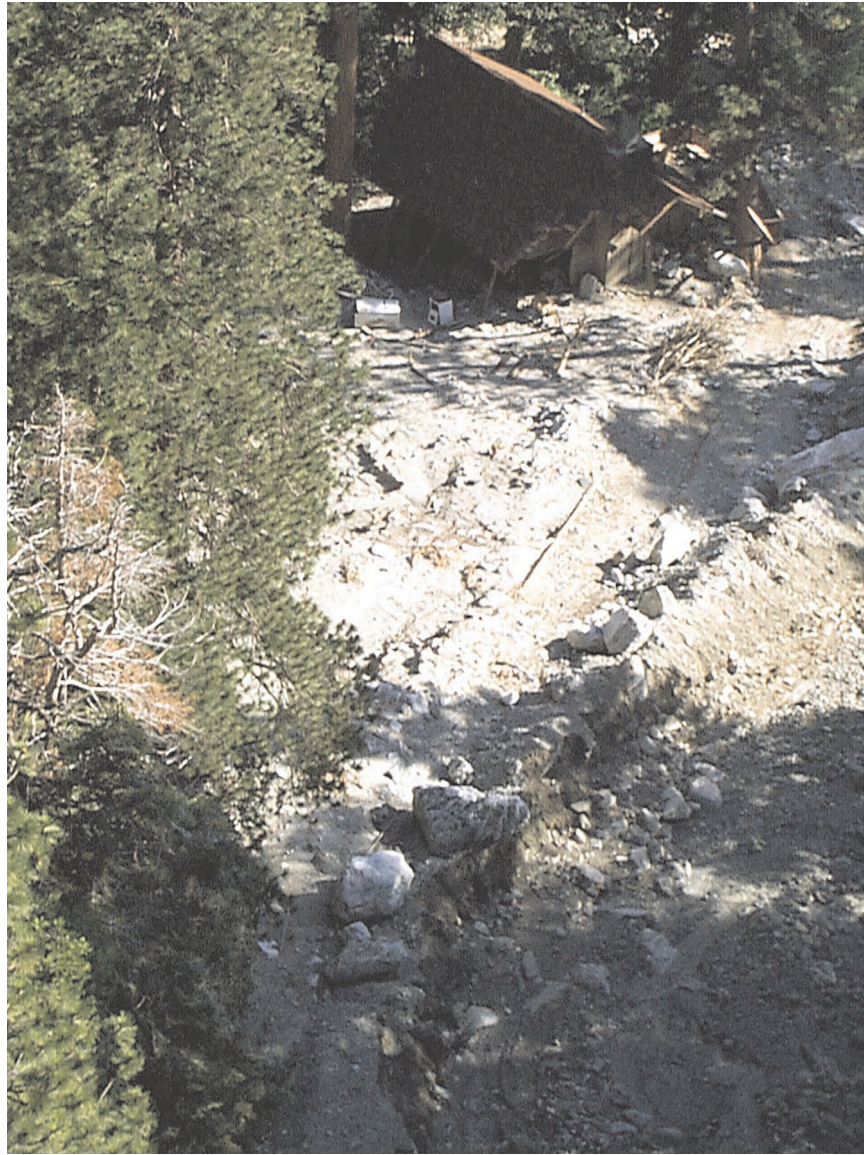
Figure 5. Medial part of Snow Creek fan. In the lower right foreground is Snow Creek debris flow channel with a newly formed, sharp-crested debris ridge. This stretch of the channel is where the debris avalanche of July 11, 1999, shot over the channel wall degrading the debris flow levee and removing vegetation. The sharp crested ridge along the channel was formed by debris flows on July 13, 1999. The house in the background was struck on the left by the 1st debris avalanche surge and struck on the right by the 2nd and/or 3rd surge. Note the flattened trees oriented parallel to the 2nd(?) and 3rd debris avalanche waves. Photograph taken July 15, 1999.

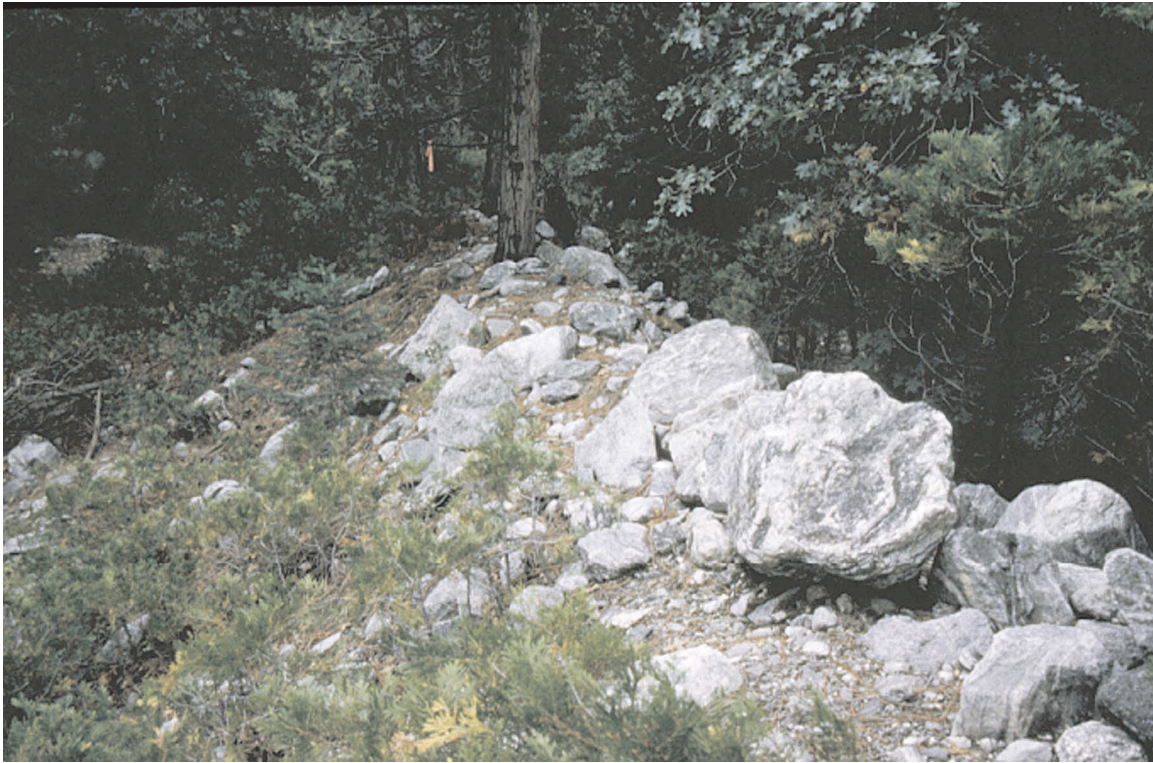
Figure 6. Sharp-crested debris flow ridge on the medial part of Rattlesnake Creek fan. The age of this ridge is over 50 years based on the size of trees growing on the crest of the ridge.

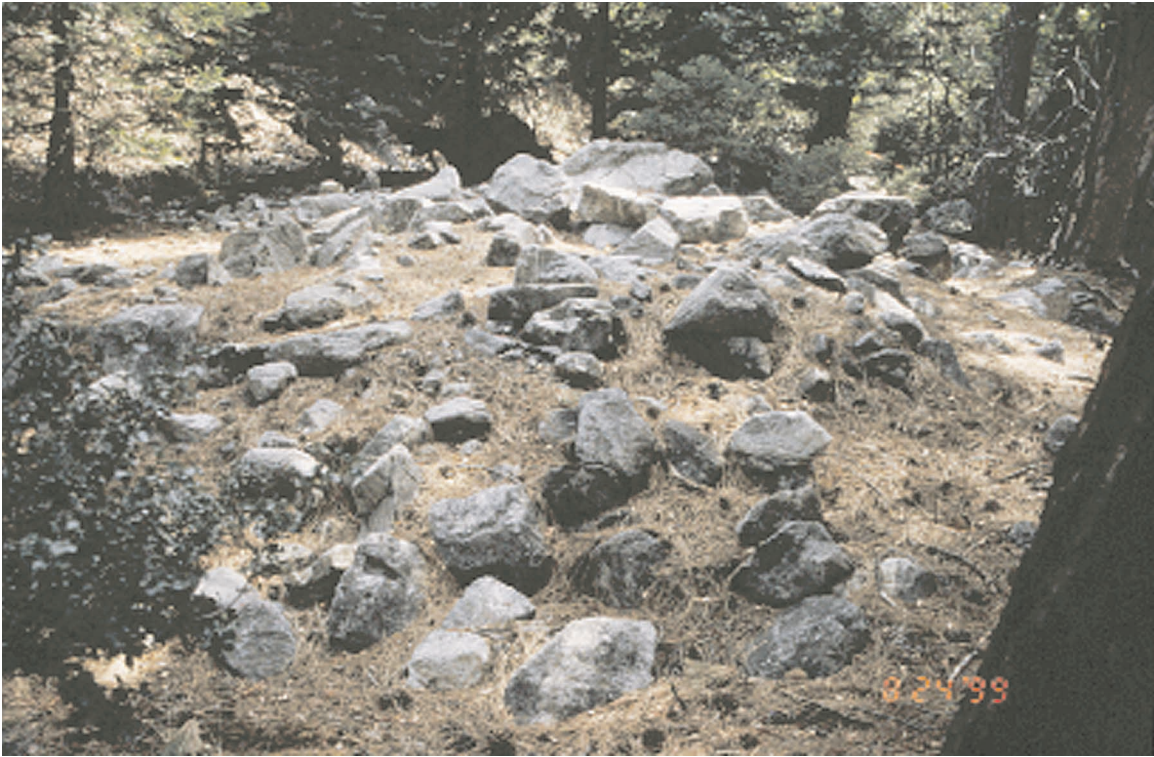
Figure 7. Rocky snout of a slow-moving debris flow on the proximal part of Snow Creek fan. This debris flow is over 250 years based on the age of trees growing on the deposit.

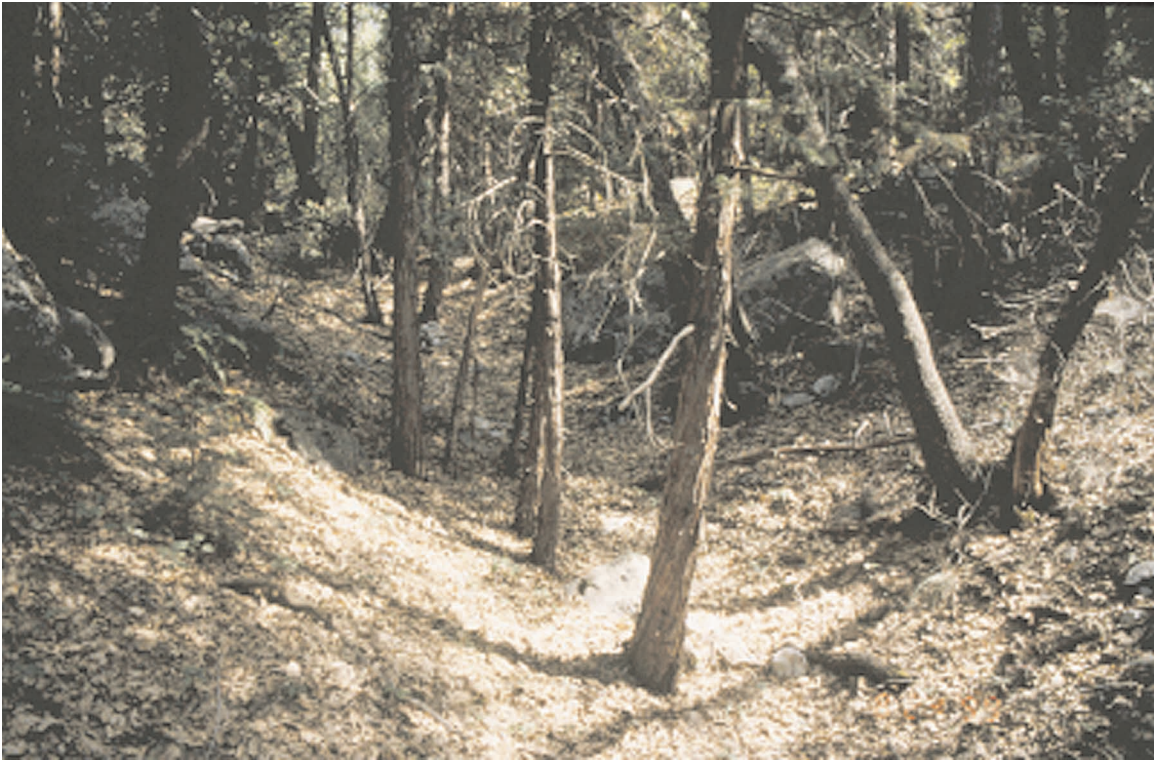
Figure 8. Abandoned debris flow channel on the medial part of Rattlesnake Canyon debris flow fan. This channel was abandoned relatively recently based on the age of the cedar trees growing in the channel.

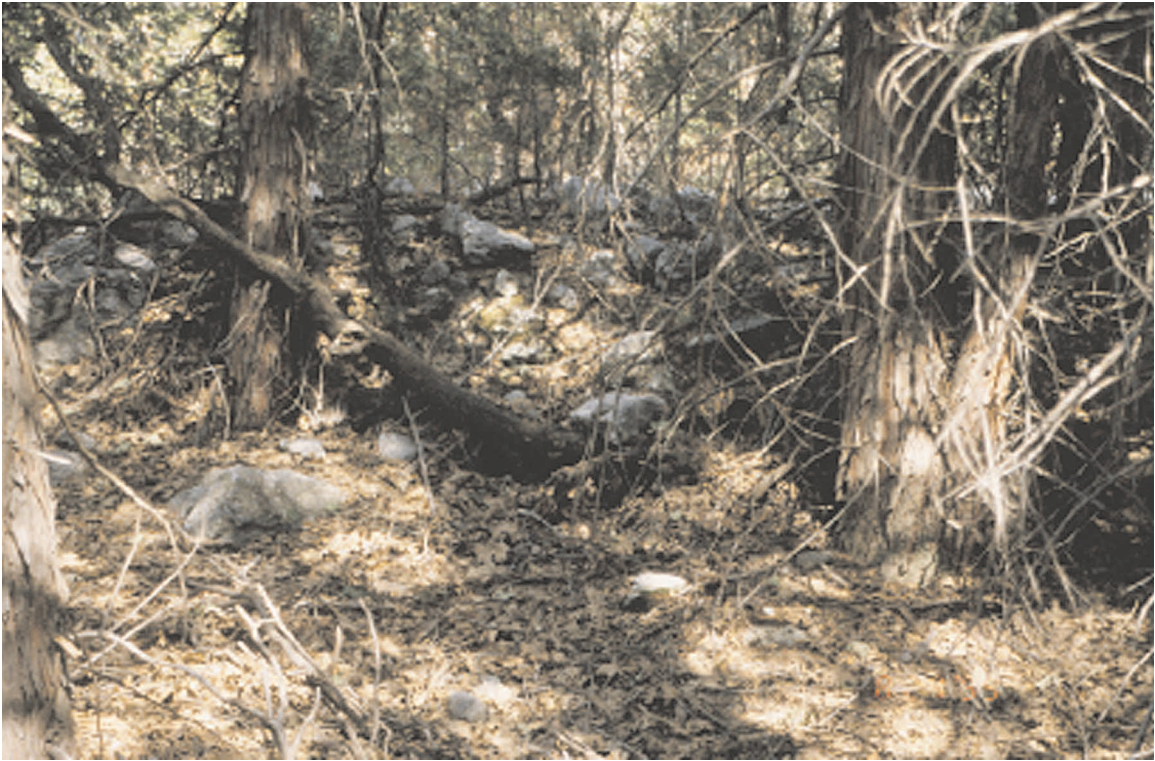
Figure 9. Steep front of broad debris flow snout on the medial part of Rattlesnake debris flow fan. Cedar trees at base of the flow predate the flow and the smaller cedar trees on the upper surface of the flow postdate the flow.

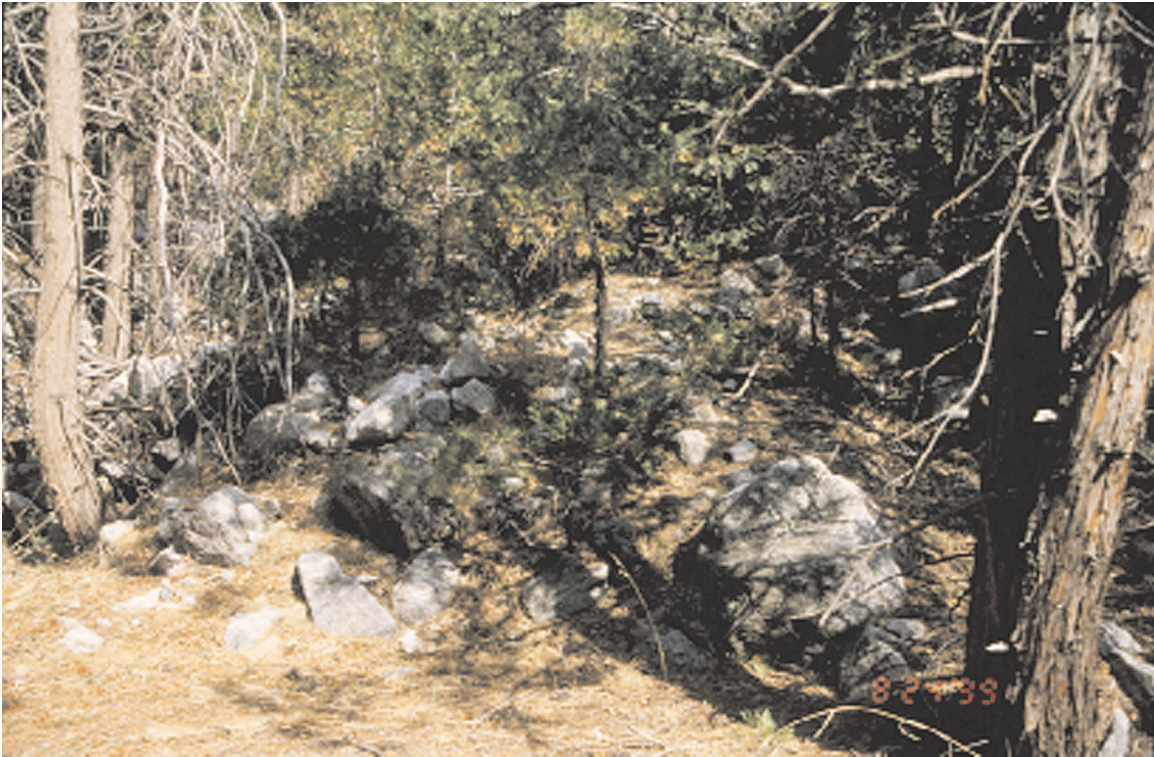
Figure 10. Snout of narrow debris flow on medial part of Rattlesnake debris flow fan. Cedar trees at base of the flow predate the flow and the smaller cedar trees on the upper surface of the flow postdate the flow.

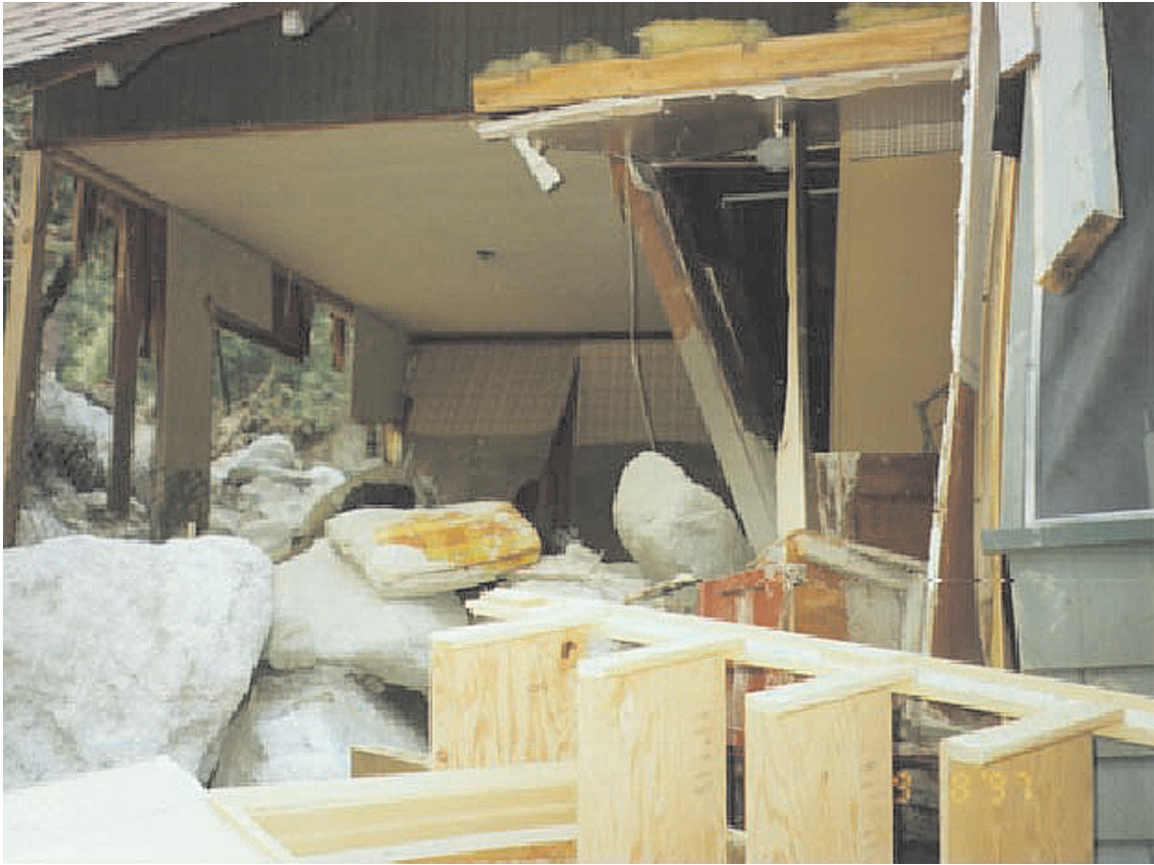
Since 1955, newspaper and other accounts record 11 significant debris flow events at Forest Falls prior to 1999. These debris flows resulted in damage to houses and vehicles (Figures 11, 12, 13, and 14). An Interoffice Memo, San Bernardino County, indicates significant debris flow occurrences in the Forest Falls area prior to 1999 were August 24, 1955; July 30, 1958; August 24, 1961; November 26 and 27, 1965; July 17 and 18, 1984; August 11, 1989; and September 4, 1997. The dates of the recorded debris flows indicate all but the November 1989 events formed in response to short-duration, high-intensity summer monsoon rains. The November events were probably the product of a very localized, intense convection cell, as nearby areas received little if any rainfall during this period.

Figure 11. House damaged by a relatively fast moving debris flow of 1997. The 'clean' nature of the deposit suggests a relatively high water content to the flow. Photograph by W.E. Reeder.

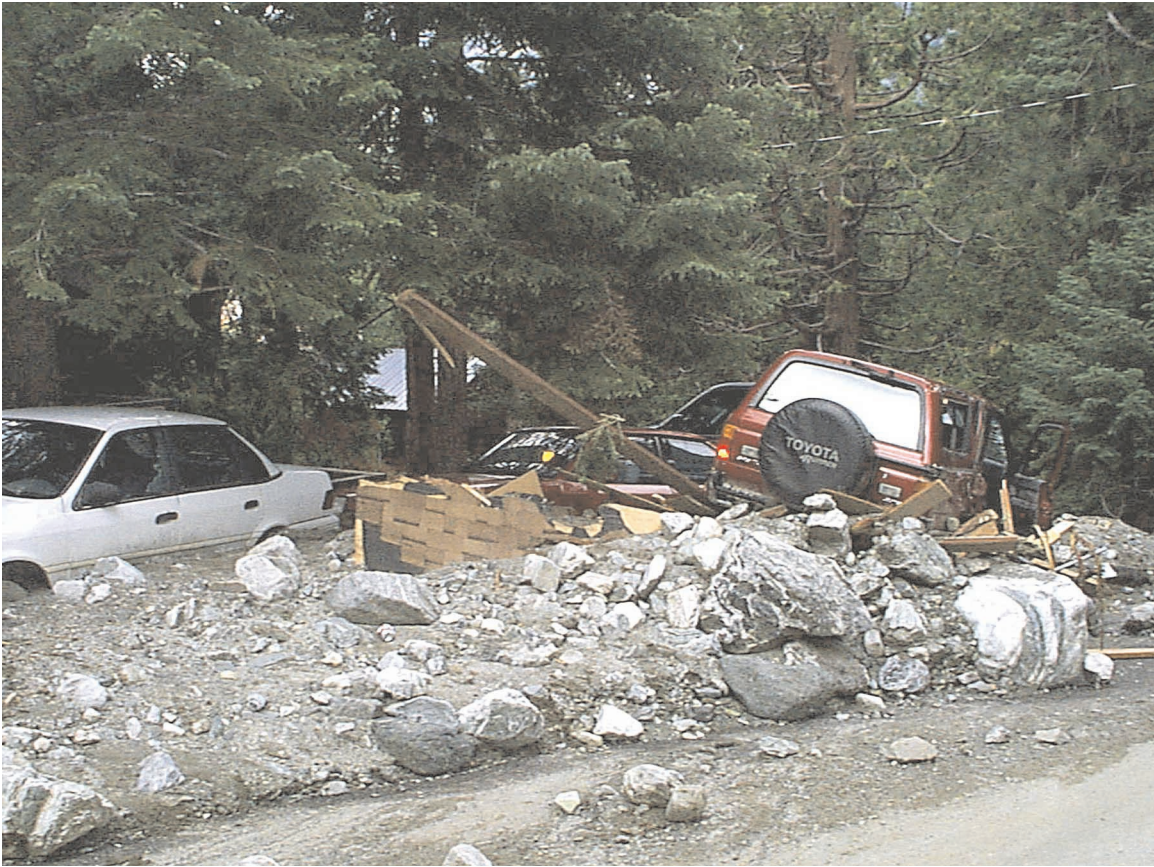
Figure 16. Remnant of the distal part of the 1999, debris avalanche. Note the 'clean' nature of the deposit. The relatively high water content of the avalanche results in the 'clean' aspect to the deposit. Compare this deposit with the muddy deposits of the slow moving debris flow in Figure 15).

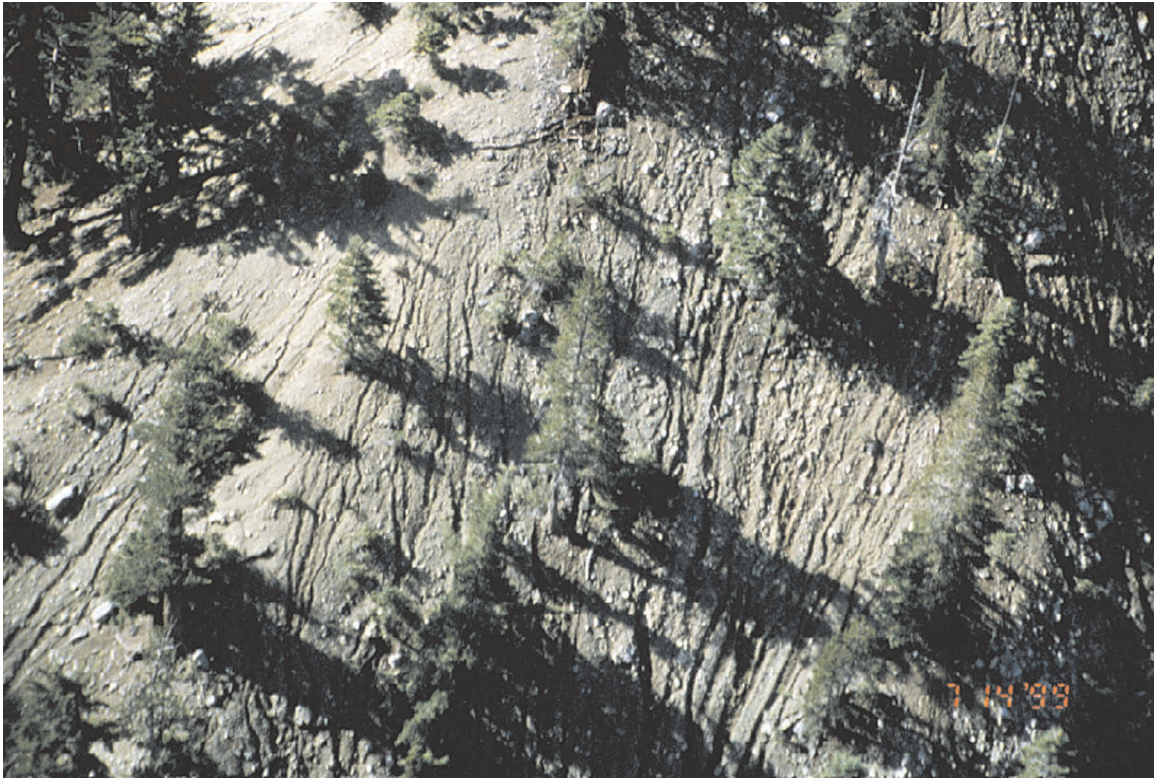
Based on observations made during the aerial survey, Yucaipa Ridge was subjected to extensive sheet wash and rilling on July 11 and 13. Pervasive, relatively large-scale rilling was observed along Yucaipa Ridge (Figures 17 and 18). The debris flows of July 11 and 13 and the avalanche appear to be the result of high intensity rainfall incorporating and mobilizing rilled material from ridge tops and sides. On entering the upper part of the fan, the mobilized rilled material in turn mobilized boulder debris from the canyon floor to develop the debris flows. The floors of the canyons above Forest Falls contain very large amounts of loose debris; the amount of loose debris constitutes potential source material for future debris flows and far exceeds the volume of debris deposited by the flows of July 11 and 13 (Figures 19 and 20). The largest clast transported during the July 11 avalanche is 16 feet in length and weighs approximately 70 tons (Figure 21). This clast is located where the debris avalanche shot over the bank of the debris flow channel of Snow Creek.

Figure 17. Rills on the upper slopes of Yucaipa Ridge. Intense rainfall of July 11 and 13, 1999 produced these rills. The rills are about one foot in width. Photograph taken July 15, 1999.

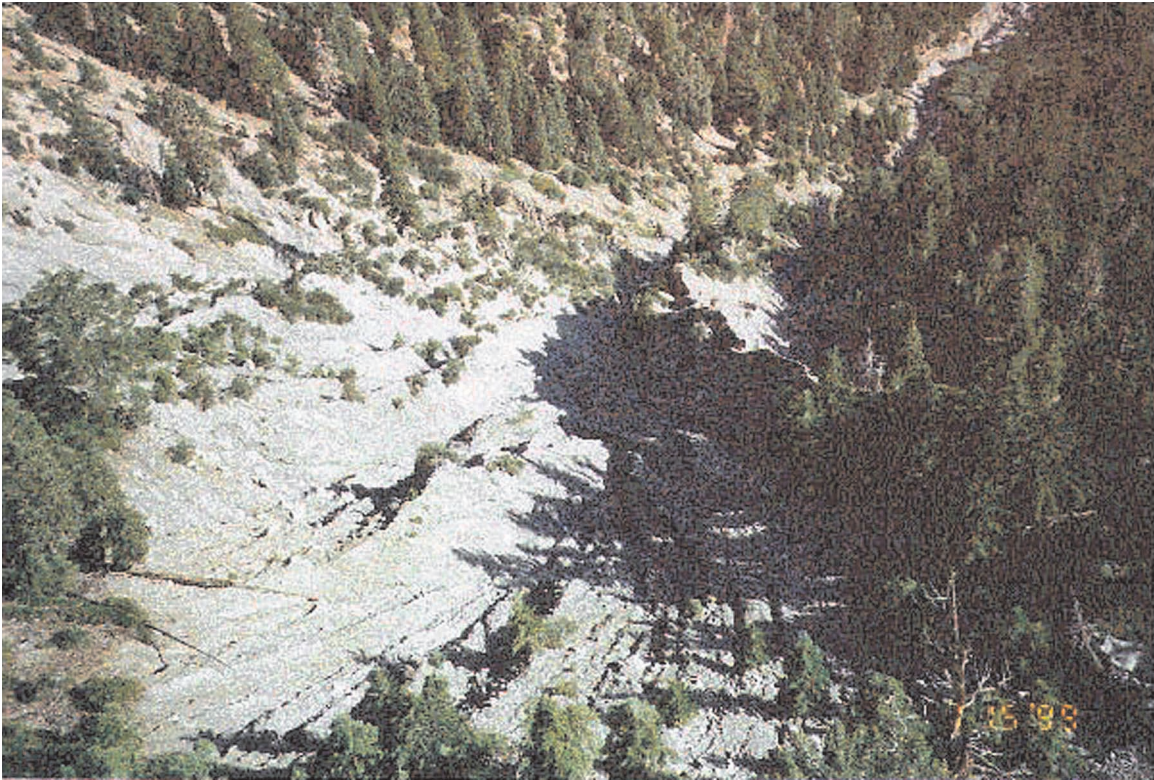
Figure 18. Rills at the head of Snow Creek funneling down slope into a single channel. Note the relatively small grain size to the hillside material and the extensive erosion of this material by the rilling. This photograph is looking down slope from the site of Figure 17. Photograph taken July 15, 1999, W.E. Reeder.

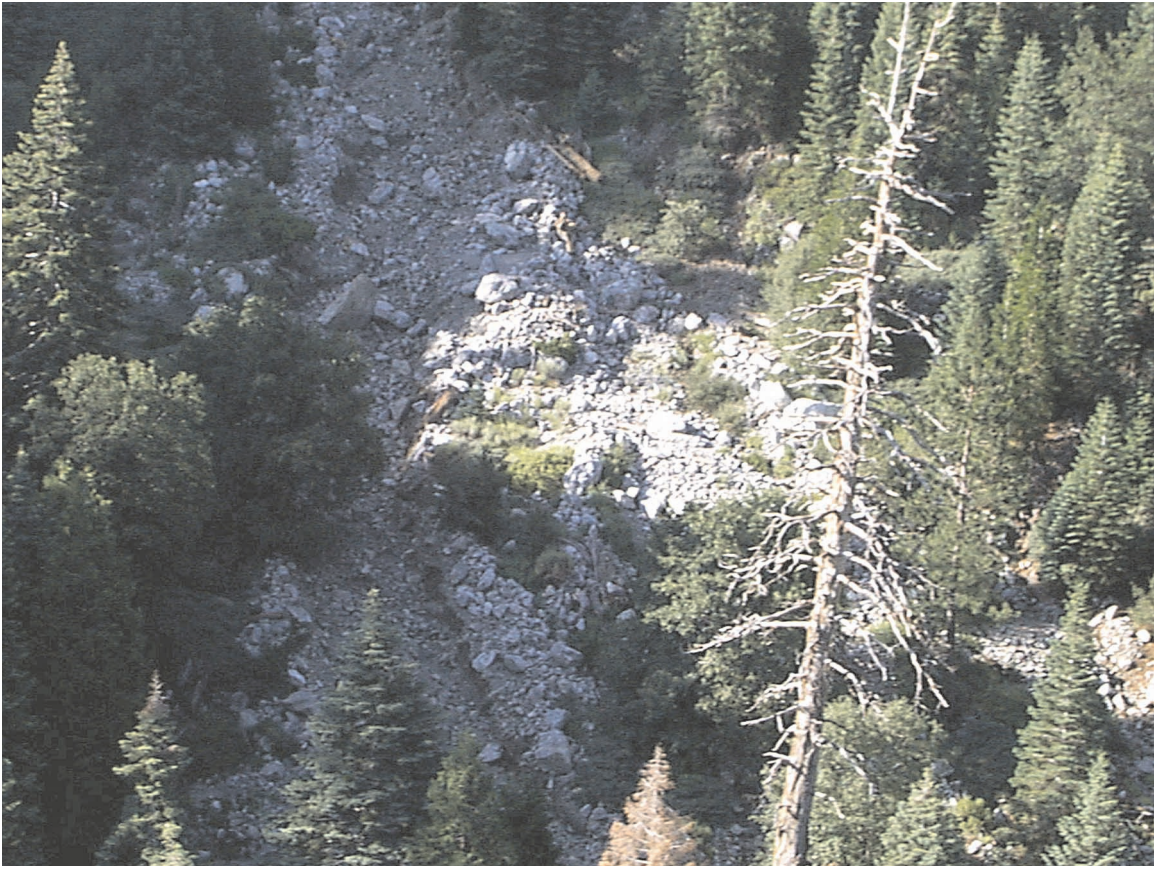
Figure 19. Debris flow deposits in the upper part of Snow Creek at the proximal part of the debris flow fan. There is no debris flow channel developed on the upper proximal part of the fan.

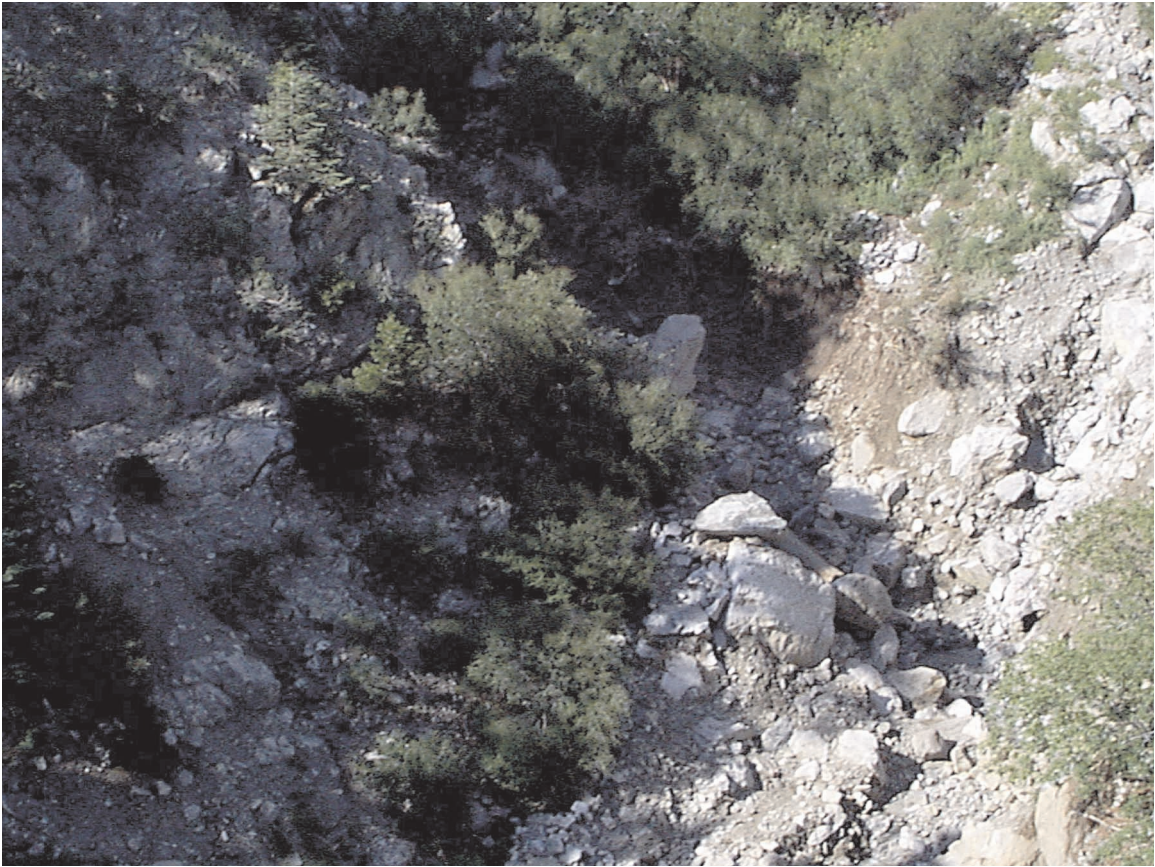
Figure 20. Debris flow deposits on the lower proximal part of Snow Creek debris flow fan. Here, on the right side of the photograph, is a new channel cut by the debris avalanche and debris flows of July 11 and 13. In this reach the relatively fine-grained rilled debris incorporated boulders at the channel was cut. Compare this channel with the well-developed channel in Figure 26. Photograph taken July 15, 1999.

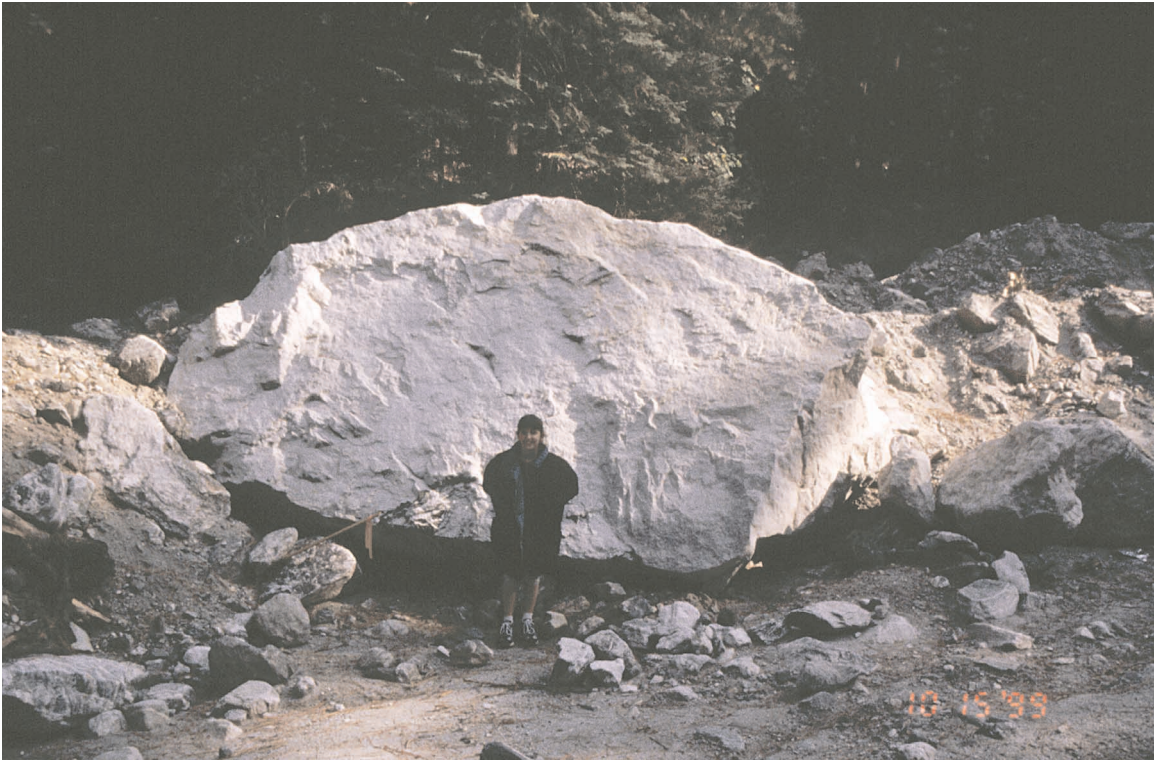
Figure 21. Boulder transported by the July 11, 1999, debris avalanche. The boulder is 16 feet in length and weighs approximately 70 tons. The rocky debris to the sides of the boulder is the result of deepening Snow Creek channel after the channel was partly filled by the debris flows of July 13, 1999.

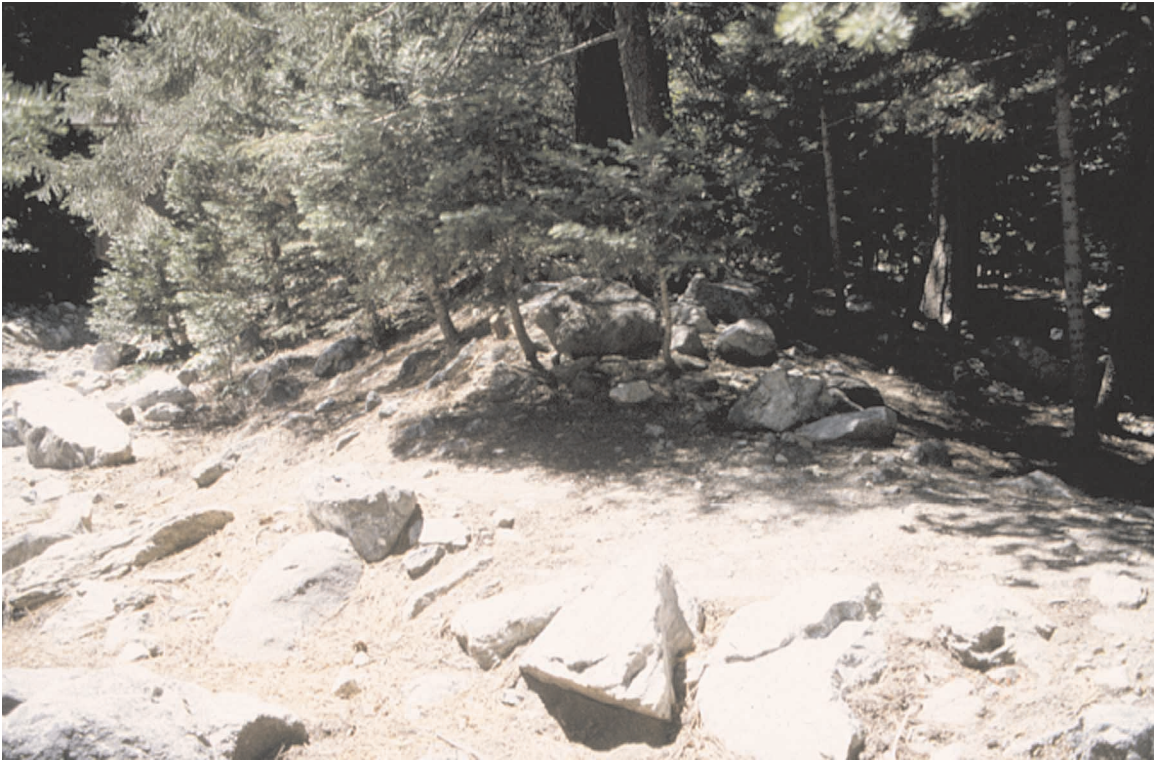
Figure 22. Snow Creek debris flow levee. Debris flow channel to the left of the photograph. The south side of the debris avalanche of July 11, 1999, crossed the levee where the shadows and small trees start. In the foreground the avalanche removed vegetation and surface material.

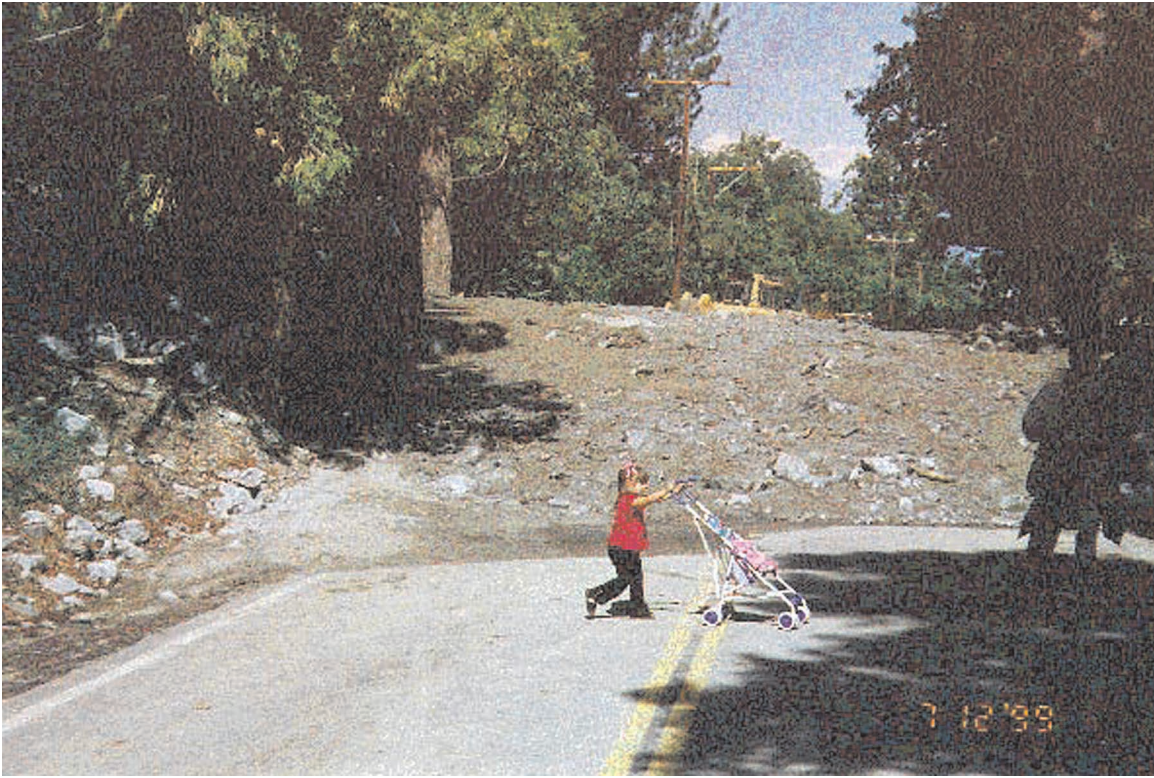
Large, slow-moving debris flows overran the channel walls of Rattlesnake Creek spreading out over the fan and covering Valley of the Falls Drive, the road into Forest Falls, to a depth of over 6 feet and a width of several hundred feet (Figure 23). Included within the debris flows were numerous large boulders, 6 to 8 feet in length (Figures 24 and 25). The currently active debris flow channel of Rattlesnake Creek in the proximal part of the fan is large and well-developed. In the medial part of the fan, slow-moving flows blocked the active channel with debris more than 12 feet deep. A new channel was developed to the west of the blocked channel. The abandoned channel was the course of 1997 debris flows (Figures 26, 27, and 28). Perched remnants of the 1999 debris flows in the abandoned channel indicate the debris flows were at heights of 6 to 8 feet above the fan surface (Figure 29)

Figure 23. Excavation through the July 11th Rattlesnake Creek debris flows, Valley of the Falls Road. Larger boulders are five-seven feet in length. Photograph taken July 12, 1999, W.E. Reeder.

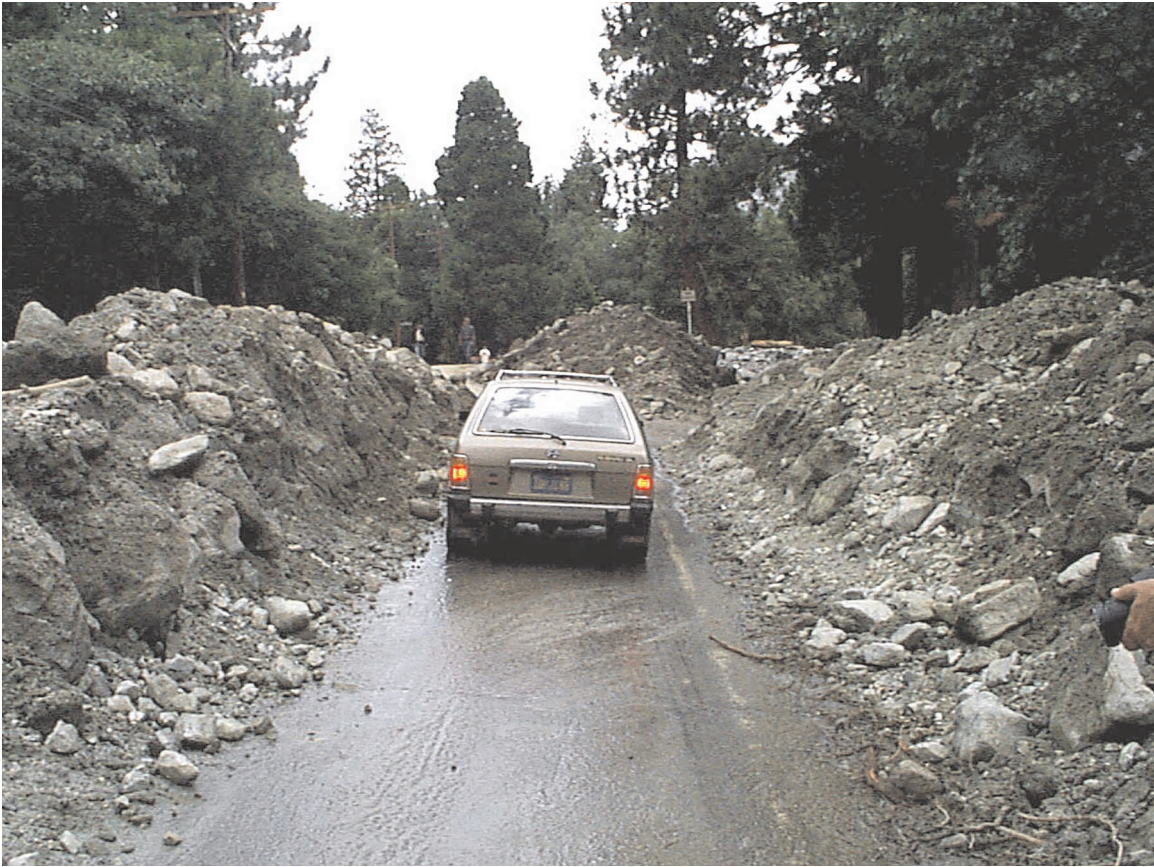
Figure 24. Debris deposited across Valley of the Falls Road by the July 11, 1999, debris flows on Rattlesnake Canyon fan. These deposits cover the road for several hundred feet. Equipment (yellow) is in the process of removing the debris from the road. Photograph taken July 12, 1999.

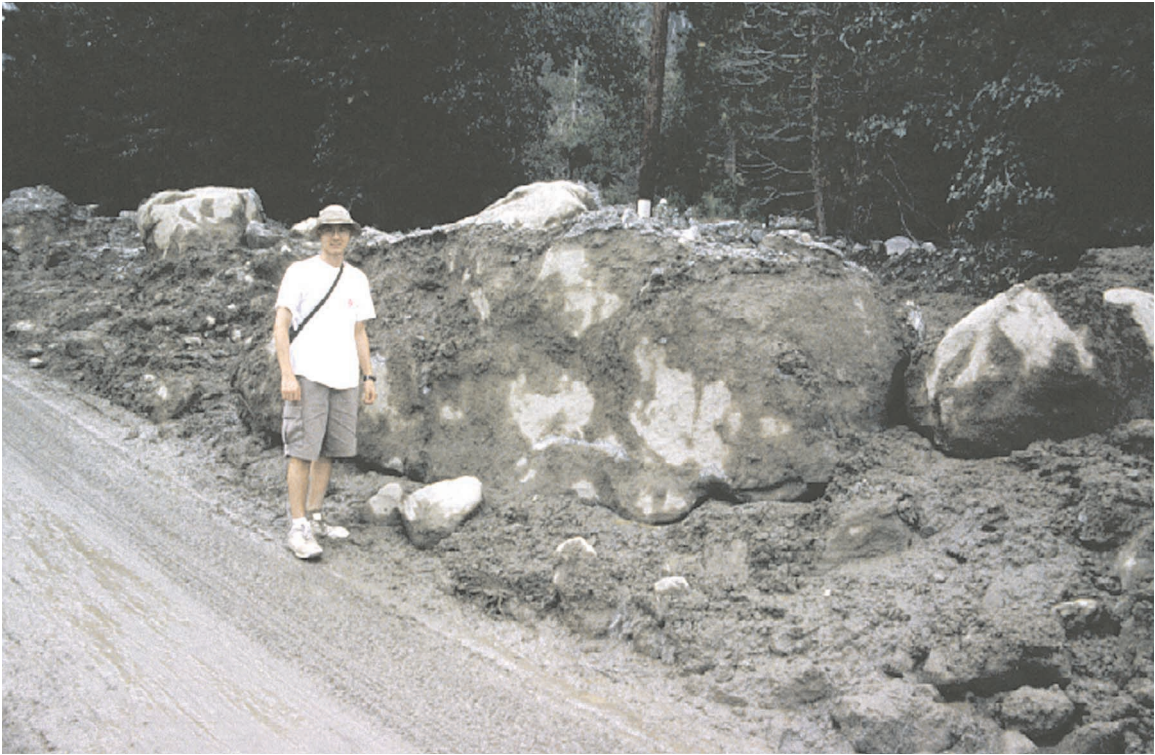
Figure 25. Debris flow deposits, across Valley of the Falls Road. Photograph taken July 12, 1999.

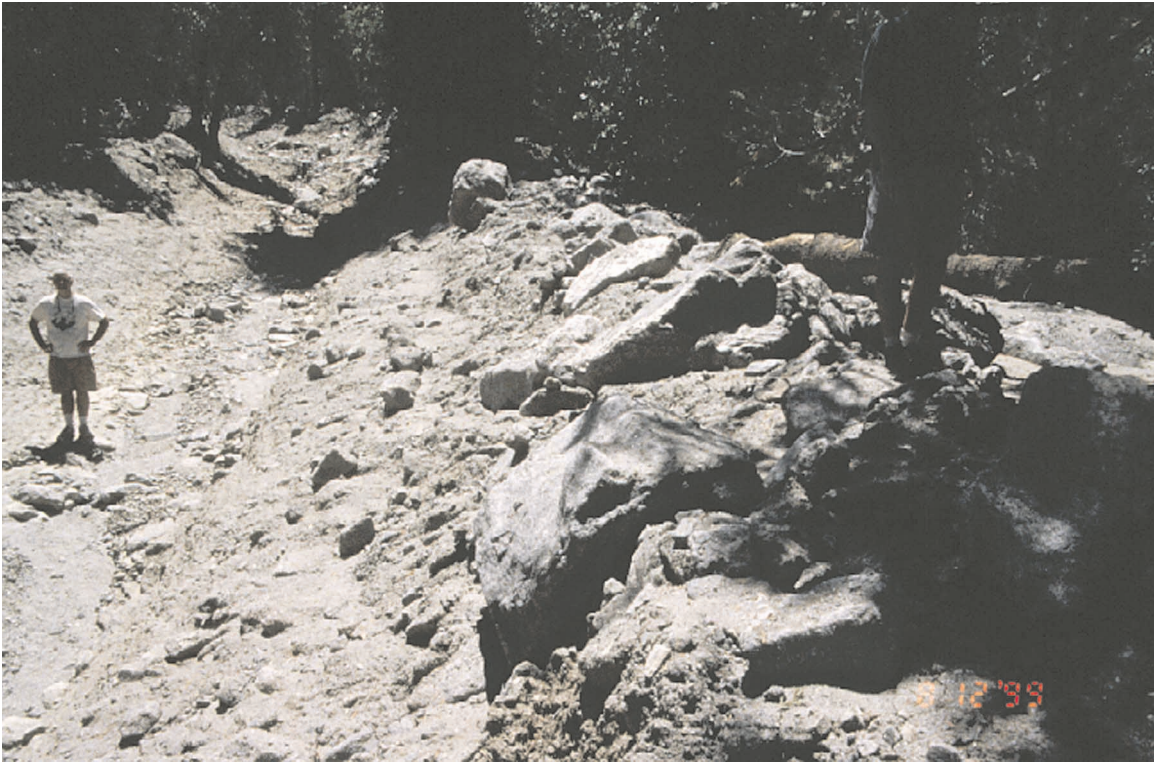
Figure 26. Well-developed debris-flow channel, looking south up the medial part of the Rattlesnake Creek fan. Debris flows of July 11 and 13, 1999, added new debris to the crest of the levee on the right side of the channel.

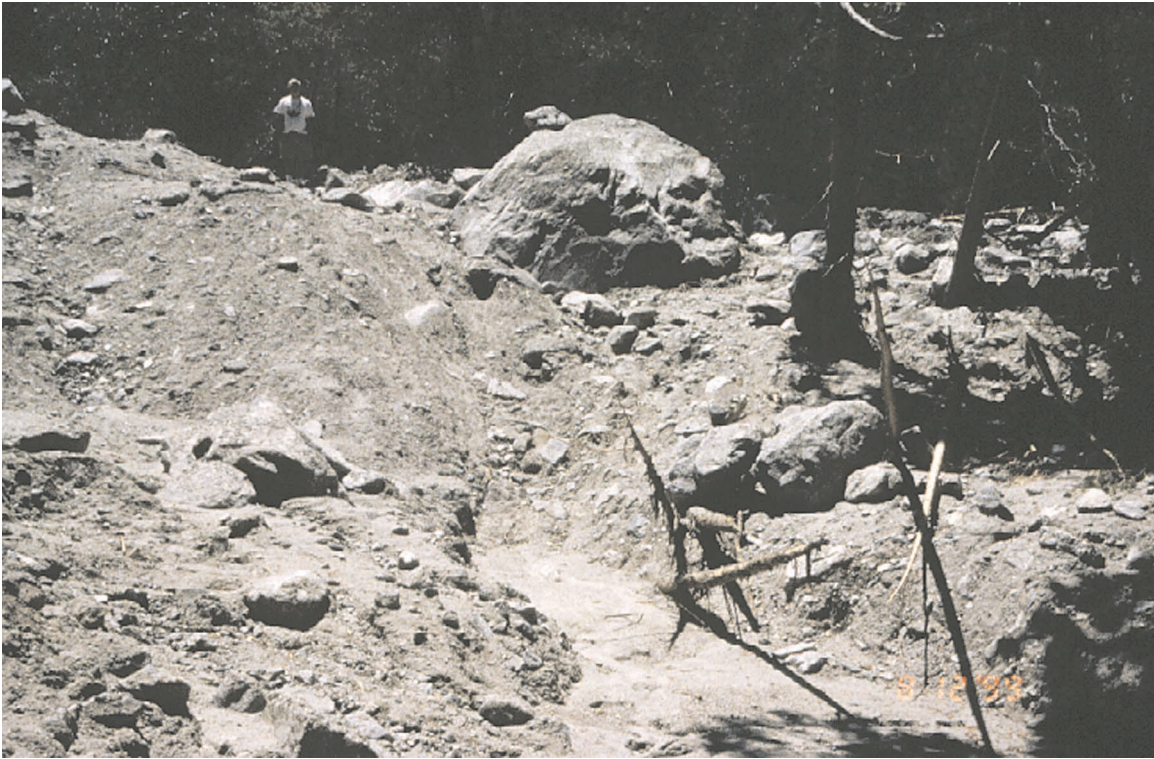
Figure 27. Looking up the blocked part of the Rattlesnake Creek debris flow channel. Person is standing on the top of the snout of the flow that blocked the channel. Figure 26 photograph was taken from the position of the person. Large boulder in center of the photograph is over 10 feet in length. Note the tree trunks in the lower right corner of the photograph that were flattened and debarked by debris flows of July 11, 1999.

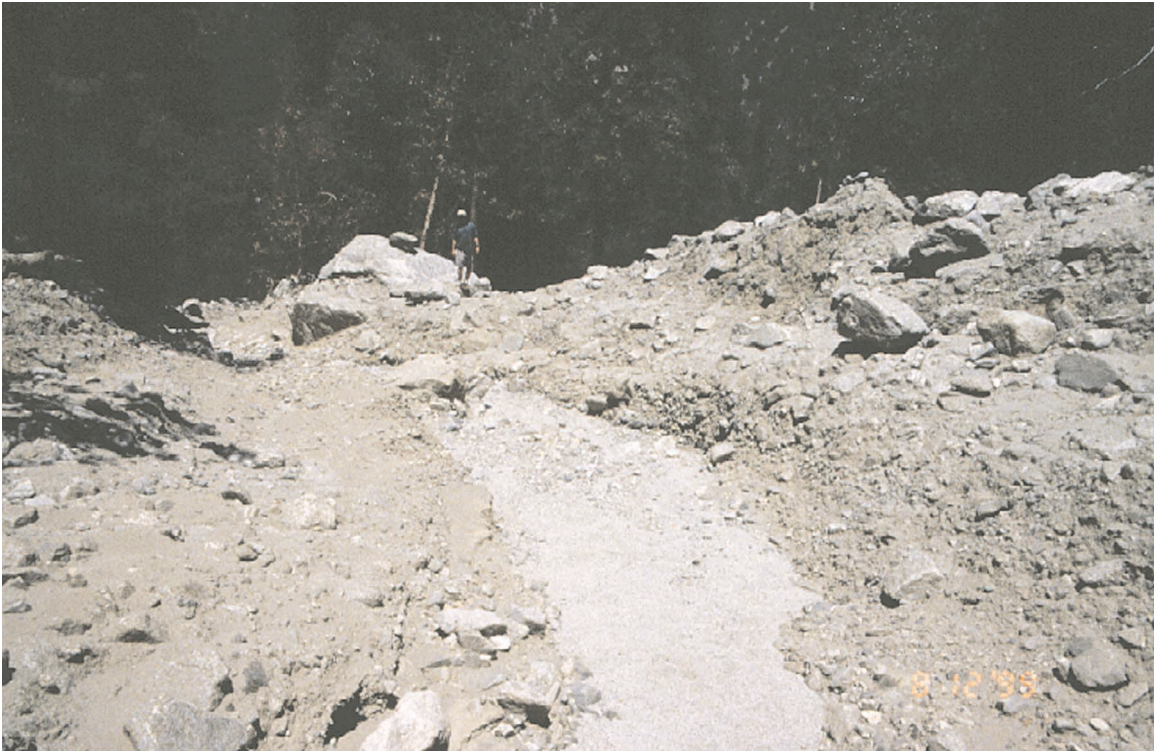
Figure 28. Looking down Rattlesnake Creek channel that was abandoned on July 11 or July 13, 1999, from the position of Figure 27 photograph. Light gray fluvial sand and gravel in channel bottom is the result of water draining from the debris flow that blocked the channel. Large boulder behind the person is about 12 feet in length.

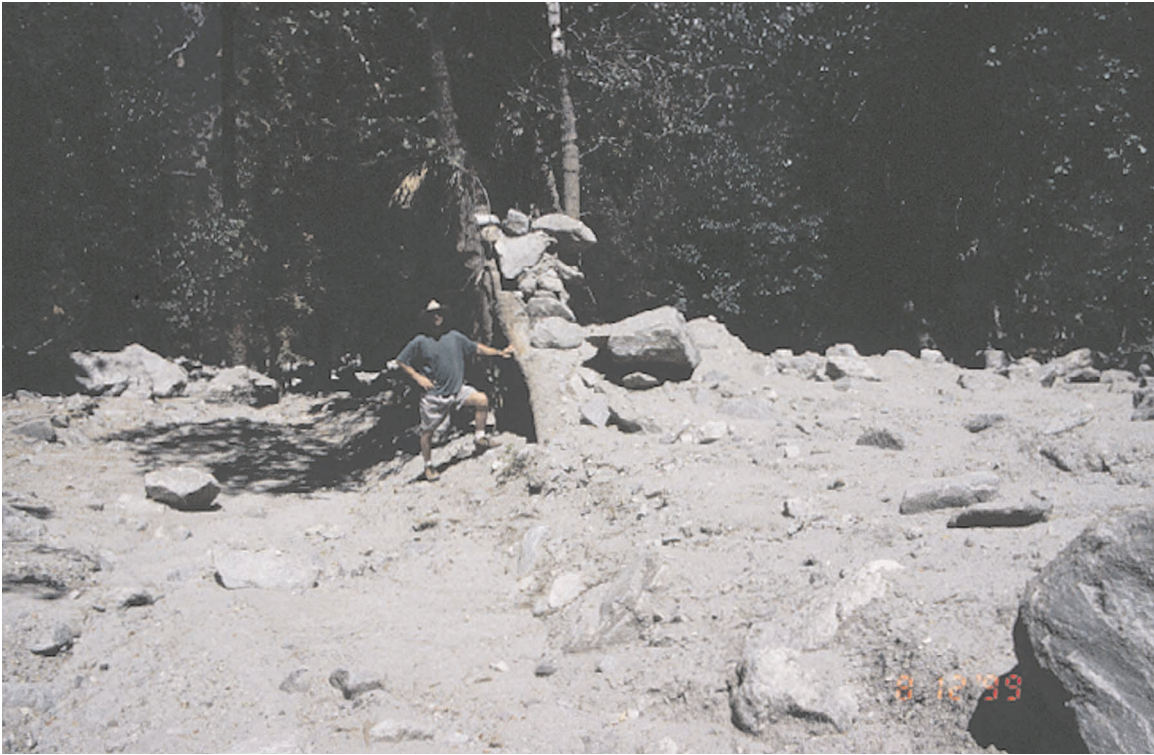
Figure 29. Clasts of the July 11, 1999, debris flows perched in tree, Rattlesnake Creek debris flow channel. The height of these clasts indicates the crest of the debris flows was over nine feet above the channel floor.
