A Debris Avalanche at Forest Falls, San Bernardino County, California, July 11, 1999

By Douglas M. Morton¹ and Rachel M. Hauser¹

Open-File Report 01-146

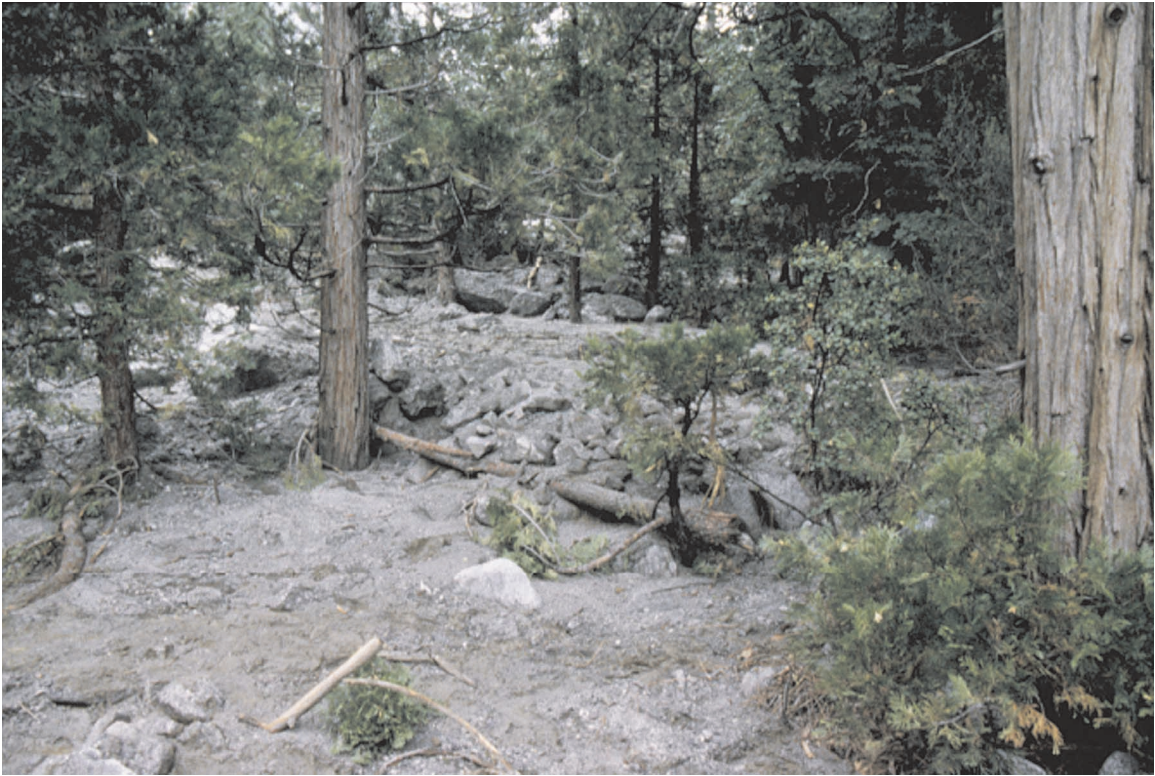
The debris avalanche did not develop the sort of blocky snout that characterizes the more slow moving debris flows (Figures 30 and 31). After exiting the channel the debris avalanche, unconfined by channel wall, laterally spread and thinned as it descended down-fan. If the debris avalanche had been constrained within the channel, it would have perhaps developed a deposit characteristic of debris flows as its velocity decreased.

Figure 30. Snout of a stabilized debris flow of July 11, 1999, on the lower part of Rattlesnake fan. This flow stopped on the surface of a larger flow that deposited debris earlier in the day. Photograph taken July 12, 1999.

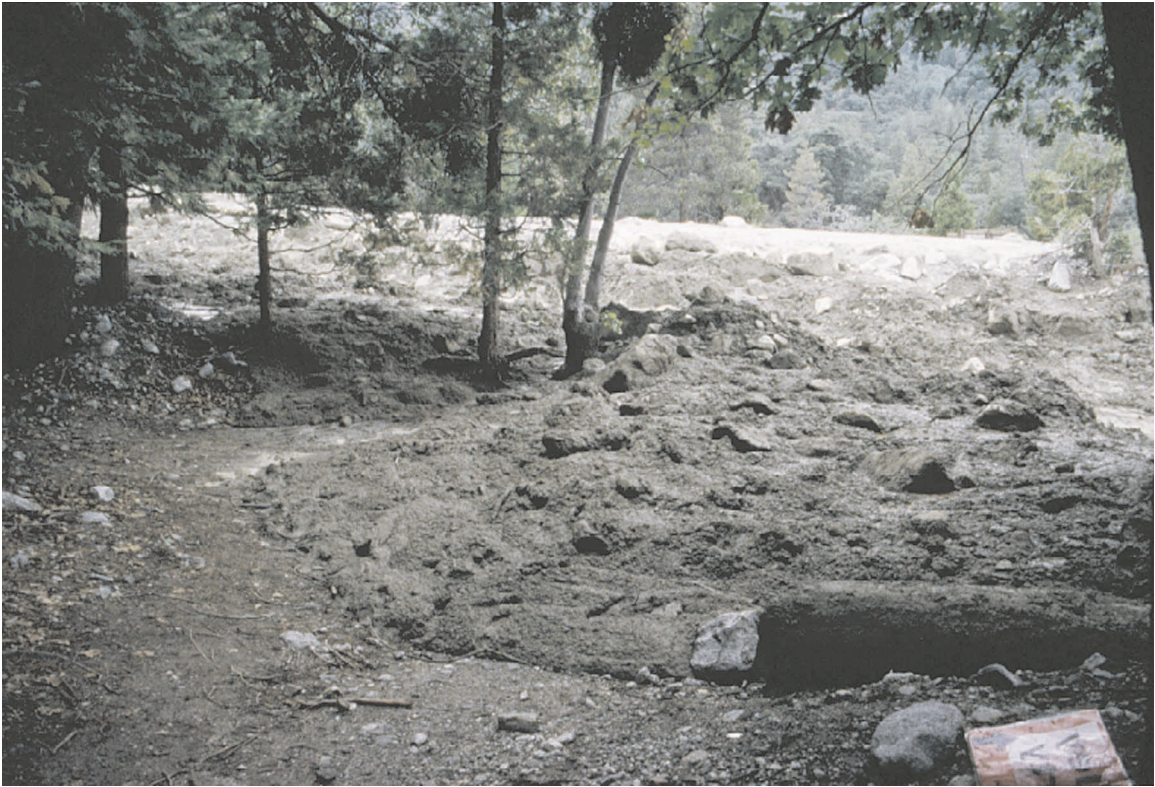
Figure 31. Snout of a stabilized debris flow of July 11, 1999, on the lower part of Rattlesnake fan. The gently sloping snout of this flow indicates the flow was relatively fluid. Note the concrete-like nature of the debris flow matrix.

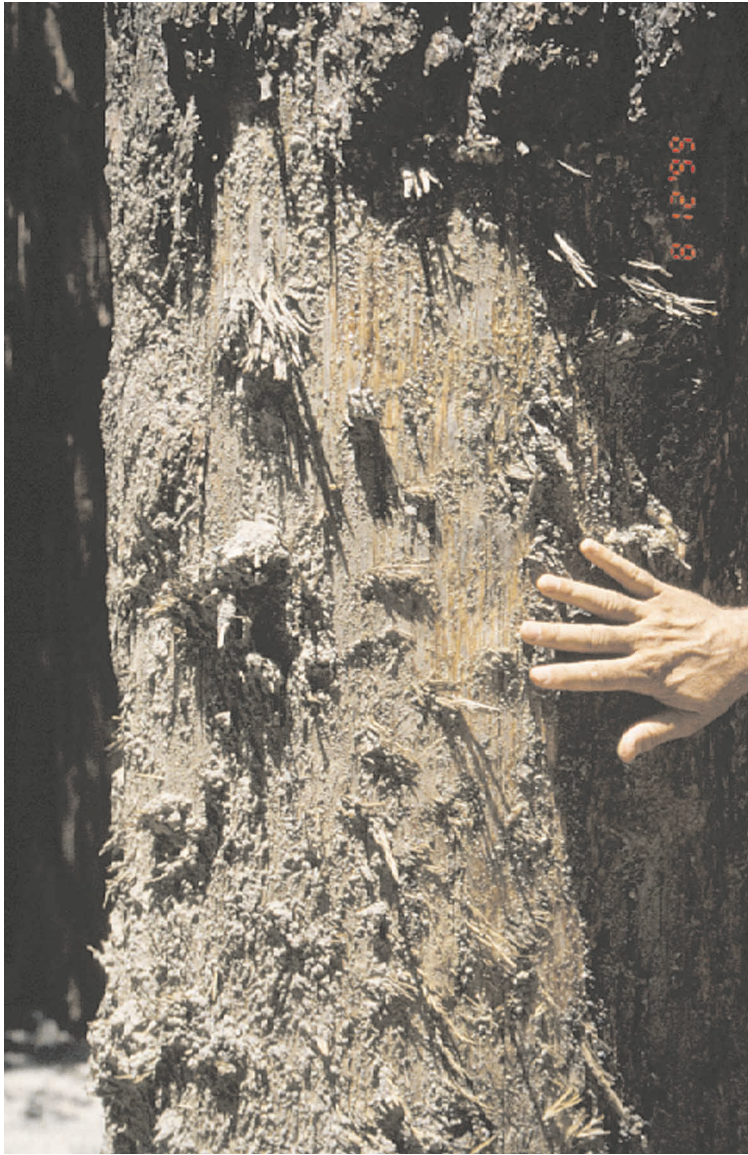
The typical slow-moving debris flows scar the up-fan side of trees, removing bark with little fragmentation of the underlying wood (Figure 33). In contrast, the debris avalanche where it ‘shot-over’ the channel bank cut down trees in the direct path of the avalanche and abraded and splintered the up-fan side of larger trees along the margins of the avalanche and down-slope from the channel (Figures 34 and 35). Rocks were embedded in the fragmented wood of some trees. Some embedded rocks were fragmented on impact with

Figure 33. Tree debarked by debris flows, Rattlesnake Creek. Scar above hand was produced by 1997 debris flows; scar below the hand was produced by a combination of both the 1997, and 1999, debris flows.

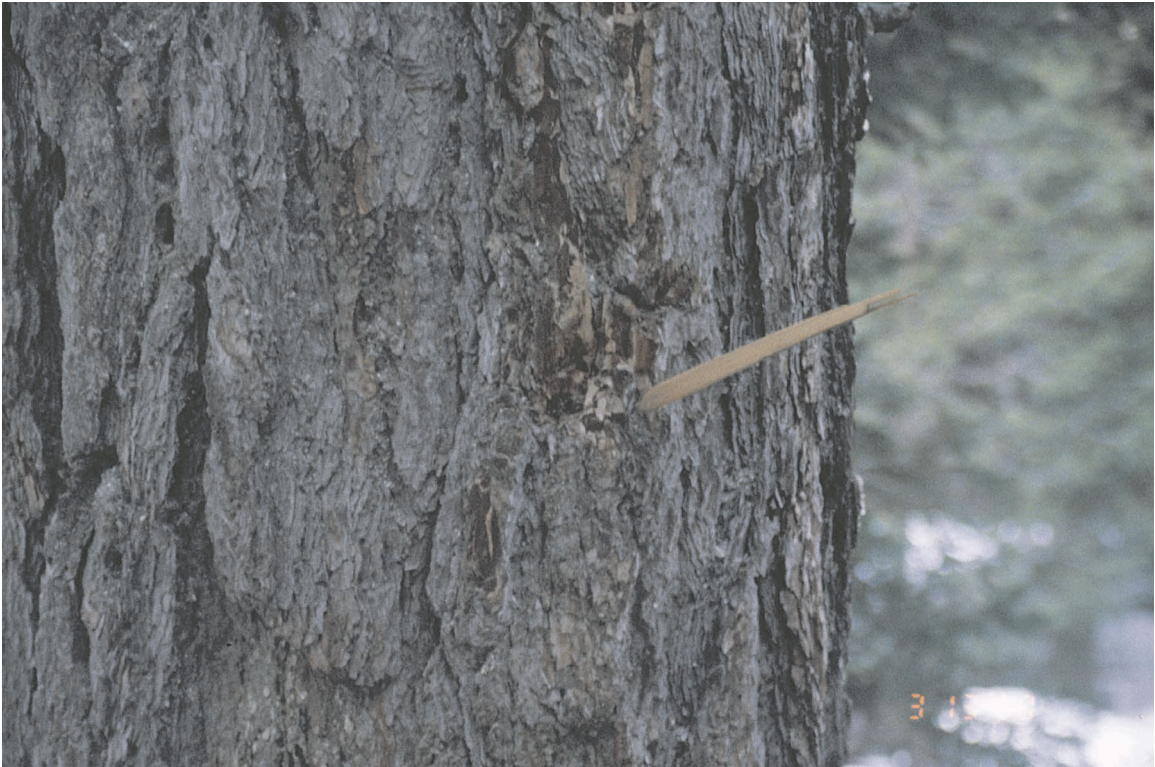
the tree (Figure 36) and some wood splinters from shattered houses flew at velocities great enough to become embedded in trees (Figures 37 and 38). Trees along the margin of the avalanche were scarred similar to the scars produced by debris flows (Figure 39).

Figure 38. Close up of the wood splinter. Splinter is about nine inches in length.

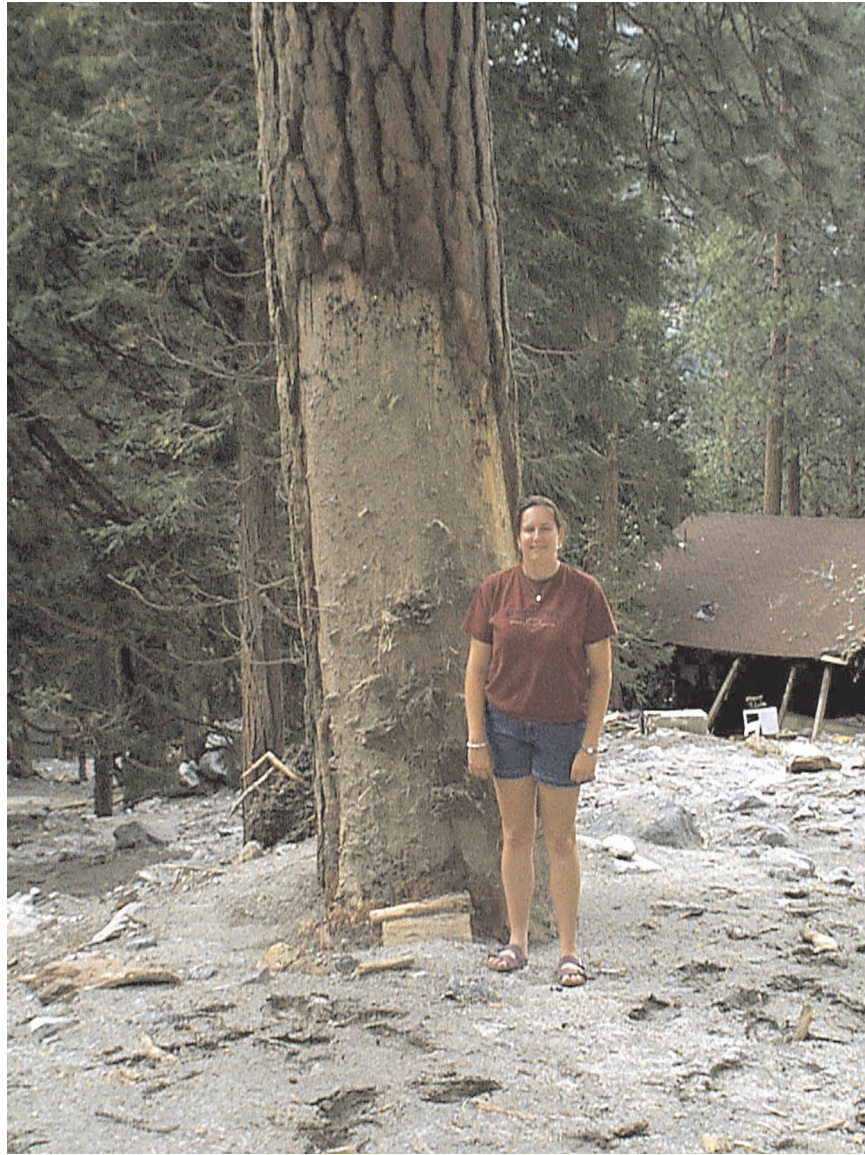
Figure 39. Tree scared by marginal part of the debris avalanche of July 11, 1999. This tree is located about 50 feet from the edge of the debris flow channel wall. Scar is eight feet above ground surface and mud was splattered ten feet above the scar.

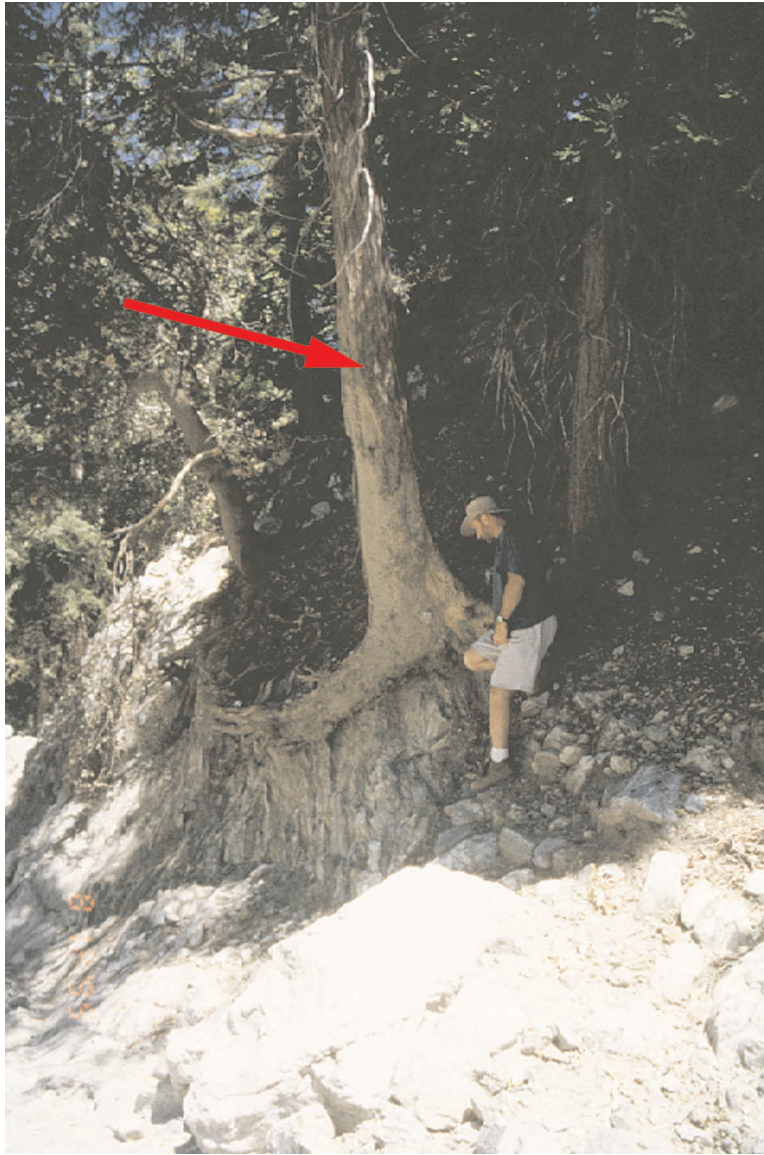
High-velocity flows descending a curving channel are elevated on the outside of the curve much as a bobsled rounding curves. This characteristic is termed “superelevation”. The degree of superelevation is a function of the velocity of the flow, the width of the flow, and the curvature of the channel. Deposits and scars on tree trunks indicating superelevation were observed at three open curves in the debris flow channel upstream from the point where the avalanche shot-over the channel wall (Figures 40 and 41). The ‘apparent’ maximum superelevation observed was 11 feet. Apparent because the low side of debris deposits used in the measurement is likely produced by a later slow-moving debris flow that filled most of the channel and was at a height greater than that on the low side of the avalanche as it descended the curve.

Figure 40. Tree scared on the high side of the superelevated avalanche. This tree is located on the outside of an open curve in the channel. The arrow points to the position where the avalanche scared the tree. Mud splattered to about eight feet above the scar. Note the avalanche did not extend to the right of the tree.

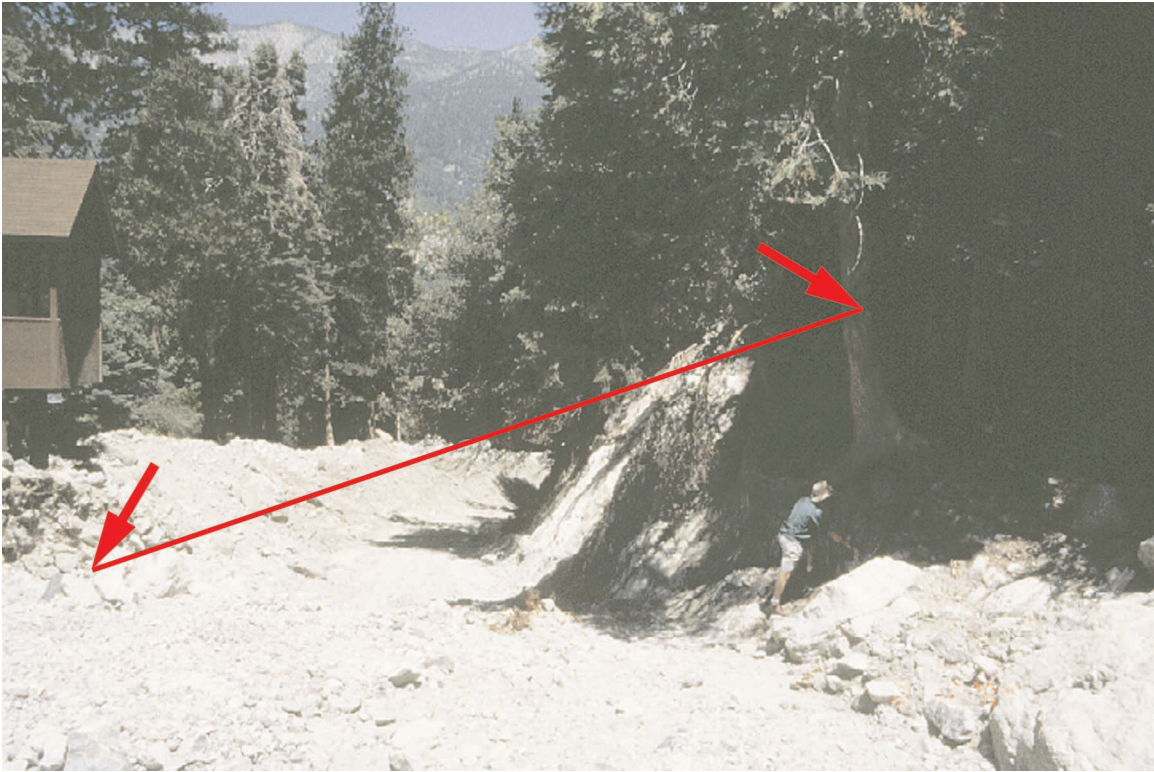
Figure 41. Arrow on the right side of the photograph is on tree is at the same position of the arrow on Figure 40. The arrow on the left side of the channel (below end of brown building) is the maximum elevation of the low side of the superelevated avalanche. The minimum elevation difference between the high and low side of the avalanche is 11 feet. This photograph was taken after the debris flows of July 13, 1999, and the arrow on the left side of the photograph probably is the height of the debris flows of July 13, 1999, rather than the debris avalanche of July 11. Thus the velocity determined for the debris avalanche at this site is a minimum velocity.

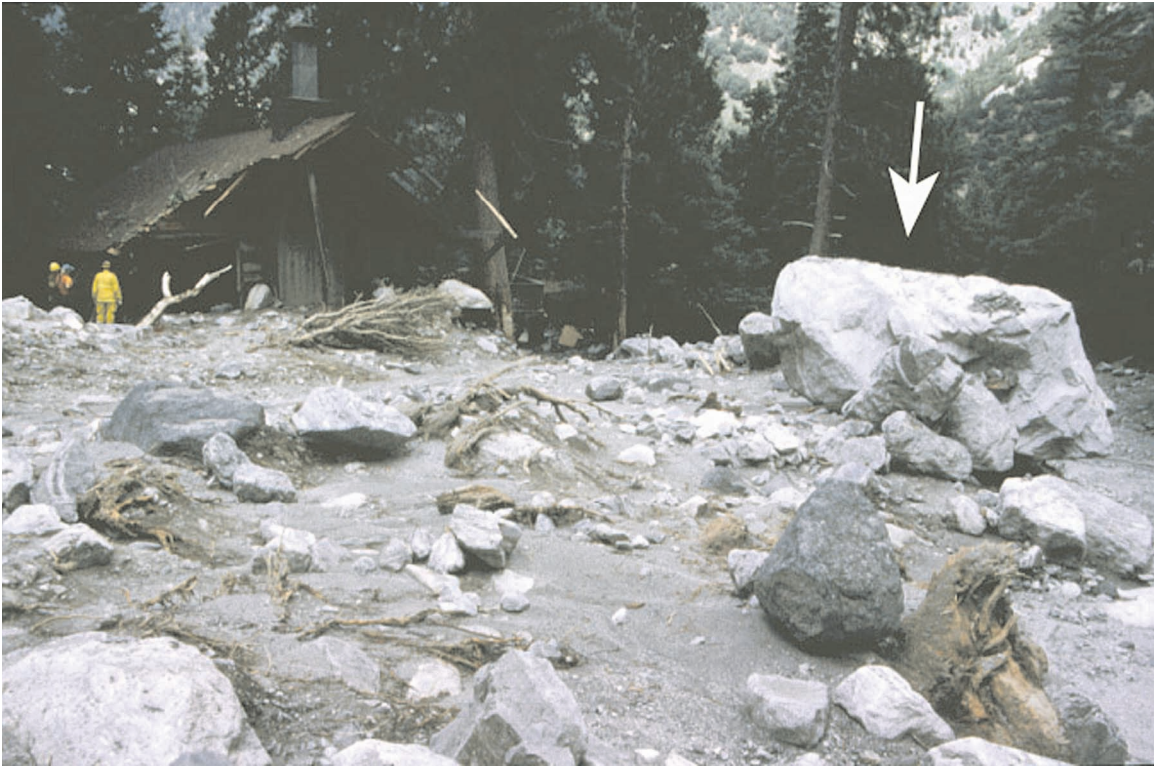
The debris avalanche at Snow Creek eroded the debris flow levee surface where it shot over the channel bank. The fast-moving avalanche stripped vegetation and oriented flattened trees parallel to the flow direction (Figures 46, 47, 48, and 49), flattened automobiles (Figures 50 and 51) and wreaked destruction of everything in its path for a short distance below the channel (Figures 52, 53, and 54). More than 100 feet beyond the channel wall, the upstream side of larger trees in the path of the avalanche were shattered and contained embedded small clasts of gneiss and granite. Further evidence of the turbulent and violent nature of the debris avalanche is an impact scar on trees that were produced by rocks thrown to heights of 6 to 8 feet above the main mass of the avalanche (Figure 55). Along the spreading margins of the avalanche bark was stripped from trees to heights of eight feet above the fan surface and mud splattered an additional 10-15 feet. Also suggestive of high velocity was the wood splinter that impaled a tree trunk about 300 feet beyond the channel.

Figure 46. Swept landscape produced by the avalanche. Large boulder (arrow) moved in the avalanche is 16 feet in length (see Figure 21). Note the 'swept' appearance of the surface. House in background was struck on the left side by the 1st 'wave' and the right side by the 2nd and/or 3rd 'wave'. Photograph taken July 12, 1999.

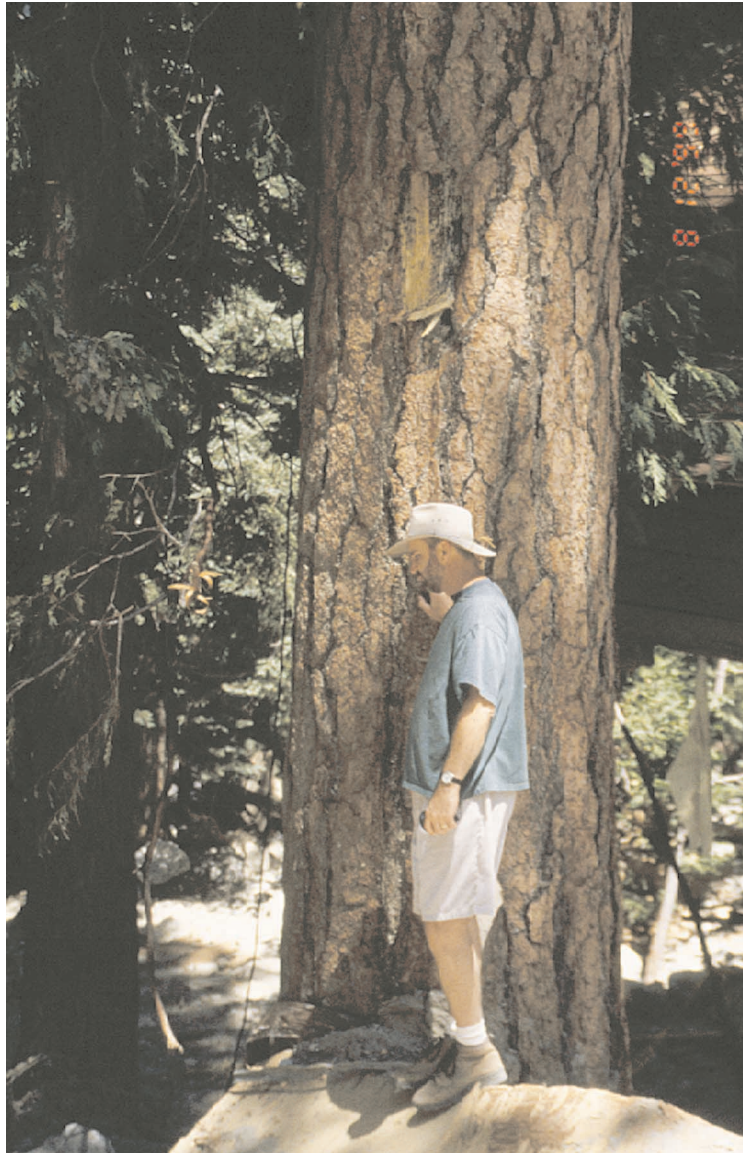
Figure 55. Scar produced by a thrown rock eight feet above the surface of the avalanche.

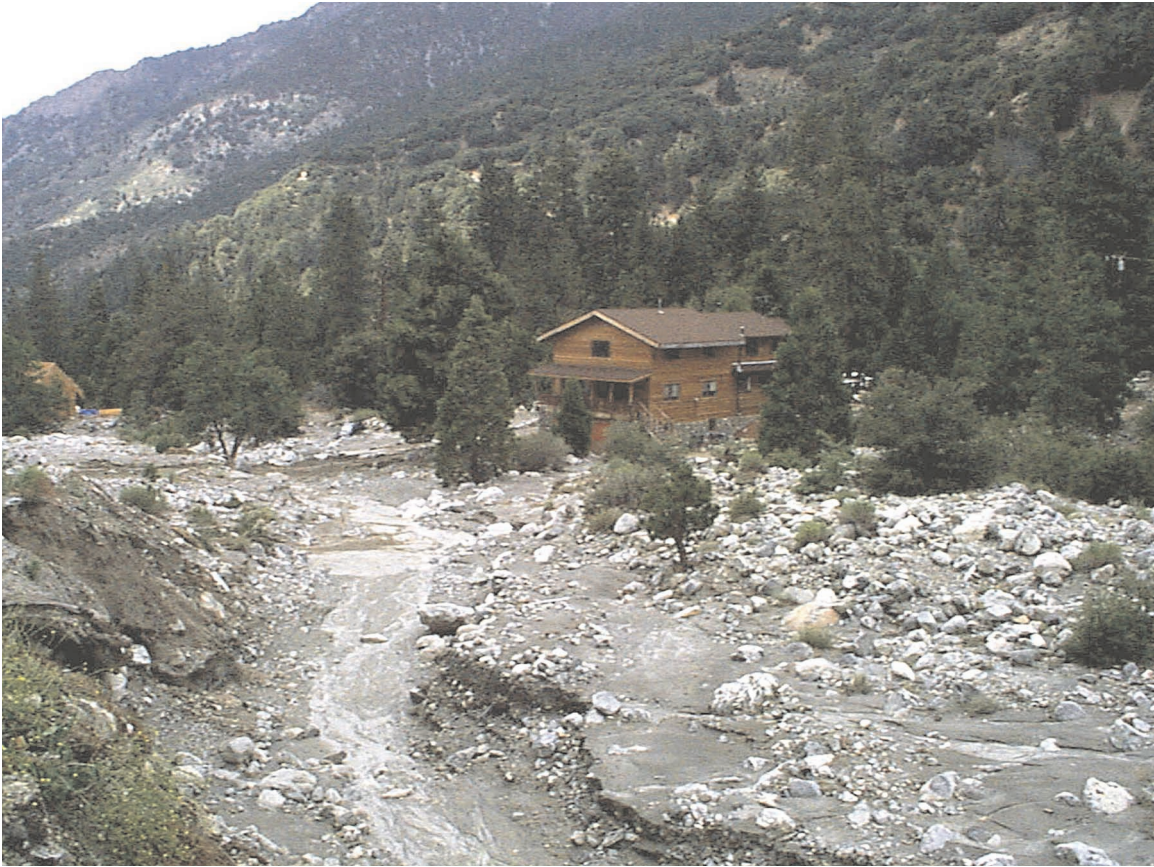
During periods of debris flow activity at Forest Falls, Mill Creek (Figure 3) apparently has high discharge. Debris flows entering Mill Creek are almost immediately diluted by the volume of water in Mill Creek which winnows matrix from the debris flows. This results in a normal fluvial aspect for the sediment in Mill Creek (Figure 57). The large boulder clasts that were transported by suspension in the matrix of the debris flows, move down

Figure 57. Fluvial deposits in the main channel of Mill Creek. Note the rounded nature of the clasts in contrast to the angular clasts in the debris flow and debris avalanche deposits.
