Assessment of Landslide Hazards Resulting from the February 13, 2001, El Salvador Earthquake

A report to the Government of El Salvador and
the U.S. Agency for International Development

Open-File Report 01-119
On-line Edition

U.S. Department of the Interior
U.S. Geological Survey

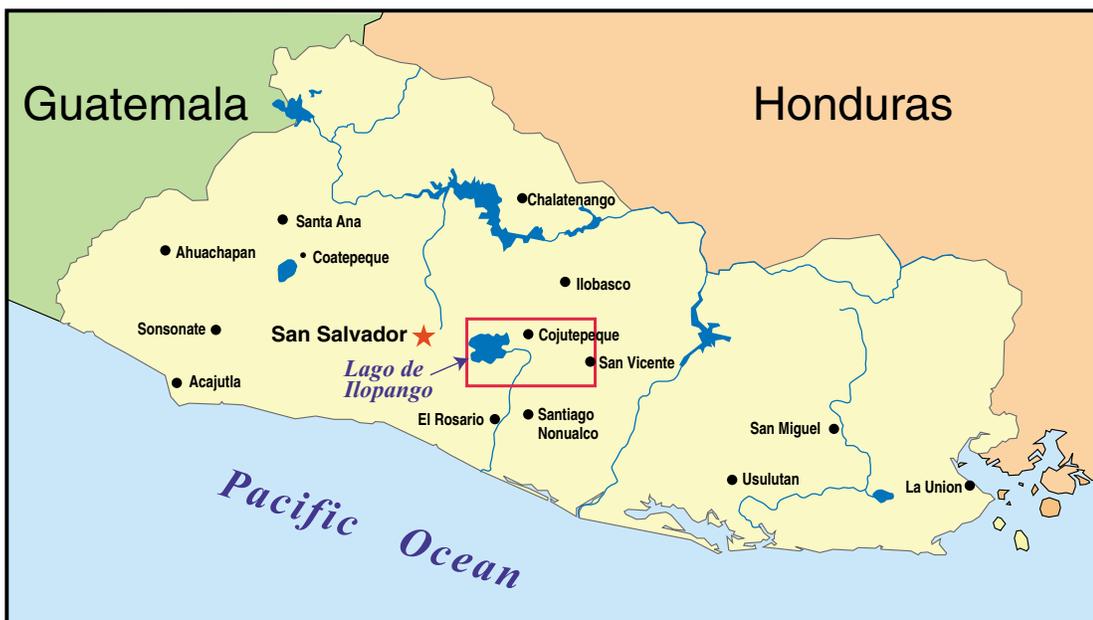
On February 13, 2001, a moment magnitude (M_w) 6.5 earthquake occurred about 40 km east-southeast of San Salvador, El Salvador, in the area east of Lago de Ilopango. The earthquake triggered thousands of landslides that are concentrated in an area of about 2,500 km² near the earthquake epicenter (figs. 1 and 2). The epicentral area is underlain by thick deposits of late Pleistocene and Holocene rhyolitic tephra and pyroclastic deposits erupted from the Ilopango caldera. The earthquake shaking triggered thousands of falls and slides in the steep-sided valleys that are incised into the tephra deposits. Most of the failures are shallow (<10 m thick) and less than 1000 m³ in volume, but they are so highly concentrated and locally abundant that they coalesce into nearly continuous failures along many canyon walls (fig. 3).

Figure 1. Map of El Salvador showing the approximate area (red rectangle) of abundant landslides associated with the February 13, 2001, M_w 6.5 earthquake. Most of the landslides were in areas underlain by thick deposits of young rhyolitic tephra erupted from Ilopango caldera, which is now filled by Lago de Ilopango. See figure 2 for detailed map of the area.

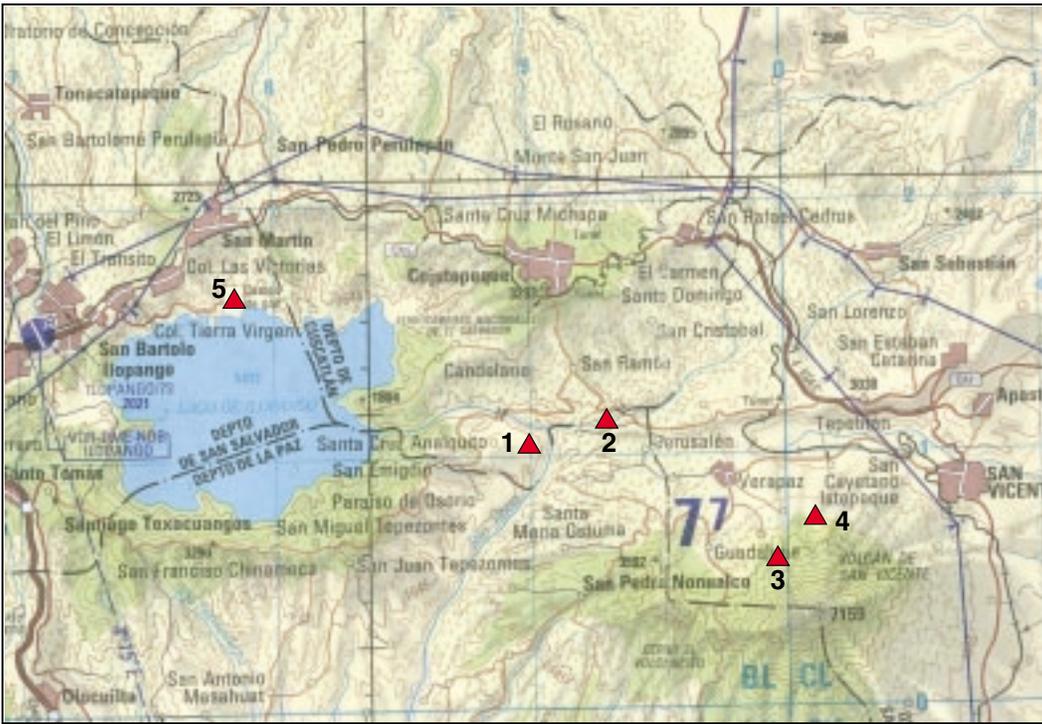
Figure 2. Detailed map showing the area of abundant landslides associated with the February 13, 2001 earthquake (shown as red rectangle in fig. 1). Numbered triangles refer to sites discussed in text:

- 1) Río El Desagüe land slide,
- 2) Río Jiboa landslide,
- 3) Quebrada Del Muerto rock slide,
- 4) Quebrada El Blanco debris slides, and
- 5) San Agustín-Quebrada El Chaquite area.

The earthquake generated two very large landslides that blocked the Río El Desagüe and the Río Jiboa, creating landslide-dammed lakes (fig. 2). At the time of the earthquake, the flow into these lakes was small because the earthquake occurred in the “dry” season; in the subsequent rainy season, which typically begins in May, the runoff supplying water to these lakes will increase substantially. The landslide dam across the Río El Desagüe has been partially breached by the construction of a small spillway, which controls the size and depth of the lake. Increased streamflow will not significantly increase the size or volume of this lake. However, the lake behind the landslide dam on the Río Jiboa continues to fill and will develop into a very large lake before it finally overtops the landslide. In mid-March 2001, the lake’s volume was only about 5 percent of its maximum potential volume of about 7 million m³.

The earthquake also triggered several significant landslides on the northern slopes of Volcán San Vicente. Prominent slides include a large rock slide in the upper part of the Quebrada Del Muerto and numerous failures along the steep valley walls in the upper part of the Quebrada El Blanco drainage (fig. 2). The large rock slide in the Quebrada Del Muerto is located above the village of Guadalupe and raised concern about the threat it posed to the town. On the north and northeast flank of the volcano, debris slides occurred in several deeply incised

The Río El Desagüe drains eastward out of Lago de Ilopango and is a tributary to the Río Jiboa. Approximately 6.5 km east of the outlet of Lago de Ilopango, the Río El Desagüe is dammed by a rotational slump/rock avalanche that has an estimated volume of about 1.5 million m³ (fig. 2). The landslide originated on the south wall of the valley (fig. 4) and is located about 100 m upvalley from the confluence of the Río El Desagüe and the Río Jiboa. Andesitic breccia of the Balsamo Formation compose about 70 percent of the landslide; rhyolitic pyroclastic deposits of the Cuscatlán Formation compose the remainder. The andesite breccia contains clasts ranging in size from coarse sand to boulders of indurated rock that are as much as 3 m in diameter. The landslide has dammed the river, and streamflow in the river has been impounded to form new lake.

Approximately 2 km upstream from the confluence of the Río El Desagüe and Río Jiboa, a block slide containing about 12 million m³ of material completely blocks the Río Jiboa drainage (figs. 2 and 5). The Río Jiboa landslide dam consists primarily of rhyolitic tephra and pyroclastic debris of the Cuscatlán Formation, and most of the landslide material is poorly compacted and extremely porous. The landslide dam is about 700 m long (parallel to the river drainage) and about 250 m wide (across the val-

Landslides triggered by the M_w 6.5 earthquake occurred in several deeply incised gullies on the northern flank of Volcán San Vicente. On the volcano's northwestern flank, a large rock slide occurred in the upper part of the Quebrada Del Muerto drainage (fig. 2). To the east and lower on the volcano's slopes, extensive failures occurred along steep valley walls of three gullies that are deeply incised into coarse unconsolidated deposits.
