Assessment of Hazards Associated with the Bluegill Landslide, South-Central Idaho

By William L. Ellis, Robert L. Schuster, and William H. Schulz

U.S. Geological Survey Open-File Report 2004-1054

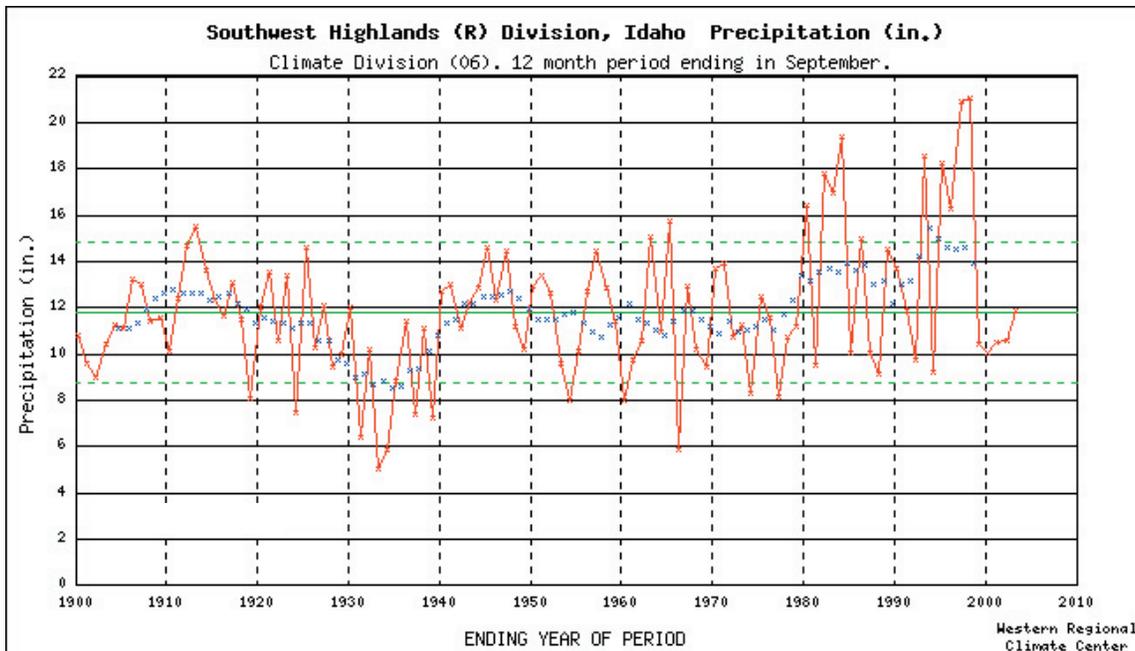
Meteorological data available from the Western Region Climate Center (www.wrcc.dri.edu) for the southwest highlands of Idaho over the past 100 years indicate that annual precipitation in the area averaged about 300 mm (12 in) per year (fig. 8). Beginning in the early 1980s, however, there are periods of much higher than normal precipitation, with some yearly precipitation exceeding 400 mm (16 in). The 4-year period from 1995 through 1998 was unusually wet, with annual precipitation ranging between 400 and 530 mm (16 and 21 in). In contrast, the period from 1999 to present has been dry, with annual precipitation less than the 100-yr average. A similar 100-yr precipitation pattern is also observed for the central plains of Idaho, just to the north of the study area, although precipitation amounts are less and periods of higher than normal precipitation began in the 1960s. Therefore, it is likely that ground-water levels in the Bluegill landslide area were near their highest point in the past 100 years at about the time of the most recent landslide movement.

Figure 8. Plot of yearly precipitation for the southwest highlands of Idaho from 1900 through 2002. Red symbols indicate total precipitation for 12-month periods ending in September. Blue symbols are the 10-year running mean precipitation. Green lines represent the average precipitation and standard deviation for the period. Note the years of high precipitation in the later part of the 1990s, which produced the highest 10-year running means of precipitation since 1900. (Data plot from Western Region Climate Center web site, www.wrcc.dri.edu/divisional.html).

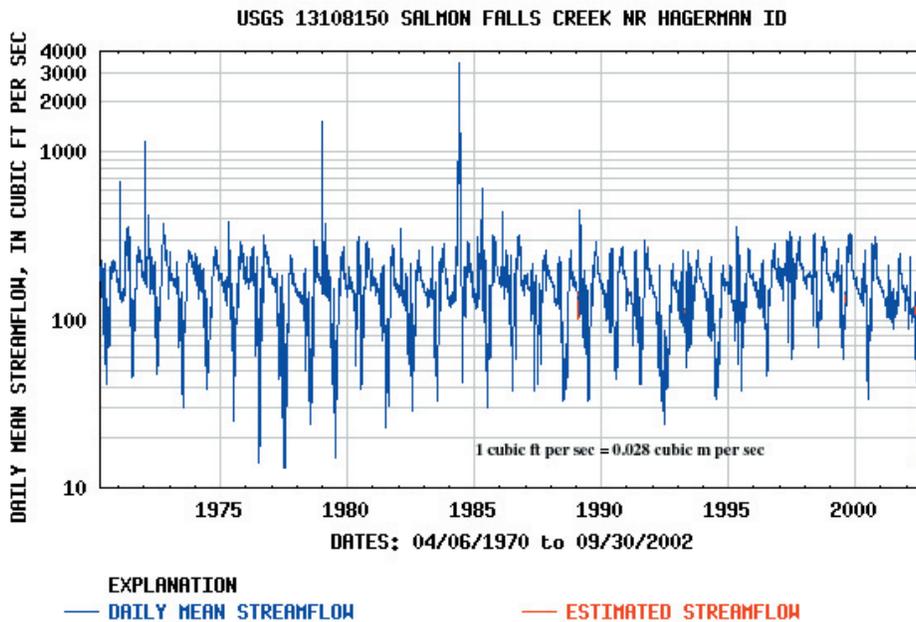
Figure 12. Daily mean stream flow of Salmon Falls Creek between 1970 and 2003 at USGS gaging station approximately 10 km downstream from the Bluegill landslide. (Data plot from USGS web site <http://nwis.waterdata.usgs.gov/id/nwis/discharge>).

0.85 and 8.5 m³/sec (30 and 300 cfs) (fig. 12). The seasonal streamflows have remained fairly constant over the 32-year period of record, and only rarely has the maximum daily-mean streamflow exceeded 11 m³/sec (400 cfs). The maximum mean-daily streamflow during the 32-year recording period was about 100 m³/sec (3500 cfs) in early 1984. Because of the regulating effect of Salmon Falls Dam, there is a low probability of an abnormally high stream-flow event impacting the Bluegill landslide dam.
