Field Reconnaissance of Debris Flows Triggered by a July 21, 2007, Thunderstorm in Alpine, Colorado, and Vicinity

By Jeffrey A. Coe¹, Jonathan W. Godt¹, T.C. Wait², and Jason W. Kean¹

Open-File Report 2007-1237

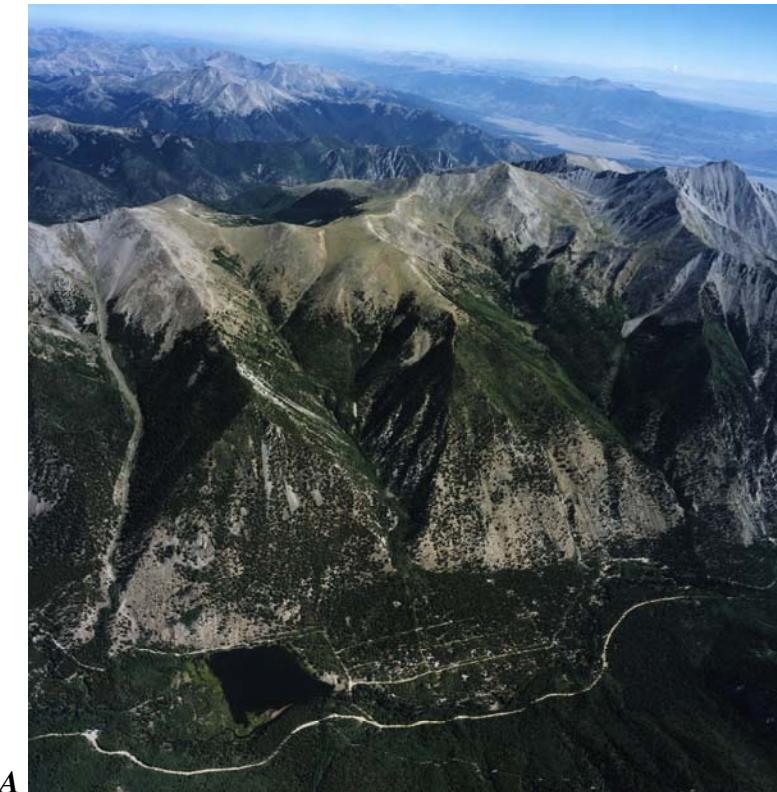
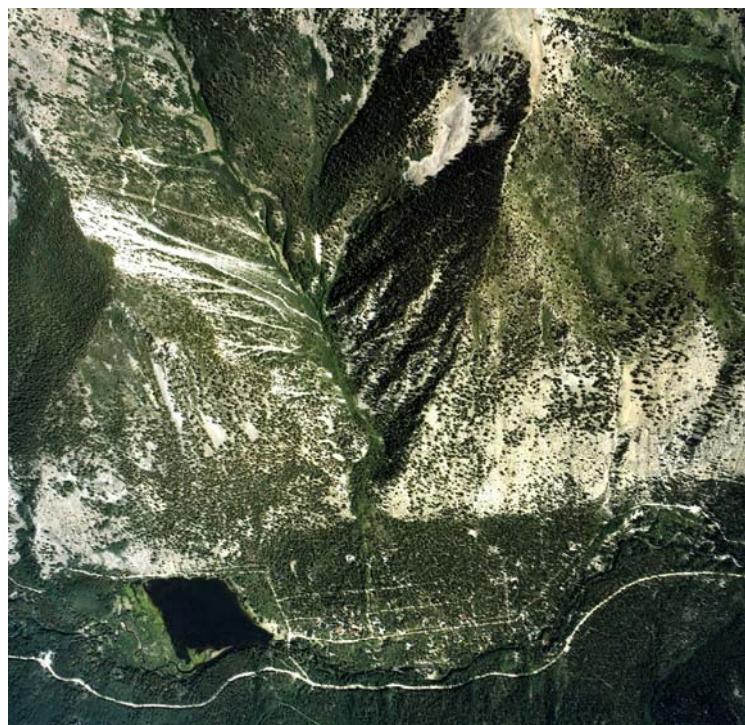
Figure 1. Aerial photos of Weldon Gulch and Alpine taken on August 10, 2002 (prior to the July 21, 2007 thunderstorm). A, Oblique photo with view to the north, and B, vertical photo.

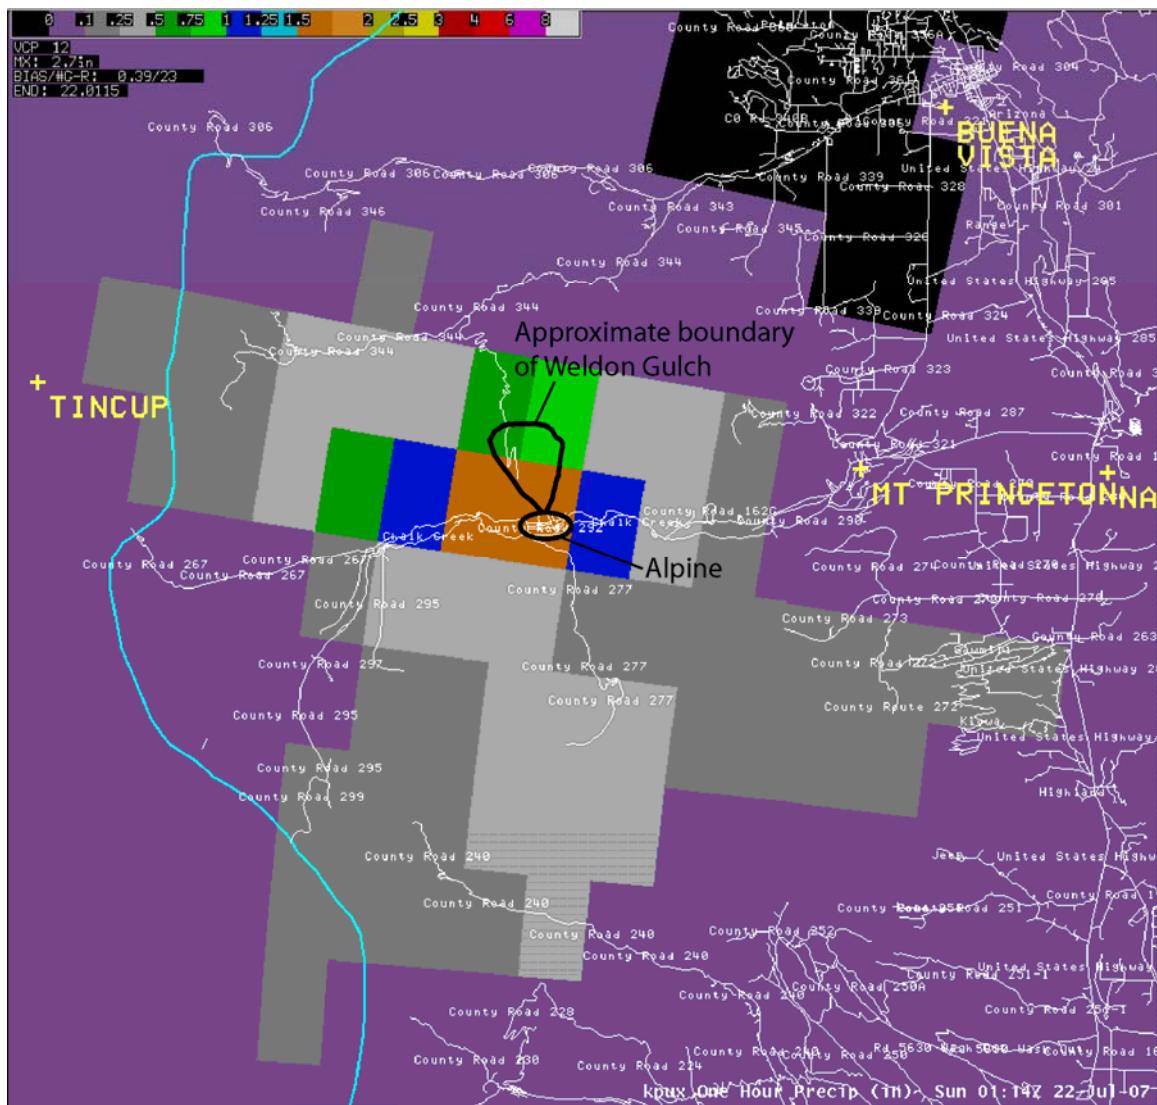
Doppler-radar data available from the NWS office in Pueblo (fig. 2) indicated that rainfall from the thunderstorm was concentrated in the immediate vicinity of Alpine between 6:14 and 7:14 p.m. One-hour precipitation totals derived from radar data during this time (fig. 2) show rainfall amounts near Alpine that ranged from 13 mm (0.5 in.) to 44 mm (1.75 in.).

Figure 2. Image showing 1-hour precipitation in the southern Sawatch Mountain Range between 6:14 and 7:14 p.m. on July 21. Index in upper left corner shows rainfall amounts in inches. Horizontal distance across the image is about 35 kilometers. Image from National Weather Service Doppler Radar station KPUX at Pueblo, Colorado. Provided by Paul Wolyn, National Weather Service, Pueblo.

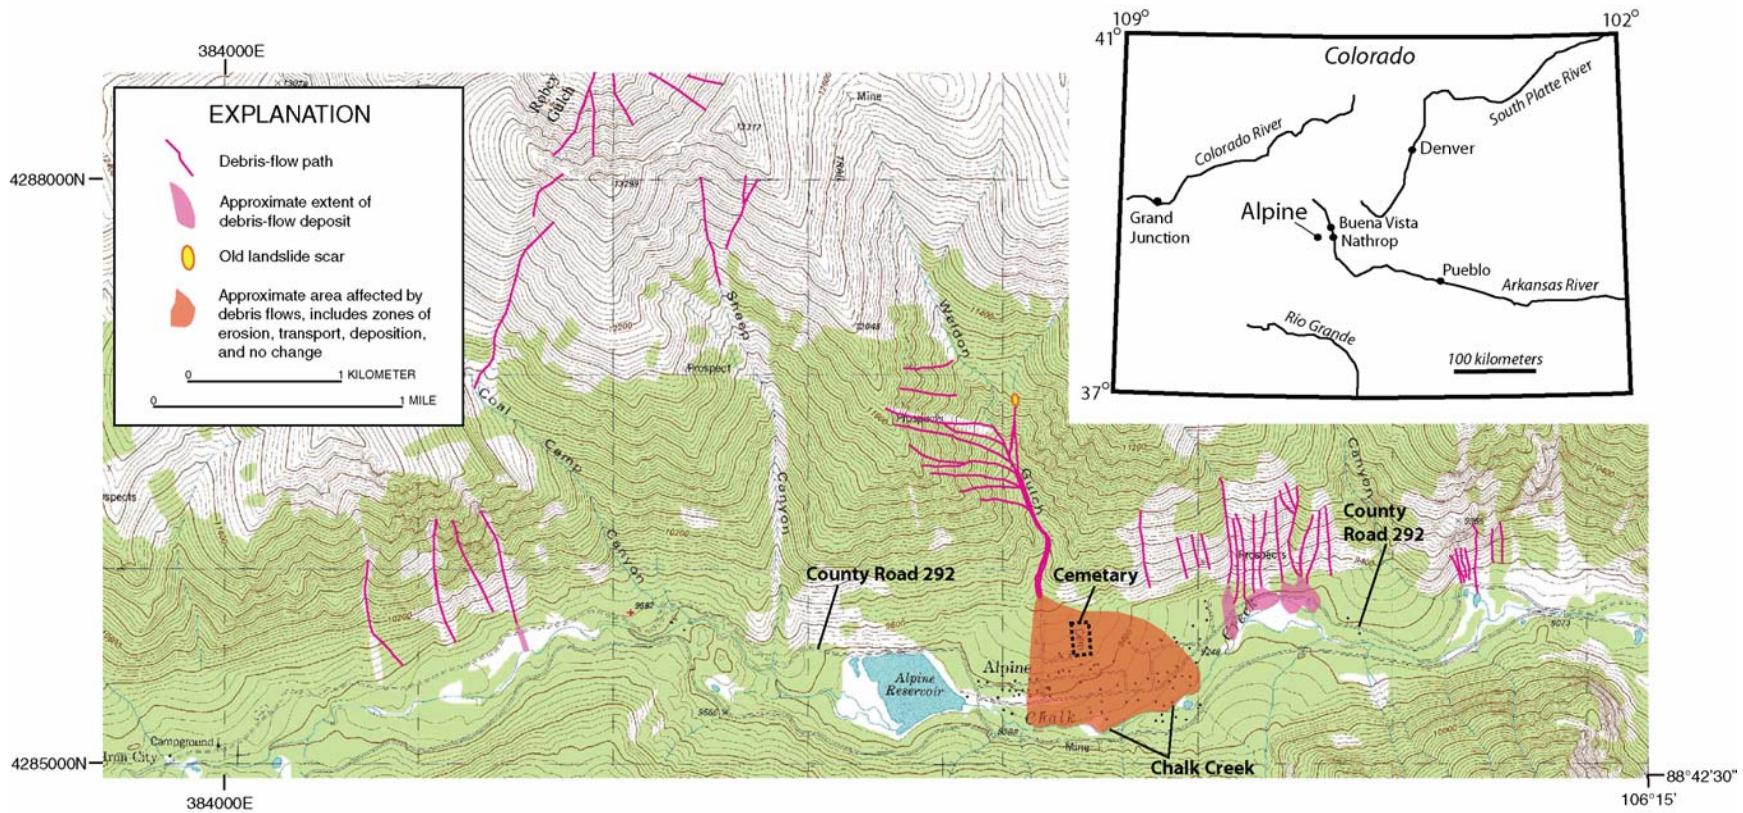
Figure 3. Reconnaissance map showing debris flows triggered by the July 21, 2007 thunderstorm. Base map from USGS St. Elmo quadrangle, scale 1:24,000. Universal Transverse Mercator, zone 13 values (meters) are shown on left side of map, latitude/longitude values are shown in lower right corner of map.

The debris flows in Weldon Gulch were investigated by entering the Gulch from both the ridgeline at the head of the Gulch and from the mouth of the Gulch at the fan. The upper one-half of the Gulch (the part above tree line) did not contain any debris flows (fig. 3). There were no scars on slopes at the head or flanks of the upper Gulch, and the channel coming from the upper half of the Gulch was not eroded and did not appear to have transported debris. All of the debris flows initiated from the east and west flanks of the lower one-half of Weldon Gulch. On the east flank, debris flows initiated from several small, shallow landslides (fig. 4), and from entrainment of sediment through rilling and channel erosion by the runoff of water (fig. 4), within a large, pre-existing landslide scar (fig. 4). The rills and shallow slides were easily visible because they contrasted with undisturbed parts of the scar, which had grass and bushes growing on the surface. There were no large, unstable blocks of old landslide material visible in the scar, but the flanks of the scar were steep and appeared to be gradually failing by raveling and periodic, small earth falls. The slope on the undisturbed northern edge of the old landslide scar was 33°. The channel downslope from the old landslide scar was eroded by water runoff and debris flows flowing from the scar. The channel split into two channels approximately 100 m downslope from the old scar (fig. 3). Both of these channels existed prior to July 21. On the basis of exposed roots and soil horizons, incision in these two channels ranged from about 0.5 to 2 m (fig. 5). In some locations, bedrock was exposed in the channel bottoms. The best estimate is that sediment eroded from these two channels on the east flank of Weldon Gulch contributed approximately 10 to 20 percent to the total amount of debris deposited on the debris fan.
