# Investigation of the M6.6 Niigata-Chuetsu Oki, Japan, Earthquake of July 16, 2007

Open File Report 2007–1365

2007

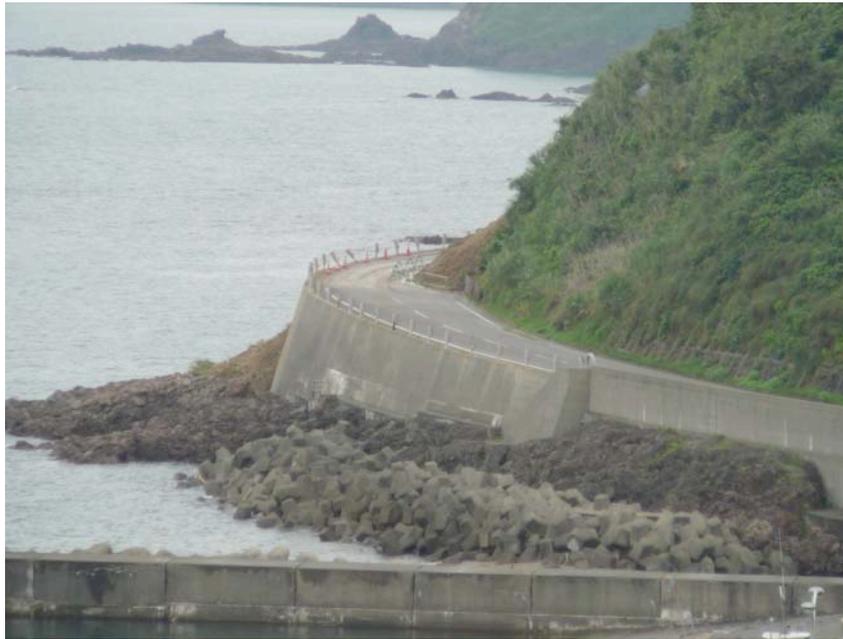
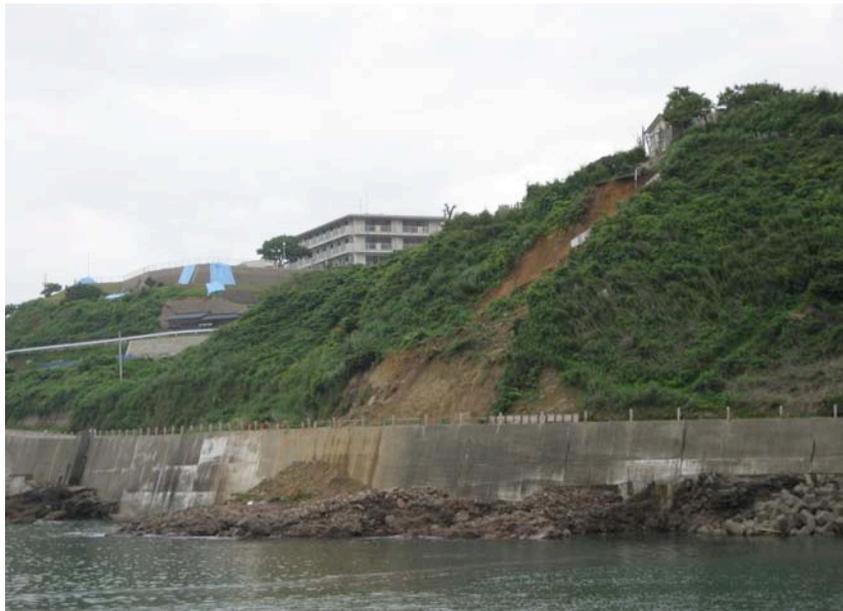
Shallow coastal landslides were observed to be between 0.5 to several meters deep in colluvial and residual soils and ranged from  $5 \text{ m}^3$  to several thousand cubic meters in volume. Typical slope surface and failure plane inclinations were between  $50^{\circ}$  and  $70^{\circ}$ , failing in translation as debris slides and slumps. These types of landslides were of sufficient size to close major transportation routes in the region, among them, the southern, coastal rail line and the coastal road (Route 352) located north of the Nuclear Power Station.

Figure 3.1: Shallow colluvial landslide located just north of the Kasashima Fishing Village, Site RK22/SA10; N37.33802° E138.46995°, photos taken 7/20/07 15:57 (top) and 7/21/07 13:35 (bottom). Dimensions are approximately 36 m wide, 24 m tall, 2 m thick. The lithology is composed of 24 m of weak mudstone overlying 6 m of more indurated, brecciated mudstone, which outcrops at the road. A 10 m tall concrete seawall leads down to the brecciated mudstone shore platform. The slide occurred in weak mudstone/colluvium, sliding over the brecciated mudstone, onto the road, and over the edge of the concrete seawall, spilling debris onto the shore platform at ocean's edge.

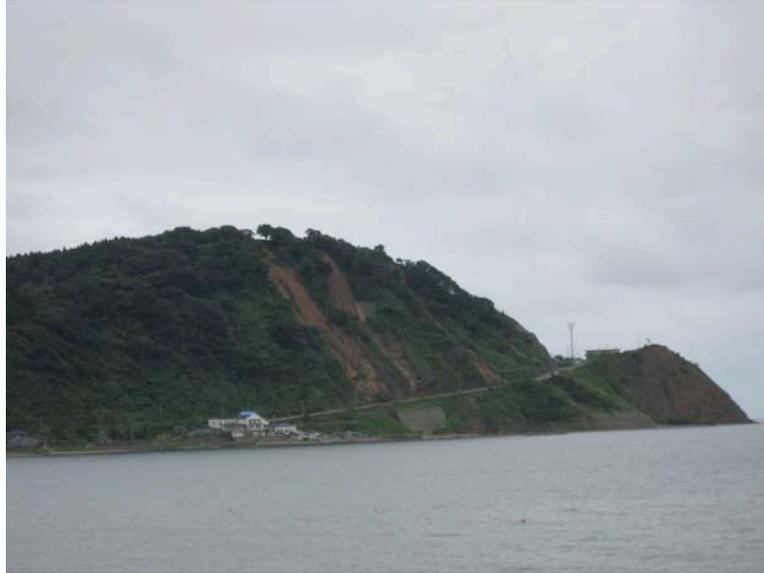
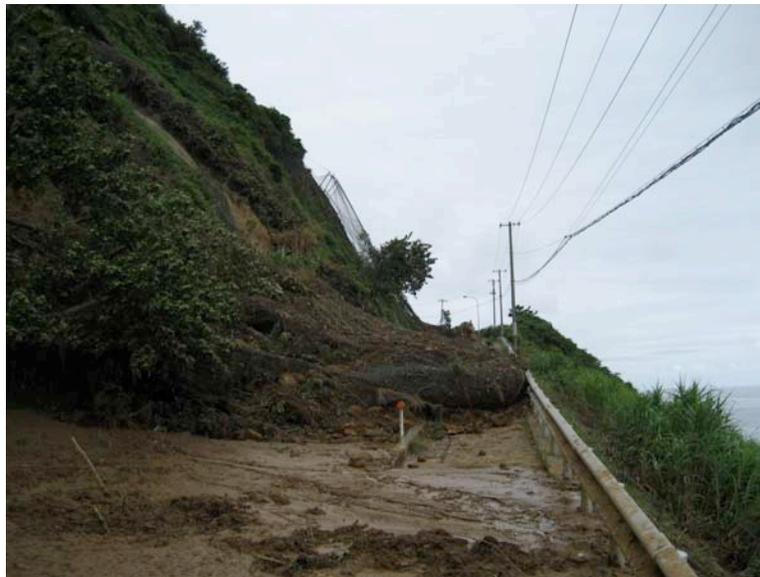
Figure 3.2: Coastal landslides on Highway 352 north of Kashiwazaki-Kariwa Nuclear Power Plant at road closure south of Route 373 (Site RK34; N37.48455° E138.62435°, photos taken 7/22/07 at approx. 10:45). This area consisted of at least eight individual slides. The landslide shown in the bottom photo consists of a slide in an area of previous instability - a shotcrete stabilization system is in effect for the bottom 50 m of this slope (total slope height is ~115 m), and overlain with a wire-mesh rock deflection system. The slide is approximately 50 to 60 m wide, 65 m long, and less than 1 meter thick. The landslide initiated above the shotcrete slope, moved into the wire-mesh and caused failure of the meshing and pull-out of the steel supports. The wire-mesh restrained most of debris, depositing the majority on the road, with only a slight quantity of the debris sliding over the road edge. The failure plane inclination is approximately 60°.

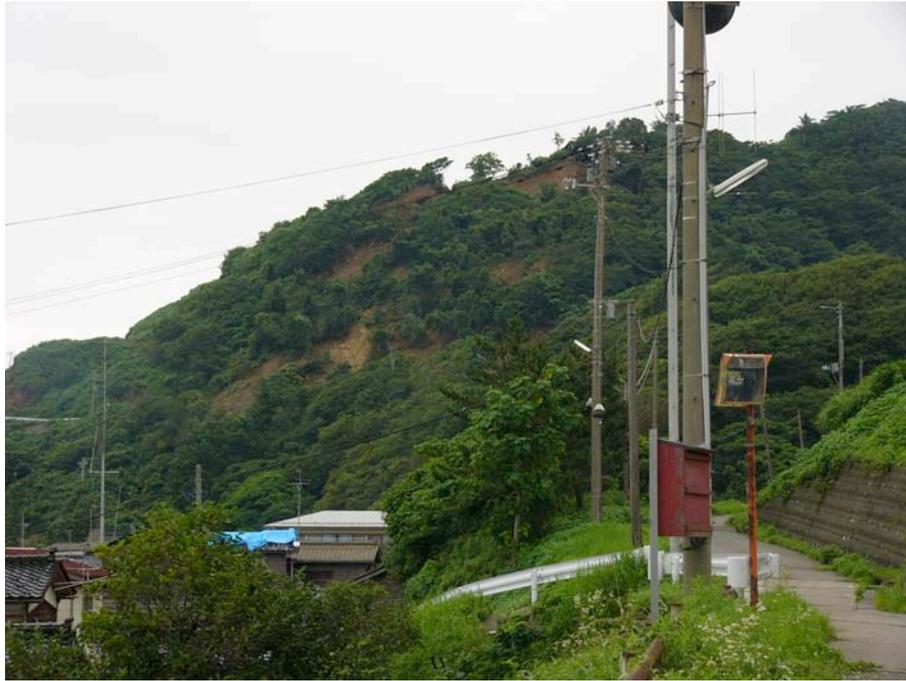
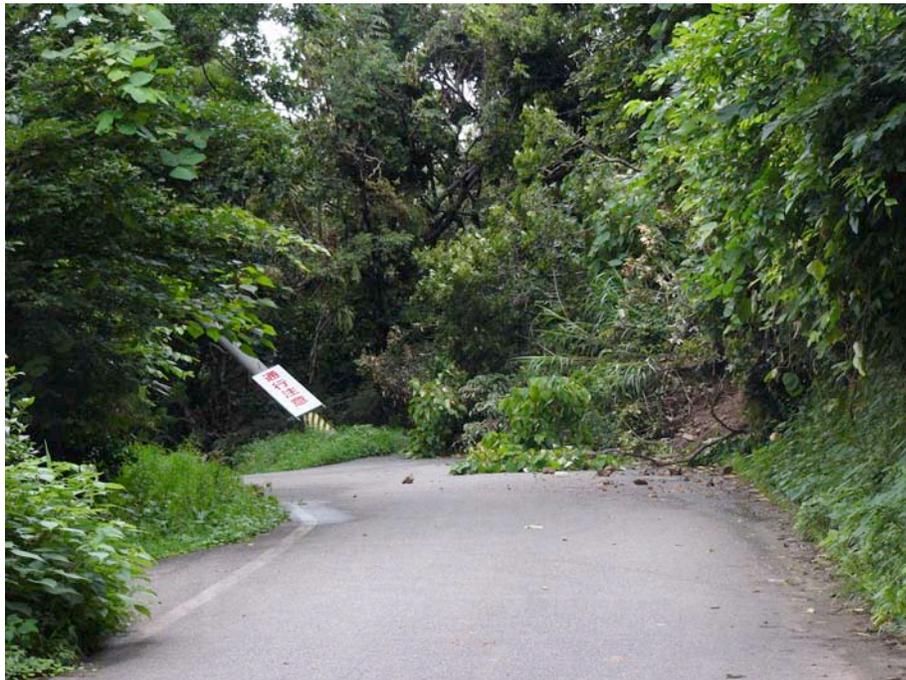
Figure 3.4: Yoneyama Landslide, located south of Kashiwazaki (Site YT17; N37.32223° E138.43828°, photos taken 7/21/07 at approximately 15:20). This slide marked the southwest-most limit of observed landslides along the Sea of Japan coast. The slide extended to the full height of the slope and blocked a paved coastal access road.

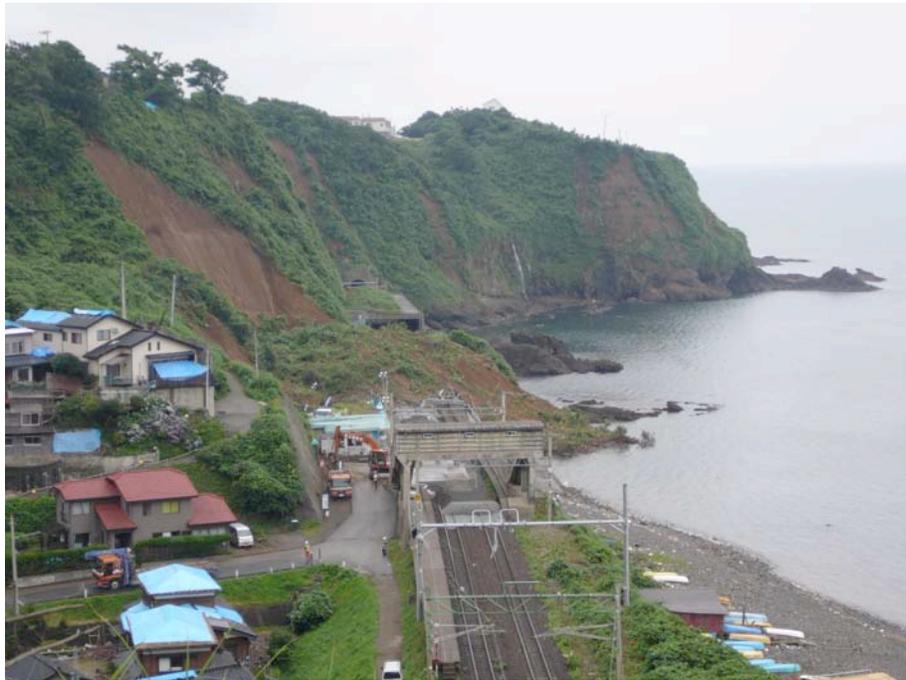
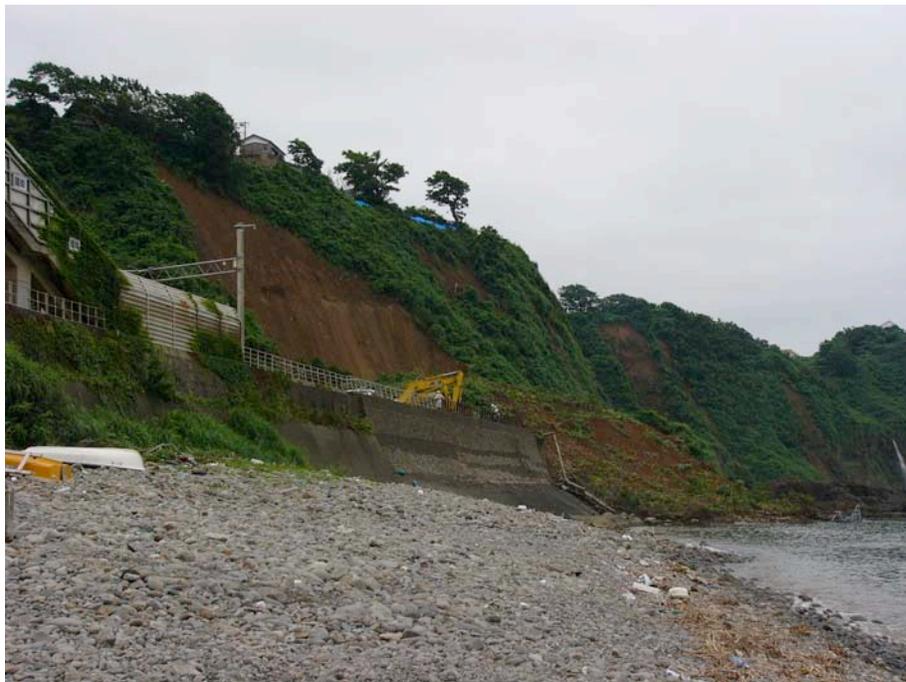
Figure 3.5: Landslide at the Oumigawa Train Station on the Shin-etsu Line (Site RK20/SA9/YT16; N37.34200° E138.48888°, photos taken 7/21/07 12:48 (top) and 7/24/07 15:00 (bottom)). This was among the largest of the coastal landslides to the south of Kashiwazaki. Site access was not possible due to construction repairs. Note that slope stability in this area has been a problem, as seen by the railway tunnel protection structure immediately behind (to the south) of this landslide. Many more smaller landslides were observed to the north and south of this location.

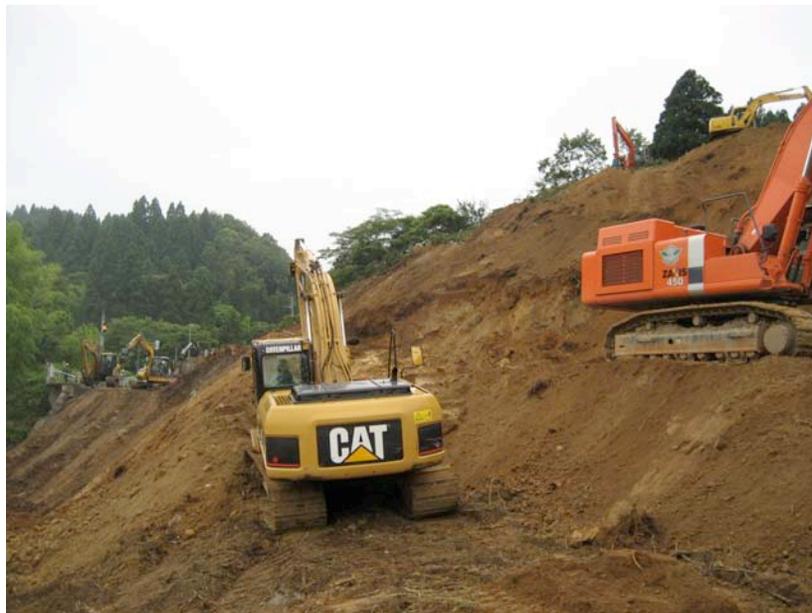
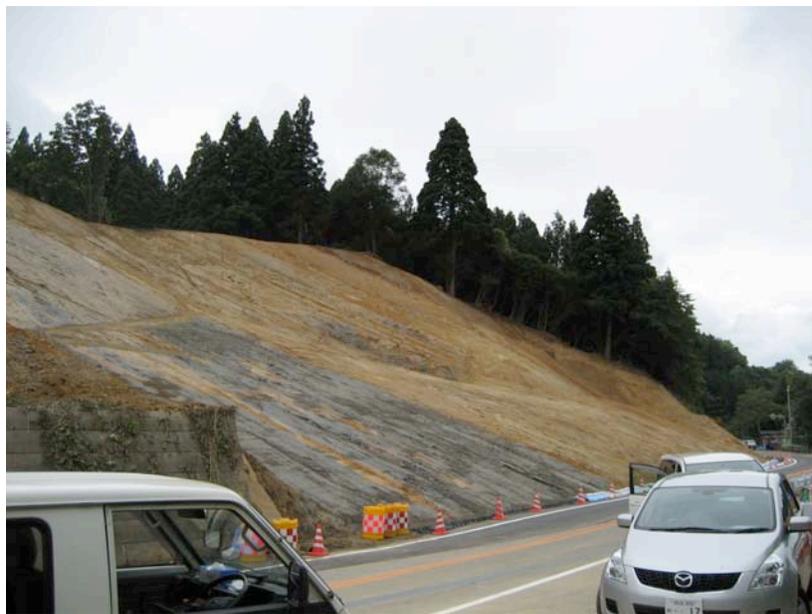
A large, deep, rotational slide occurred in weak mudstones and colluvial materials fairly far (~10 km) inland from the coast. The Ozumi Senbon landslide (Fig. 3.6) consisted of approximately  $150,000 \text{ m}^3$  of total displaced material and led to destruction of a large road section on Route 8. According to on-site construction personnel, the slide plane was located at a depth ranging between 6 and 11 meters. Nearby to this site, several debris slumps/colluvial slides were also observed, however these required only

Figure 3.6: Ozumi Senbon Landslide at Highway 8 north of intersection with Route 252 (Site RK1/YT1; N37.41422° E138.71347°, photos taken 7/20/07 10:24 (top) and 7/23/07 13:04 (bottom)). This slide is approximately 150 meter wide, 100 meters long and 10 meters deep. According to construction personnel at the site during the reconnaissance, the slide plane occurred near the colluvial/bedrock interface, at a depth of between 6 and 11 meters. Signs of rotational movement were noted from back-rotated guardrails at the toe of the slide. This landslide forced closure of both lanes of traffic along Highway 8, just north of the intersection with Route 252, however both lanes had been reopened as early as 8 days following of the earthquake when reconnaissance team members revisited the site. Bottom photo shows excavated slide and subsurface bedrock lithology and structure.

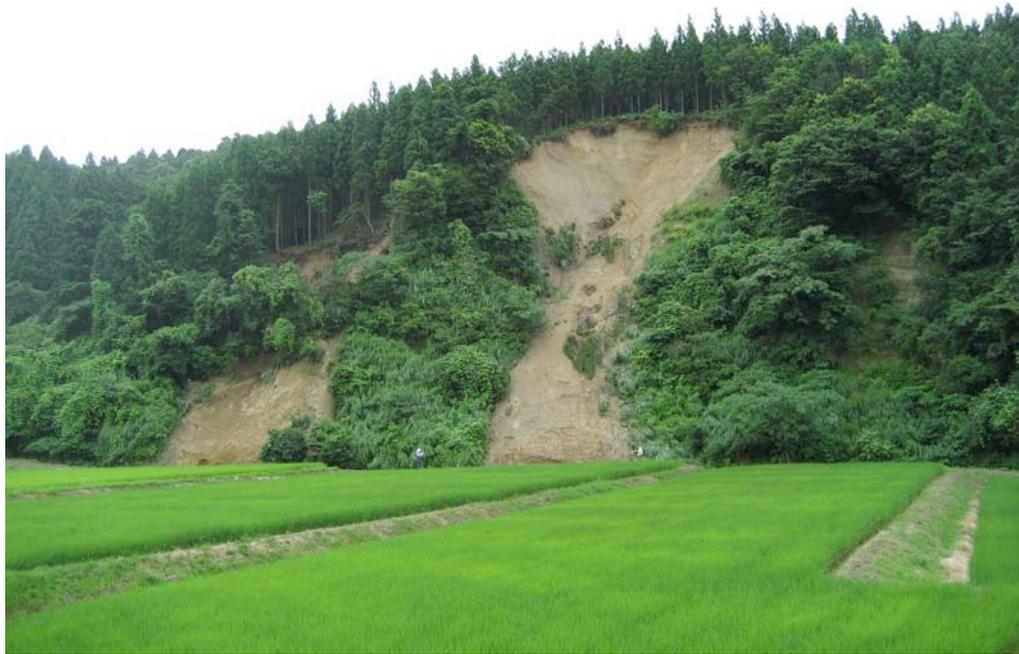
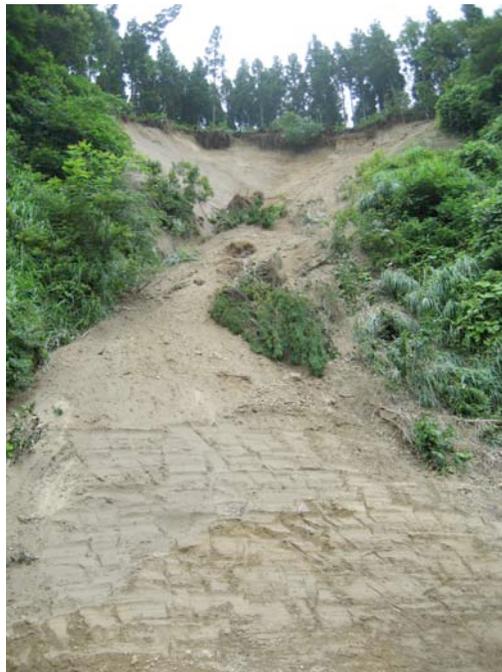
minimal grading efforts and maintenance to keep channels open for rice farming irrigation (Fig. 3.7).

Figure 3.7: Ozumi-Mishimayamachi Landslides (Site RK2/YT2; N37.44057° E138.70467°, photos taken 7/20/07 at approximately 11:30). These slides occurred on a native hill slope and consisted of debris slumps in mudstone/siltstones and colluvium materials. High-resolution, topographic data was collected of these landslides using the terrestrial LiDAR scanning method.

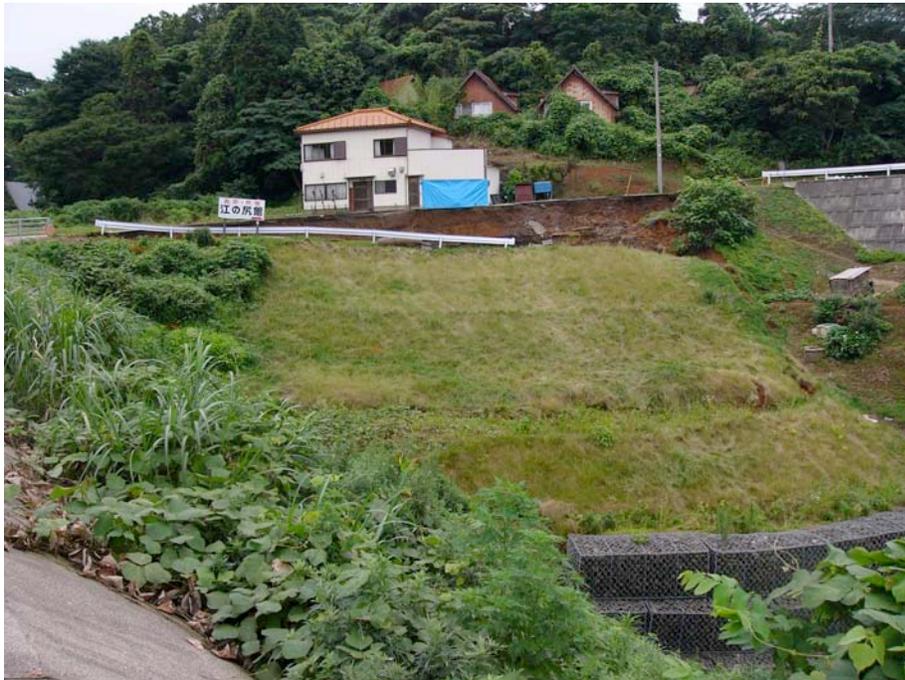
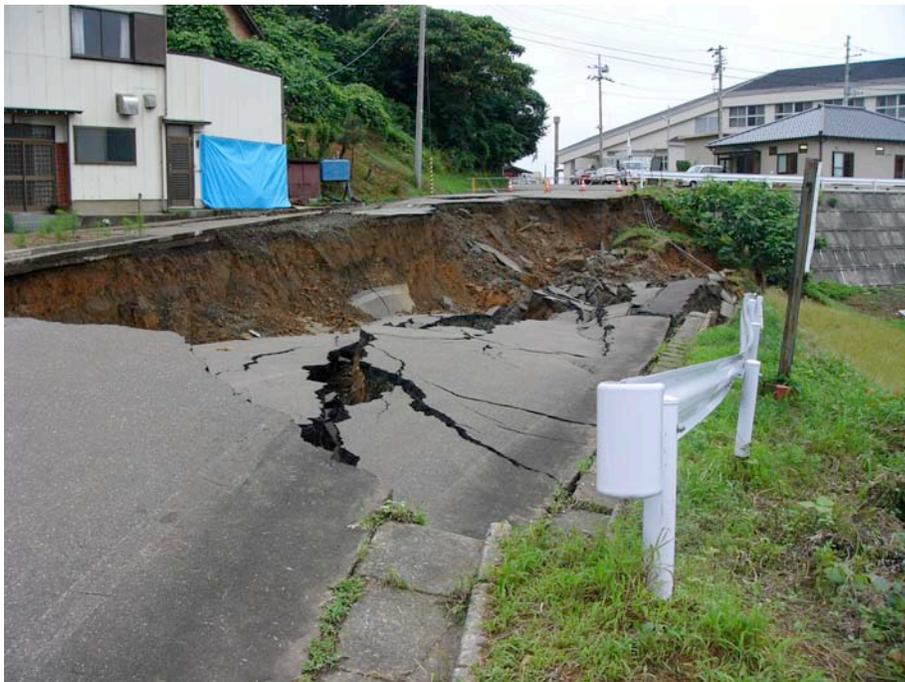
Embankment failures were typical in road fills along the coast (Fig. 3.8), and were also observed at three sites located further inland (e.g. Figs. 3.9 - 3.10). Embankments underwent from 10 cm up to one meter of vertical displacement (Fig. 3.8), extending between 10 and to 60 meters in length. Three embankment failures required full closures of roads, and/or protection with tarps to reduce rainfall infiltration and the associated potential for additional movement. Among these was a 15-meter high, 97.5-meter wide, earth-fill dam located to the east of the region (Fig. 3.9), where cracking through the midpoint of the crest was observed. However, the dam was not storing water at the time of our visit and the reservoir had not been filled recently. Further, from on-site design documents, it appears that the normal water level is typically 8 meters below the crest of the dam. At a water supply dam located southwest of the city of Kashiwazaki (Fig. 3.10), cracking of the crest was also observed along with minor concrete cracking and spalling on the upstream side. Here, the reservoir water level was within several meters of the dam crest at the time of observation.

Figure 3.8: Road embankment failure off Route 8 on the way to Kasashima (Site YT18; N 37.33325 ° E 138.46500°, photos taken 7/21/07 at approximately 15:40). The slope appears to have undergone previous stabilization using slope grading and gabion baskets to support the toe.

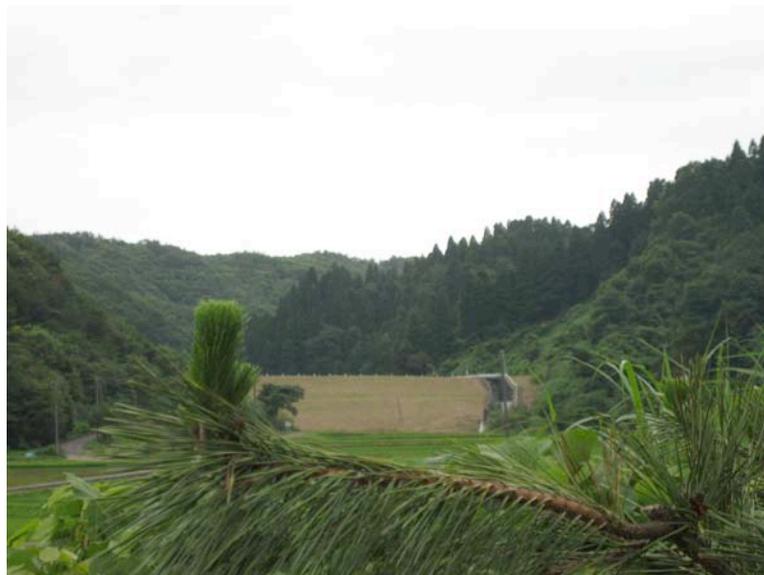
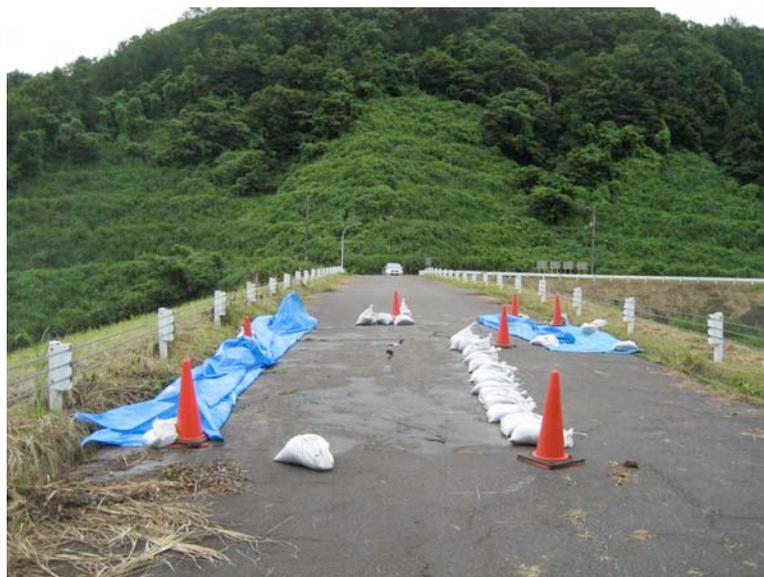
Figure 3.9: Embankment cracking and settlement of South Dam near Miyamo Parking Area along Highway 8, Nagaoka-Shi region (Site RK50; N37.43267° E138.73674°, photos taken 7/23/07 at approximately 11:15). The dam is a 15-meter tall, 97.5-meter wide earth fill structure with 3(H):1(V) downstream and 3.5(H):1(V) upstream benched slopes. Crest elevation is 63 meters and normal pool elevation is 55 meters. Observations were made of an embankment slope failure along the crest of this dam, through half the crest width (~4 m). Settlement and deformation occurred along a 10 m long section with up to 4 cm each of lateral and vertical deformation in the down slope direction. Contour-parallel ground cracking (2-4 cm wide, 1-2 m long) along the ground-spillway interface were also observed, two-thirds of the way down the dam face. The reservoir was empty and appeared to not have been filled in some time judging by the height of vegetation growing in the reservoir area.

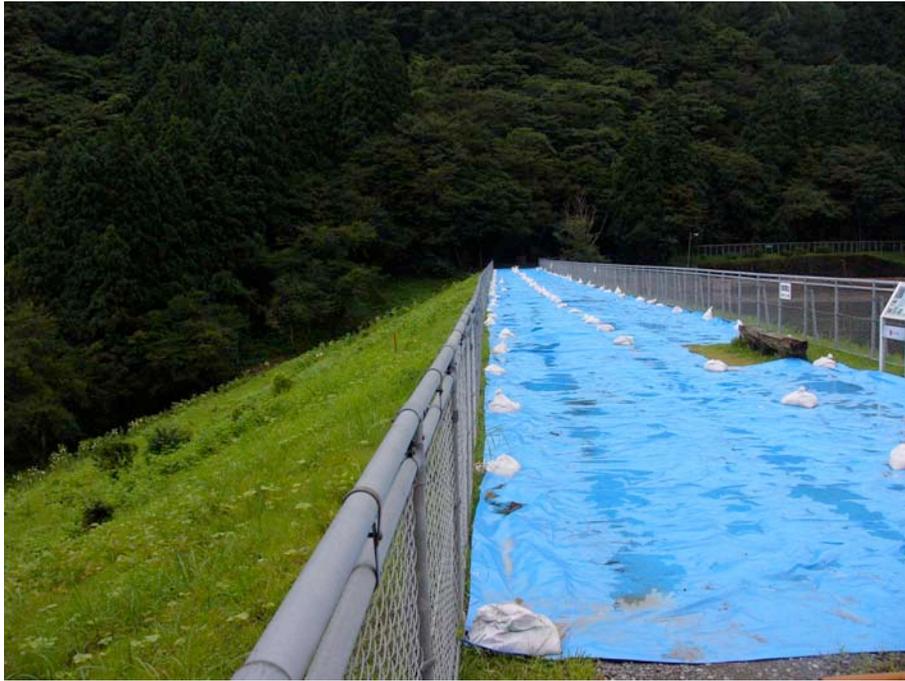
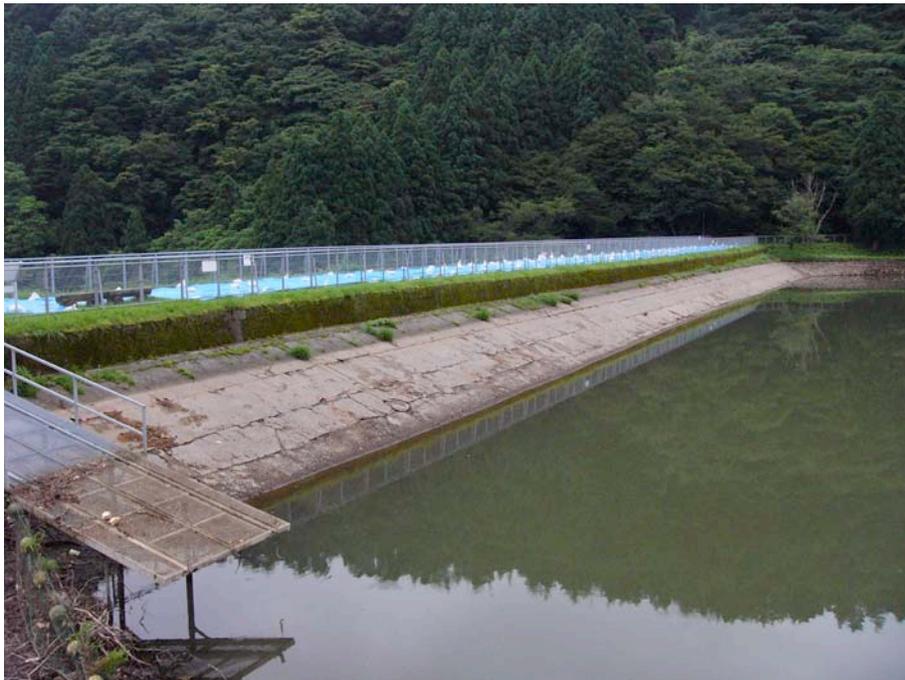
Figure 3.10: Embankment cracking at the crest of Kawauchi Dam, constructed in 1938. (Site YT19; N37.33635° E138.52410°, photos taken 7/21/07 at approximately 16:20).

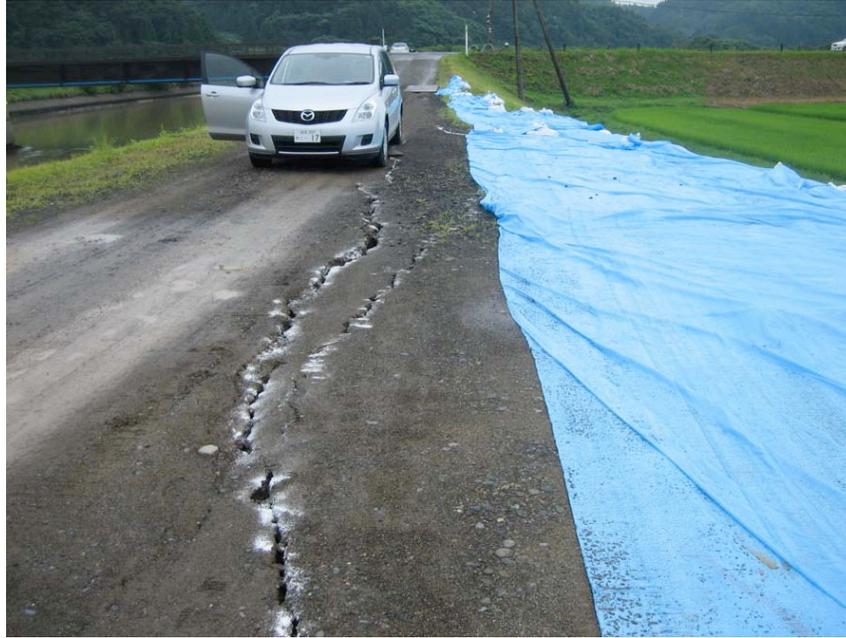
Extensive cracking of levee embankment. Repairs were taking place to the levee/weir intersection with sand bags to support an embankment failure. We observed good performance of the weir, with no signs of damage. The control building suffered damage to the foundation with settlement of fill beneath the structure: 15 cm on downstream side of building at the retaining wall, 30 cm at the building, and 30 cm at the upstream side retaining wall that formed contributory channel. Three to four sets of transverse cracks parallel to the river ran through the embankment fill that the structure was built upon. Liquefaction and lateral spreading with ground cracks were observed upstream of the operations building and the contributory channel to the south.

Figure 4.1: Fujii Weir downstream from Tashiou Bridge crossing of river. (Site RK16; N  $37.34875^{\circ}$  E  $138.61670^{\circ}$ , visited 7/21/2007 11:28 am UTZ+8). Extensive cracking of levee embankment.

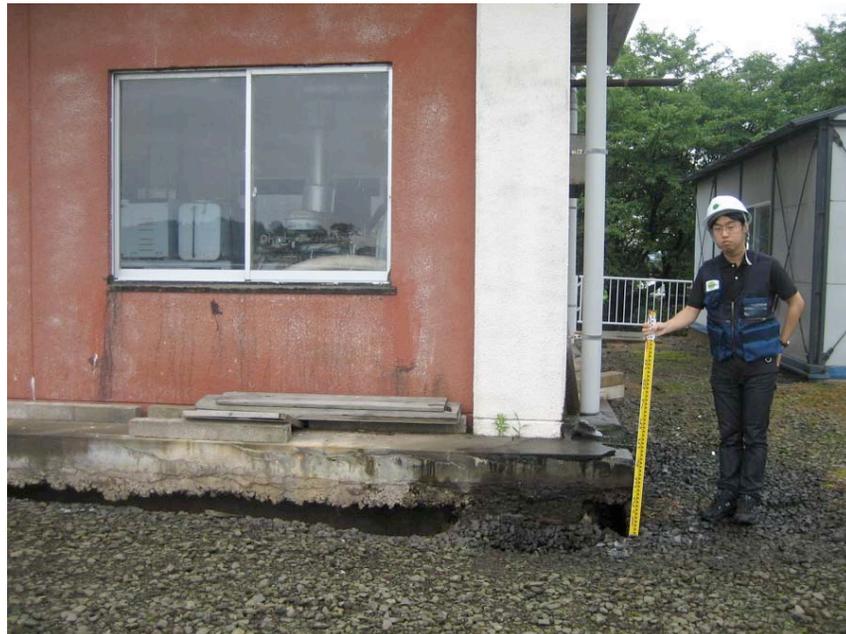
Figure 4.2: Fujii Weir downstream from Tashiou Bridge crossing of river. (Site RK16; N  $37.34875^{\circ}$  E  $138.61670^{\circ}$ , visited 7/21/2007 11:28 am UTZ+8). The control building exhibited damage to the foundation with settlement of fill beneath the structure.

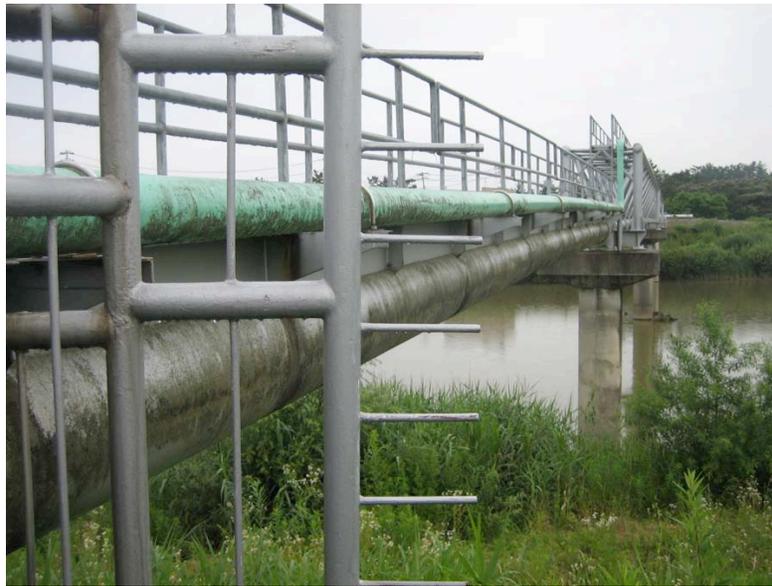
This area experienced liquefaction, lateral spreading, bridge-ground differential settlement, pavement cracking, structural damage, and embankment failure. We observed approximately one meter of ground extension consisting of several 10-20 cm wide cracks (covered by tarps) in a river levee embankment over a distance of 45 meters associated with lateral spreading. Near an adjacent bridge, we measured pipeline rupture and pipe offsets of 13 cm in the horizontal direction, 10 cm in the vertical direction, and with 40 cm of associated nearby settlement between the pipeline and the ground. In a nearby house to the south, extensive signs of liquefaction were observed with sand boils, uplifted manholes, and large-scale ground cracking. A nearby home had been red-tagged due to distortions that appeared to line up with ground cracks.

Figure 4.3: Kai-Un Bridge over Sabaishi River (Site RK4 N37.39233°,E 138.58063°, 7/19/2007, 1:40 p.m.). A water pipeline rupture was found with pipe offsets of 13 cm in the horizontal direction, 10 cm in the vertical direction, and with 40 cm of associated nearby settlement between the pipeline and the ground.

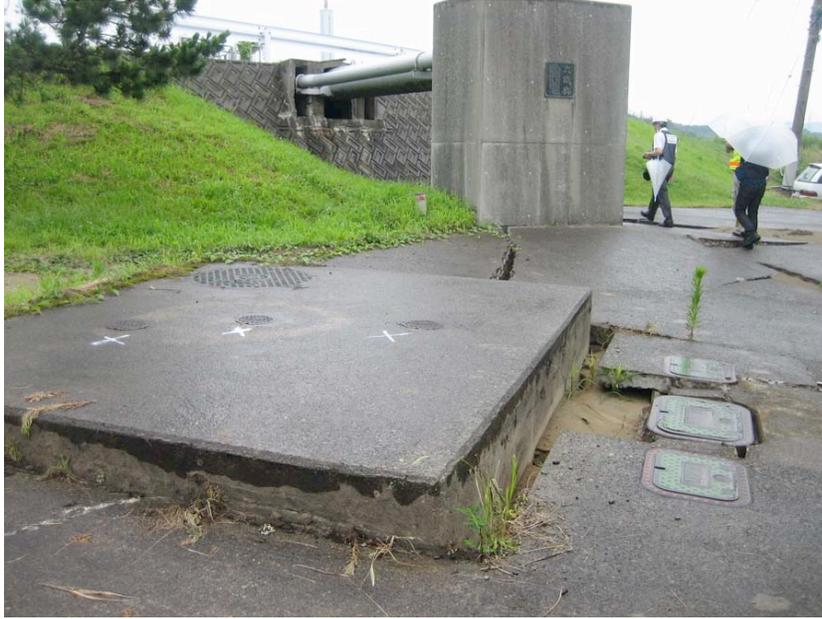
Figure 4.4: Kai-Un Bridge over Sabaishi River (Site N37.39233°, E138.58063°, 7/19/2007, 1:40 p.m.). A water cistern near the pipeline rupture uplifted in liquefied ground.

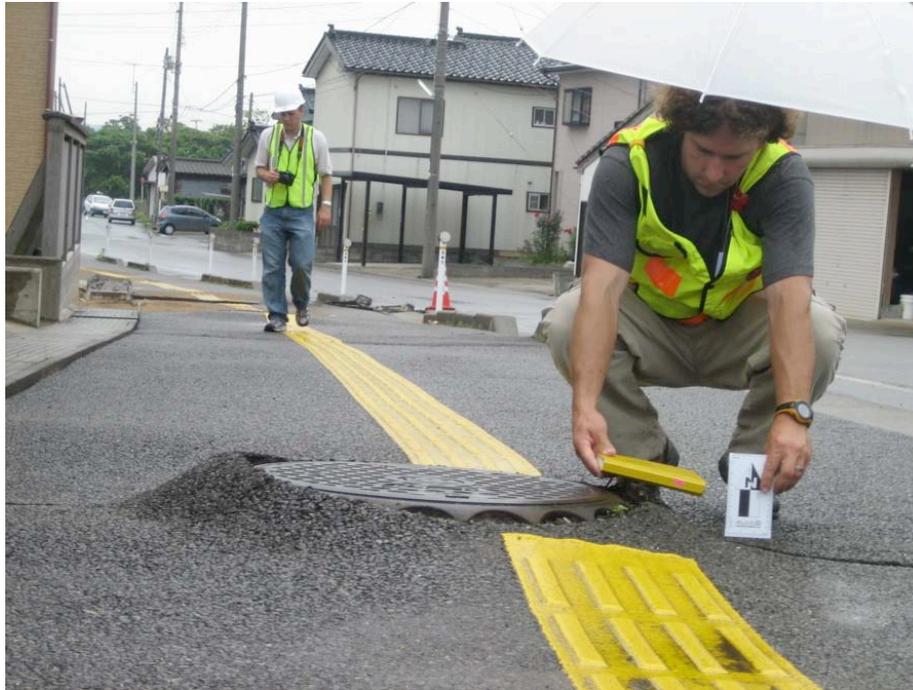
Figure 4.6: Kai-Un Bridge area Sabaishi River (Site RK4 N37.39233° E138.58063°, 7/19/2007, 1:40 p.m.). Numerous manholes on the southeast bank near the Sabaishi River uplifted in liquefied ground.

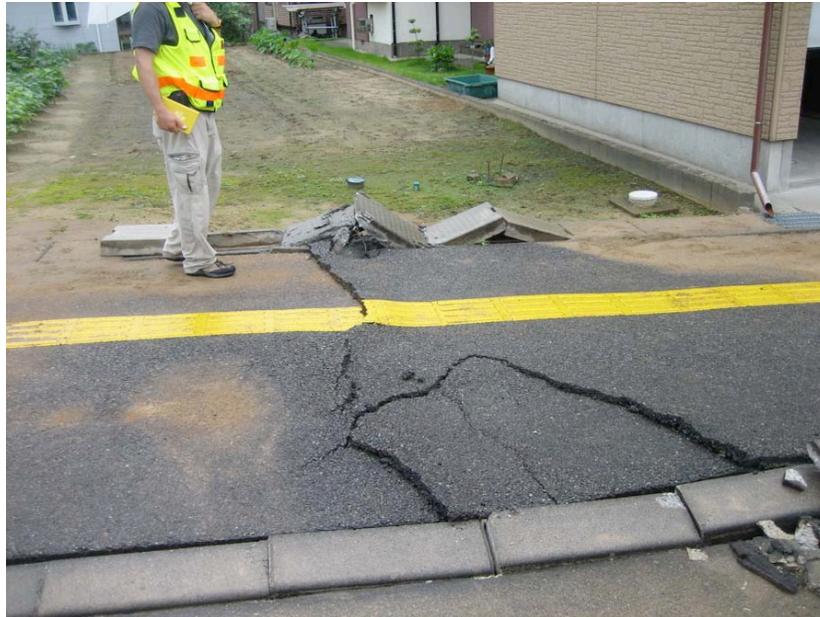
Figure 4.7: Kai-Un Bridge area Sabaishi River (Site RK4 N37.39233° E138.58063°, 7/19/2007, 1:40 p.m.). A sub-linear zone of lateral spreading, sand boils and settlement that may be associated with a buried shoestring sand deposit from the former channel of the Sabaishi River resulted in damage in the neighborhood immediately south of the Kai-Un Bridge.

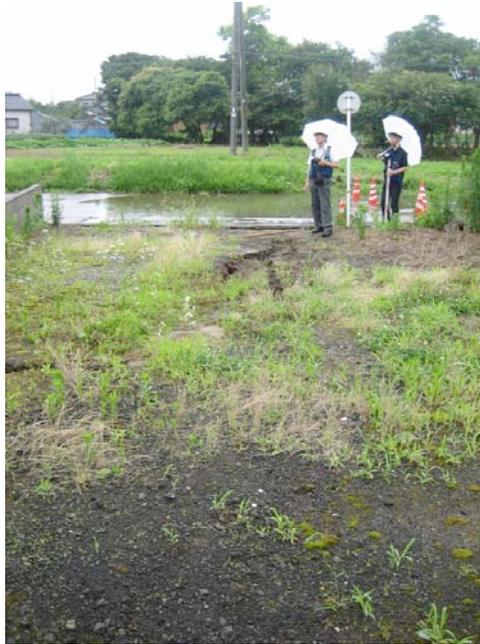
Figure 4.8: Kai-Un Bridge area Sabaishi River (Site RK4 N37.39233° E138.58063°, 7/19/2007, 1:40 p.m.). A sub-linear zone of lateral spreading, sand boils and settlement that may be associated with a buried shoestring sand deposit from the former channel of the Sabaishi River resulted in damage in the neighborhood immediately south of the Kai-Un Bridge.

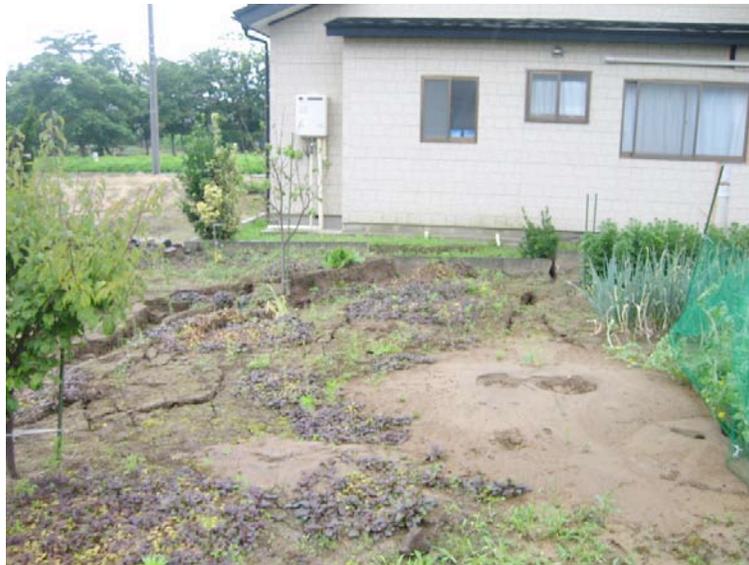
Figure 4.9: Kai-Un Bridge area Sabaishi River (Site RK4 N37.39233° E138.58063°, 7/19/2007, 1:40 p.m.). A sub-linear zone of lateral spreading, sand boils and settlement that may be associated with a buried shoestring sand deposit from the former channel of the Sabaishi River resulted in damage in the neighborhood immediately south of the Kai-Un Bridge. Here, settlement caused damage to a residential structure.

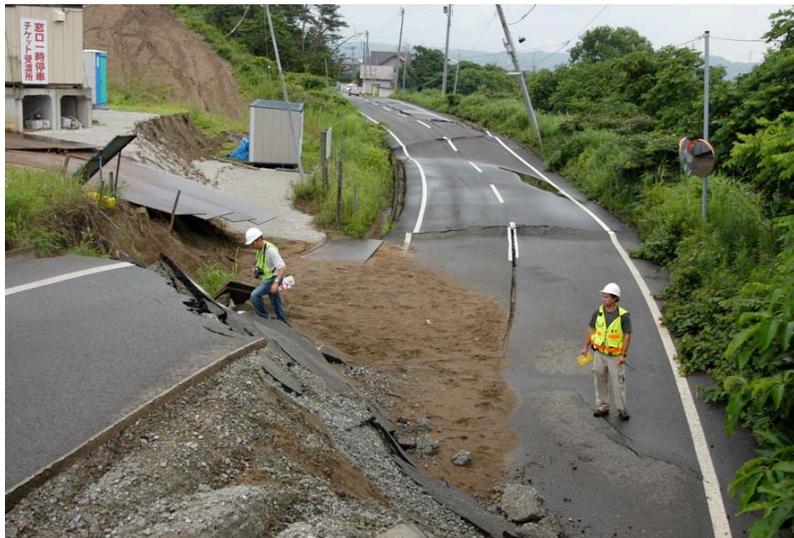
We observed lateral spreading, liquefaction, slope failures, and associated retaining wall failures at this site. This site was scanned with terrestrial LiDAR for documentation purposes and for further analysis. A massive embankment failure was observed to have occurred from liquefaction and lateral spread slope movement in aeolian sands. Movement was from north to south, from sand quarry area towards river. Vertical displacement of head scarp was a maximum of 2.8 m and diminished in height moving away from road crossing of head scarp. Measurements were made of total lateral displacement along a representative track-line through the failure representing the maximum likely displacement of the failure ~10 m over 55 m distance between head scarp and river edge (approximately 18% strain). The inclination of slope from road to river was measured to be approximately 14°. Nearby, a slope lateral spread caused failure of a 2.6-meter-tall, concrete block, gravity retaining wall, that resulted in the red-tagging of an otherwise undamaged home. The damaged retaining wall section was 25 meters in length and constructed of 40 cm by 30 cm by 100 cm sized concrete blocks. No backfill, drainage, or tieback reinforcement were observed.

Figure 4.11: North side of Kai-Un Bridge area of the Sabaishi River - Lateral Spread on road to Kashiwazaki Municipal Incinerator (Site RK6, N37.39343° E138.58555°, 7/19/2007). A zone of lateral spreading, sand boils and settlement crossing the present-day Sabaishi River, and that may be associated with a buried shoestring sand deposit of a former channel, resulted in failure of a road on the north side of the river adjacent to the Kashiwazaki Municipal Incinerator.

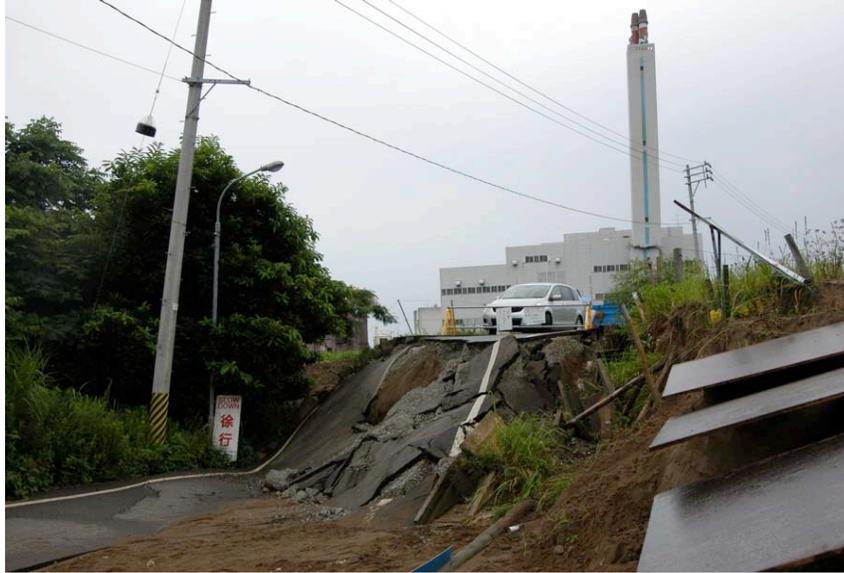
Figure 4.12: North side of Kai-Un Bridge area of the Sabaishi River - Lateral Spread on Road to Kashiwazaki Incinerator (Site RK6, N37.39343° E138.58555°, 7/19/2007). A zone of lateral spreading, sand boils and settlement crossing the present-day Sabaishi River, and that may be associated with a buried shoestring sand deposit of a former channel, resulted in failure of a road on the north side of the river adjacent to the Kashiwazaki Municipal Incinerator.

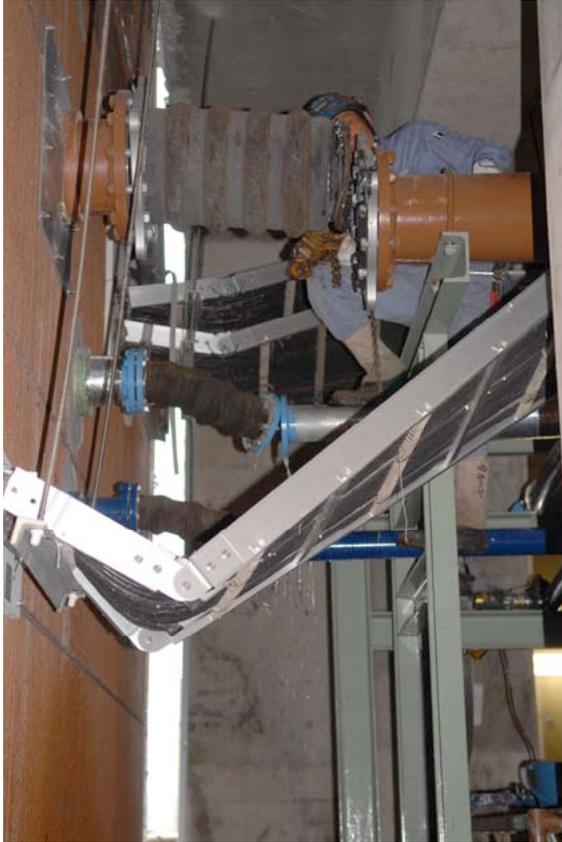
Figure 4.16b: Kashiwazaki Wastewater Treatment Plan on the south side of Sabaishi River near its outlet to the Sea of Japan (Site RK9 N37.38748° E138.56587°) Pipe breaks are due to separation of two adjacent building sections (Photo taken at 7/21/07 9:15)

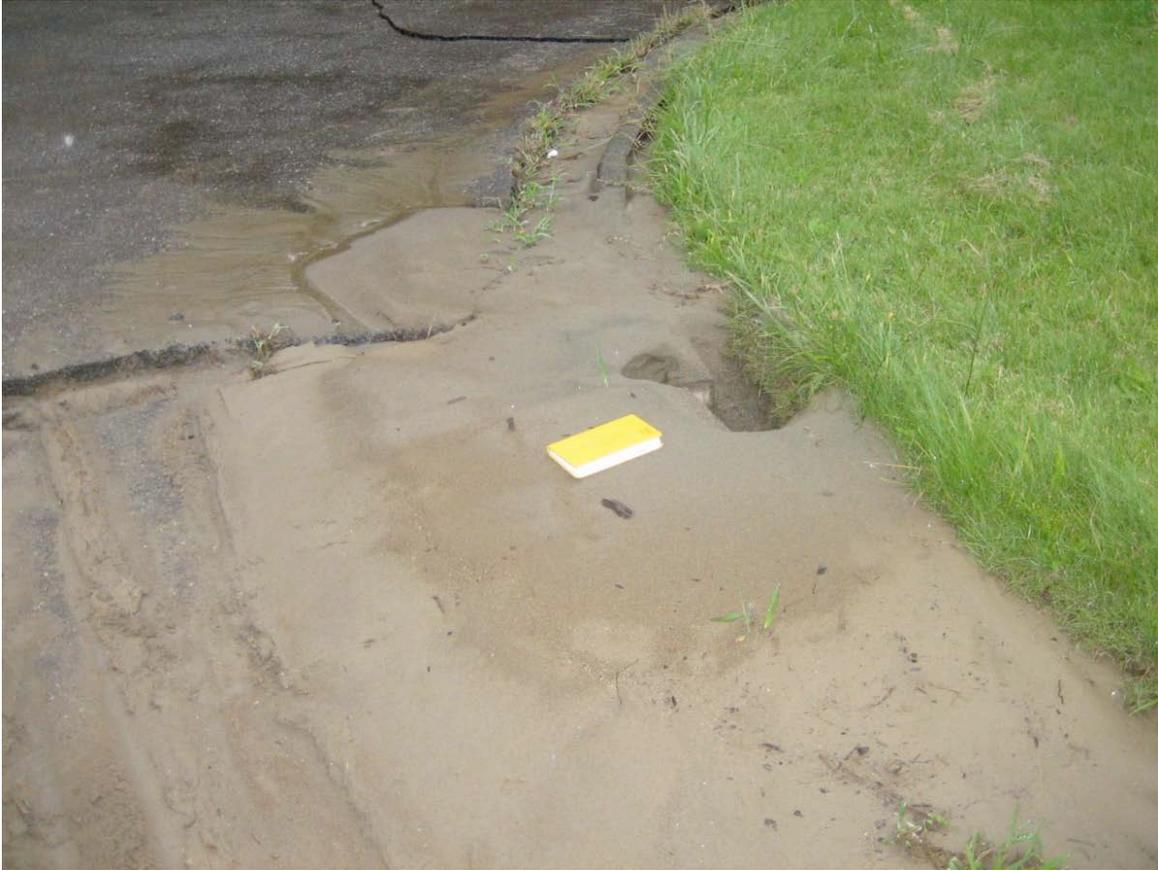
Figure 4.17: Kashiwazaki Wastewater Treatment Plant on the south side of Sabaishi River near its outlet to the Sea of Japan (Site RK9 N37.38748° E138.56587°, 7/19/2007). Liquefaction features were abundant near the wastewater treatment facility.

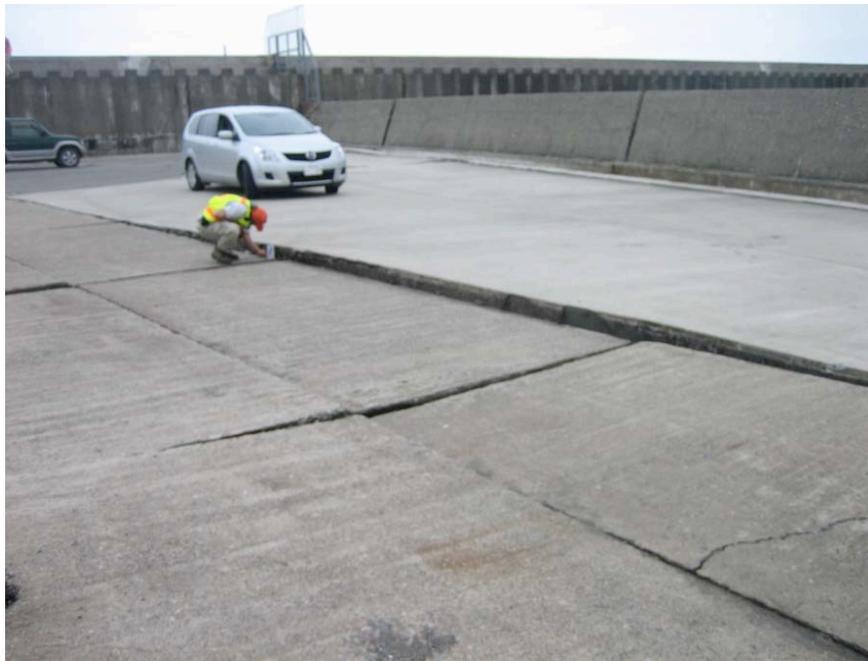
This area experienced ground damage from liquefaction induced lateral spreading. We observed sand boils in the grassy area behind the port office building and on the west end of the pier between separated pier slab sections. Some areas of concrete had 15 cm of vertical and 20 cm of lateral displacement. A track-line measurement was performed with a cloth tape. Measurements indicate that 0.7 m of lateral displacement occurred over 79 meters resulting in 0.9% strain, as measured between the seawall on the west to the edge of the pier to the east. The displacement direction was inland to the east. Terrestrial LiDAR scanning was performed at this site.

Figure 4.18: Kashiwazaki Harbor - South area experienced ground damage from liquefaction induced lateral spreading and settlement of separated pier slab sections (Site RK25, N37.36713° E138.53210°, 7/20/2007).

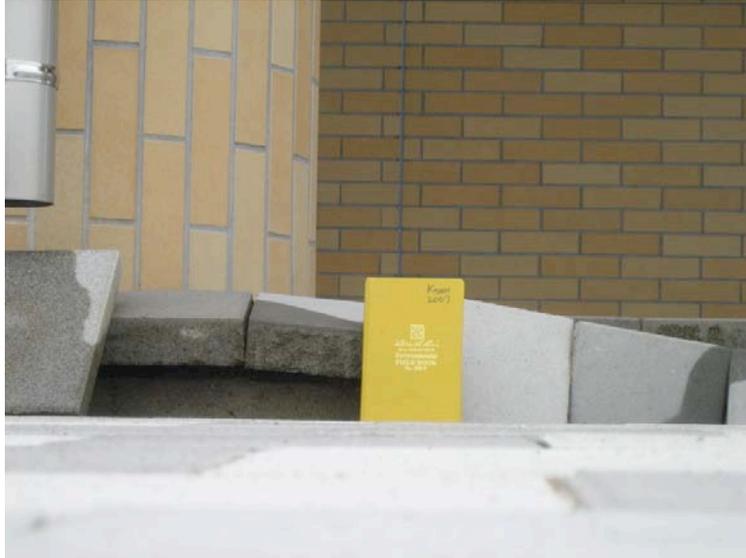
Figure 4.19: Kashiwazaki Harbor - South area experienced ground damage from liquefaction-induced lateral spreading and settlement immediately adjacent to the pile-supported port office building. (Site RK25, N37.36713° E138.53210°, 7/20/2007).

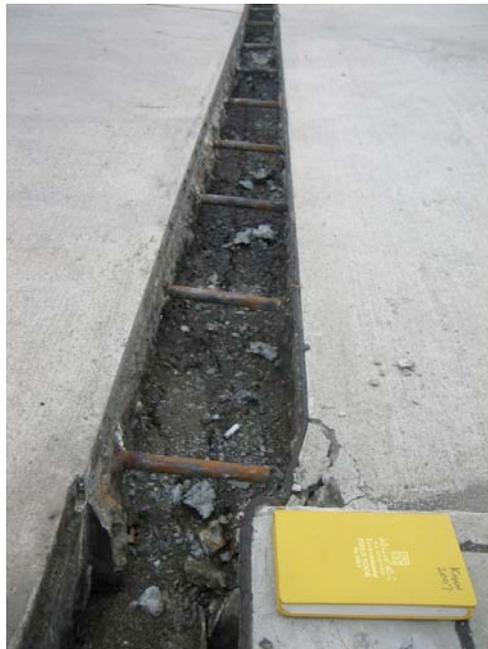
Figure 4.20: Kashiwazaki Harbor - South area experienced ground damage from liquefaction-induced lateral spreading resulting in separated pier slab sections (Site RK25, N37.36713° E138.53210°, 7/20/2007).

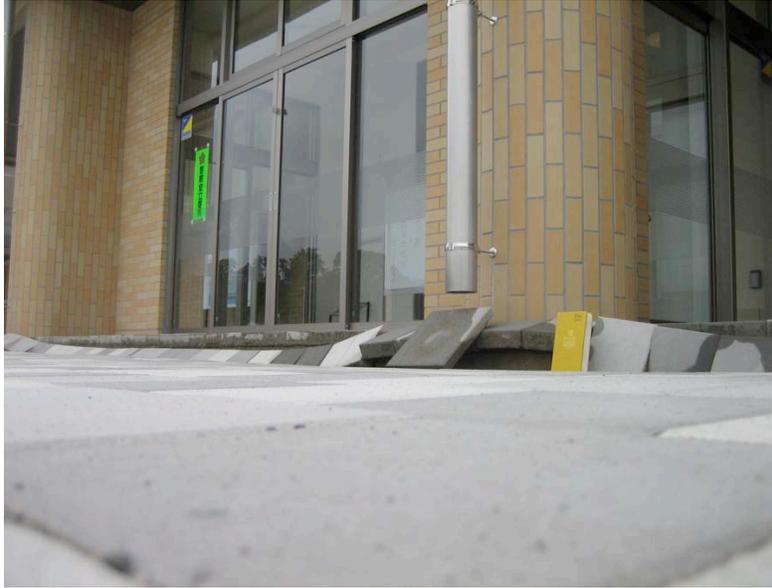
Figure 4.22: Kashiwazaki Harbor - The southern area experienced ground damage from liquefaction-induced lateral spreading and settlement. We observed settlement immediately adjacent to the pile supported port office building. (Site RK25, N37.36713° E138.53210°, 7/20/2007).

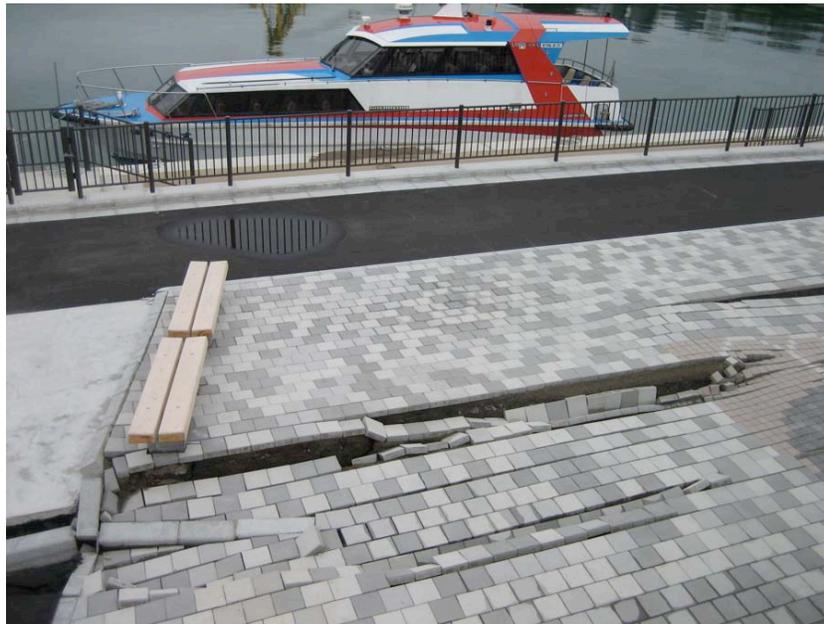
Figure 4.23: Kashiwazaki Harbor - The southern area experienced ground damage from liquefaction-induced lateral spreading and settlement. A harbor-front caisson rotated toward the harbor, uplifting the asphalt and tiled section shown here and initiating lateral displacement of the soil behind it, between the caisson and port building (Site RK25, N37.36713° E138.53210°, 7/20/2007).
