# Investigation of the M6.6 Niigata-Chuetsu Oki, Japan, Earthquake of July 16, 2007

Open File Report 2007–1365

2007

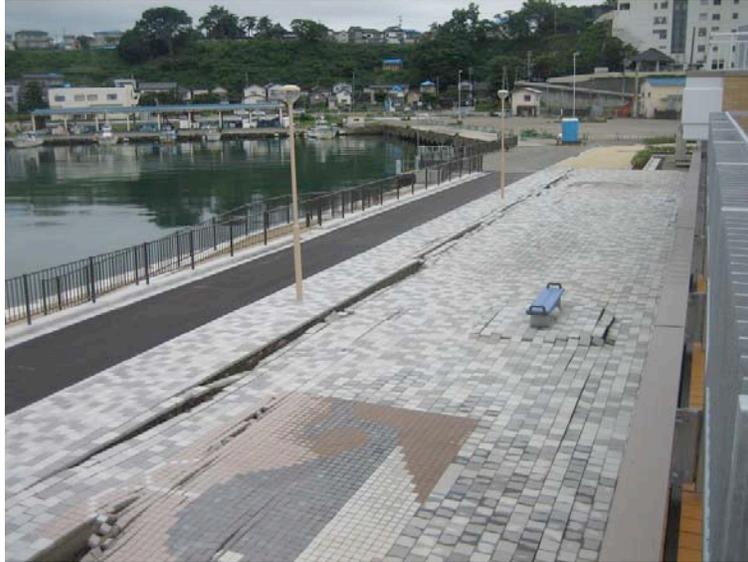
Figure 4.25: Kashiwazaki Harbor - South area experienced ground damage from liquefaction-induced lateral spreading and settlement. A harbor front caisson rotated toward the harbor, to the left of the photo, initiating lateral displacement of the soil behind it, between the caisson and port building. Settlements can also be seen in this photo. (Site RK25, N37.36713° E138.53210°, 7/20/2007)

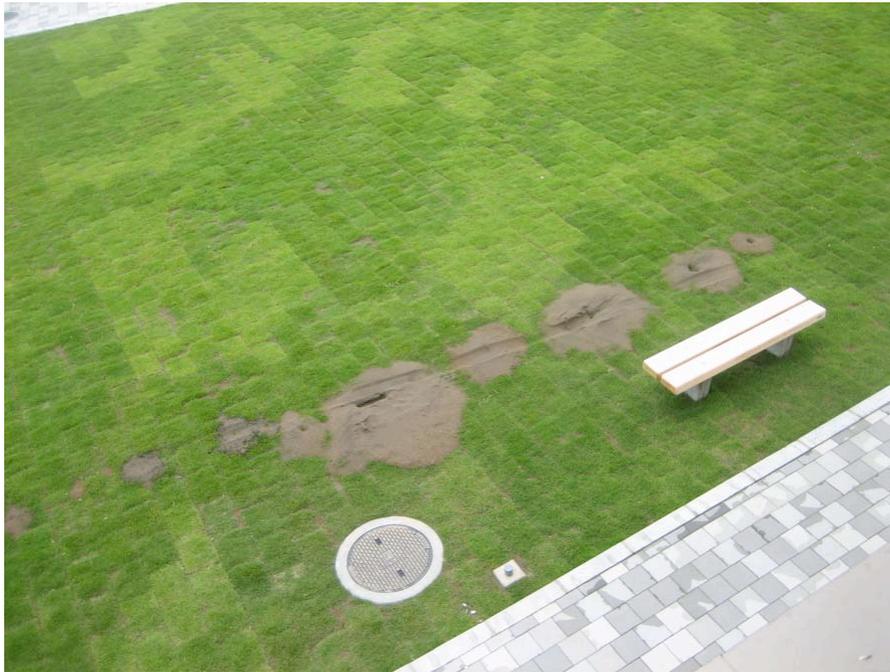
Figure 4.26: Kashiwazaki Harbor - South area exhibited surficial features of liquefaction on all sides of the port building. (Site RK25, N37.36713° E138.53210°, 7/20/2007).

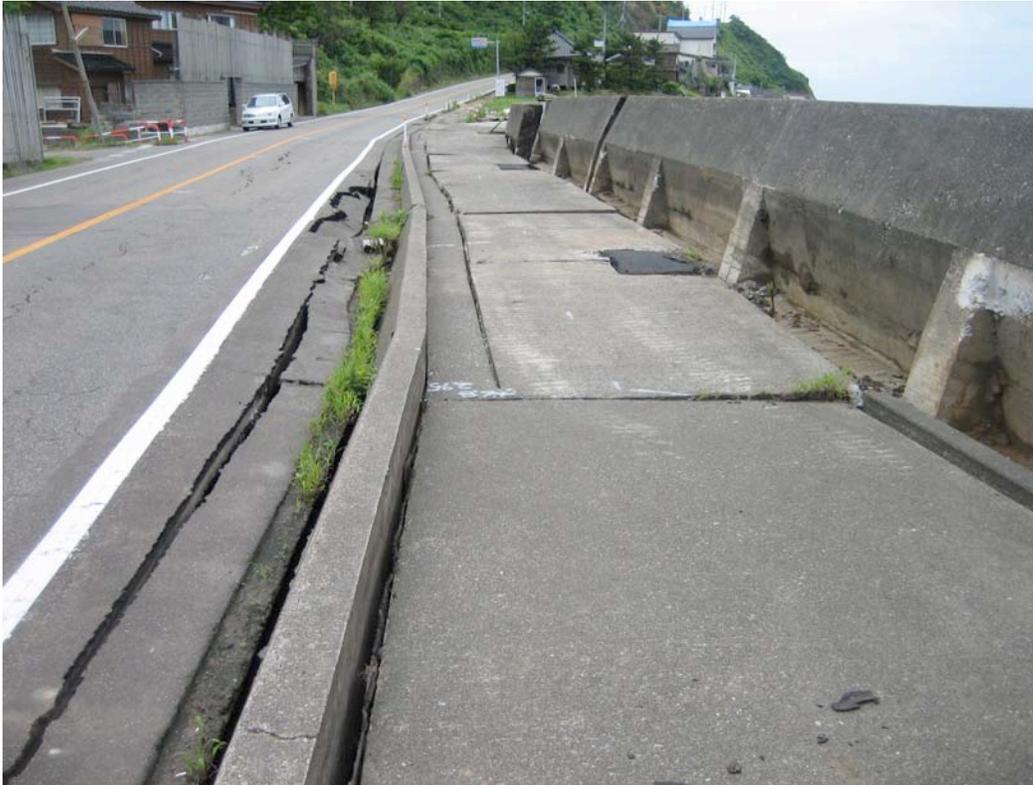
Liquefaction of beach sand led to lateral spreading of a road embankment and both rotation and translation of a 30-meter-long segment of concrete seawall. Deformations were on the order of 25 cm vertical, and up to 64 cm horizontal, with a component of rotation as measured by 32 cm lateral deformation at the base of wall and 64 cm lateral deformation at 2m height of wall.

Figure 4.27: Liquefaction of beach sand led to lateral spreading of a road embankment and both rotation and translation of a 30-meter-long segment of concrete seawall. (Site RK35, N37.48497° E138.62645°, 7/22/2007).

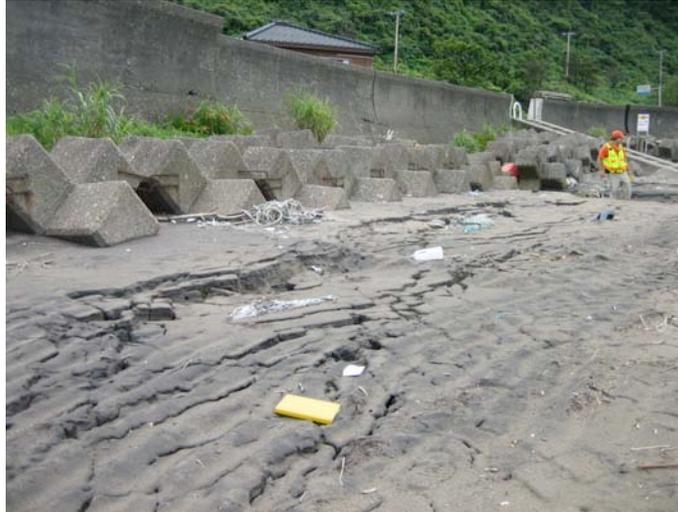
Figure 4.28: Liquefaction of beach sand resulted in lateral spreading, above, in front of a 30-meter-long segment of concrete seawall. (Site RK35, N37.48497° E138.626°, 7/22/2007)

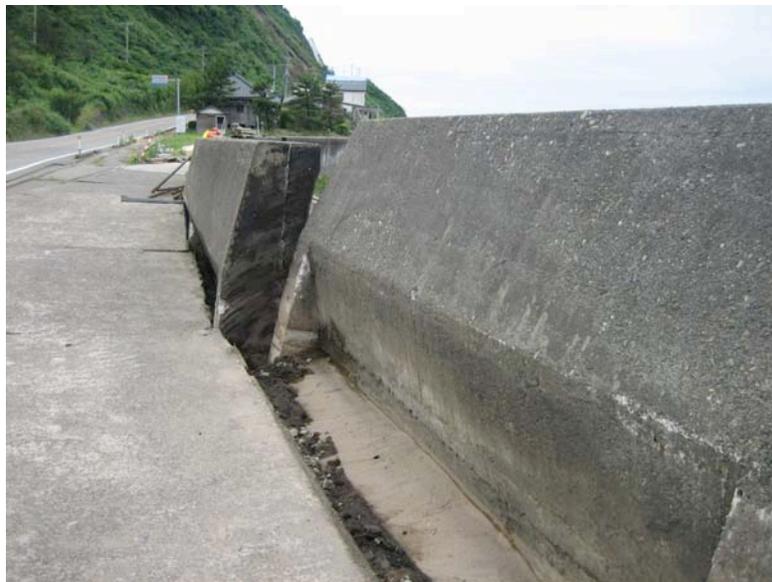
Figure 4.29: Liquefaction of beach sand led to lateral spreading of a road embankment and both rotation and translation of a 30-meter-long segment of concrete seawall. (Site RK35, N37.48497° E138.62645°, 7/22/2007). Deformations were on the order of 25 cm vertical, and up to 64 cm horizontal, with a component of rotation as measured by 32 cm lateral deformation at the base of wall and 64 cm lateral deformation at 2 m height of wall.

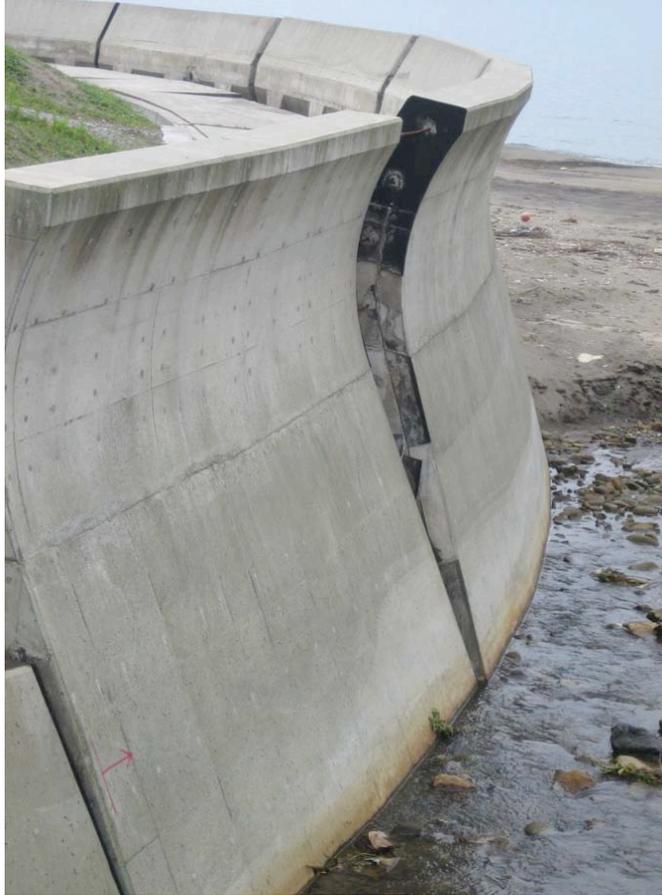
Embankment failure and lateral spread from liquefaction of beach sands at toe of seawall. We measured 21 cm of vertical displacement and 55 cm of horizontal displacement of a wall section from an adjacent non-failed wall section. The total length of failed sections was 40 m.

Figure 4.31: Seawall Failure as a result of embankment movement into a seawall founded on top of liquefied beach sands. (Site RK37, N37.45478° E138.60927°, 7/22/2007).

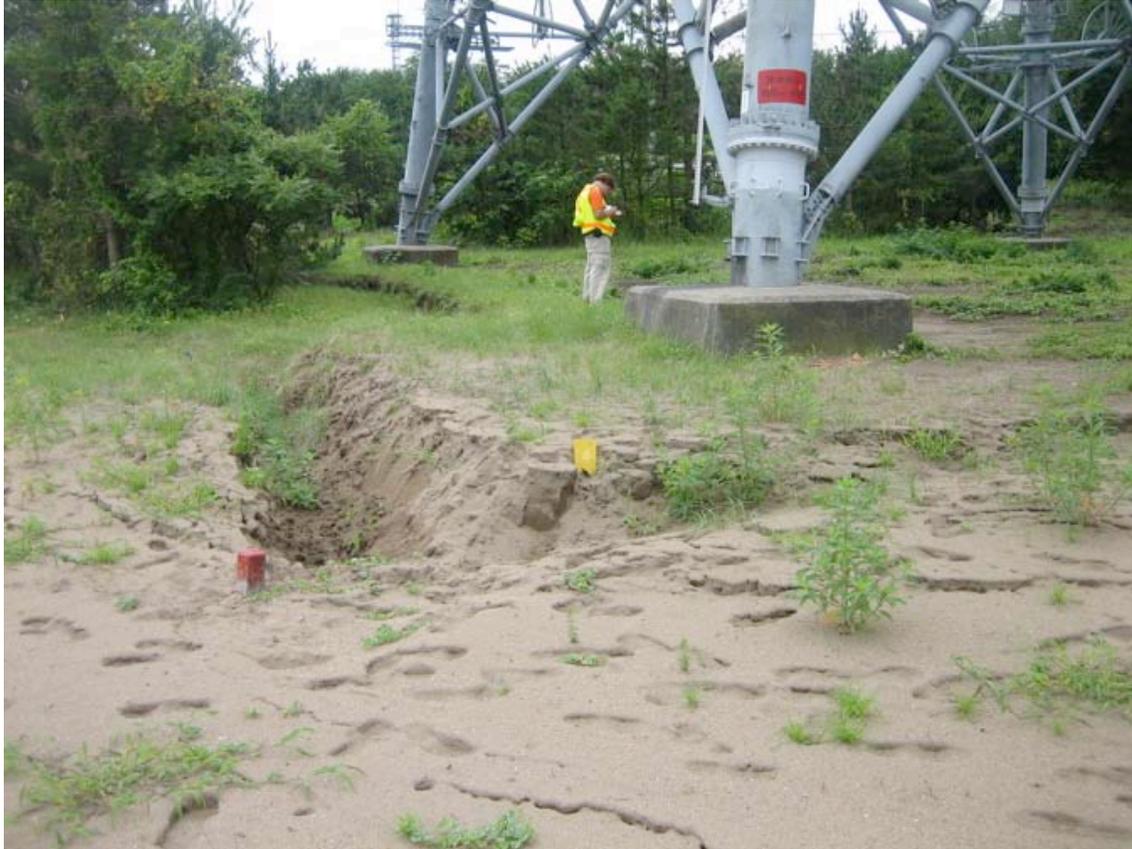
Liquefaction and lateral spread of dune sand adjacent to tower footings. We measured 40 cm of vertical displacement and 12 cm of horizontal displacement over a 20-meter track-line moving away from the footing for 0.6% of measured ground strain.

Figure 4.33: Liquefaction and lateral spread of ground adjacent to High Voltage Transmission Line Tower (Site RK40, N37.41633° E138.60792°, 7/22/2007).

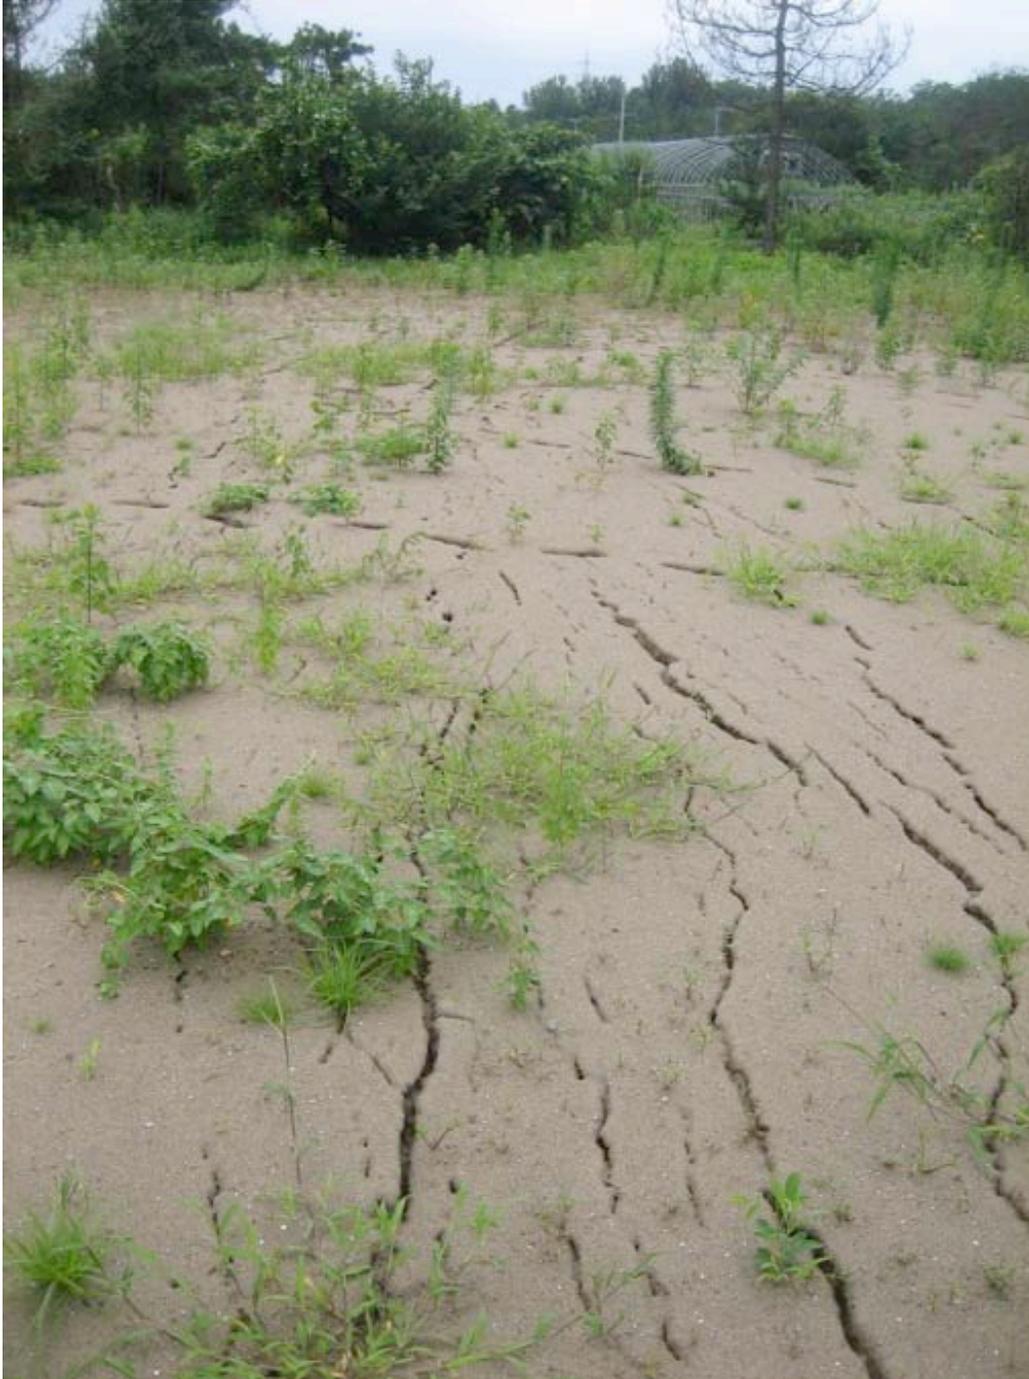
Figure 4.34: Lateral spreading in dune sand down slope of high voltage power transmission tower. We measured 0.6% of ground strain at the site. (Site RK40, N37.41633° E138.60792°, 7/22/2007).

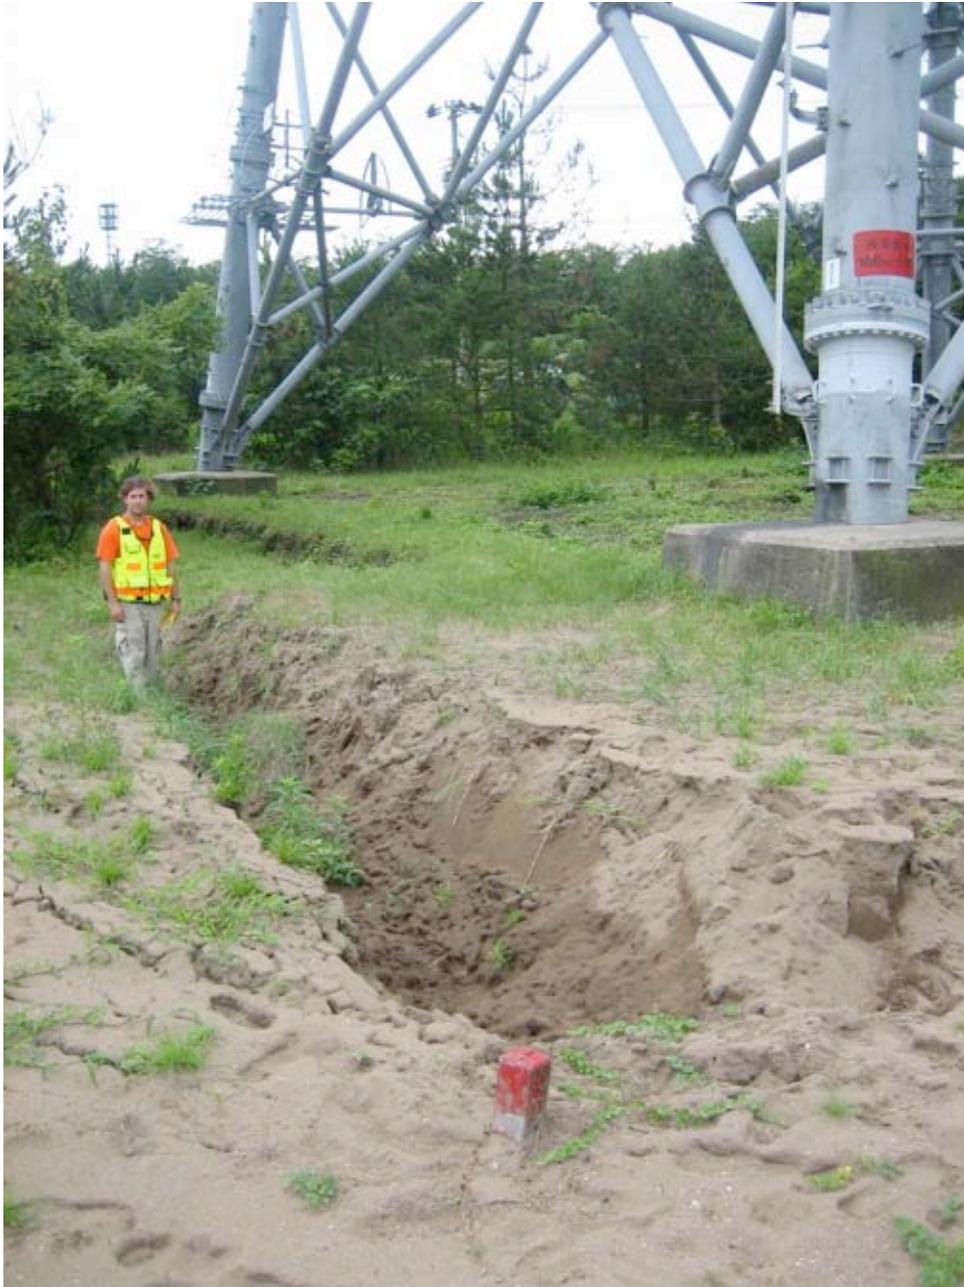
Figure 4.35: Settlement of ground adjacent to grade beam between footings of a high voltage transmission line tower (Site RK40, N37.41633° E138.60792°, 7/22/2007).

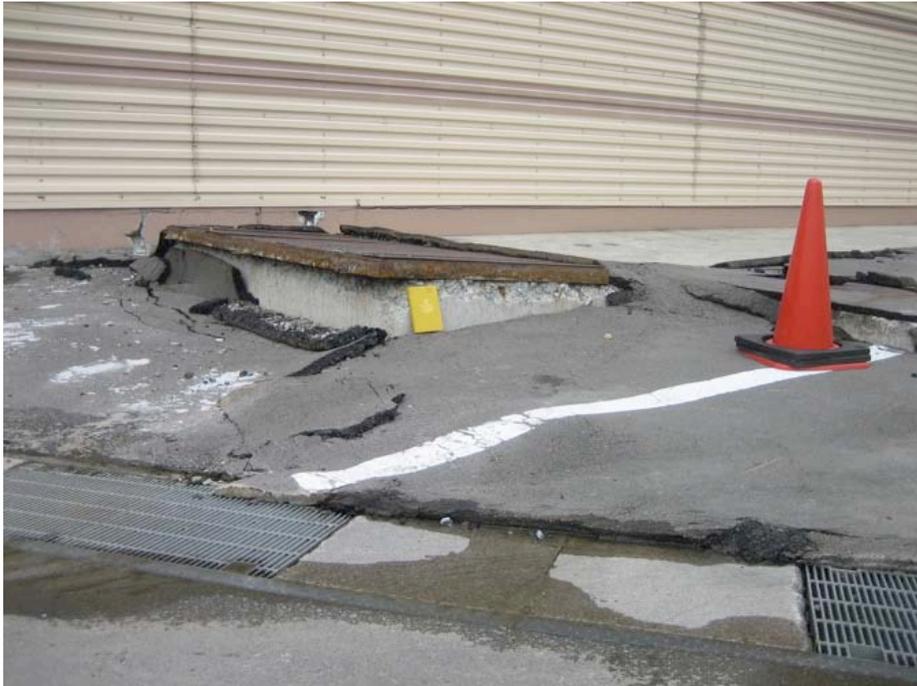
We observed structural damage and ground settlement of a large warehouse-type department store. The interior columns were deformed and leaning, and the interior floor slab reinforcing bars had buckled and were exposed. Reinforcing bars and concrete also failed at a corner of the building. Ground settlement was observed around the building and an underground storage tank had been uplifted (this was the only obvious sign of liquefaction).

Figure 4.36: Plant 5 Store - Ground settlement in dune sand was observed around the building and an underground storage tank had been uplifted (Site RK41, N37.41468° E138.6084°, 7/22/2007).

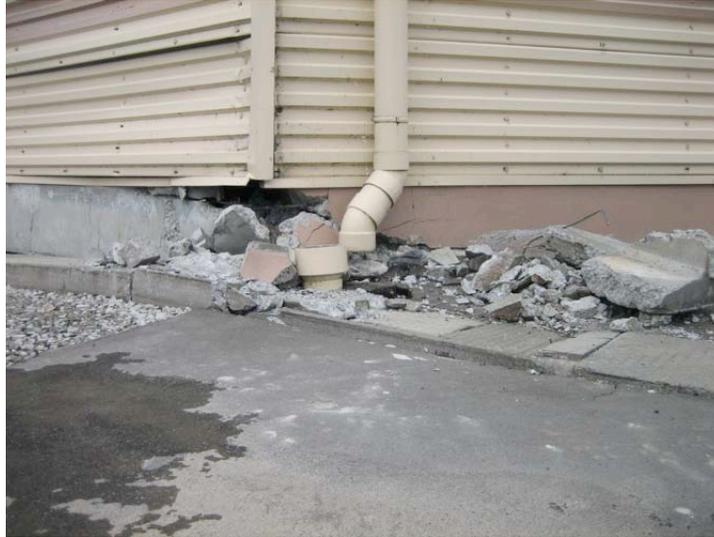
Figure 4.37: Plant 5 Store showing foundation corner area of failed reinforced concrete. (Site RK41, N37.41468° E138.60840°, 7/22/2007).

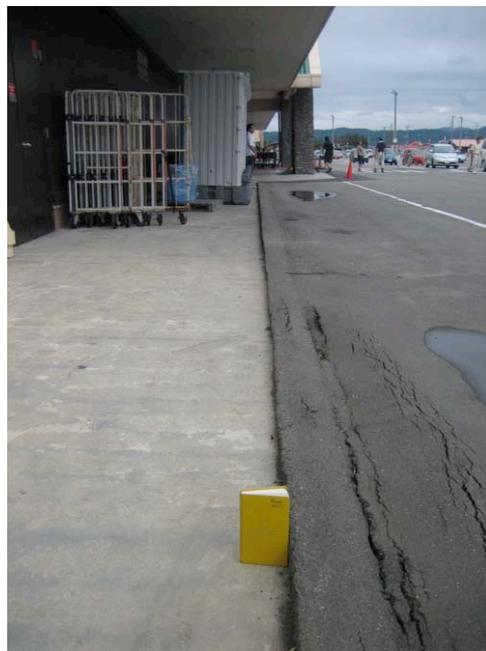
Figure 4.38: Plant 5 Store - Ground settlement in dune sand was observed around the building and an underground storage tank had been uplifted (Site RK41, N37.41468° E138.60840°, 7/22/2007).

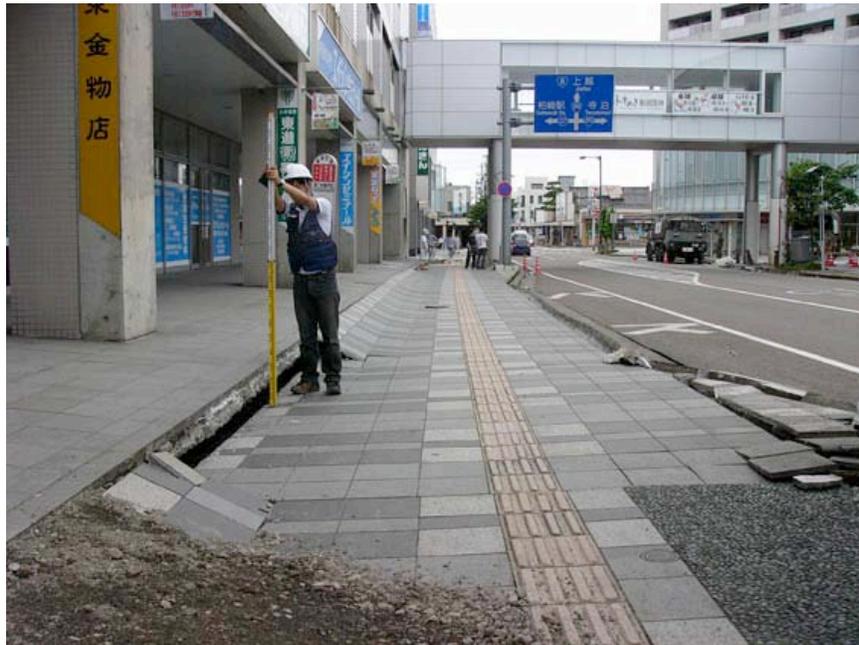
Damage to old wooden houses were concentrated in the downtown area of Kashiwazaki City where the old sand dune deposit is thought to cover the most of the area. Because of strong shaking in these sand deposits with water level at some depth below the surface, a deep seated lateral flow of ground appears to have occurred, resulting in various surface ground distortions in the Nishi-Honmachi area. This hypothesis was first presented by Prof. Konagai of Univ. of Tokyo who conducted a reconnaissance of the area immediately after the quake (July 17, 2007). Yellow markers in Fig. 4.40 show the locations where EERI & GEER team identified signs of ground lateral flow. Photos of each of these areas can be viewed in the Google Earth database available through the USGS website. The ground movement occurred typically from areas of higher elevation to lower elevation, and we observed open tension cracks at higher ground and compressive heaves in lower ground. Fig.4.41 (SiteYT24\_YT\_19 as shown in Fig. 4.40) shows the ground distortion near a department store building that seems to be supported by deep foundation and shows no major structural damage. The road on the hill side (northern side) settled and moved downwards to result in the large opening and distortion at the road side.

Fig. 4.41: Downtown Kashiwazaki Lateral Spread (SiteYT24, N37.36949°, E138.5541°, photo taken 7/22/07, SiteYT24\_YT\_19 as shown in Fig. 4.40).

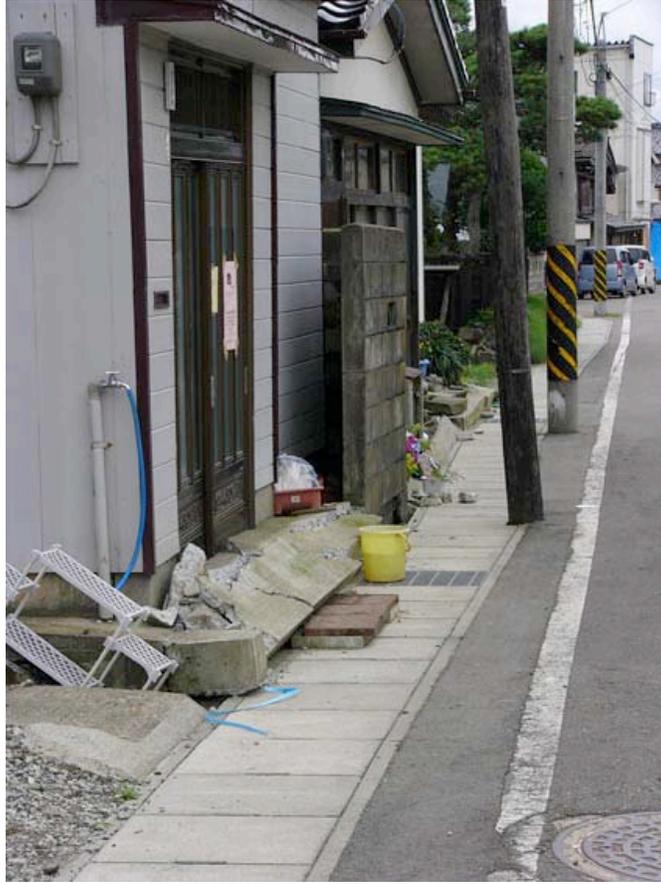
The reconnaissance was made to define the extent of such a deep-seated lateral flow from ground surface distortions. Fig. 4.42 (Site YT24-YT\_03 in Fig. 4.40) shows damage at the north-western limit, whereas Fig. 4.43 (Site YT24-YT\_14 in Fig. 4.40) shows damage at the south-eastern limit. Thus, the area covered between Fig. 4.42 and Fig. 4.43 may have suffered deep seated lateral flow from higher ground to lower ground. The damages due to such lateral flow extend to the north-eastern direction of downtown. The arcaded street next to (east) Fig. 4.43 (Site YT24-YT\_14 in Fig. 4.40) was closed because of heavy structural damages of shops along the street.

Fig. 4.42: Downtown Kashiwazaki Lateral Spread (SiteYT24, N37.36963°, E138.5486°, photo taken 7/22/07, SiteYT24\_YT\_03 as shown in Fig. 4.40).

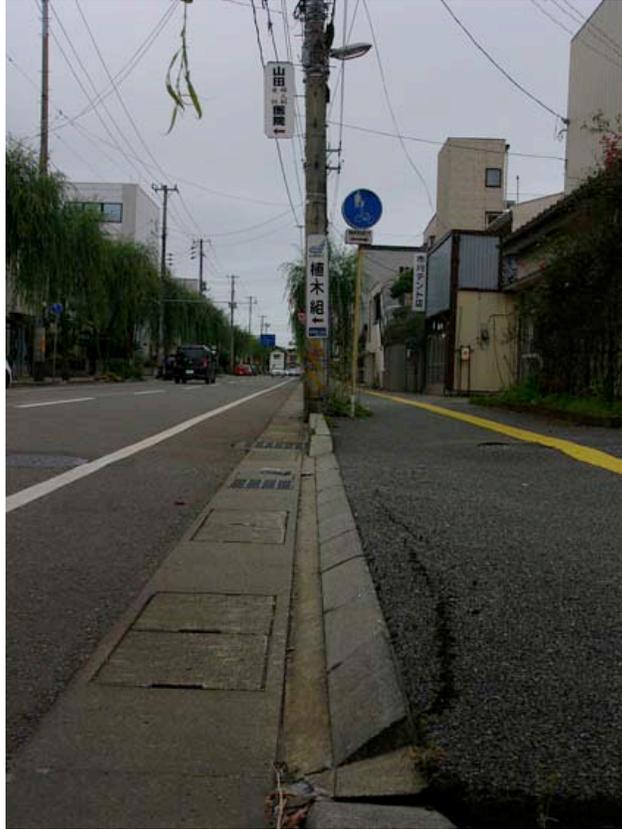
Fig. 4.43: Downtown Kashiwazaki Lateral Spread (SiteYT24, N37.36731°, E138.5522°, photo taken 7/22/07, SiteYT24\_YT\_14 as shown in Fig. 4.40).

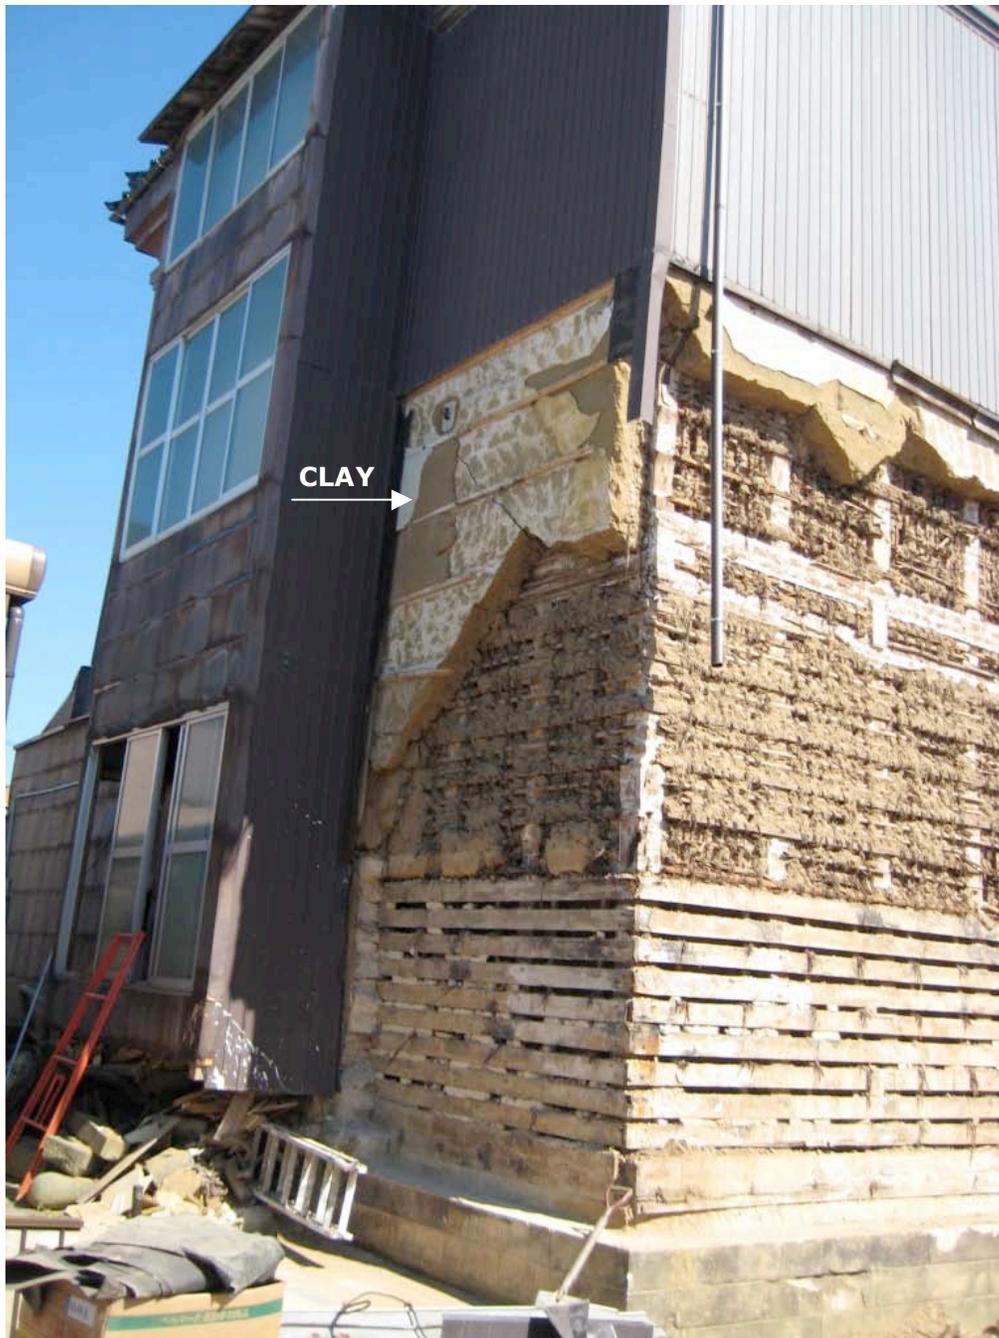
A large fraction of the houses affected were of old-style heavy clay-tile kawara roofs with walls constructed of wood, and walls of soil and bamboo-lathe known in Japanese as *tsuchi-kabe* or “soil wall” (Fig. 5.11). The clay-wood combination can be used effectively if provided with braces for lateral strength and stiffness, however in general, results in heavy and brittle building components. Soft story collapses were observed in buildings with open businesses on the ground floor. The business arcade of Higashi-Honcho Dori was particularly hard hit, accompanied by ground movement/settlement on the south side of the street that was located on the shoulder of sand dunes.

Figure 5.11: Traditional Japanese tsuchi-kabe (“soil wall”) construction technique (Site SP13, N37.37056°, E138.55694°).

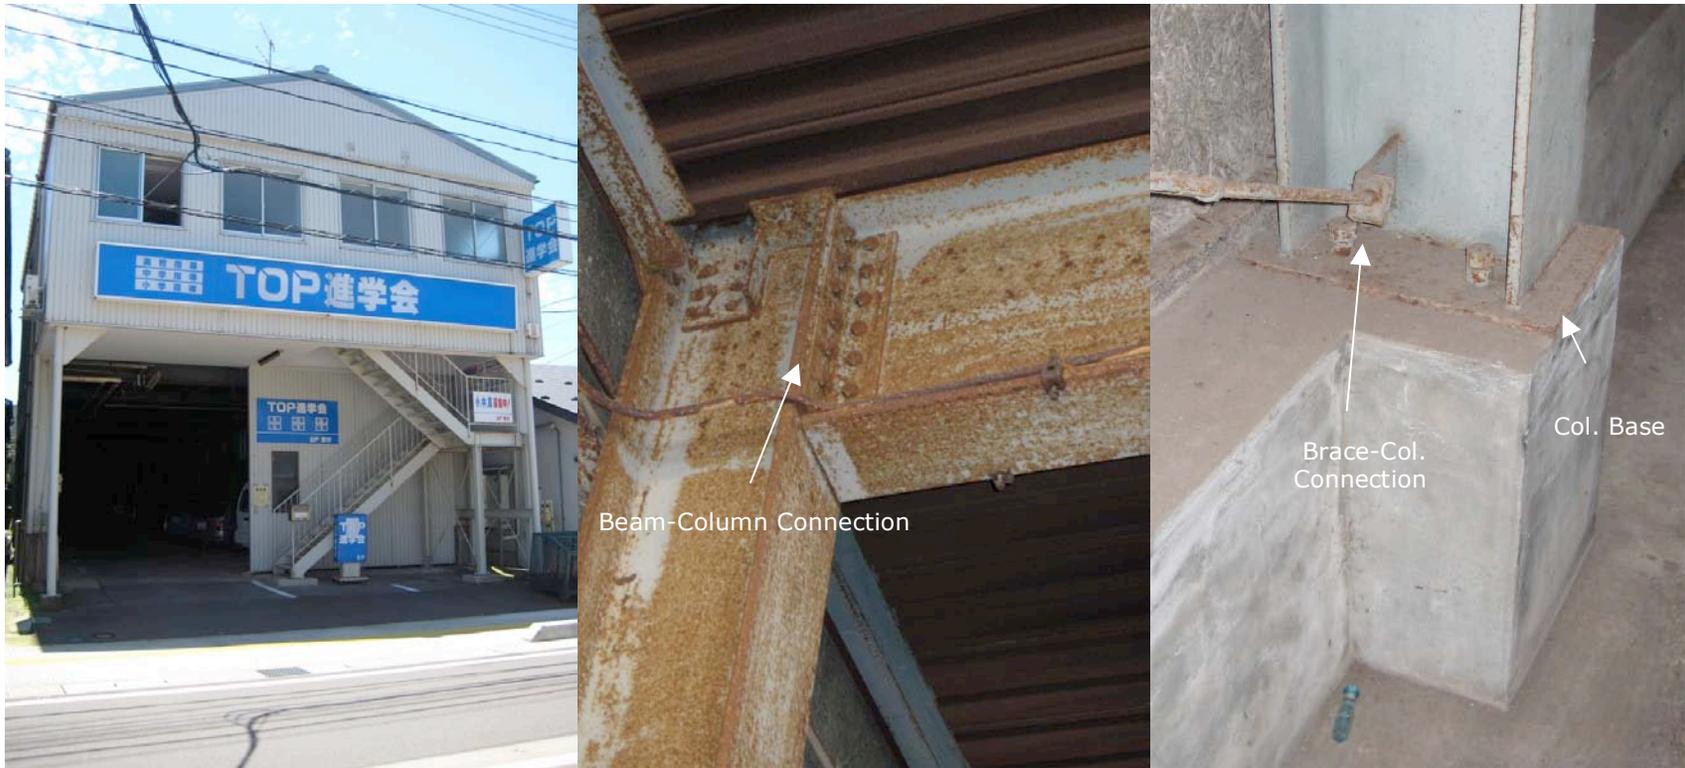
Another example of a surviving steel structure is illustrated in Fig. 5.13 (Site SP29). This structure was located at approximately 270 m from the K-NET NIG018 station, which measured PGV=100m/s. The two-story structure included nine, one-bay

frames parallel to the EW direction. The five frames closer to the front of the structure had no moment connections. The four frames closer to the back did have moment connections. The frames were connected to one another by a concrete slab cast on a steel deck at the second level and presumably by the roof. The slab had a step in the span that connects the moment resisting frames in the back and the gravity frames in the front. Braces were visible along the NS walls of the structure. The braces were connected to the webs of columns in the front frames through brackets as shown in Figure 5.13.

Figure 5.13: Parking structure in Kashiwazaki (Site SP29, N37.3707° E138.5566°).

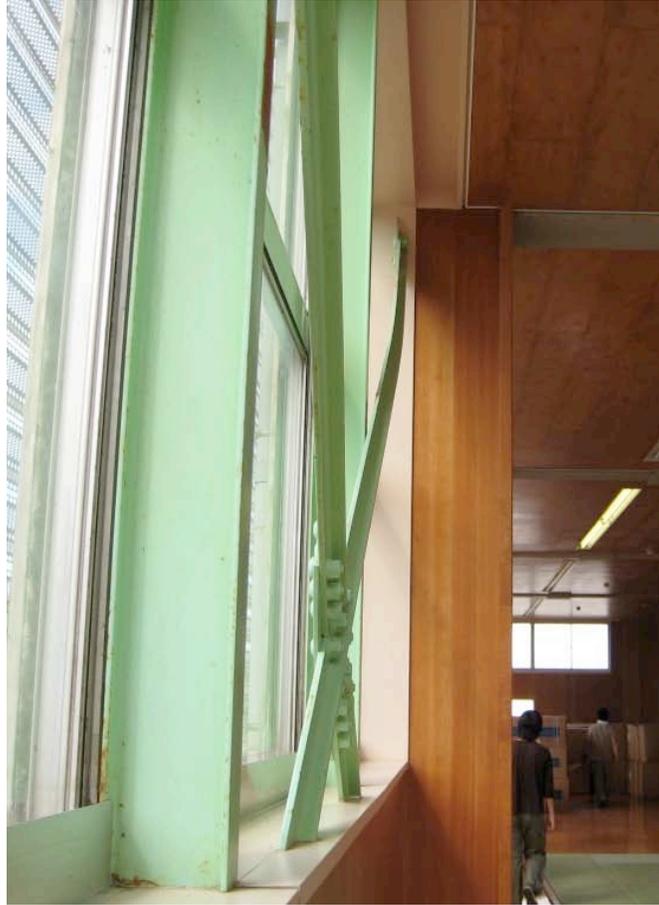
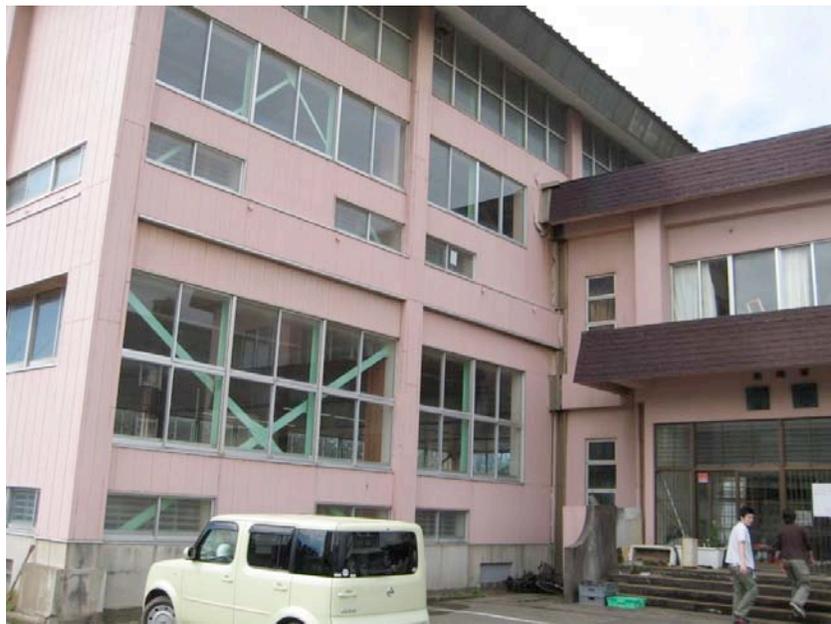
We inspected another gymnasium (Fig. 5.14 - Site SP7) with a steel structure. In this structure, located 430 m from the K-NET station, we observed buckling of steel braces in the lower of the two stories in the structure. The braces had T-shape cross sections with a thickness of 12 mm. The flange measured 150 mm, and the stem 45 mm. The braces had a slope of 2/3 with respect to the horizontal. Four pairs of braces reinforced each story in the NS direction. The floor plan was approximately 20 m in the EW direction and 33 m in the NS direction.

Figure 5.14: Buckling of braces in gymnasium in Kashiwazaki (Site SP7, N37.3755° E138.5541°).

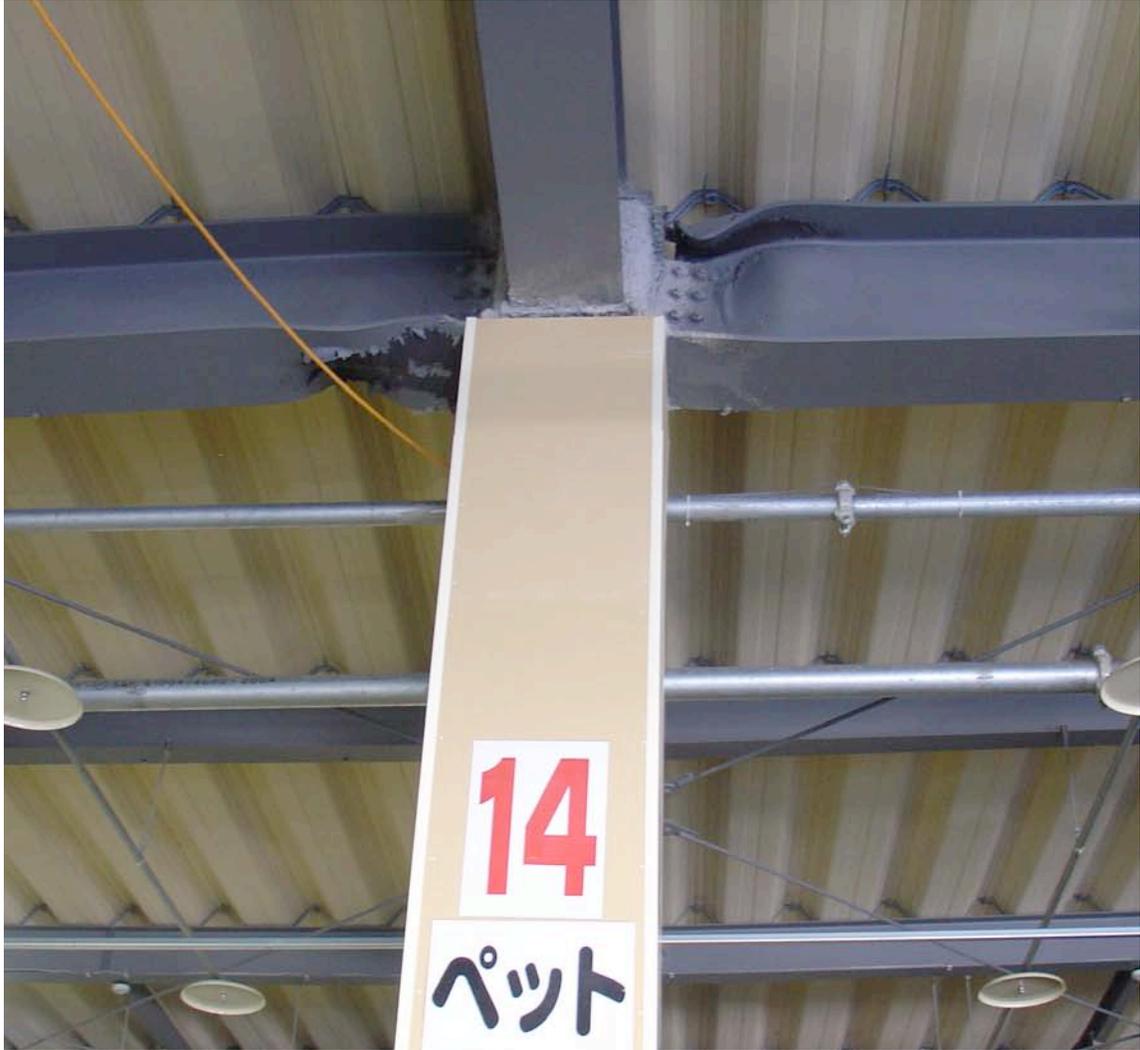
The storage at site RK41 was affected by large ground distortion (see Section 4). At this site, we observed buckling of flanges of beams at bolted connections (Fig. 5.15).

Figure 5.15: Buckling of beam flanges (Site RK41, N37.41472° E138.60833°, photo by Peter Yanev).

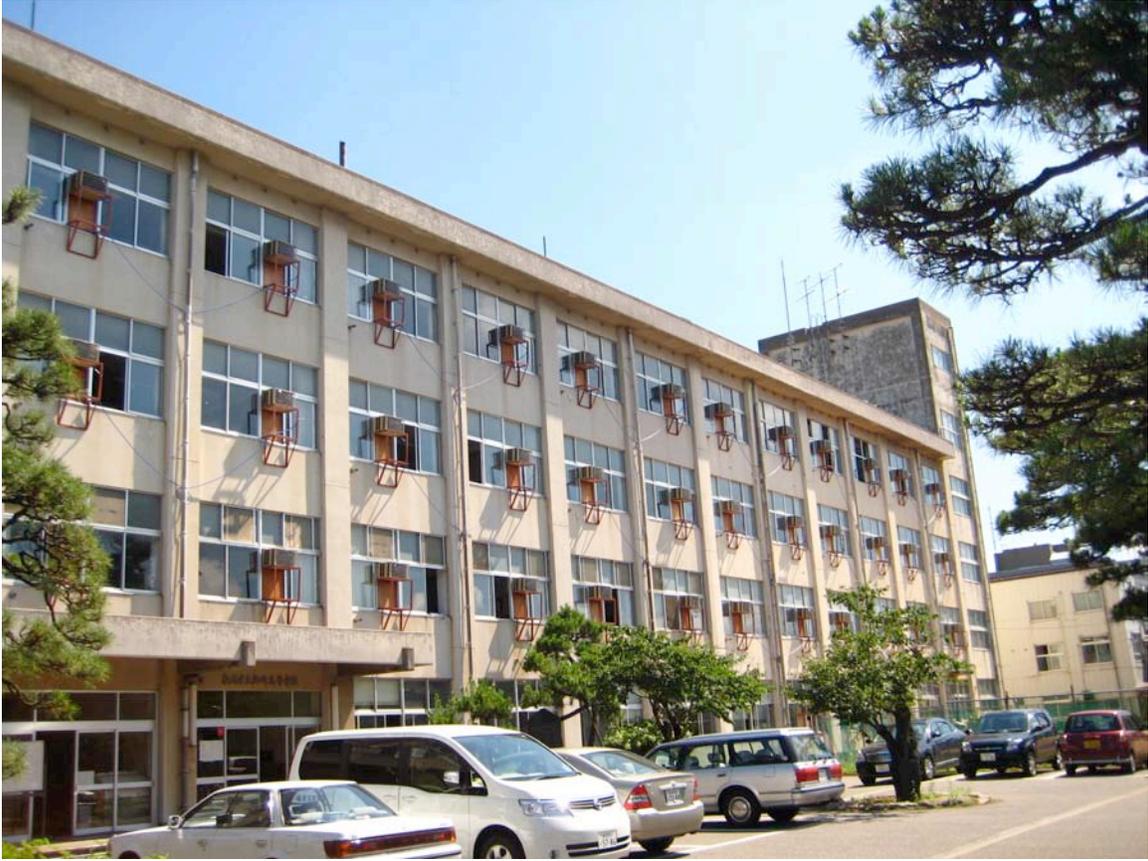
We observed 1-mm thick inclined cracks in a column and 1 to 2.5-mm-thick inclined cracks in reinforced concrete walls in the Kashiwazaki High School (Site SP11), located at 100 m from the K-NET NIG018 station. The high school facilities included two reinforced concrete buildings (Figs. 5.16 to 5.20). We observed the south building to be a four-story building with shear walls in the NS direction and moment-resisting frames in the EW direction. The walls with cracks filled bays in one of the frames parallel to the EW direction in the south building and had a thickness of 12 cm. These walls were reinforced with bars with a diameter of 10 mm, spaced at 20 cm in the vertical and

horizontal directions. The inclined cracks described had the same orientation in the column and the walls, and indicated movement of the second level towards the west. The wall with the largest cracks had a door opening (bay 3-4). Refer to the Google Earth map accompanying this report for additional information.

Figure 5.16: Kashiwazaki High School, south building (Site SP11, N37.3721° E138.5569°).

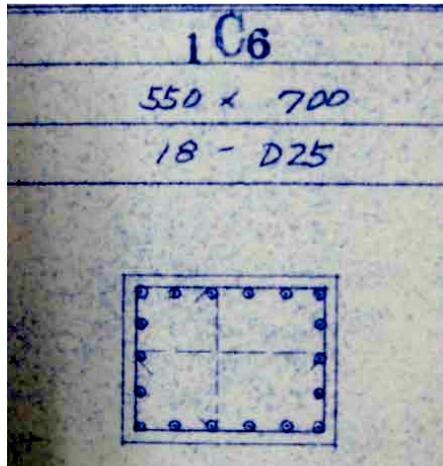
The column observed to have an inclined crack had a clear height of 1.3 m. Other columns in the building had clear heights ranging from 1.3 to 3 m. The column with an inclined crack was located at the intersection of column lines C and 19. The cross section of column C-19 was rectangular with dimensions of 70 cm and 55 cm in the EW and NS directions, respectively (Fig. 5.21). Ties were specified to be 13 mm in diameter and to have an even spacing of 10 cm. A maximum tie spacing of 10 cm has been mandatory in Japan since 1972. In drawings of buildings built before 1972, one may find specifications calling for larger tie spacing (30cm). Cross ties with a diameter of 9 mm were to be provided every 50 cm. Column C-19 supported a single level (a slab that serves as roof beyond column line 18). Averages obtained for buildings from the same vintage indicate that concrete strength is likely to be close to 3 ksi. The yield stress of the reinforcement is estimated to be  $f_y = 45$  ksi.

Figure 5.21: Column in first story of The Kashiwazaki High School, cross section and observed crack pattern (Site SP11, N37.3721°, E138.5569°).

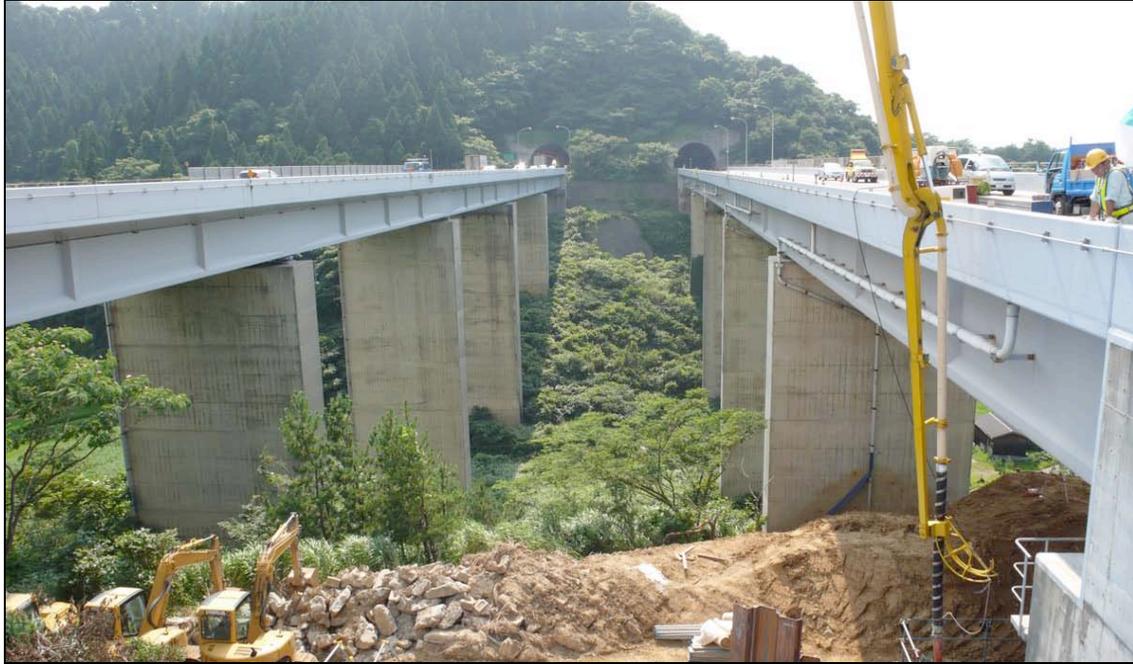
These are two parallel five-span concrete 'I' girder bridges on seat-type abutments and tall (30m+) pier walls (Fig. 6.2). The three northern spans are continuous over steel bearings with an expansion joint at the end of the third span. The piers are on piles except where there is rock near the surface. The bridges are just north of the Yoneyama tunnel, which was also damaged. Our team went under the bridge to study the bottom of the piers but the undergrowth was so thick we couldn't get close to them.

Fig. 6.2. Looking south at the Hachisaki Bridges.

When we arrived at the scene (on August 5<sup>th</sup>), both directions of traffic had been diverted to the east bridge, they had finished driving sheet piles around the abutment to stabilize the soil, and were casting a large pad at the west bridge so that they could jack up the southern three spans and repair the girders and bearings.

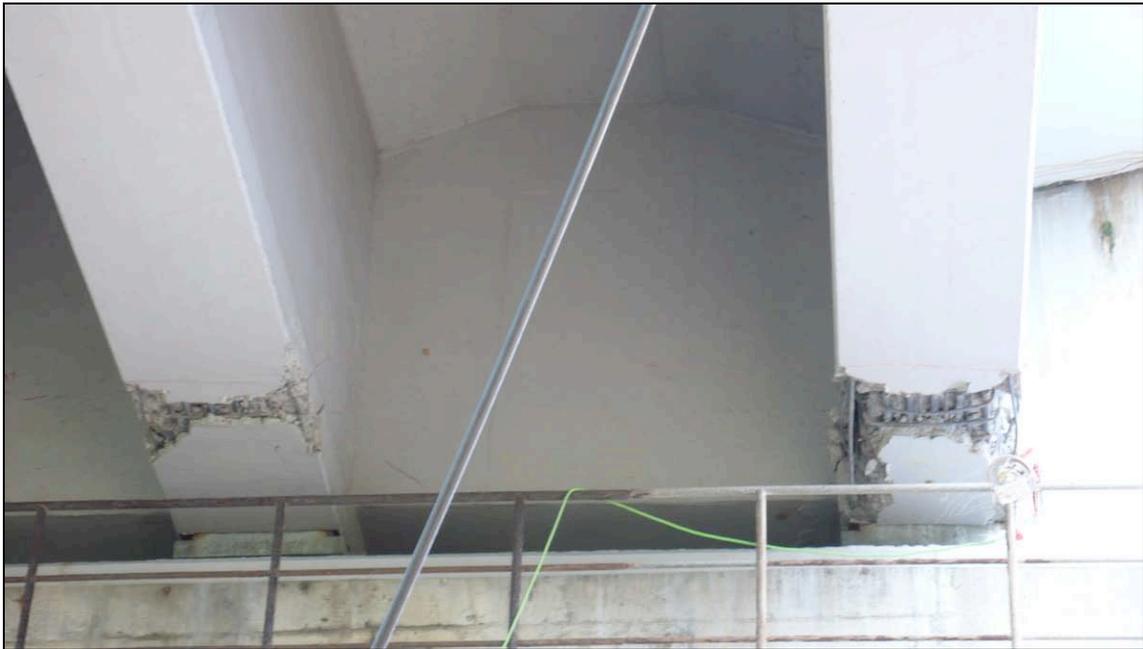
shear force exceeded the shear strength of girder at the bearing connection. There was a spall at the bottom of the girders about 0.6m from the abutment backwall and on the other side of the bearing. Perhaps, as the abutment moved downward, large shear forces in the girders caused them to spall (Fig. 6.4). The damage occurred at the north end of the west bridge (small cracks were observed on the east bridge).

Fig. 6.4. Closer view of girders on the west Hachisaki Bridge.

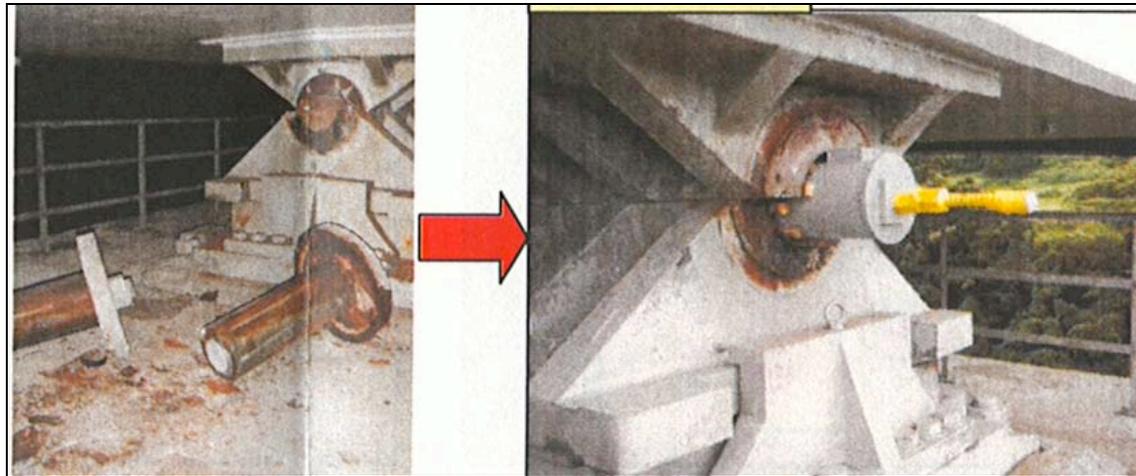
These are two haunched, three-span, segmentally-constructed cast-in-place, concrete box girder bridges on very tall hollow, reinforced concrete piers (Fig. 6.5). Like several other bridges in the same area, the superstructures moved enough during the earthquake to break the fixed steel bearings (Fig. 6.6). Perhaps the weakest member, in this case the

steel bearings, acted as fuses to protect the structure from more catastrophic damage. Jacking up these long, continuous superstructures is no easy task, and jacking them back transversely is also a lot of work, but it's also one of the most common types of bridge damage that occurs during earthquakes.

Fig. 6.6. Damage and Repair to Omigawa Bridge (photo courtesy of the Nippon Expressway Company.).

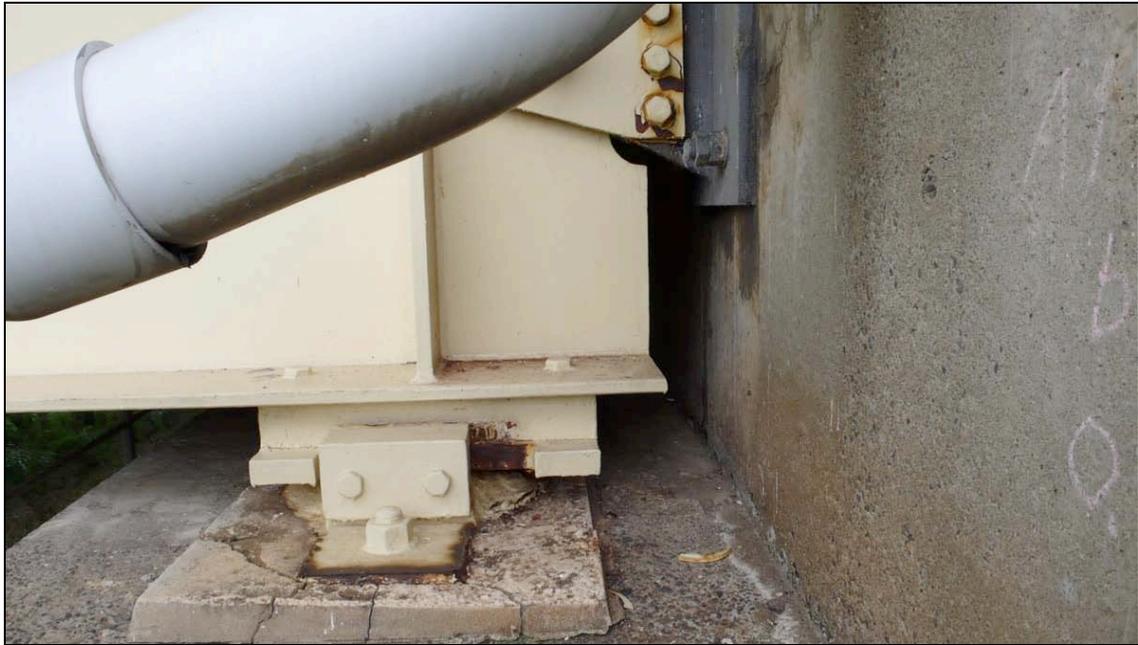
These are two, long steel I girder bridges on single column bents and seat-type abutments. The bridges were being retrofit at the time of the earthquake (Fig. 6.7). Expressway bridges are built with an approach slab that is pinned to the abutment backwall, but this connection broke due to the ground shaking combined with the approach settlement (Fig. 6.8). The only other noticeable damage was the grout plate that

the steel abutment bearing was seated on had shattered as the steel girders banged against the steel longitudinal keys that were to limit movement (Fig 9).

Fig. 6.9. Bearing at south abutment of Yoshiigawa Bridges.
