# Investigation of the M6.6 Niigata-Chuetsu Oki, Japan, Earthquake of July 16, 2007

Open File Report 2007–1365

2007

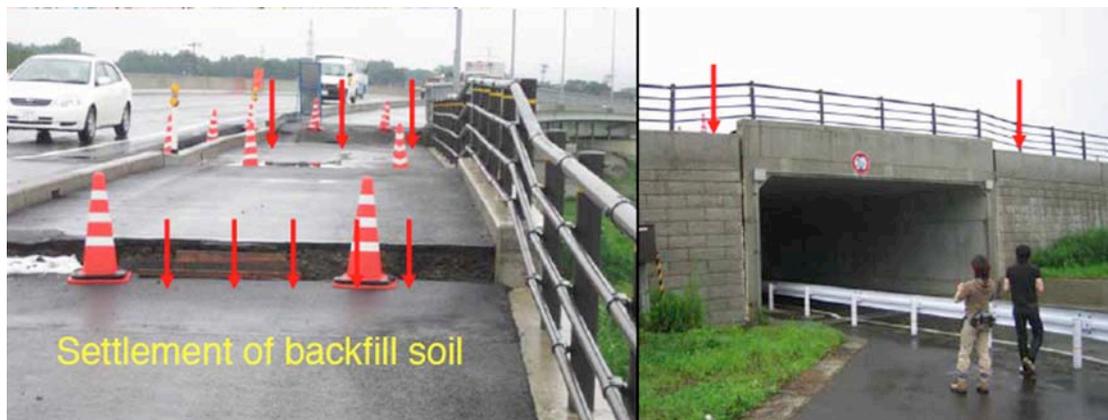
Fig. 6.13. Settlement of west embankment (courtesy G. Watanabe, Tokyo Institute of Technology).

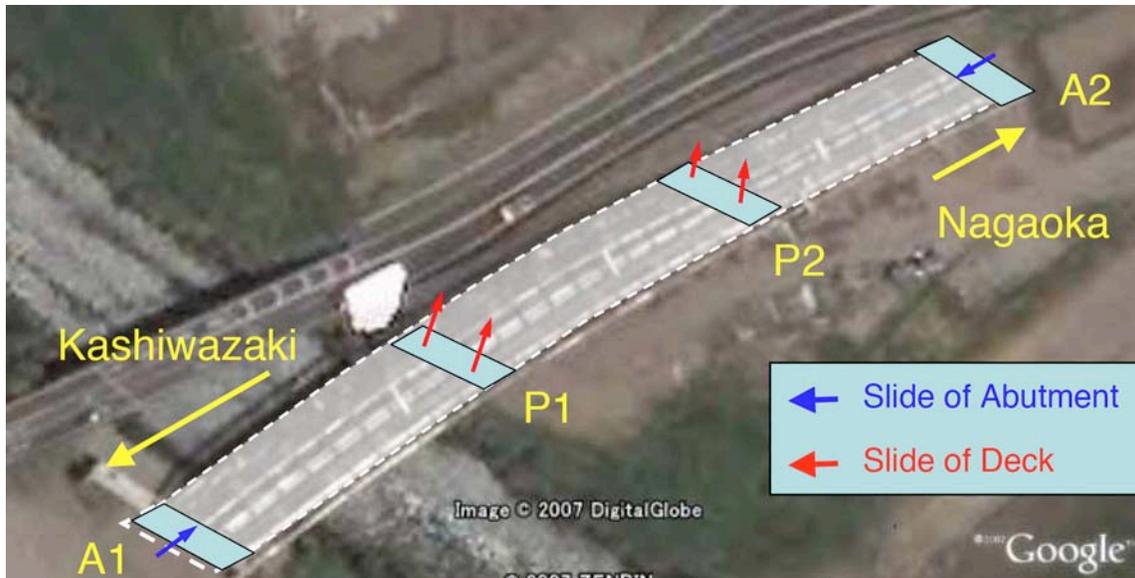
Fig. 6.14. Movement of Toyota Bridge (courtesy G. Watanabe, Tokyo Institute of Technology).

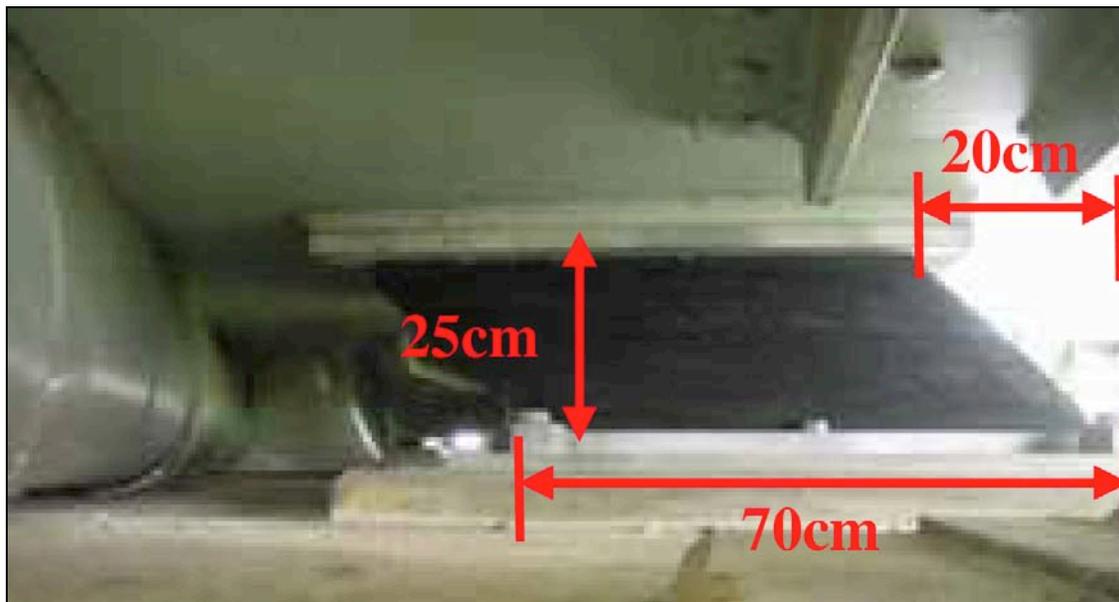
Fig. 6.15. Displacement of Bearing Bridge (courtesy G. Watanabe, Tokyo Institute of Technology).

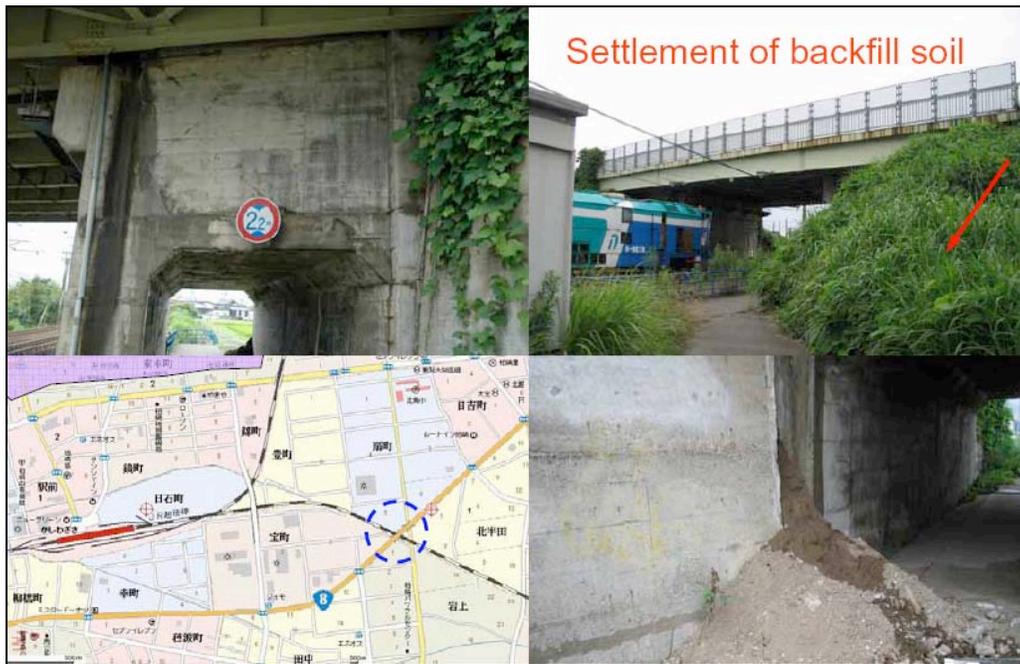
In downtown Kashiwazaki, on Highway 8 there are a couple of older bridges that are beginning to be maintenance problems. However, the only noticeable damage from the earthquake was some embankment damage behind the abutments on the Route 522 and the Japan Rail Bridges (Fig 6.16 and 6.17).

Fig. 6.17. Damage and repairs where railway crosses Highway 8 Bridge (courtesy G. Watanabe, Tokyo Institute of Technology).

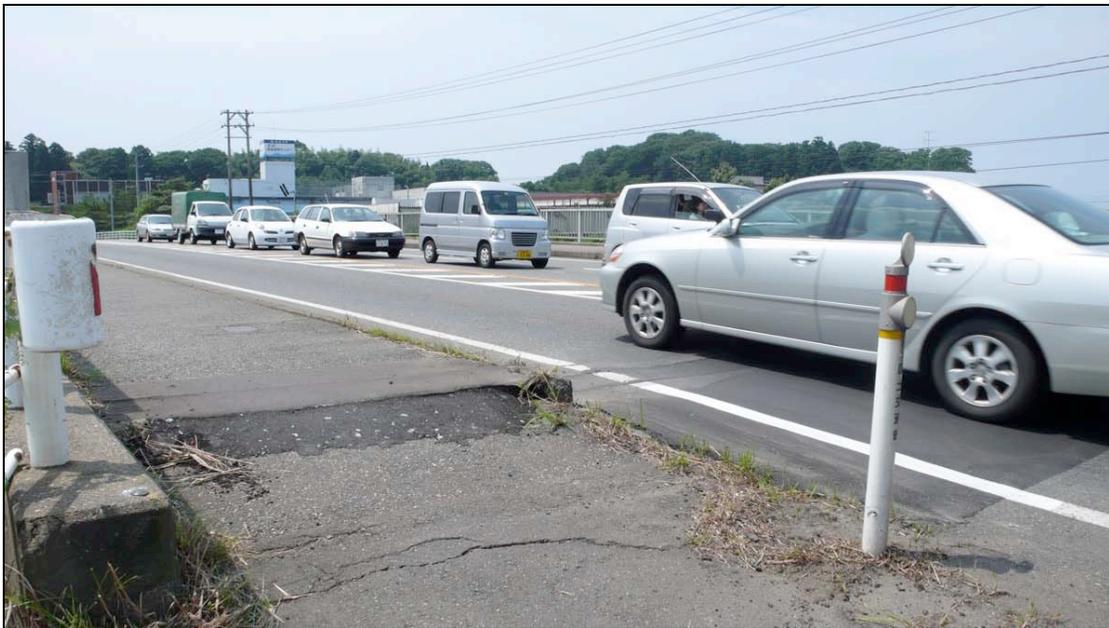
This is a two-span concrete I girder bridge on a pier wall and seat-type abutments (Fig. 6.18). Although bridges closer to the mouth of the Ugawa River sustained damage due to lateral spreading, this bridge (about 1.2 km upstream) had just a little bit of embankment

settlement that was quickly repaired (Fig. 6.19). Just north of the bridge were several manholes raised above another roadway's surface and a nearby stonecutter's shop had toppled statuary suggesting a  $PGA > 0.25g$ , and that liquefaction was a problem at this site. However, the embankment settlement was only about 10cm and continued to decrease upstream, suggesting better soil and/or weaker accelerations.

Fig. 6.19. Slight (10cm) settlement at bridge approaches.

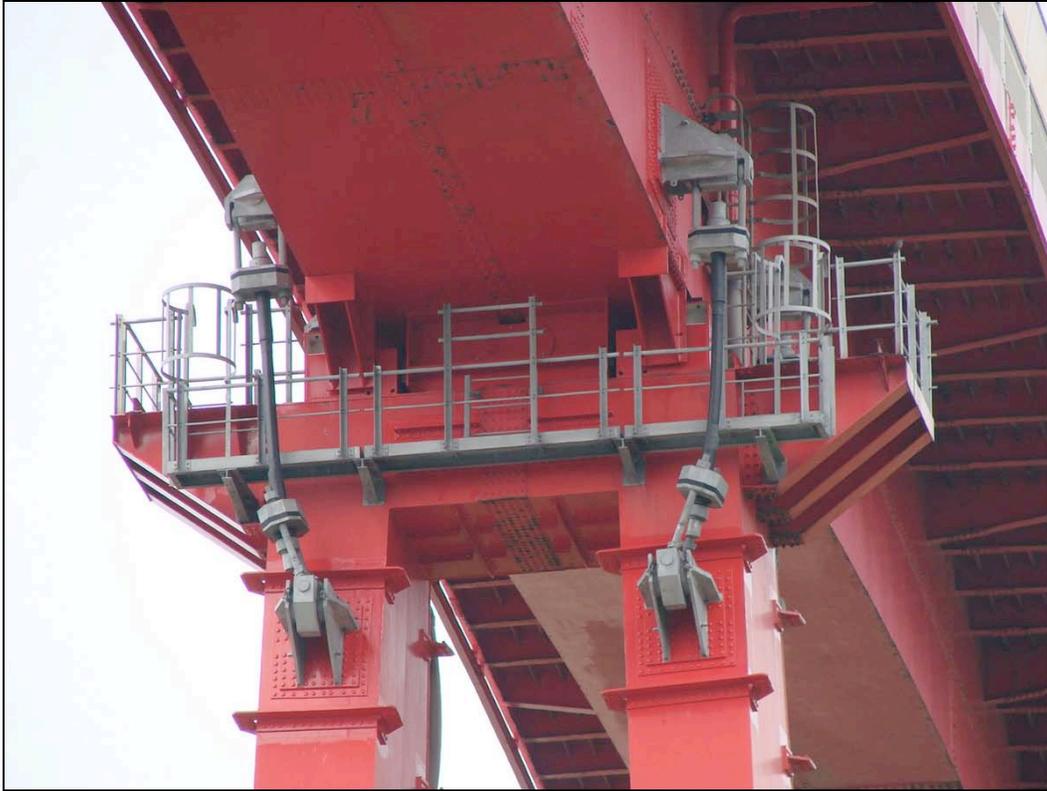
The bridge had been retrofit before the earthquake, which may have helped reduce the amount of damage that occurred. Lateral and vertical restrainers and stoppers were added at the superstructure (Fig. 6.22). The steel towers had been filled with concrete and stiffeners and doubler plates had been added to make the towers very stiff and strong. The bearing damage was very slight. It was just the failure of the stopper key element and deformation of the pin-cap, which did not affect the bearing function (Fig. 6.23). Other damage occurred as a result of the superstructure pounding against the abutment backwall.

Fig. 6.22. Retrofitted bent cap at Yoneyama Bridge (courtesy of S. Unjoh, PWRI).

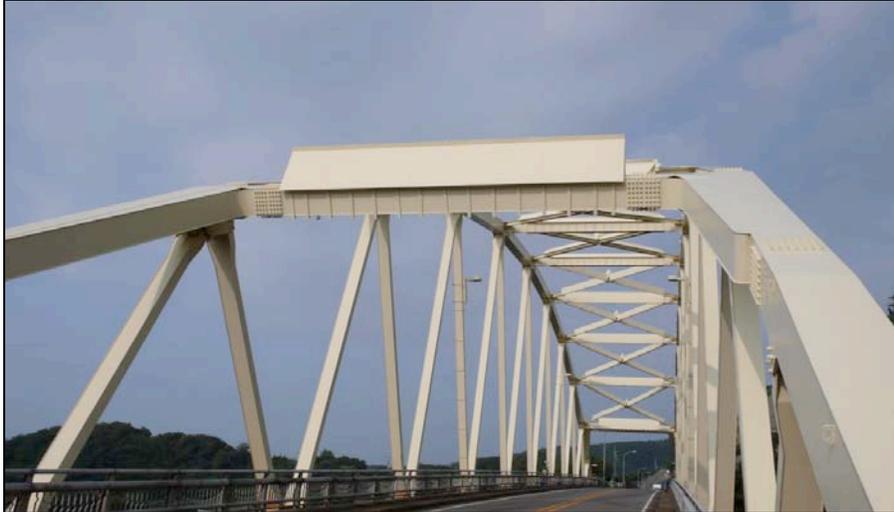
This is a 120 m long through truss arch, crossing over a narrow canyon (Fig. 6.24) south of Kashiwazaki. We saw a landslide scarp on the uphill side of this bridge, and because it is supported by spread footings, it was probably a combination of ground movement and strong shaking that caused it to rack during the earthquake.

Fig. 6.24. Looking at the struts and cross-bracing of the Yonahime Bridge.

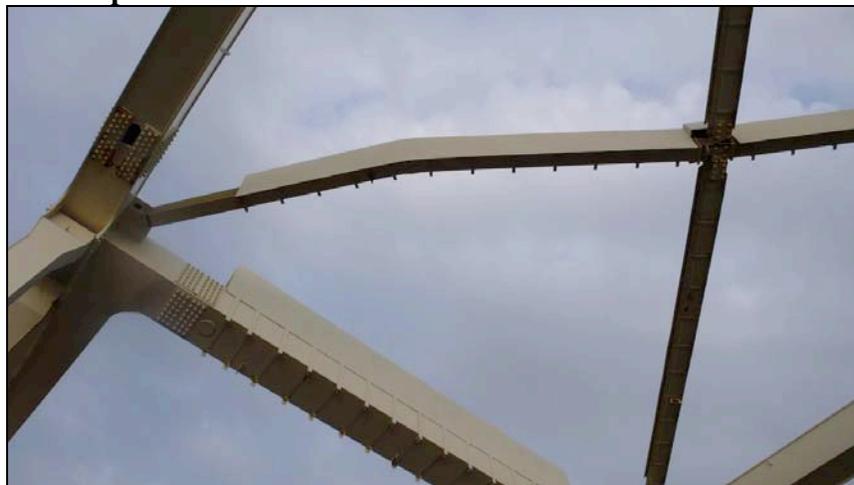
When we visited the bridge (on Aug. 4<sup>th</sup>) we saw many of its members had buckled (Fig. 6.25) and some of its connections were damaged (Fig 6.26) along with its bearings (Fig. 6.27). Still, the bridge remained in service. Metal boxes were placed around the bearings to support the bridge in case a strong aftershock occurs. This is a very common bridge type. However, the struts and bracings need to be designed against lateral wind force and lateral earthquake force. It appears that the earthquake force during this earthquake exceeded the design force. A deck arch bridge, the Agewa Bridge immediately to the north was undamaged by the earthquake (Fig. 6.28). It might be possible to retrofit the Yonahime bridge for large earthquakes, possibly by supporting it on isolation bearings. Certainly, these fixed bearings, which we saw damaged on several of the longer span bridges, are a lot of trouble to replace.

Fig. 6.25. Buckled cross bracing on Yonahime Bridge.

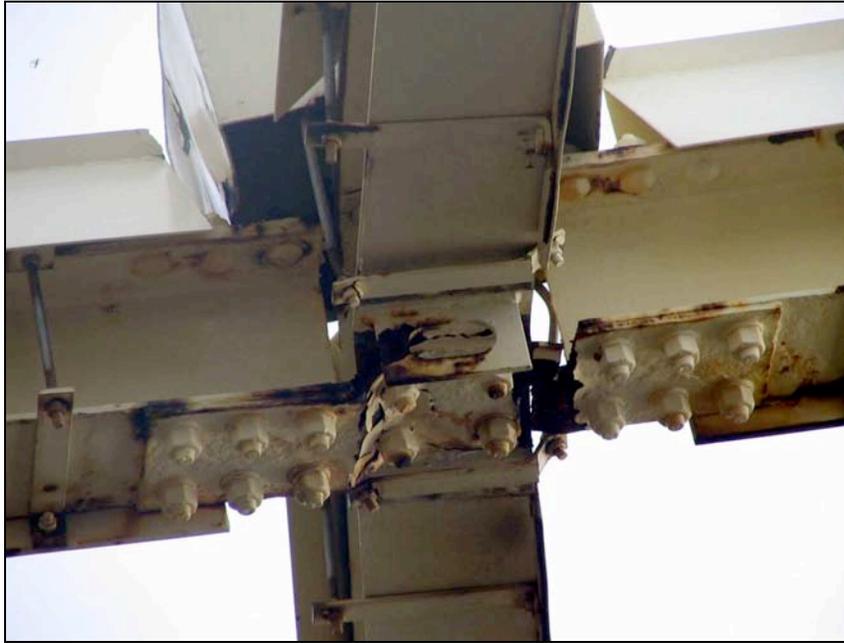
Fig. 6.26. Torn cross bracing connection on Yonahime Bridge.

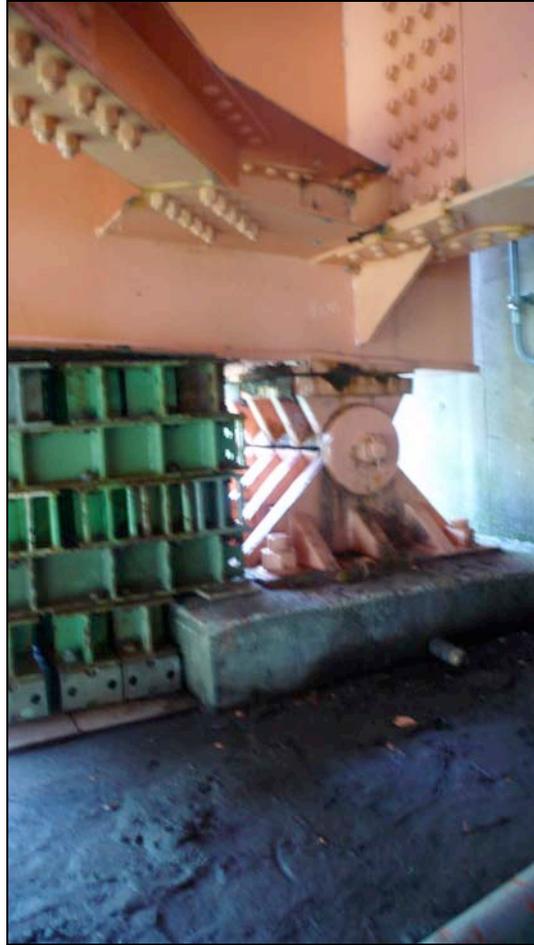
Fig. 6.27. Damage of set bolts and the additional steel box support to prepare the aftershocks)

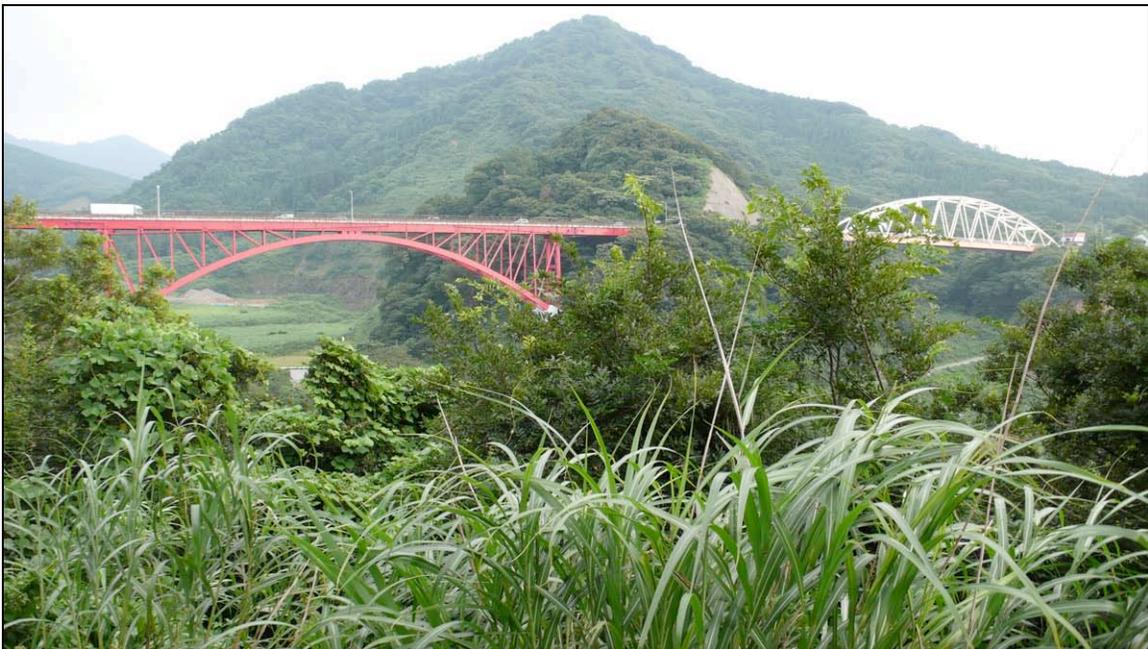
Fig. 6.28. Undamaged Agewa (Deck Arch) Bridge just north of damaged Yonahime Bridge.

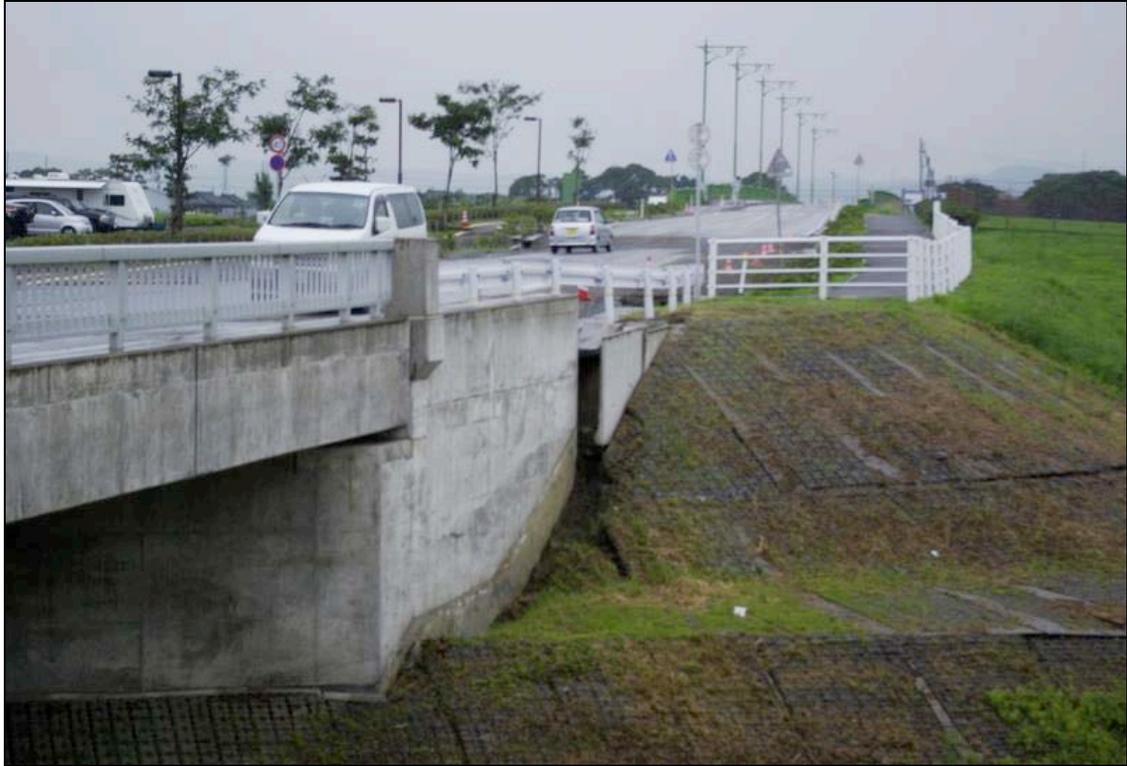
During the earthquake, the south bridge embankment settled as the bank spread into the river. The wingwalls weren't attached to the abutment (which was on piles) and moved with the embankment (Fig. 6.31). The lateral spread was the result of liquefaction of the island (Fig. 6.32). Figure 33 shows about 400 cm settlement of the south embankment.

Fig 6.31. Looking southeast at Heisei bridge abutment, settled embankment, and the island.

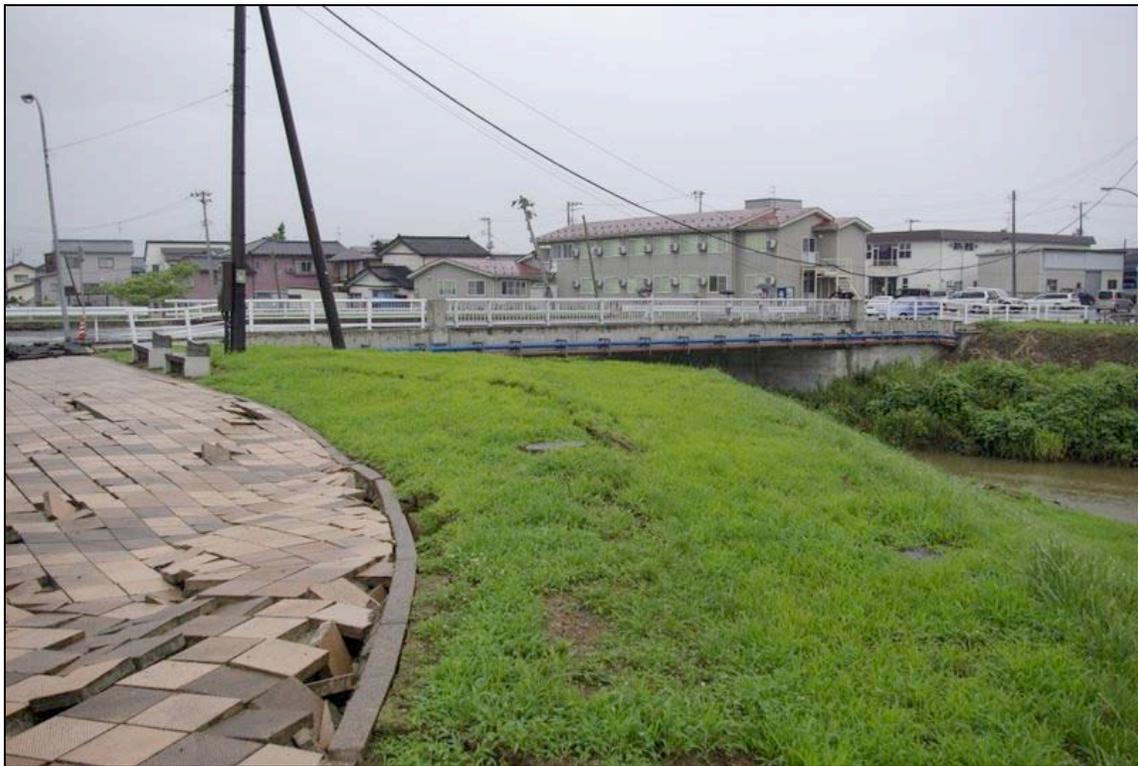
Fig. 6.32. Looking northwest at liquefaction of island and the Heisei Bridge.

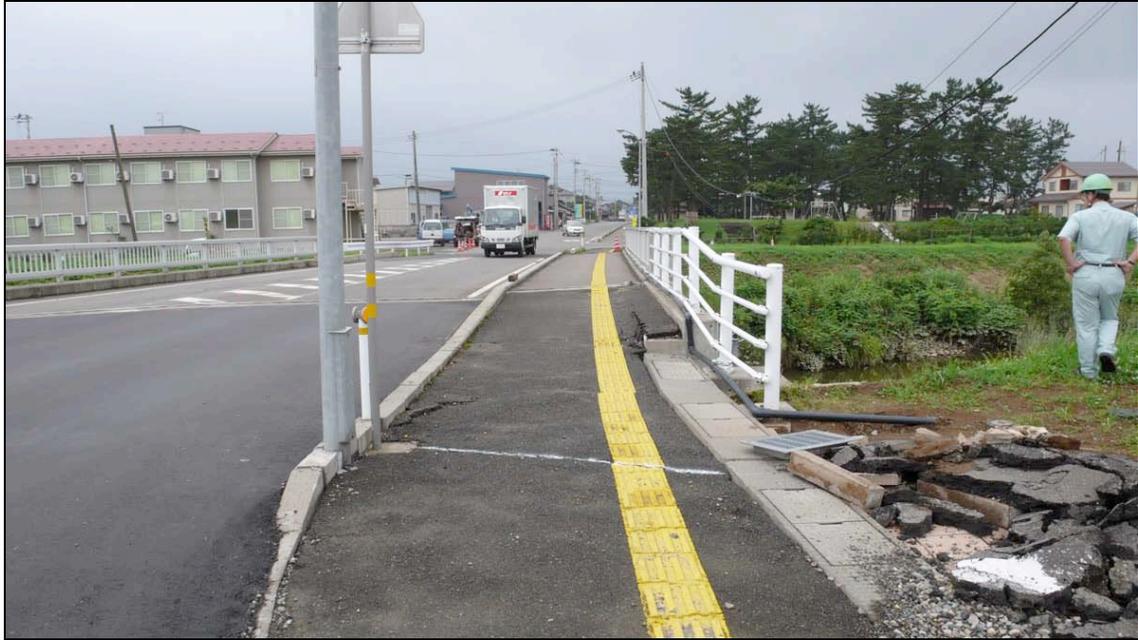
Fig. 6.33. Looking north from island at Hashi bridge deck.

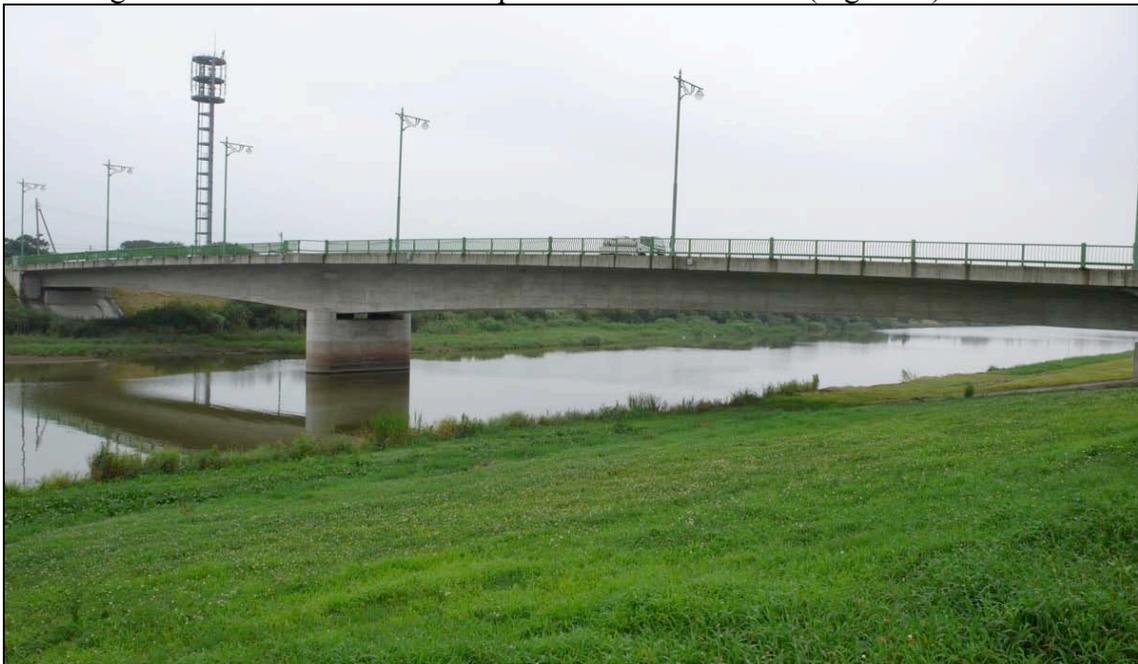
Fig. 6.34. Heisei O'Hashi

This is a continuous, two-span, concrete box girder bridge supported on seat abutments and a pier wall (Fig. 6.34). During the earthquake, the north bridge embankment settled about 40 cm (Fig 6.35). There were also signs that the bridge underwent shaking and pounding (Fig. 6.36). Although the abutments were on piles, the bearings were distorted, indicating that the abutments had been pushed toward the river (Fig. 6.37).

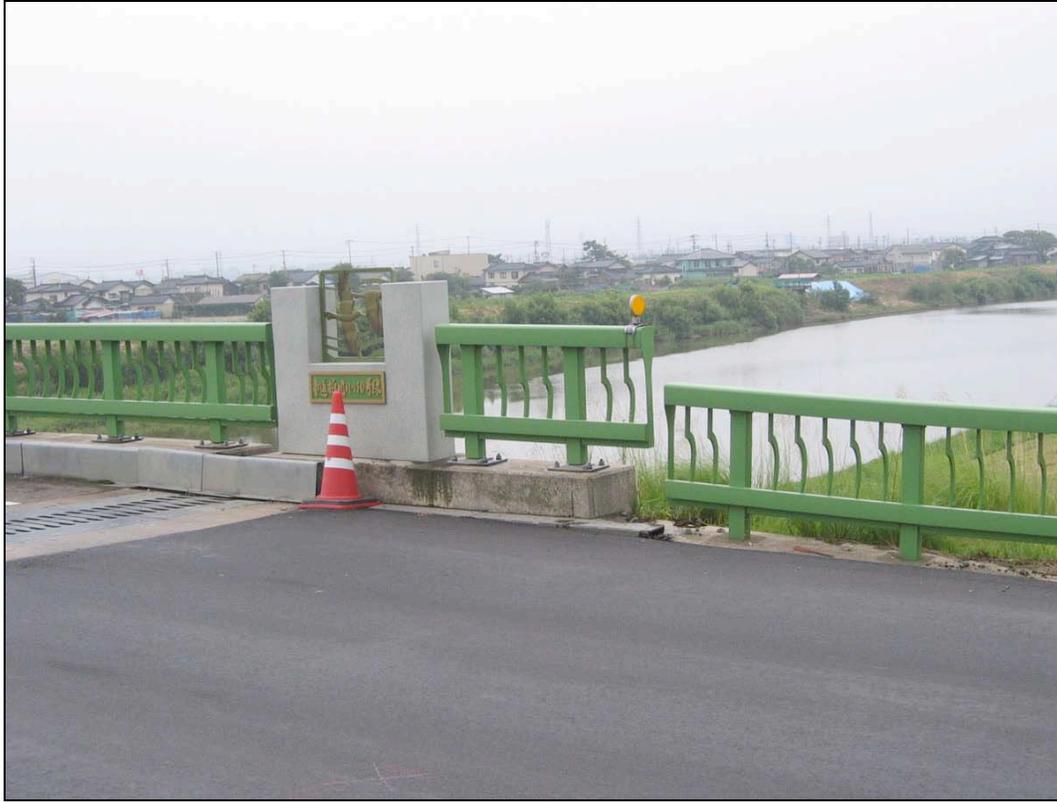
Fig. 6.35. Settlement of north bridge approach.

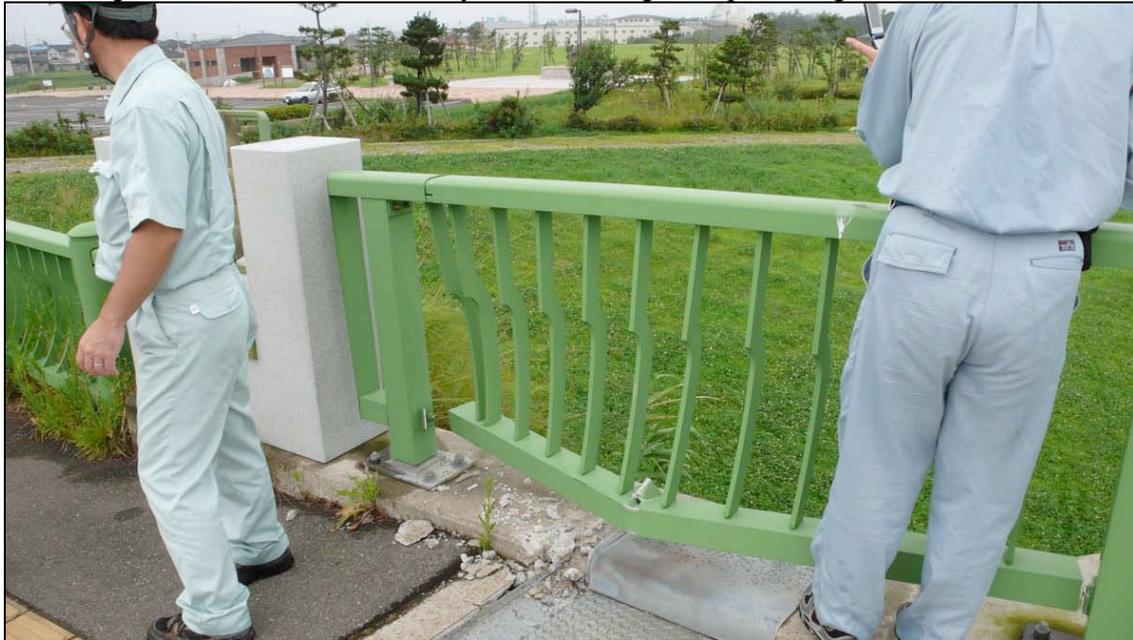
Note that unlike the north Heisei Bridge, there are apparently piles under the short wingwalls on the south Heisei Bridge. Figures 6.38 and 6.39 show the wingwalls at the same height as the abutment and they also show signs of pounding between them.

Fig. 6.38. Pounding between abutment and wingwall.

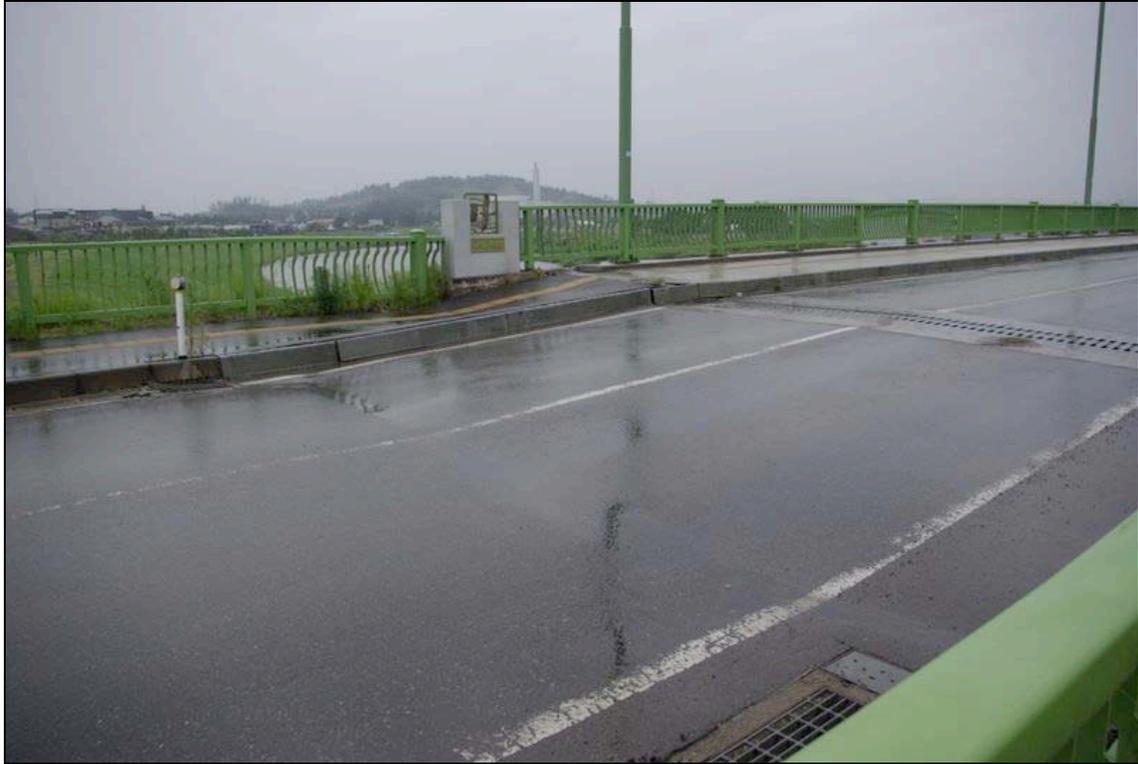
Fig. 6.39. Settlement of north bridge abutment.

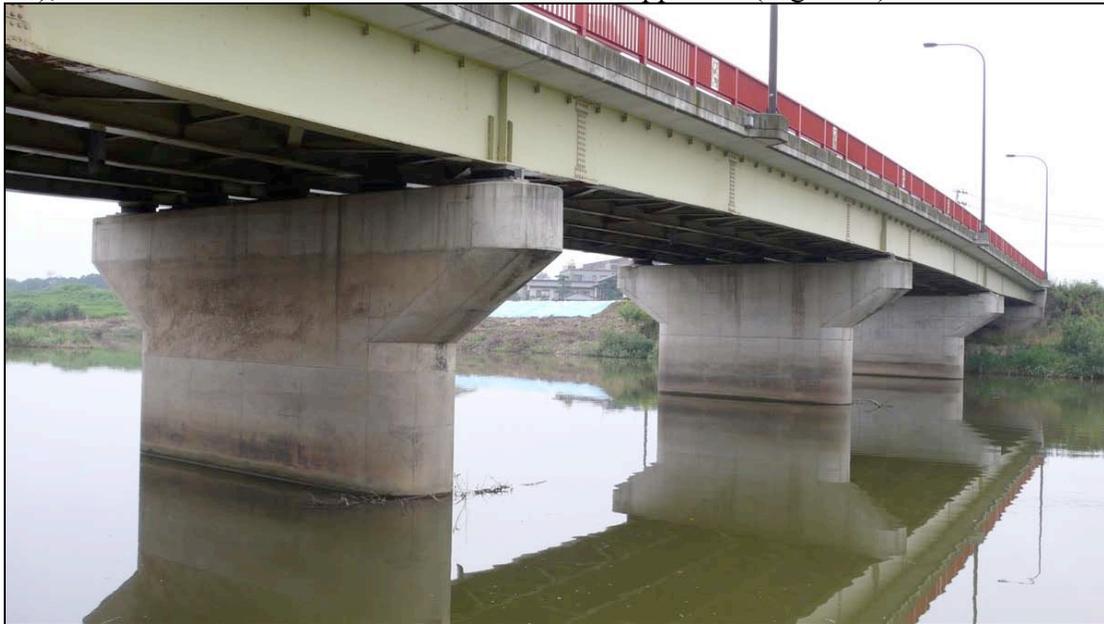
About 1/2 km upstream from the Heisei Bridges sits the four span Kaiun Bridge (Fig. 6.40), which had a 1 meter settlement of the south approach (Fig. 6.41).

Fig. 6.40. The four, steel 'I' girder span Kaiun Bridge on pier walls and seat abutments.

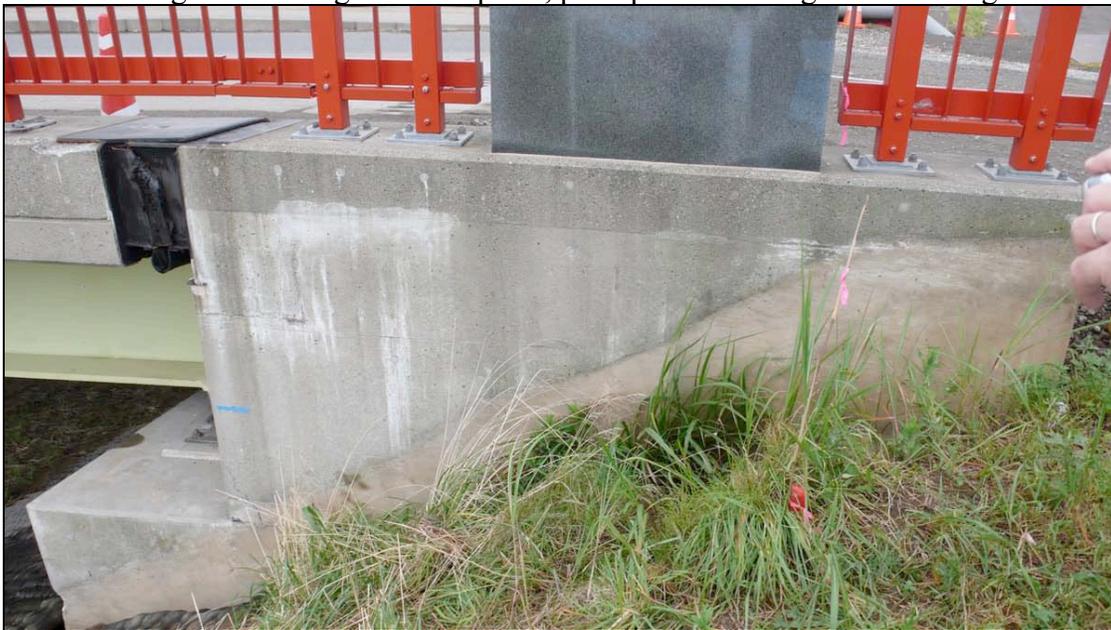
Like the other Sabaishi bridges, this settlement was caused by the riverbank spreading toward the river (Fig. 6.42). Although the expansion joint, the abutment, and the bearings should have been isolated from this movement by the pile supports, they were distorted as shown in Fig. 6.43 during the earthquake, perhaps due to the ground shaking.

Fig. 6.42 The soil around the south abutment moved towards the river during the earthquake.

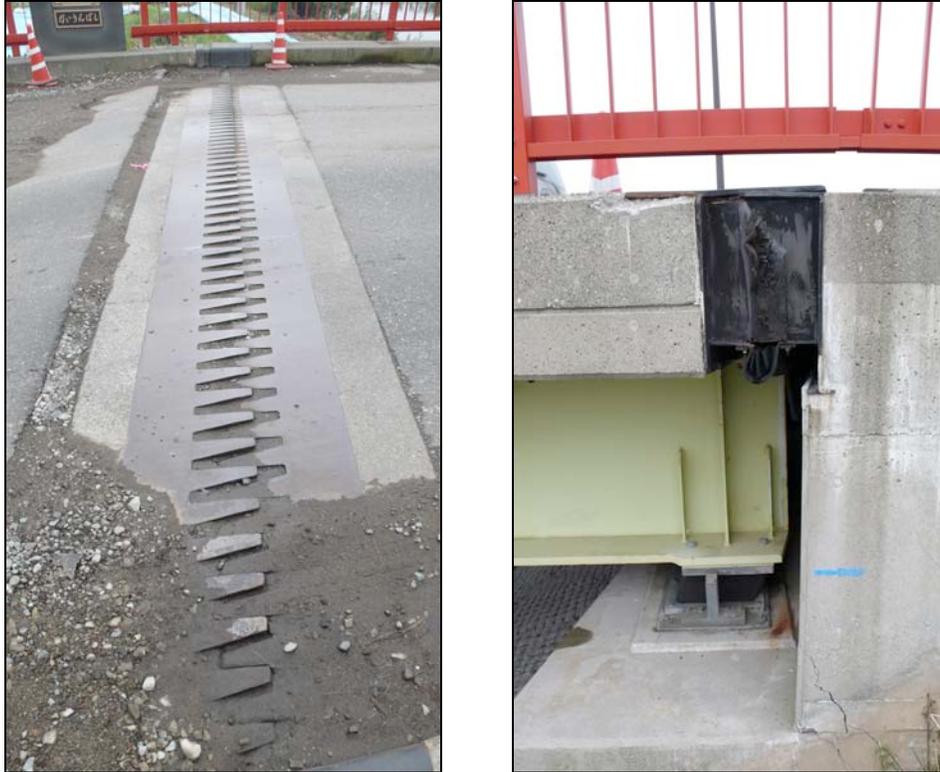
Fig. 6.43. Distortion of expansion joint, bearings, and abutment on Kaiun Bridge.

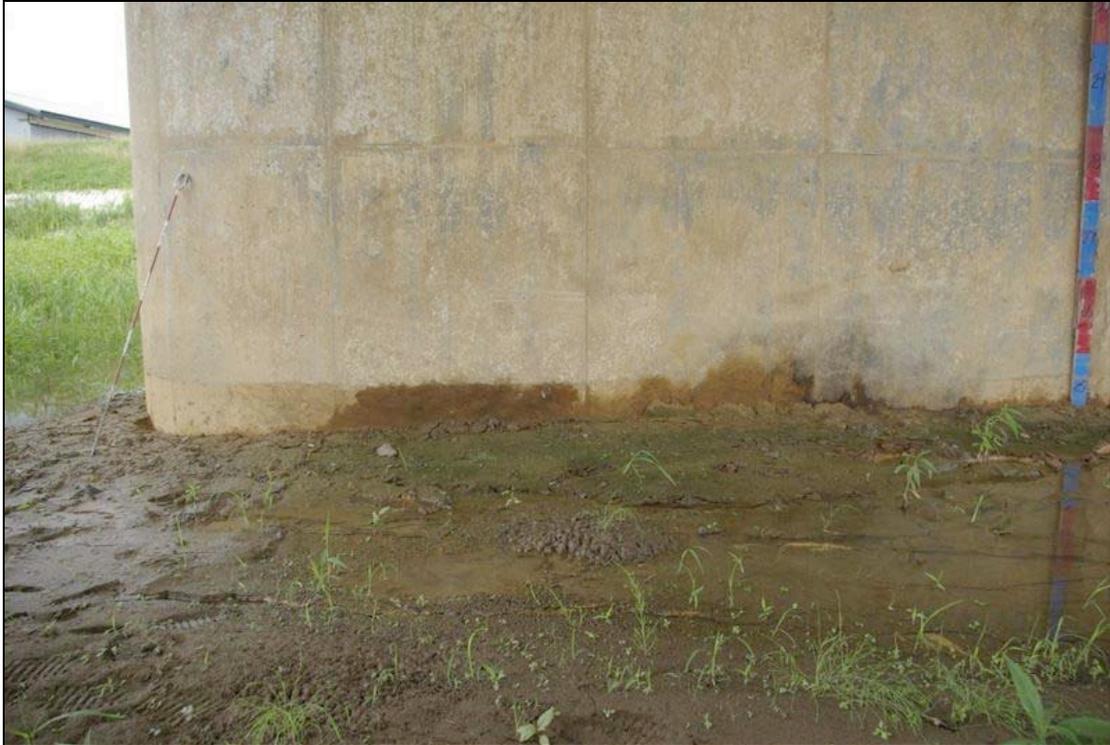
This is a three span steel girder bridge on pier walls and seat-type abutments (Fig. 6.44). There was evidence of fine grain soil being ejected at depth to the ground surface (along with settlement) at the saturated riverbanks (Fig. 6.45). There was damage to the abutment backwall (Fig. 6.46) and to the bridge approaches (Fig. 6.47).

Fig. 6.45. Soil settled around pier in riverbank (photo courtesy of Scott Brandenburg).

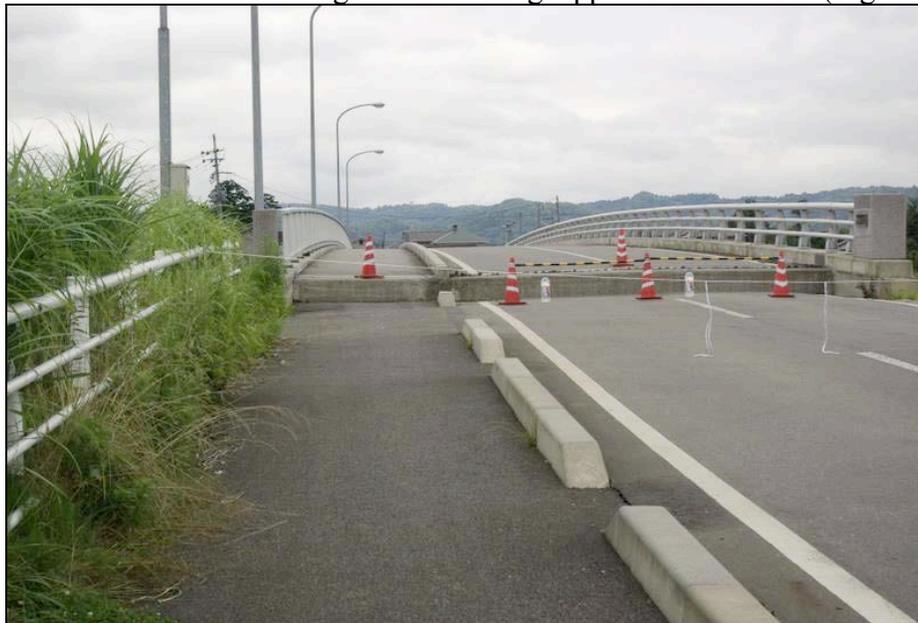
This is the last Sabaishi River bridge that had a big approach settlement (Fig. 6.48).

Fig 6.48 Genji Bridge (photo courtesy of Scott Brandenburg).

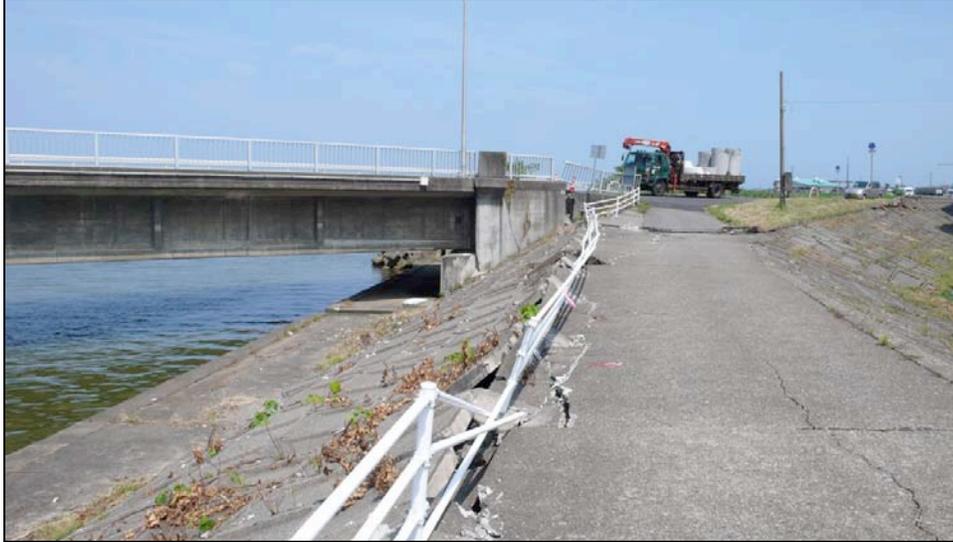
This is a two span concrete I girder bridge on seat abutments and a single column bent with a hammerhead cap at the mouth of the Ugawa. This location had the most lateral spreading on the Ugawa. The entire levee was dragged toward the river (Fig. 6.50) and the abutment was damaged and separated from the wingwall (Fig. 6.51).

Fig 6.50. Rinko Yasaka Bridge at the mouth of the Ugawa.

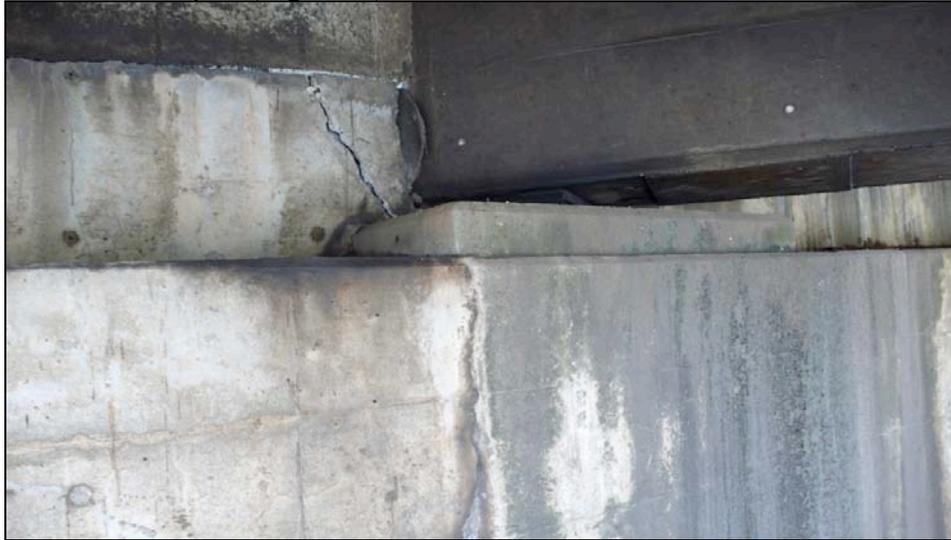
The concrete I girders broke the abutment backwall (Fig. 6.52), the bridge approaches were damaged but quickly repaired (Fig. 6.53), and it appeared that repair work was going on at the center pier (Fig. 6.54).

Fig. 6.52. Backwall-Diaphragm damaged by earthquake.

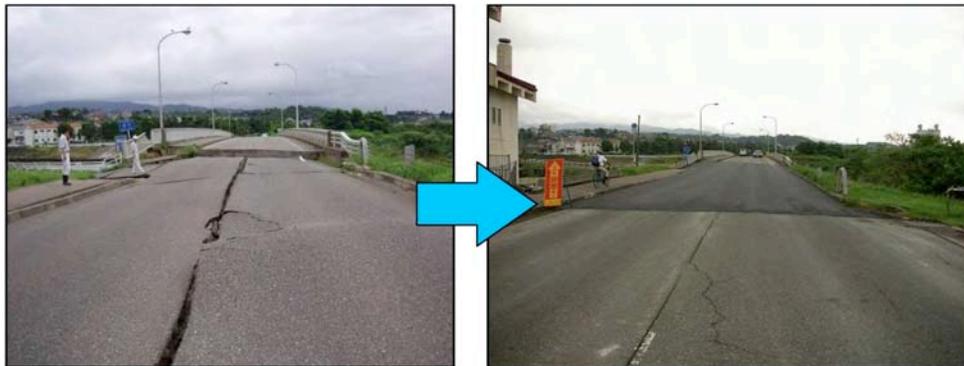
Fig. 6.53. Before and after views of approach and bridge deck.

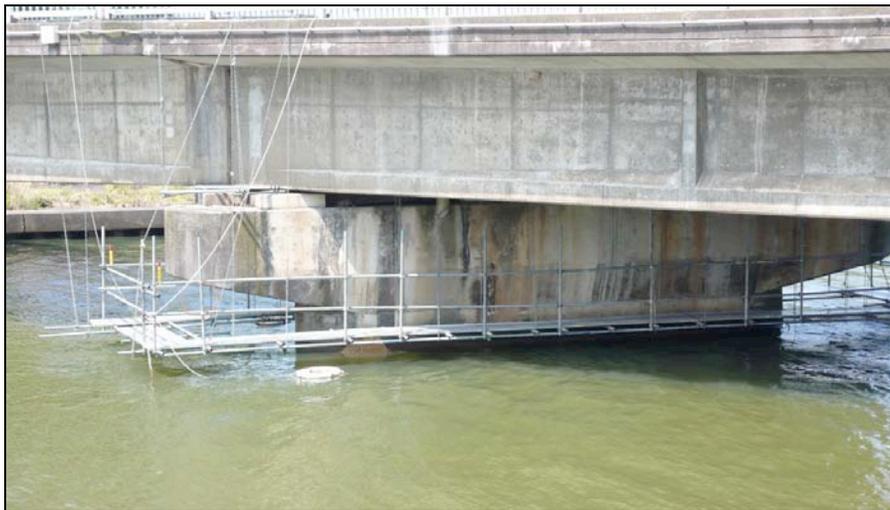
Fig. 6.54. Pier supporting Rinko Yasaka Bridge.

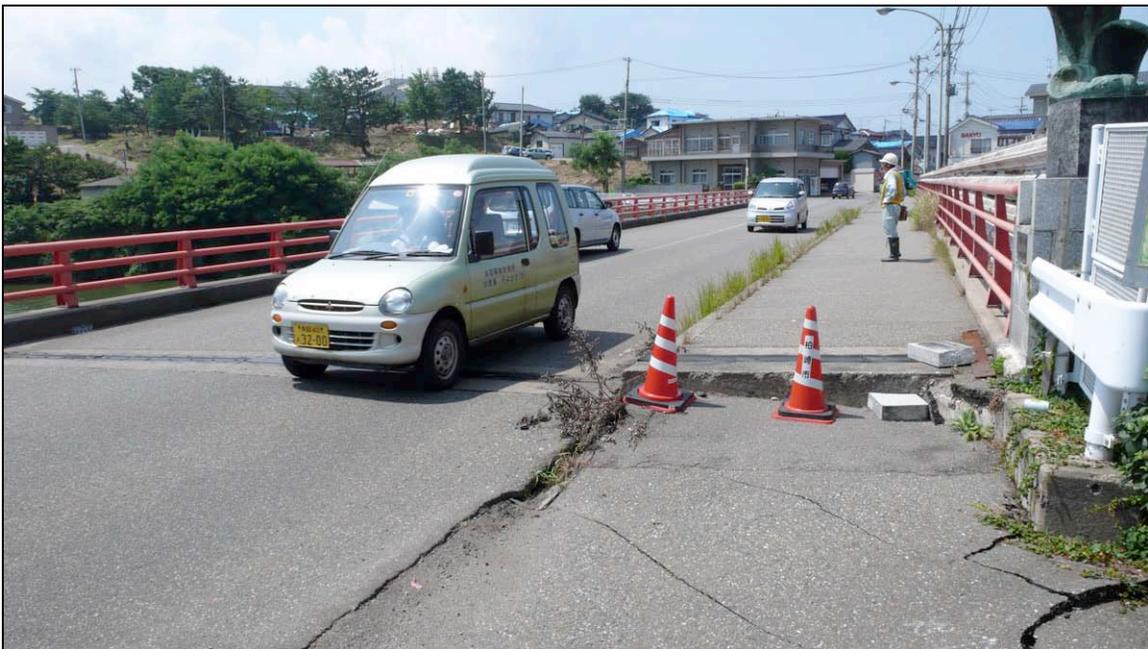
Like most of the bridges over the Ugawa, this is a two span, simply-supported river crossing, but with steel girders, and supported on a pier wall and seat-type abutments (Fig. 6.55). It is about 200 meters from the more heavily damaged Rinko Yasaka Bridge, but the soil was much firmer at this site, there was less than 100 cm of settlement at the approaches, and no damage to the abutments or wingwalls (Fig. 6.56).

Fig. 6.56. Approach and deck of Yasaka Bridge.

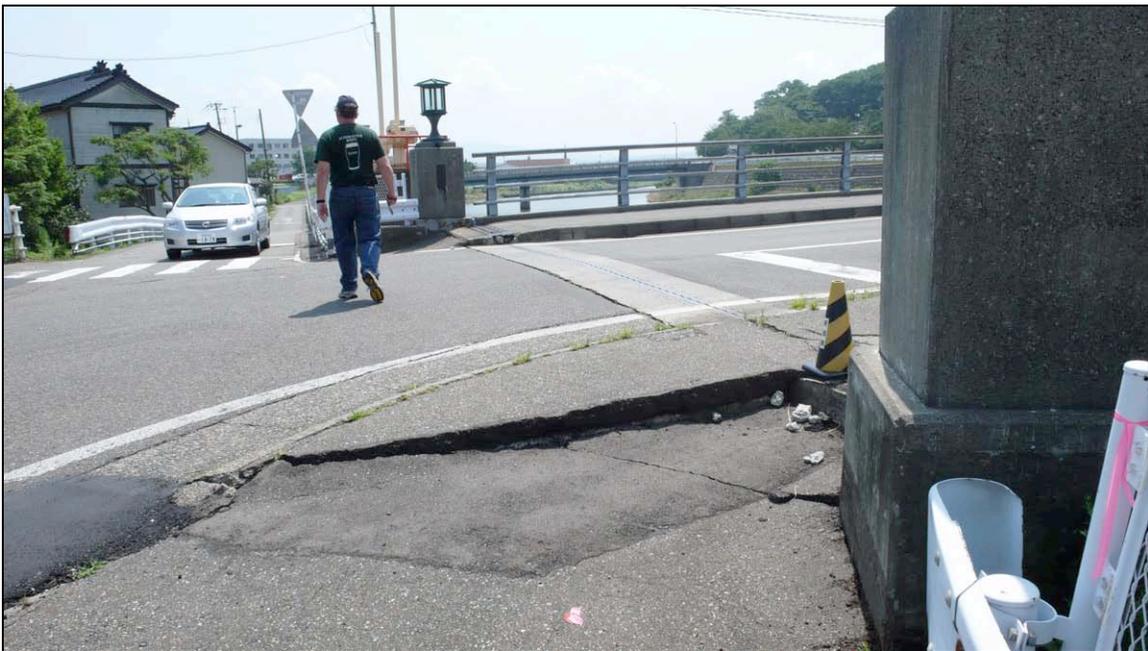
Continuing to walk upstream another 300 meters, we came to the third bridge crossing the Ugawa. The Ukawa bridge is a two (simple) span 'I' girder bridge supported by a pier wall and seat-type abutments (Fig. 6.57). All of these bridges are about 60 meters long. As seen in Figure 6.58 the only damage was some settlement of the sidewalk on the south end of the bridge.

Fig. 6.58. Approach to Ukawa Bridge.

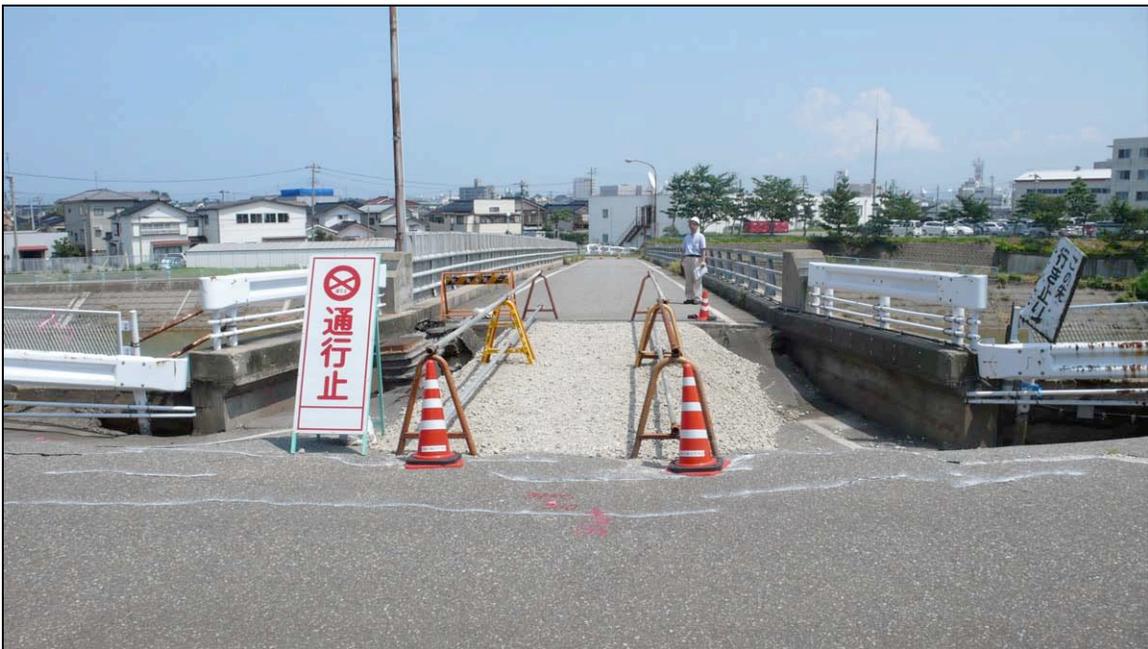
The fourth crossing, a narrow (6 m wide) two-span concrete box girder bridge on a single-column bent and tall and short abutments (Fig. 6.59) had more damage. Although the south levee moved very little, the embankment between the levee and the bridge settled a meter (Fig. 6.60) and there was damage to the abutment including a leaking waterline (Fig. 6.61). Figure 6.62 provides a closer view of the settled embankment.

Fig. 6.60. Looking north at the south approach to Osu Bashi.

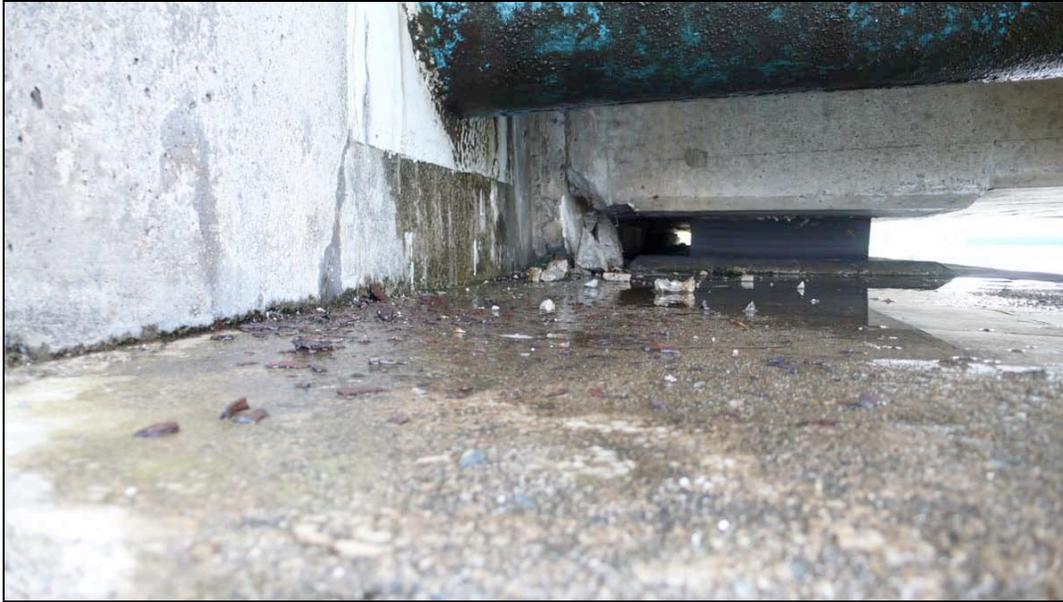
Fig. 6.61. The superstructure is supported on a single bearing (note waterline).
