# Investigation of the M6.6 Niigata-Chuetsu Oki, Japan, Earthquake of July 16, 2007

Open File Report 2007–1365

2007

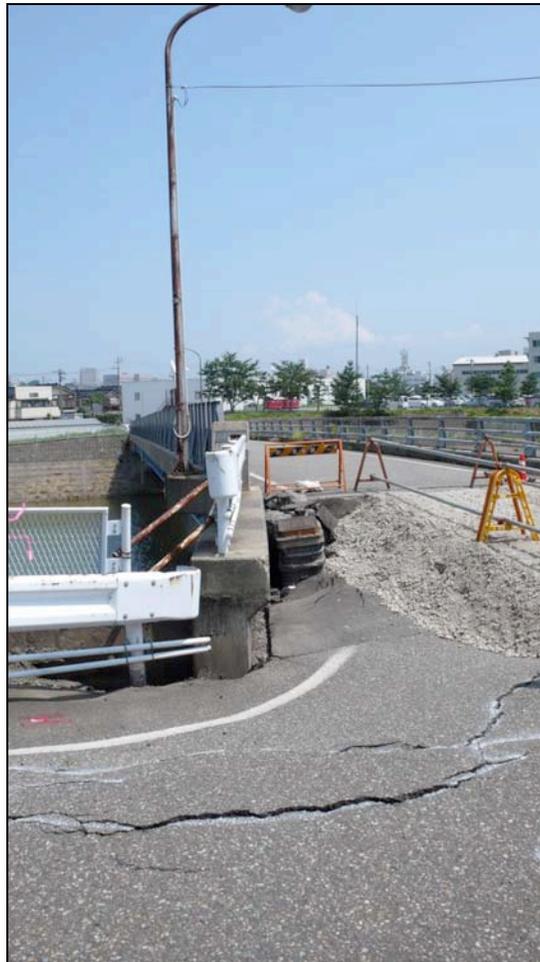
The fourth crossing, a narrow (6 m wide) two-span concrete box girder bridge on a single-column bent and tall and short abutments (Fig. 6.59) had more damage. Although the south levee moved very little, the embankment between the levee and the bridge settled a meter (Fig. 6.60) and there was damage to the abutment including a leaking waterline (Fig. 6.61). Figure 6.62 provides a closer view of the settled embankment.

Fig. 6.62. Closer view of settlement at south abutment.

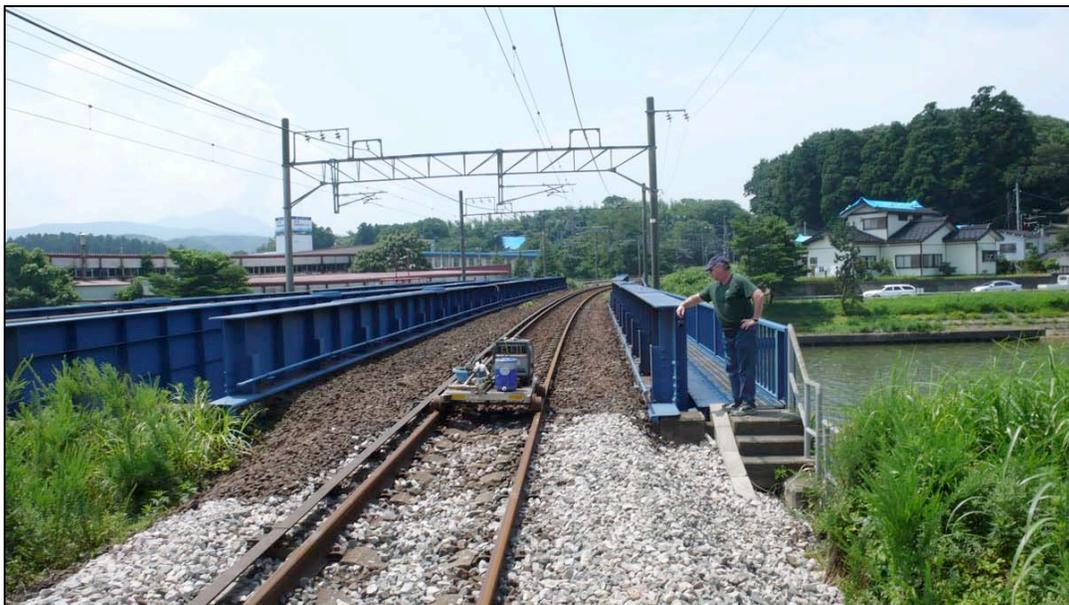
These are two through girder bridges on steel rocker bearings, seat-type abutments, and a pier wall 200 meters upstream from Osu Bashi (Figures 63 and 64). They are much beefier than the road bridges we had previously studied. When we arrived on August 6<sup>th</sup>, rail crew were re-attaching the rails and there was new ballast on the approaches. However, they went off to lunch before we could ask them if they were repairing earthquake damage. The rails were rusty, suggesting they hadn't been used in awhile, but its possible that the railway was closed due to damage down south at Omigawa Station. The bridge was built in 1997.

Fig. 6.64. Looking at rails on the west bridge where rail crew had left their tools.

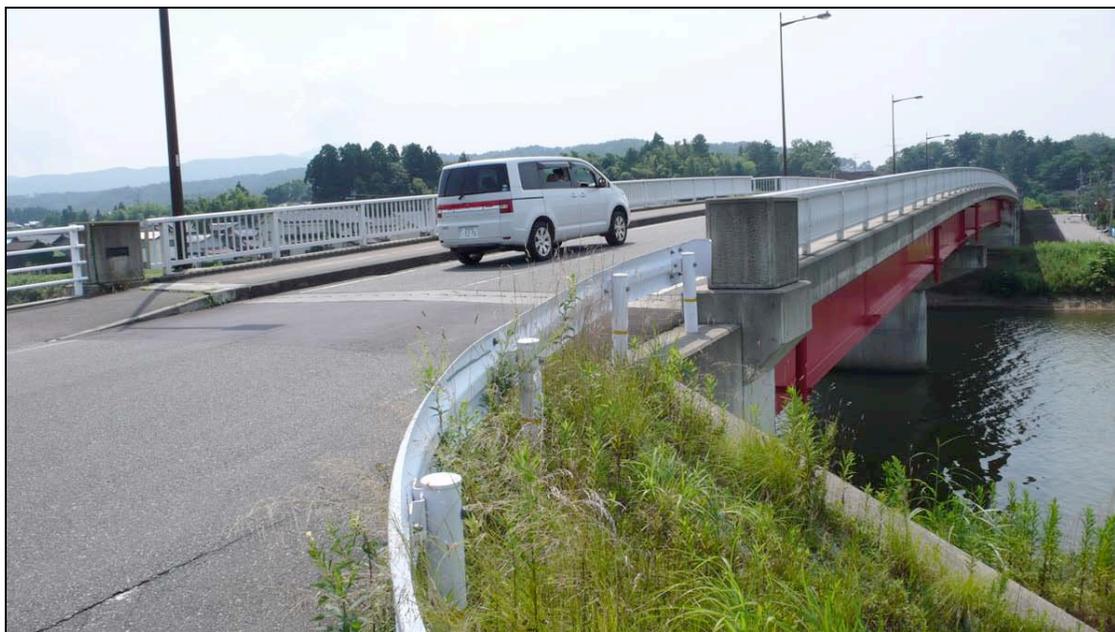
This was the last bridge across the Ugawa where we saw any sign of approach settlement. It's a four-simple span steel 'I' girder bridge that crosses over the river, the levees, and a river road. We walked past a lot of flood control facilities along the river including the flood gate seen in Figure 6.65. This bridge has a long embankment on the south side. Figure 6.66 shows a very slight settlement at the north approach.

Fig. 6.66. Looking at the north approach.

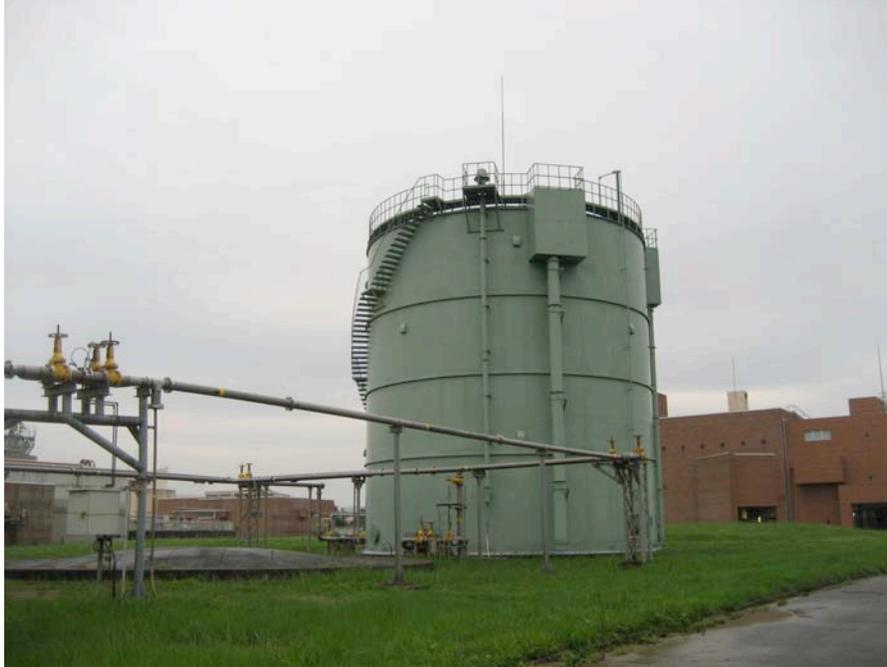
- Wastewater tanks at a site of extensive liquefaction. Both concrete and steel tanks were observed at the Ansei-Chou waste water treatment plant adjacent to the Sabaishi River (Figure 7.1). Sand boils and ground settlement adjacent to the tanks were observed, however the concrete tanks appeared undamaged. A large steel tank exhibited a section with very minor ripples along the wall that may have been due to the earthquake (Figure 7.2). Overall it appeared to be in good condition and maintained full operation.

Figure 7.1: Steel tank at the Ansei-Chou waste water treatment plant (Site RK9, N37.38748°, E138.56587°, photo taken 7/20/07 16:40). Sand boils and slight overturning of the support member to the far-most right of the photograph were observed, as was extensive lateral spreading and road damage. Indications of minor distress of the tank was identified but for the most part appeared in good service.

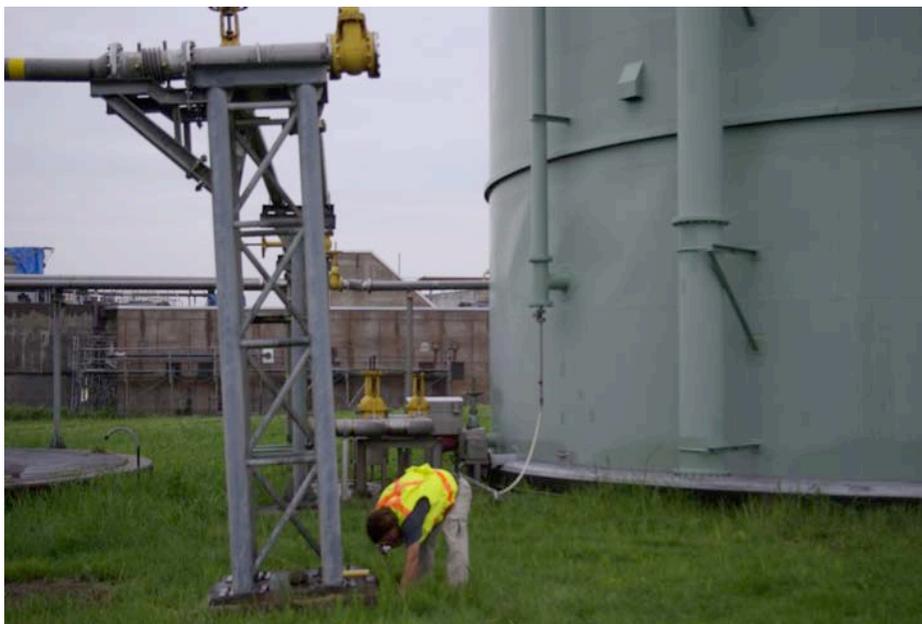
Figure 7.2: Steel tank at the Ansei-Chou waste water treatment plant (Site RK9, N37.38748°, E138.56587°, photo taken 7/20/07 16:40). Minor distress to the wall was observed roughly 3 m above the base of the tank.

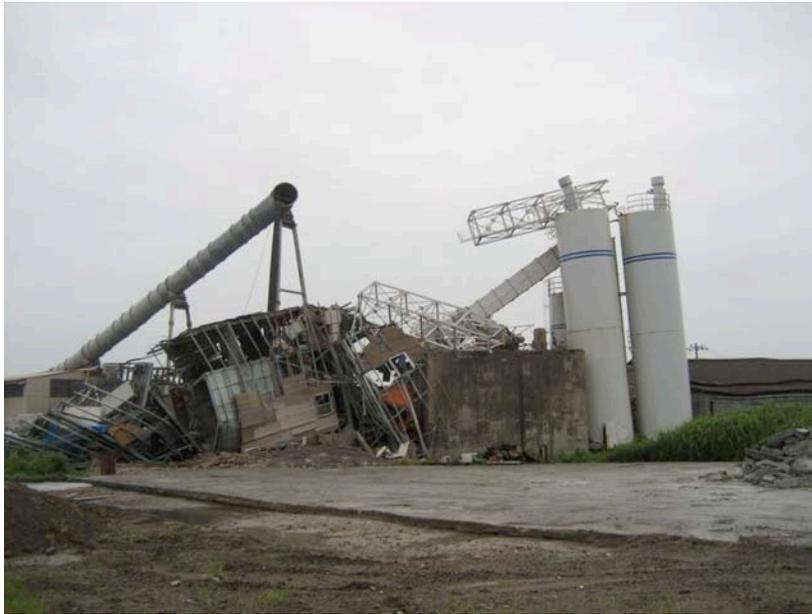
- Failure of two cement-plant storage tanks. Buckling failure of the tank bases was observed in an area of extensive liquefaction damage (Figures 7.3 and 7.4). Mast-structures perched above the tanks also failed at the mast-tank connection. The tanks, although recently painted and appearing to be operational, were also empty at the time of investigation, possibly indicating that the tanks were not currently in use or maintained.

Figure 7.3: Damage to steel tanks at the cement plant located adjacent to the mouth of the Sabaishi River (Site RK10, N37.38795°, E138.56508°, photo taken 7/20/07 17:10). Tank damage likely caused by the cumulative effects of inertial loading, ground failures, and lateral loads due to the failure of appurtenant structures.

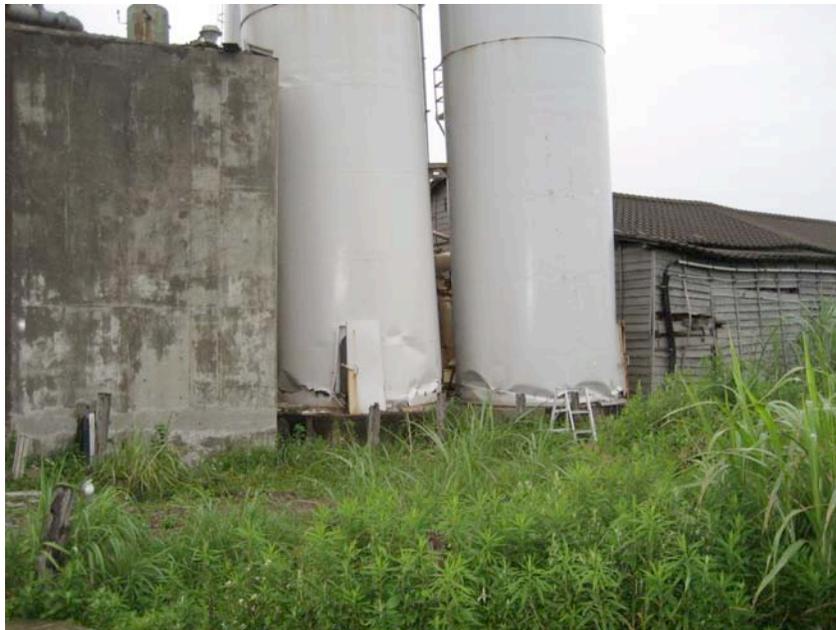
Figure 7.4: Close-up of damage to steel tanks at the cement plant located adjacent to the mouth of the Sabaishi River (Site RK10, N37.38795°, E138.56508°, photo taken 7/20/07 17:20). Buckling at the base of the tanks is evident.

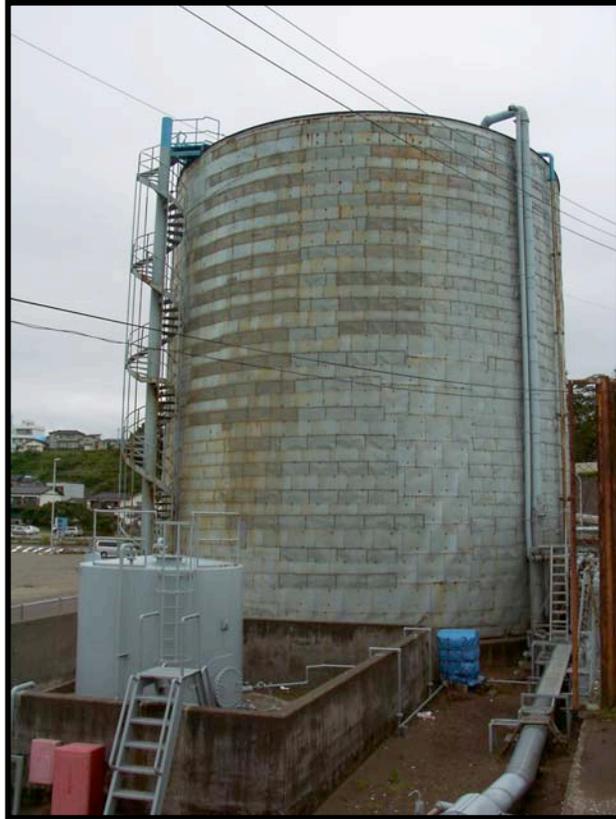
- Asphalt storage tank located in the western portion of the Port of Kashiwazaki (Take Naka Facility). The facility was in operation at the time of the reconnaissance and the inspection focused on the performance of a large, insulated asphalt holding tank (Figure 7.5). The tank is secured at its base by a bolt and flange detail (Figure 7.6). Many of the flanges were bent, however none of the bolts appeared to have failed. No “elephant’s foot” bulking of the tank was noted, although the exterior of the tank is covered with a layer of insulation which prohibited a more thorough inspection (Figure 7.7). The tank structure and appurtenant pipes appeared to be undamaged except for minor failures of the tank anchor system. This structure is also addressed in the section on Port and Harbors.

Figure 7.5: Kashiwazaki Port - Asphalt storage and transport facility located in the western portion of the port (Located near Site RK25, N37.36713° E138.53210°, photo taken 7/21/07 15:58).

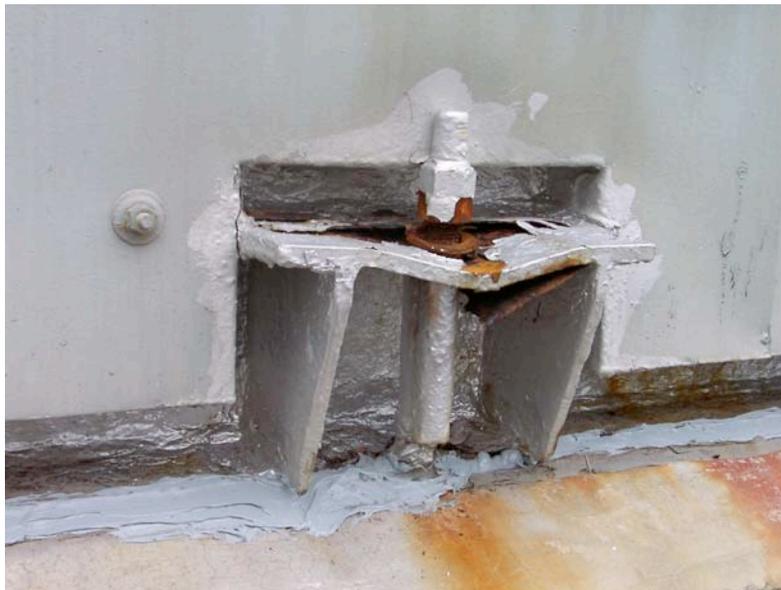
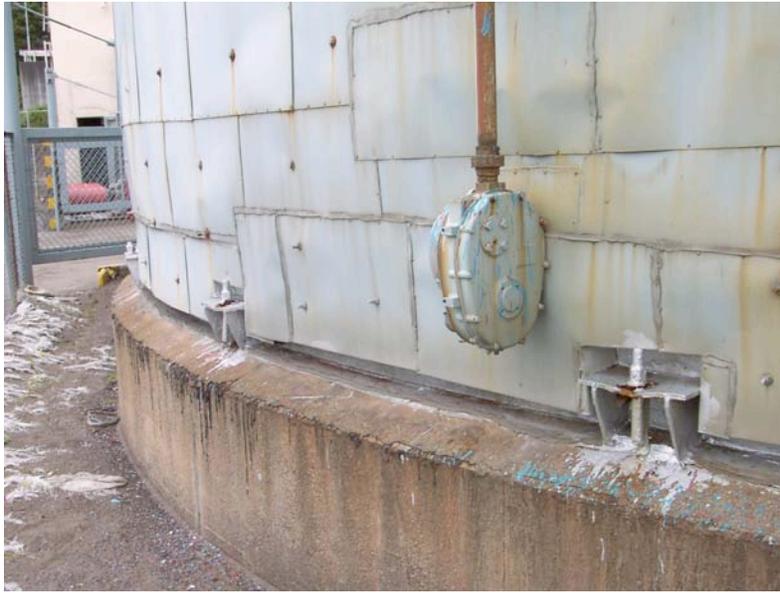
Figure 7.6: Kashiwazaki Port - Anchorage of asphalt storage tank (Located near Site RK25, N37.36713° E138.53210°, photo taken 7/22/07 12:37).

Figure 7.7: Kashiwazaki Port - Anchorage of asphalt storage tank (Located near Site RK25, N37.36713° E138.53210°, photo taken 7/22/07 12:37).

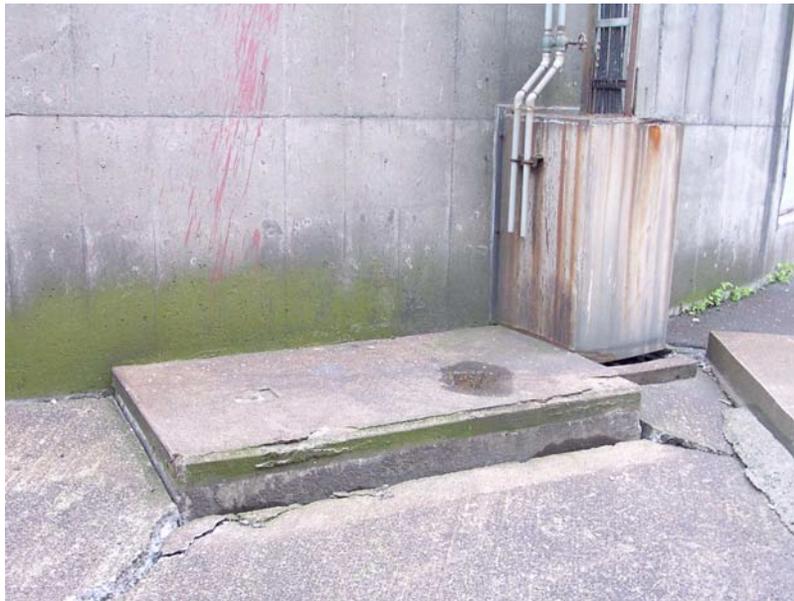
Figure 7.8: Kashiwazaki Port (Taiheiyo Cement Facility) - Evidence of minor to moderate settlement of sandy fill adjacent to one of the large diameter tanks (Site SD 9, approximately N37.36665° E138.53983°, photo taken 7/22/07 15:48).

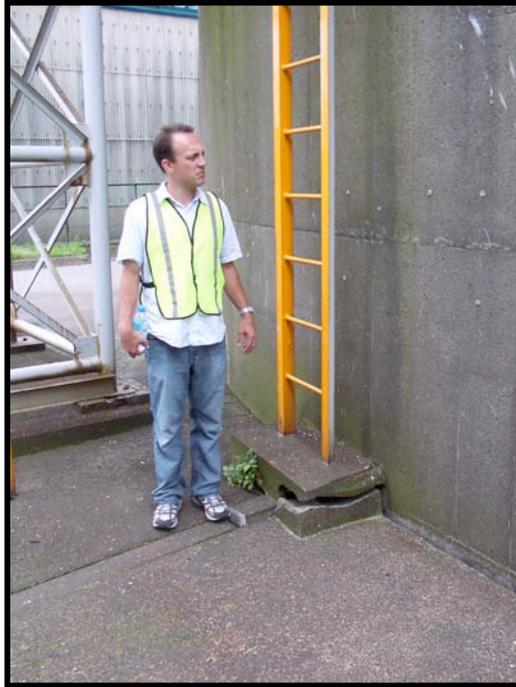
Figure 7.9: Kashiwazaki Port (Taiheiyo Cement Facility) - Evidence of minor to moderate settlement of sandy fill adjacent to one of the large diameter tanks (Site SD 9, approximately N37.36665° E138.53983°, photo taken 7/22/07 15:48).

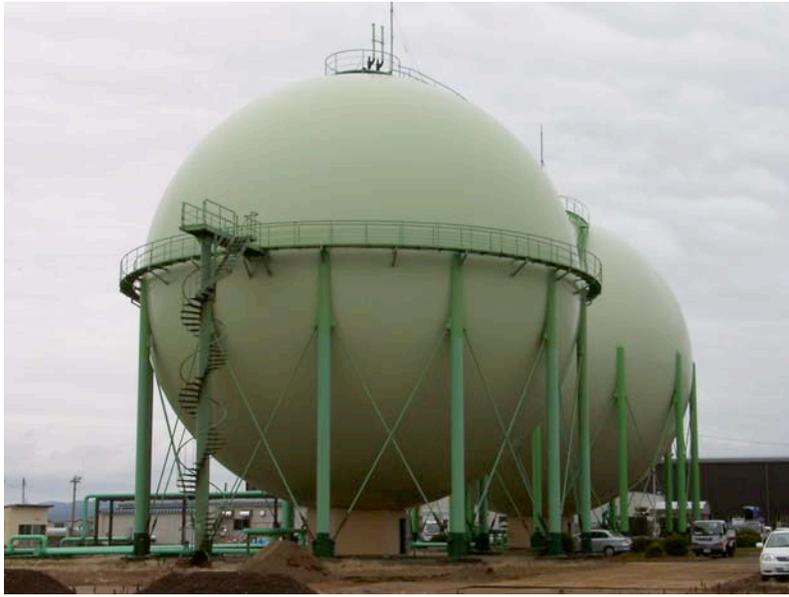
Figure 7.10: Steel natural gas tanks undergoing inspection by the operator and engineering consultants (Site SD13/RK57, N37.37253°, E138.59488°, photo taken 7/23/07 12:37). Trenching and below grade inspections had already taken place prior to the field investigation. No damage was observed to the tanks, pipe connections, or mains, however observations were made from the perimeter of the facility, a short distance from the structures.

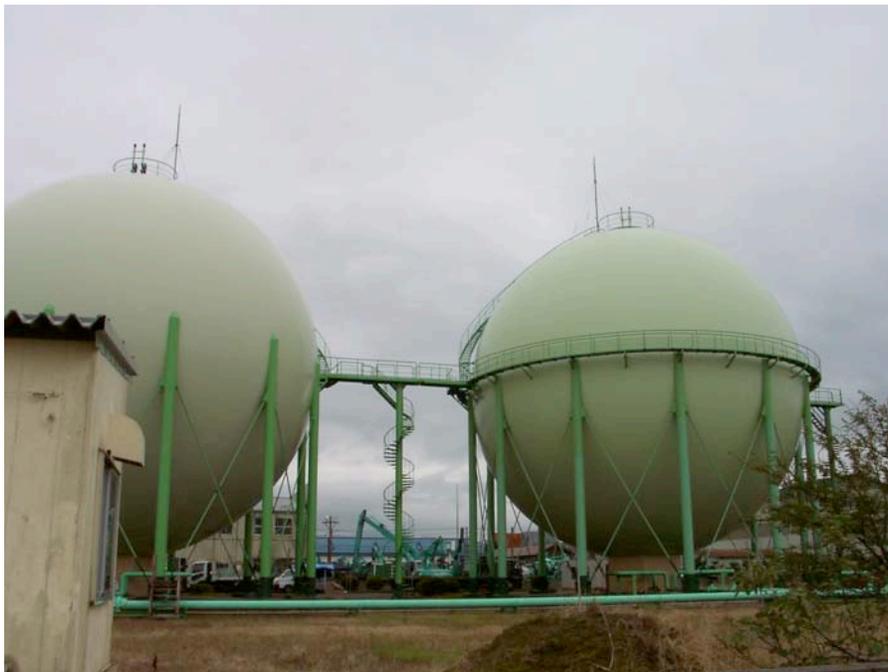
Figure 7.11: Steel natural gas tanks undergoing inspection by the operator and engineering consultants (Site SD13/RK57, N37.37253° E138.59488°, photo taken 7/23/07 12:31).

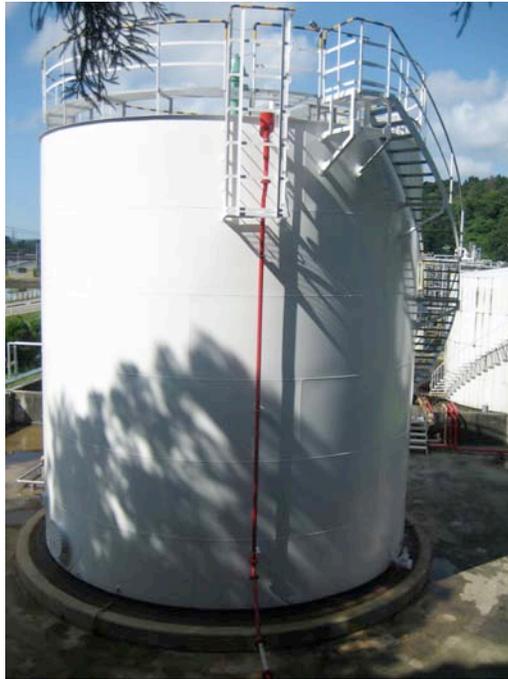
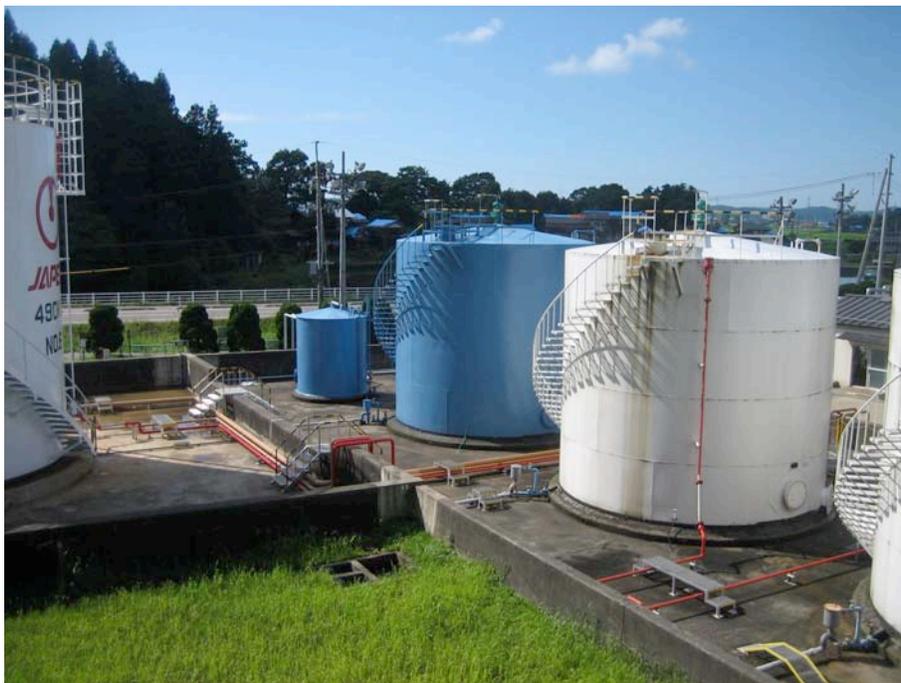
Figure 7.12: Oil storage tanks (Site RK55, N37.38917° E138.63377°, photos taken 7/23/07 12:30). No damage was observed at this site.

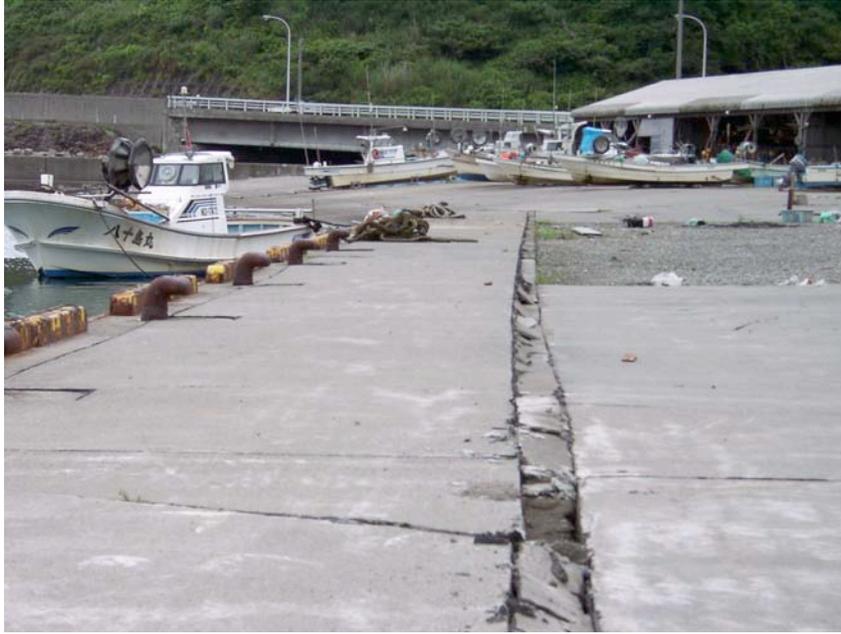
The Kasashima harbor exhibited negligible to very minor evidence of ground deformation and seismic effects to coastal infrastructure (e.g. quay walls, seawalls, breakwaters). Trace remnants of very small, localized ground deformations were observed, and it appears that the ground motions in this area were just strong enough for incipient lateral deformation of the ground and waterfront earth retention structures (Figure 8.1). This site is useful for investigating the regional extent of liquefaction-induced ground failure at ports located southwest of the meiseismic region. Lateral spreading of 7 cm to 12 cm was observed in beach deposits with lateral deformation of short concrete quay walls of 1 cm to 2 cm. No movement of larger caisson-type quay walls or breakwaters was observed. Settlement of paved aprons of roughly 10 cm to 12 cm was noted behind the short quay wall (Figures 8.2 and 8.3). The investigation team did not inspect coastal facilities located southwest of Kasashima harbor. It is possible that very minor evidence of liquefaction occurred to the west, however in the absence of significantly different site effects, the impact on coastal infrastructure is likely minimal. The investigation team did not receive reports of significant damage to coastal facilities west of Kasashima, despite the occurrence of several moderate to large landslides in cut slopes for highways and rail routes in this area.

Figure 8.2: Kasashima Harbor - Ground settlement and minor lateral deformation adjacent to quay walls (Site RK21, N37.33702° E138.46680°, photo taken 7/21/07 14:40).

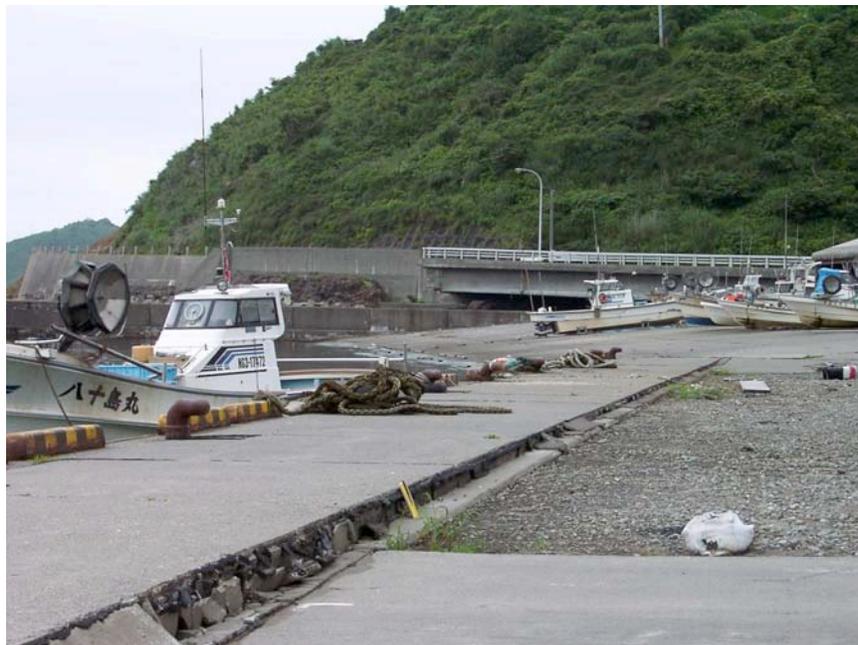
Figure 8.3: Kasashima Harbor - Settlement of fill behind quay walls (Site RK21, N37.33702° E138.46680°, photo taken 7/21/07 14:48).

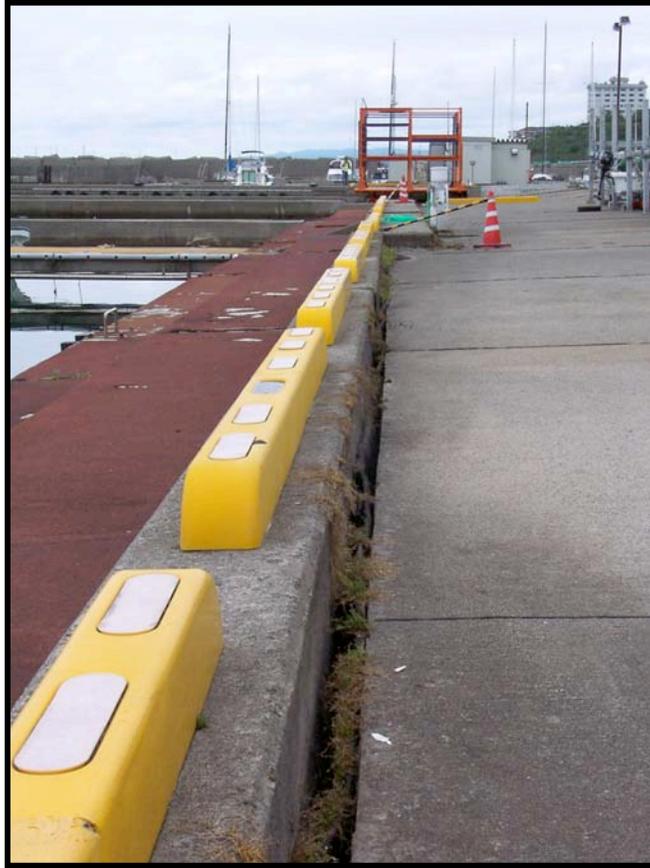
From Kasashima the reconnaissance moved eastward toward the epicentral region. The Kashiwazaki Marina was inspected and considered a site of minor damage. Evidence of ground deformation was observed in the form of minor lateral movement (generally 2 cm to 7 cm) of short quay walls and maximum ground settlements adjacent to quay walls of roughly 7 cm to 15 cm (Figures 8.4 and 8.5). Small sand boils were observed in isolated portions of the boat storage yard. The alignment of the quay walls was very good indicating fairly uniform, minor lateral movement. Estimates of maximum lateral wall movement are 6 cm to 10 cm. Minor ground cracking and lateral deformation was observed around the perimeter of the marina property. Paved and unpaved parking areas located in filled areas adjacent to the facility exhibited very minor cracks with cumulative displacements on the order of 3 cm to 5 cm. A park with a multi-story observation structure is located immediately to the west of the marina property (Onodachi Seaside Park). The structure appears to be located on fill, although the foundation type is not currently known to the team. The sloping, grass-covered fill at this site exhibited very minor cracking indicating incipient ground failure.

Figure 8.4: Kashiwazaki Marina - Evidence of minor lateral movement of quay walls and associated settlement of the paved apron (Site SD3, N37.36093° E138.52027°, photo taken 7/22/07 12:59).

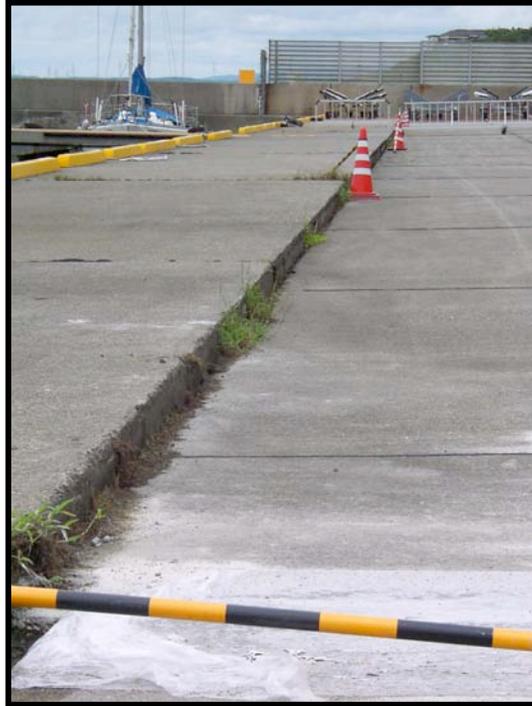
Figure 8.5: Kashiwazaki Marina - Evidence of minor settlement behind quay walls (Site SD3, N37.36093° E138.52027°, photo taken 7/22/07 13:12).

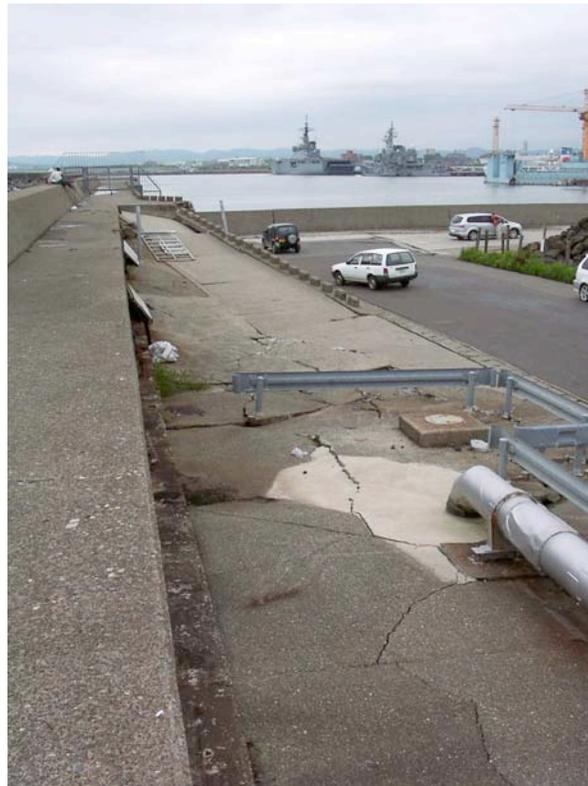
Westernmost section – From the landward portion of this section of the port to the outer harbor this area includes; (a) an older portion of the berth that appears to be relatively unused, (b) an asphalt heating and pumping facility, (c) a new facility that includes sightseeing boat mooring and a single-story office building, (d) an outer harbor-front quay wall, and (e) the major seawall and breakwater that extends from the beach into the harbor a total length of approximately 2.4 km. The landward portion of the berth (a) appears to include both concrete caissons and a wharf deck supported by vertical concrete piles (Figure 8.6). No lateral movement of this portion of the wharf was noted and no damage to the piles was noted, although only the waterfront row of piles was visible during the investigation. The Take Naka asphalt facility (b) exhibited very little damage (Figures 8.7 - 8.9). The facility was in operation at the time of the reconnaissance and the inspection focused on the performance of the large, insulated asphalt holding tank. The tank is secured at its base by a bolt and flange detail. Many of the flanges were bent, however none of the bolts appeared to have failed. No “elephant’s foot” bulking of the tank was noted, although the exterior of the tank is covered with a layer of insulation prohibiting a more thorough inspection. The asphalt distribution pipe, which is slightly elevated above the ground, did not exhibit signs of distress despite extensive ground failure along the adjacent area near the sightseeing facility (Figure 8.10).

Figure 8.10: Kashiwazaki Port - Seawall and exposed end of the elevated asphalt pipe (Located near Site RK25, N37.36713° E138.53210°, photo taken 7/21/07 15:51).

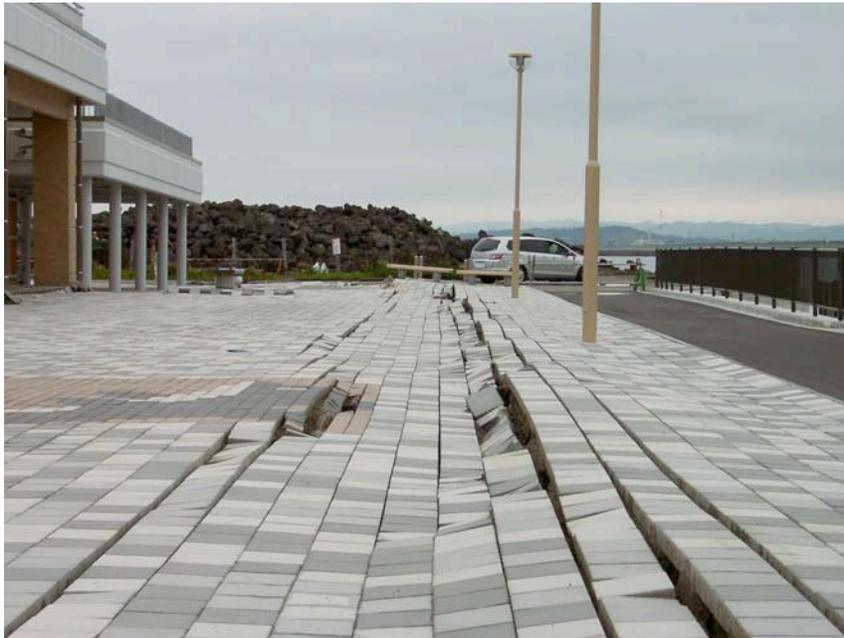
The new sightseeing facility (c), including a new single-story structure, associated pedestrian areas, and wharf, were subjected to the effects of widespread liquefaction, lateral spreading and settlement. The structure performed very well, but did exhibit minor distress along two pedestrian-accessible roof areas on either side of the main structure. It is believed that the distress is due to adjacent lateral spreading and differential settlement between the ground and structure. The paved areas and walkways surrounding the building were extensively damaged (Figure 8.11). Settlements exceeded 30 cm in many areas and a pronounced graben formed between the building and the waterfront quay wall. The quay wall has moved laterally and tilted a minor amount (Figure 8.12). This area was extensively investigated by the team and it was the focus of a ground-based LiDAR survey.

Figure 8.11: Kashiwazaki Port - Liquefaction-induced damage to the sightseeing wharf (Site RK25/SA25/YT4, N37.36713° E138.53210°, photo taken 7/21/07 16:03).

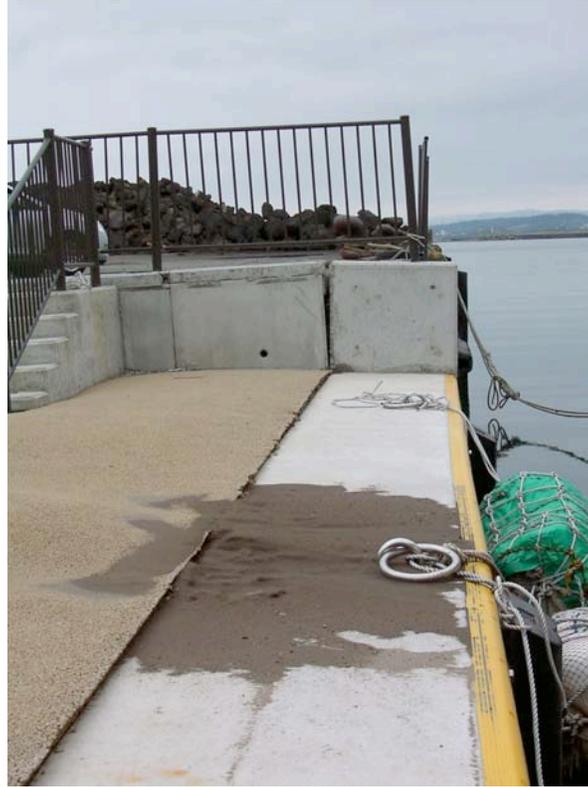
Figure 8.12: Kashiwazaki Port - Liquefaction-induced damage to the sightseeing wharf with minor displacement of the caisson quay wall (Site RK25/SA25/YT4, N37.36713° E138.53210°, photo taken 7/21/07 16:09).

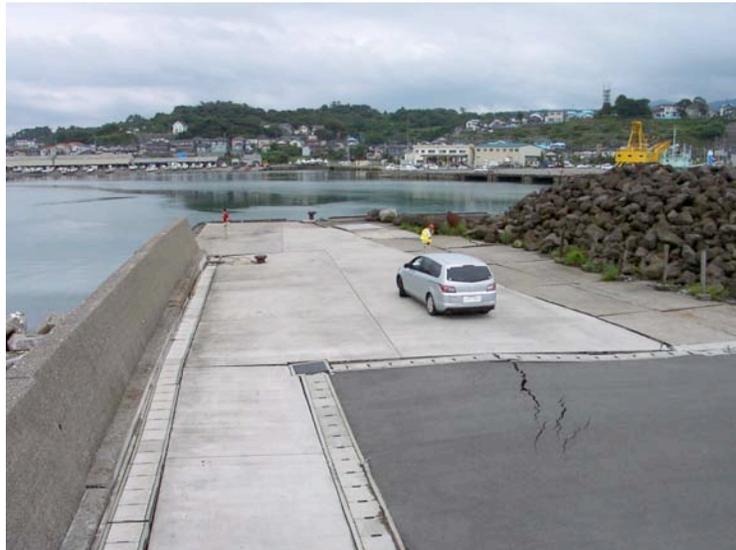
The outer quay wall area has been subjected to large lateral ground deformation and settlement due to liquefaction (Figures 8.13 and 8.14). The seawall/breakwater was inspected landward from the beach adjacent to the asphalt handling facility to the outer quay area. The breakwater exhibited negligible to very minor displacement adjacent to the beach. The waterfront side of the seawall is armored with concrete tetrapods. The tetrapods appear to be unreinforced and numerous units showed damage due to rocking during the earthquake (Figure 8.15). This type of damage to tetrapods and other wave armor units was noted throughout the Kashiwazaki Port and long seawall located northeast of the Sabaishi River.

Figure 8.13: Kashiwazaki Port - Evidence of lateral ground deformation adjacent to the outer quay wall (Located near site RK25/SA25/YT4, N37.36713° E138.53210°, photo taken 7/21/07 15:49).

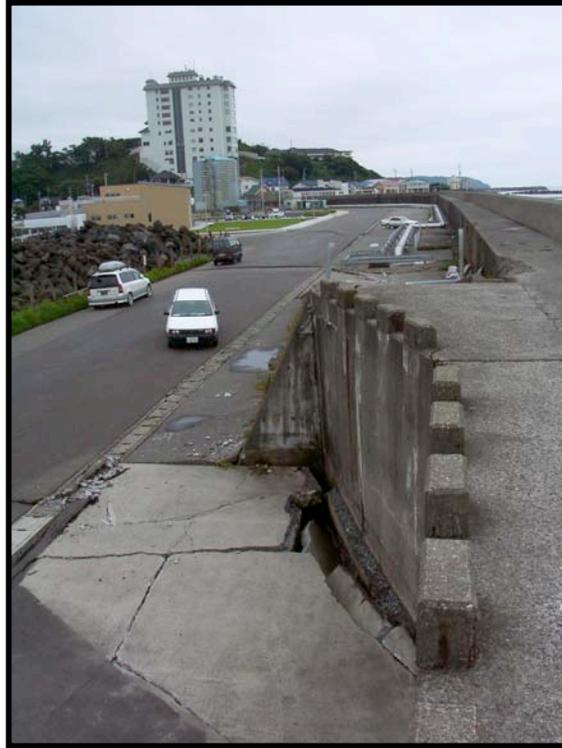
Figure 8.14: Kashiwazaki Port - Evidence of ground failure adjacent to the seawall at the outer quay wall area (Located near site RK25/SA25/YT4, N37.36713° E138.53210°, photo taken 7/21/07 15:50).

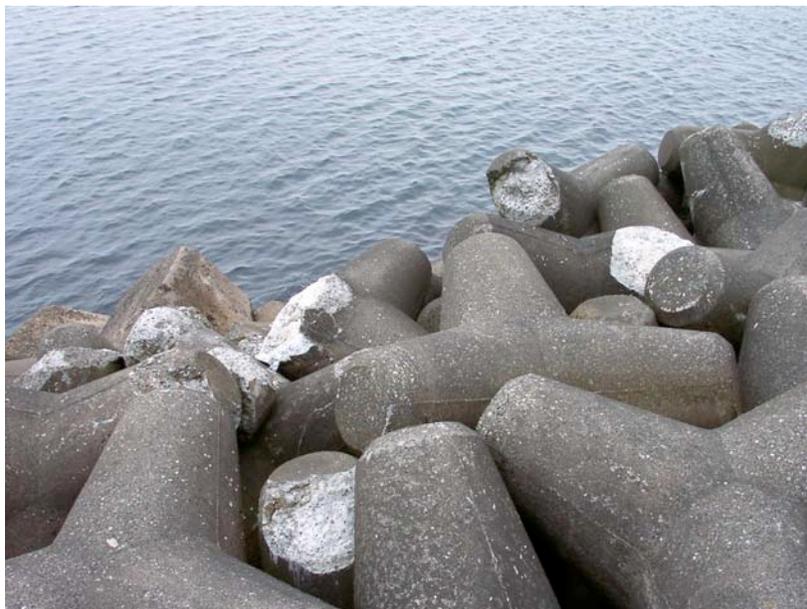
Figure 8.15: Kashiwazaki Port - Likely earthquake-related damage to tetrapod wave armor units (Located near site RK25/SA25/YT4, N37.36713° E138.53210°, photo taken 7/21/07 15:53).

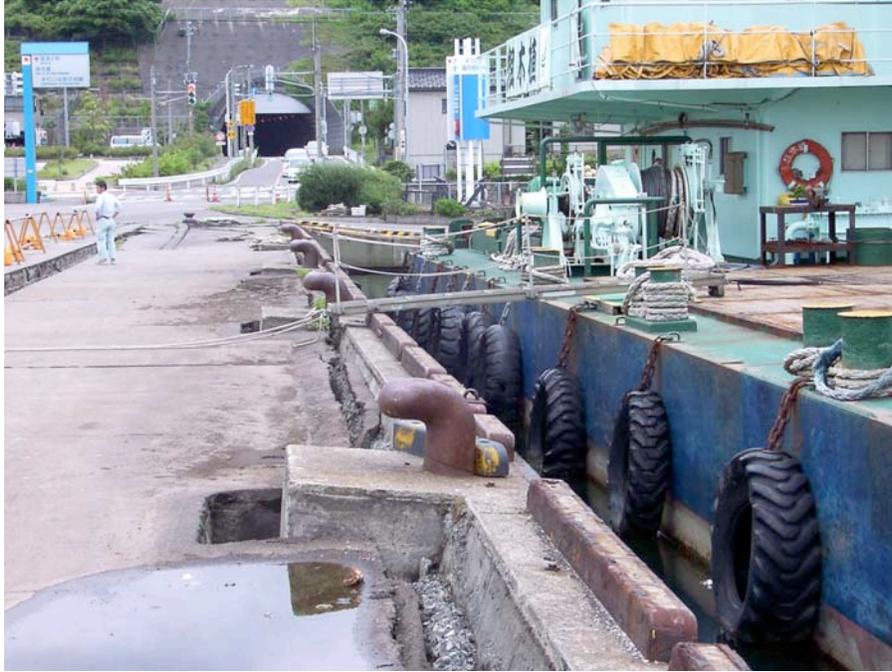
Southwestern pier – The portion of the Port of Kashiwazaki referred to herein as the “southwestern pier,” appears to be a shallow water terminal used along one berth as a staging area for a dredging barge and on the opposite side of the terminal as a fishing and/or light cargo handling area. This berth exhibited extensive liquefaction-induced damage. Lateral movement of the quay wall (anchored sheetpile wall) along the western face was approximately one meter with settlements of roughly 0.5 m to 0.6 m (Figures 8.16 and 8.17). The quay wall tilted roughly 5°. The lateral deformation along the eastern face was much less pronounced (roughly 0.3 m), although the settlement of the backfill was equally severe (0.6 m) (Figure 8.18). It appears that the eastern portion of the terminal has been constructed of concrete caissons. It is believed that a portion of the difference in the observed lateral quay wall movement is due to the use of different structures during construction of the terminal. The heights of the sheetpile walls and caissons could not be discerned during the reconnaissance.

Figure 8.16: Kashiwazaki Port - West facing portion of the “Southwestern Pier” showing displacement of the sheet pile wall and ground settlement due to liquefaction of sandy backfill (Site SD5, N37.36532° E138.53213°, photo taken 7/22/07 13:57).

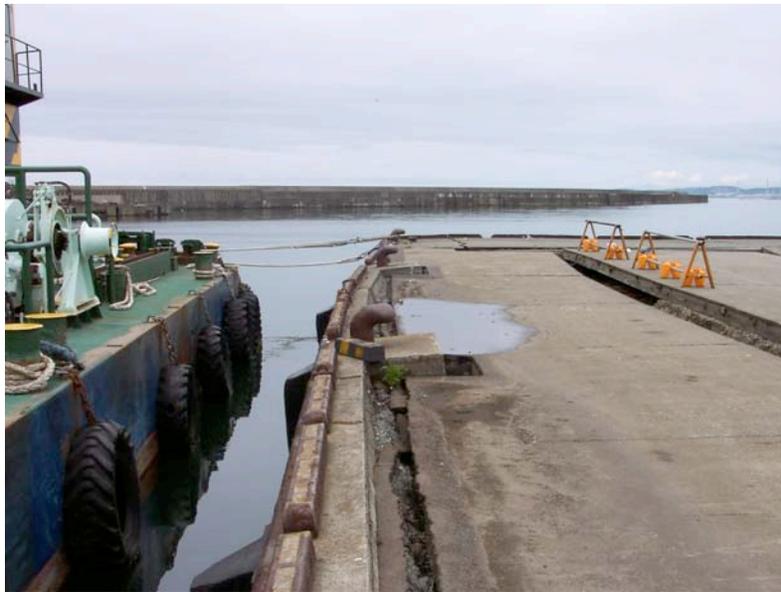
Figure 8.17: Kashiwazaki Port - West facing portion of the “Southwestern Pier” showing displacement of the sheetpile wall and ground settlement due to liquefaction of sandy backfill (Site SD5, N37.36532° E138.53213°, photo taken 7/22/07 13:58).

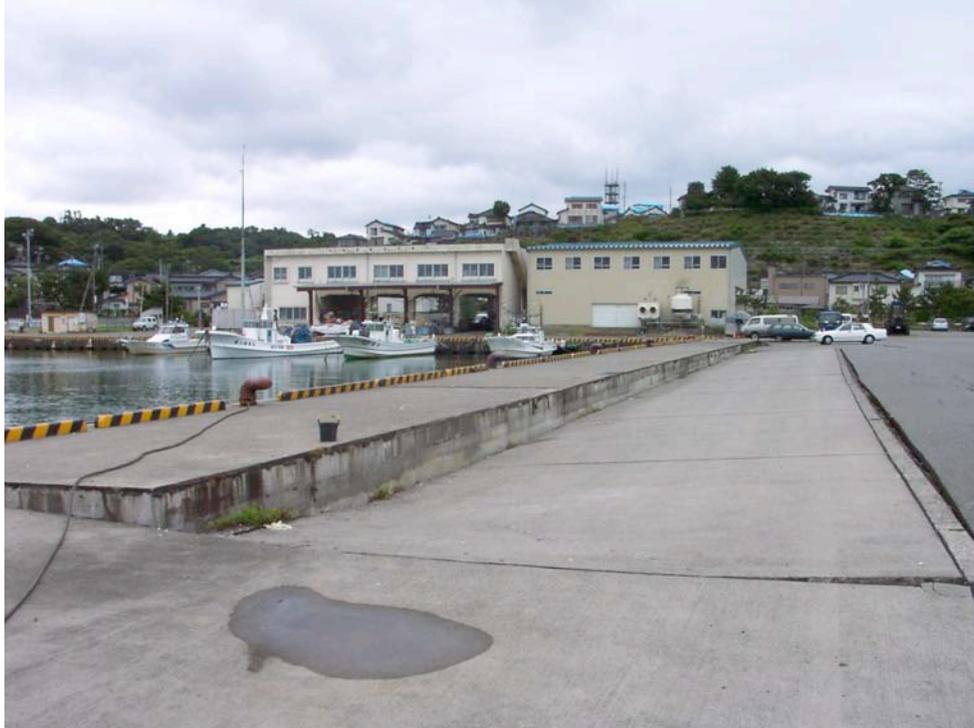
Figure 8.18: Kashiwazaki Port - East facing portion of the “Southwestern Pier” showing pronounced ground settlement (Site SD5, N37.36532° E138.53213°, photo taken 7/22/07 14:05).

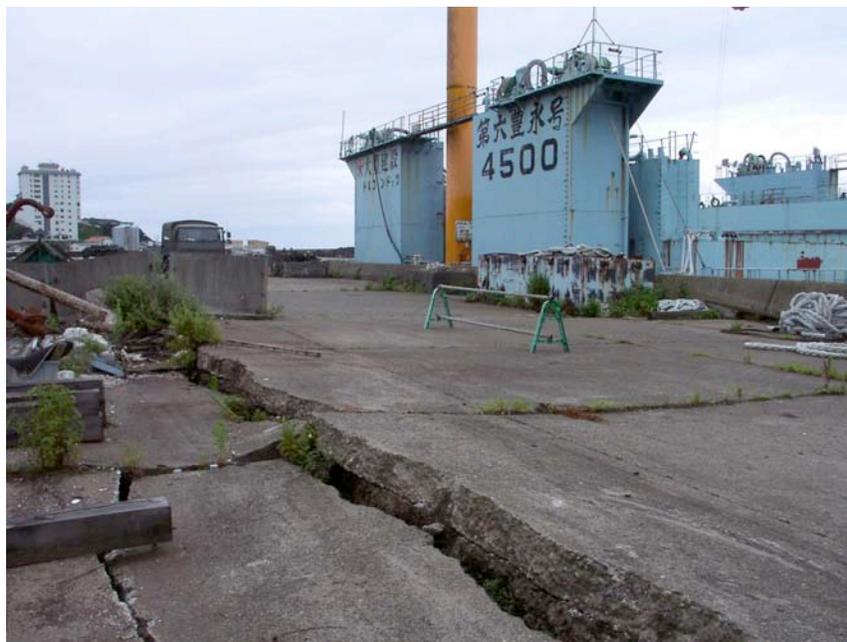
Steel Scrap Handling Facility – Moving eastward along the port complex the next major industrial facility is a steel scrap handling and transport wharf. Sand boils, ground cracks and liquefaction-induced settlement were pervasive throughout this facility, particularly around the waterfront perimeter. Waterfront settlements up to approximately 35 cm were noted and lateral wall movements varied between 2 cm and 30 cm depending on the orientation of the quay wall (Figures 8.19 and 8.20). Pronounced pavement disruption and ground cracks in the landward section of the facility indicated lateral deformation of the anchor system for the sheetpile walls (Figure 8.19). Lateral movement and rotation of near-shore concrete blocks with bollards and damage to wave armor units were also observed.

Figure 8.19: Kashiwazaki Port - Steel Scrap Transport Facility showing evidence of ground failure due to liquefaction of sand fill and damage to concrete aprons (Site SD6, N37.36668° E138.53565°, photo taken 7/22/07 14:46).

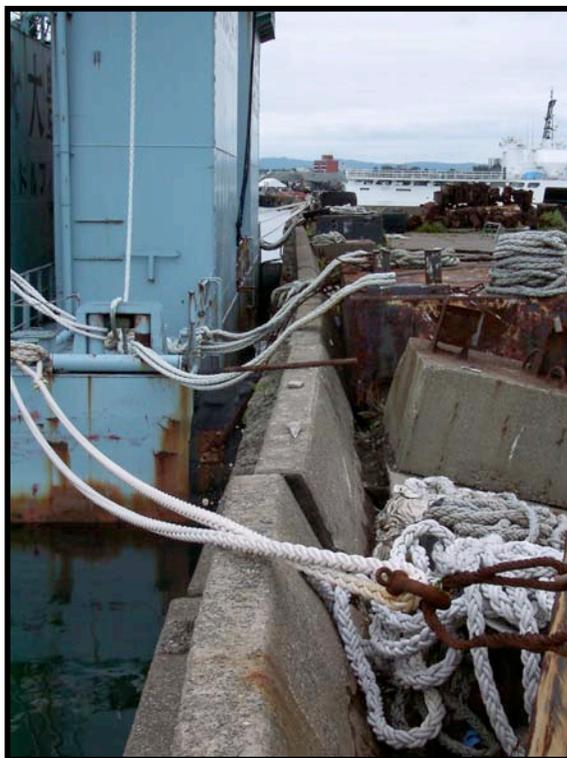
Figure 8.20: Kashiwazaki Port - Steel Scrap Transport Facility showing caisson displacement (Site SD6, N37.36668° E138.53565°, photo taken 7/22/07 14:56).

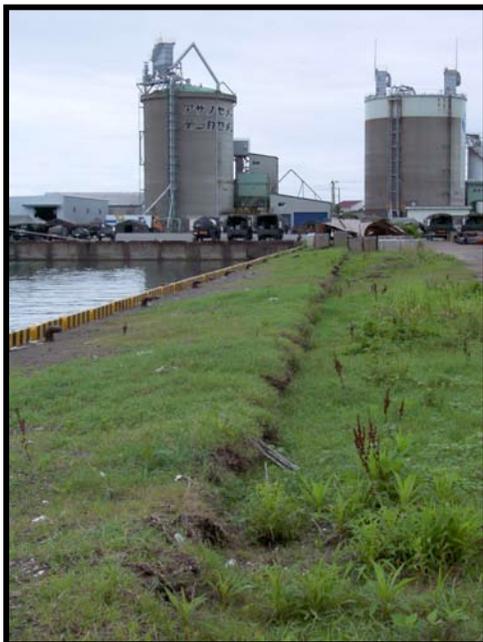
Interior, north facing quay wall (end of Coast Guard Berth) – This landward and short length of quay wall is located between the Steel Scrap Handling Facility and the terminal that was being used at the time of the reconnaissance by the Japan Coast Guard described in the following subsection. The water depth in this portion of the port is relatively small although the exact depth of water and height of caissons was not determined during the investigation. The caissons were laterally displaced roughly 30 cm to 45 cm (Figure 8.21). The caissons are approximately 4.5 m wide.

Figure 8.21: Kashiwazaki Port - North facing, landward quay wall exhibiting lateral movement and rotation of caissons (Site SD7, N37.36593° E138.53692°, photo taken 7/22/07 15:12). The Taiheiyo Cement Tanks are in the background.

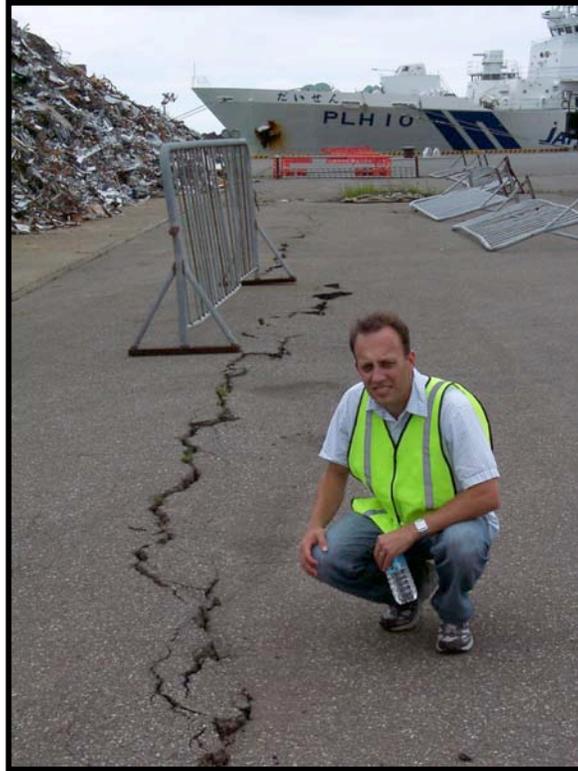
Figure 8.22: Kashiwazaki Port - Minor ground cracks located parallel to the western quay wall used as the berth for the Japan Coast Guard (Site SD8, N37.36680° E138.53825°, photo taken 7/22/07 15:17).

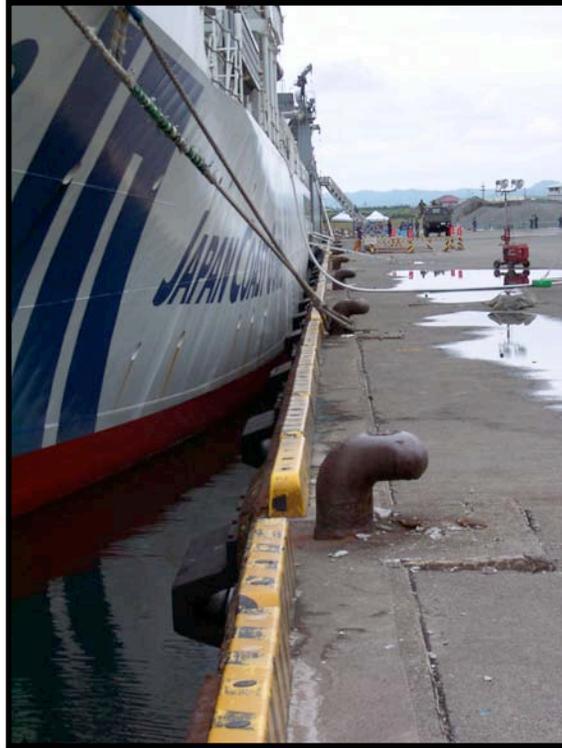
The west end of the north facing quay was also utilized by the Japan Coast Guard. This portion of the quay exhibited negligible lateral displacement ( $\leq 4$  cm) and minor settlement (Figures 8.23 and 8.24). Overall, the seismic performance of this portion of the terminal was very good. The middle to eastern end of the quay was being used to berth a ship of the Japan Self Defense Forces at the time of the survey. The effects of liquefaction were similarly minor with localized apron cracking and minor lateral displacement along much of the berth (Figure 8.25). It is interesting to note however that the evidence of liquefaction-related ground failure and quay wall displacement increased along the berth to the east (i.e. closer to the eastern boundary of the berth at the mouth of the U River, Figure 8.26). Within roughly 100 m of the U River the effects of liquefaction became pronounced. Significant damage was observed to the quay wall with lateral displacement and failure of the upper portion of the wall (Figures 8.27 and 8.28).

Figure 8.23: Kashiwazaki Port - Evidence of very minor lateral movement of quay walls and minor settlement located along the northern face of the terminal used as the berth for the Japan Coast Guard (Site SD8, N37.36680° E138.53825°, photo taken 7/22/07 15:22).
