# Investigation of the M6.6 Niigata-Chuetsu Oki, Japan, Earthquake of July 16, 2007

Open File Report 2007–1365

2007

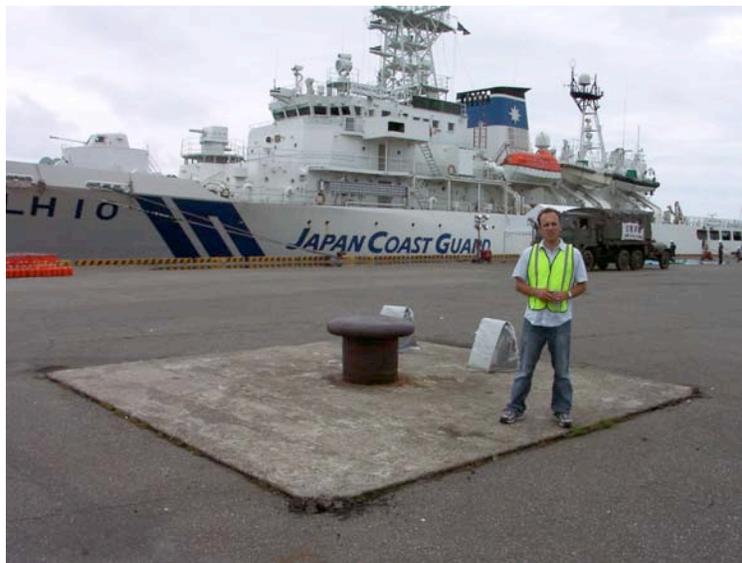
The west end of the north facing quay was also utilized by the Japan Coast Guard. This portion of the quay exhibited negligible lateral displacement ( $\leq 4$  cm) and minor settlement (Figures 8.23 and 8.24). Overall, the seismic performance of this portion of the terminal was very good. The middle to eastern end of the quay was being used to berth a ship of the Japan Self Defense Forces at the time of the survey. The effects of liquefaction were similarly minor with localized apron cracking and minor lateral displacement along much of the berth (Figure 8.25). It is interesting to note however that the evidence of liquefaction-related ground failure and quay wall displacement increased along the berth to the east (i.e. closer to the eastern boundary of the berth at the mouth of the U River, Figure 8.26). Within roughly 100 m of the U River the effects of liquefaction became pronounced. Significant damage was observed to the quay wall with lateral displacement and failure of the upper portion of the wall (Figures 8.27 and 8.28).

Photo 8.24: Kashiwazaki Port - Evidence of minor settlement adjacent to a pile-supported (?) bollard anchorage located along the northern face of the terminal used as the berth for the Japan Coast Guard (Site SD8, N37.36680° E138.53825°, photo taken 7/22/07 15:21).

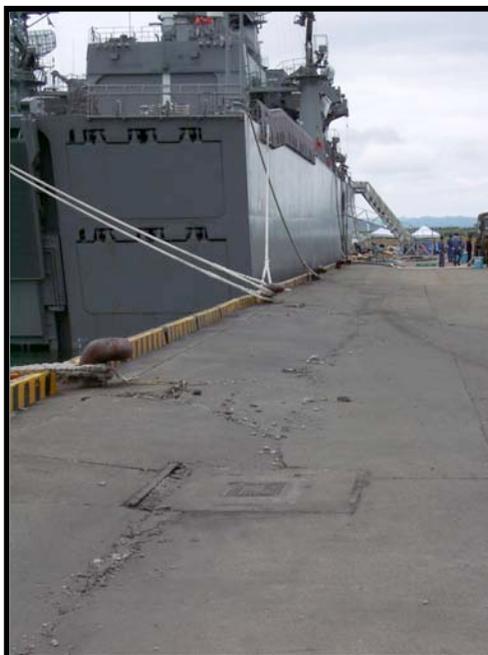
Figure 8.25: Kashiwazaki Port - Evidence of very minor lateral movement of quay walls and minor settlement located along the northern face of the terminal used as the berth for the Japan Self Defense Force (Site SD8, approximately N37.36680° E138.53825°, photo taken 7/22/07 15:24).

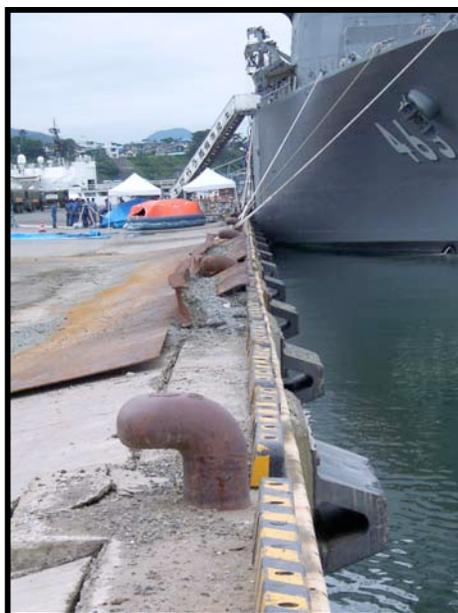
Figure 8.26: Kashiwazaki Port - Evidence of more extensive lateral caisson displacement and ground settlement adjacent to the quay wall located along the eastern end of the north face of the terminal (Site SD8, approximately N37.36680° E138.53825°, photo taken 7/22/07 15:36).

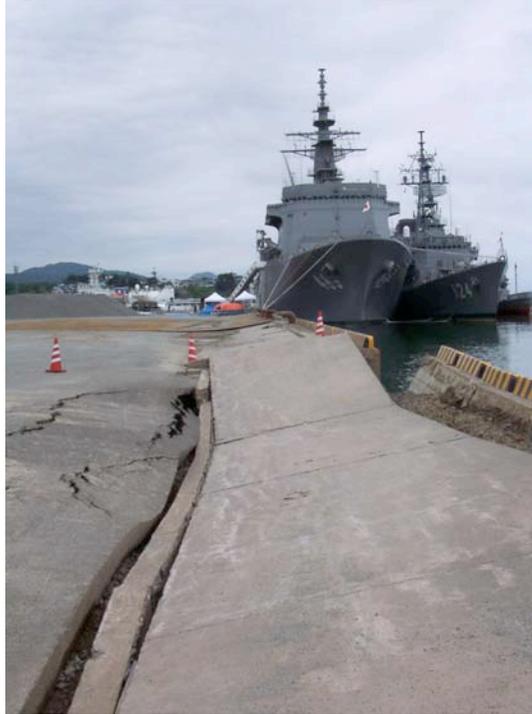
Figure 8.27: Kashiwazaki Port - Significant liquefaction-related damage to the quay walls located at the eastern edge of the terminal adjacent to the mouth of the U River (Site SD8, approximately N37.36680° E138.53825°, photo taken 7/22/07 15:32).

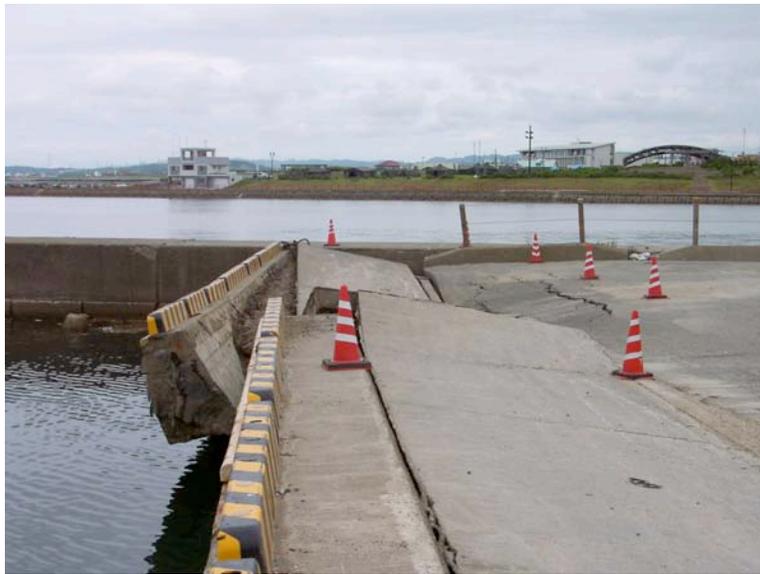
Figure 8.28: Kashiwazaki Port - Significant liquefaction-related damage to the quay walls located adjacent to the U River (Site SD8, approximately N37.36680° E138.53825°, photo taken 7/22/07 15:36).

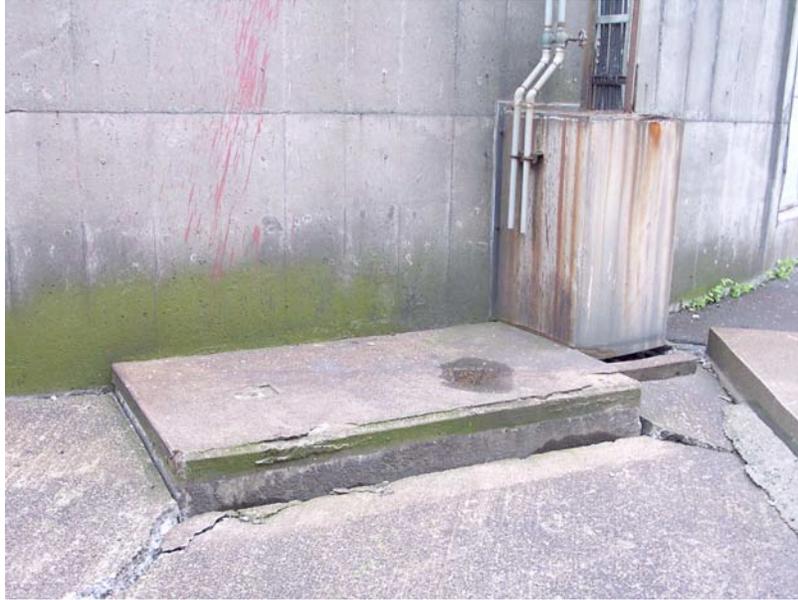
Taiheiyo Cement Tanks – This facility is located in the backland portion of the terminal and it is the site of two large cement tanks. Inspection of the tank foundations revealed minor ground settlement of 5 cm to 12 cm adjacent to the tank foundations (Figures 8.29 and 8.30). Liquefaction effects are negligible in this area. The tanks and appurtenant piping appeared to be in good shape with negligible damage.

Figure 8.29: Kashiwazaki Port (Taiheiyo Cement Facility) - Evidence of minor to moderate settlement of sandy fill adjacent to one of the large diameter tanks (Site SD9, approximately N37.36665° E138.53983°, photo taken 7/22/07 15:48).

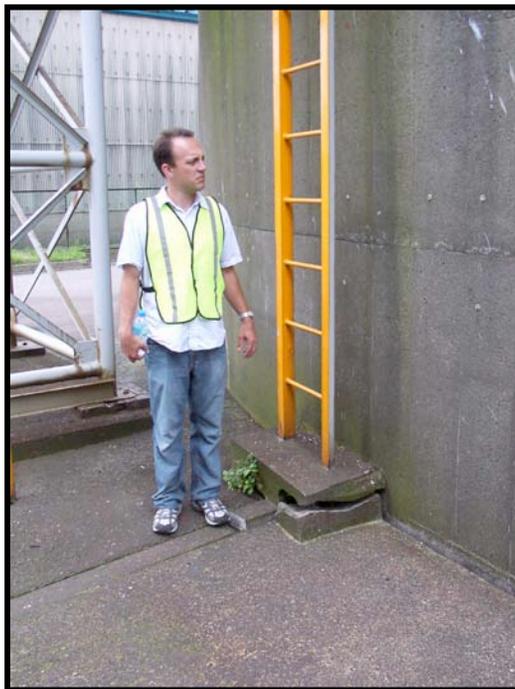
Figure 8.30: Kashiwazaki Port (Taiheiyo Cement Facility) - Evidence of minor to moderate settlement of sandy fill adjacent to one of the large diameter tanks (Site SD9, approximately N37.36665° E138.53983°, photo taken 7/22/07 15:48).

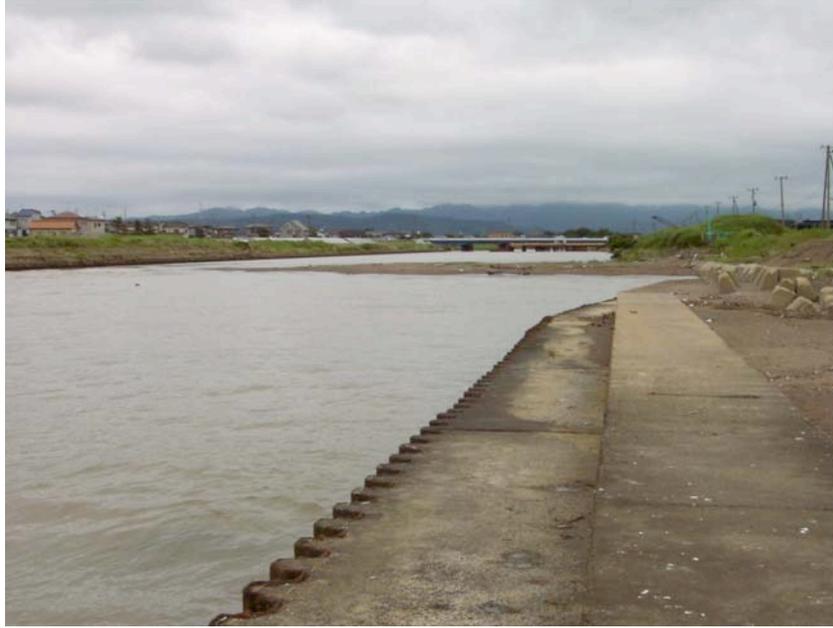
The mouth of the Sabaishi River is protected along its southwest bank by a wall constructed of sheet piles with concrete filling (Figure 8.31). Negligible lateral movement of the riverfront wall was noted and roughly 5 cm to 7 cm of settlement was noted adjacent to the sheet pile wall. Evidence of approximately 30 cm of lateral spreading in the sand deposits behind the sheet pile shore protection was observed. Minor lateral deformation and damage to the concrete slope armor panels was observed across the river from this site.

Figure 8.31: Mouth of the Sabaishi River showing the erosion control measures (Site SD 1, approximately N37.38868° E138.56508°, photo taken 7/22/07 11:07). The Ansei Bridge (Sites SA6/SD2/RK8) is visible in the background.

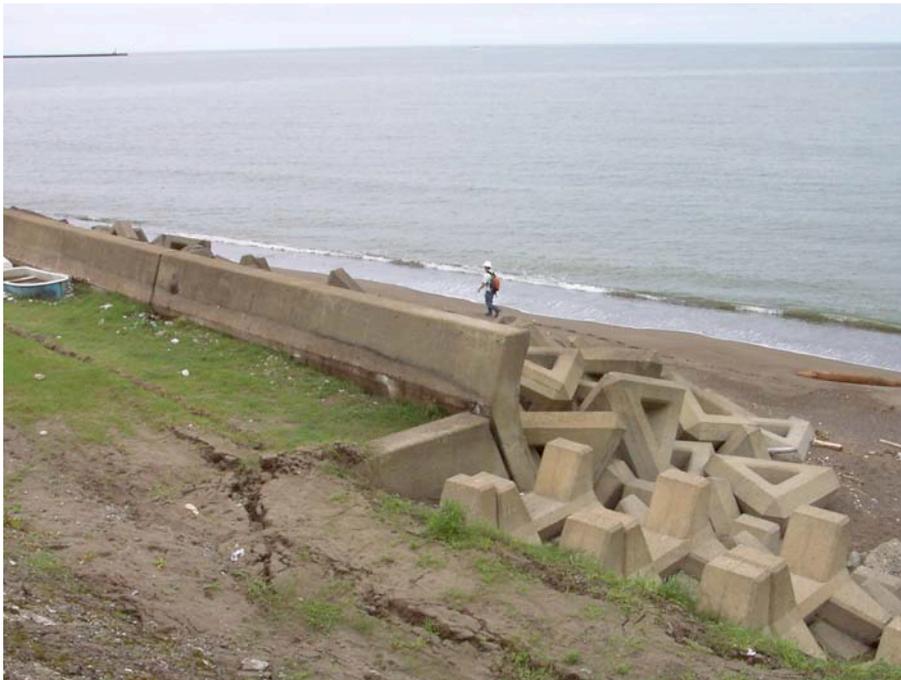
roughly 2.0 km towards the Minatomachi Seaside Park. This seawall was inspected for over a 1 km length. Observations were made from the river mouth southwest to an armored rockfill breakwater located roughly 900 m from the cement plant site. The initial portion of the seawall is located along a narrow beach with wave armor units. This portion of the seawall exhibited lateral deformation, rotation, and structural damage along the counterfort ends of several of the individual wall sections (Figure 8.32).

Figure 8.32: Eastern end of the seawall located adjacent to the damaged cement plant and mouth of the Sabaishi River (Site SD1, approximately N37.38868° E138.56413°, photo taken 7/22/07 10:56). Lateral spreading behind the wave armor units, as well as ground settlement and minor sea wall damage was widespread.

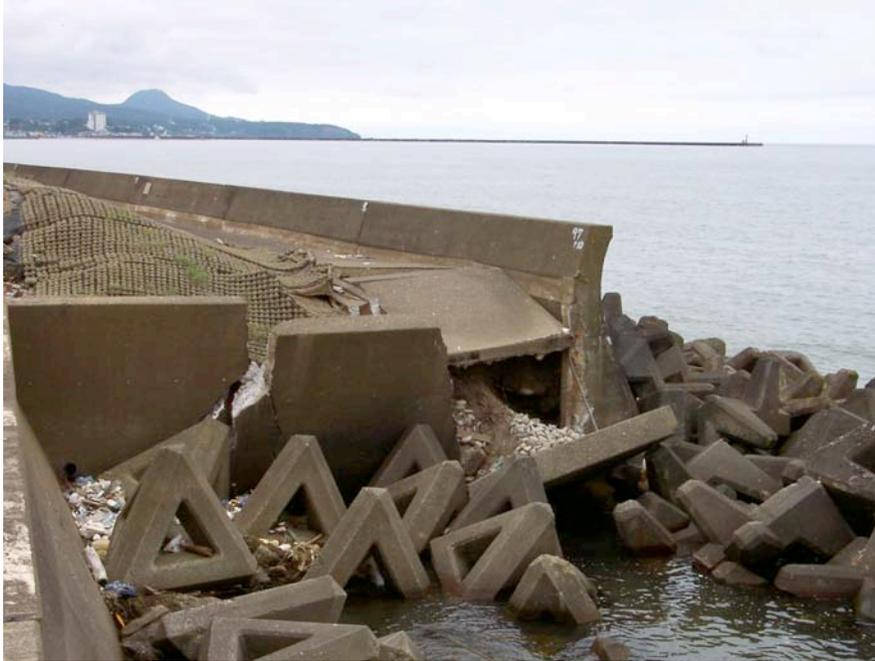
There is a seaward step in the seawall located immediately southwest of the cement plant site. This point was the location of a seawall failure that included a collapsed section of wall, significant settlement and cracking of the backfill, and settlement of the concrete panels located behind the seawall (Figure 8.33). The backfill adjacent to the seawall is composed of clean, rounded cobbles (diameter > 15 cm) (Figure 8.34). The lateral wall movement in this area was roughly 0.6 m.

Figure 8.33: Partial collapse of a portion of the seawall located at the lateral, seaward step in alignment just west of the damaged cement plant (Site SD1, N37.38868° E138.56413°, photo taken 7/22/07 11:18).

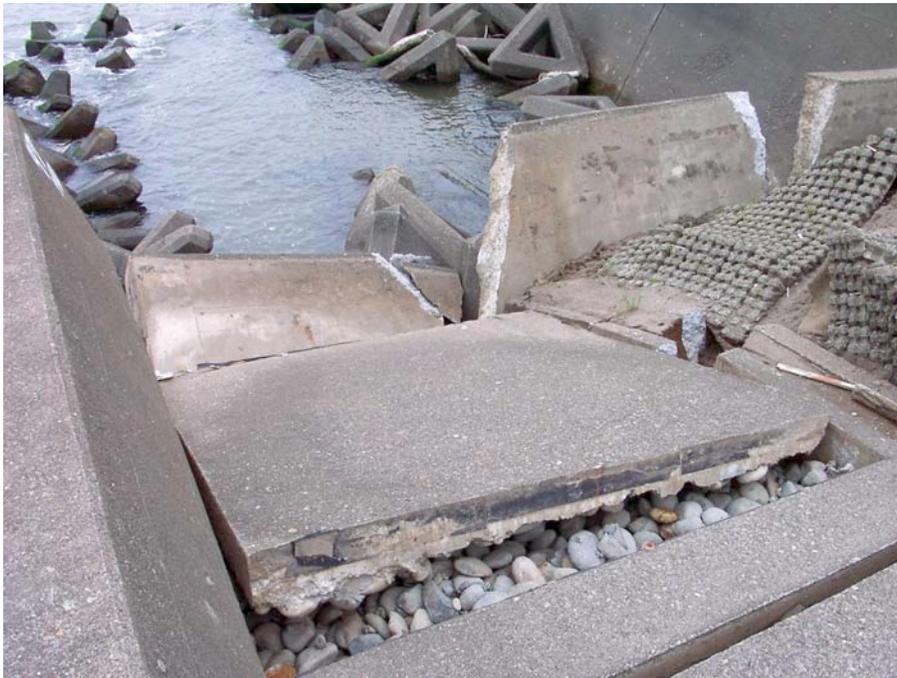
Figure 8.34: Close-up of the collapsed portion of the seawall showing the clean cobble backfill (Site SD1, N37.38868° E138.56413°, photo taken 7/22/07 11:23).

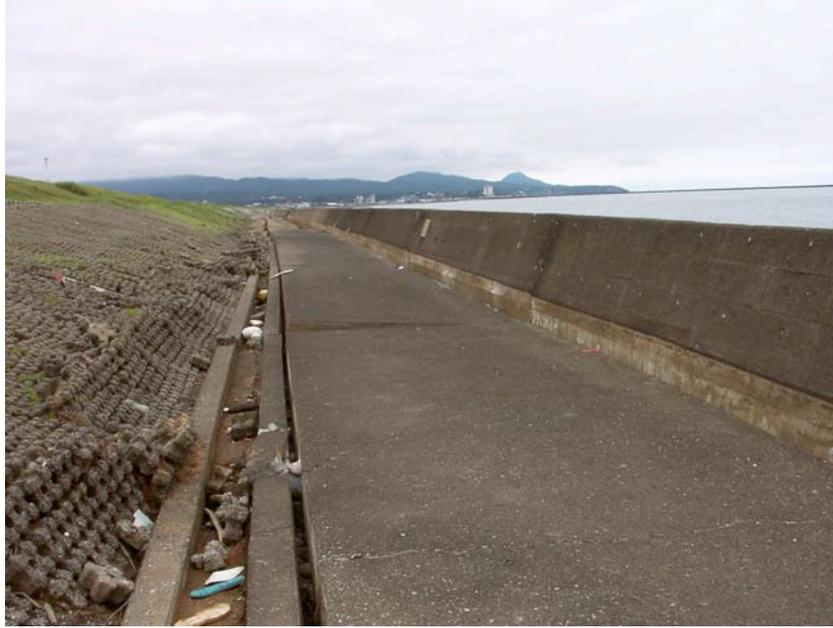
Figure 8.35: Evidence of seawall rotation, ground settlement, and longitudinal cracking of the benched embankment (Moving southwest of Site SD1, approximately N37.38868° E138.56413°, photo taken 7/22/07 11:25).

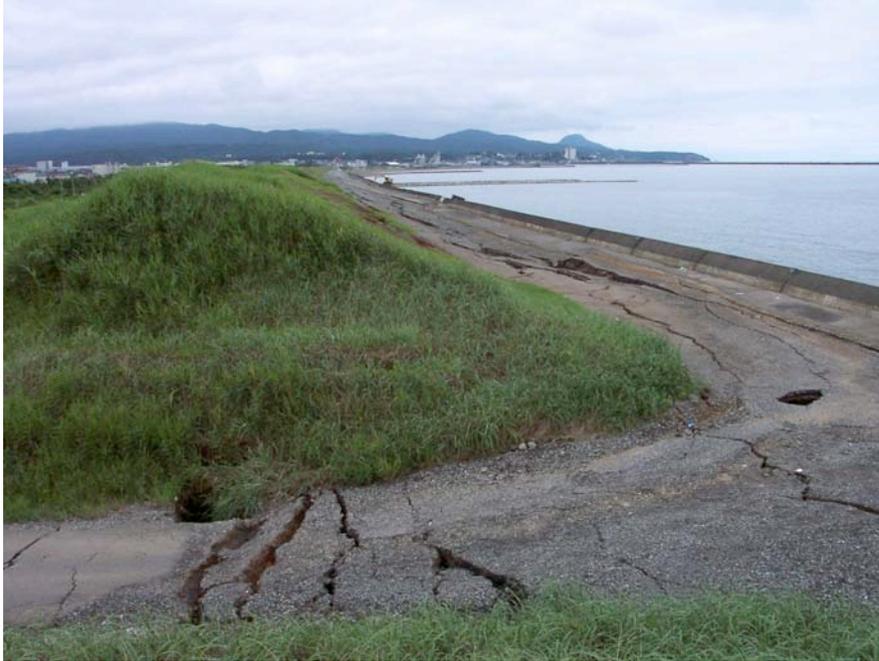
Figure 8.37: Ground deformations adjacent to the embankment and seawall (Location is southwest of Site SD1, photo taken 7/22/07 11:41).

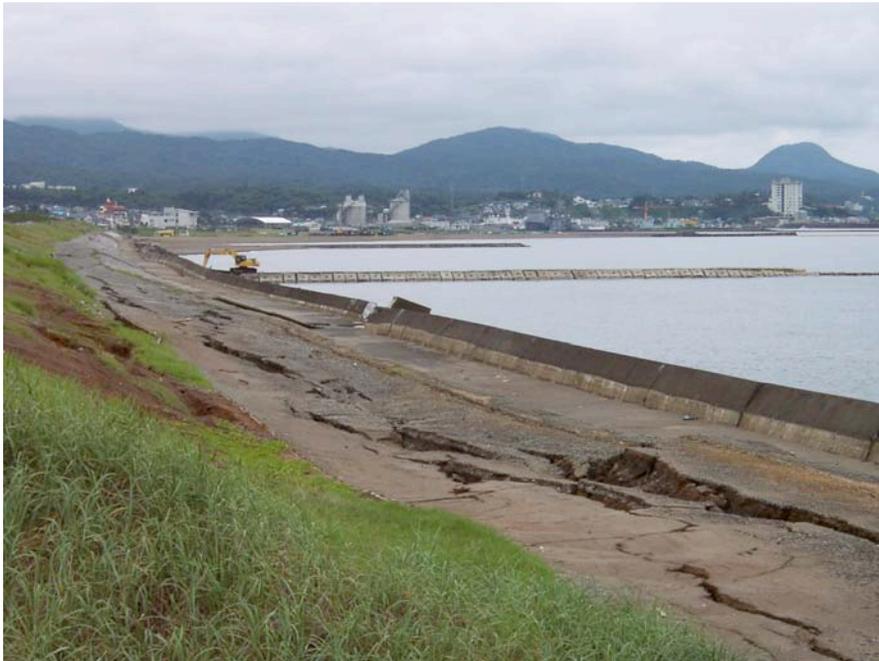
The lateral ground deformation associated with these embankment and foundation failures impacted the seawall and contributed to the development of larger displacements (Figure 8.38). At one location near the southwestern end of this area ground settlement and lateral movement of the seawall was accompanied by the failure of the top of the wall (Figure 8.39). The inspection of the seawall was terminated at the location of an armored groin structure (possibly an outfall structure). At the time of the investigation a track-hoe was being utilized to move rockfill between the seawall and the concrete armor blocks that overlie the rockfill offshore (Figure 8.40).

Figure 8.38: Ground deformations adjacent to the embankment and seawall (Location is southwest of Site SD1, photo taken 7/22/07 11:42).

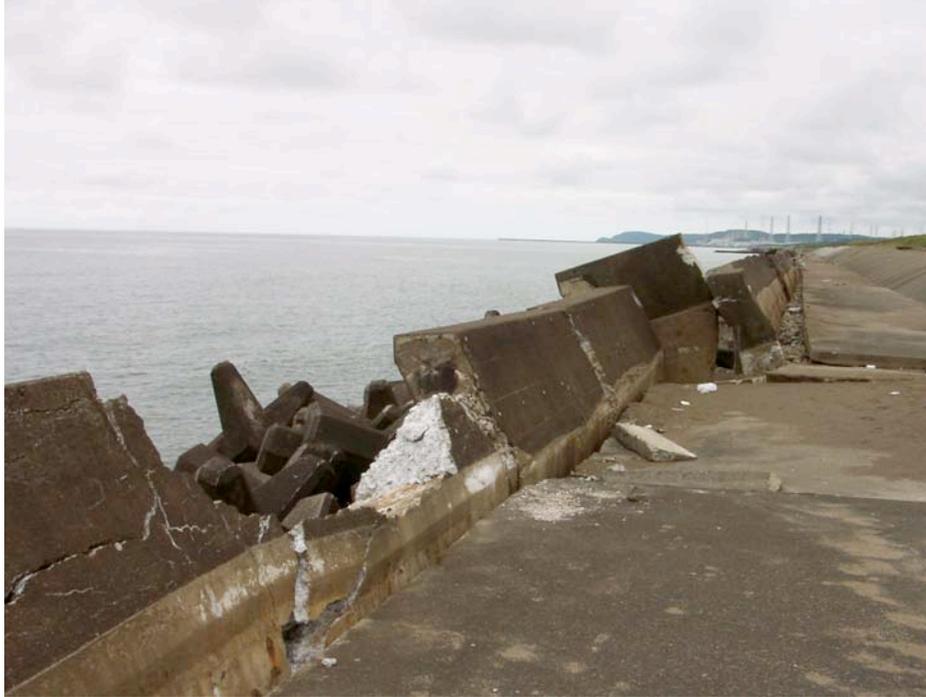
Figure 8.39: Lateral displacement, rotation, and structural damage to the seawall (Location is southwest of Site SD1, photo taken 7/22/07 11:45).

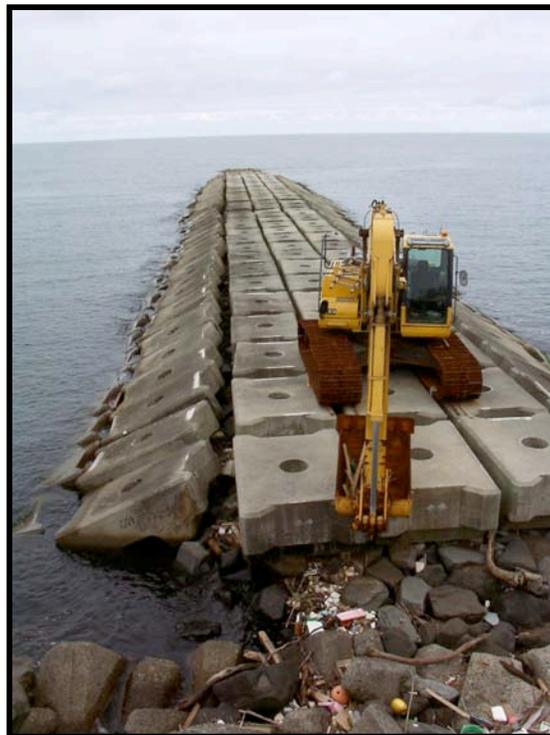
Figure 8.40: Repair of an armored, rockfill breakwater (possibly an outfall structure). (Location is southwest of Site SD1, photo taken 7/22/07 11:49).

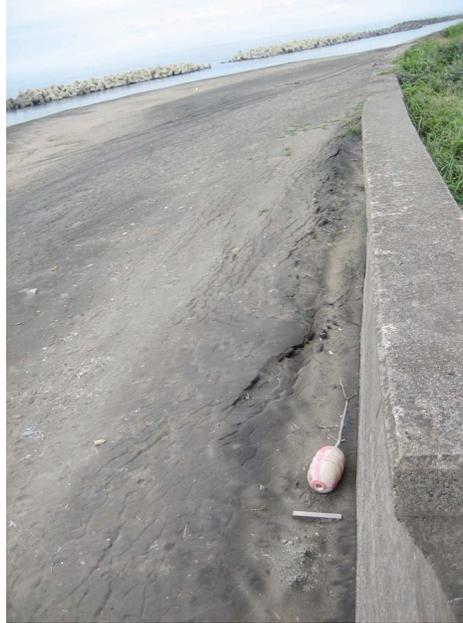
Figure 8.41: Evidence of minor liquefaction and lateral spreading in sandy beach deposits adjacent to the seawall (Site RK37, N37.45478°, E138.60927°, photo taken 7/23/07).

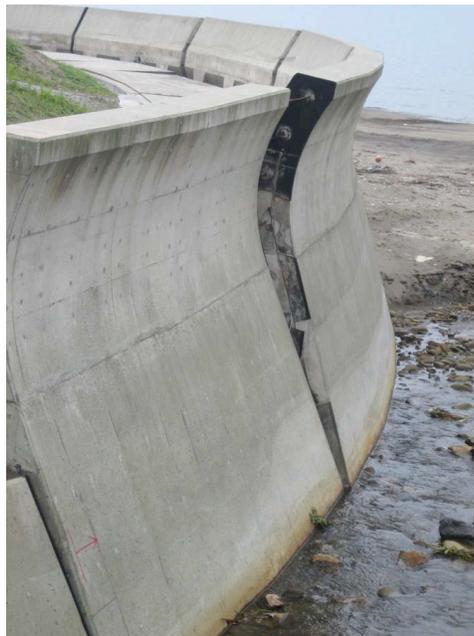
Figure 8.42: Rotation and lateral displacement of the concrete seawall (Site RK37, N37.45478°, E138.60927°, photo taken 7/23/07).

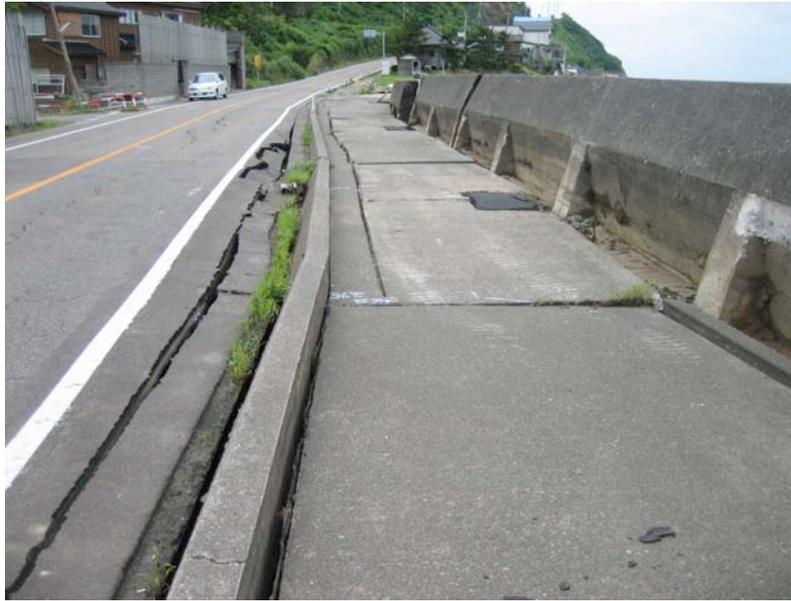
Figure 8.43: Liquefaction-induced damage to the seawall and adjacent roadway (Site RK35, N37.48497°, E138.62645°, photo taken 7/23/07).

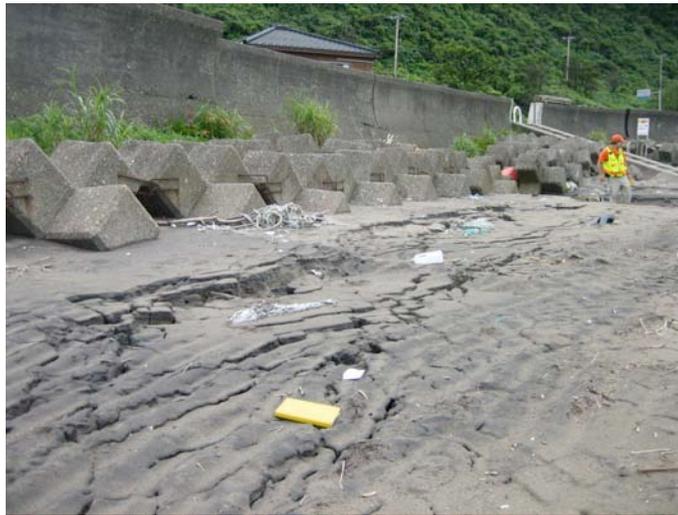
Figure 8.44: Lateral spreading associated with liquefaction of beach sand (Site RK35, N37.48497°, E138.62645°, photo taken 7/23/07).

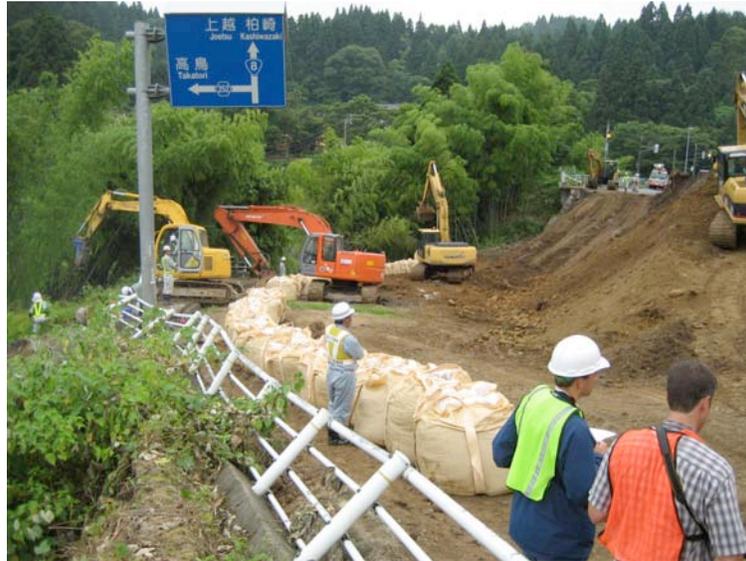
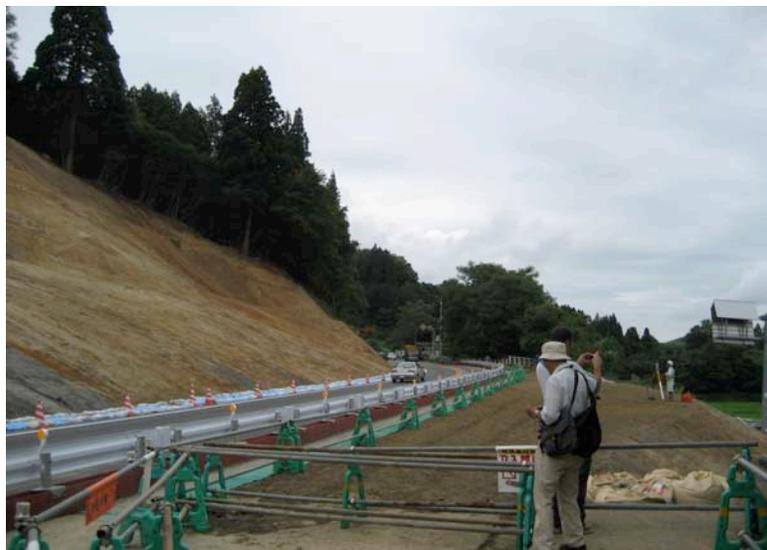
The most striking damage to the transportation network was caused by large landslides destroying sections of roads. The Ozumi Senbon Landslide (Fig. 9.1 - Site RK1) closed both lanes of Highway 8 just north of the intersection with Route 252. The roadway traversed the landslide at approximately its mid-elevation, and the roadway moved down slope with the slide. The landslide geometry and roadway damage were clearly observed on Friday, July 20<sup>th</sup>, and by Monday, July 23<sup>th</sup>, the landslide and roadway had been repaired almost completely, including asphalt, yellow-center striping, and guard rails, permitting two-way passage of traffic through the affected region. A roadway approaching the Kashiwazaki municipal waste incinerator plant was destroyed by a liquefaction-induced lateral spread (Fig. 9.2). The head scarp of the lateral spread traversed a section of the roadway, causing a vertical offset of approximately 2.5 meters at one section of road. The pavement was heavily damaged on the portion of the roadway affected by the lateral spread.

Figure 9.1: The Ozumi Senbon Landslide (Site RK1, N37.41422° E138.71347°), located along Highway 8 just north of the intersection with Route 252, closed both lanes of traffic. The upper photo, taken 7/20/07 at 11:30, four days after the earthquake, shows the displaced roadway which ran from the distance vehicles to the upper right of the photo to just in front of the investigation team members in the lower right. The bottom photo, taken 7/23/07 at 13:00, shows the nearly completed landslide and roadway repair, complete with guard rails, pavement, and center striping, just three days later.

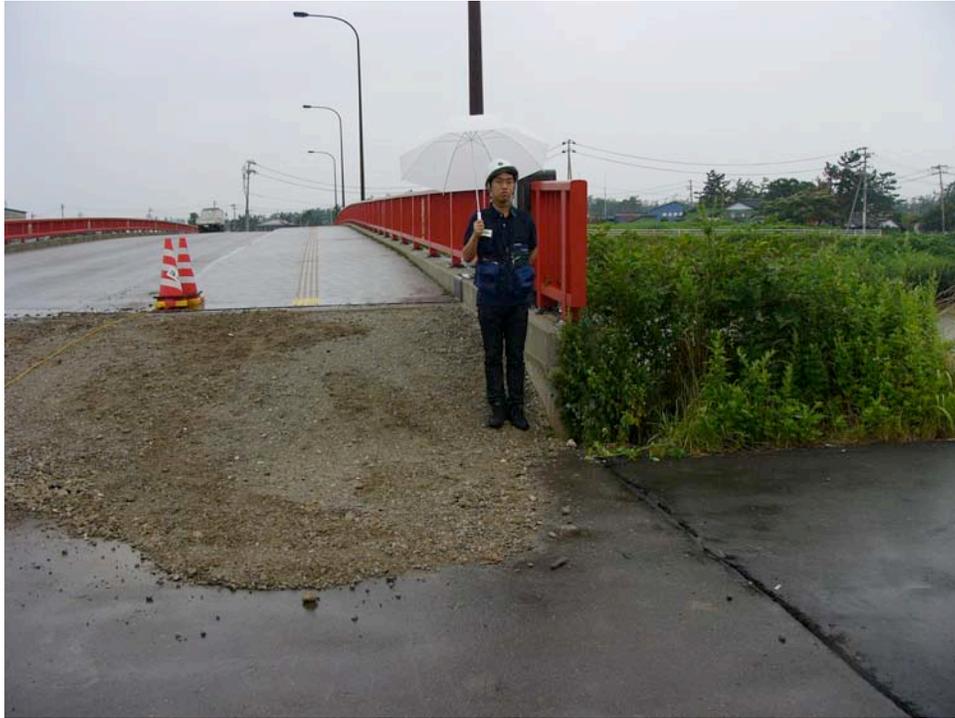
Settlement of soils at bridge approach fills caused vertical offsets at many bridges by as much as one meter (Figs 9.6 and 9.7, additional details are provided in the “Bridges Section”). The offsets required placement of gravel or asphalt pavement to maintain a smooth transition for traffic flow onto the bridges. At the beginning of the reconnaissance mission during July 20-24, 2007, fill had been placed at nearly all of the bridges requiring such repair and only two bridges remained closed. It is not clear how the bridge offsets affected traffic during the first three days following the earthquake.

Figure 9.6: Vertical offset at the approach of Kai-Un Bridge that has been temporarily repaired with gravel fill to permit access (Site YT3, N37.39232° E138.58063°, photo taken 7/20/07 12:42). A vertical offset of 33 cm was measured at the adjacent abutment (left of this photo).

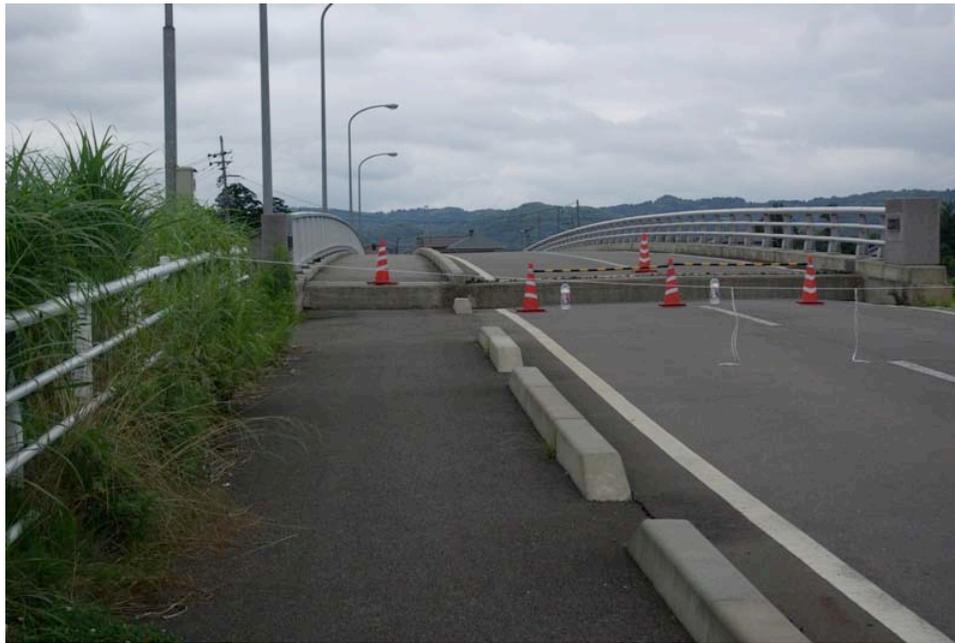
Figure 9.7: Vertical offset at approach of rural bridge that has not yet been repaired (Site SA22 N37.38439° E138.60083°, photo taken 7/21/07 15:00).

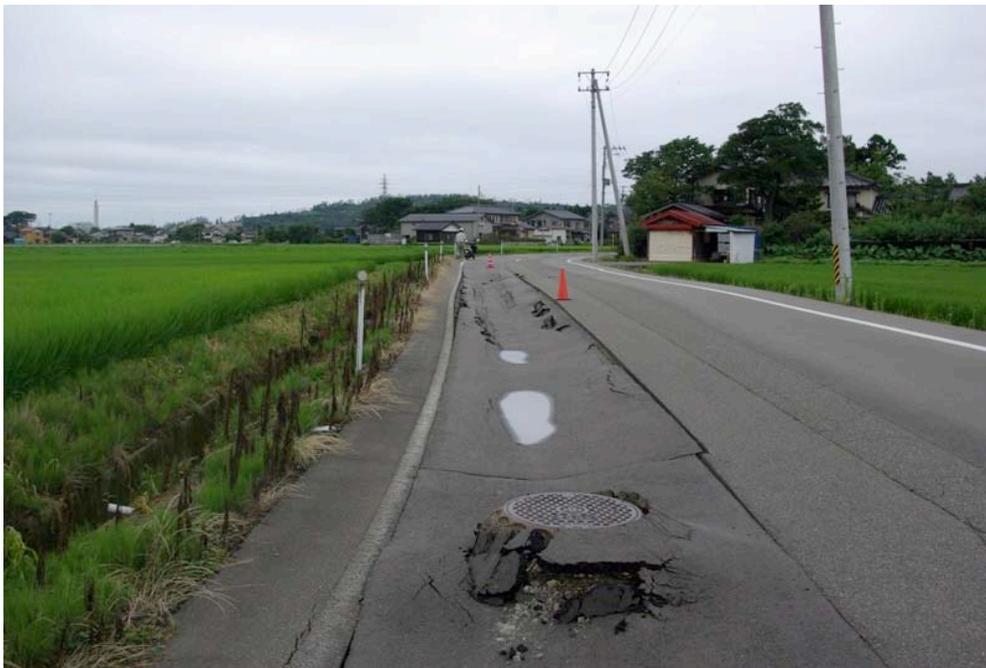
A common cause of pavement damage was liquefaction of utility trench fills, and/or uplift of buried utilities due to buoyancy in liquefied ground. Fig. 9.9 is an example of this widespread pavement damage mechanism. Such damage typically caused closure of one lane of traffic, and in only a few cases were closure of entire roadways necessary due to utility trench fill liquefaction failures.

Figure 9.9: Pavement damage caused by utility trench liquefaction (Site SA21, N37.38950° E138.59662°, photo taken 7/21/07 14:57).

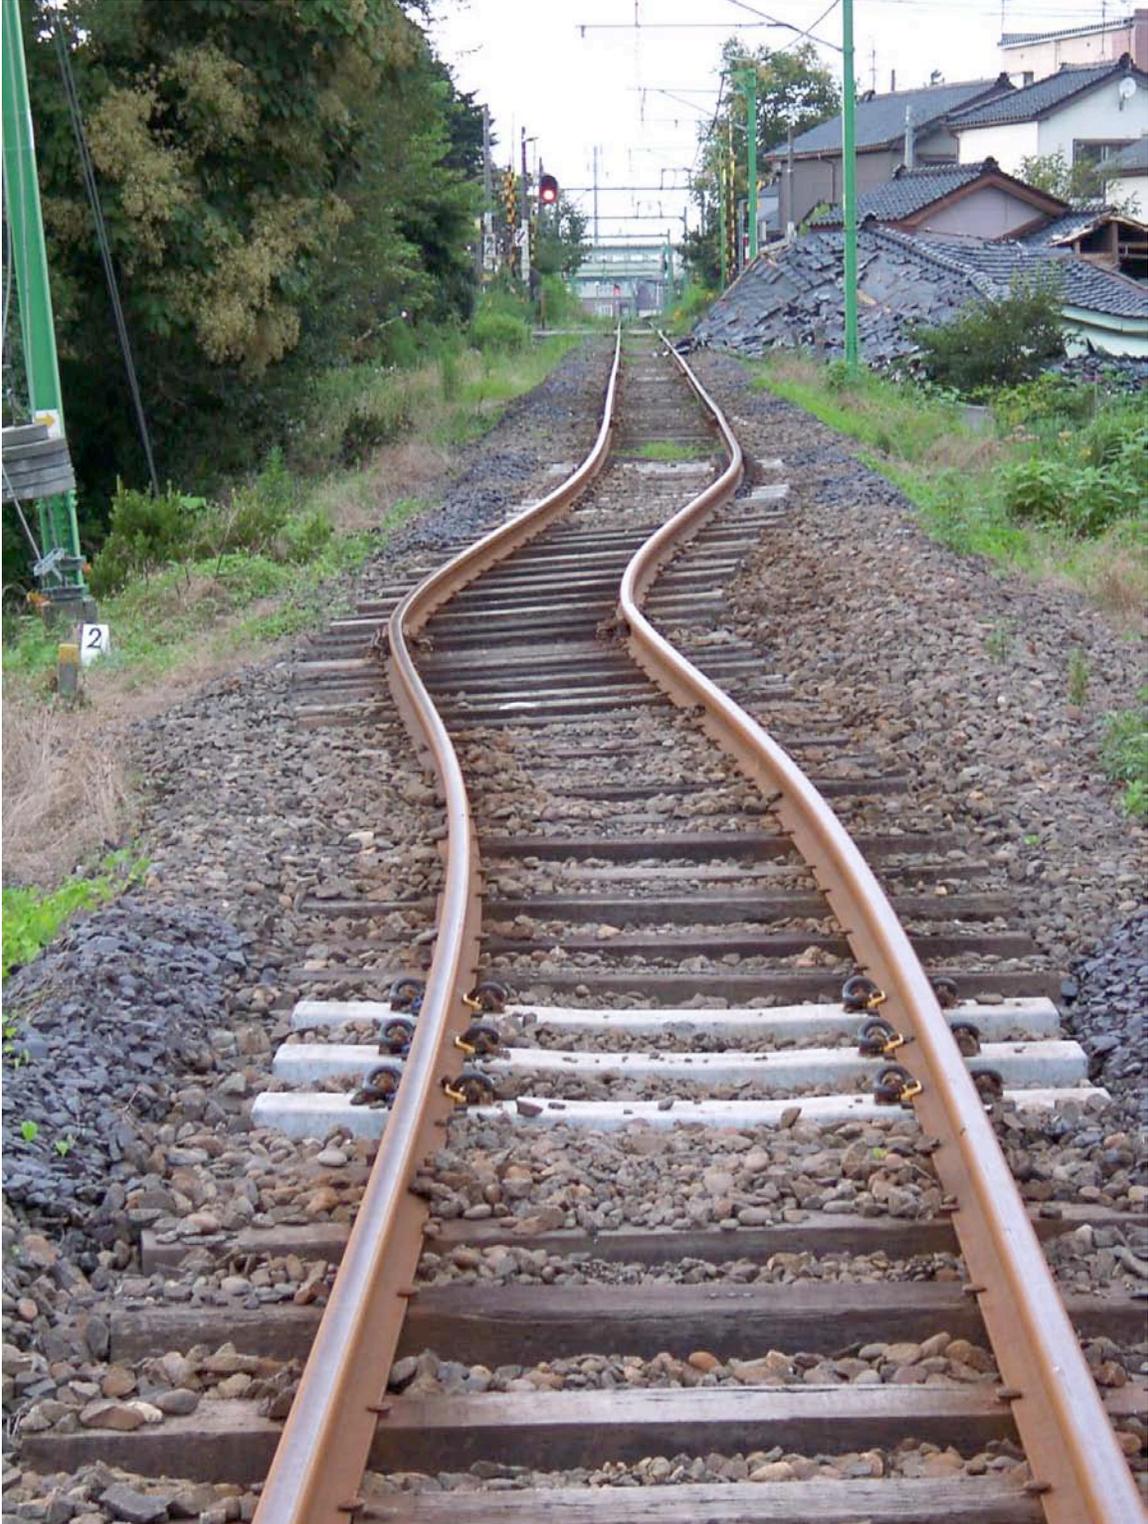
Figure 9.13: Lateral railway buckling (Site RK28, N37.37037° E138.56475°, 7/21/07 18:01).

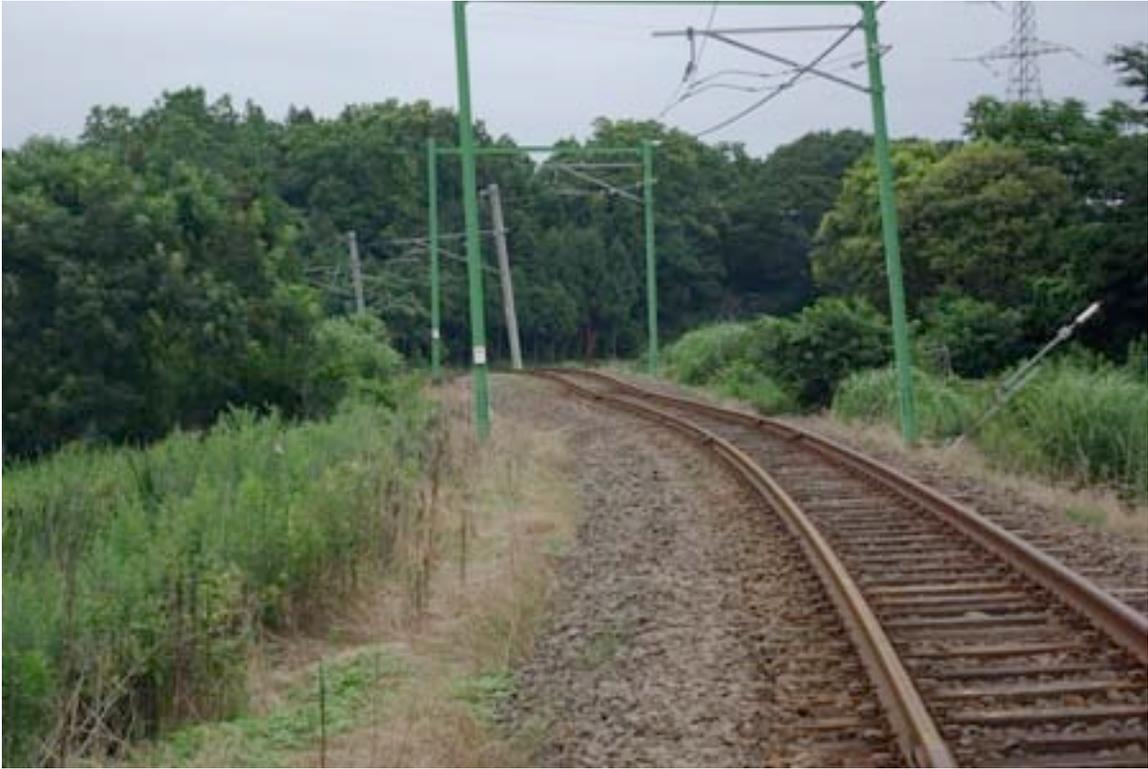
observed in the railway (Fig. 9.14). Numerous other rail disruptions due to foundation settlement and permanent ground deformations were observed by the reconnaissance team. In most cases the deformations were minor, yet significant enough to preclude rail traffic during the period of the reconnaissance. During this time, rail crews were observed making inspections of several rail lines in order to place them back into service.

Figure 9.14: Vertical deformation in train tracks (Site SA24, N37.39323° E138.59520°, 7/21/07 15:44).

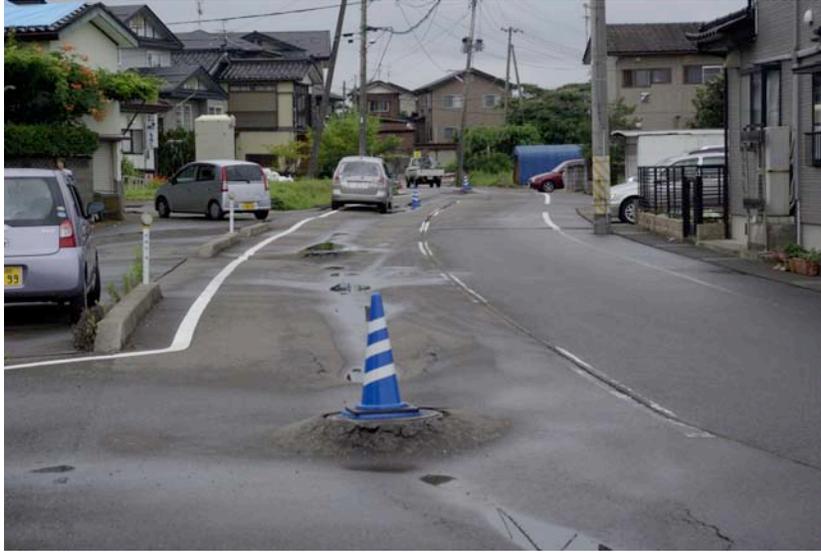
Figure 10.1: Example of an elevated manhole caused by settlement of road fill. The depression caused by densification of lightly compacted trench backfill during cyclic loading was evident along extensive sections of the roadway. This area was conspicuous for pipe breaks associated with ground deformation (Site SD11, N37.36650° E138.58868°, photo taken 7/23/07).

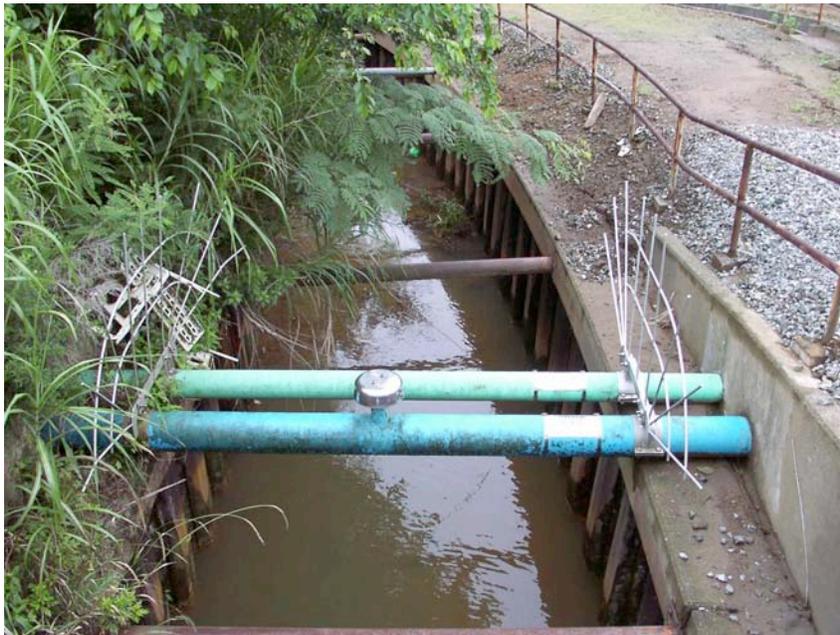
- Numerous water and gas pipes were observed at stream crossings. Many unsupported pipes were observed spanning small, channelized streams. No pipe breaks were observed at the small to moderate stream crossings despite evidence of minor lateral and vertical ground deformations (Fig. 10.2).

Figure 10.2: Example of short span pipes (water and gas) across a channelized stream exhibiting very minor ground deformation. No damage to the pipes was observed (Site SD12, N37.36663° E138.59223°, photo taken 7/23/07).

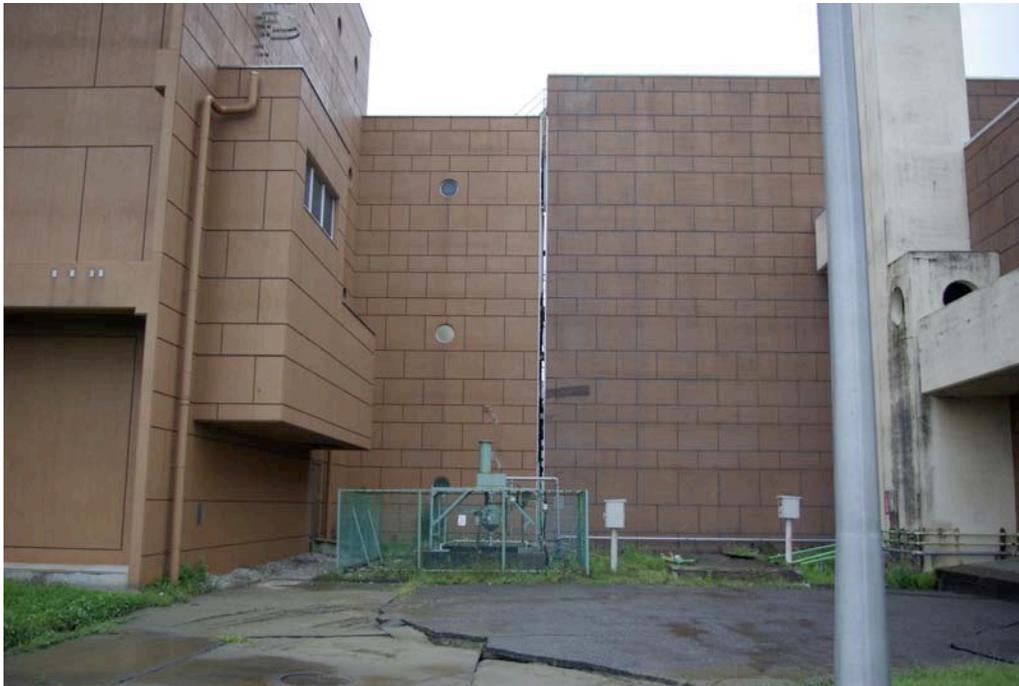
- The site of the Ansui-Chou waste water treatment plant (Site RK9) located adjacent to the Sabaishi River exhibited widespread liquefaction-induced ground deformation. The facility was out of operation at the time of the field survey due to extensive structural damage to the facility. Lateral spreading resulted in separation of one building (Fig. 10.4). Despite this level of ground deformation (vertical and lateral) the initial inspection revealed no rupture of pipes located at grade or in elevated pipe racks. No trenching had been performed at the time of the investigation therefore the performance of buried pipes could not be assessed. No surface evidence of buried pipe breaks was noted. This is an important location for subsequent investigation.

Figure 10.4: Ansui-Chou waste water treatment plant showing evidence of lateral spreading and extension of the structure (Site RK9, N37.38748° E138.56587°, photo taken 7/20/07).

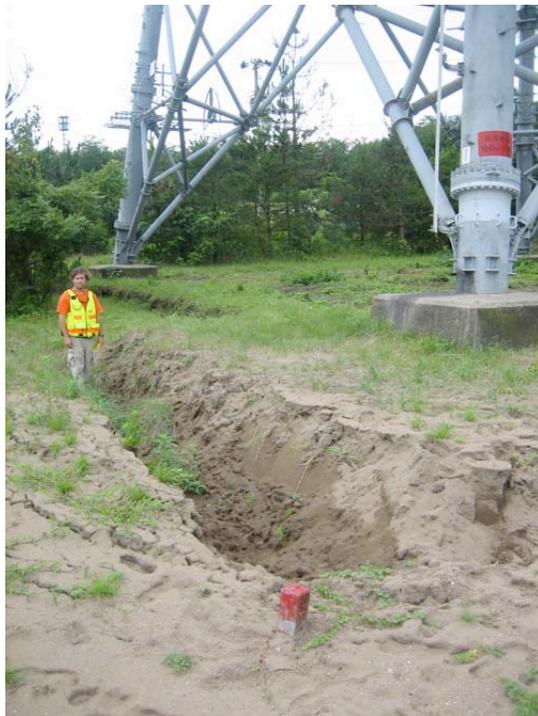
Figure 10.5: Ground failures at the site of a high voltage tower (Site RK40, N37.41633° E138.60792°, photo taken 7/24/07). No evidence of structural damage to the towers was observed.

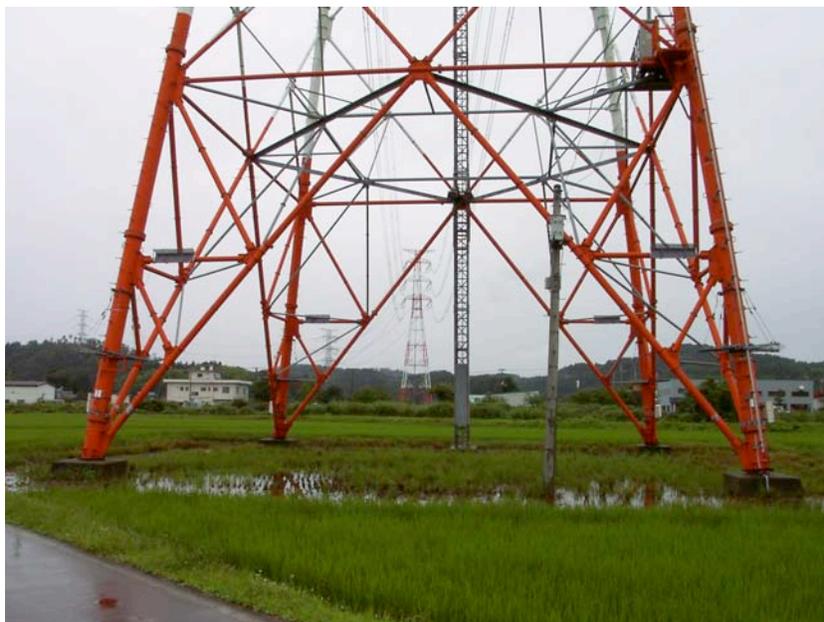
Figure 10.6: High voltage power line towers located in the Kashiwazaki area (Site RK12, N37.44113° E138.63390°, photo taken 7/21/07). No evidence of structural damage to the towers was observed.

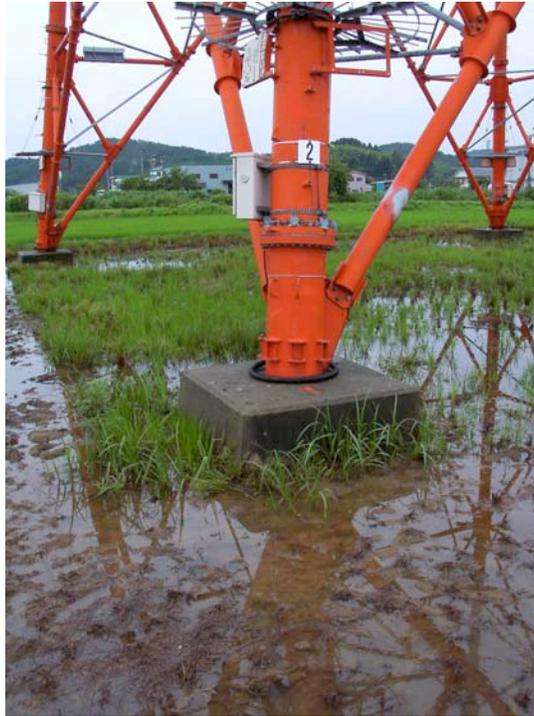
Figure 10.7: High voltage power line towers located in an area of soft ground (Site RK12, N37.44113° E138.63390°, photo taken 7/21/07). No evidence of ground failure, settlement, or structural damage to the towers was observed.

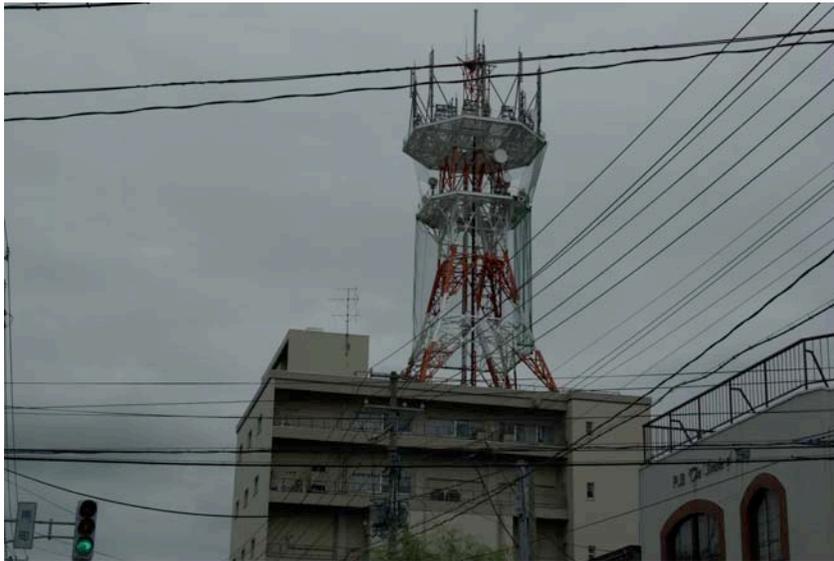
Figure 10.8: NTT communications building in downtown Kashiwazaki (Site SD20, N37.36847° E138.55813°, photo taken 7/23/07). No evidence of major structural damage to the tower was observed however no information on the performance of the electronics was available at the time of the investigation.
