# Investigation of the M6.6 Niigata-Chuetsu Oki, Japan, Earthquake of July 16, 2007

Open File Report 2007–1365

2007

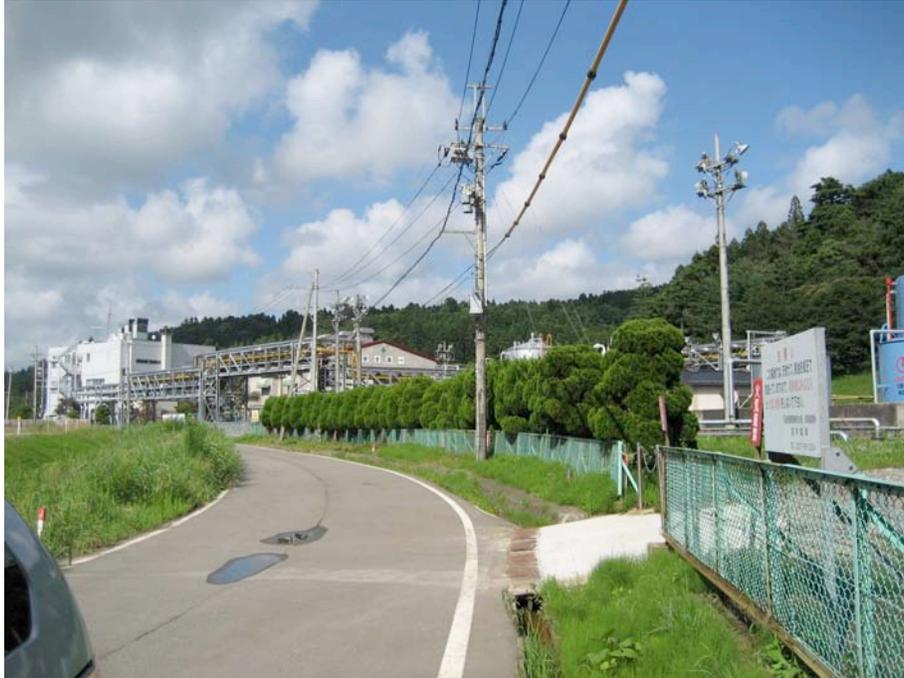
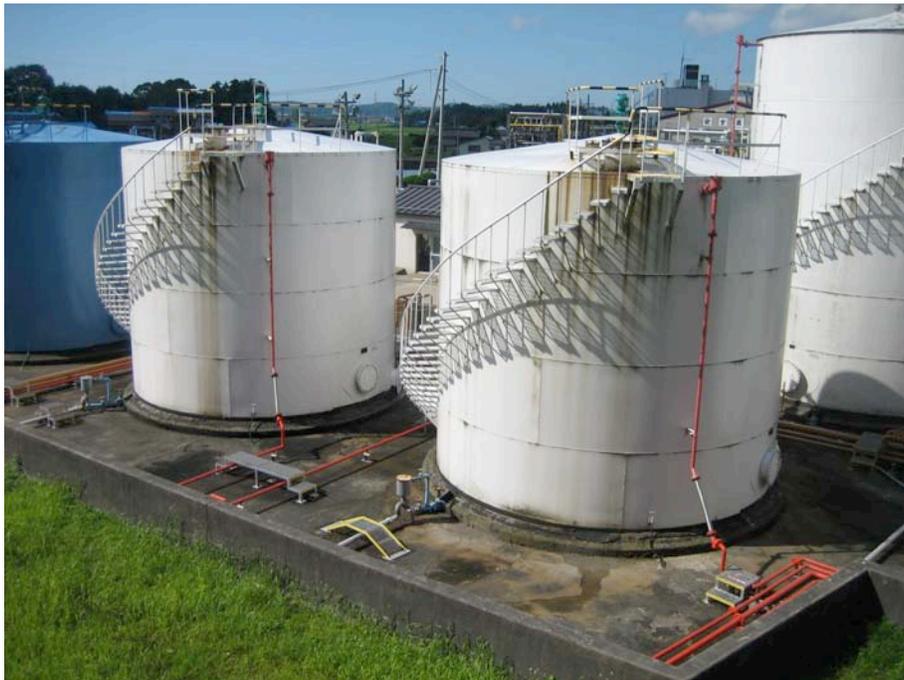
Figure 10.10: Oil storage and distribution facility (Site RK55, N37.38917° E138.63377°, photos taken 7/23/07 12:30). No damage was observed at this site.

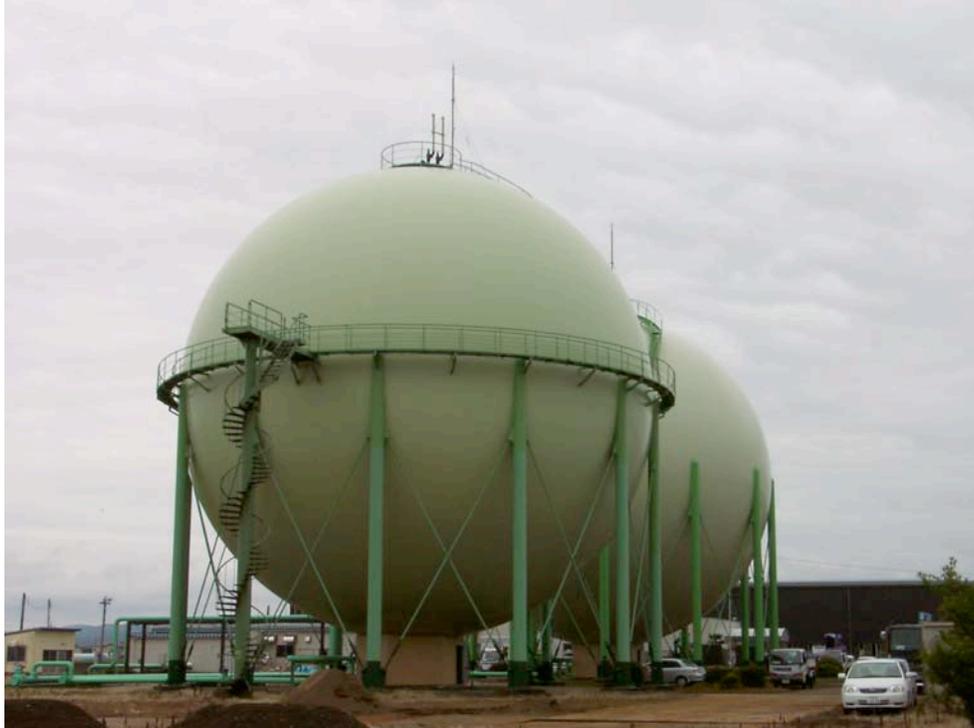
Figure 10.11: Natural gas tanks being inspected by local engineers (Site SD13/RK57, N37.37253° E138.59488°, photo taken 7/23/07). Very minor ground settlement and later movement near ditches was observed in the vicinity but the no damage was apparent to the tank foundations, appurtenant piping, or the tanks.

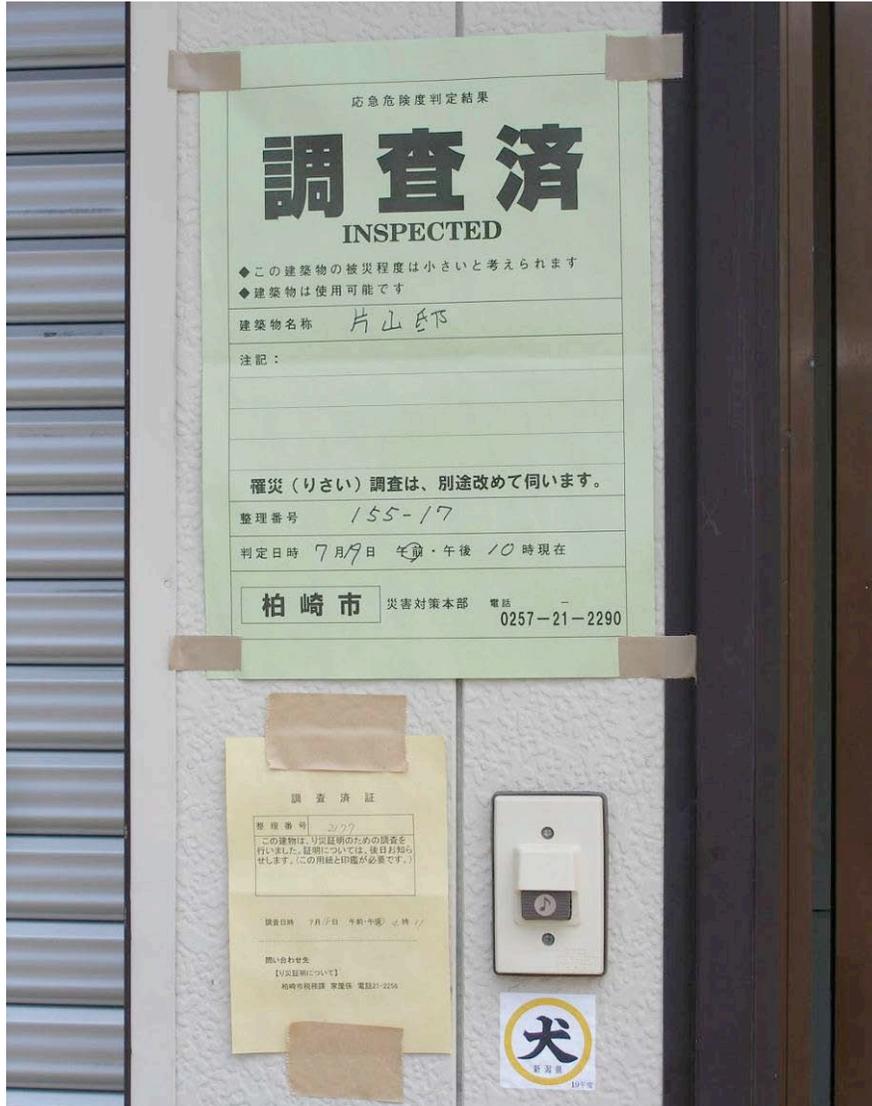
Figure 11.7: A building in Kashiwazaki city that has been through two surveys, with both a green tag as well as a standard yellow notice that the damage certification survey has also been completed.
