## Triggered Surface Slips in Southern California Associated with the 2010 El Mayor-Cucapah, Baja California, Mexico, Earthquake

**Open-File Report 2010-1333**

**Jointly published as California Geological Survey Special Report 221**

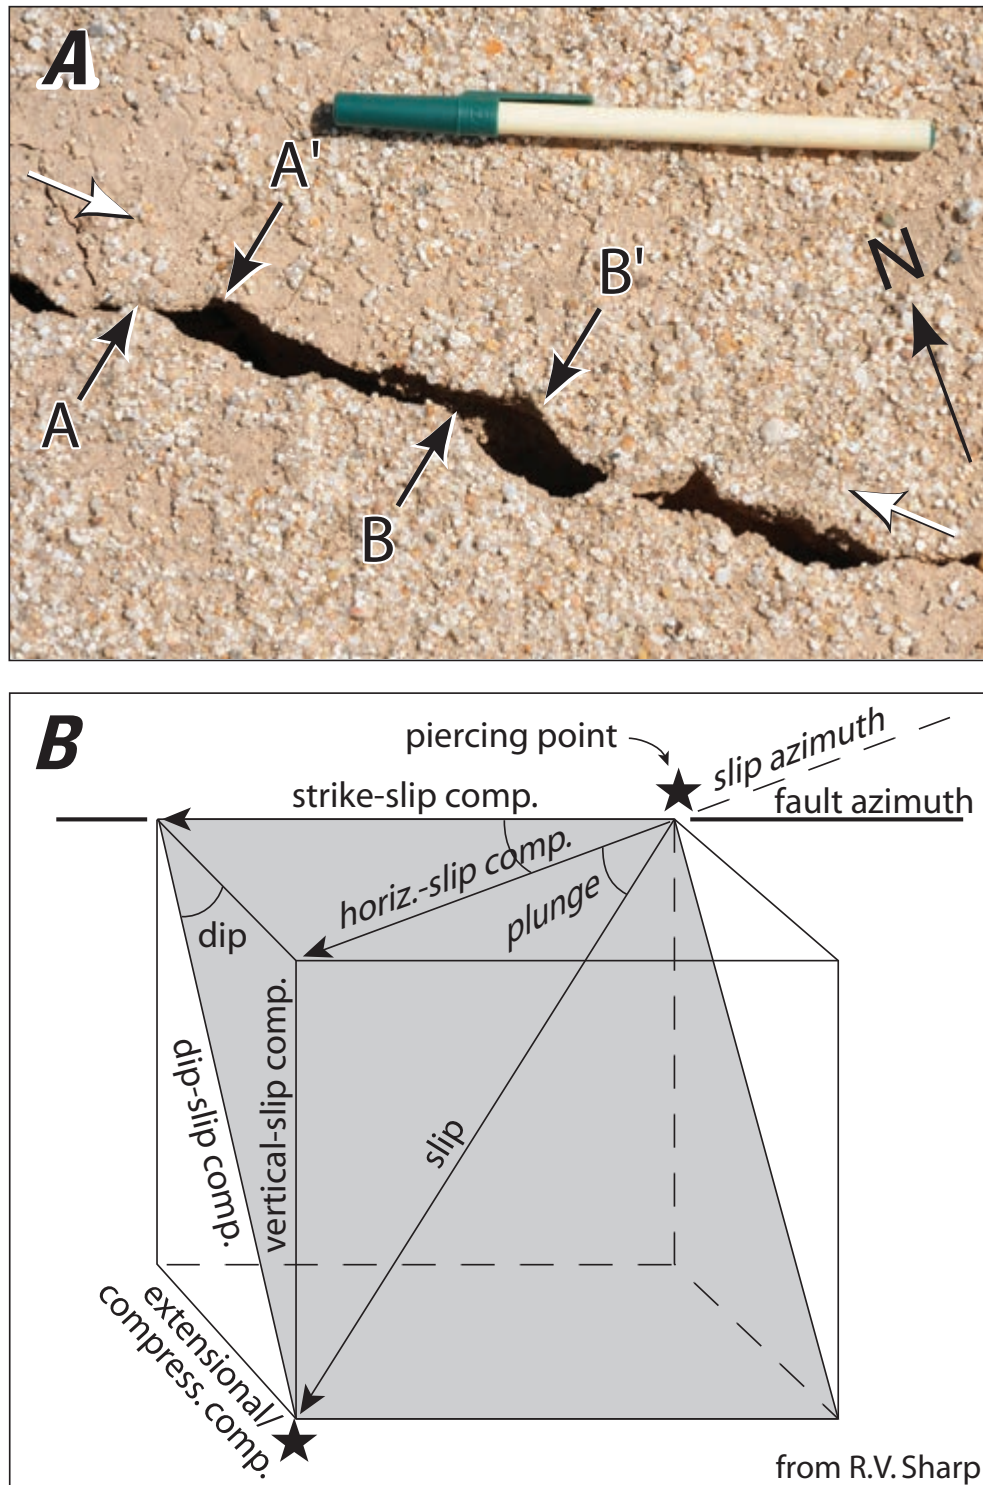
**Figure 3.** Photograph and diagram showing determination of components of slip. **A**, Photograph of fracture along Laguna Salada Fault, east branch. Corresponding piercing points A and A' and B and B' (black arrows) constrain the calculated amount of right-lateral strike-slip component of displacement (see fig. 25 for location). White arrows, orientation of local fault azimuth. Right-lateral component of displacement at time of photograph was 20 mm; photograph taken April 6, 2010. **B**, Schematic block diagram showing components of fault slip and how to calculate fault parallel component of displacement (see text for explanation).

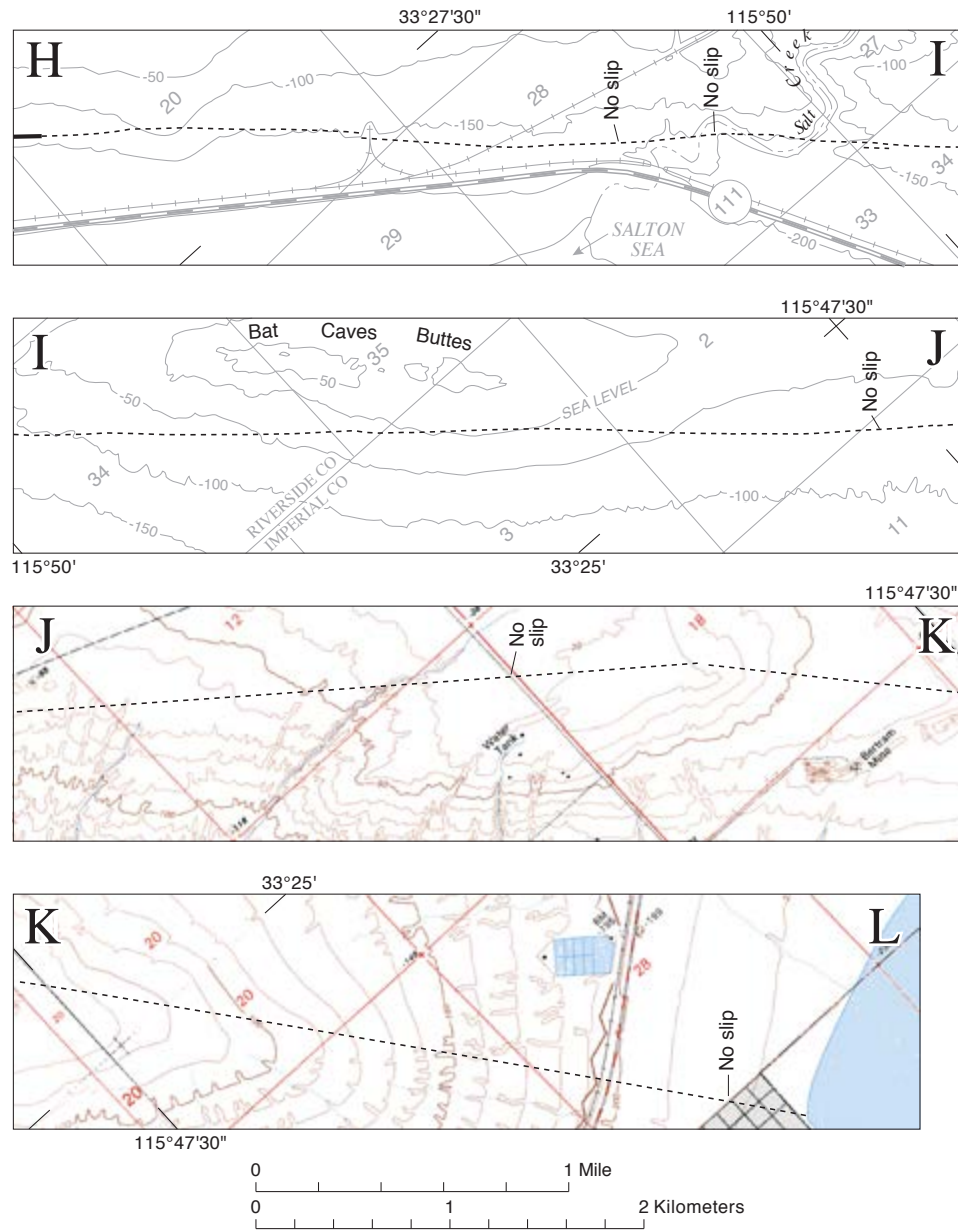
We observed discontinuous surface breaks along the San Andreas Fault over a distance of about 29 km (figs. 1, 4; table 1), spanning distances from the El Mayor-Cucapah epicenter of about 144 and 172 km, from the southeast to the northwest, respectively (table 1). Breaks developed in two broad areas, the Mecca Hills (figs. 5A–C) and between North Shore and Salt Creek (fig. 4, panels A–B, B–C, and G–H). Surface breaks formed predominantly in uplifted Pleistocene fine-grained lacustrine and fluvial deposits.

**Figure 4.** Strip maps from northwest to southeast (A to L) along the southern San Andreas Fault with location of surface fractures formed in response to 2010 El Mayor-Cucapah earthquake. Dashed line, San Andreas Fault; solid line, location of documented 2010 surface fractures. Amount of slip shown in millimeters for right-lateral (R) and vertical (V) components. Maps derived using selected contours from 1:24,000-scale topographic maps; location of fault from Clark (1984); location of strips shown in figure 1.

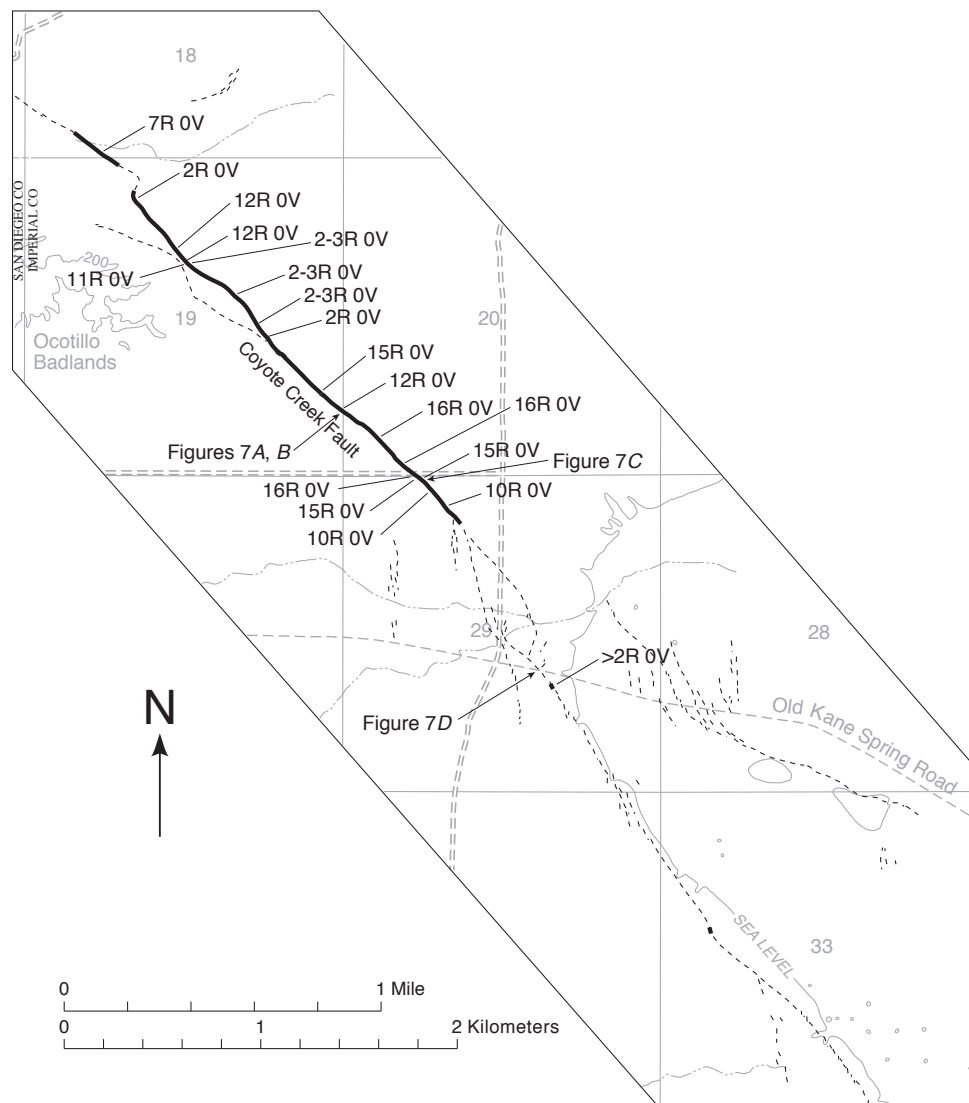
1987; the first of these was primary (coseismic) tectonic slip (Clark, 1972) and the second was slip triggered by the 1987 Superstition Hills earthquake (Hudnut and Clark, 1989). In 2010, discontinuous surface breaks formed along the Coyote Creek Fault over a distance of about 5 km (figs. 1, 6; table 1), at distances of 119–122 km from the El Mayor-Cucapah epicenter (table 1). The distribution and amounts of triggered slip were remarkably similar to those observed by Hudnut and Clark (1989) for the 1987 event. Breaks developed primarily in one broad area, immediately southeast of the Ocotillo Badlands (figs. 6, 7A–C) and in two, short isolated patches to the southeast (fig. 6). Displacements were small. Maximum measured dextral slip was only 16 mm. A feature of interest

that was seen during field studies is a mostly infilled, collapsed graben (fig. 7D). This feature is along the Coyote Creek Fault, but not in an area with new surface slip (fig. 6). Similar features were common along the Coyote Creek Fault following the 1968 Borrego Mountain earthquake (Clark, 1972).

**Figure 6.** Strip map of central part of Coyote Creek Fault showing location of fractures formed in response to 2010 El Mayor-Cucapah earthquake (see fig. 1 for location of map area). Amount of slip shown in millimeters for right-lateral (R) and vertical (V) components. Map derived using selected contours from topographic maps; location of faults from Clark (1972). Map covers same section of Coyote Creek Fault as shown by Hudnut and Clark (1989).

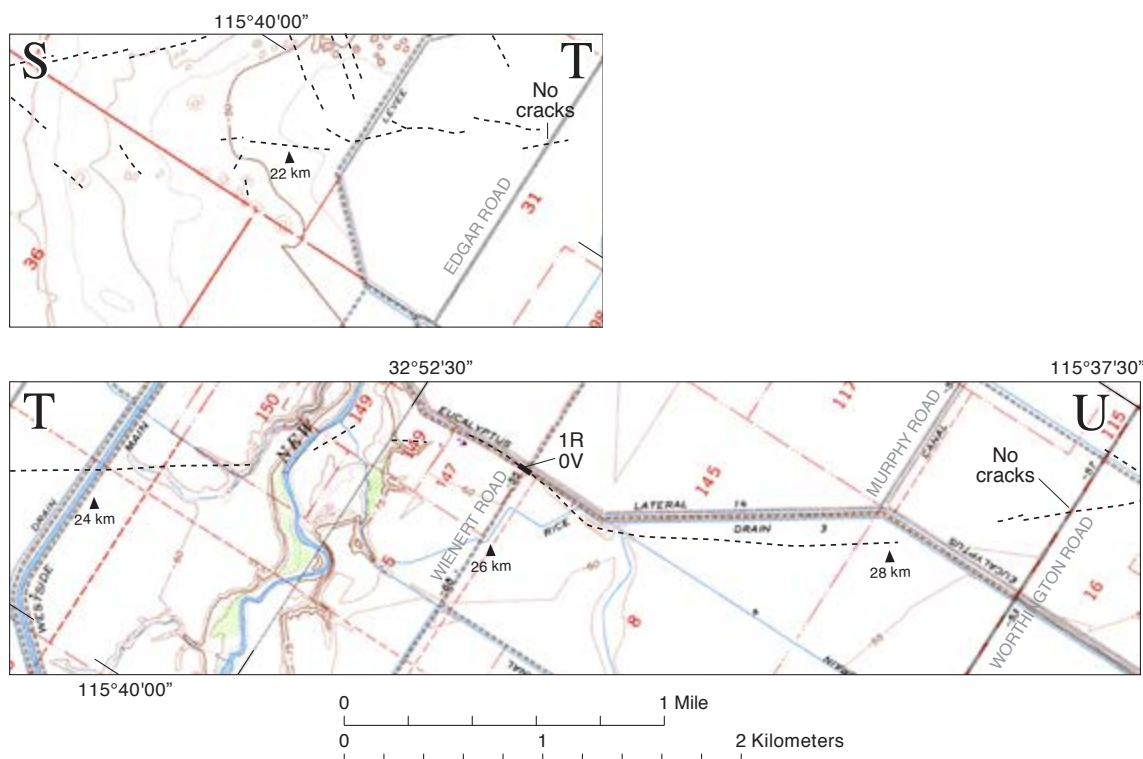
Triggered slip in 2010 along the Wienert Fault in the western Imperial Valley occurred in the same location where the fault had moved tectonically in a previous moderate earthquake, the 1987 Superstition Hills event. We documented left-stepping, en echelon fractures crossing Wienert Road; the fractures extended into adjacent fields, where evidence of fresh fracturing was obscured by abundant desiccation cracks in the soil. We also checked for fresh surface fractures along Edgar Road and Worthington Road, to the northwest and southeast of Wienert Road, respectively (fig 10); however we did not observe fresh surface fractures along these roads.

**Figure 10.** Strip maps of Wienert Fault (Wienert strand of the Superstition Hills Fault) with location of surface fractures formed in response to 2010 El Mayor-Cucapah earthquake (see fig. 1 for location of panels S–U). Dotted line, Wienert Fault; solid line, location of documented 2010 surface fractures. Amount of slip shown in millimeters for both right-lateral (R) and vertical (V) components. Map strips derived from topographic maps. Distance scale along fault is the same as used by Sharp and others (1989), with reference point located near western end of Superstition Hills Fault.

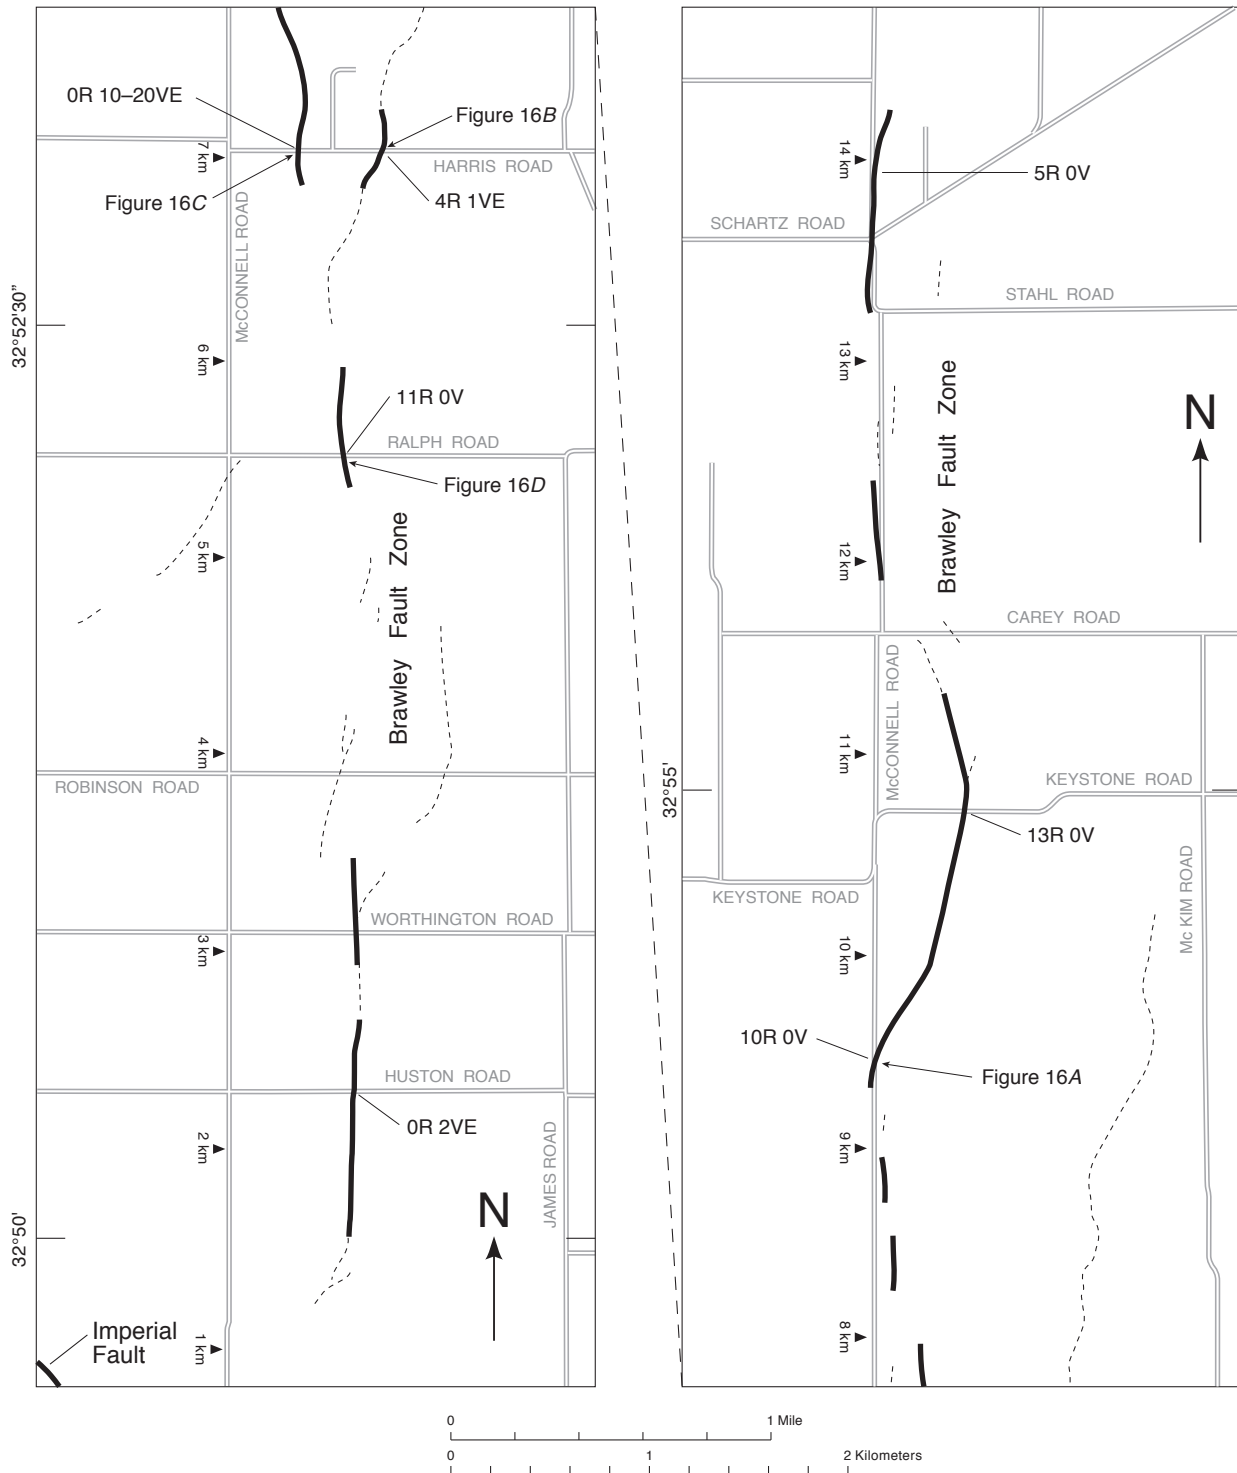
**Figure 15.** Strip maps of Brawley Fault Zone with location of surface fractures formed in response to 2010 El Mayor-Cucapah earthquake (see fig. 1 for location of map strips). Dotted line, Brawley Fault Zone; solid line, location of documented 2010 surface fractures. Amount of slip shown in millimeters for both right-lateral (R) and vertical (V) components. Vertical component of slip, where present, indicated with either west (W) or east (E) side up. Map strips depict local roads from Holtville West and Alamo 7 1/2-minute topographic maps. Distance scale along fault is the same as used by Sharp and others (1982), with reference point located near southern end of Imperial Fault.

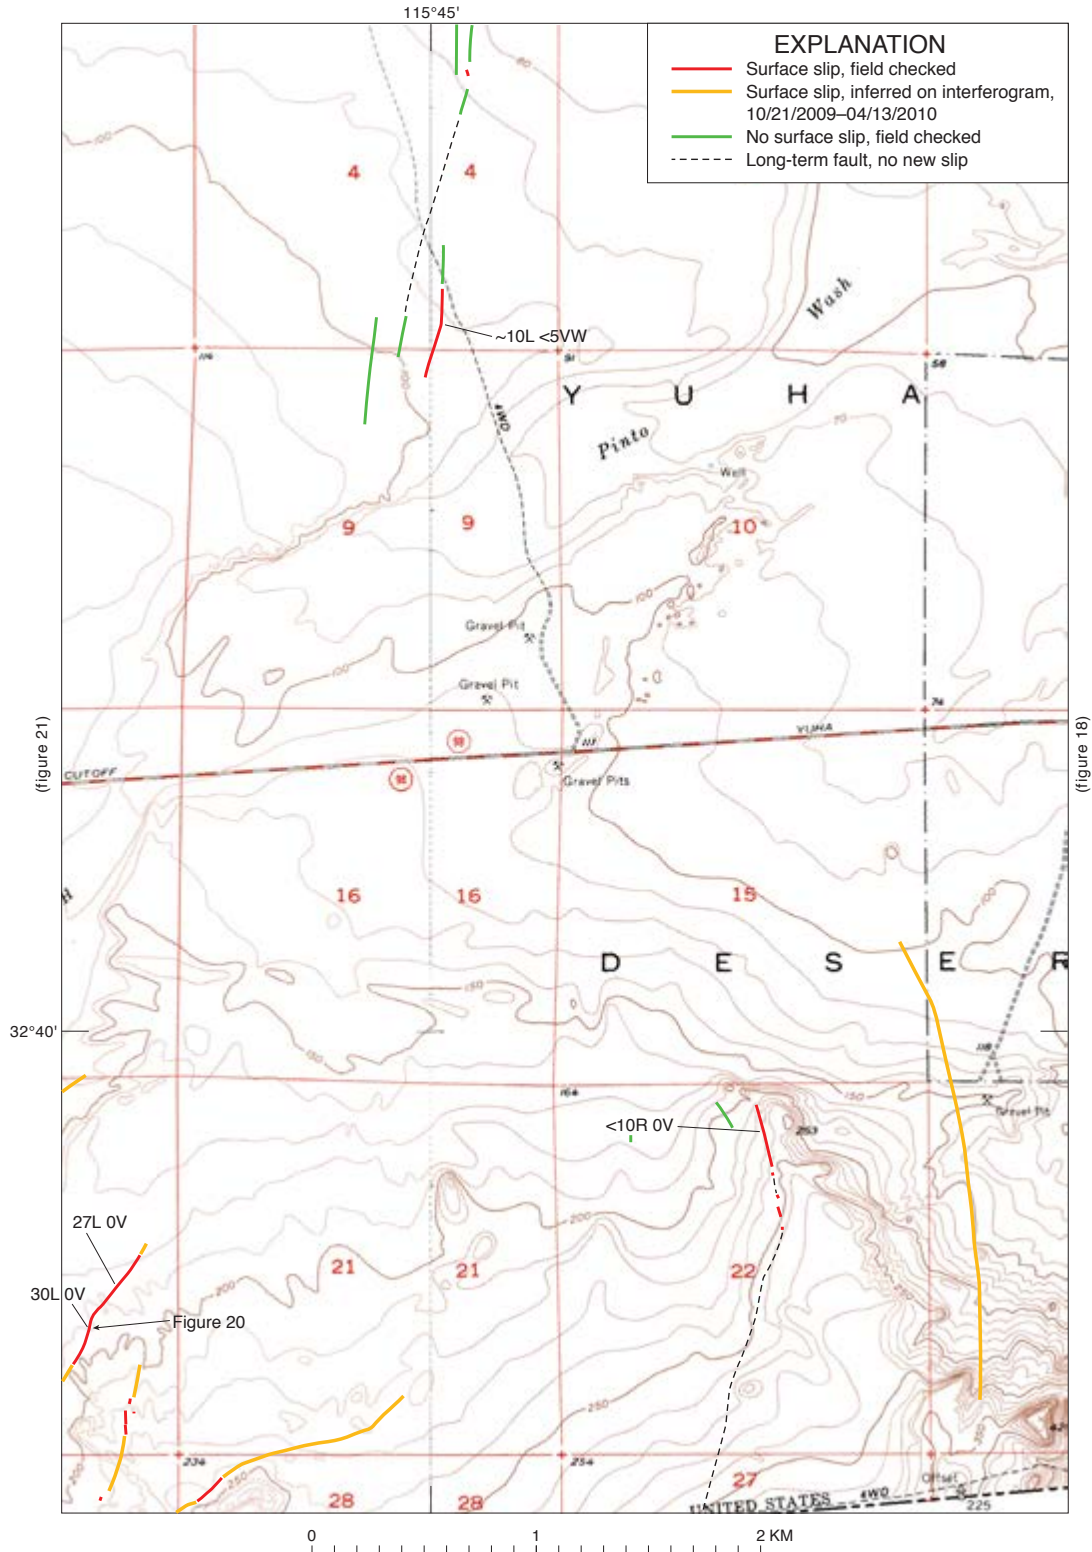
fig. 19), which has an obvious fault scarp that extends at least 3.4 km south of the U.S.-Mexico border. More prominent surface slip is reported south of the border (Sinan Akciz, written commun., 2010, 2011; Fletcher and others, 2010).

**Figure 19.** Map of faults and surface fractures in eastern Yuha Desert. Faults shown include elements of the Northern Centinela Fault Zone (Sections 14 and 15, 22 and 23), Yuha Fault (sections 4 and 9) and faults south of Pinto Wash (Section 20, 21, 28, and 29). Amount of slip shown in millimeters for both right-lateral (R), or left-lateral (L), and vertical (V) components. Vertical component of slip, where present, is indicated with either west (W) or east (E) side up. Map base from portions of the Mount Signal and Yuha Basin 7 1/2-minute topographic quadrangles. See figure 17 for location of map area.

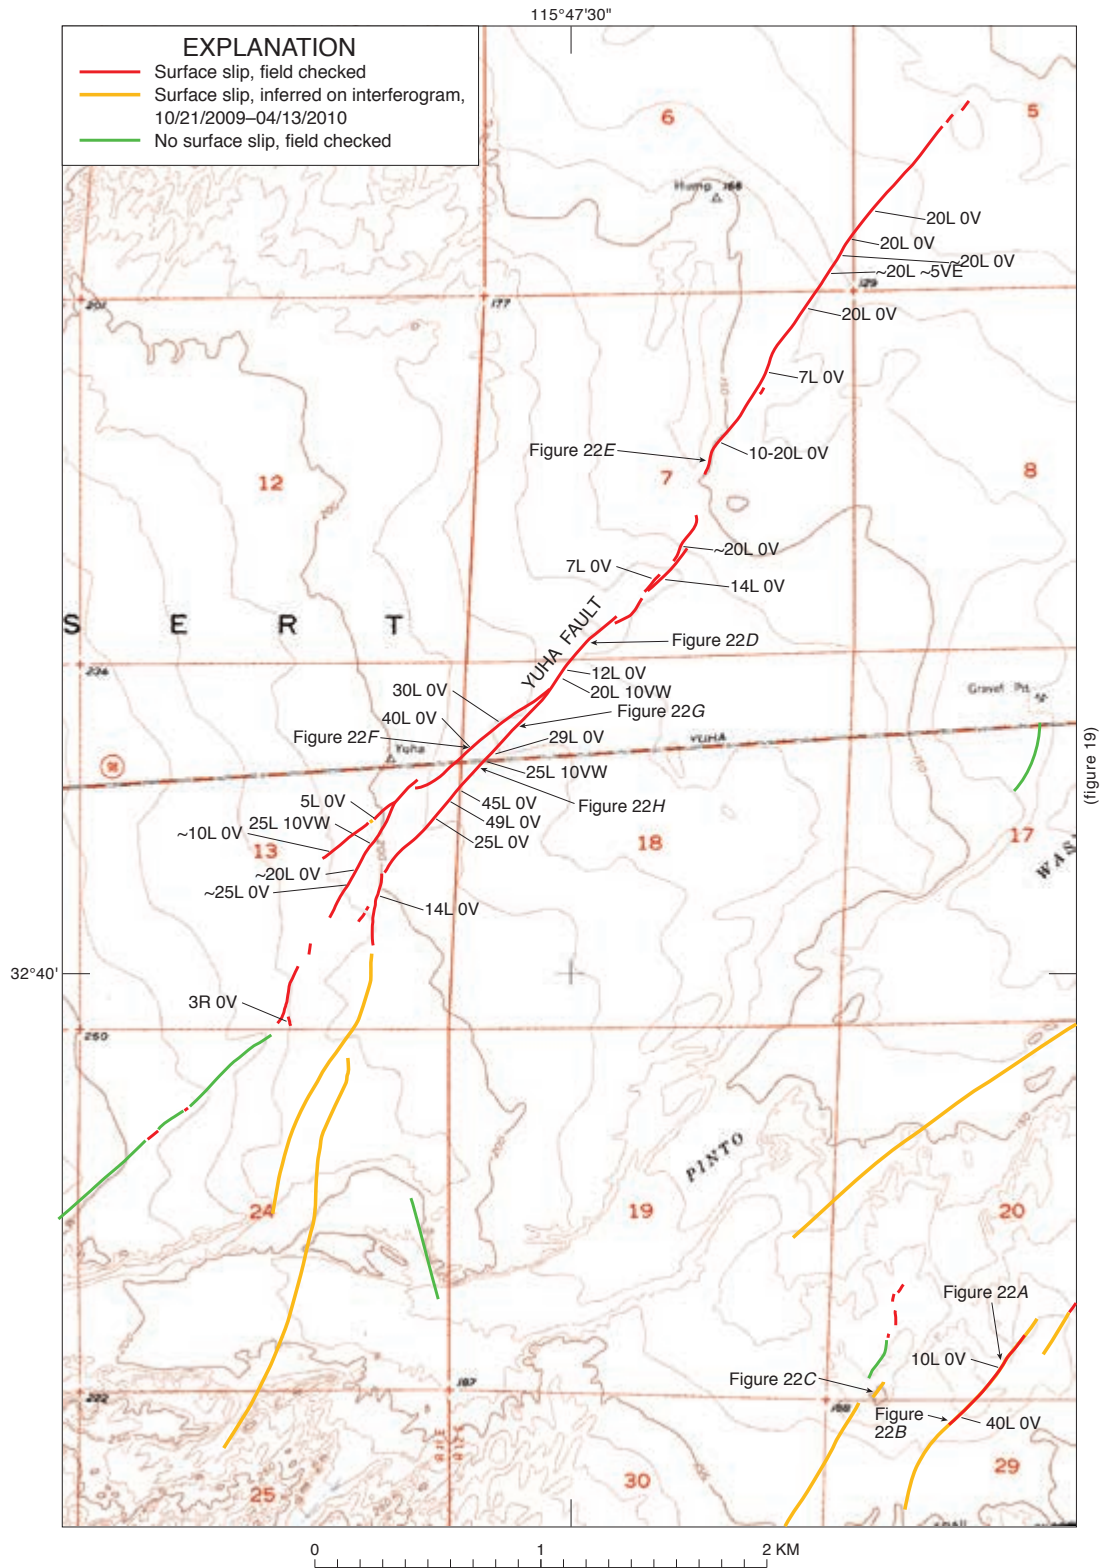
**Figure 21.** Map of faults and surface fractures in central Yuha Desert. Faults shown are the Yuha Fault and several faults south of Pinto Wash (Sections 20, 29–30). Amount of slip shown in millimeters for both right-lateral (R), or left-lateral (L), and vertical (V) components. Vertical component of slip, where present, is indicated with either west (W) or east (E) side up. Map base from a portion of the Yuha Basin 7 1/2-minute topographic quadrangle. See figure 17 for location of map area.

measured cumulative left-lateral slip on the two main traces of the fault totaling about 60–70 mm (the largest slip measurement on a single fault break was 49 mm; figs. 21, 22*D*, *E*). The Yuha Fault moved in association with the El Mayor-Cucapah mainshock, but also had a second episode of slip, sometime in late May to early June (see discussion, below, on timing and location of slips in the Yuha Desert area). The Yuha Fault exhibits some structural complexity. Not only are there two significant subparallel fault traces (see near State Highway 98 in fig. 21), but the northeastern end of the fault is characterized by several small right steps across low, narrow pressure ridges. A broader right step transfers minor displacement to a more northerly trending fault trace that is marked by a prominent vegetation lineament in older imagery.

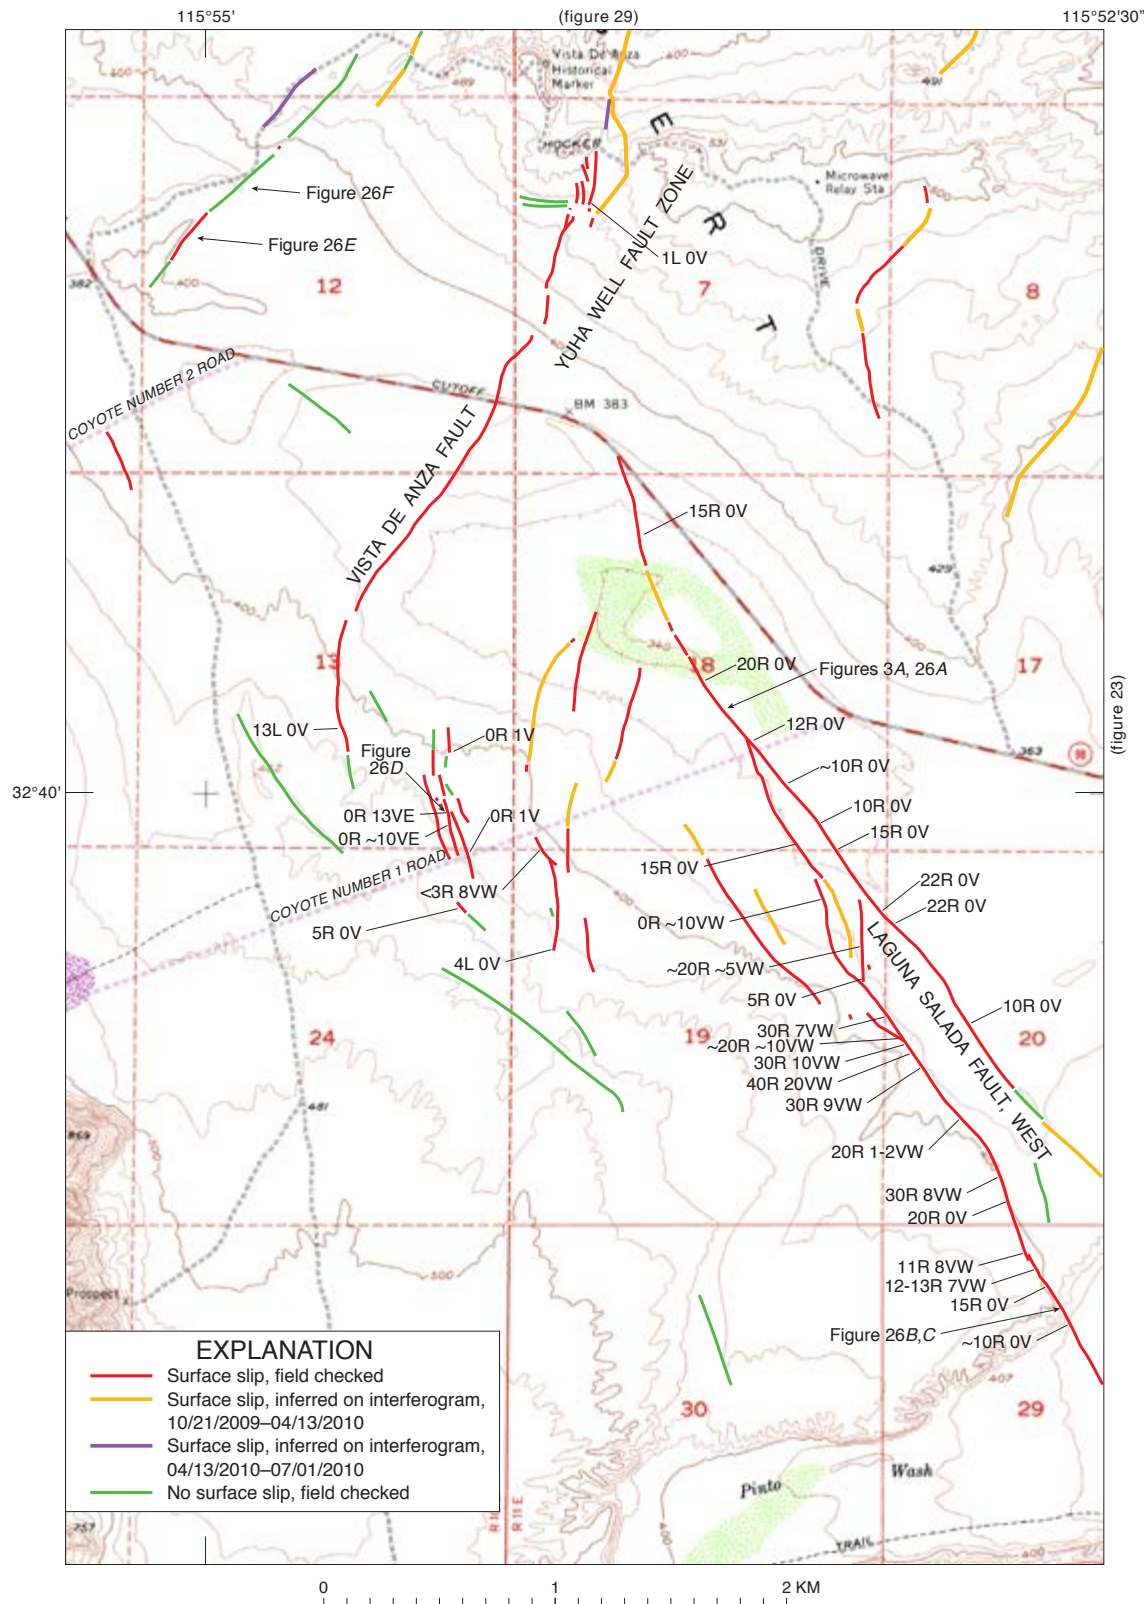
Triggered slip in 2010 along the Laguna Salada Fault, west branch, predominantly occurred along previously mapped fault traces (figs. 23, 25); local structural complexities were revealed in the new surface slip, including at least two subparallel traces, both of which extend discontinuously to the border. The terrain between the two dominant traces is depressed, with preexisting scarps facing into the depression. We mapped nearly continuous fresh surface breakage for about 5 km. The fault is marked locally by prominent fault scarps (for example, figs. 26*B–C*). Measured slip along the Laguna Salada Fault, west branch, generally amounted to about 10–40 mm for the right-lateral component and 0–20 mm for the vertical component, up on the west side (fig. 25) of the western splay (fig. 25).

**Figure 25.** Map of faults and surface fractures in the central Yuha Desert. Faults include the west branch of the Laguna Salada Fault and the southwestern end of the Yuha Well Fault Zone. Amount of slip shown in millimeters for both right-lateral (R), or left-lateral (L), and vertical (V) components. Vertical component of slip, where present, is indicated with either west (W) or east (E) side up. Map base from a portion of the Coyote Wells 7 1/2-minute topographic quadrangle. See figure 17 for location of map area.

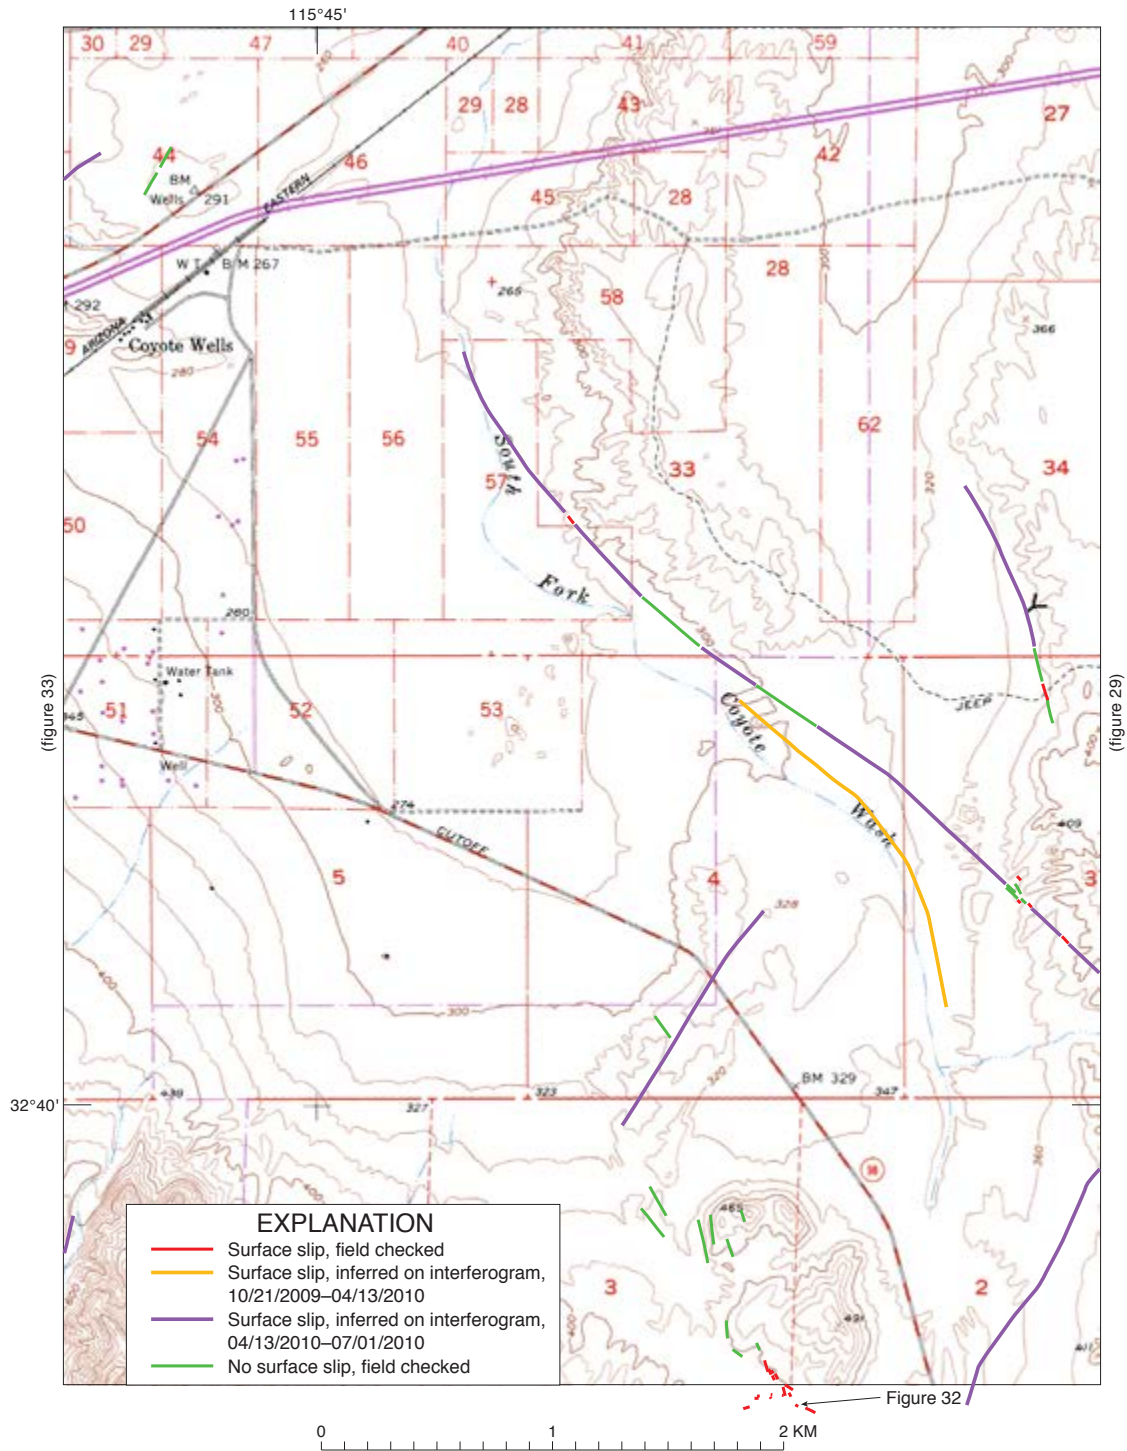
A weakly defined lineament in the UAVSAR interferogram that postdated the June 14 aftershock suggested the possibility of a northwest extension of the Laguna Salada Fault, west branch, that projects toward the southeastern end of the Elsinore Fault Zone. On August 3, 2010, two of us (J.A.T. and K.J.K.) checked several locations along this lineament, northeast of the South Fork of Coyote Wash (fig. 31).

Field inspection of several localities along the lineament identified preexisting scarps, supporting the presence of a throughgoing fault. However, little evidence was found to indicate that brittle surface breakage had occurred. On the basis of the strength of the UAVSAR interferogram data, we infer that fault slip probably occurred at depth, resulting in right-lateral shear too diffuse to map at the surface.

**Figure 31.** Map of faults and surface fractures in Yuha Desert. The principal structure is the inferred northwest extension of the Laguna Salada Fault. Map base from a portion of the Coyote Wells 7 1/2-minute topographic quadrangle. See figure 17 for location of map area.

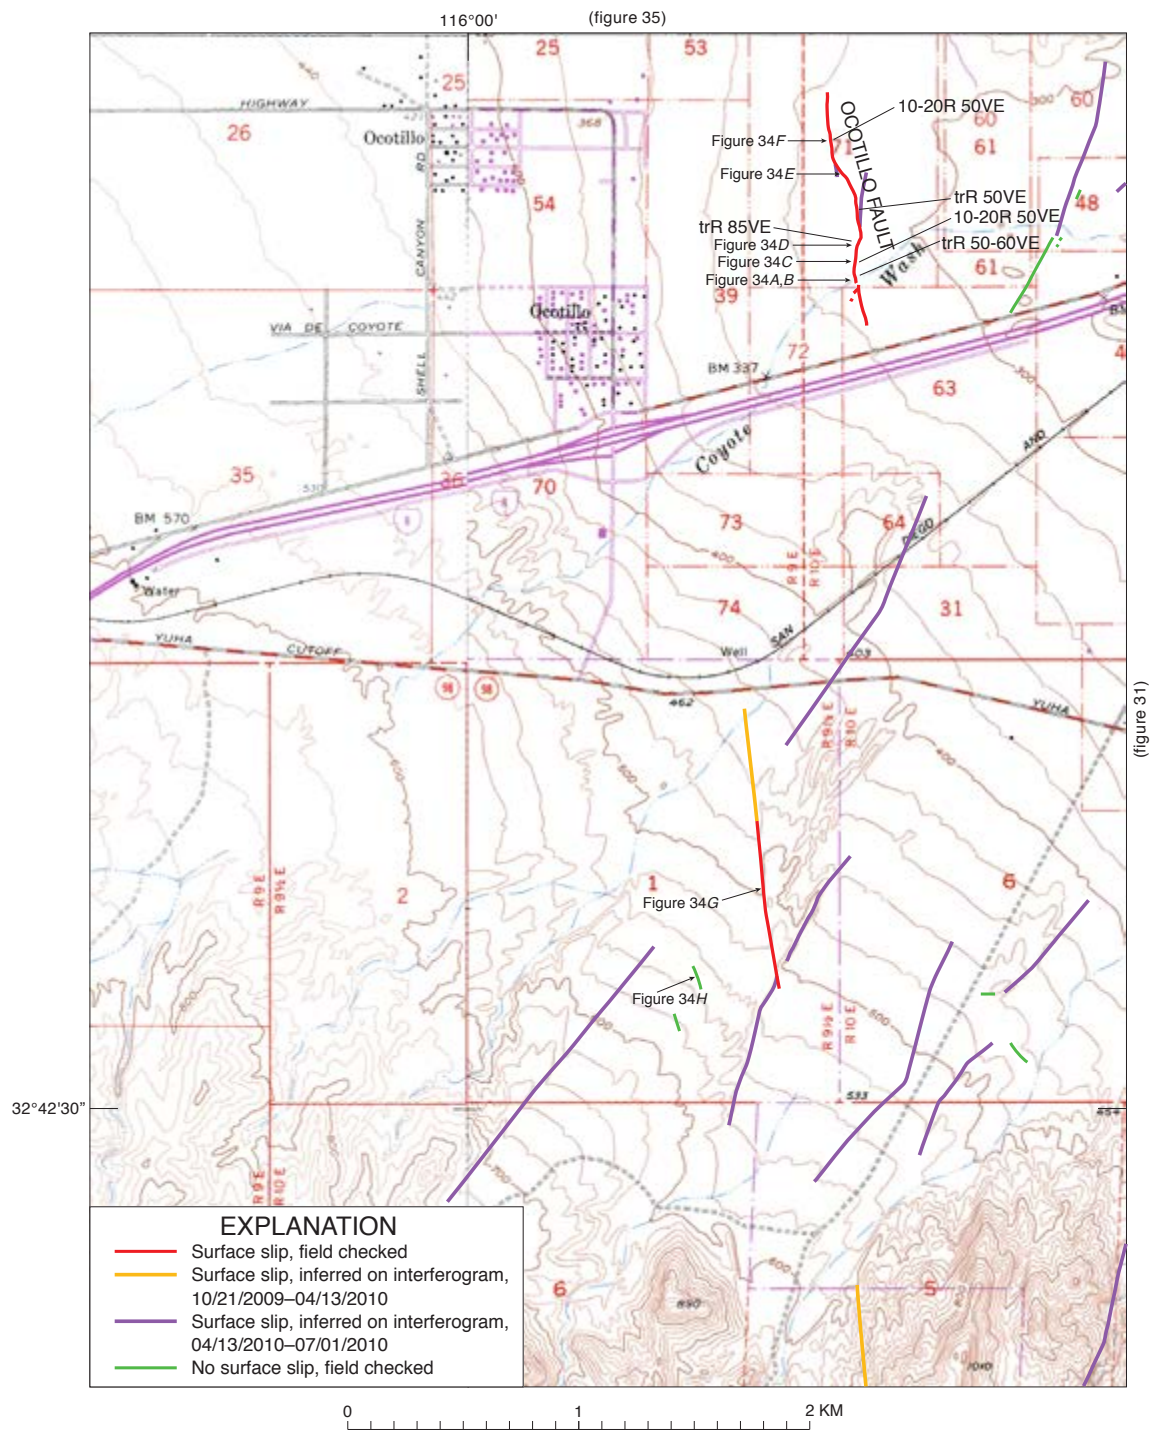
Within the southern Ocotillo Fault Zone, continuous surface slip was mapped along a preexisting scarp (figs. 33, 34G). Relatively continuous surface breakage was also identified to the north (fig. 35) and died out south of a preexisting scarp (fig. 36). Less continuous surface slip was also observed on a similarly oriented fault north of the Elsinore Fault (fig. 35, Section 18).

**Figure 33.** Map of faults and surface fractures in the Yuha Desert surrounding the community of Ocotillo. Amount of slip shown in millimeters for both right-lateral (R) and vertical (V) components. Vertical component of slip, where present, is indicated with either west (W) or east (E) side up. 'tr' indicates trace amount. Map base from portions of the Coyote Wells and In-Ko-Pa Gorge 7 1/2-minute topographic quadrangles. See figure 17 for location of map area.

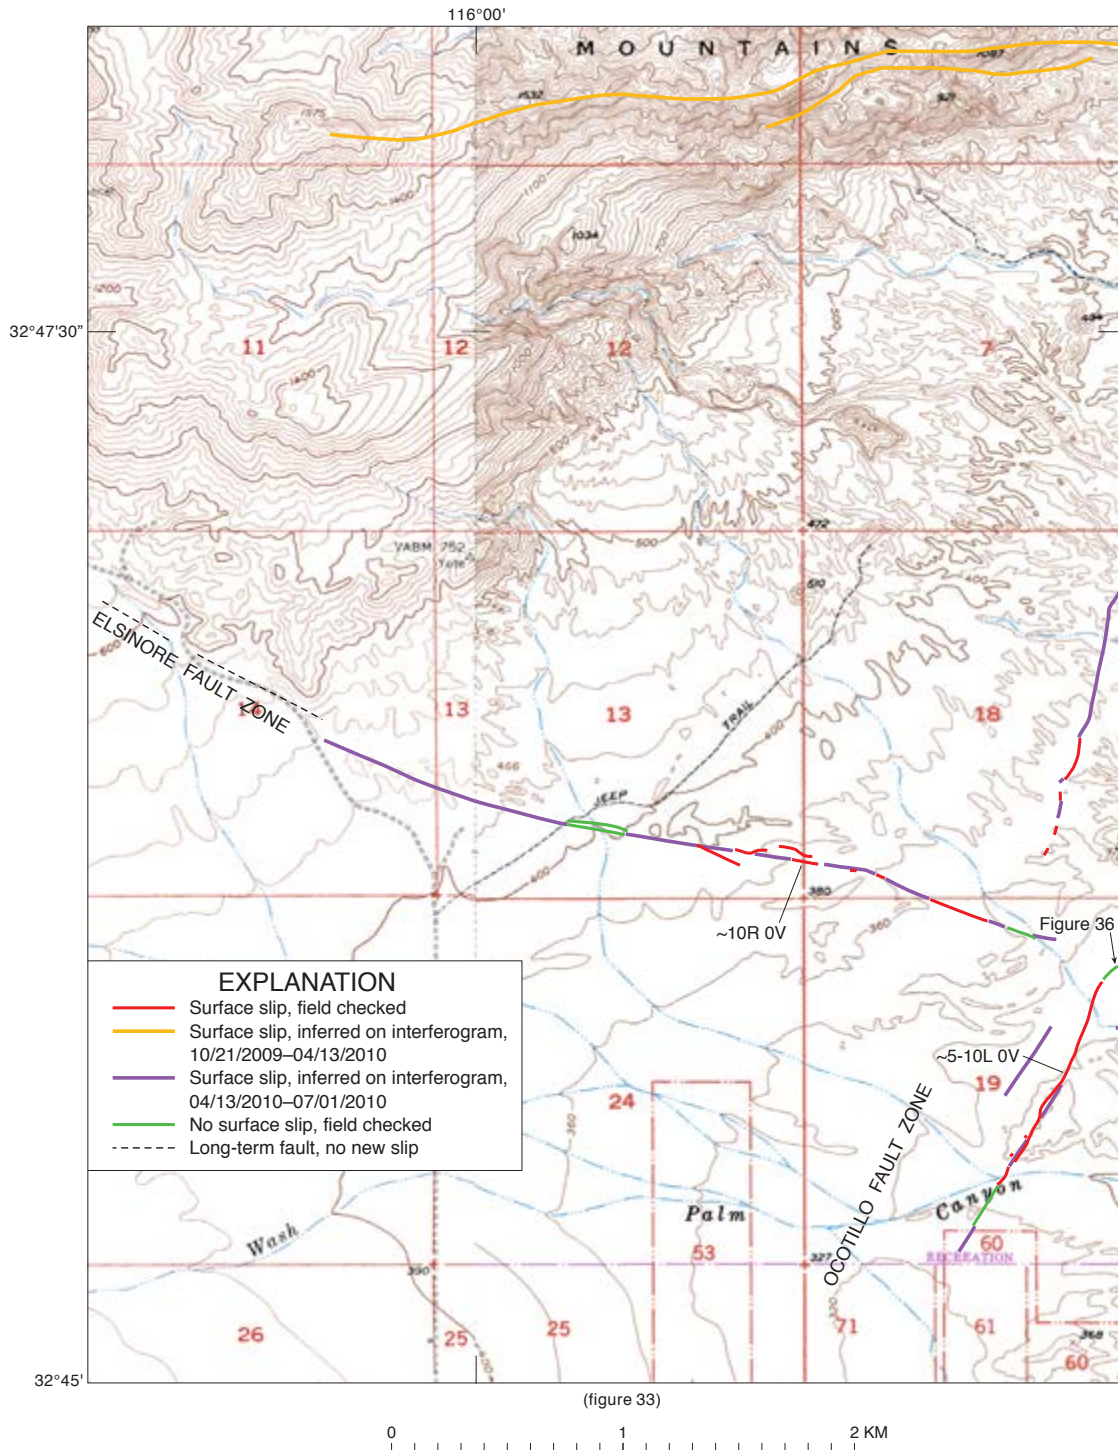
**Figure 35.** Map of faults and surface fractures in Yuha Desert. Amount of slip shown in millimeters for both right-lateral (R), or left-lateral (L), and vertical (V) components. Map base from portions of the Painted Gorge and Carrizo Mountain 7 1/2-minute topographic quadrangles. See figure 17 for location of map area.
