# **Shoreline Surveys of Oil-Impacted Marsh in Southern Louisiana, July to August 2010**

**Open-File Report 2011–1022**

**U.S. Department of the Interior  
U.S. Geological Survey**

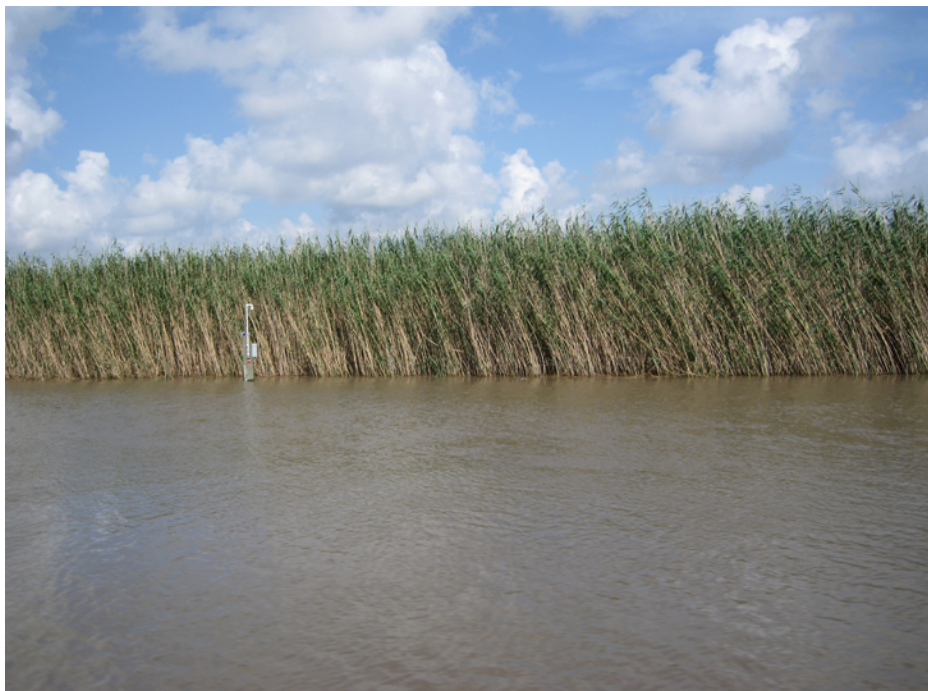
Figure 6. DWO-2-DEL-02 photo 1 taken on July 8, 2010. Site vegetation included *Phragmites australis*.

Oil was not observed at this site.

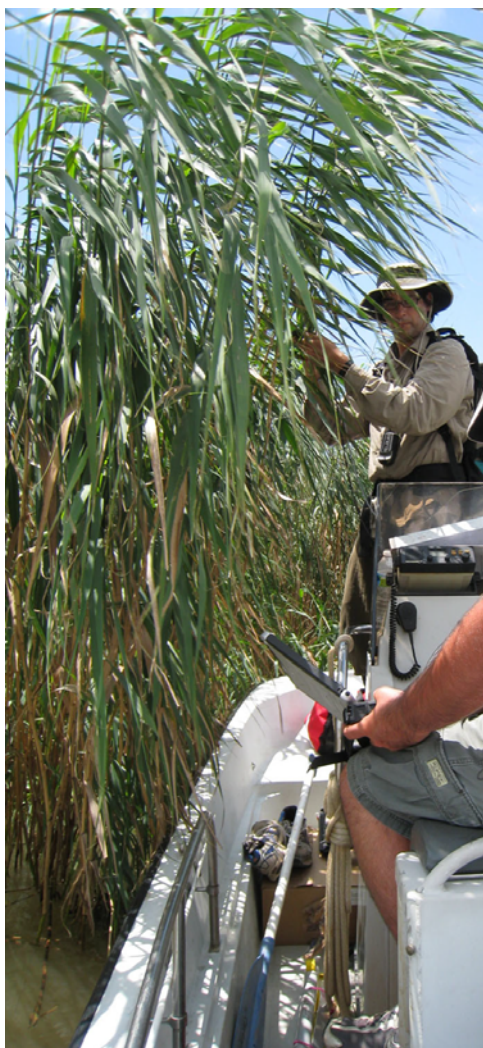
Figure 9. DWO-2-DEL-03 photo 1 taken on July 8, 2010. Site vegetation included *Phragmites australis* and *Eicchornia crassipes*. Oil was not observed at this site.

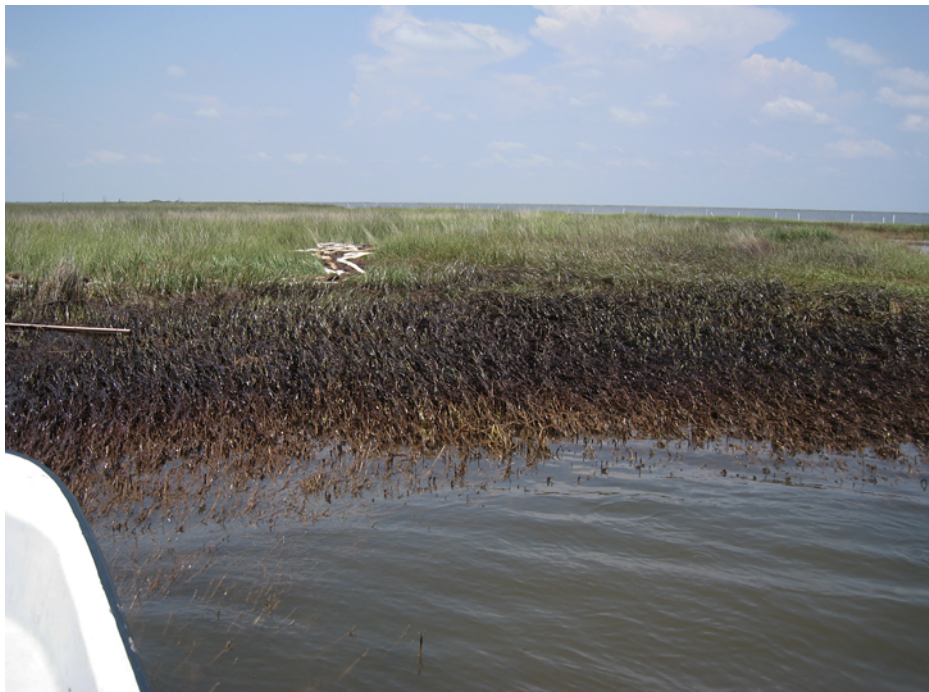
**Figure 26.** DWO-2-BAT-11 photo 2 taken on July 10, 2010. Site vegetation included *Spartina alterniflora* and *Juncus roemerianus*. Oiled vegetation was observed at this site, including oil-damaged canopy.

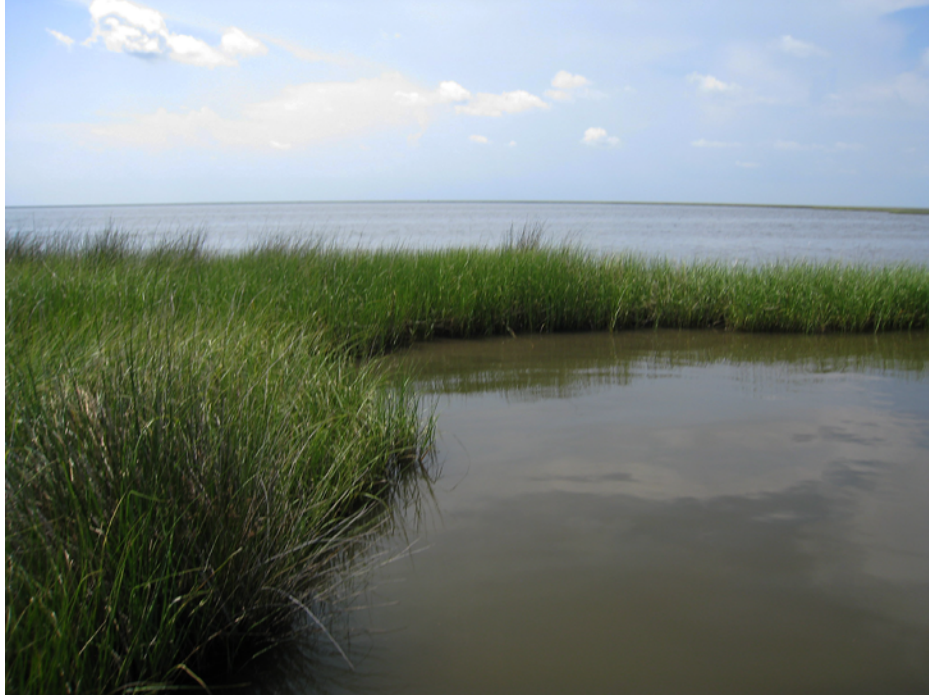
Figure 28. DWO-2-BAT-12 photo 1 taken on July 10, 2010. Site vegetation included *Spartina alterniflora* and *Juncus roemerianus*. Oil was not observed at this site.

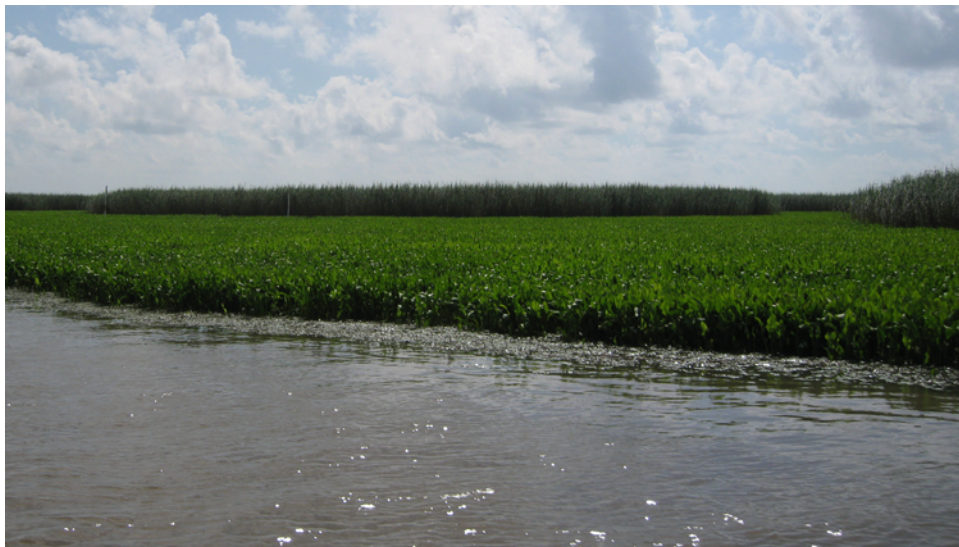
**Figure 35. OBS-2-DEL-09 photo 2 taken on July 8, 2010. Vegetation included bulltongue. Oil was not observed at this site.**

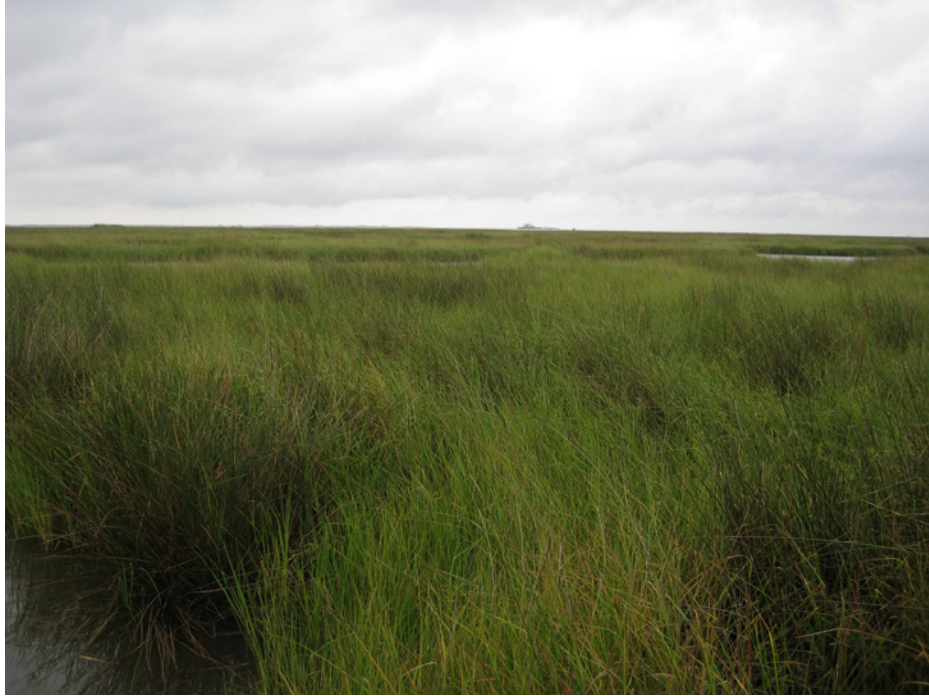
Figure 41. DWO-3-BAT-02 photo 1 taken on August 12, 2010. Site vegetation included *Spartina alterniflora* and *Juncus roemerianus*. Oil was not observed at this site.

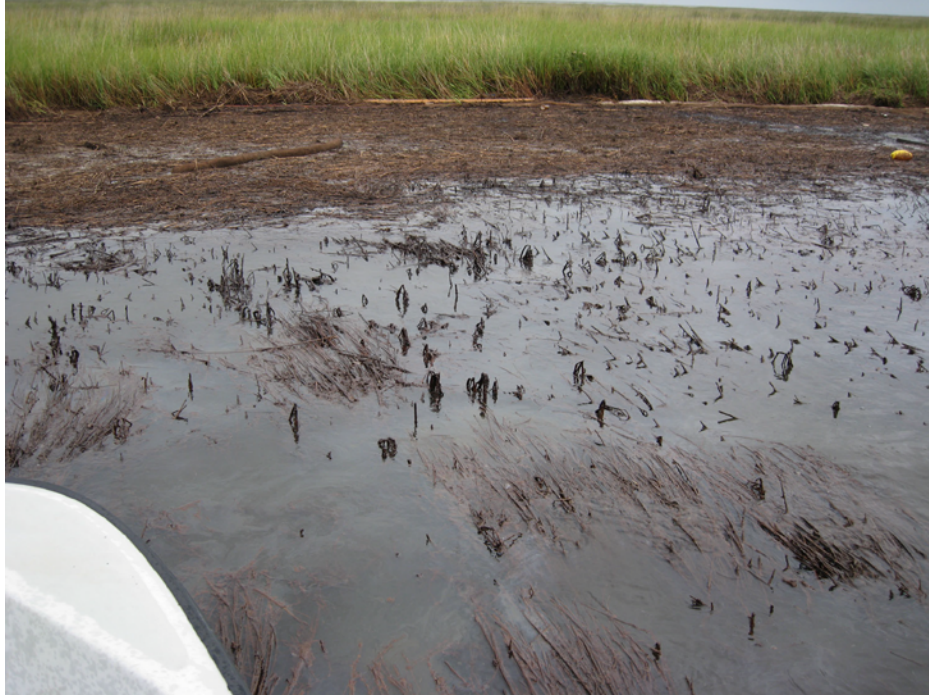
Figure 45. DWO-3-BAT-03 photo 2 taken on August 12, 2010. Site vegetation included *Spartina alterniflora* and *Juncus roemerianus*. Oiled vegetation and oil-damaged canopy were observed at this site.

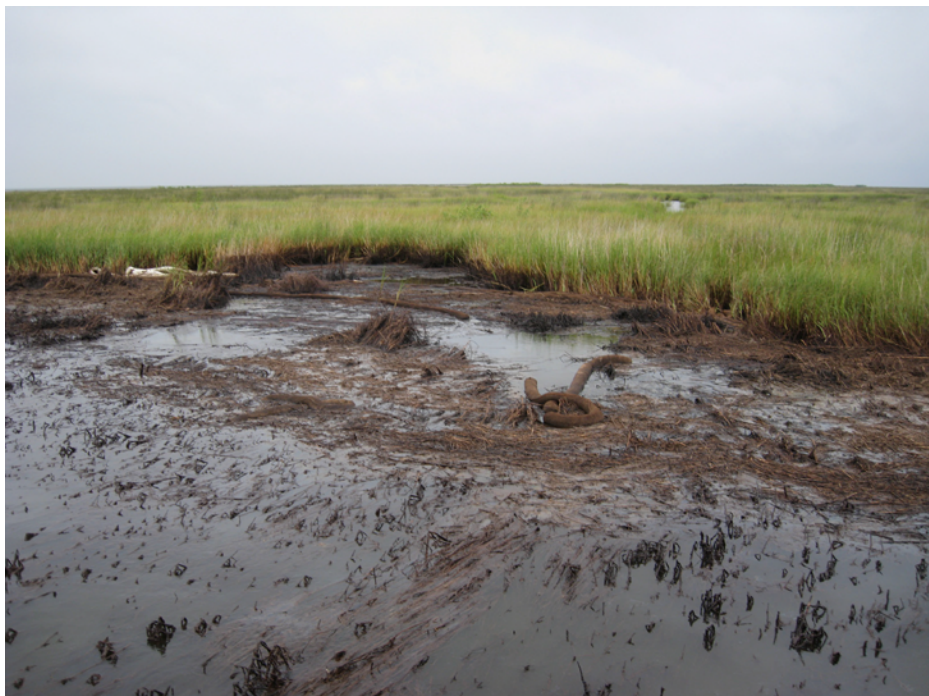
Figure 46. DWO-3-BAT-03 photo 3 taken on August 12, 2010. Site vegetation included *Spartina alterniflora* and *Juncus roemerianus*. Oiled vegetation and oil-damaged canopy were observed at this site.

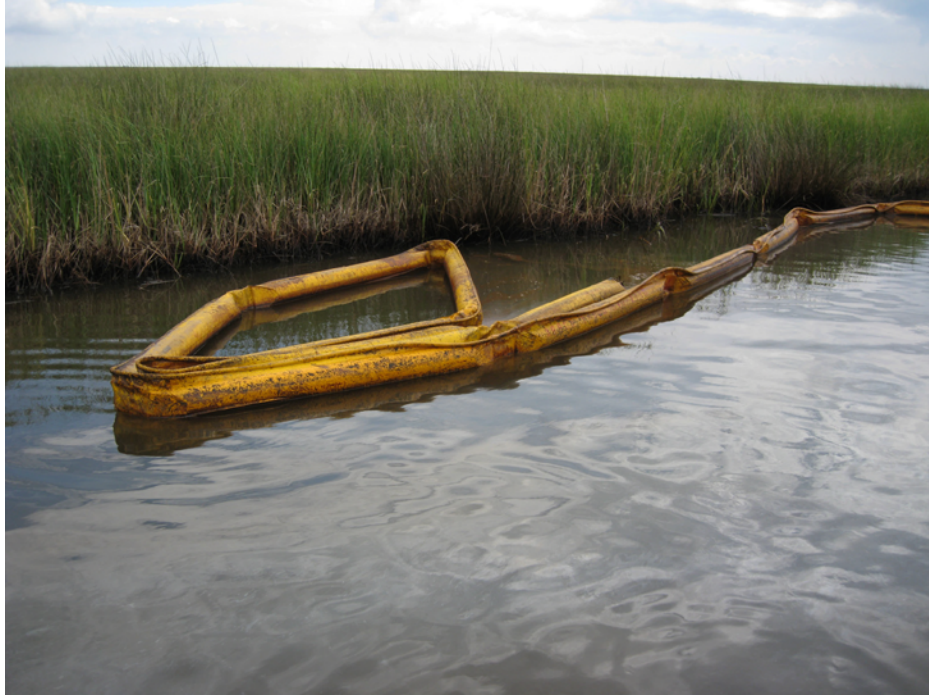
Figure 47. DWO-3-BAT-05 photo 1 taken on August 12, 2010. Site vegetation included *Spartina alterniflora*, *Juncus roemerianus*, and *Distichlis spicata*. Oiled stems were observed at this site.

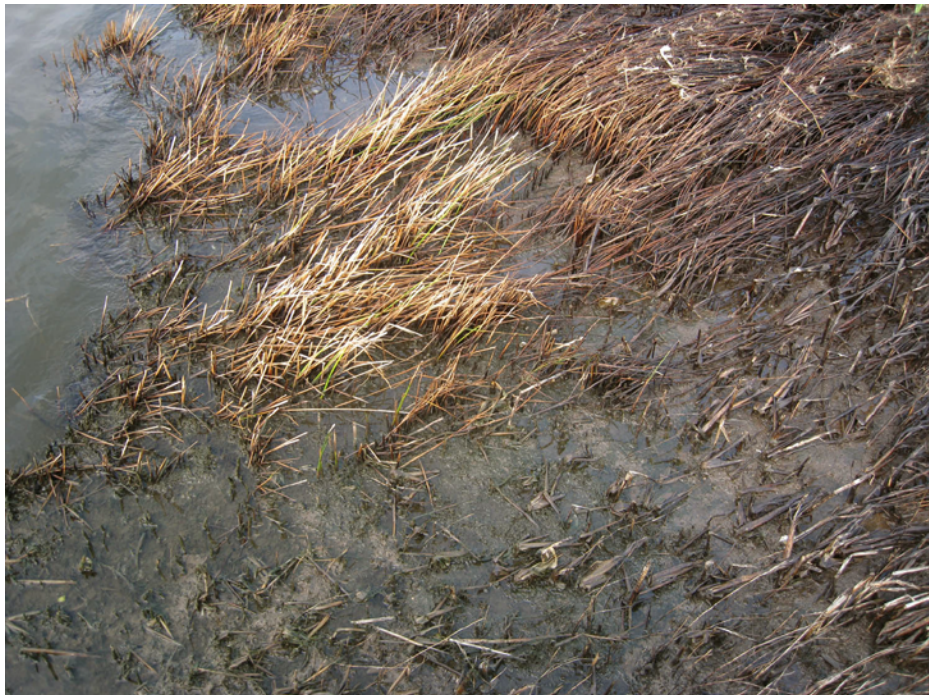
Figure 50. DWO-3-BAT-06 photo 2 taken on August 13, 2010. Site vegetation included *Juncus roemerianus* and *Spartina alterniflora*. Oiled vegetation and oil-damaged canopy were observed at this site.

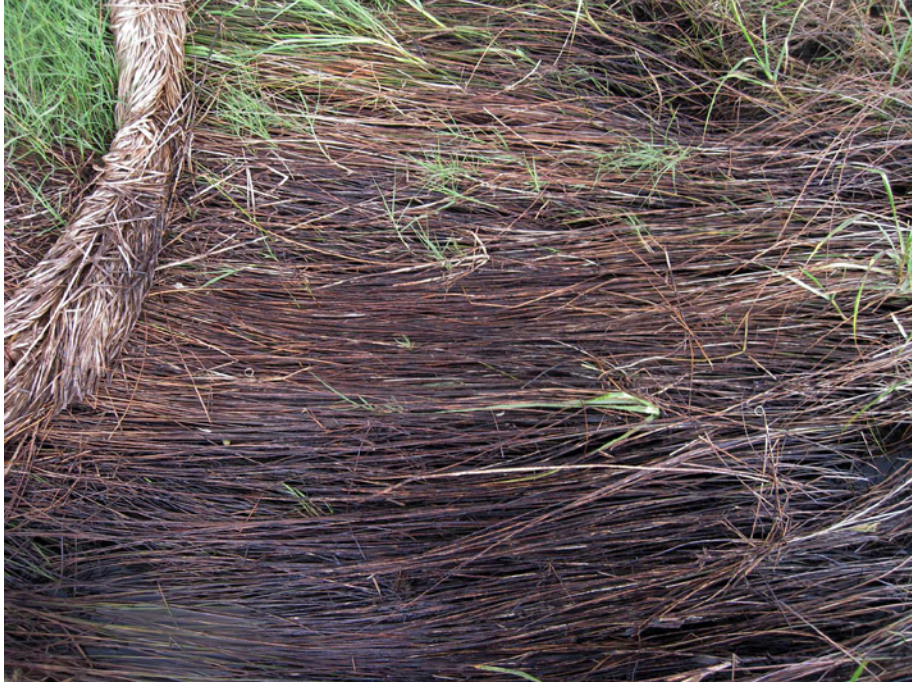
Figure 52. DWO-3-BAT-07 photo 2 taken on August 13, 2010. Site vegetation included *Spartina alterniflora*, *Juncus roemerianus*, *Distichlis spicata*, and *Iva frutescens*. Oiled vegetation and oil-damaged canopy were observed at this site.

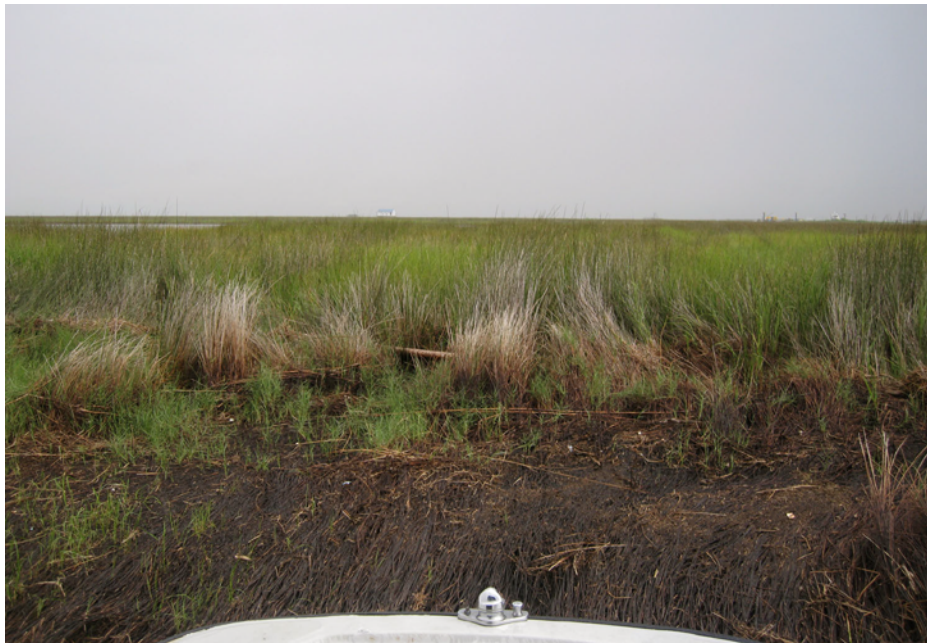
Figure 53. DWO-3-BAT-08 photo 1 taken on August 13, 2010. Site vegetation included *Spartina alterniflora* and *Distichlis spicata*. Oiled vegetation and oil-damaged canopy were observed at this site.

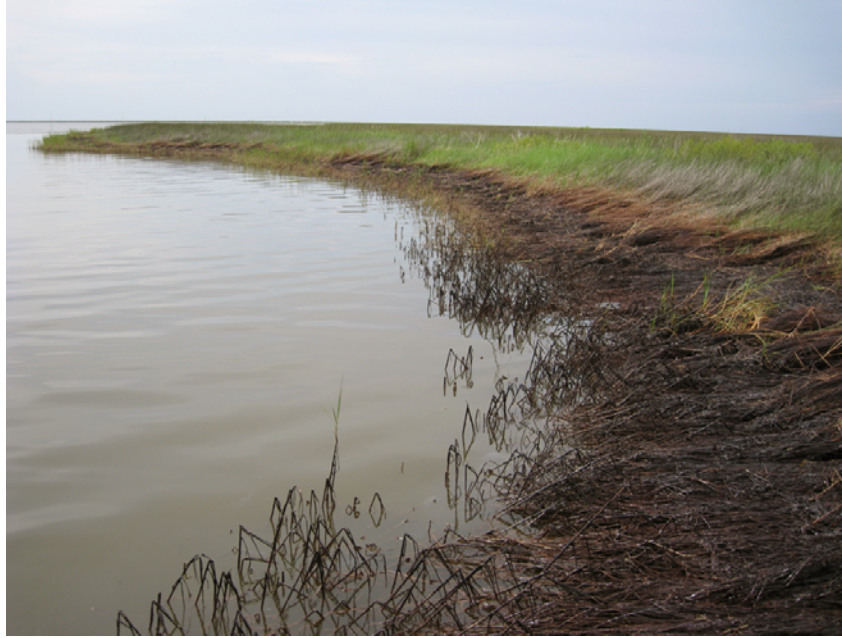
Figure 56. DWO-3-BAT-09 photo 1 taken on August 13, 2010. Site vegetation included *Juncus roemerianus* and *Spartina alterniflora*. Oiled vegetation and oil-damaged canopy were observed at this site.

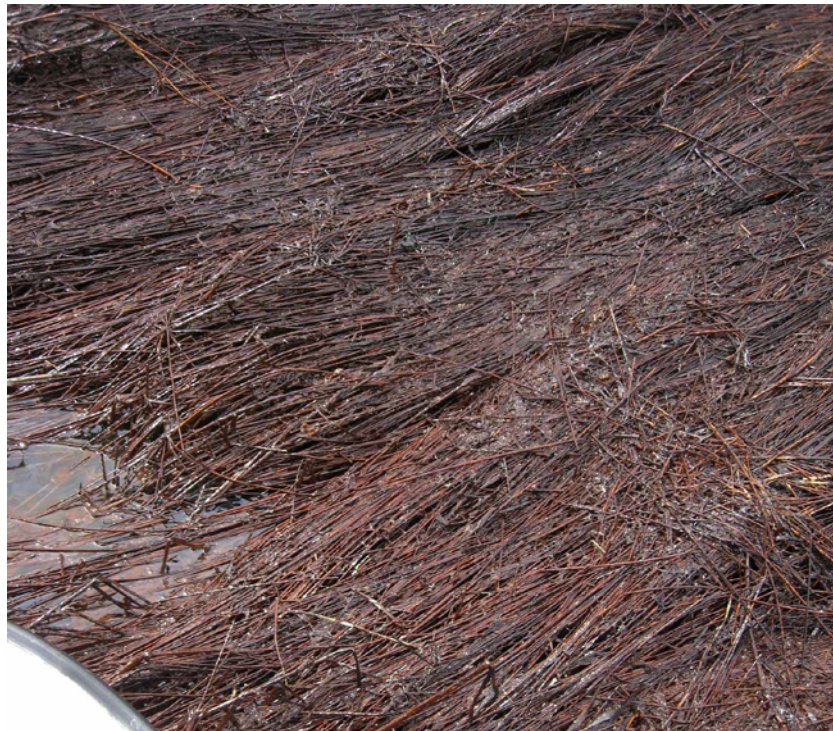
Figure 57. DWO-3-BAT-09 photo 2 taken on August 13, 2010. Site vegetation included *Juncus roemerianus* and *Spartina alterniflora*. Oiled vegetation and oil-damaged canopy were observed at this site.

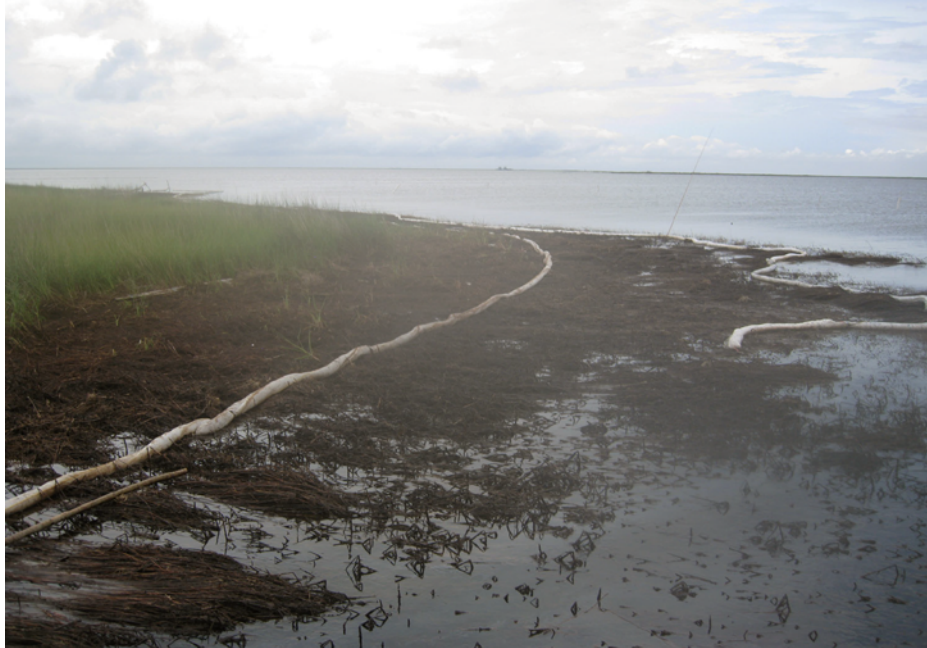
Figure 60. OBS-3-BAT-01 photo 1 taken on August 12, 2010. Site vegetation included *Spartina alterniflora* and *Juncus roemerianus*. Oiled vegetation and oil-damaged canopy were observed at this site.

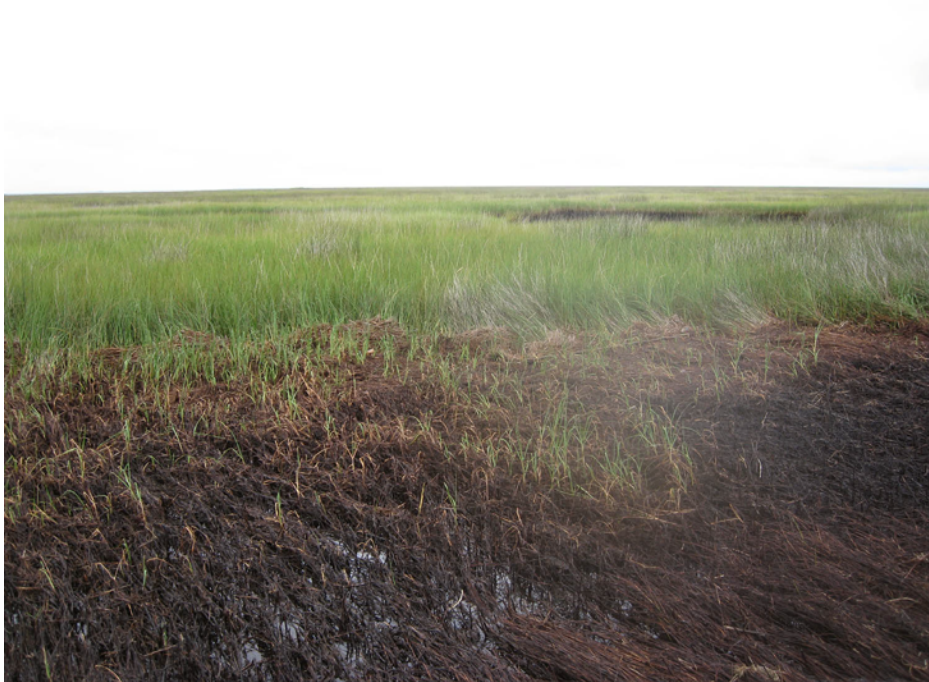
Figure 63. OBS-3-BAT-02 photo 2 taken on August 12, 2010. Site vegetation included *Spartina alterniflora* and *Juncus roemerianus*. Oiled vegetation and oil-damaged canopy were observed at this site.

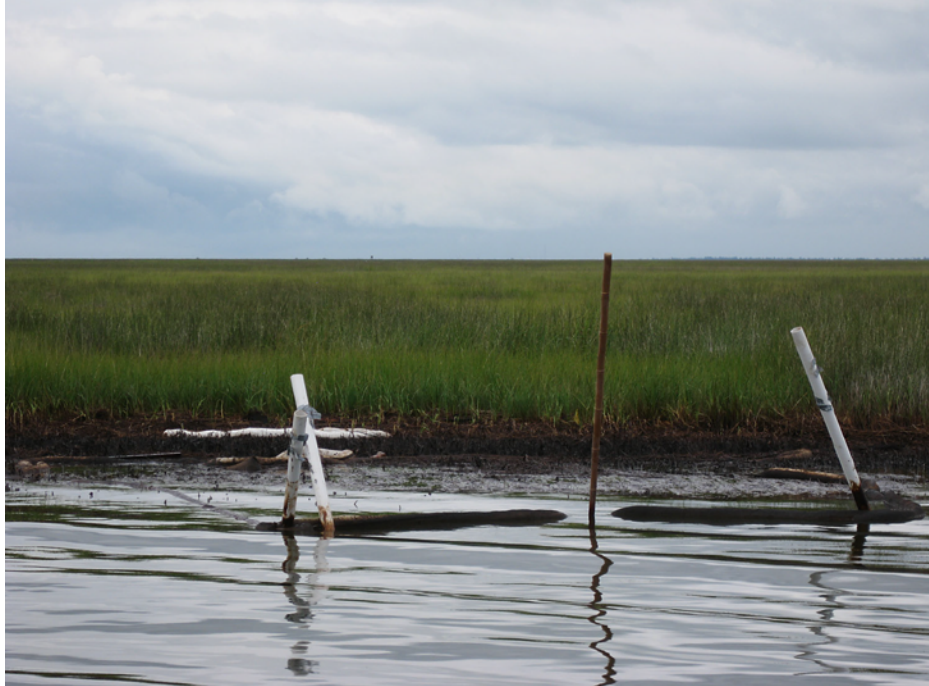
Figure 64. OBS-3-BAT-03 photo 1 taken on August 12, 2010. Site vegetation included *Spartina alterniflora* and *Juncus roemerianus*. Oiled vegetation and oil-damaged canopy were observed at this site.

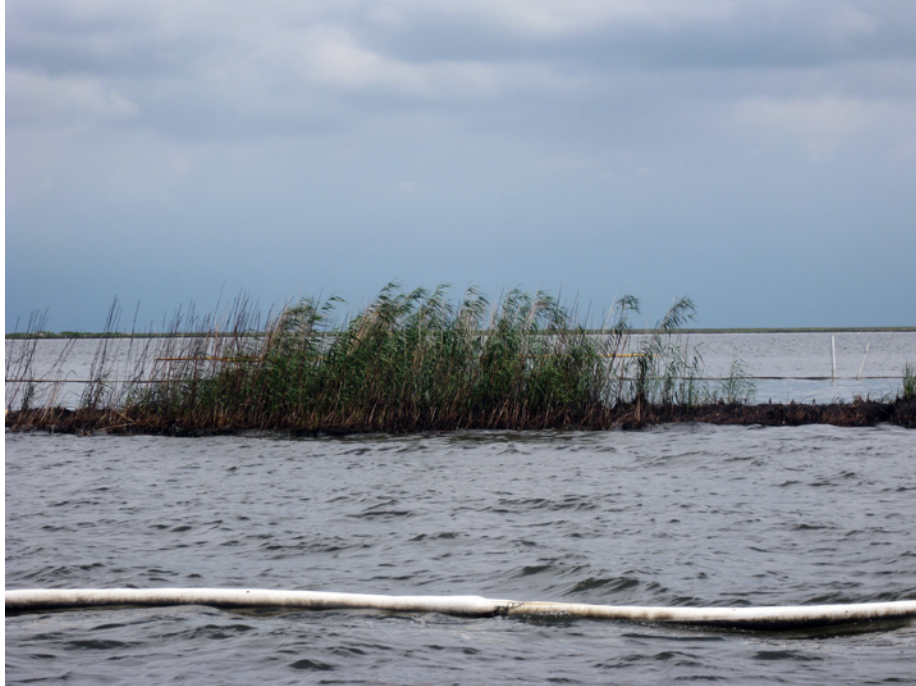
Figure 81. OBS-3-BAT-15 photo 1 taken on August 13, 2010. Site vegetation included *Phragmites australis*. Oiled vegetation and oil-damaged canopy were observed at this site.

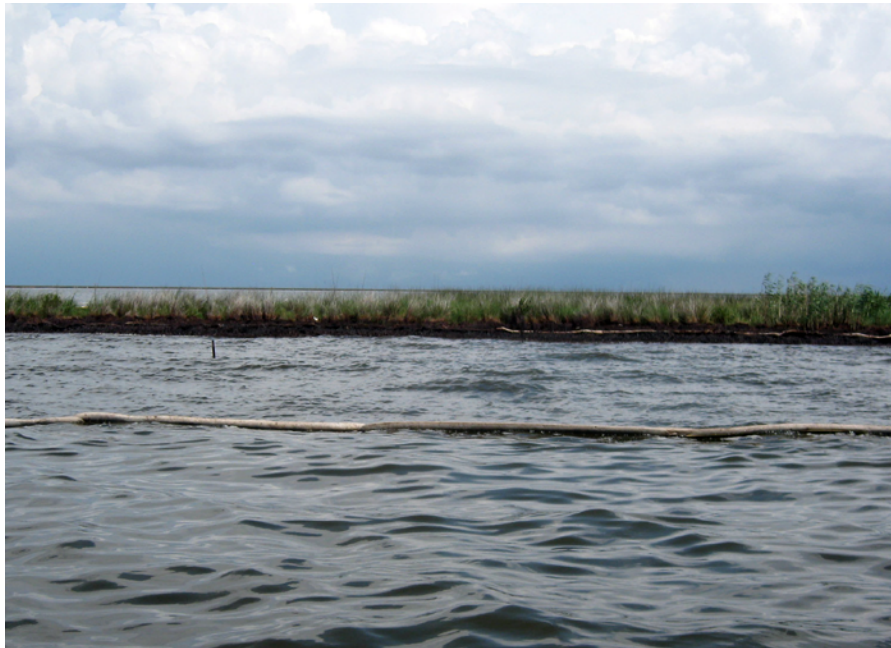
Figure 82. OBS-3-BAT-19 photo 1 taken on August 13, 2010. Site vegetation included *Spartina alterniflora*, *Juncus roemerianus*, and *Distichlis spicata*. Oiled vegetation and oil-damaged canopy were observed at this site.

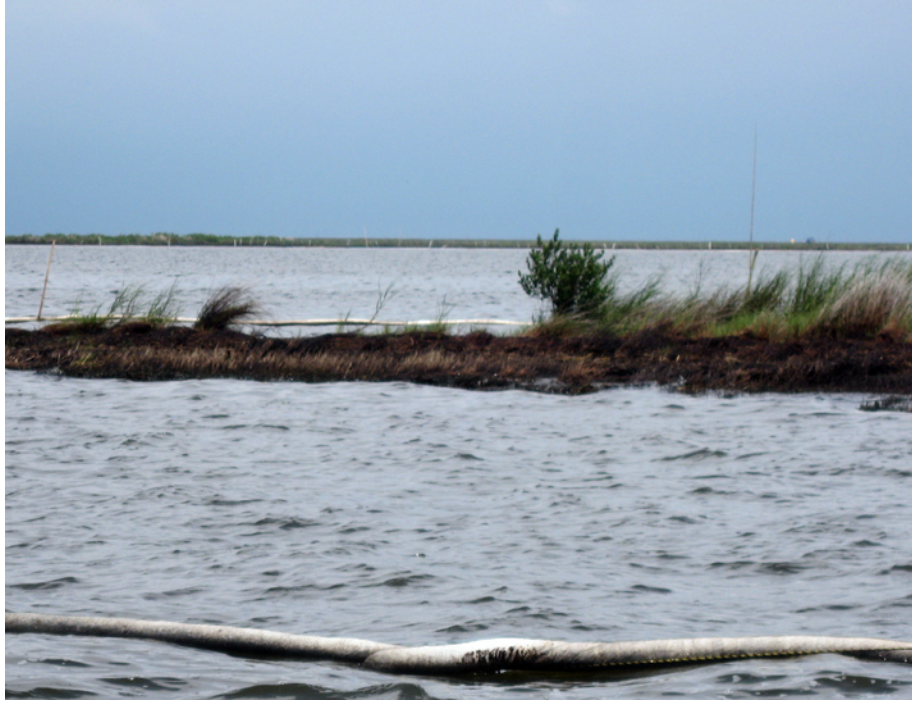
Figure 83. OBS-3-BAT-20 photo 1 taken on August 13, 2010. Site vegetation included *Spartina alterniflora*, *Juncus roemerianus*, and *Distichlis spicata*. Oiled vegetation and oil-damaged canopy were observed at this site.

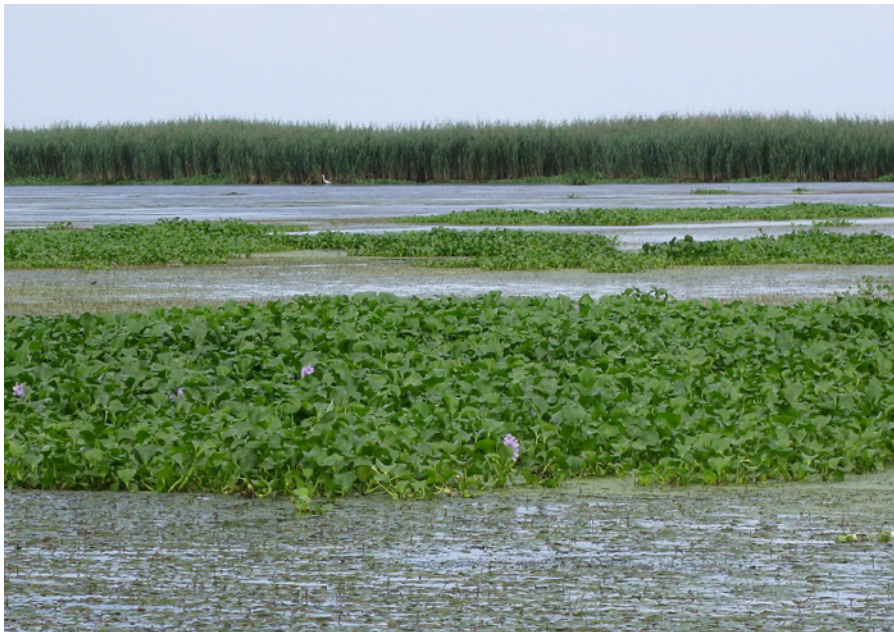
Figure 84. OBS-3-DEL-01 photo 1 taken on August 14, 2010. Site vegetation included *Eicchornia crassipes* and *Nymphaea* sp. Oil was not observed at this site.

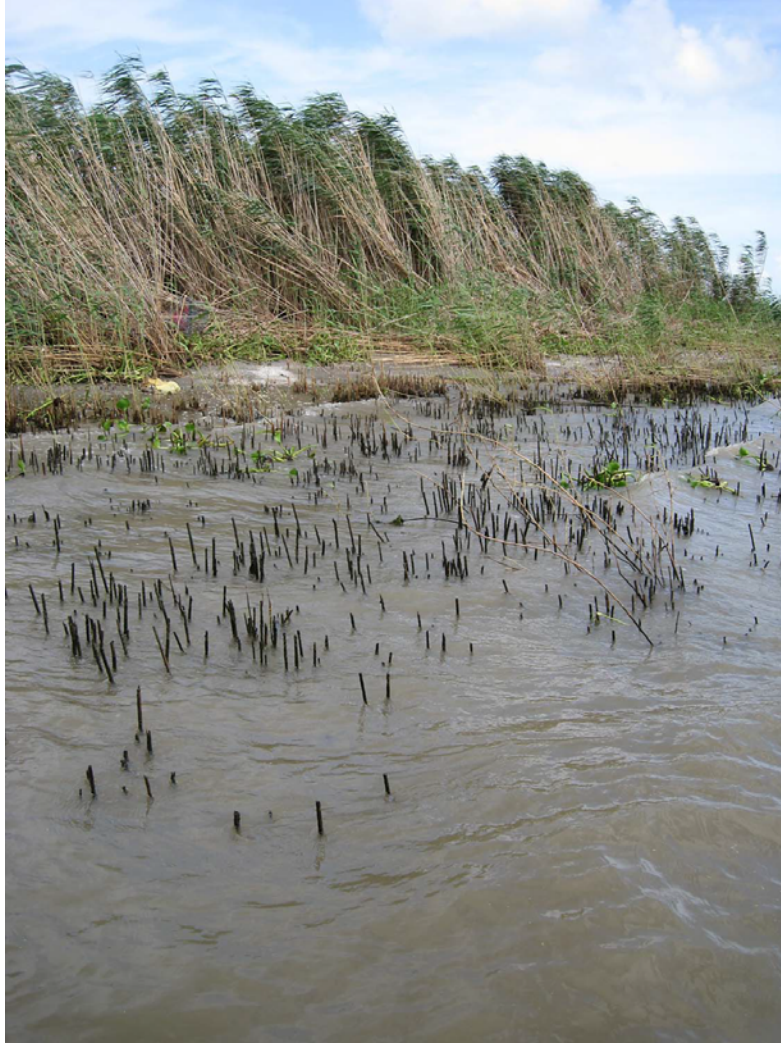
Figure 89. OBS-3-DEL-07 photo 1 taken on August 14, 2010. Site vegetation included *Phragmites australis* and *Eicchornia crassipes*. Damage to the plant canopy, apparently from oil, was observed at this site.

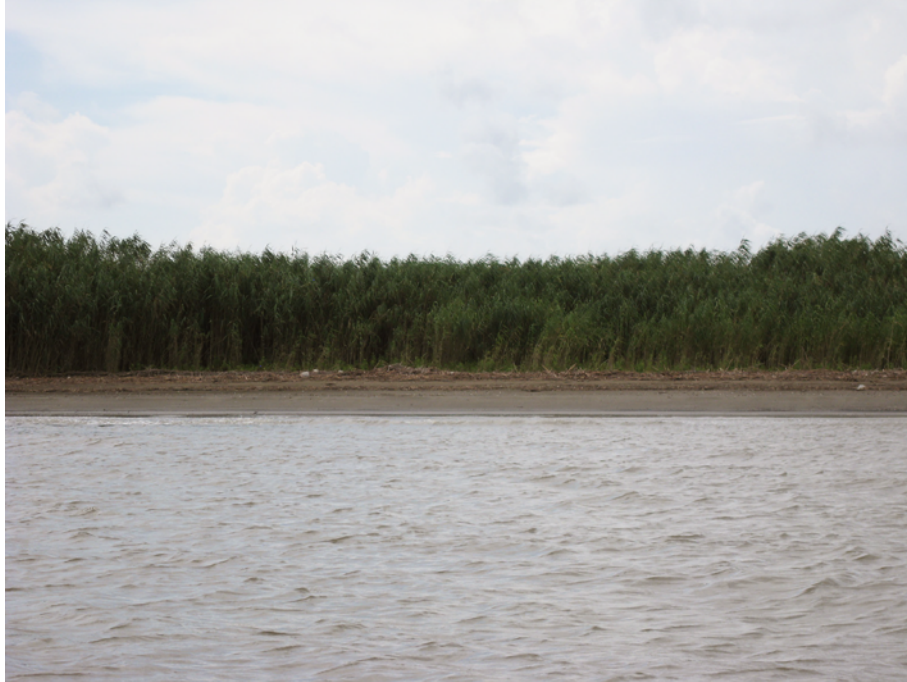
**Figure 90. OBS-3-DEL-09 photo 1 taken on August 14, 2010. Site vegetation included *Phragmites australis*. Oil was not observed at this site.**

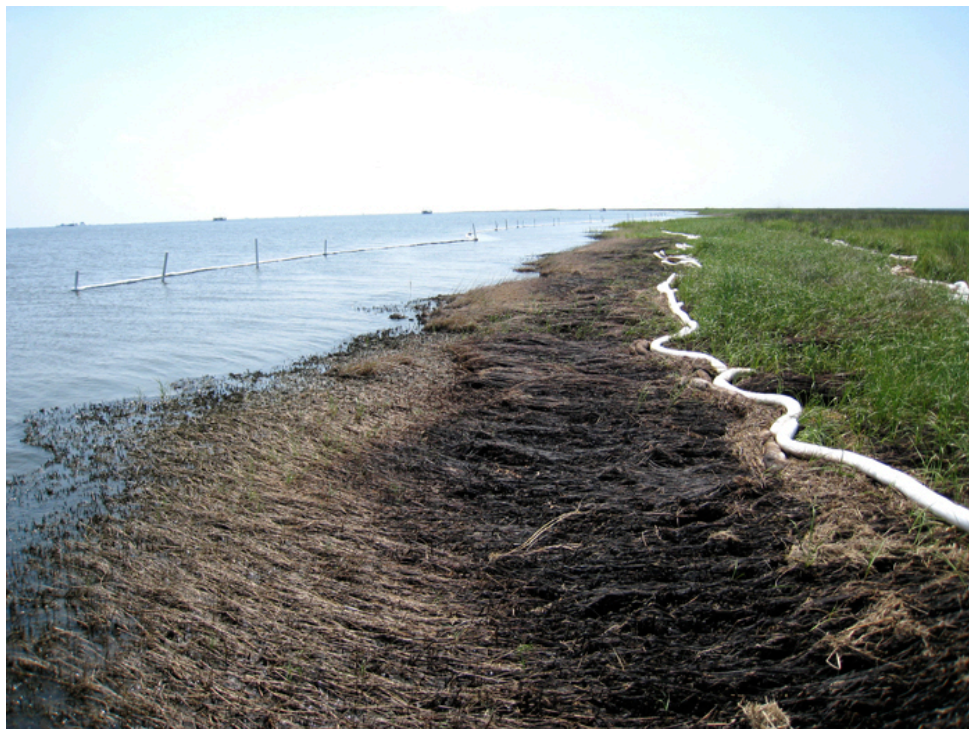
Figure 92 DWO-4-BAT-01 photo 1 taken on August 24, 2010. Site vegetation included *Spartina alterniflora*, *Juncus roemerianus* and *Spartina patens*. Oiled vegetation and oil-damaged canopy were observed at this site.

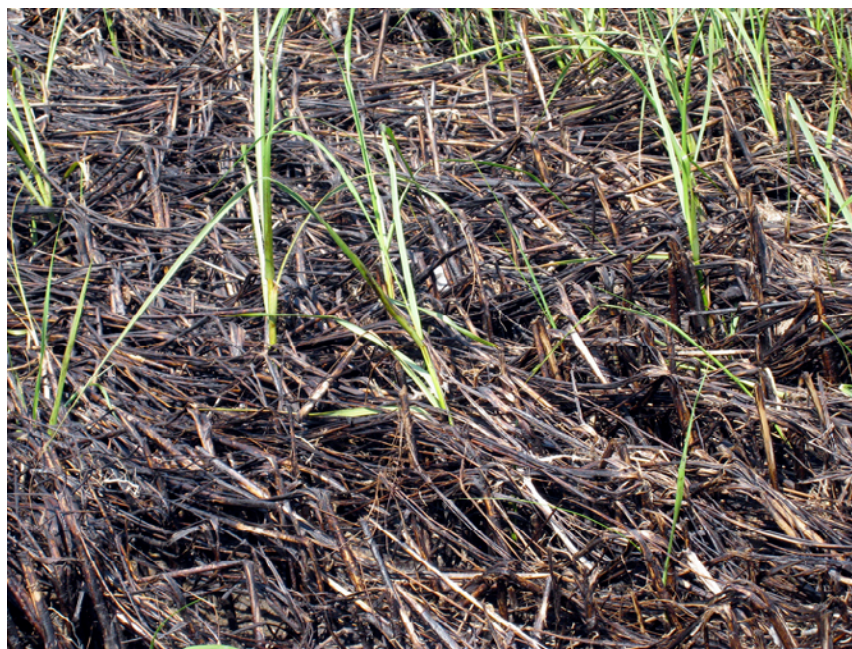
Figure 93. DWO-4-BAT-01 photo 2 taken on August 24, 2010. Site vegetation included *Spartina alterniflora*, *Juncus roemerianus* and *Spartina patens*. Oiled vegetation and oil-damaged canopy were observed at this site.

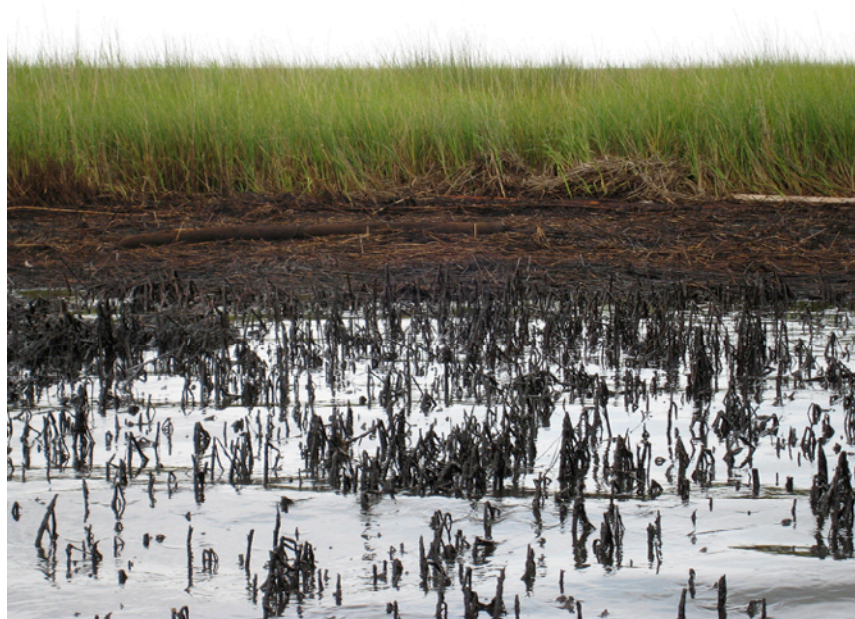
Figure 94. DWO-4-BAT-03 photo 1 taken on August 26, 2010. Site vegetation included *Spartina alterniflora* and *Juncus roemerianus*. Oiled vegetation and oil-damaged canopy were observed at this site.

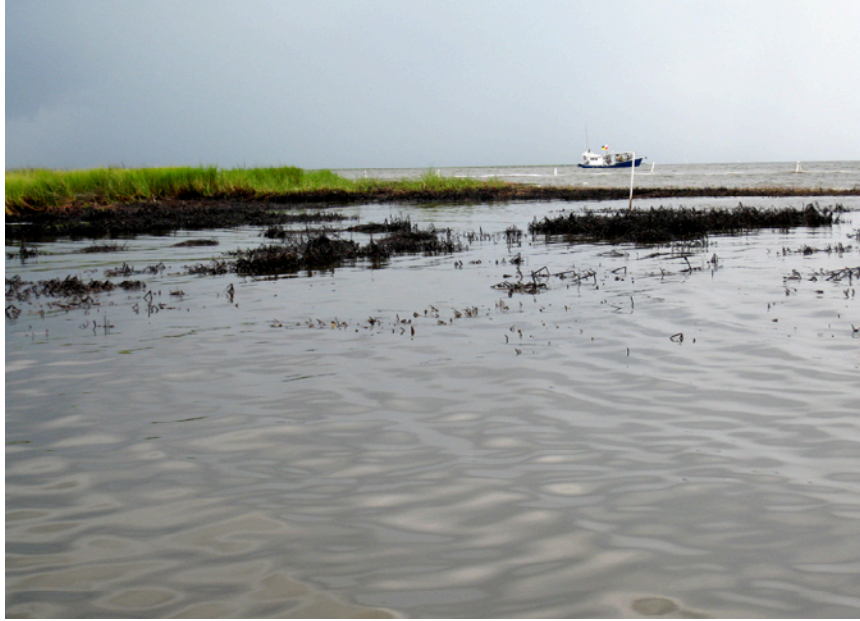
Figure 95. DWO-4-BAT-03 photo 2 taken on August 26, 2010. Site vegetation included *Spartina alterniflora* and *Juncus roemerianus*. Oiled vegetation and oil-damaged canopy were observed at this site.

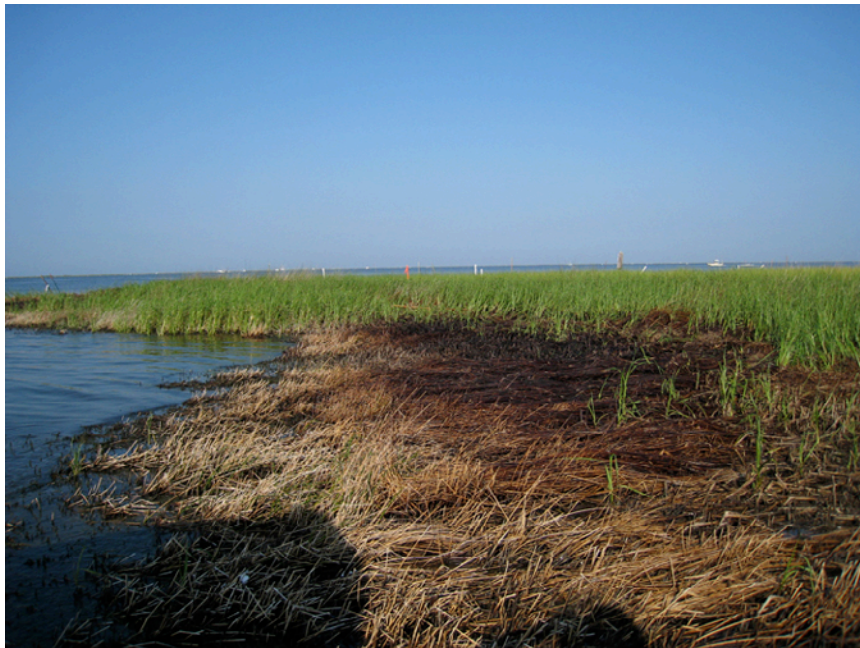
Figure 96. DWO-4-BAT-06 photo 1 taken on August 24, 2010. Site vegetation included *Juncus roemerianus*, *Distichlis spicata* and *Spartina alterniflora*. Oiled vegetation and oil-damaged canopy were observed at this site.

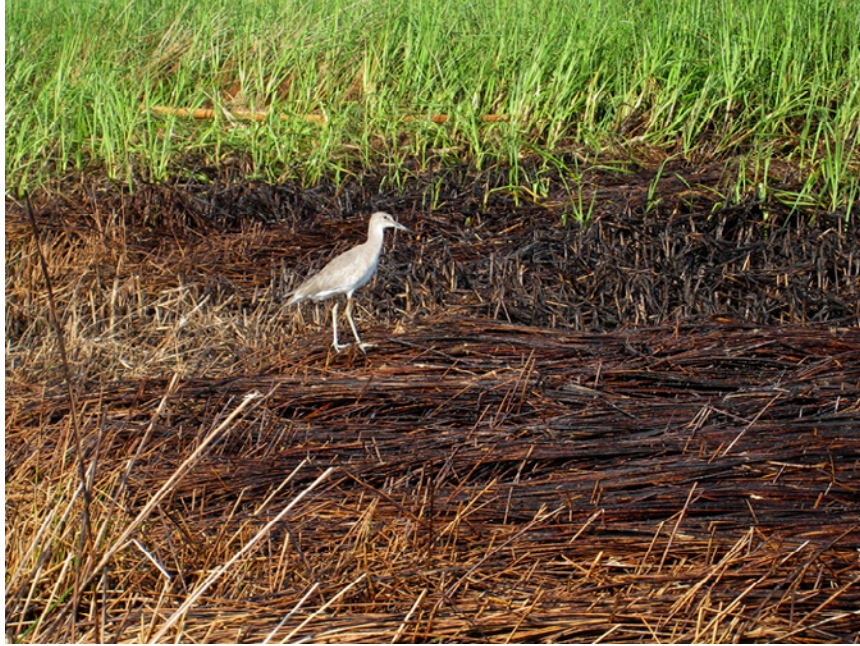
Figure 97. DWO-4-BAT-06 photo 2 taken on August 24, 2010. Site vegetation included *Juncus roemerianus*, *Distichlis spicata* and *Spartina alterniflora*. Oiled vegetation and oil-damaged canopy were observed at this site.

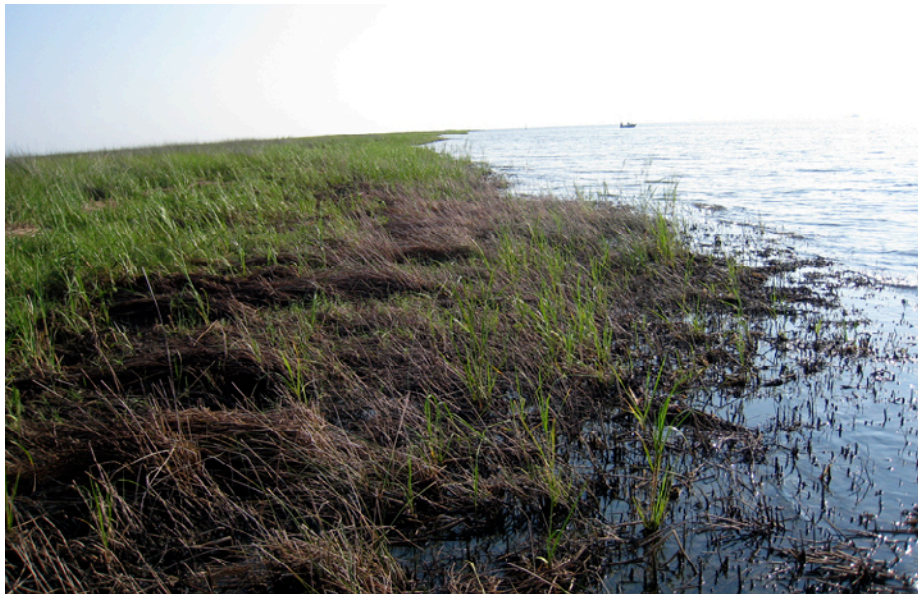
Figure 98. DWO-4-BAT-06 photo 3 taken on August 24, 2010. Site vegetation included *Juncus roemerianus*, *Distichlis spicata* and *Spartina alterniflora*. Oiled vegetation and oil-damaged canopy were observed at this site.

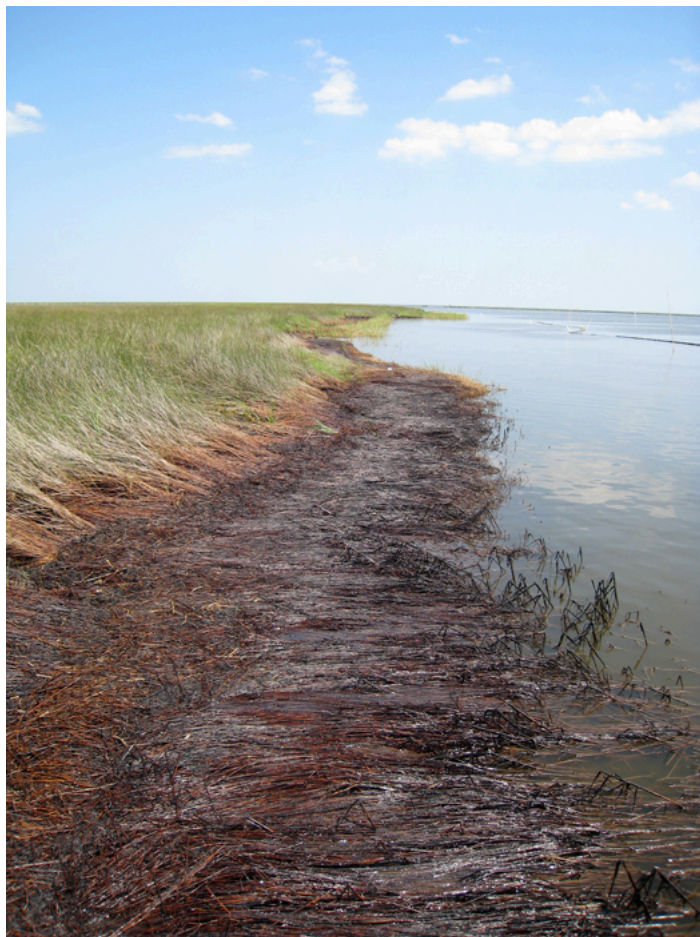
Figure 99. DWO-4-BAT-09 photo 1 taken on August 24, 2010. Site vegetation included *Juncus roemerianus*, *Spartina patens*, *Spartina alterniflora*, and *Distichlis spicata*. Oiled vegetation and oil-damaged canopy were observed at this site.

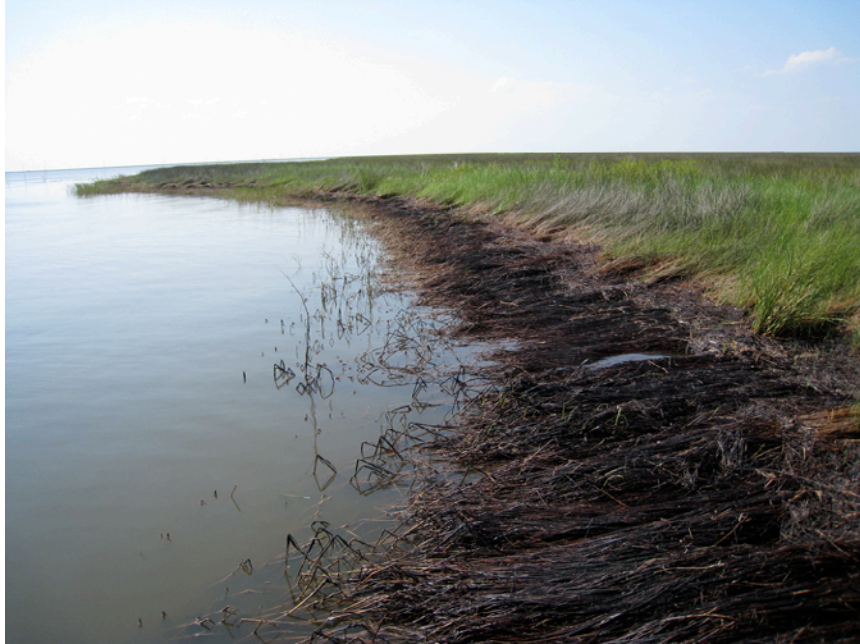
Figure 100. DWO-4-BAT-09 photo 2 taken on August 24, 2010. Site vegetation included *Juncus roemerianus*, *Spartina patens*, *Spartina alterniflora*, and *Distichlis spicata*. Oiled vegetation and oil-damaged canopy were observed at this site.

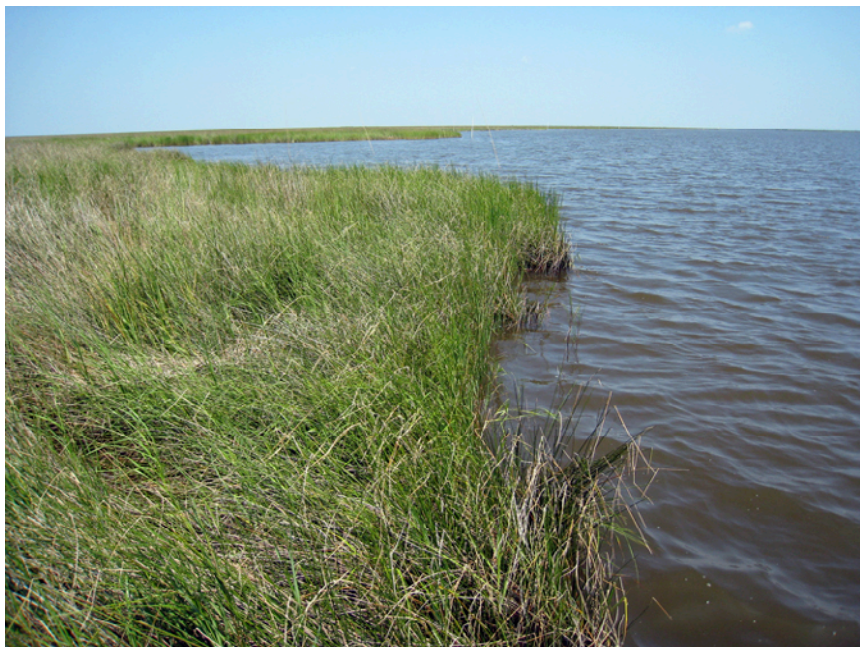
Figure 101. DWO-4-BAT-10 photo 1 taken on August 25, 2010. Site vegetation included *Juncus roemerianus* and *Spartina alterniflora*. Oil was not observed at this site.

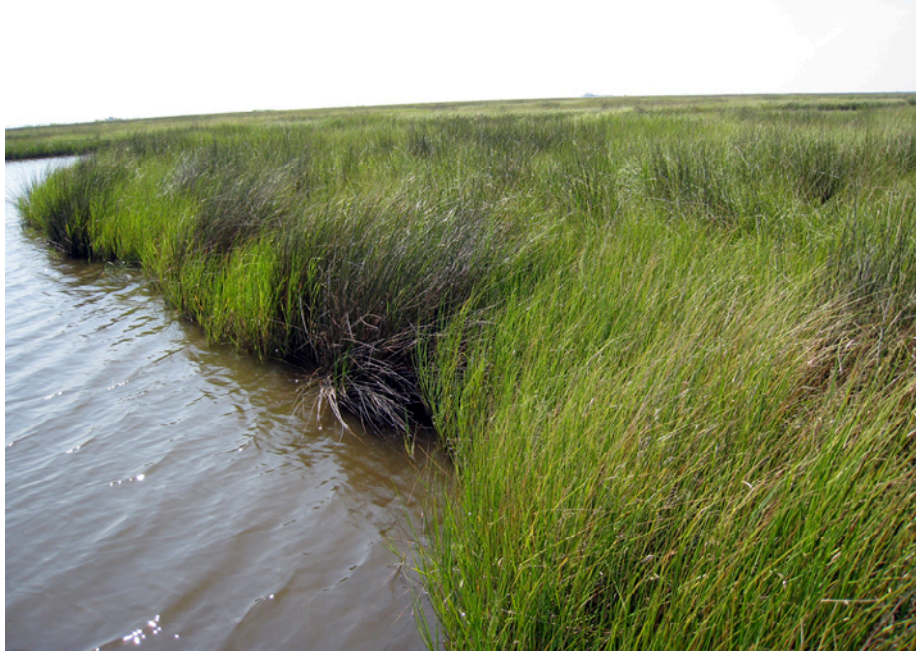
DWO-4-BAT-12	29.45748	89.86707	Aug. 24, 2010	No oil was observed on the plants, <i>Spartina alterniflora</i> and <i>Juncus roemerianus</i> ; unimpacted site. Near previous survey point DWO-2-BAT-12 and DWO-3-BAT-02. A photo of the site is shown in figure 102.
DWO-4-BAT-13	29.47919	89.90720	Aug. 25, 2010	Oiled marsh vegetation: <i>Spartina alterniflora</i> , <i>Juncus roemerianus</i> , and <i>Distichlis spicata</i> ; 7 m oiled zone with 4-5 m of oil-stained and bent grasses, grasses with intact stems oiled at their base extend an additional 1-2 m inland. Regrowth covering 10 percent of the oiled zone was observed. Photos of the site are shown in figures 103 and 104.
OBS-4-BAT-01	29.42089	89.83468	Aug. 26, 2010	Oiled marsh vegetation: <i>Spartina alterniflora</i> ; 11 m oiled zone; 4 m from water edge sparsely populated, remainder heavily oiled, laid over with stubble. Minor <i>S. alterniflora</i> regeneration, deeper green regrowth relative to unaffected vegetation; oil sheen in water. A photo of the site is shown in figure 105.

Figure 102. DWO-4-BAT-12 photo 1 taken on August 24, 2010. Site vegetation included *Spartina alterniflora* and *Juncus roemerianus*. Oil was not observed at this site.
