# **Shoreline Surveys of Oil-Impacted Marsh in Southern Louisiana, July to August 2010**

**Open-File Report 2011–1022**

**U.S. Department of the Interior  
U.S. Geological Survey**

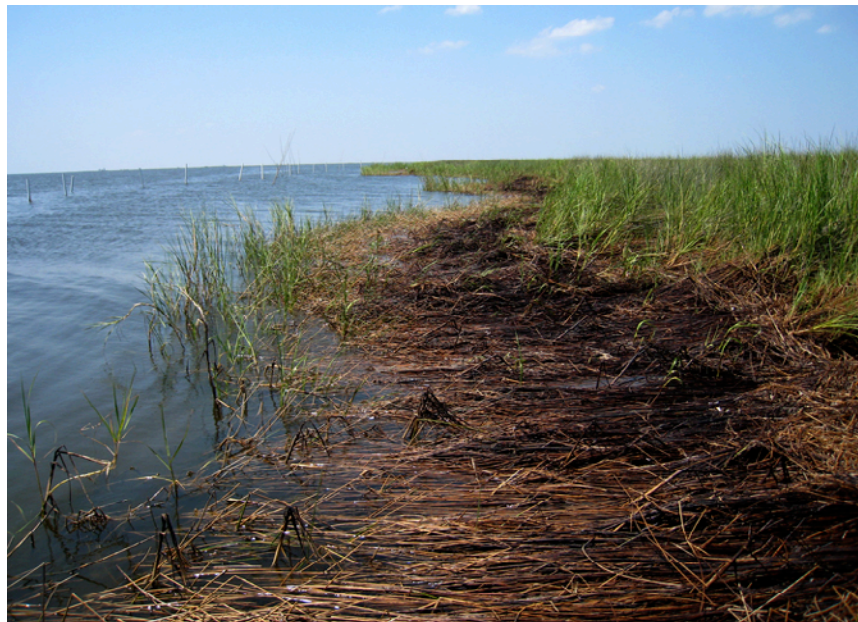
Figure 103. DWO-4-BAT-13 photo 1 taken on August 25, 2010. Site vegetation included *Spartina alterniflora*, *Juncus roemerianus*, and *Distichlis spicata*. Oiled vegetation and oil-damaged canopy were observed at this site.

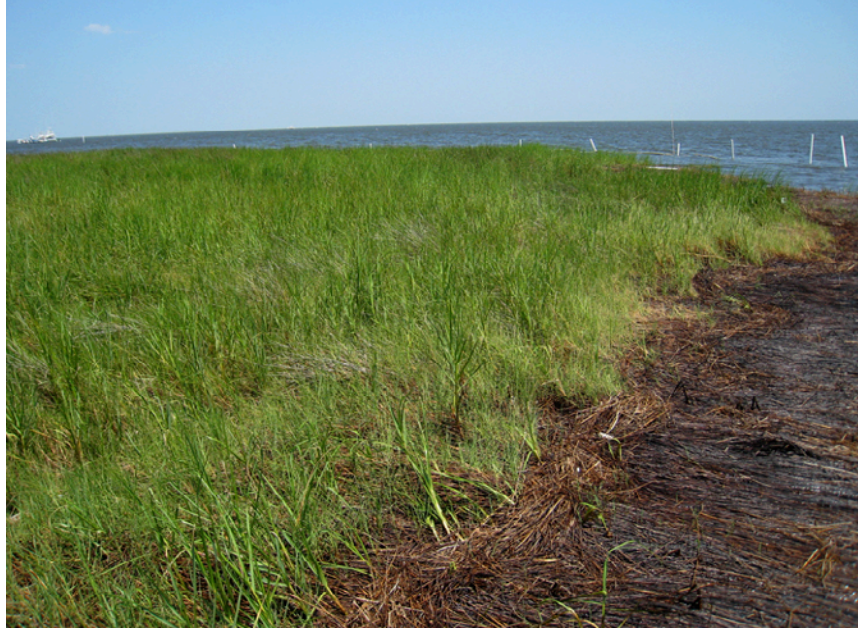
Figure 104. DWO-4-BAT-13 photo 2 taken on August 25, 2010. Site vegetation included *Spartina alterniflora*, *Juncus roemerianus*, and *Distichlis spicata*. Oiled vegetation and oil-damaged canopy were observed at this site.

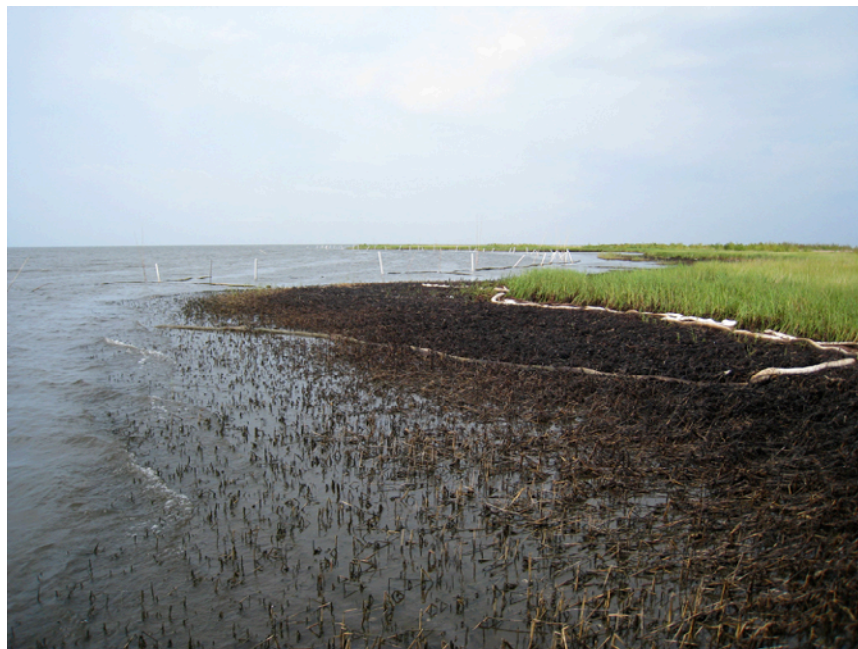
Figure 105. OBS-4-BAT-01 photo 1 taken on August 26, 2010. Site vegetation included *Spartina alterniflora*. Oiled vegetation and oil-damaged canopy were observed at this site.

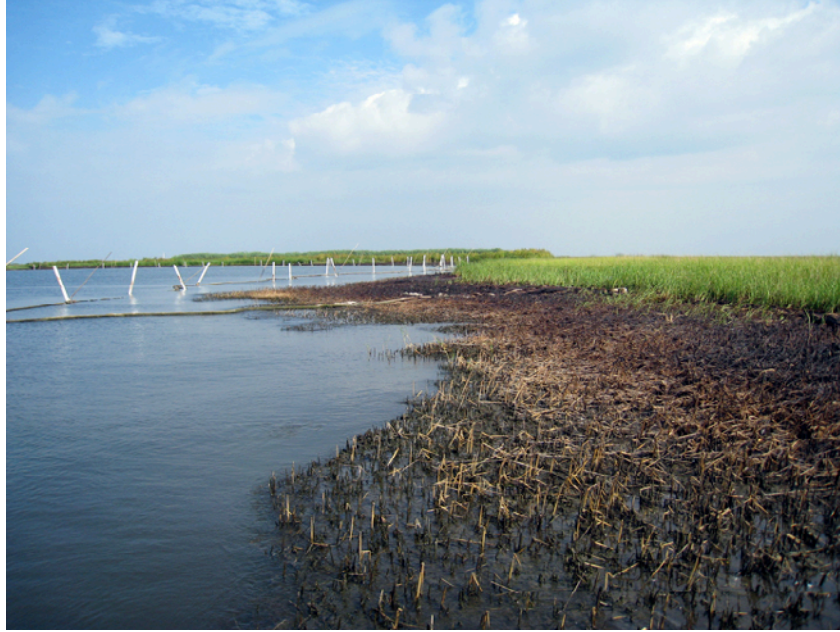
Figure 106. OBS-4-BAT-02 photo 1 taken on August 26, 2010. Site vegetation included *Spartina alterniflora*, *Juncus roemerianus*, and *Spartina patens*. Oiled vegetation and oil-damaged canopy were observed at this site.

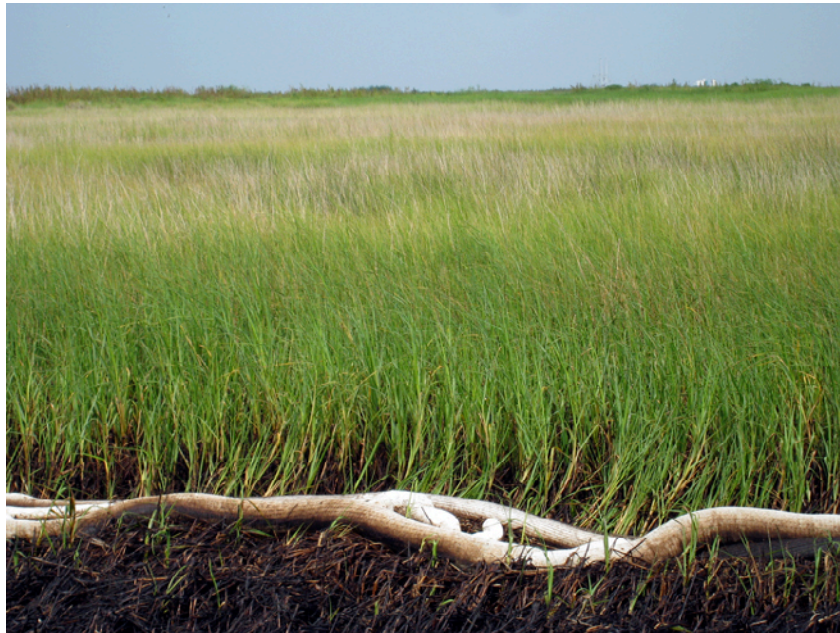
Figure 107. OBS-4-BAT-02 photo 2 taken on August 26, 2010. Site vegetation included *Spartina alterniflora*, *Juncus roemerianus*, and *Spartina patens*. Oiled vegetation and oil-damaged canopy were observed at this site.

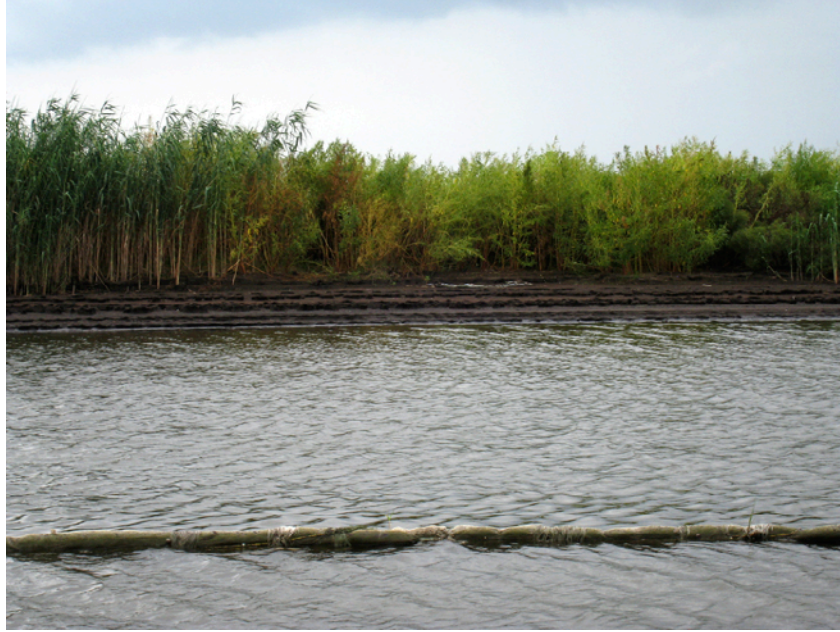
dark brown sediment reworked by wave/tidal activity. No visual evidence of oil impact. Photos of the site are shown in figures 108 and 109.
OBS-4-BAT-04	29.49129	89.90100	Aug. 26, 2010	Oiled marsh vegetation: <i>Spartina alterniflora</i> and <i>Juncus roemerianus</i> ; 8 m oil-impacted zone containing oil-coated plants with bent stems. Regrowth of <i>S. patens</i> and <i>D. spicata</i> was observed. Oil sheen was observed in the water. Photos of the site are shown in figures 110 and 111.
OBS-4-BAT-05	29.45898	89.90786	Aug. 26, 2010	Oiled marsh vegetation: <i>Juncus roemerianus</i> and <i>Spartina patens</i> , and trace <i>Phragmites australis</i> ; 3-6 m zone of oiled, laid over vegetation extending for ~20m along shore where boom has broken. Regrowth of <i>S. patens</i> over ~10 percent of oiled area was observed; regrowth is a darker green color relative to less-impacted grass. Oyster shells sporadically deposited along oiled shoreline. Photos of the site are shown in figures 112 and 113.

Figure 108. OBS-4-BAT-03 photo 1 taken on August 26, 2010. Site vegetation included *Phragmites australis*, *Iva frutescens*, *Spartina alterniflora*, *Solidage* sp., and *Distichlis spicata*. Oil was not observed at this site.

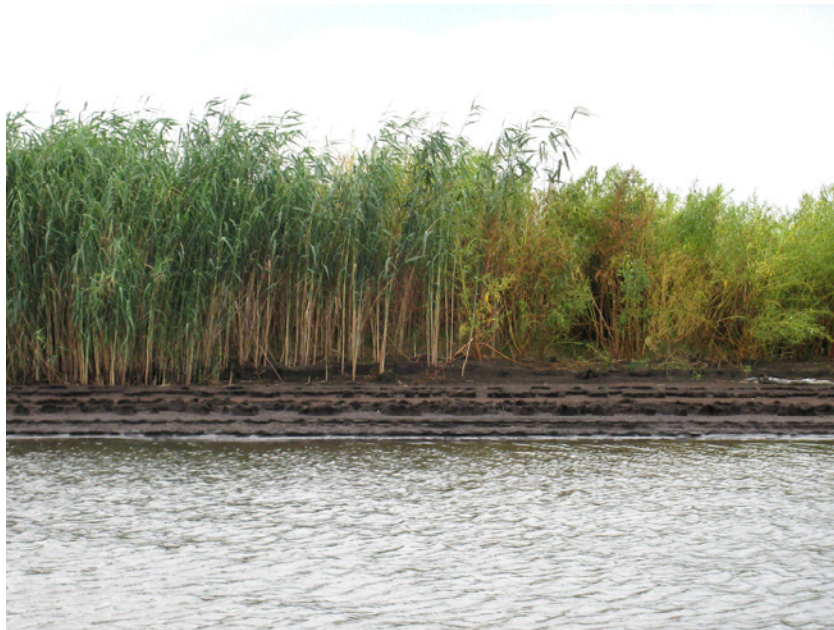
Figure 109. OBS-4-BAT-03 photo 2 taken on August 26, 2010. Site vegetation included *Phragmites australis*, *Iva frutescens*, *Spartina alterniflora*, *Solidage* sp., and *Distichlis spicata*. Oil was not observed at this site.

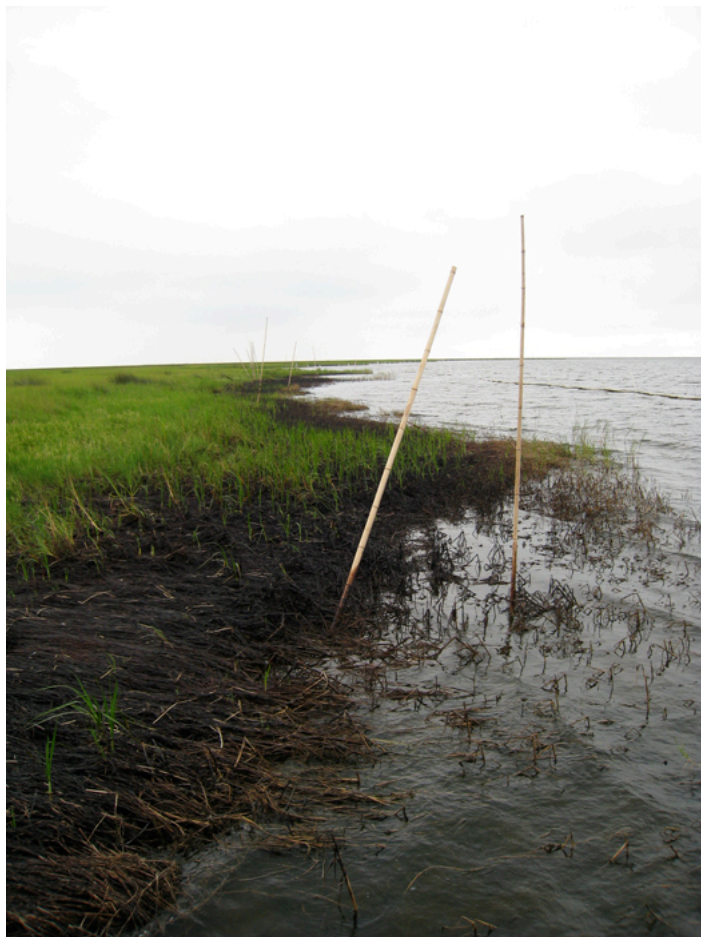
Figure 110. OBS-4-BAT-04 photo 1 taken on August 26, 2010. Site vegetation included *Spartina alterniflora*, *Juncus roemerianus*, *Distichlis spicata*, and *Spartina patens*. Oiled vegetation and oil-damaged canopy were observed at this site.

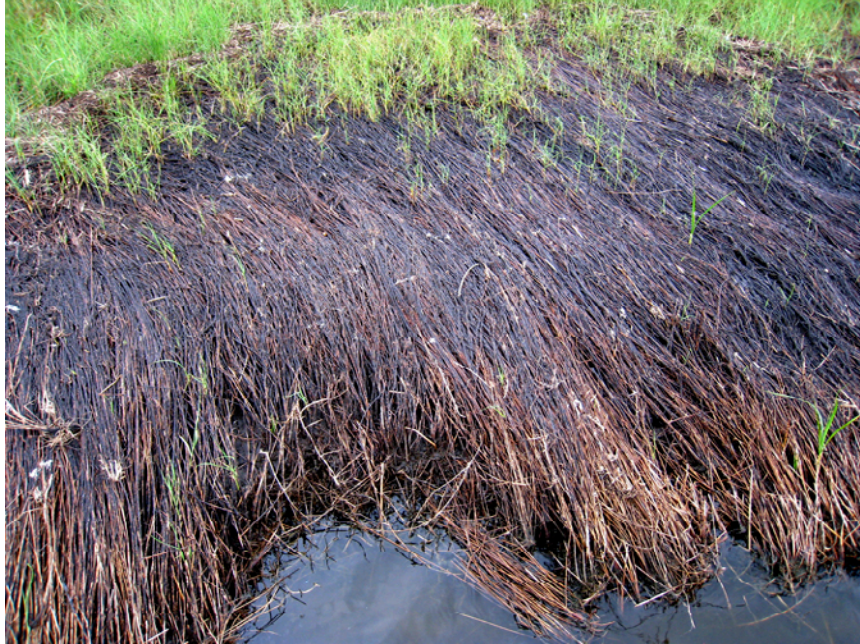
Figure 111. OBS-4-BAT-04 photo 2 taken on August 26, 2010. Site vegetation included *Spartina alterniflora*, *Juncus roemerianus*, *Distichlis spicata*, and *Spartina patens*. Oiled vegetation and oil-damaged canopy were observed at this site.

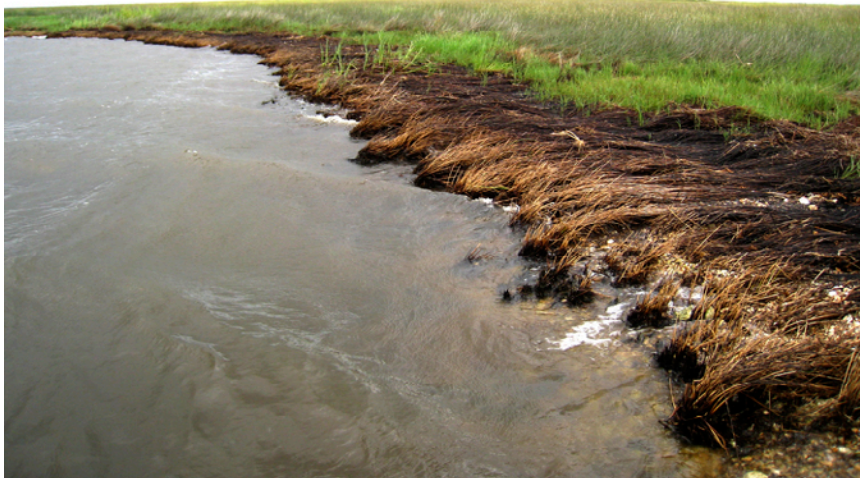
Figure 112. OBS-4-BAT-05 photo 1 taken on August 26, 2010. Site vegetation included *Juncus roemerianus* and *Spartina alterniflora*. Oiled vegetation and oil-damaged canopy were observed at this site.

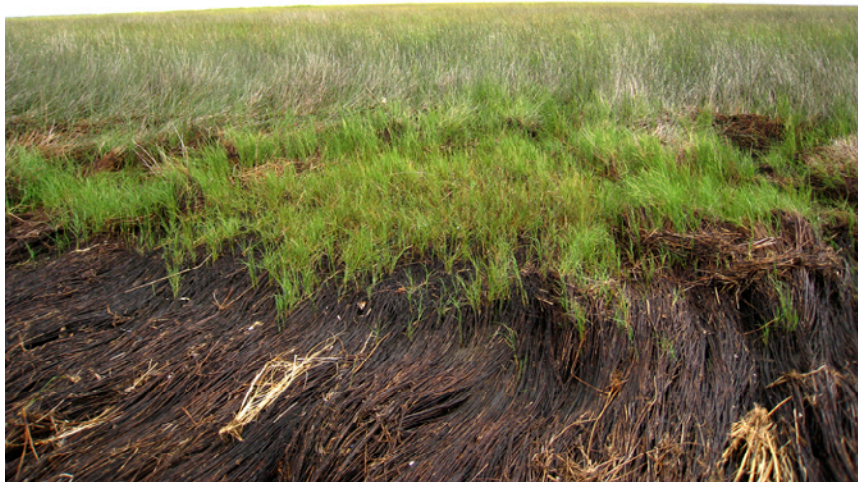
Figure 113. OBS-4-BAT-05 photo 2 taken on August 26, 2010. Site vegetation included *Juncus roemerianus* and *Spartina alterniflora*. Oiled vegetation and oil-damaged canopy were observed at this site.

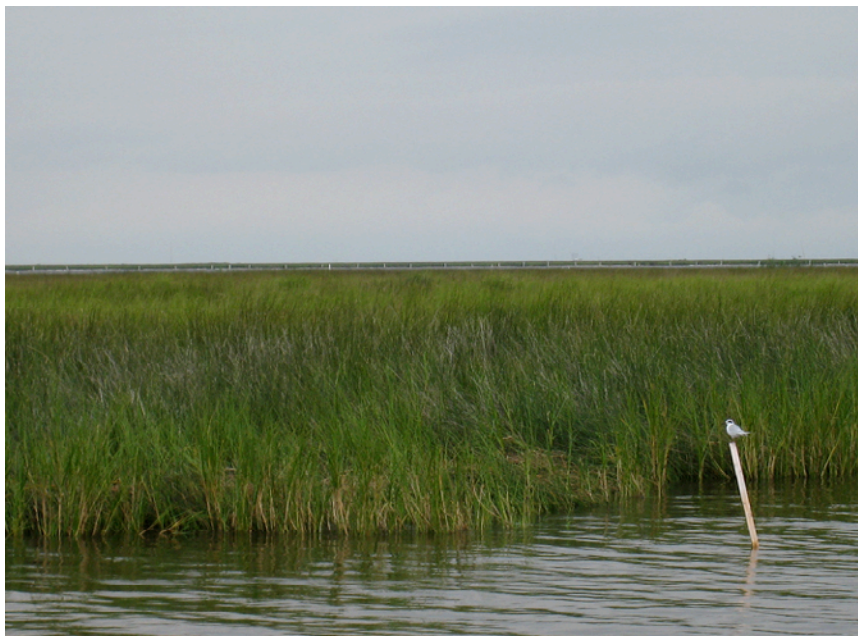
OBS-4-BAT-06	29.46134	89.90941	Aug. 26, 2010	No visible oiling. Dominant plants: <i>Juncus roemerianus</i> and <i>Spartina</i> sp. along water's edge. Photos of the site are shown in figures 114 and 115.
OBS-4-BAT-07	29.47507	89.91019	Aug. 26, 2010	Oiled marsh vegetation: <i>Juncus roemerianus</i> and <i>Spartina alterniflora</i> ; 3-5 m wide zone across >60 m of shoreline. The oiled zone is patchy with sporadic areas of oiled and laid over plants rather than a continuous oil coating. Regrowth of <i>Spartina alterniflora</i> , having a brighter green color relative to less-impacted grasses, was observed. Photos of the site are shown in figures 116 and 117.
OBS-4-BAT-08	29.47607	89.90960	Aug. 26, 2010	No visible oiling. Off-shore survey point. Unable to access site due to intact boom. Shoreline vegetation dominated by <i>Spartina</i> sp. and <i>Juncus roemerianus</i> . A photo of the site is shown in figure 118.

Figure 114. OBS-4-BAT-06 photo 1 taken on August 26, 2010. Site vegetation included *Juncus roemerianus* and *Spartina* sp. Oil was not observed at this site.

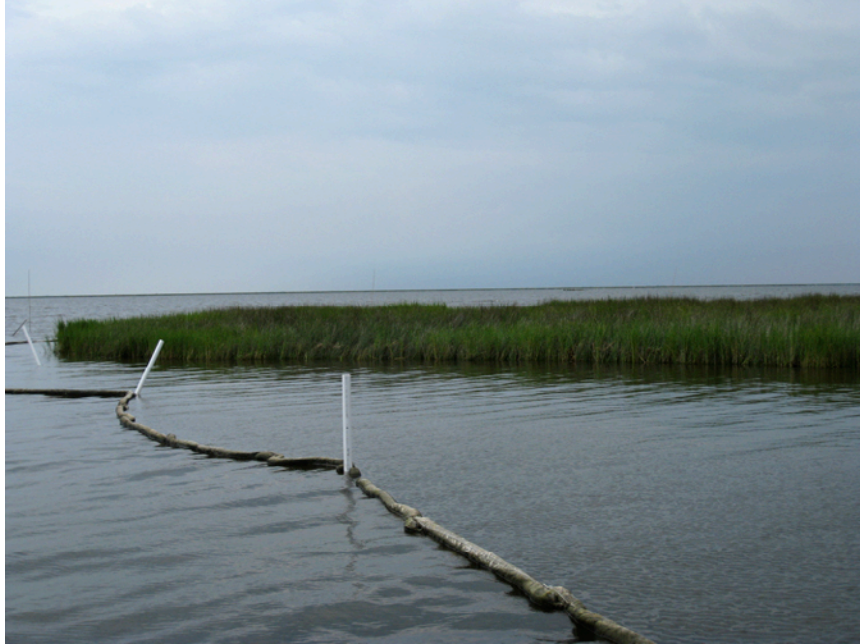
Figure 115. OBS-4-BAT-06 photo 2 taken on August 26, 2010. Site vegetation included *Juncus roemerianus* and *Spartina* sp. Oil was not observed at this site.

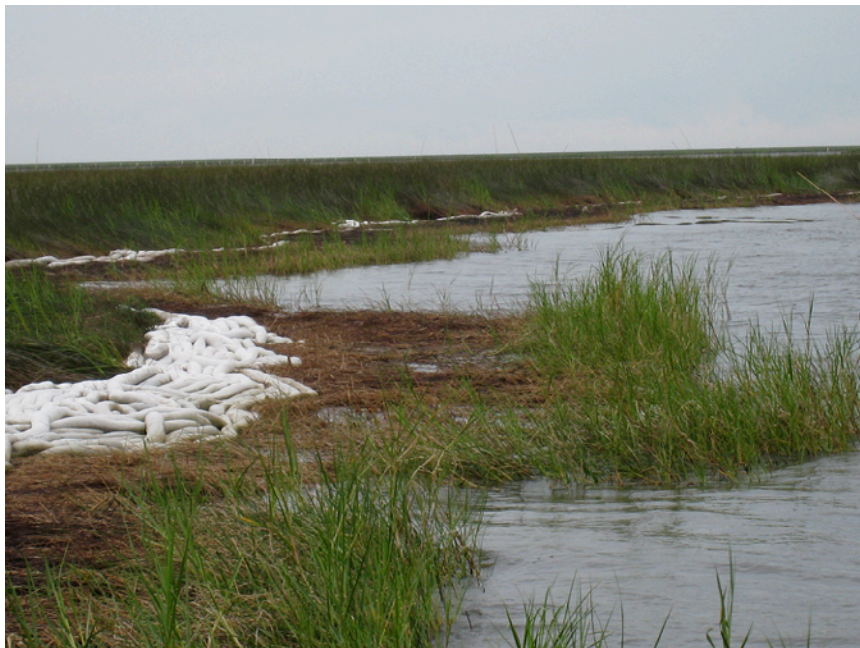
Figure 116. OBS-4-BAT-07 photo 1 taken on August 26, 2010. Site vegetation included *Juncus roemerianus* and *Spartina alterniflora*. Oiled vegetation and oil-damaged canopy were observed at this site.

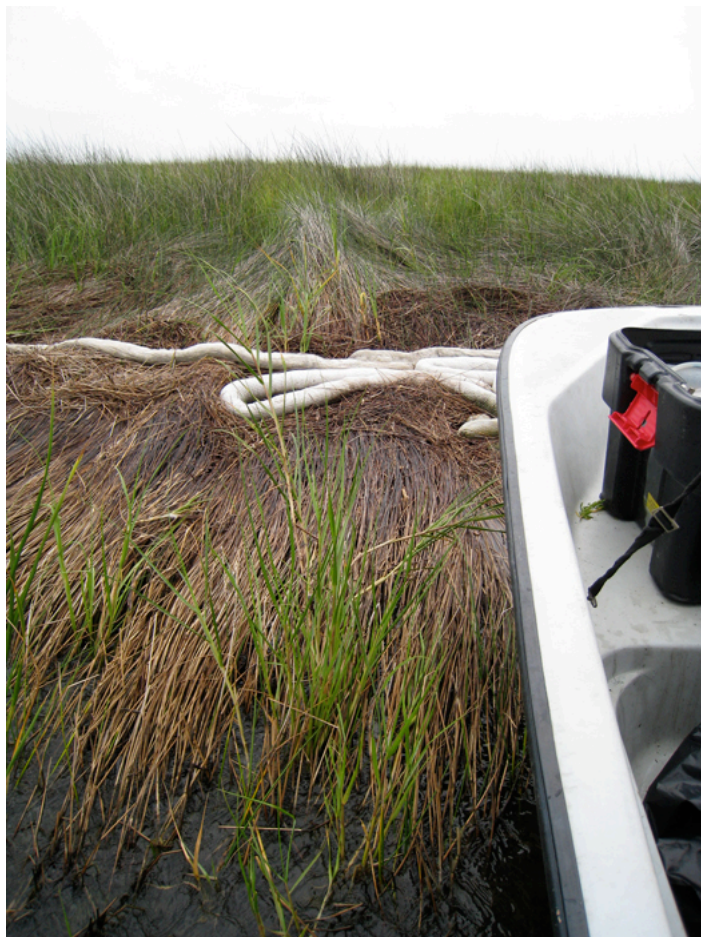
Figure 117. OBS-4-BAT-07 photo 2 taken on August 26, 2010. Site vegetation included *Juncus roemerianus* and *Spartina alterniflora*. Oiled vegetation and oil-damaged canopy were observed at this site.

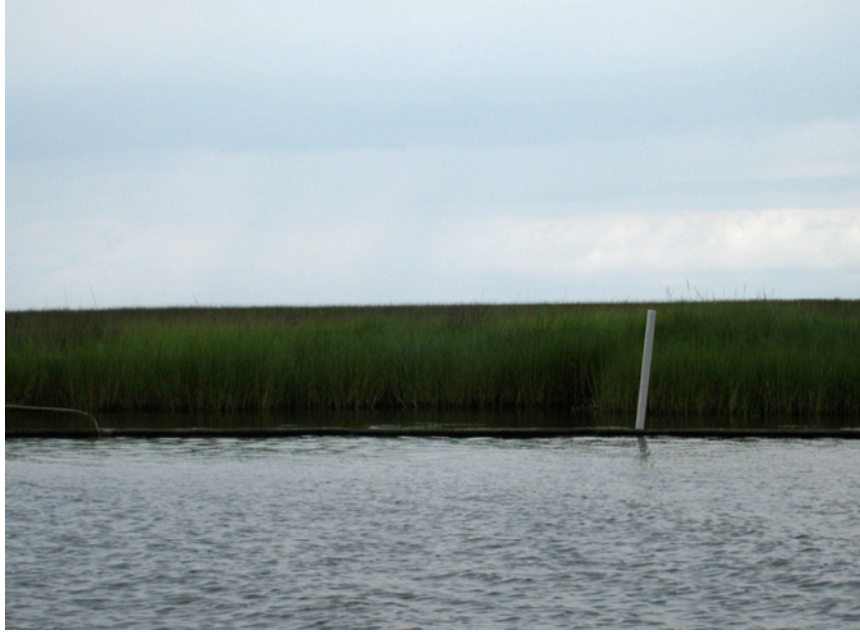
Figure 118. OBS-4-BAT-08 photo 1 taken on August 26, 2010. Site vegetation included *Spartina* sp. and *Juncus roemerianus*. Oil was not observed at this site.

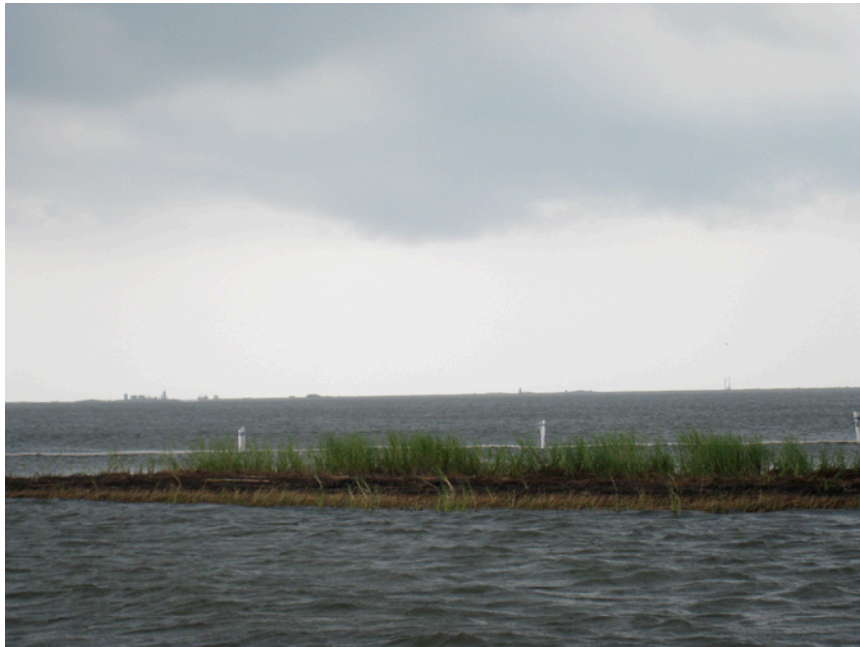
OBS-4-BAT-09	29.44618	89.90702	Aug. 26, 2010	Off-shore survey point. Site access was restricted by intact boom. Heavy oiling was observed. The oiled zone is bounded by regrowth of <i>Spartina</i> sp. A photo of the site is shown in figure 119.
OBS-4-BAT-10	29.44975	89.90336	Aug. 26, 2010	No visible oiling. Site access restricted by intact boom. Dominant vegetation: <i>Juncus roemerianus</i> and <i>Spartina</i> sp. Photos of the site are shown in figures 120 and 121.
OBS-4-BAT-11	29.44450	89.87408	Aug. 26, 2010	Oiled marsh vegetation: <i>Juncus roemerianus</i> and <i>Spartina alterniflora</i> ; ~10 percent cover by bent grasses with a heavy oil coating; regrowth throughout the oiled zone was darker green in color compared to adjacent unimpacted zone. In the oiled zone, ~60 percent of the area of regrowing grasses was submerged at the time

Figure 119. OBS-4-BAT-09 photo 1 taken on August 26, 2010. Site vegetation included *Spartina* sp. Oiled vegetation and oil-damaged canopy were observed at this site.

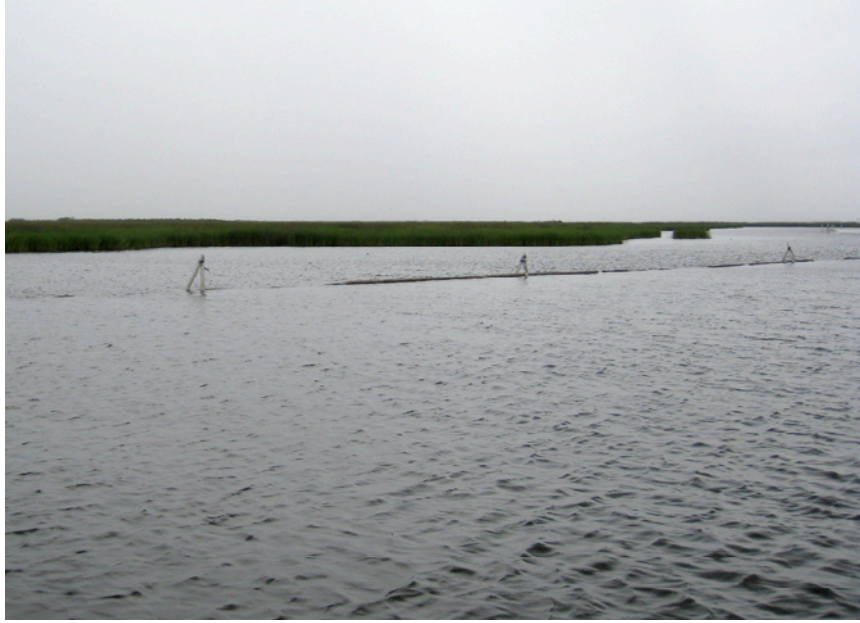
Figure 120. OBS-4-BAT-10 photo 1 taken on August 26, 2010. Site vegetation included *Juncus roemerianus* and *Spartina* sp. Oil was not observed at this site.

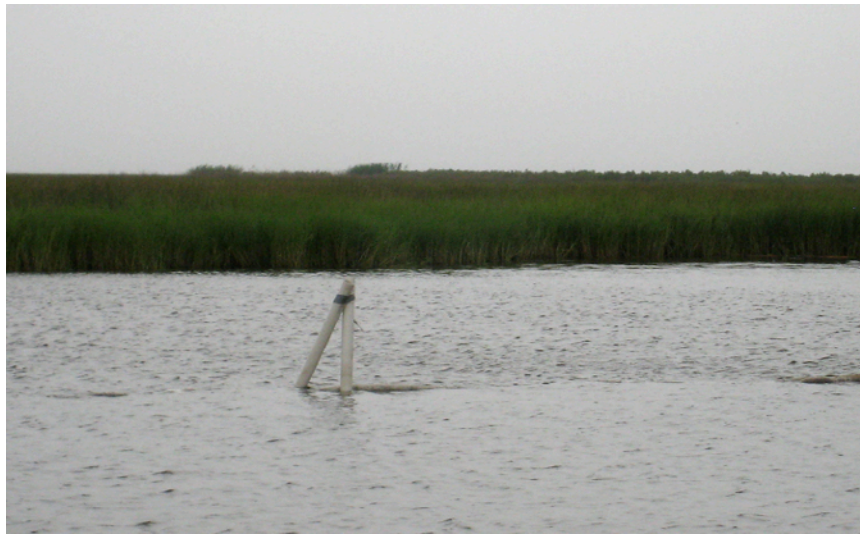
Figure 121. OBS-4-BAT-10 photo 2 taken on August 26, 2010. Site vegetation included *Juncus roemerianus* and *Spartina* sp. Oil was not observed at this site.

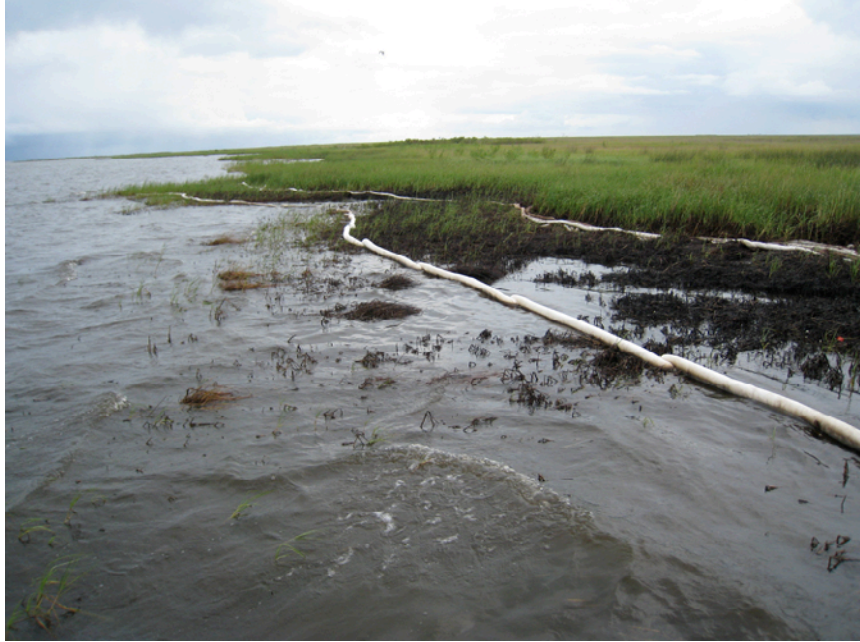
OBS-4-BAT-12	29.44618	89.87867	Aug. 26, 2010	of the survey. Photos of the site are shown in figures 122 and 123. No visible oiling. Dominant plants: <i>Juncus roemerianus</i> and <i>Spartina</i> sp. with stands of <i>Phragmites australis</i> . A photo of the site is shown in figure 124.
--------------	----------	----------	---------------	---

Figure 122. OBS-4-BAT-11 photo 1 taken on August 26, 2010. Site vegetation included *Juncus roemerianus* and *Spartina alterniflora*. Oiled vegetation and oil-damaged canopy were observed at this site.

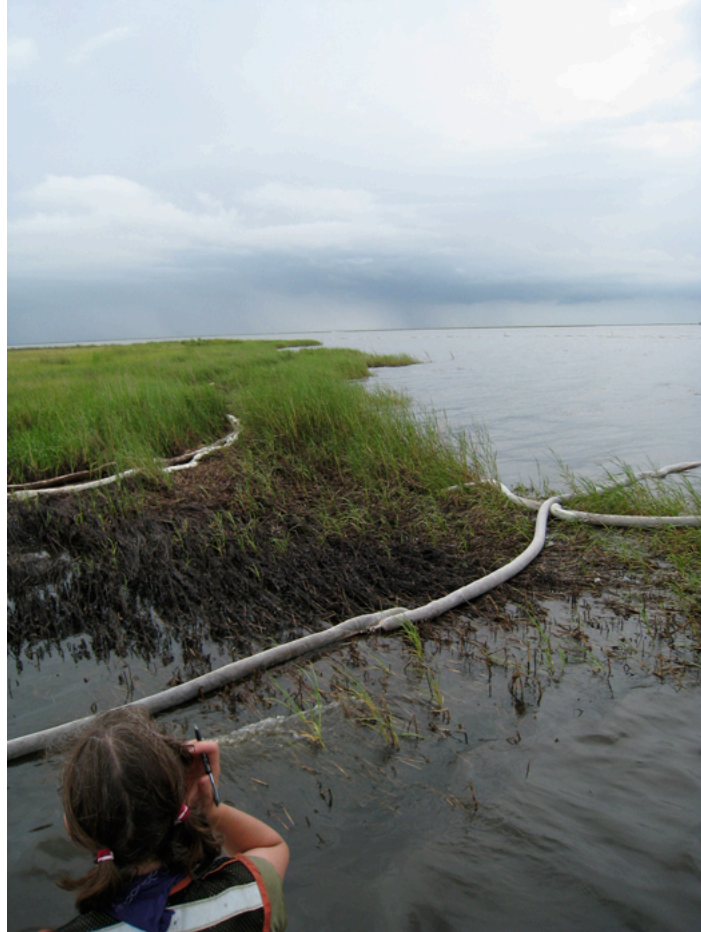
Figure 123. OBS-4-BAT-11 photo 2 taken on August 26, 2010. Site vegetation included *Juncus roemerianus* and *Spartina alterniflora*. Oiled vegetation and oil-damaged canopy were observed at this site.

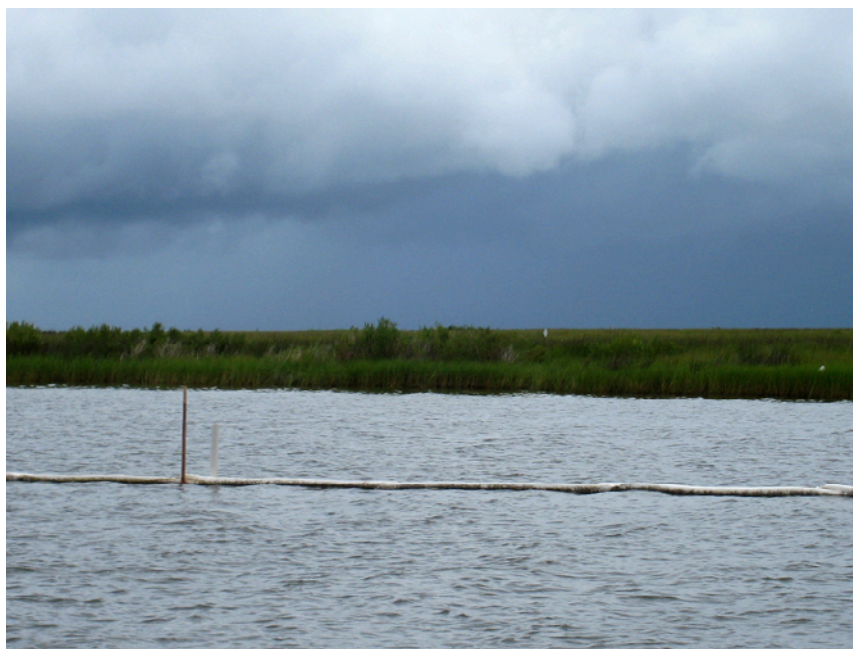
Figure 124. OBS-4-BAT-12 photo 1 taken on August 26, 2010. Site vegetation included *Juncus roemerianus* and *Spartina* sp. Oil was not observed at this site.

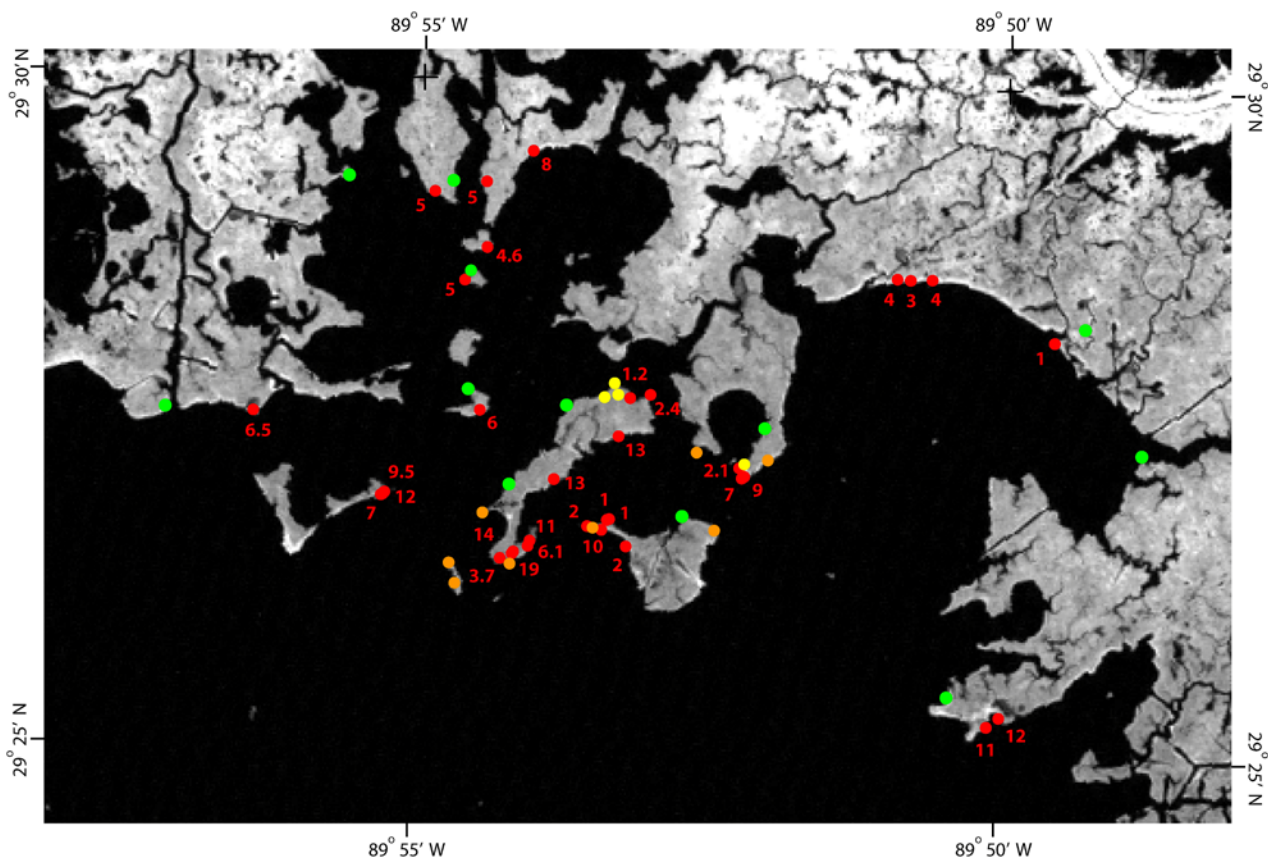
Oil-damaged canopy extended to a maximum of 19 m inland (the widest oil damaged zone was at survey point DWO-4-BAT-03). For the Barataria Bay survey areas, figure 125 shows the magnitude of observed oil impacts in four classes, indicated by colors: green indicates that oil was not observed, yellow indicates oil was found on stems of upright and intact plants, orange indicates that oil-damaged canopy was observed but the depth of penetration of the oil-damaged zone was not measured, and red indicates oil-damaged canopy was observed and its extent measured, with the adjacent number indicating the depth (in meters) that the oil damage extended into the marsh.

**Figure 125. Survey points in Barataria Bay, oil damage indicated by color codes: green indicates that oil was not observed, yellow indicates oil was found on stems of plants, orange indicates that oil-damaged canopy was observed but the depth of penetration of the oil-damaged zone was not measured, and red indicates oil- damaged canopy was observed and the adjacent number indicates the extent (in meters) that the oil damage extended into the marsh.**

Oil was not observed at 15 of the 61 survey points in Barataria Bay. The presence of oil on plant stems, but not oil-damaged canopy, was observed at four survey points. Oil-coated vegetation with accompanying damaged canopy in the form of broken and laid over vegetation, was observed at a total of 42 survey points. For the 34 survey points with measurements of oil-damaged canopies, the mean depth of penetration of the oil-damaged zone was 6.7 m, with a
