# Liquefaction and Other Ground Failures in Imperial County, California, from the April 4, 2010, El Mayor–Cucapah Earthquake

By Timothy P. McCrink, Cynthia L. Pridmore, John C. Tinsley, Robert R. Sickler, Scott J. Brandenburg, and Jonathan P. Stewart

U.S. Geological Survey Open-File Report 2011–1071

California Geological Survey Special Report 220

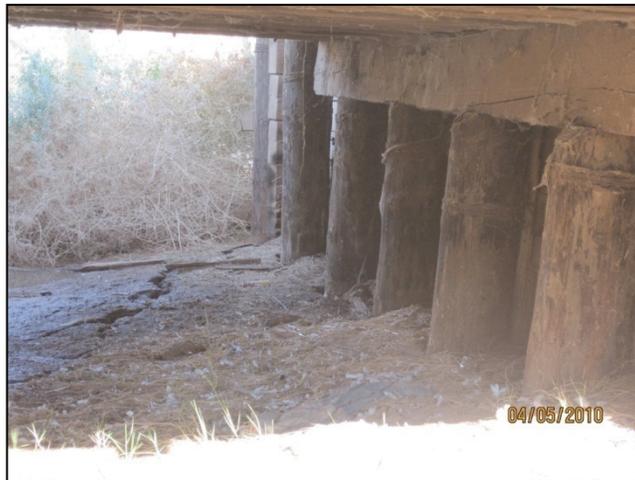
The Brockman Road crossing of Greeson Drain consists of a timber bridge supported on timber piles. The plan dimensions of the bridge are approximately 7 m × 8 m. No vented sand was observed at this bridge or the surrounding area. However, lateral spreading of the south bank of the drain (fig. 4), settlement of fill at both approaches, and lateral spreading of the northeast fill shoulder (fig. 5A) suggest that liquefaction occurred either below or within the fill. Strong shaking of the bridge structure appears to have split one of the guardrail support posts (fig. 5A). The fill settlement was pronounced enough for the authorities to close the bridge to traffic, though it could still be safely crossed at slow speed.

**Figure 4.** Lateral spread ground cracking on the north bank of Greeson Drain beneath the Brockman Road Bridge (R02). Photo by E. Seyhan, 4/5/10.

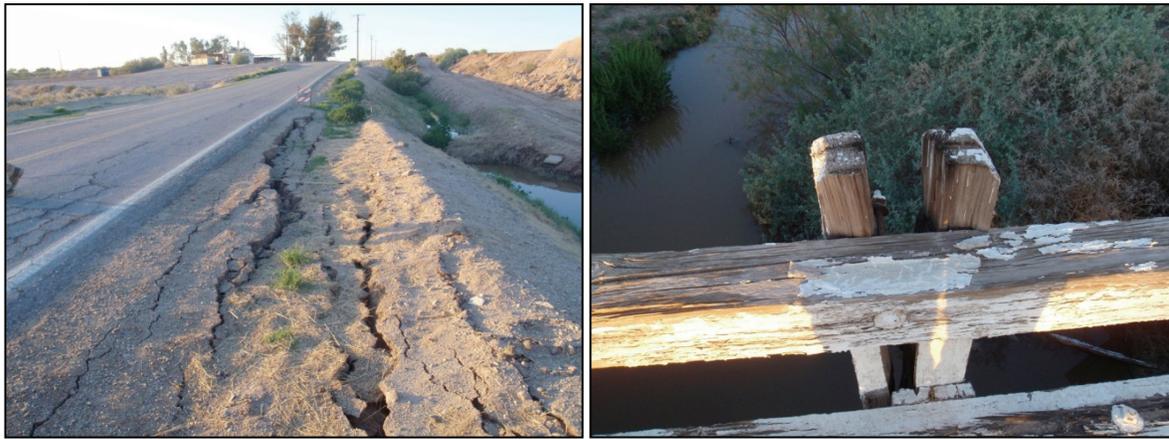
**Figure 5.** A, View along east margin of Brockman Road near Greeson Drain (R02) showing fractures and slumping of road fill. Tape in middle ground is 1 m long. Extensional cracking also affected pavement of Brockman Road. B, Strong ground shaking and ground deformation in fill drove the wood guardrail from south to north, causing posts supporting the guardrail to split. Photos by J. Tinsley, 4/7/10.

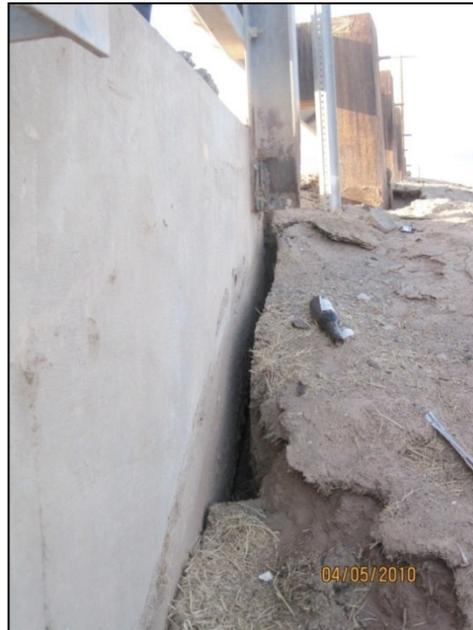
The Brockman Road overcrossing of the New River exhibited ground deformation consisting of embankment fill separating from the abutment in the transverse (fig. 6) and longitudinal directions, and longitudinal cracking of the pavement at both approaches (fig. 7). The single-span bridge had plan dimensions of approximately 10 m × 25 m and is supported on concrete piles. On the north side of the bridge, separation between the soil and pile of approximately 8 cm was observed. Along both sides of the road, modest ground cracking, settlements and lateral deformation of 8 cm width and 5 cm height were observed. Surface evidence of liquefaction in the form of vented sand was not found at this site, though the patterns of ground deformation are consistent with the effects of liquefaction documented at other bridge sites.

**Figure 6.** Approximately 5 cm separation of embankment soil from the concrete abutment at the Brockman Road Bridge over the New River (R05). Photo by E. Seyhan, 4/5/10.

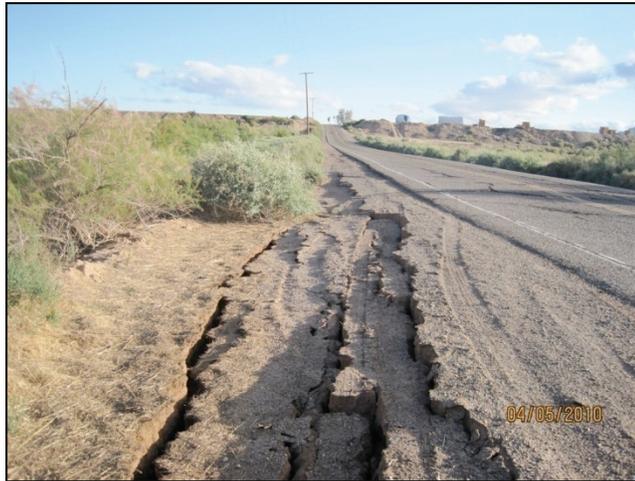
**Figure 7.** Ground cracking, settlement, and lateral deformation along the south approach to the Brockman Road Bridge crossing the New River (R05). Photo by E. Seyhan on 4/5/10.

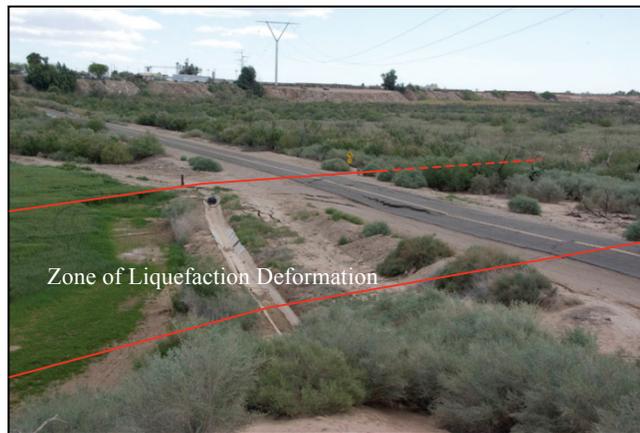
Liquefaction-induced lateral spreading occurred in the New River floodplain at Lyons Road at a distance of roughly 200 m west of the New River bridge crossing and again about 100 m east of the bridge, where the road name changes to Nichols Road. Southwest of the bridge, lateral spreading occurred primarily toward the field on the north side of Lyons Road (fig. 8), though deformation to the east-northeast toward the river was also apparent south of Lyons Road for a distance of at least 100 m. Ground deformation caused horizontal and vertical offsets in road pavement (fig. 9); the road was closed following the earthquake. An irrigation canal adjacent to the north side of Lyons

**Figure 8.** View of damage to Lyons Road and adjacent irrigation canal owing to lateral spreading toward field on left side of image (R06). The approximate area that experienced liquefaction deformation is indicated. The bridge structure over the New River is roughly 200 m farther to the northeast (upper left background in the photo) and suffered no apparent damage. Photo by S. Brandenburg, 4/5/10.

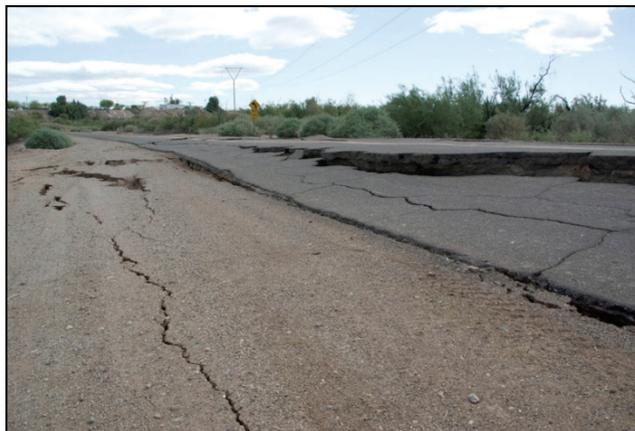
**Figure 9.** Settlement of Lyons Road pavement and north shoulder owing to lateral spreading within the zone of liquefaction deformation shown in the preceding photo (R06). Photo by S. Brandenburg, 4/5/10.

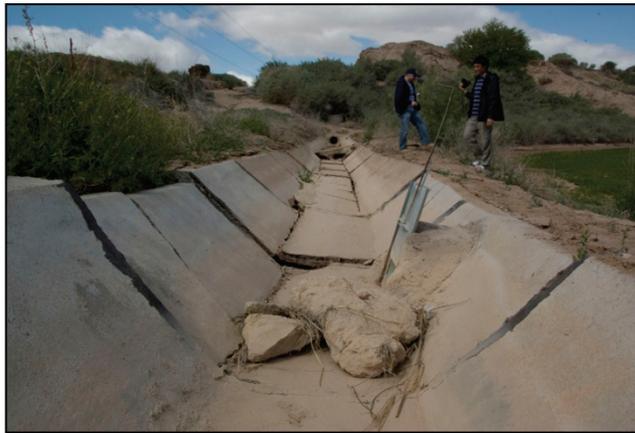
**Figure 10.** Effects of lateral spreading on the small irrigation canal adjacent to Lyons Road (R06). Photo by S. Brandenburg, 4/5/10.

Road was also substantially damaged by liquefaction-related deformation (fig. 10). Vented clean fine sand was observed in several places in the southwest corner of an agricultural field north of Lyons Road (fig. 11).

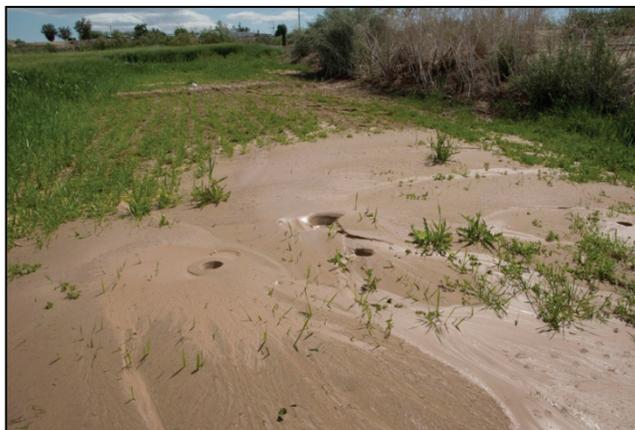
**Figure 11.** Vented sand in the agricultural field immediately north of Lyons Road (R06). Photo by S. Brandenburg, 4/5/10.

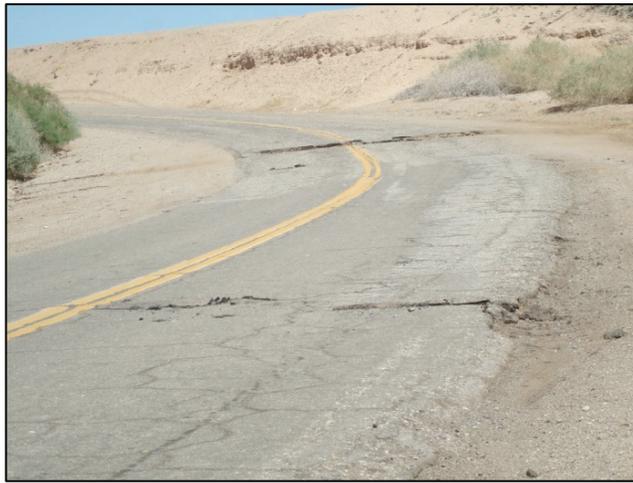
Roughly 100 m northeast of the bridge, on Nichols Road, less severe settlement was observed, and no vented sand was apparent. A pair of fissures 20 to 30 m apart cross the paved road (fig. 12) and extend into and through the fill embankment on both sides. The upper fissure had about 5 cm vertical separation, down on the downslope side. The lower fissure showed minor compression of the asphalt. Road-parallel fissures formed in the southeast embankment suggesting some insipient lateral spreading on this side. Dense vegetation precluded observations of the surrounding flood plain deposits.

**Figure 12.** Possible liquefaction-related settlement in fill underlying Nichols Road, northeast of the New River (R06). Upper fissure had about 5 cm vertical displacement with extension in the asphalt, whereas the lower fissure had little vertical displacement but showed compression in the asphalt. Road-parallel fissures were observed in the fill embankment to the right of this photo. Photo by T. McCrink, 4/9/10.

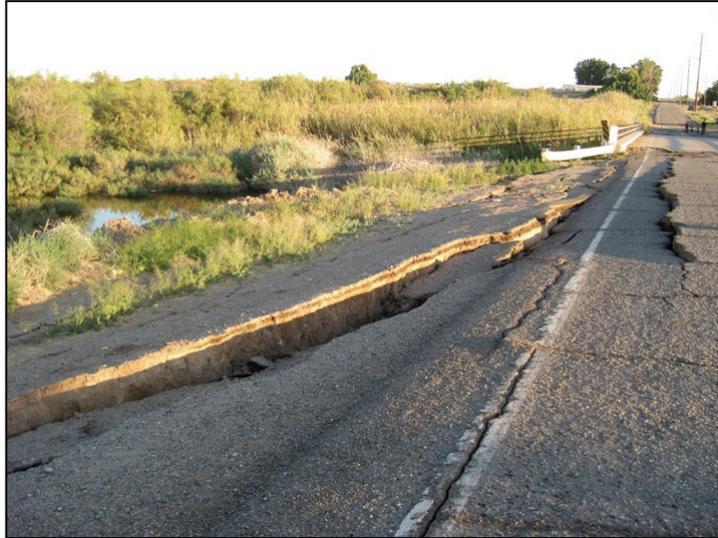
The approach fill on the north side of the bridge spread laterally, opening large road-parallel fissures and grabens (fig. 14). Pre-existing cracks in asphalt were opened up and showed evidence of adjacent asphalt slabs pounding and grinding against each other. Asphalt adjoining the concrete bridge structure on both sides was pushed up and broken into cobble- and gravel-size particles (fig. 15).

**Figure 14.** Lateral spreading of the north approach fill to the Drew Road Bridge (R07). Vented sand shown in figure 13 is immediately left of this photo. View to the south. Photo by T. McCrink, 4/8/10.

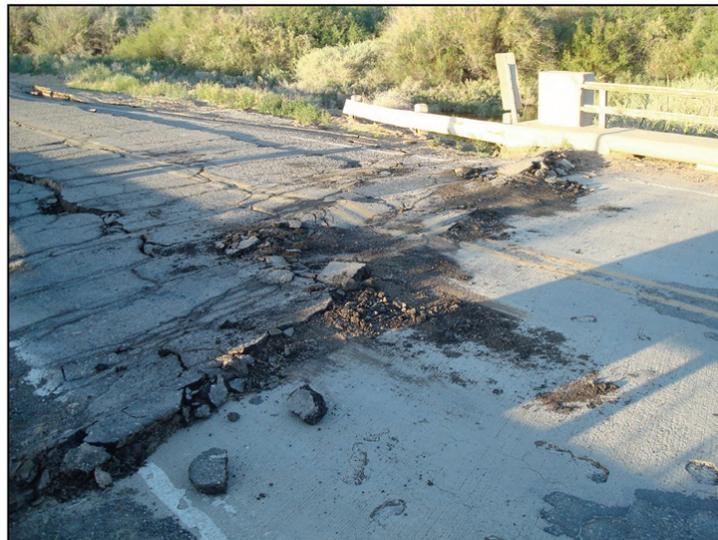
**Figure 15.** Battered asphalt on the north side of the concrete Drew Road Bridge structure (R07). Similar deformation was found on the south side as well. View to the northeast. Photo by T. McCrink, 4/8/10.

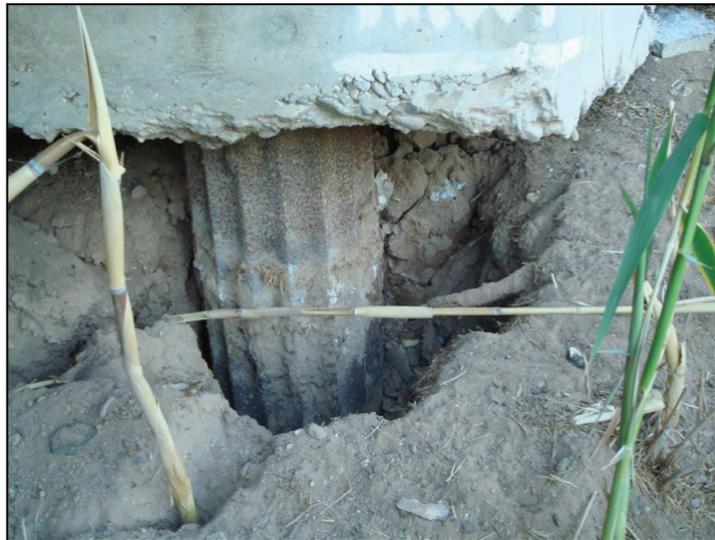
Fill at the north bridge abutment dropped at least 10 cm. The bridge piers under the north abutment pushed surrounding soil leaving 10 to 20 cm openings, and the concrete abutment was cracked and spalled (fig. 16). Combined with the battered asphalt at the bridge edges, the soil

disturbance around the piers suggests significant north-south movement of the bridge structure during the earthquake due to shaking.

**Figure 16.** View of the concrete pier under the northeast corner of the Drew Road Bridge abutment (R07). Soil pushed away from the pier coupled with the battered asphalt on the road above (fig. 15) suggests that the bridge structure experienced large shaking displacements. Note spalled and cracked concrete in the abutment in the upper right corner of photograph. Photo by T. McCrink, 4/8/10.

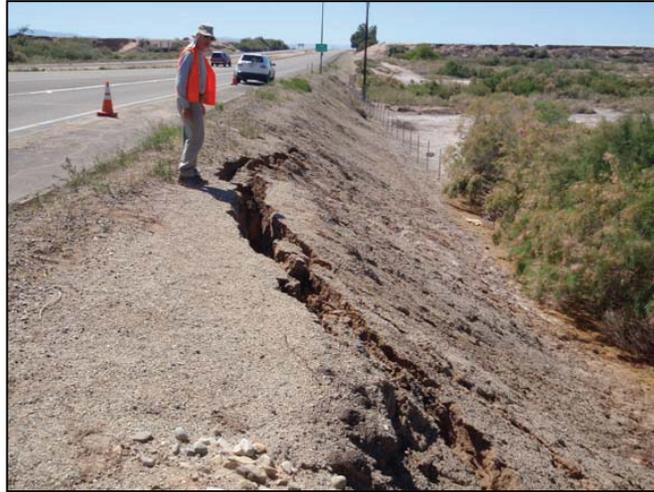
**Figure 18.** Extensional fractures and fill failure on the north side of Interstate Highway 8 and east bank floodplain of the New River, just north of the extensional fractures shown in figure 17 (R08). All deformation here inferred to be due to liquefaction on the basis of the presence of lateral spread fissures and vented sand on the New River flood plain 50 m or less to the west. Photo by J. Tinsley, 4/7/10.

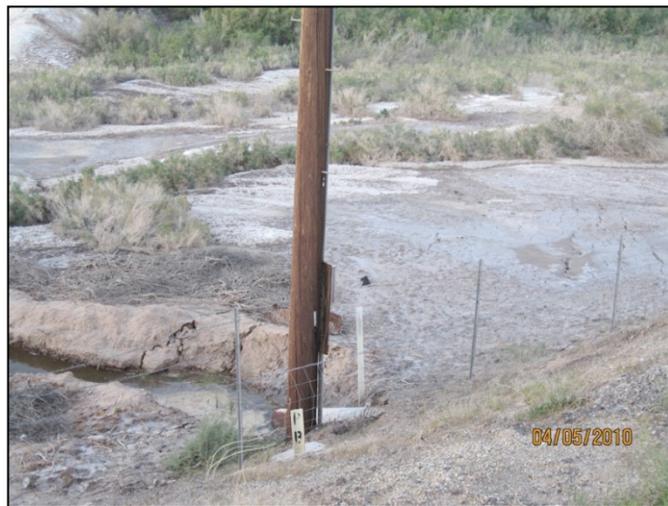
**Figure 19.** Lateral spread fissures and vented sand north of Interstate Highway 8 on the east bank of the New River (R08). These liquefaction features were only 50 m or less from the fill failure and pavement fractures shown in the previous figures, and they strongly suggest that liquefaction is responsible for the deformation of the highway. Photo by E. Seyhan, 4/5/10.

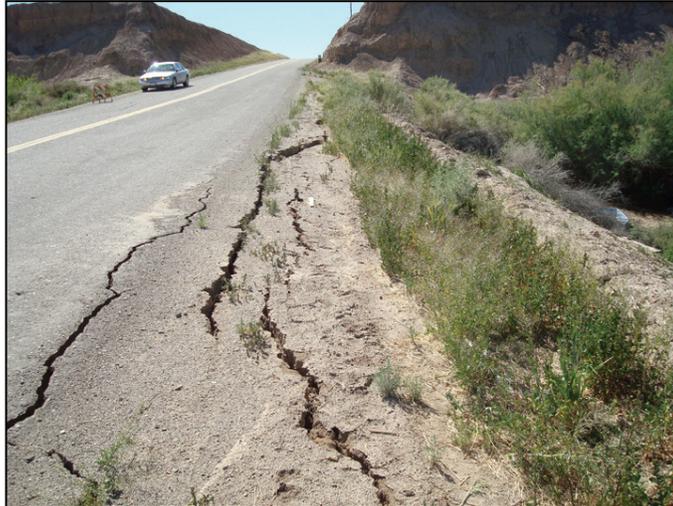
**Figure 23.** Lateral spreading fissures in approach fill on the northwest side of the Worthington Road Bridge over the New River (R18). Similar fissures were observed on the south side, but no vented sand was found. View is to the west. Photo by T. McCrink, 4/8/10.

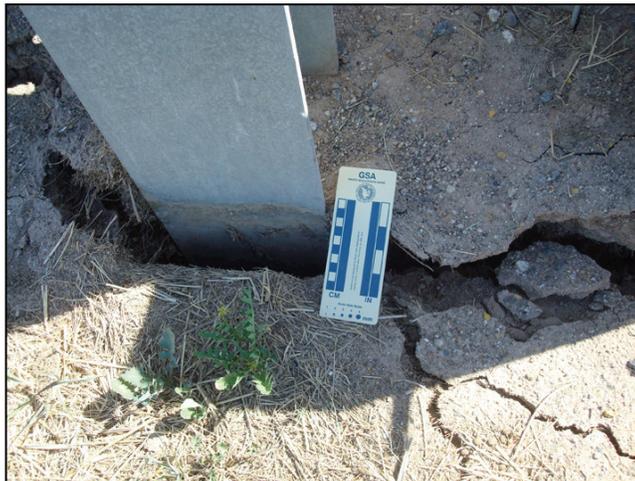
**Figure 24.** Bridge fill pushed away by the Worthington Road Bridge abutment due to strong shaking (R18). Photo by T. McCrink, 4/8/10.

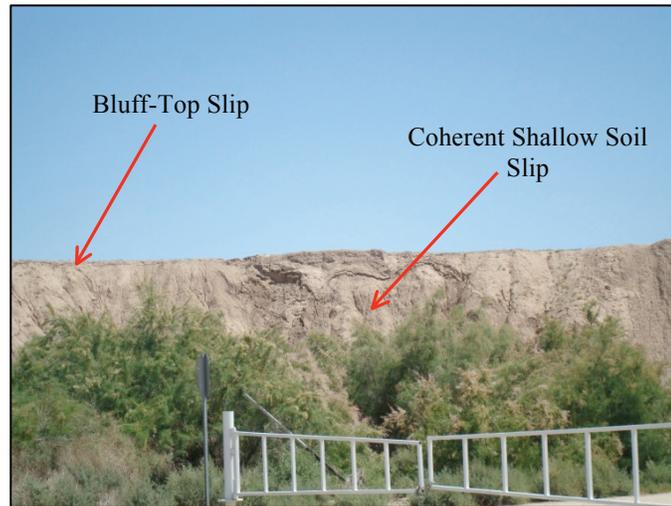
Observations were made at the Forrester Road crossing of the New River, just north of the intersection with Larsen Road. Cracks in road fill and adjacent alluvium along Larsen Road next to the river indicate some minor movement (2 millimeters (mm)) toward the river free face. No vented sands were found. The driven pile foundation of the Forrester Road Bridge appeared undamaged. Shallow soil slips of loose colluvial material were observed on the steep bluffs south and southeast of the bridge. These soil slides occurred as 5- to 20-m-wide coherent crusts of colluvial material with 10 to 30 cm of displacement at their heads, or linear slip cracks at the interface of the colluvial material and well-cemented soil near bluff tops with 5 to 10 cm of displacement (figure 25).

**Figure 25.** Shallow colluvial soil slips on steep slopes southeast of the Forrester Road Bridge over the New River (R22). Photo by T. McCrink, 4/8/10.

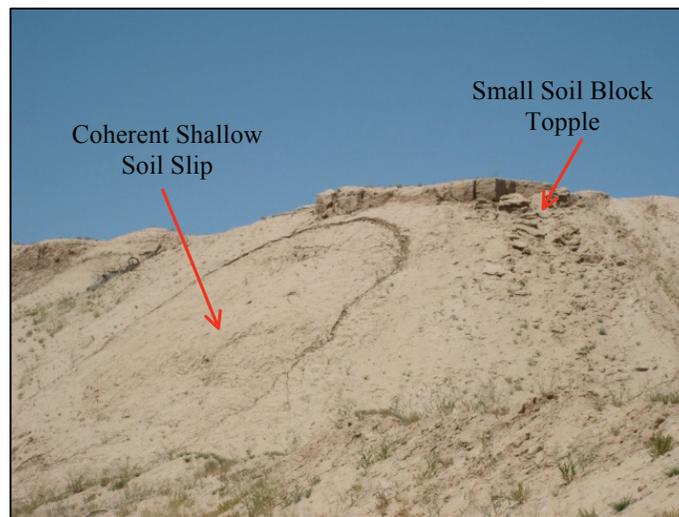
**Figure 26.** View of the roadcut northwest of the Keystone Road Bridge (R23). A shallow soil slip with 10 to 15 cm displacement is evident on the left side of the photo, and a soil block topple is visible on the upper right. Photo by C. Pridmore, 4/8/10.

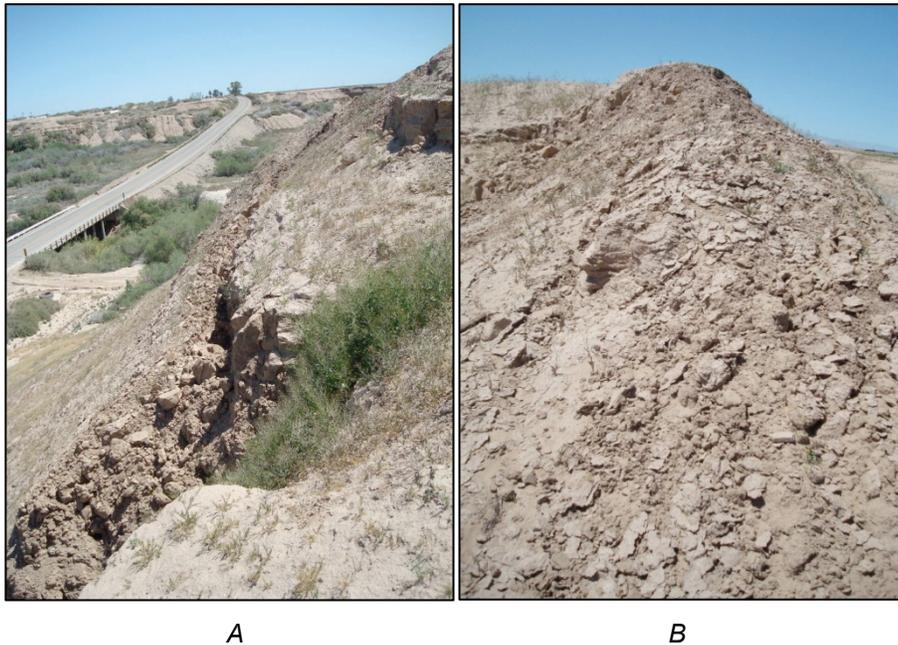
**Figure 27.** Slope effects near the top of the New River bluff at the Keystone Road Bridge (R23). *A*, View of Keystone Road Bridge at the New River with detached mass of colluvial soil in foreground. View to the northeast. *B*, Shattered soil crust on small east-west ridge southwest of the Keystone Road Bridge. Photos by T. McCrink, 4/8/10.

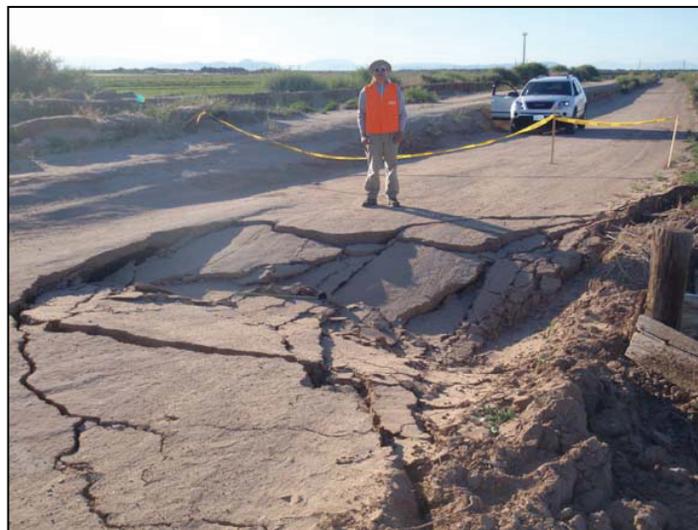
Approximately 450 m south of Highway 98, a part of the Westside Main Canal's western levee collapsed into a void of uncertain origin (fig. 38). An absence of vented sand suggests that the observed ground failure may be ascribed to pre-earthquake piping that caused voids to form beneath the road surface within the levee materials. A nearby well and pump installation also showed evidence of ground settlement.

**Figure 38.** Collapse of the Westside Main Canal's western access road (C05). Undermining of the road surface probably reflects pre-earthquake piping along transverse subgrade structures or other zone of seepage from the canal. No vented liquefied materials were noted in the area. Photo by J. Tinsley, 4/6/10.

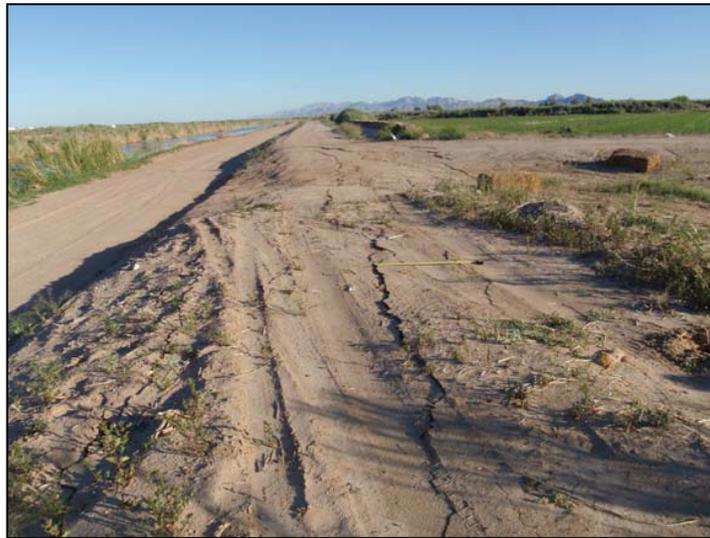
A substantial lateral spread spanned the 19 m width of the west bank levee of the Westside Main Canal and extended into an area of higher ground farther west (fig. 39). These arcuate fractures continue for about 100 m along the channel, and cumulative extensional displacements amounted to about 10 cm at the head of the failure. No vented sand was observed, but liquefaction is a likely cause of the deformation.

**Figure 39.** View of extensional fractures at head scarp of lateral spread crossing the embankment in the foreground and including Westside Main Canal's service road to the left (C06). Riparian vegetation is tilted towards the canal owing to lateral spreading. Photo by J. Tinsley, 4/6/10.

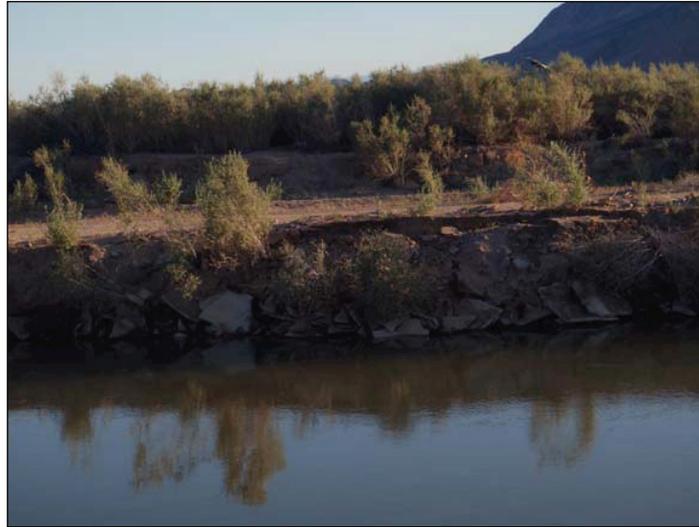
A series of shallow slumps in the east and west banks of the Westside Main Canal extended almost continuously for nearly a kilometer north of State Highway 98. Vented soil materials were not observed in association with these bank failures, and the failures likely are due to strong shaking rather than liquefaction. Figure 41 shows a typical example of this type of ground failure.

**Figure 41.** Bank failure probably unrelated to liquefaction in the west bank of Westside Main Canal (C08). This style of failure was observed on both sides of the Westside Main Canal for nearly a kilometer north of State Highway 98. Failures seldom extended more than a meter or two into the levee materials and the bulk of the levees remained undamaged. Photo by J. Tinsley, 4/7/10.

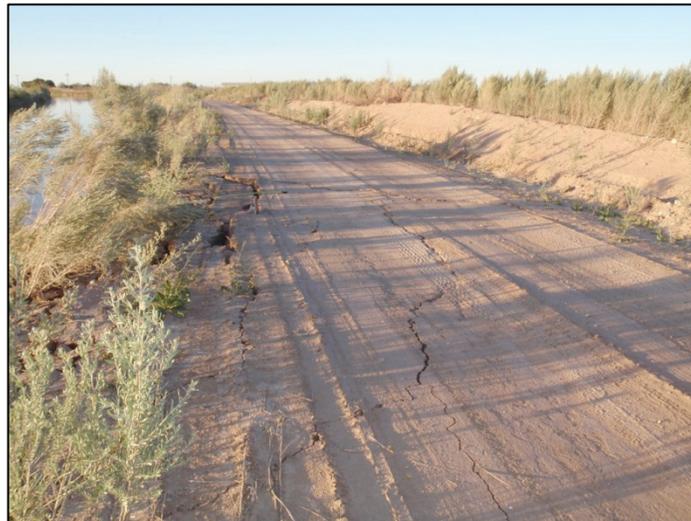
A small ground failure, possibly a lateral spread, was observed (fig. 42). Extensional fractures were open to a depth of 94 cm and one single block shows a maximum differential

vertical separation of 16.5 cm near the canal's bank. Neither vented materials nor leakage associated with this ground failure in levee materials was observed. However, the geometry of the failure is consistent with liquefaction.

**Figure 42.** View to north across inferred liquefaction lateral spread in the east bank of the Westside Main Canal (C14). Extensional fractures are open to 95 cm depth and extend across entire width of Westside Main Canal east service road for tens of m. Photo by J. Tinsley, 4/6/10.

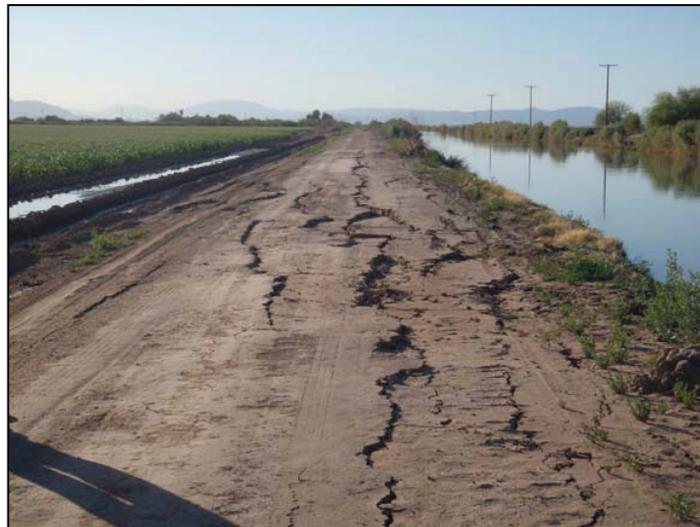
**Figure 45.** View to the northwest along the western levee of the Westside Main Canal showing large lateral spread ground failure that spanned the entire width of the levee (C25). The ground failure extended about 200 m along the levee, and the small in-facing scarplets indicate that the levee mass sank differentially into a liquefied substrate. Photo by J. Tinsley, 4/7/10.

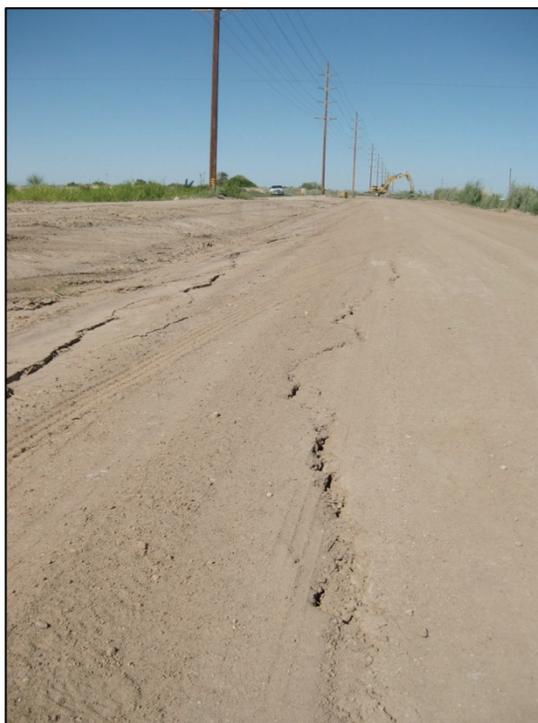
**Figure 56.** View to the northeast of fractures running through the outer edge of the Westside Main Canal levee road (C51). Extensional and vertical displacements are one to several centimeters with displacement downward and toward the canal. Photo by C. Pridmore, 4/8/10.

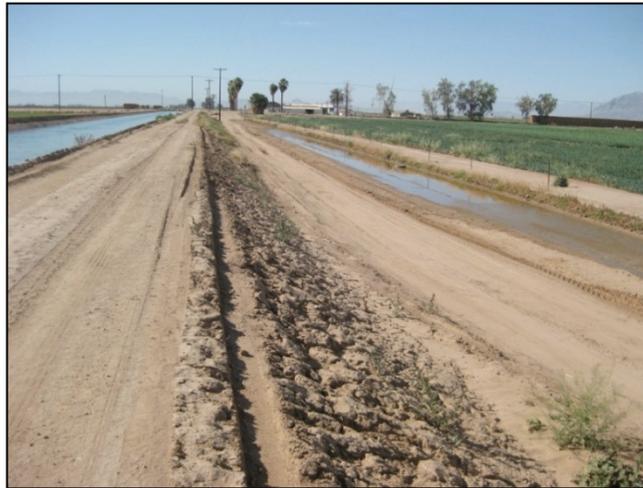
The Eucalyptus Canal was the only irrigation canal that exhibited clear evidence of water seicheing over the canal levee. This evidence was observed in two places, the first along a 150 m length north of McCabe Road (fig. 67). Surface soils on the west levee clearly showed the effects of water flow, and a large puddle of water was still on the adjacent Nichols Road one week after the earthquake.

**Figure 67.** View to the southwest along Nichols Road showing ponded water in a low lying area along Nichols Road (C40). This area is located approximately 150 m north of McCabe Road, which is marked by the trees in the background. Soils on the outer levee side that have not been disturbed by postearthquake traffic show erosion caused by water flow. Photo by C. Pridmore, 4/11/10.

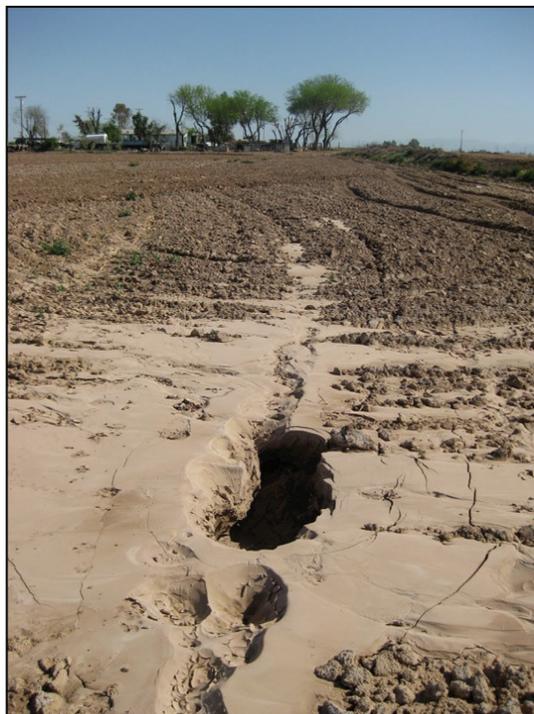
observed (fig. 75). The large sand boil had an unusually large crater that was 1 m long, 20 cm wide, and 40 cm deep. The sand boils formed along a linear fissure about 40 m east of and parallel to the canal. Another fissure in the field, 30 to 35 m east of the canal and north of that just described, showed evidence of water seepage with little or no vented sediment (fig. 76). Because the focus of the levee repairs was adjacent to this fissure, it appears that liquefaction may have damaged the levee and allowed considerable seepage onto the field. Repairs by compaction with

**Figure 75.** Large sand boil that formed along a fissure on the east side of the Rosita Canal (C56). The sand boil has an unusually large crater and the concentric cracks suggest subsequent caving. View to the south; the Rosita Canal is to the right of the picture. Photo by C. Pridmore, 4/11/10.

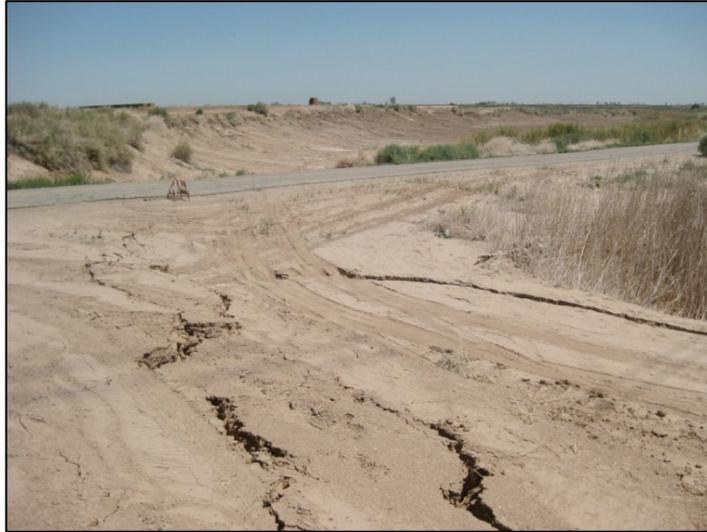
Settlement and lateral spread deformation was observed in fill and natural deposits in Greeson Drain south of Lyons Road. Lyons Road fill at the west edge of the drain also appears to have experienced settlement in line with settled fill (fig. 77). Most fractures were observed in access road fills south of Lyons Road and west of the drain. These fills range in thickness from 1 to 2 m and contain arcuate cracks with as much as 30 cm vertical separations and extension on the order of 10 cm (fig. 78). The edge of the west access road along the drain had a linear extensional separation that was followed for a distance in excess of 300 m. The separations were as much as 50 cm wide. Some portions of this dirt access road showed the development of paired fissures with down-dropped graben between them. No vented sand was observed but liquefaction is inferred from the morphology and extent of the failures.

**Figure 77.** View looking northeast across Lyons Road and down Greeson Drain (D03). The culvert under Lyons Road is located to the right of this photo but the settlement in fill in the foreground appears to continue beneath Lyons Road. North of Lyons Road the drain bottom, slopes, and upper edges have all recently been regraded. Photo by C. Pridmore, 4/9/10.

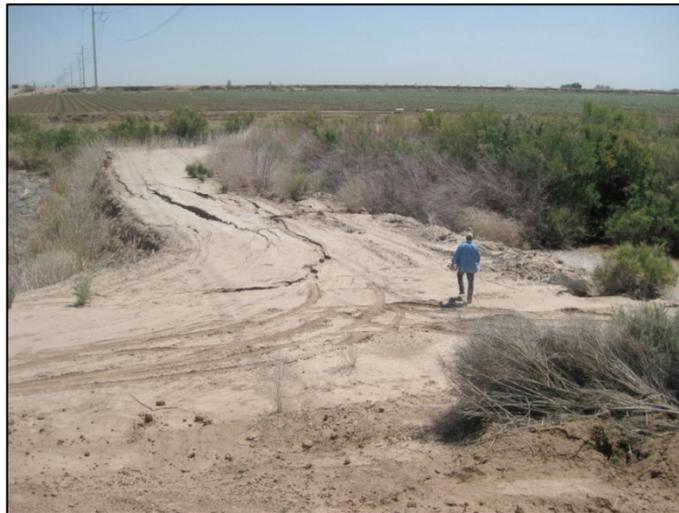
**Figure 78.** View to the east across Greeson Drain at liquefaction lateral spread fissures in the access road fill prism (D03). The full width of the road fill settled and the northern two-thirds spread to the north. Photo by C. Pridmore, 4/9/10.

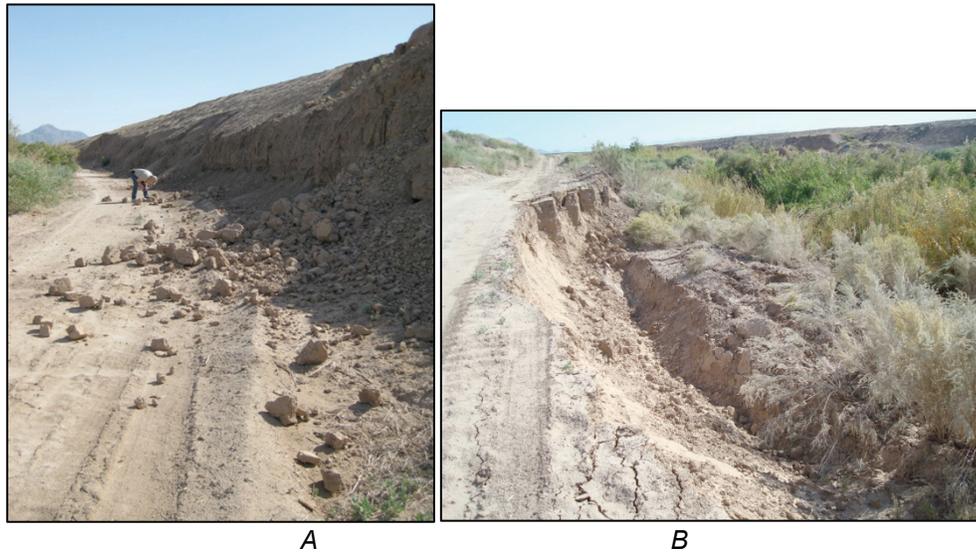
Access to the west side of Fig Drain was partially blocked by numerous soil block falls onto the dirt road, roughly 500 to 600 m south of where the drain enters the New River (fig. 79). These talus cones of blocky soil could be observed on the road for several hundred meters farther to the south. On the east side of the drain in the same area, a 20- to 30-m-wide slump dropped the outer 2 m of the dirt road into the drain. It could not be determined if liquefaction of the saturated soil along the edge of the drain was involved in this slump, as dense vegetation obscured any view of the drain channel or its banks.

**Figure 79.** Access roads along Fig Drain, south of Fig Lagoon (D07). *A*, Blocky soil topple/fall on the west side of Fig Drain. Several more talus cones of material can be seen in the distance. *B*, Slump of the outer edge of the dirt road on the east side of Fig Drain. Both photos looking south. Photo *A*, by C. Pridmore, and photo *B* by Tim McCrink; 4/10/10.

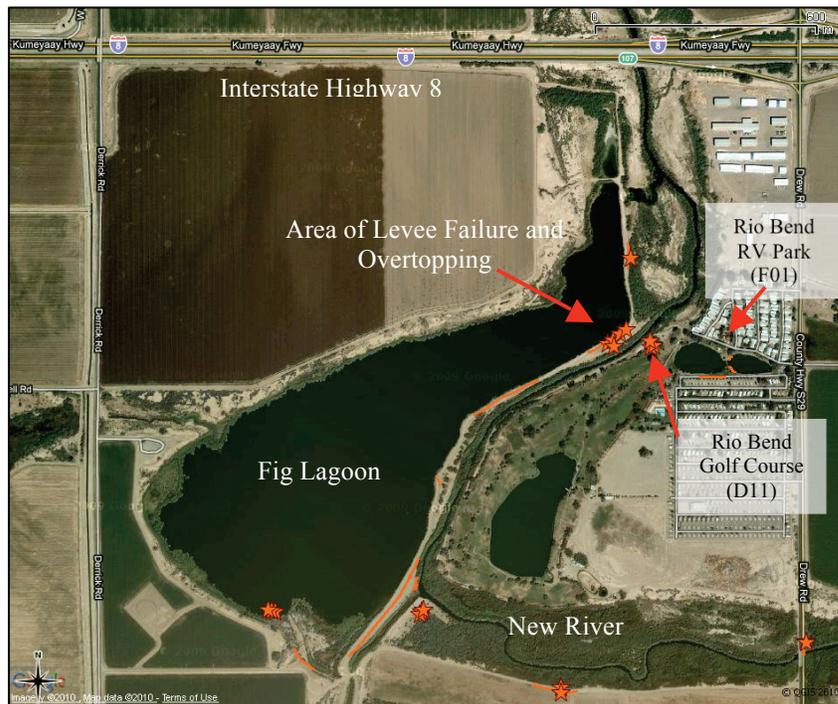
**Figure 80.** Diagrammatic sketch of liquefaction-related features in the vicinity of Fig Lagoon (D10). Red lines represent lateral spread cracks and red stars represent areas of vented sand. Fig Lagoon lies south of Interstate Highway 8, west of Drew Road, and east of Derrick Road. Also shown are the Rio Bend RV Park and Rio Bend Golf Course sites, which will be discussed in under site entries F01 and D11 respectively. Base image is from Google Maps.

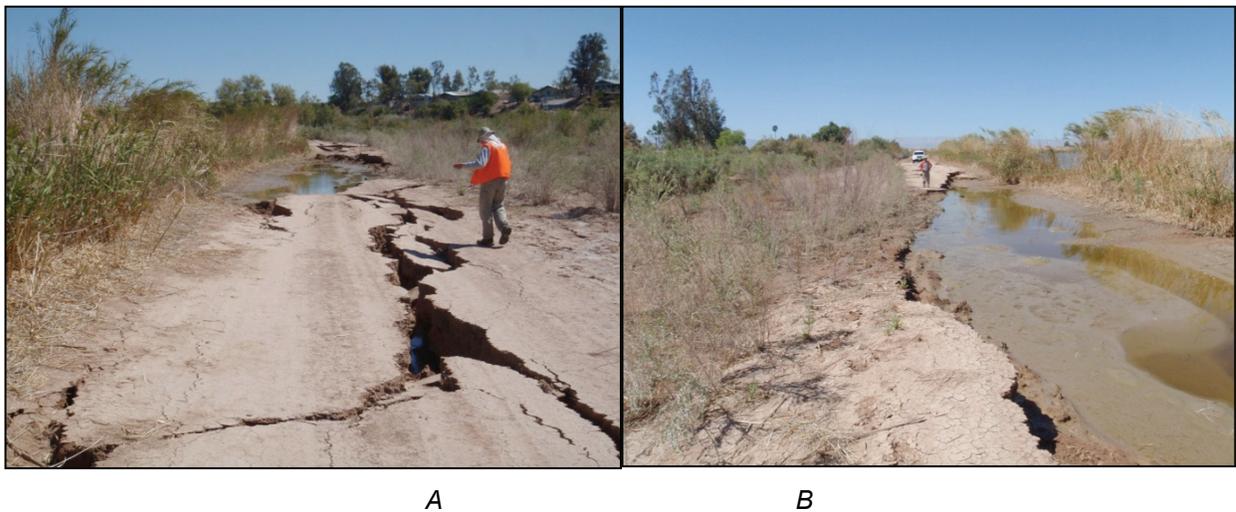
**Figure 81.** Lateral spread–slump failure of the levee between Fig Lagoon and the New River (D10). *A*, View to the northeast along the levee impounding Fig Lagoon, showing liquefaction lateral spread cracks and the large slump that allowed a breach in the levee, overtopped by seiche wave activity. Lake is to the left of riparian vegetation in left foreground of image. *B*, View to the southwest showing the slump and breach in the Fig Lagoon levee. Fig Lake is visible through the vegetation on the right of the image. Standing water is about at the level of Fig Lake. After the earthquake Fig Lake drained near here through an overflow channel that was eroded by escaping lake water. Photos by J. Tinsley, 4/7/10.

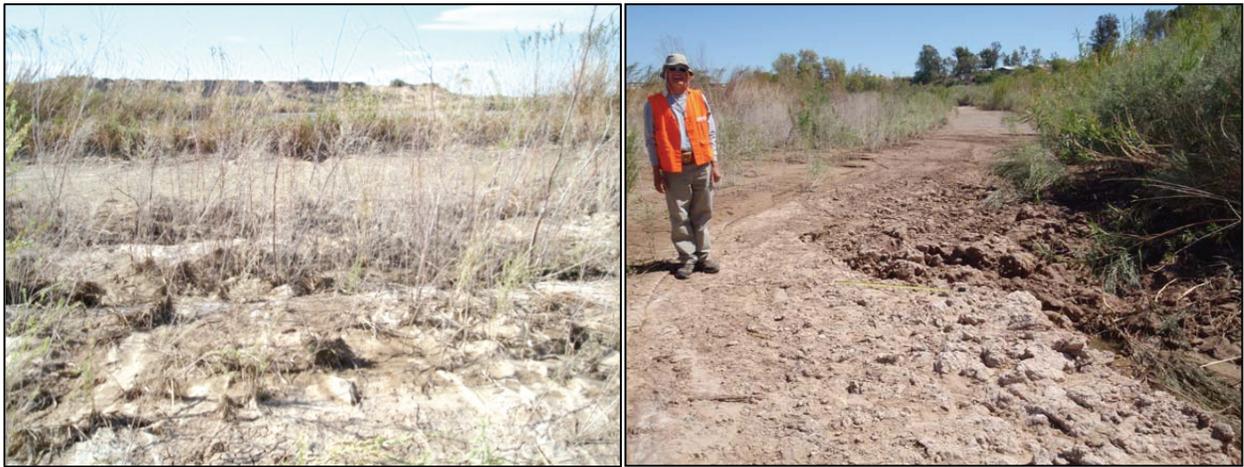
**Figure 82.** Depositional and erosional features resulting from seiche wave overtopping of Fig Lagoon levee (D10). *A*, Sand deposition and flow features on the Fig Lagoon levee as a result of overtopping by seiche waves. Water flow came toward the photographer. Lateral spread slump is in the middle background; Fig Lagoon is beyond riparian vegetation on the outer edge of the slump. Photo by T. McCrink, 4/10/10. *B*, Outwash channel eroded into the Fig Lagoon levee adjacent to the New River. Lateral spread slump shown in figure 80 is immediately left of this photo, and the New River is immediately to the right. Photo by J. Tinsley, 4/7/10.

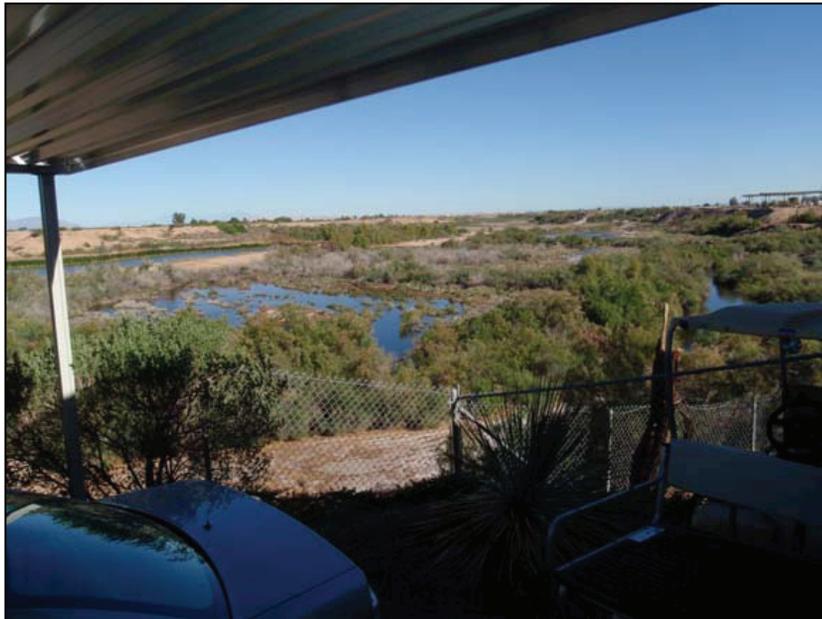
**Figure 83.** View to north and west from the upland east of the New River channel, showing flooding of the New River floodplain between Fig Lagoon, upper left, and the New River, middle right (D10). Photo by J. Tinsley, 4/7/10.

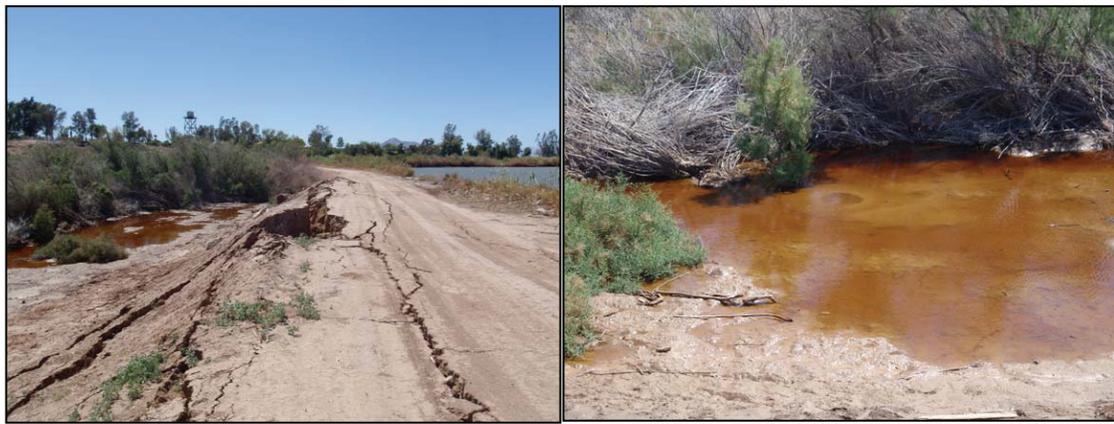
The Fig Lagoon area was first visited by the USGS team on 4/7/10. Some grading had been done towards the south end of the impounding levee, but numerous lateral spreads, occurrences of differential subsidence and abundant vented sand indicated that liquefaction of underlying New River deposits was prevalent. Farther north, liquefaction-induced lateral spreads resulted in subsidence and nearly foundered the impounding levee (fig. 81). An outwash channel had developed there, indicating substantial amounts of water had decanted from the lake by way of the channel into the New River and onto the adjacent floodplain (fig. 82). Eyewitness accounts of the appearance of widespread floodwaters on the floodplain following the earthquake were substantiated on April 7, 2010, by the presence of standing water on the floodplain between the New River and the Fig Lagoon levee, downvalley from the liquefaction-induced outflow channel (fig. 83). Evidence of liquefaction continued to be widespread toward the north end of the levee, involving chiefly the alluvial materials underlying the levee, with consequent lateral spread failures induced into the overlying levee itself (fig. 84).

**Figure 84.** Zone of liquefaction-triggered ground failure in Fig Lagoon levee 175 m north of the slump and overflow channel depicted in preceding photos (D10). *A*, Scarps in the levee indicate that differential subsidence into a liquefied substrate probably occurred. *B*, Sand boil deposits presently underwater atop late Holocene floodplain deposits of New River at Fig Lagoon. Preservation of vented materials is morphologically excellent, indicating that a subaqueous eruption is probable. Photos by J. Tinsley, 4/7/10.

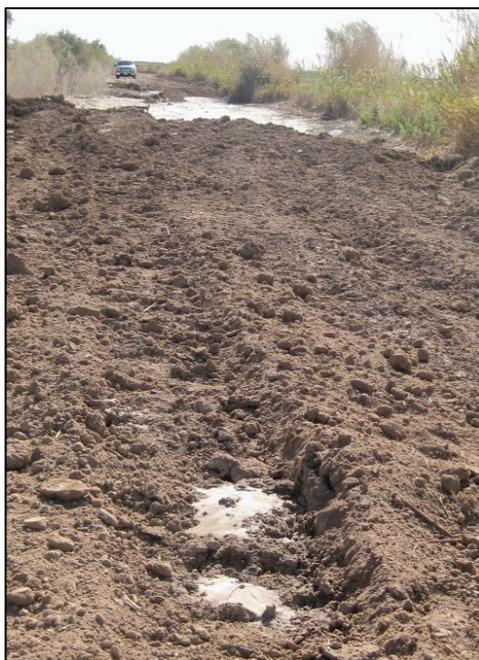
**Figure 86.** Vented sand (bottom center) on a recently regraded levee next to Fig Lagoon, indicating that liquefaction of saturated soils continued to occur during aftershocks (D10). Fig Lagoon lies to the right of the vegetation in the upper right. Wet area between graded material in the foreground and vehicle in the background is where lateral spreading and overtopping of lake water occurred (figs. 80 and 81). Photo by C. Pridmore, 4/10/10.

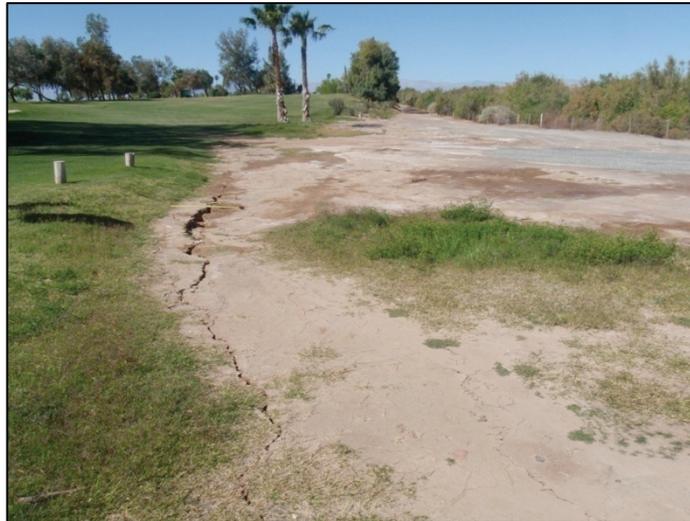
Liquefaction lateral spreading was found on the north side of the golf course adjacent to the New River, across the river southeast of the main levee breach between Fig Lagoon and the New River (see fig. 80). This arcuate spread displaced the ground about 15 cm horizontally to the northwest, toward the active channel of the New River, and included both fill and recent alluvium of the New River. Vented sand, still wet three days after the earthquake, was found near the upper parts of this spread (fig. 87).

**Figure 87.** Liquefaction lateral spread west of the Rio Bend RV Park (D11). Golf course on the left and New River active channel is at the right immediately beyond the line of riparian vegetation. A horizontal extension of about 15 cm was measured. Wet vented sand, dark brown in the photo, was observed here, 3 days after the mainshock. Photo by J. Tinsley, 4/7/10.

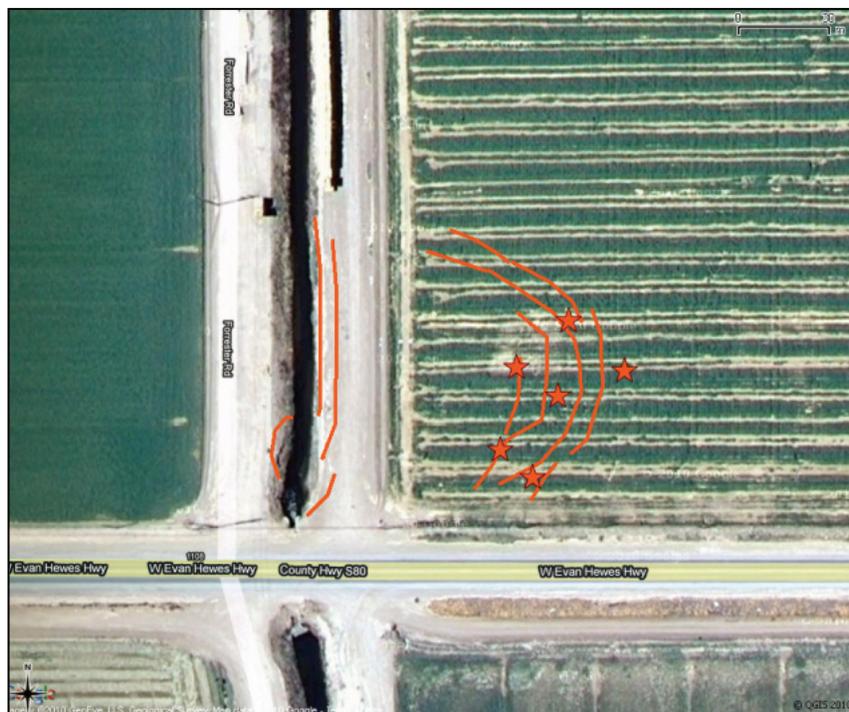
A large liquefaction lateral spread occurred at the southwest corner of an agricultural field located immediately north of Evan Hewes Highway, halfway between the towns of Seeley and El Centro. The lateral spread moved to the west toward the Rice No. 3 drain (fig. 88). The affected area is roughly 80 to 100 m along the Rice Drain, and extends 90 m to the east of Rice Drain.

**Figure 88.** Diagrammatic sketch of liquefaction-related features north of Evan Hewes Highway and east of Rice Drain No. 3 (D12). Lines represent approximate location of cracks and fissures, and star symbols indicate approximate location of sand boils. Base image is from Google Maps; Google label for Forrester Road appears to be in error.

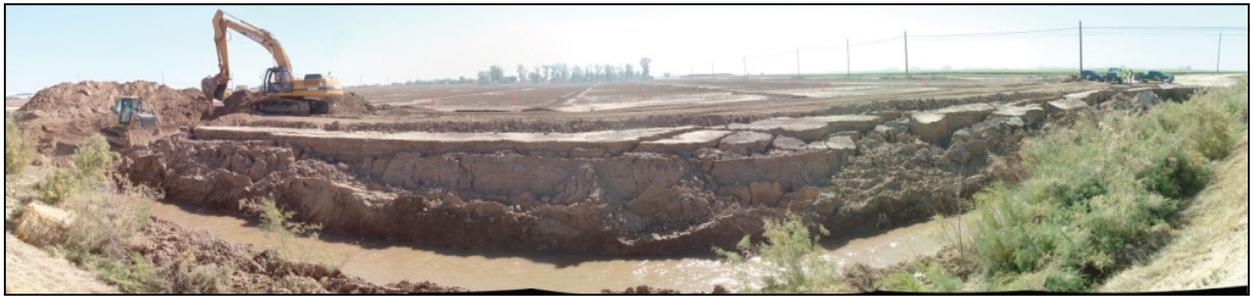
**Figure 89.** Panoramic view of the lateral spread at Evan Hewes Highway (on the right along the line of telephone poles) and Rice Drain No. 3 (foreground) (D12). Repairs underway on the left consist of excavation and replacement of the levee materials. Photos by T. McCrink, 4/9/10.

Repairs to the lateral spread were underway at the time of the visit (April 9, 2010) and were concentrated on the east bank of the Rice Drain (fig. 89). According to the owner of the field, the west-facing bank of the drain was transported across the drain, depositing salt cedar bushes on the opposite bank. The road on the east bank was severely disrupted by open fissures reported to have been as much as 1 m wide and 30 cm deep prior to the start of repairs (fig. 90). The operator of the

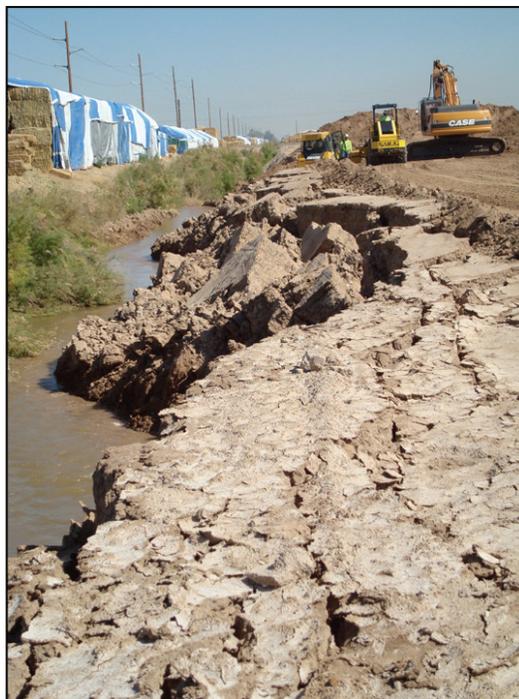
**Figure 90.** View looking north at the lateral spread into the Rice No. 3 Drain (D12). Owner of the agricultural field reported that the salt cedar bushes now on the west bank were on the east bank before the earthquake. Photo by T. McCrink, 4/9/10.
