# Liquefaction and Other Ground Failures in Imperial County, California, from the April 4, 2010, El Mayor–Cucapah Earthquake

By Timothy P. McCrink, Cynthia L. Pridmore, John C. Tinsley, Robert R. Sickler, Scott J. Brandenburg, and Jonathan P. Stewart

U.S. Geological Survey Open-File Report 2011–1071

California Geological Survey Special Report 220

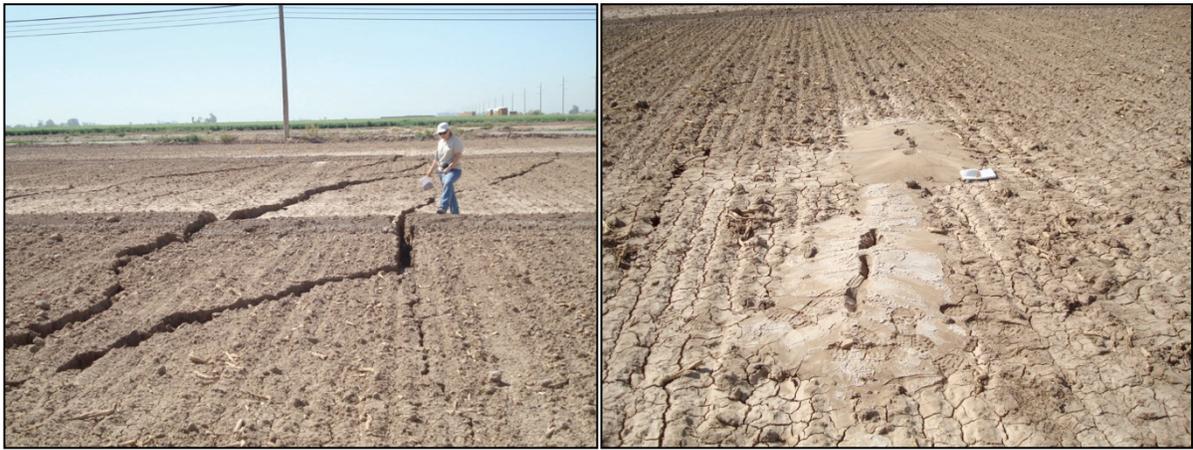
The eastern portion of the lateral spread manifested as a series of arcuate cracks and several sand boils (fig. 91). The sand boils were generally not associated with the fissures, but vented from within soil blocks between them. However, all cracks wide enough to see into were filled to various depths with liquefied silty sand. The fissures showed extensional movement from a few mm to 30 cm wide and a vertical displacement as much as 20 cm.

**Figure 91.** A, Arcuate lateral spread fissures and B, vented sand near the eastern extent of the lateral spread at Rice Drain No. 3 (D12). Photos by T. McCrink, 4/9/10.

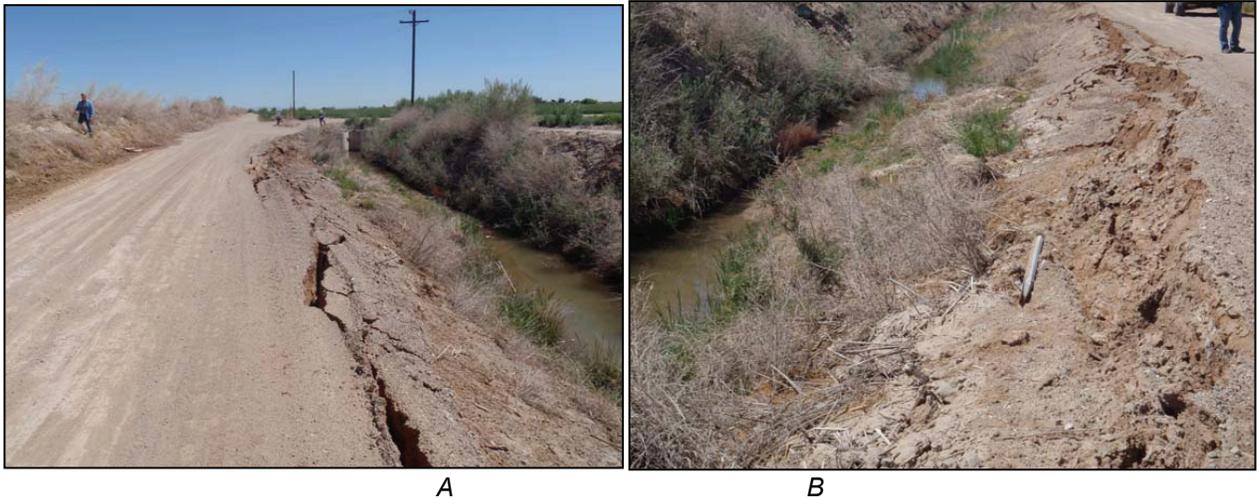
The northernmost inferred liquefaction was found as a slump into Cook Drain along Fites Road, approximately 350 m east of where Urquhart and West Carter roads intersect. This location is adjacent to the southeast levee of the Westside Main Canal, and the surface of Fites Road is approximately 2 m lower than the levee top. The slump extended along Cook Drain for 40 to 50 m, dropped the edge of Fites Roads as much as 1 m, and the toe of the slump in two places flowed across the width of the drain channel impeding water flow (fig. 92). The slump corresponded to a stretch of the Westside Main Canal levee that was wet and had enough seepage to create a puddle on Fites Road (fig. 93). A road caution sign was lying on the ground near the puddle water on Fites road and showed indications of having been there for a long time, suggesting that seepage at this location has been prevalent for a while. The correspondence of the seepage zone with the slump and the morphology of the slump itself suggest that seepage extended beneath Fites Road, creating the opportunity for liquefaction to contribute to the triggering of the slump.

**Figure 92.** *A*, View to northeast showing probable lateral spread ground failure into Cook Drain along Fites Road (D15). Wet sediment noted on west side of the road is believed to be seepage from Westside Main Canal, located to the left of the photo. Slump displacement is to the right; it visibly narrows the channel in the middle of the image. *B*, View of toe of slope failure where it partially blocks flow within the Cook Drain. Ground failure narrowed the channel at two different points along the zone. Photos by J. Tinsley, 4/8/10.

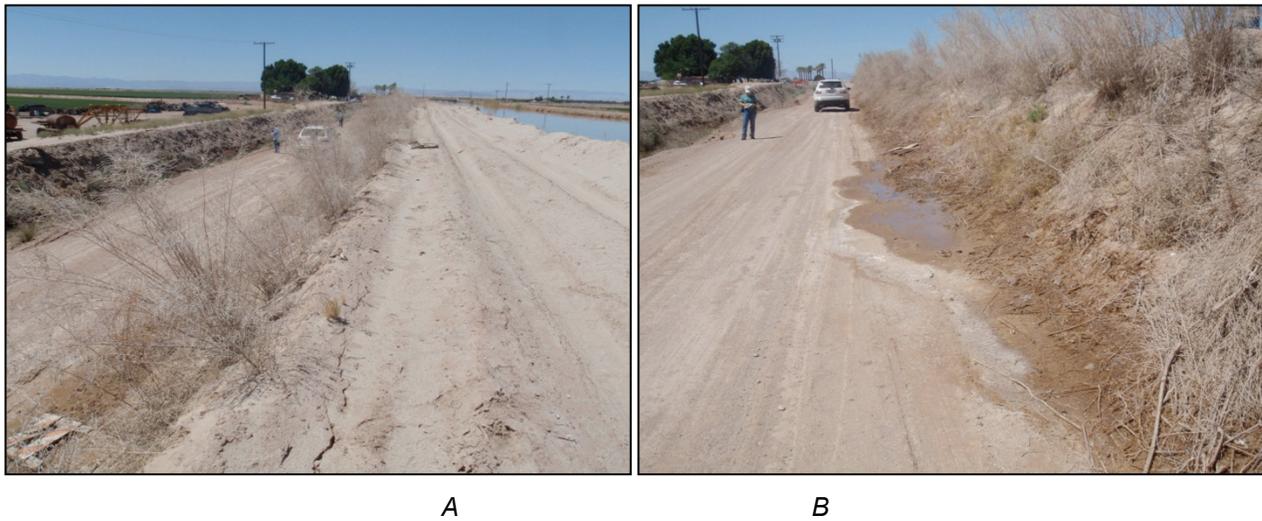
**Figure 93.** *A*, Overview of southeast levee confining the Westside Main Canal adjacent to Fites Road, showing minor extensional cracking at the outer edge (D15). Extensional cracking extended for a fraction of the length of the slope failure adjacent to the drainage channel at left. No vented liquefied materials were observed along the Westside Main Canal levee. *B*, View to southwest along Fites Road showing seepage from the Westside Main Canal, which created a puddle of standing water on Fites Road. Photos by J. Tinsley, 4/8/10.

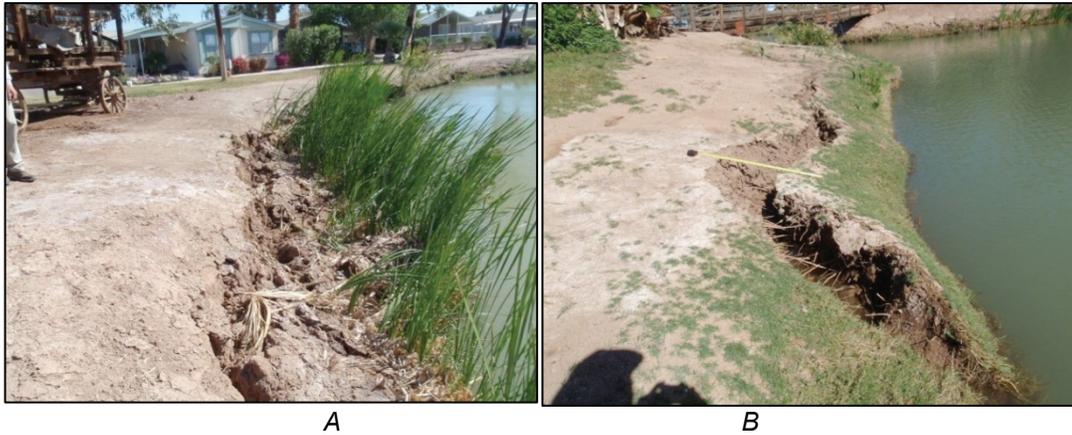
A small man-made lake at the Rio Bend recreational vehicle (RV) Park experienced two small bank failures, which may be related to liquefaction, and some clearly liquefaction-related lateral spreading on the southwest side of the lake. The small bank failures occurred on the north and south sides of the lake, and on the east side where the lake narrows and is crossed by a bridge. Both features are suggestive of having been caused by liquefaction, but no vented sand was observed (fig. 94). Maximum extensional displacement was measured at roughly 52 cm. Lateral spreading with associated vented sand was observed at the edge of pavement near the southwest side of the lake, and similarly oriented small cracks were observed in the asphalt pavement (fig. 95). Separation amounting to less than a centimeter was observed between the asphalt and a concrete verge on the south side of the deformed pavement.

**Figure 94.** Bank failures around Rio Bend RV Park Lake (F01). *A*, Bank failure on the north side of the lake. *B*, Bank failure on the south side. This failure extended underneath the footbridge seen in the distance. Photos by J. Tinsley, 4/7/10.

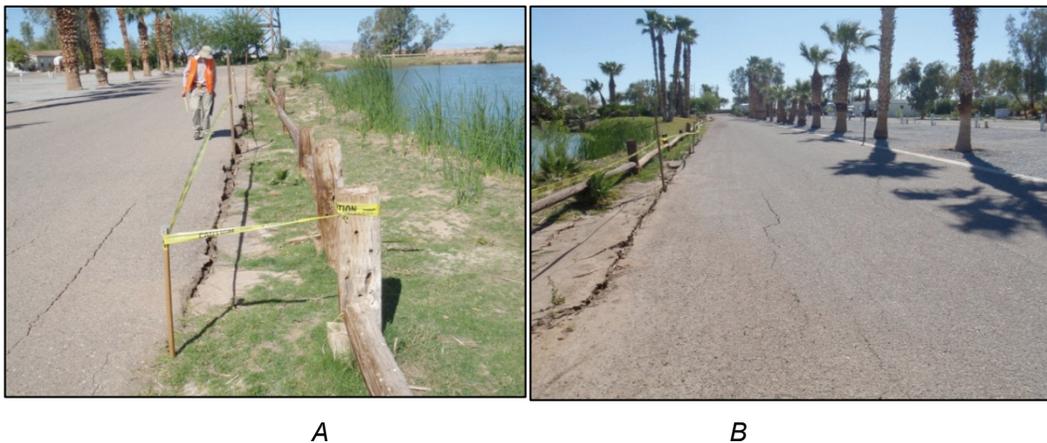
**Figure 95.** Liquefaction lateral spread at the southwest side of the Rio Bend RV Park Lake (F01). *A*, View to the west; deformed asphalt pavement and adjacent fence. Liquefied fine silty sand vented from fracture that opened along northern limit of paving. *B*, View to the east showing an echelon extensional cracks in asphalt pavement and the open extensional fissures at the left of photo. Photos by J. Tinsley, 4/7/10.

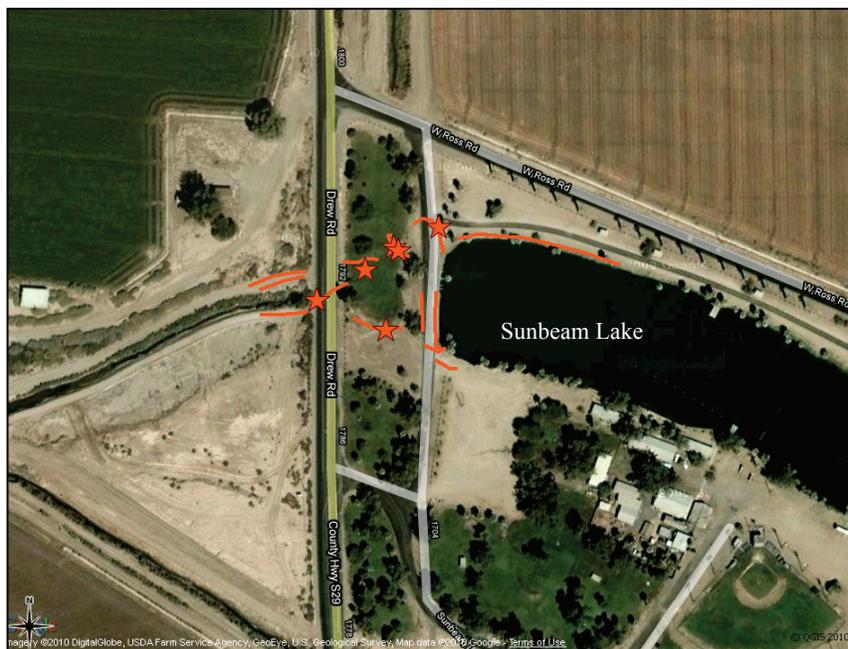
Earthquake shaking from the mainshock on April 4 caused liquefaction of the dam crest, of the gently sloping embankment between the dam crest and Drew Road, and in Drew Road fill materials (fig. 97). The Sunbeam Lake park ranger witnessed water geysering through the asphalt surface of Drew Road, and photographs taken soon after the earthquake show both settlement and lateral displacement of the road (fig. 98). Unfortunately, the road had been leveled with dirt by the time any postearthquake investigators arrived, and no displacement could be measured. The road fill above the outlet pipes was washed away by water flow through the embankment soon after the earthquake (fig. 99), exposing several types of utilities and breaking at least one of them. It was reported that a gas main was also located in the roadbed on the east side of Drew Road.

**Figure 97.** Diagrammatic representation of the damage observed at Sunbeam Lake Dam and Drew Road (F02, R12). Lines represent approximate areas where fissures and cracks were observed, and stars show the approximate locations of sand boils. Base image is from Google Maps.

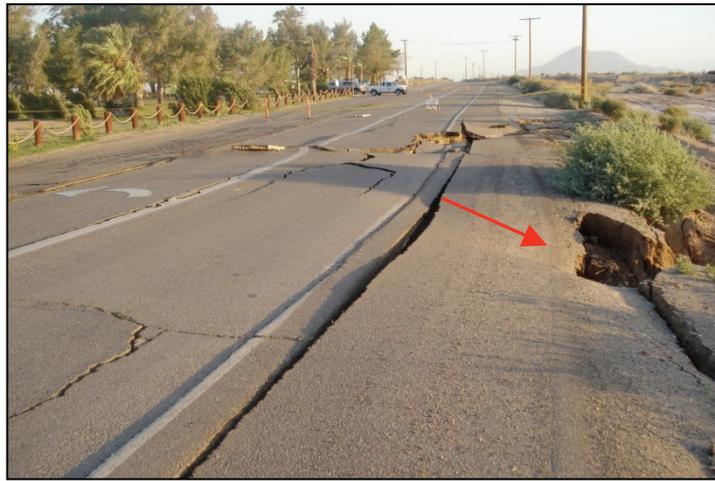
**Figure 98.** Liquefaction-related settlement and lateral spreading of Drew Road, immediately west of Sunbeam Lake Dam (R12). View is toward the south with El Centinela Peak in the distance. An eyewitness reported water geysering out of the pavement during the earthquake. Outlet pipes from Sunbeam Lake and from a large irrigation drain enter the stream to the right of the prominent slump in the center-right of the photo, indicated by the arrow. Both apparently were damaged by liquefaction. Photo taken 4/4/10; courtesy of the Imperial County Planning and Development Services Department.

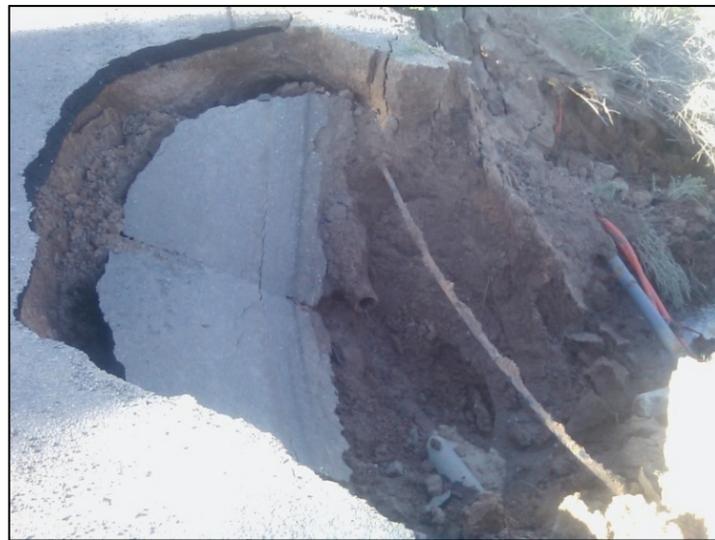
**Figure 99.** Close-up of the slump on the west side of Drew Road mentioned in the previous photo (R12). Several utility lines are exposed and some are broken. The outlet flow from Sunbeam Lake and probably the Seeley irrigation drain are just visible on the right. Photo courtesy of Imperial County Planning and Development Services Department.

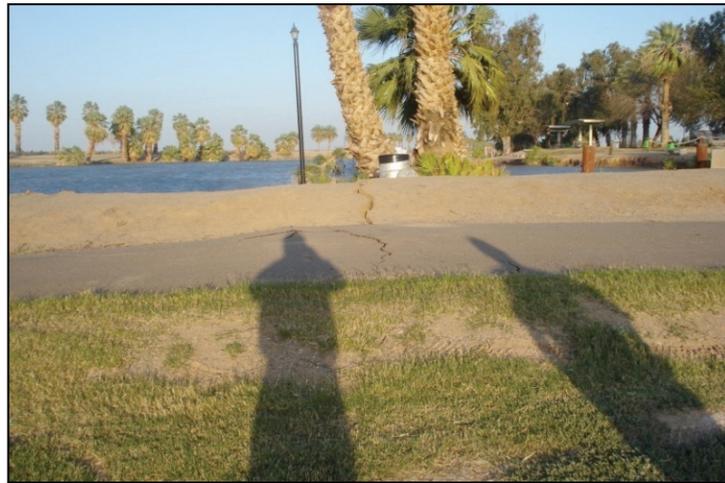
The south half of the dam crest settled vertically between 15 and 30 cm and the upstream face spread toward the lake (figs. 100, 101 and 102A). Arcuate cracks at the north end of the dam

**Figure 100.** View of the south end of the Sunbeam Lake Dam crest, looking east (F02). Photo was taken soon after the earthquake. Dam crest to the left has dropped 15 to 30 cm relative to the area to the right of the large crack in the center of the photo. Photo courtesy of Imperial County Planning and Development Services Department.

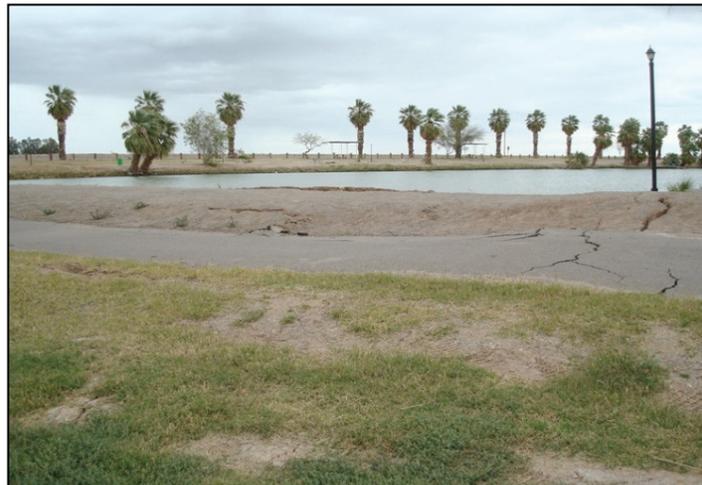
**Figure 101.** View of the south end of the Sunbeam Lake Dam crest, looking northeast (F02). Photo was taken 8 days after the earthquake. Transverse crack on the crest is larger and new cracks parallel to it are now visible. Cracks in asphalt are more pronounced and several newly visible cracks extend into the lawn area. The continued deformation may be the result of a week of strong aftershocks. Photo by T. McCrink, 4/12/10.

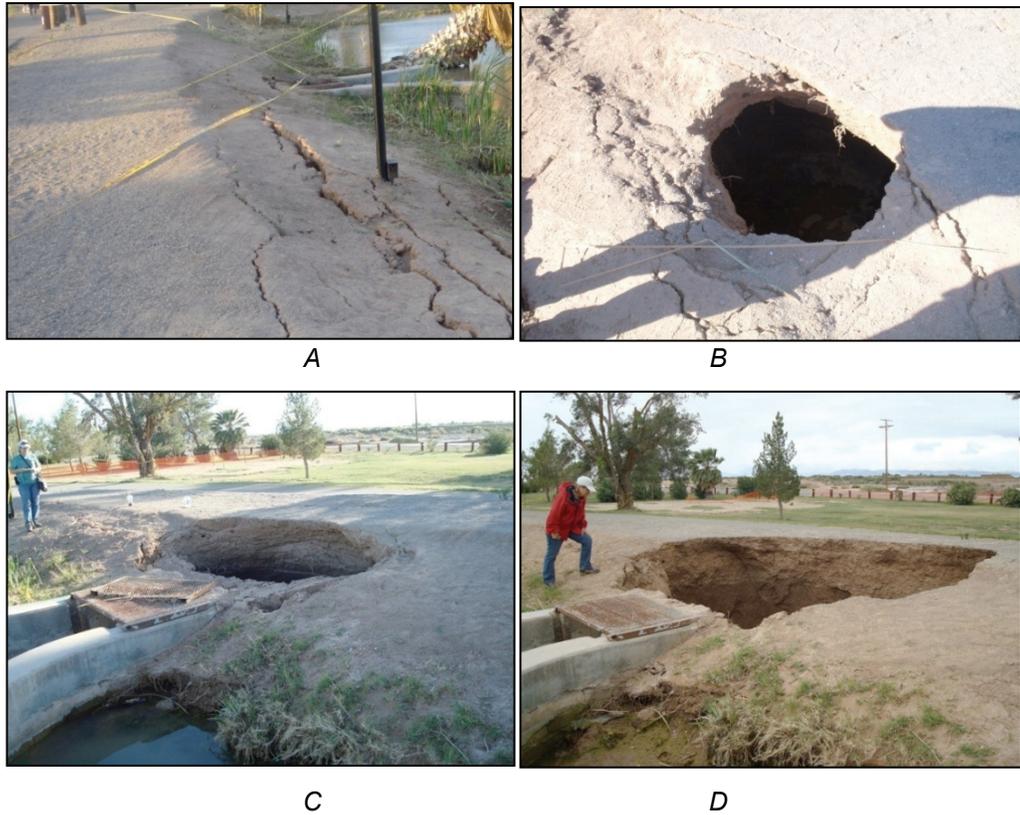
Liquefaction-related settlement and lateral spreading of the dam crest disrupted the outlet pipes near the lake outflow weir structure. Water flowing outside of the pipes and through the

embankment began piping away embankment soils leading to the development of a sinkhole on the dam crest (fig. 102). After a week, the sinkhole had grown to an estimated 15 m<sup>3</sup> depression on the top of the dam and threatened its integrity. On April 20, 2010, after field work had ceased, the assistant director for Imperial County Public Works informed one of the authors of this report (McCrink) that the dam outlet had been repaired by excavating to a depth of 6 m and replacing three sections of pipe (fig. 103). On June 8, 2010, McCrink had the opportunity to revisit the Sunbeam Lake dam and found repairs included those described by the county to the outlet, placement of concrete rubble on the upstream side of the dam, repairs to the outlet pipe on the west side of Drew Road, and regrading of the dirt access roads on both sides of the drain west of Drew Road. However, as of September 15, 2010, Drew Road was still closed and waiting for repairs.

**Figure 102.** Time sequence photographs of a sinkhole that formed on the Sunbeam Lake Dam (F02). *A*, The dam crest and outlet weir on the day of the earthquake. Photo courtesy of Imperial County Planning and Development Services Department. *B*, Early stage of sinkhole formation on the morning of 4/7/2010; the person whose shadow partly covers the sinkhole is standing on the outlet weir. Photo by J. Tinsley. *C*, Sinkhole on the evening of 4/8/2010. Photo by T. McCrink. *D*, Sinkhole on 4/12. Photo by T. McCrink.

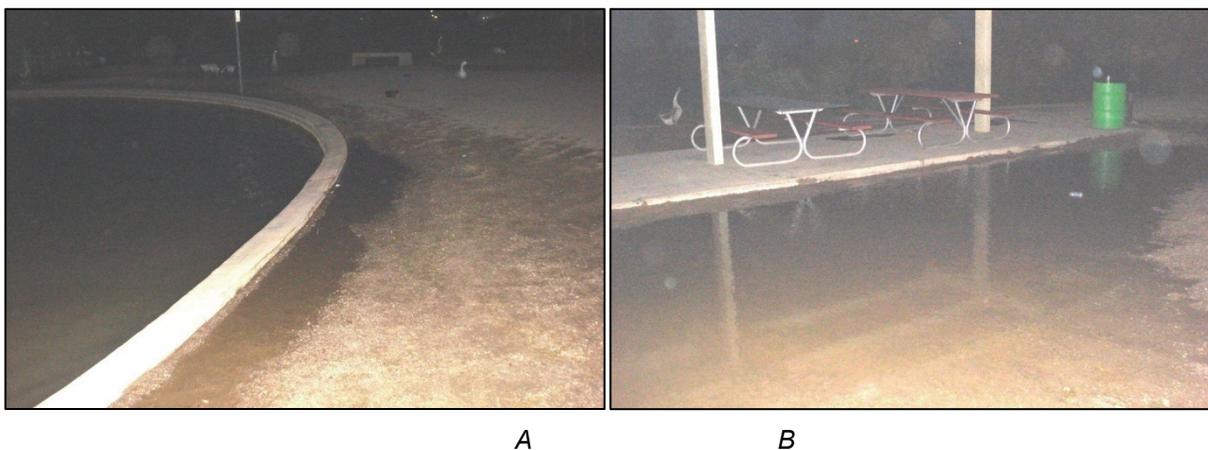
Seicheing was also observed at Sunbeam Lake Park. According to the county's park ranger, the swimming pool on the south side of the lake sloshed enough water to flood the surrounding picnic areas and nearby restrooms (fig. 104). In addition, the banks of the lake are shown to be wet in photographs taken by Imperial County personnel in the evening after the earthquake (fig. 105). In order to wet the banks of the lake, seiche waves had to be locally on the order of half a meter high.

**Figure 104.** Standing water resulting from earthquake-generated seiche waves at Sunbeam Lake Park (F02). *A*, Photograph of the swimming pool south of Sunbeam Lake. Wet area shows the extent of the water that sloshed out of the pool. *B*, Picnic area adjacent to the pool flooded by water sloshed out of the pool. Photos courtesy of Imperial County Parks and Recreation; taken 4/4/10.

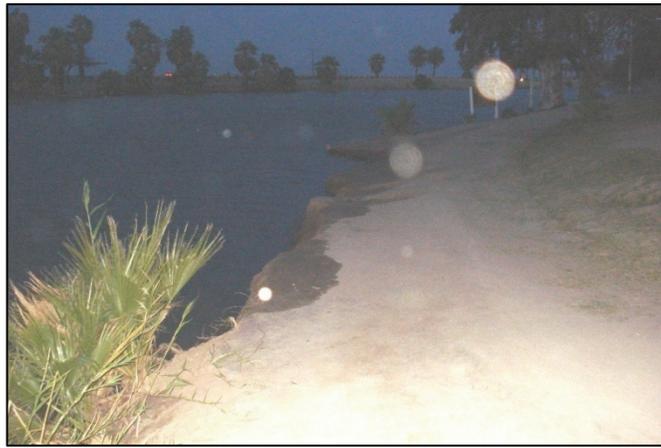
**Figure 105.** Photograph of the south bank of Sunbeam Lake (F02). Wet areas, shown as dark soil at the edge of the dirt path, indicates where water splashed out of the lake. The steep sides of the bank are on the order of 0.5 m high. Photo courtesy of Imperial County Parks and Recreation; taken 4/4/10.

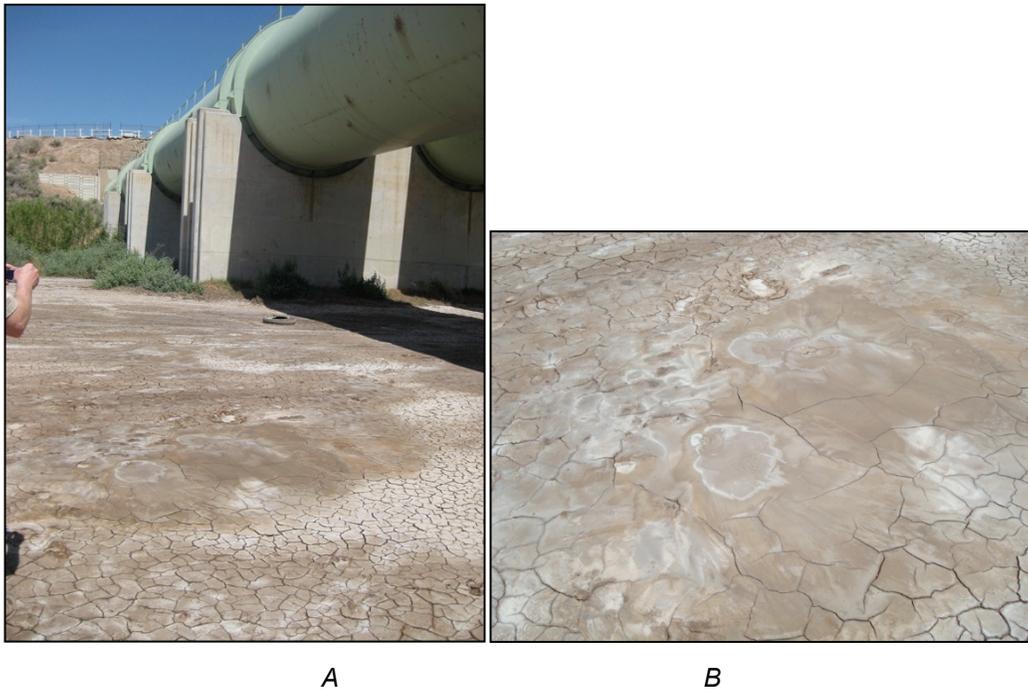
The All American Canal crosses the New River through a closed aqueduct system composed of two approximately 4-m-diameter pipes, which are elevated above the riverbed by four massive, rectangular concrete supports (fig. 106). By April 10, 2010, when the site was visited, much of the flat floodplain area of the New River had been graded. However, considerable evidence of liquefaction in this area was still observed. A 30-m-wide lateral spread slump were seen on the south bank of the New River 150 m upstream from the aqueduct. Sand boils were found in nearly all flood plain areas left ungraded around the aqueduct, particularly underneath and west of the structure. Vented sand was characterized by very fine grained ejected material, often displaying shrinkage cracks, in relatively small volumes (fig. 106). At the base of one concrete support, a linear string of these fine-grained sand boils paralleled the support structure, suggesting

**Figure 106.** Liquefaction vented sand near the All American Canal aqueduct over the New River (F03). Relatively low volumes of fine-grained ejected material characterize the sand boils in this area. *A*, View of vented sand on the New River flood plain, looking northeast toward the aqueduct. Photo by C. Pridmore, 4/10/10. *B*, Close-up of vented sand. Photo by T. McCrink, 4/10/10.

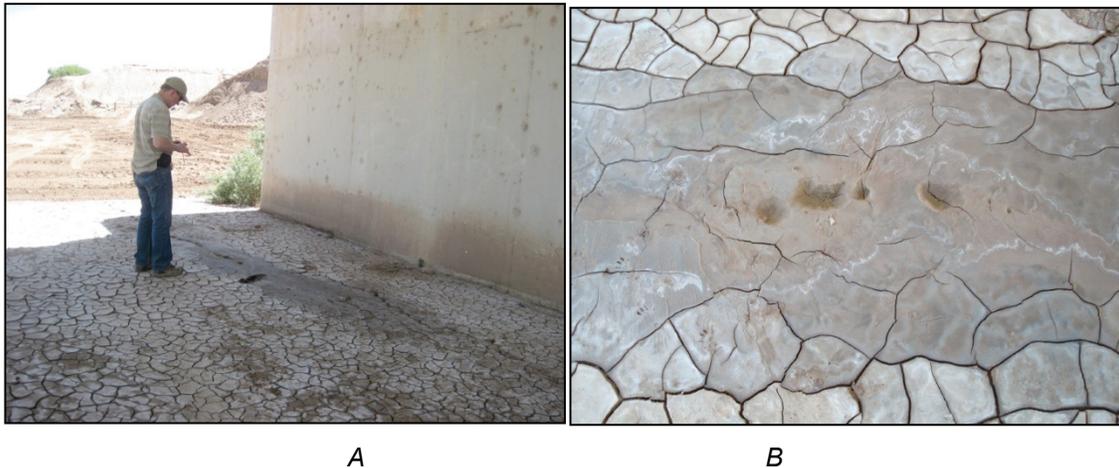
some influence of the structure on liquefaction at this location (fig. 107). A timber bridge crossing the New River east of the aqueduct (R15) was closed on April 10, 2010, but the damage that caused the closure was not readily discernible.

**Figure 107.** Liquefaction sand boils near the base of one All American Canal aqueduct support structure (F03). A, Line of sand boils parallel to the support structure. Photo by C. Pridmore, 4/10/10. B, Close-up of the vented fine sand. Note desiccation cracks forming in ejected material. Photo by T. McCrink, 4/10/10.

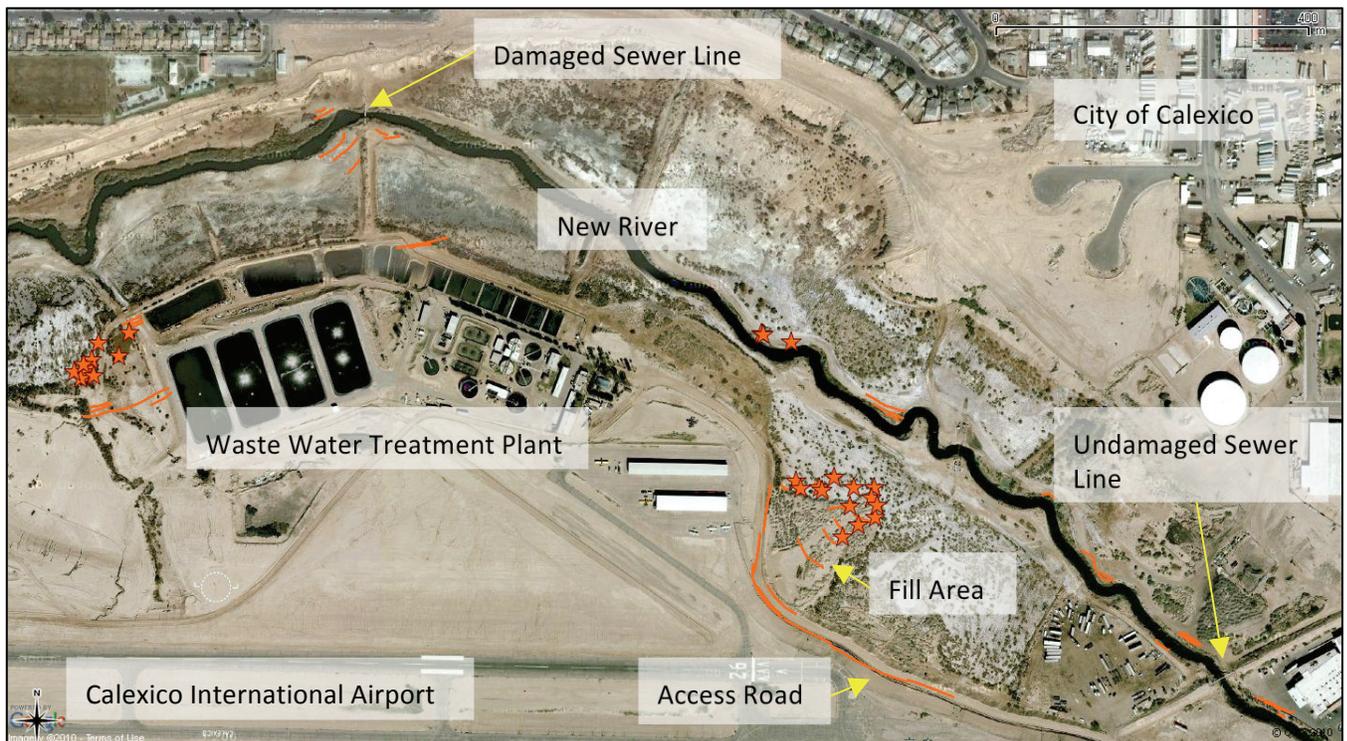
Airport (fig. 108). Extensive liquefaction-related deformation was observed on the plant access road east of the airport, resulting in the closure of the road, and on the west side of the plant where liquefaction lateral spreading damaged embankments that impound partially solidified sludge and gray water. Lateral spreading fissures also were observed traversing sludge ponds near the central area of the plant. The UCLA team found liquefaction-induced lateral spreads and associated vented

**Figure 108.** Map of liquefaction features at the Calexico Waste Water Treatment Plant and New River Floodplain (F04). Liquefaction-related ground deformation severely affected the access road on the east side of the plant, and fissuring observed on the west side and central area may extend into ponds. Lines represent approximate observed fissure locations; stars represent approximate observed sand boil locations. Base image is from Google Maps.

sand on the north bank of the New River east of the Waste Water Treatment Plant on April 5, 2010. At the time of the California Geological Survey team's visit on April 10, 2010, crews were actively engaged in reconnecting a 91-cm-diameter sewer trunk line broken where it crosses the New River. Lateral spread fissures were observed on the north and south New River flood plain in this area, but the cause of the broken sewer line was not determined.

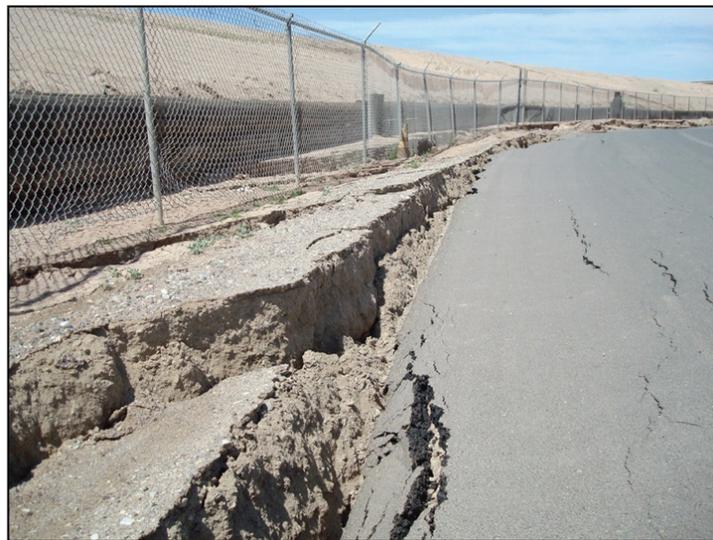
Liquefaction damage to the access road extends for a distance of about 350 m with the greatest damage in the central portion where the road curves. Cumulative vertical displacement on the inboard (southwest) side of the road may be as much as 1 m maximum, and horizontal displacement is on the order of 20 to 30 cm (figs. 109 and 110). No evidence of slump and spread movement at the base of the road embankment was found along the southeast half of the damaged access road, perhaps because it was masked by rubble piles. Additionally, no evidence of cracking or sand boils was observed on the flood plain immediately northeast. Damage to the outboard (east-northeast) side of the road was not apparent except where the road adjoins a large nonengineered fill lying to the east-northeast (fig. 108). Here, uphill-facing scarps with less vertical displacement than on the inboard side indicate both settlement and rotation of the road fill prism. Geotextile was found in road base beneath asphalt in an exposed crack on the northeast side of the road, and this may explain why the pavement did not experience the same intensity of damage as the sides of the road. It was reported that this road was reconstructed and paved in the last four years.

**Figure 109.** Liquefaction lateral spread and slump of waste water treatment plant access road (F04). A matching but smaller uphill-facing scarp on the other side of the road indicates that the soil under the pavement settled and rotated. Geotextile was observed in exposed road base, which may have helped keep pavement from experiencing the intensity of fissuring observed on the sides of the road. View to the west. Photo by T. McCrink, 4/10/10.

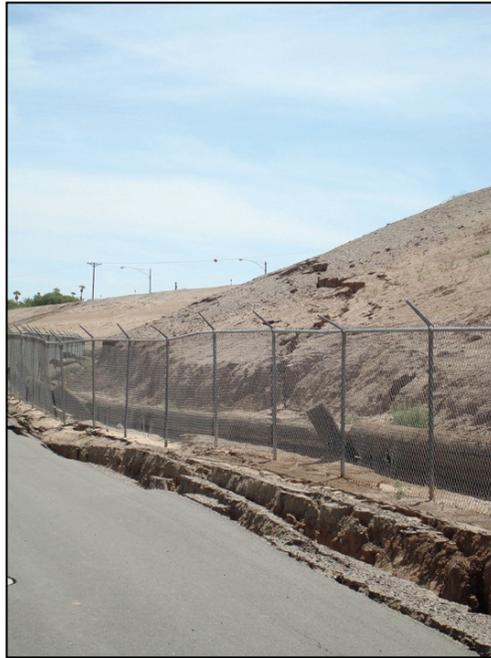
**Figure 110.** Liquefaction lateral spread and slump of waste water treatment plant access road (F04). A portion of the hill, probably fill, also experienced slumping. View to the southeast. Photo by T. McCrink, 4/10/10.

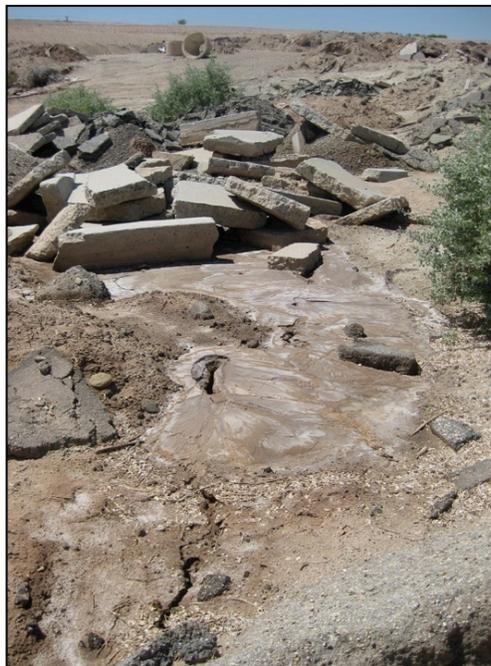
Extensional cracks were found throughout most of the fill area, and numerous sand boils were seen toward the northeast where the fill thins (fig. 111). On the flood plain north and east of the fill, numerous fissures and related sand boils were found (fig. 112).

**Figure 111.** Liquefaction vented sand and related cracking in nonengineered fill adjacent to the Treatment Plant access road (F04). Access road is at the base of the hill in the distance and the airport is just beyond. View to the southwest. Photo by C. Pridmore, 4/10/10.

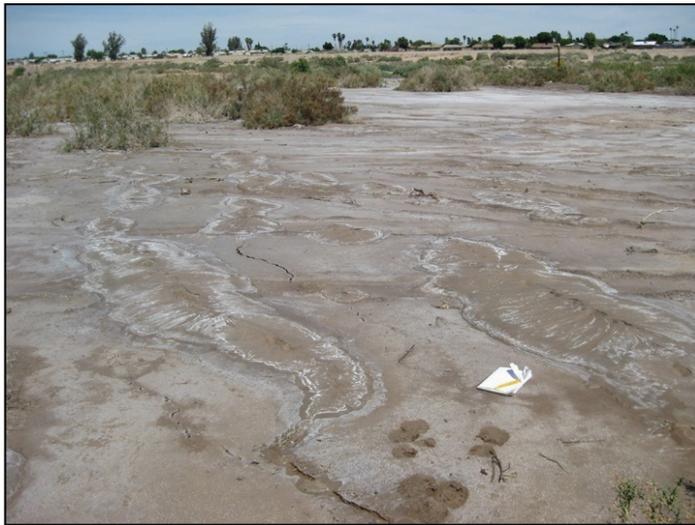
**Figure 112.** Liquefaction sand boils and fissures on the New River flood plain, just north of the nonengineered fill along the Treatment Plant access road (F04). Stains on sand boils are thought to be salts contained in the groundwater that turn white upon drying. Most sand boils were wet in this area, and are believed to have been reactivated by a M4.4 aftershock that occurred the night before. View to the north. Photo by C. Pridmore, 4/10/10.

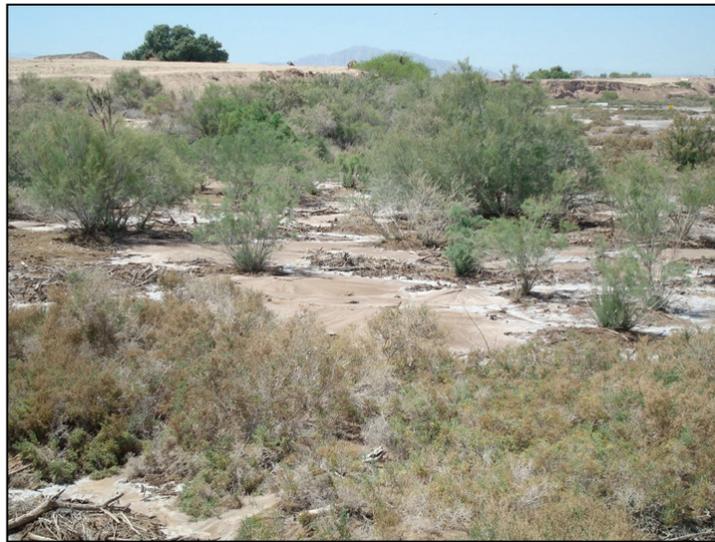
The west side of the waste water treatment plant is characterized by extensive areas of sand boils and lateral spread cracks (figs. 113 through 116). Sand boils appear confined to floodplain areas, though considerable volumes of sand were ejected. Lateral spread fissures occur on the floodplains associated with sand boils and extend into and through fill areas, including pond embankments at the plant.

**Figure 113.** Extensive vented sand flooding areas between bushes on the New River floodplain west of the waste water treatment plant (F04). View to the west. Photo by T. McCrink, 4/10/10.

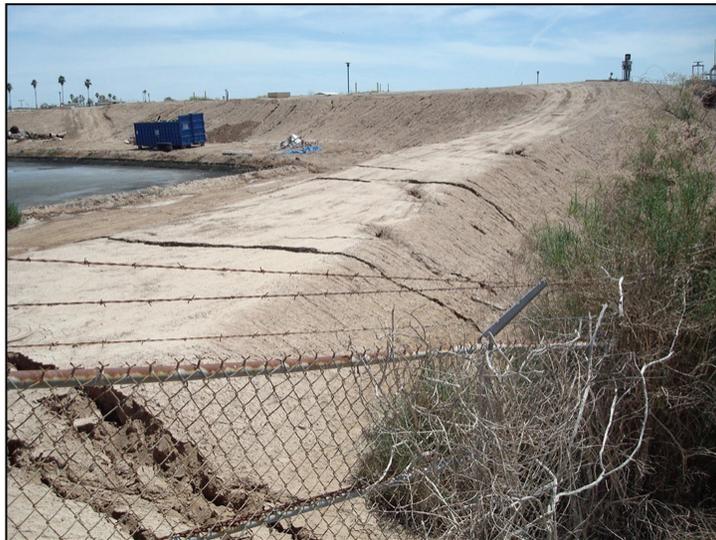
**Figure 114.** Lateral spread fissures extending through sludge drying ponds on the west side of the waste water treatment plant (F04). Fissure in the foreground is extensional and those in the middle of the picture show vertical displacement on the order of 2 to 5 cm. View to the southeast. Photo by T. McCrink, 4/10/10.

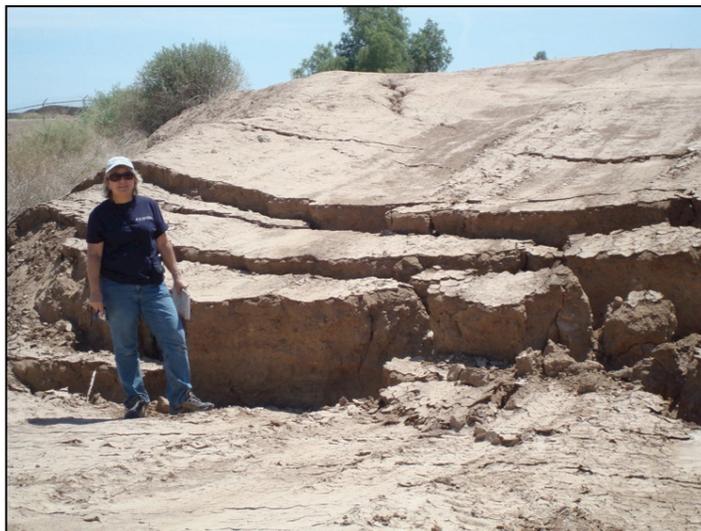
**Figure 115.** View to the southeast of a large scarp at the head of a liquefaction lateral spread on the west side of the Calexico Waste Water Treatment Plant (F04). Cumulative vertical displacement is about 1 m. Photo by T. McCrink, 4/10/10.

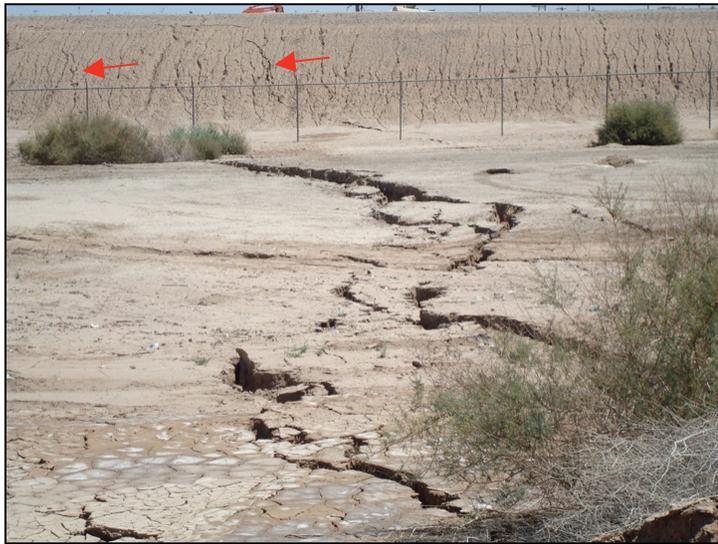
**Figure 116.** Liquefaction lateral spread fissures extending across New River flood plain into pond embankments on the west side of the Waste Water Treatment Plant (F04). Arrows point to fissures in the embankment. At the time of the California Geological Survey visit, a track-mounted excavator (orange machine arm in the top center of this photo) was making repairs in the center of the plant at a point suspiciously in line with these fissures. View to the east from the large scarp shown in figure 115. Photo by T. McCrink, 4/10/10.

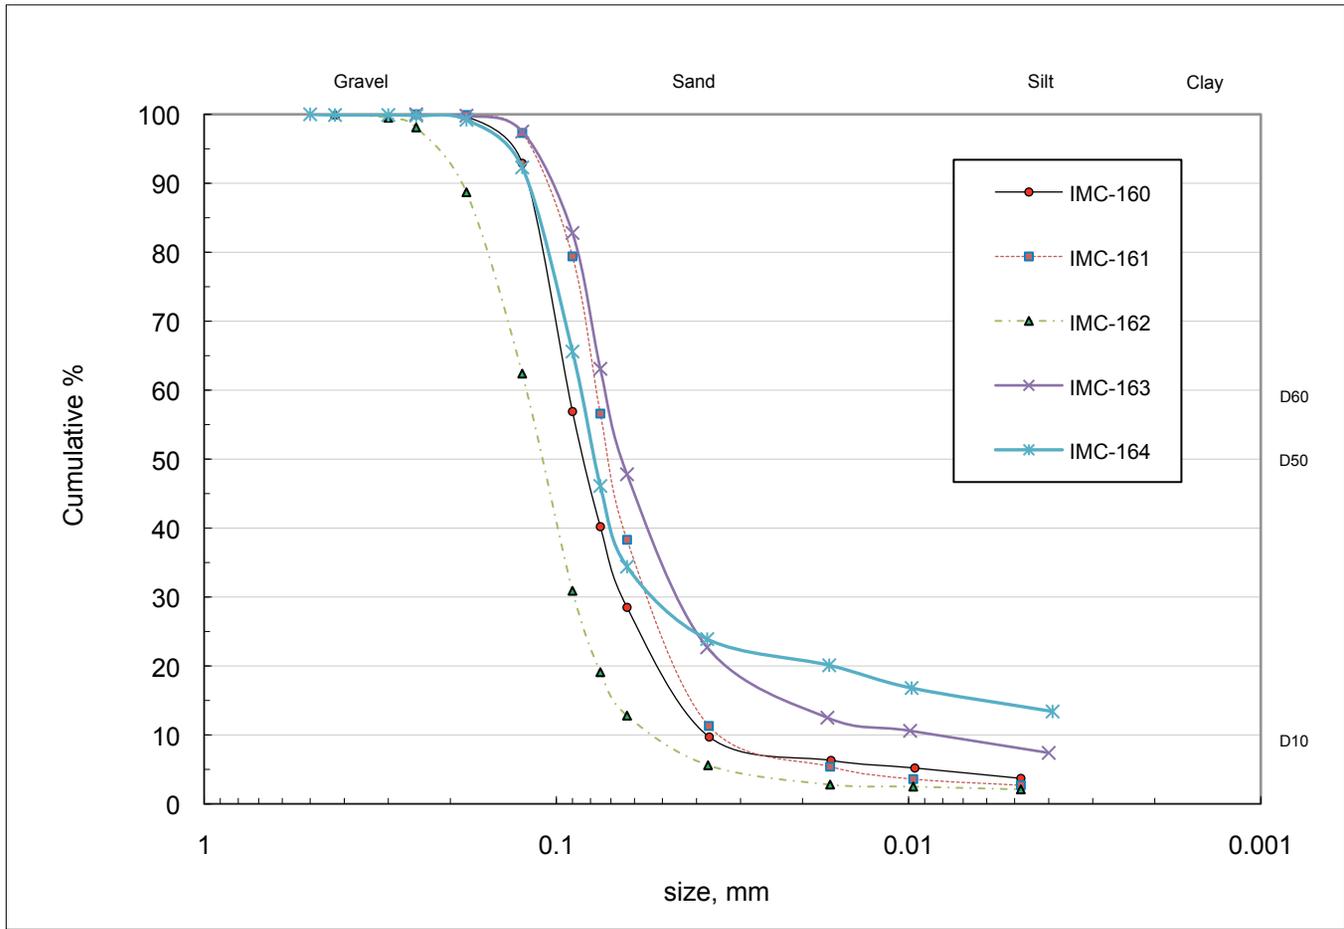
The  $D_{50}$  or 50<sup>th</sup> percentile particle size values for the sand samples range between 0.06 and 0.09 mm, spanning the fine sand to coarse silt range; no gravel clasts occurred in these samples. We note the sample IMC-164 from the “flowing fissure fill” collected by one of us (McCrink) was unusually high in clay (16% by weight), a value at or just above the empirical limit at which geotechnical opinion deems sediment to be too cohesive to liquefy. The issue is discussed more completely by Seed and Idriss (1982, p. 111-113). The particle size ranges collected are described in the USC as silty sand and sandy silt; both types of soil are commonly found comprising vented sediment during postearthquake liquefaction studies (for example, see Bennett and Tinsley, 1995).

**Figure A1.** Cumulative percent particle-size curves for samples IMC160 through IMC 164 are shown as weight % versus particle size in mm. Soils are silty sand and sandy silt, a particle size range commonly observed in materials vented during earthquake-triggered liquefaction.
