Comments on the Yule Marble Haines Block—Potential Replacement, Tomb of the Unknown Soldier, Arlington National Cemetery

Open-File Report 2013-1182

Comments on the Yule Marble Haines Block— Potential Replacement, Tomb of the Unknown Soldier, Arlington National Cemetery

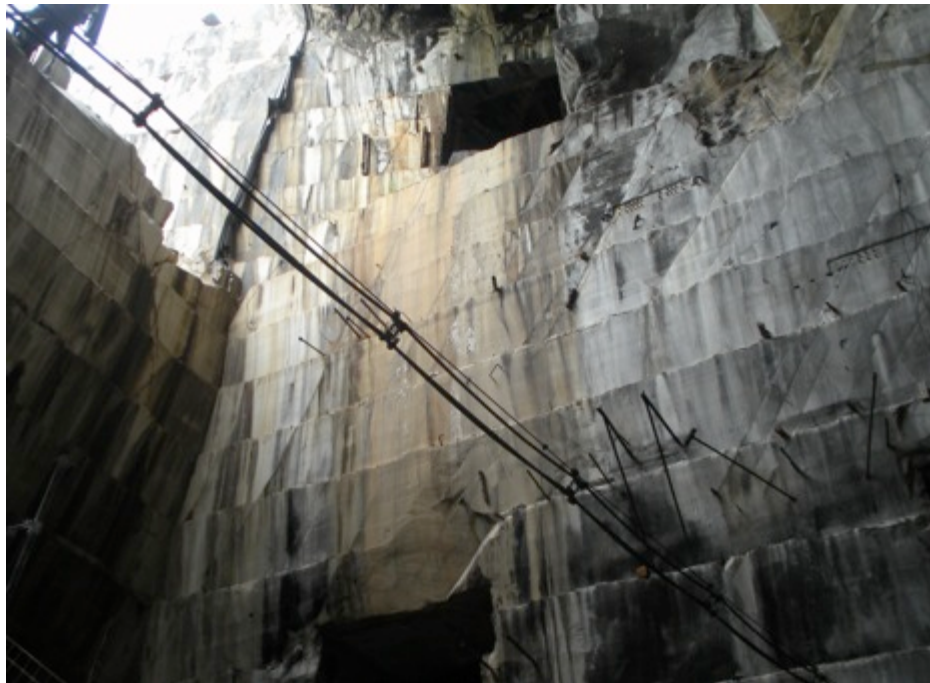
Figure 2. View of Yule subterranean marble quarry below portal two.

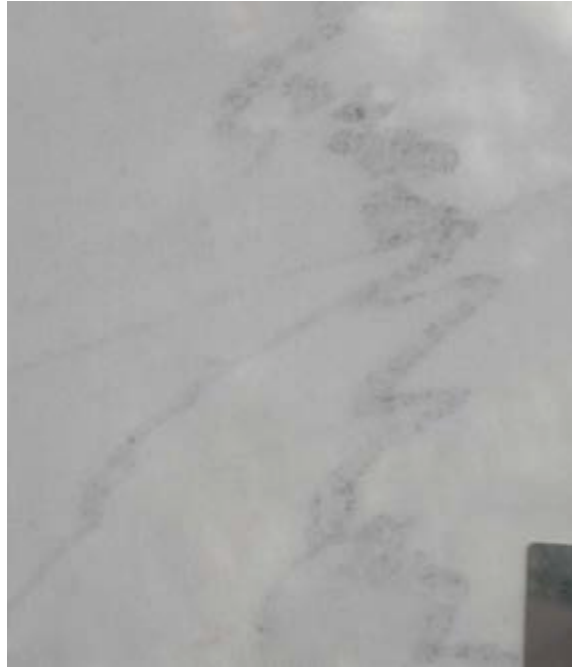
Figure 3. Photograph of light gray mineral inclusions trains, not unlike those on the Arlington National Cemetery die and on the Lincoln Memorial.

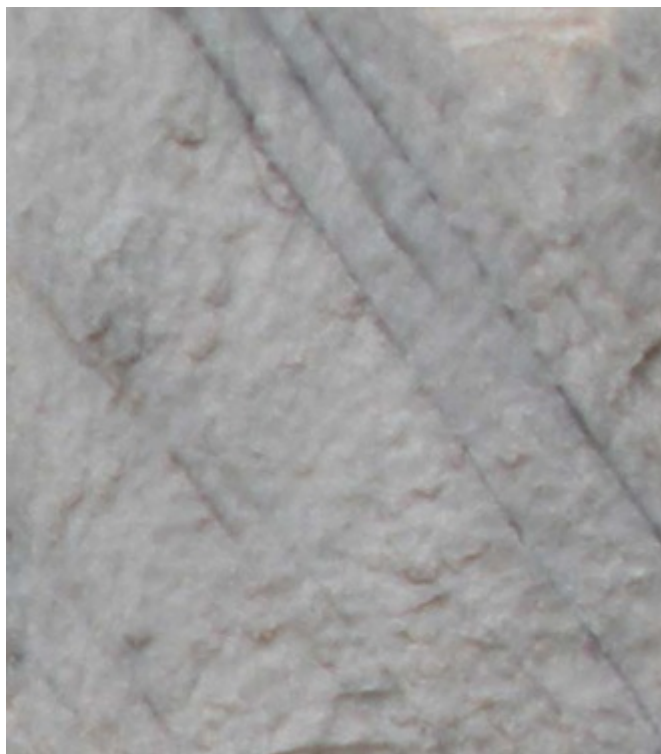
Figure 5 is a photograph of the back side of a block of stone that was first cut by wire saw and subsequently broken from the quarry wall; the final circular track of the wire saw is apparent at the separation of the smoothly cut surface from the rough broken surface. On the sawed faces, the natural internal texture of the block is shaved off and otherwise obscured by the action of the saw, whereas the broken corner shows internal texture of the block to the depth of the breakage. Although the wire saw freed most of the block from the rock formation, the entire corner of the block was sacrificed by the hydraulic technique that broke the remaining corner attachment wall, resulting in some mechanical shock to the block. At the scale of observation in figure 5, there appears to be no directional correlation of the inclusion trains with structural features associated with the host rock. Figure 6, a blow-up of the visible inclusion trains in figure 5, shows that inclusions penetrate the stone below the cut surface and that the growth history for the trains probably involved fluid flow along original bedding planes.

Figure 6. Close-up photograph of inclusion trains on the block shown in figure 5.

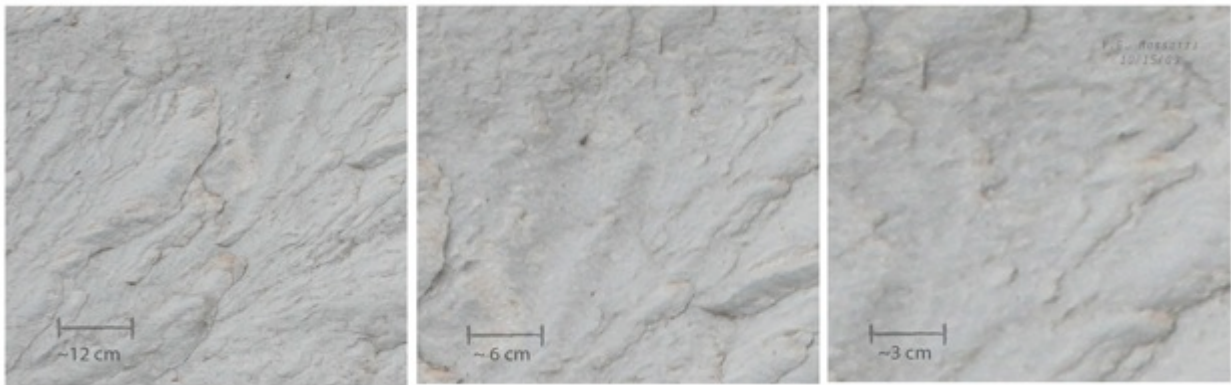
Figure 8 shows a series of images at increasing resolution of the broken skyward-facing surface of a block of marble resting next to the Haines block at the quarry. These photos show a complex network of natural grain aggregations that permeate the stone at all scales. One can discern lenticular grain aggregations in the exposed surface, possibly resulting from a preferred stacking of calcite crystals, in these images. Thousands of micro aggregations appear to be closely packed in a given volume of stone and the stone contains a smaller number of larger aggregations. Because the basic pattern of packed aggregations includes sizes covering a wide range of scale, the pattern appears to be scale invariant. Such textures are described as fractal, which in this case implies that there are no characteristic boundary lengths or characteristic distances between boundary intersections. While such fractal structure may be consistent with the classification of Yule Marble as massive over a range of scales for which textural properties are isotropic, the power-law distribution of lenticular grain aggregations allows for a finite probability of local schistosity over complementary scales. The finite probability of alignment of grain aggregations is significant, because water may anisotropically penetrate the stone over a spectrum of scales by preferentially flowing along the flat faces of the grain aggregations. Also, the grain aggregation boundaries are analogous to expansion joints in concrete sidewalks. As such, they represent a mechanism that inhibits crack propagation due to weathering or mechanical shock, also over a spectrum of scales. Just as a crack in a concrete sidewalk is stopped by an expansion joint, the probability of a fracture propagating across the stone by weathering along connected grain boundaries is expected to be quite low, as long as the shear strength threshold of the grain aggregations is not exceeded by mechanical shock. One would expect that natural weathering along such boundaries would follow a jagged course. Figure 9, a close-up photograph of interlocking grain aggregations, highlights a possible mechanism by which the growth of micro-cracks by natural weathering might be inhibited; the stone in figure 9 is located in the marble storage yard near the Yule Marble Quarry.

Figure 8. A series of images, at systematically increasing resolution (zoomed-in), of Yule Marble internal texture as revealed on the broken surface of a block. Note that the network of natural boundaries between grain aggregations appears unchanged across the range of scale.

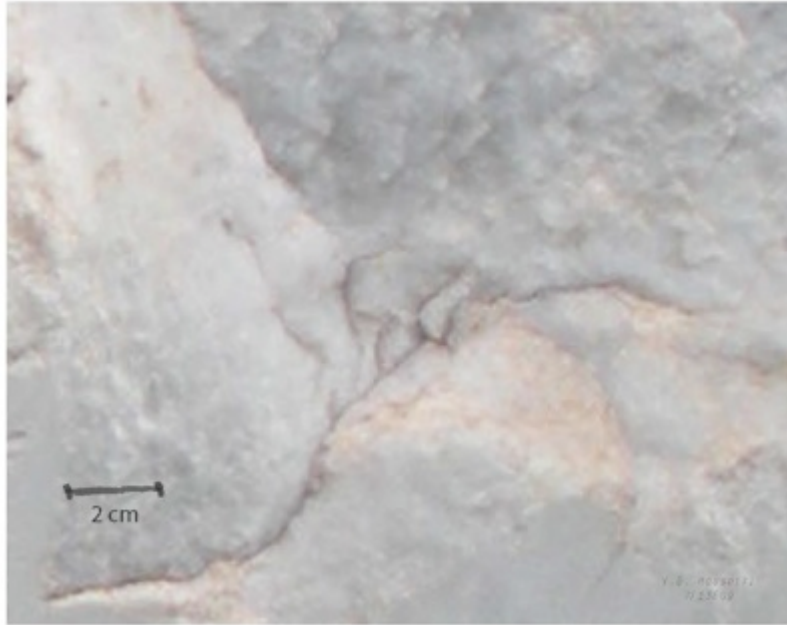
Figure 9. Close-up photograph of interlocking grain aggregations—a possible mechanism by which the growth of micro-cracks by natural weathering might be inhibited. Photograph of the back side of a block, about 1.7 m across, cut by wire saw, and broken from the Yule Quarry wall.
