# Faulting, Damage, and Intensity in the Canyon Dam Earthquake of May 23, 2013

By K. Chapman, M.B. Gold, John Boatwright, J. Sipe, V. Quitoriano, D. Dreger, and Jeanne Hardebeck

Open-File Report 2016-1145

U.S. Department of the Interior  
U.S. Geological Survey

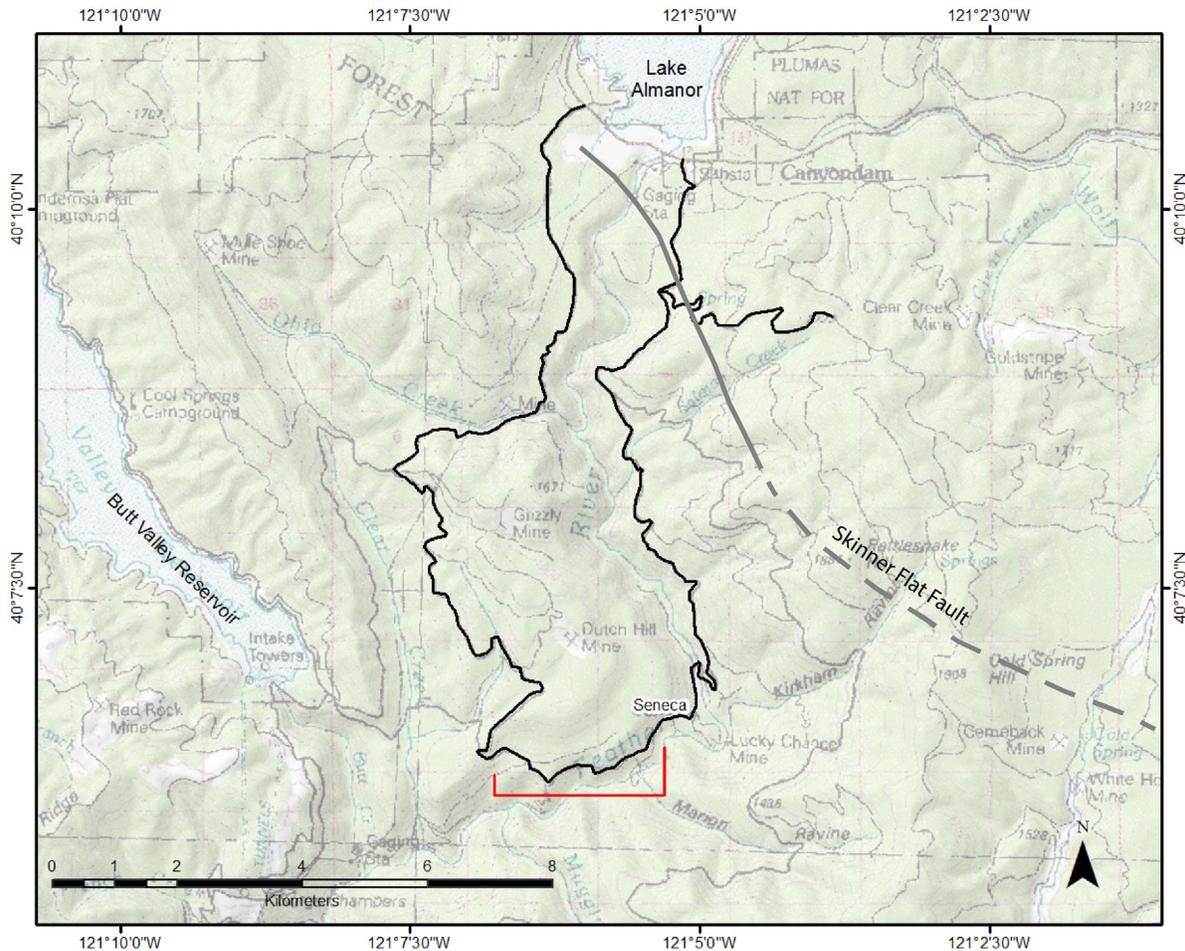
At the time of the field reconnaissance to Lake Almanor, the best estimate of where the fault might daylight was 1–3 km south of Lake Almanor, 2–4 km south of the epicenter. John Parrish (California Geological Survey) speculated that the earthquake occurred on an extension of the Indian Valley Fault (Merriam, 2013), while Pat Muffler (U.S. Geological Survey [USGS], written commun., May 28, 2013) proposed that the Skinner Flat Fault was a likely candidate. The route we followed in our search for surface rupture, shown in figure 7, attempted to cover as much ground as possible in the area where the fault was estimated to daylight. This driving route intersected the Skinner Flat Fault in multiple locations. Dirt and gravel logging roads, many of which were impassable, provided the only access in the area. Almost all of the accessible land was covered by a shallow layer of soil covered by pine needles (pine duff), making it difficult to find the geology, let alone any surface faulting. We found no surface faulting during our reconnaissance, although the disturbance of the ground cover would have had to be substantial to allow us to identify surface faulting. Generally,  $M_w < 6$  strike-slip earthquakes do not produce surface faulting, although the normal faulting  $M_w$  5.7 Oroville earthquake did. Along the

southern part of the route, we found numerous rocks strewn on the road that could have been rockfalls caused by the earthquake.

**Figure 7.** Map showing route of the search for surface rupture from the May 23, 2013, Canyon Dam earthquake. The solid gray line shows the location of the surface trace of the Skinner Flat Fault; the dashed line is the inferred trace. No surface faulting was found. The red bracket shows the location of rock falls possibly caused by the earthquake.

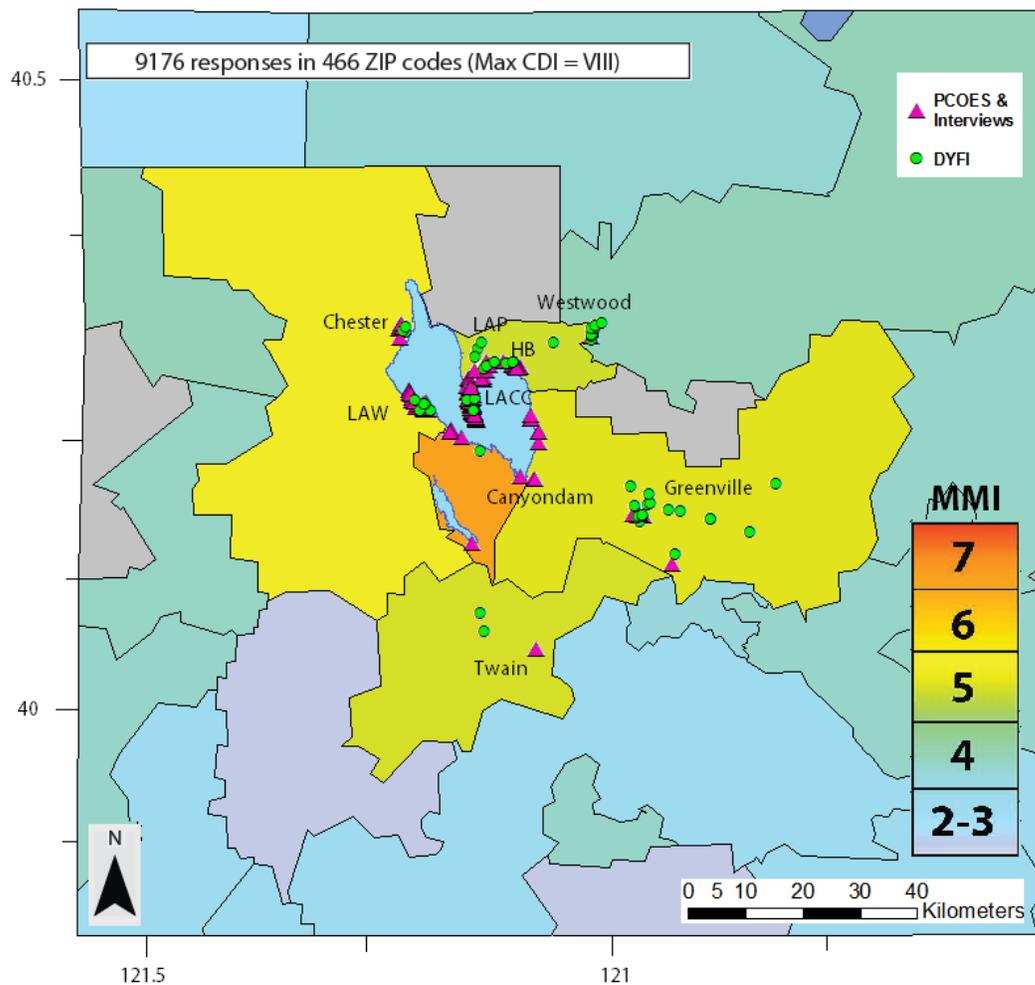
We began our surveys in areas that reported high intensities to “Did You Feel It” (DYFI), knocking on the doors of houses that appeared occupied. We asked each person we interviewed if they had filled out a DYFI report to avoid double counting. After we completed the field survey, we contacted the Plumas County Office of Emergency Services (PCOES) and obtained copies of the damage reports that they had gathered from residents and local fire departments. The site locations and intensity assignments are gathered in Appendix 1. Our 54 interviews are compiled in table 1–1, the 63 PCOES reports are compiled in table 1–2, and the 50 nearby geocoded DYFI reports are compiled in table 1–3. Figure 8 shows the DYFI ZIP-Code map for the area around Lake Almanor with the locations of the geocoded DYFI reports, interviews, and PCOES reports superimposed. There were 31 DYFI responses without addresses in the nearby ZIP Codes.

**Figure 8.** “Did You Feel It” (DYFI) ZIP-Code map for the area around Lake Almanor. Locations for our interviews (table 1–1), the Plumas County Office of Emergency Services (PCOES) reports (table 1–2), and the geocoded DYFI reports (table 1–3) are superimposed on the map.

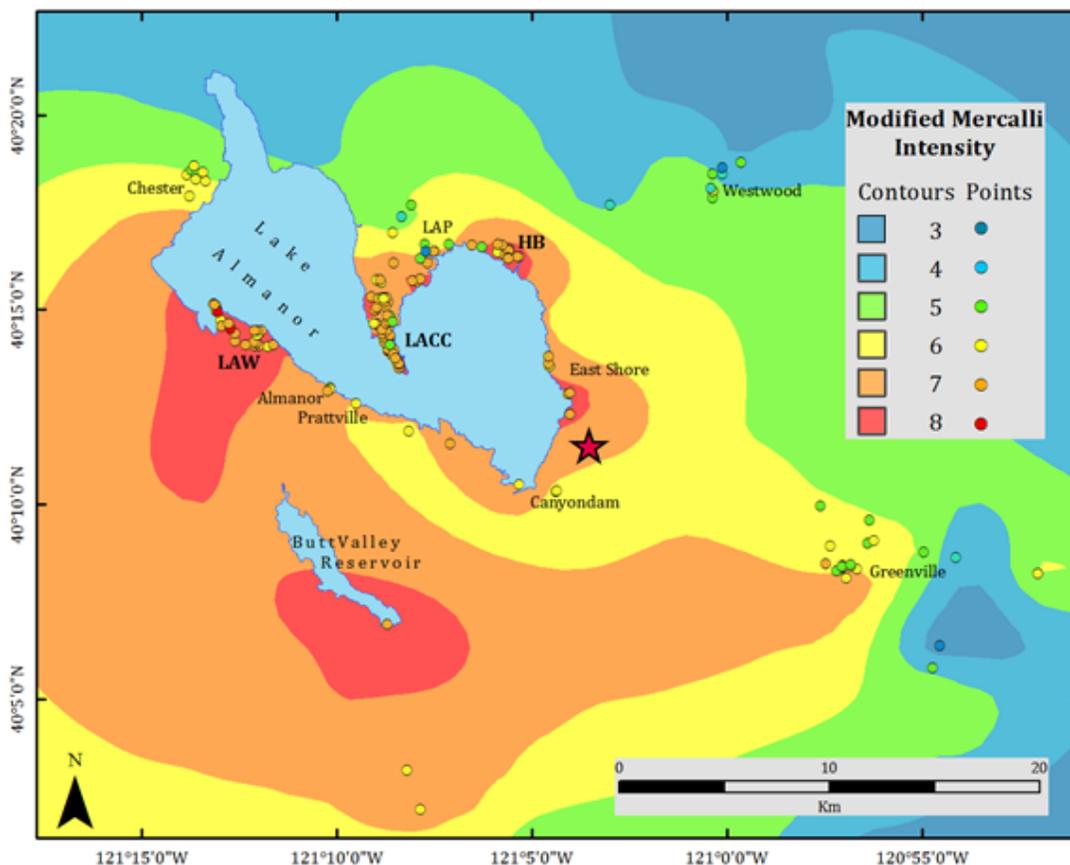
To determine the intensity distribution around Lake Almanor, we assigned MMI values to each interview and PCOES report. We combined these estimates in GIS with the DYFI CDIs obtained from their web questionnaire to obtain the isoseismal map shown in figure 9. The map shows that the highest intensities are localized in Lake Almanor West (LAW) and the Lake Almanor Country Club (LACC); it also shows how the intensity increased from north to south on the Lake Almanor peninsula, especially along Lassen View Drive, which runs along the western shore of the country club. There is an element of false detail in the map that results from the GIS contouring; however, the map accurately portrays what we saw and what was reported to us.

**Figure 9.** Map showing the May 23, 2013, Canyondam earthquake isoseismal distribution map for the area surrounding Lake Almanor. Intensity is well constrained in Lake Almanor Country Club (LACC) and adequately constrained in Lake Almanor West (LAW), Hamilton Branch (HB), Lake Almanor Peninsula (LAP), Westwood, and Chester, but poorly constrained to the north, east, and west of the lake, where there are no communities.

The intensity is best determined in LACC, where the sites are the densest, with 58 sites and the accelerograph recording. LAW and HB are well constrained, with 17 and 10 sites, respectively, and consistent intensity estimates. Chester, LAP, and Westwood are also well constrained with 10, 8, and 7 intensity sites, respectively, and consistent intensity estimates. Greenville has 14 sites, but the intensity estimates vary from MMI 3 to 7. Almanor, Prattville, Canyon Dam, and East Shore have relatively few sites, but the intensities there are constrained by the presence or absence of chimney damage. Four of 5 sites within the East Shore have damaged chimneys, but no chimney damage was reported in the other communities. Butt Valley Dam is fairly well constrained with an accelerograph and a single intensity site. The intensity at Lake Almanor Dam could not be determined because we could not gauge the shaking from the slight displacement of the bent supporting the roadway. Despite the relatively few intensity sites in either Almanor or Prattville, no chimney damage was reported to us when we visited these communities, and we are confident of our intensity estimates there.

If we compare the intensity distribution in figure 9 to the geologic map in figure 3, we see that the communities with the most damage—LAW, LACC, and HB—are situated on Tertiary and Quaternary basalts, whereas Chester and Greenville are on Quaternary sediments. The geology underlying these sites implies that the highest intensities are not amplified by site response; in fact, it makes the difference in intensity between Lake Almanor West and Chester more marked. Clearly, the strong damage in LAW, the increase of damage to the south in LACC, and the somewhat isolated damage is not a result of amplification by the surficial geology. We note that these damaged areas are situated partly on ridges and hillsides, which argues against the possibility of site amplification caused by low-velocity sediments trapped beneath the basalt.
