The M_w 6.0 South Napa Earthquake of August 24, 2014—Observations of Surface Faulting and Ground Deformation, with Recommendations for Improving Post-Earthquake Field Investigations

By Daniel J. Ponti, Carla M. Rosa, and James Luke Blair

Open-File Report 2019–1018

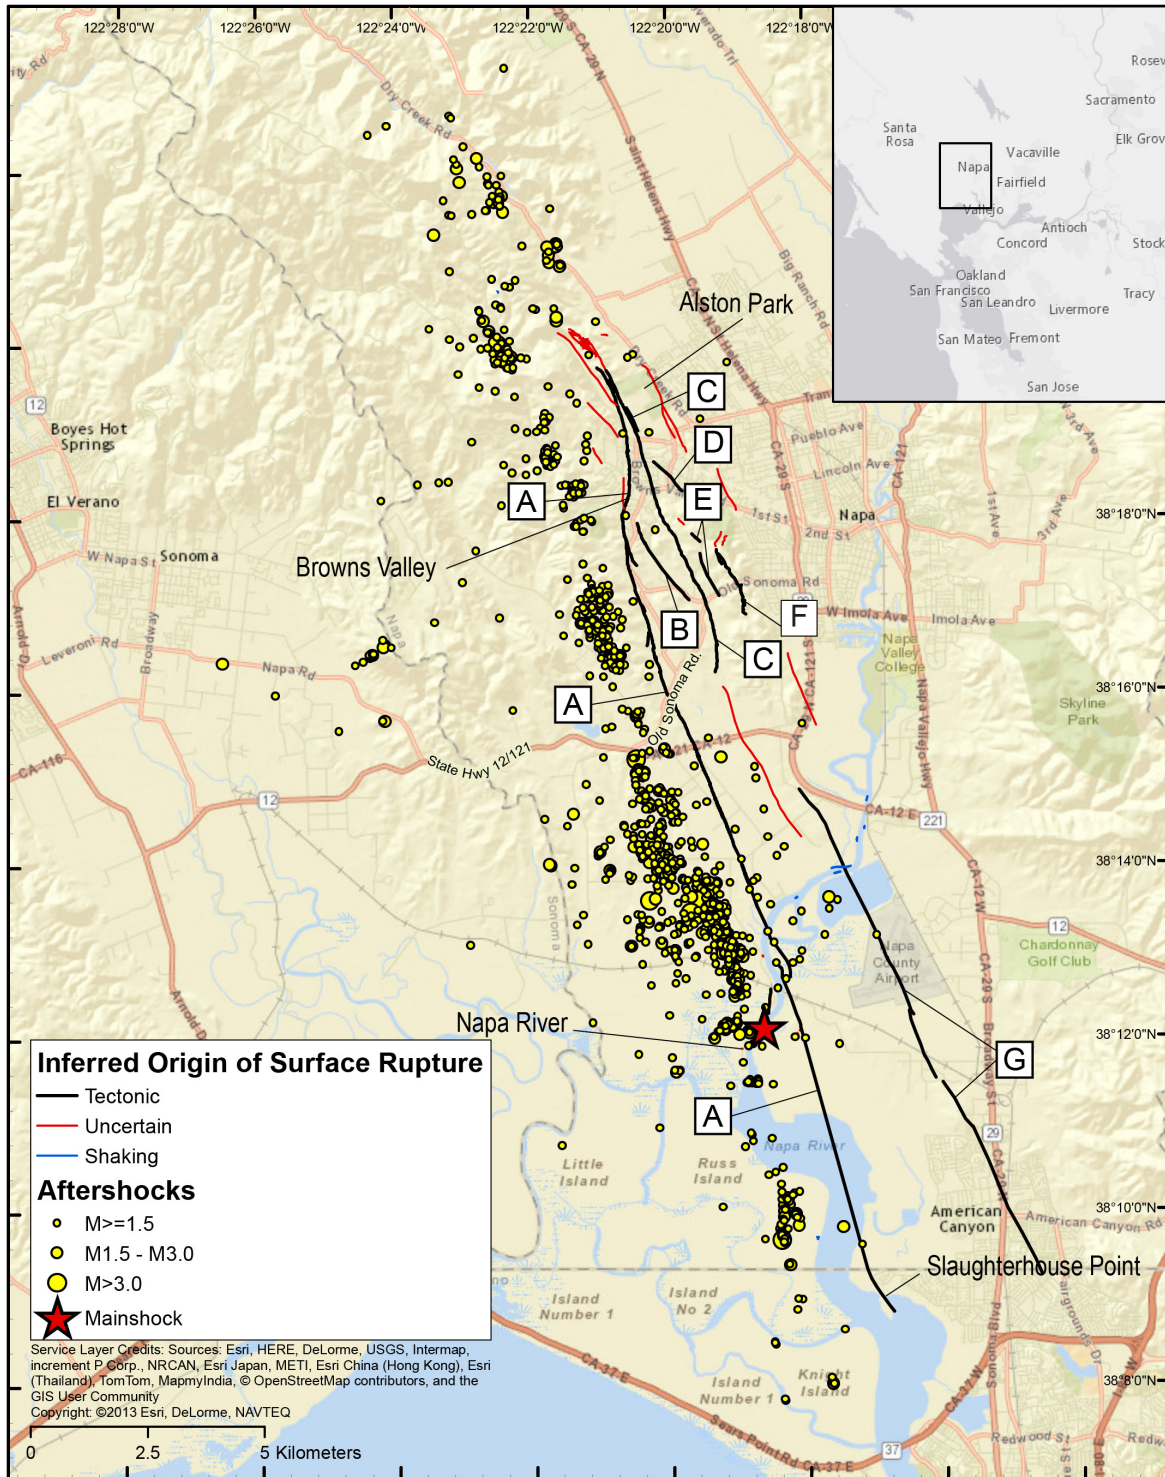
Figure 1. Map of surface faulting and ground deformation produced by the August 24, 2014, South Napa earthquake, locations of the mainshock and aftershocks that occurred between August 24 and November 4, 2014 (Hardebeck and Shelley, 2016), and locations referenced in the text. A–G show principal tectonic fault traces. Inset shows location of map area relative to San Francisco (located ~50 km south) and other major northern California cities.

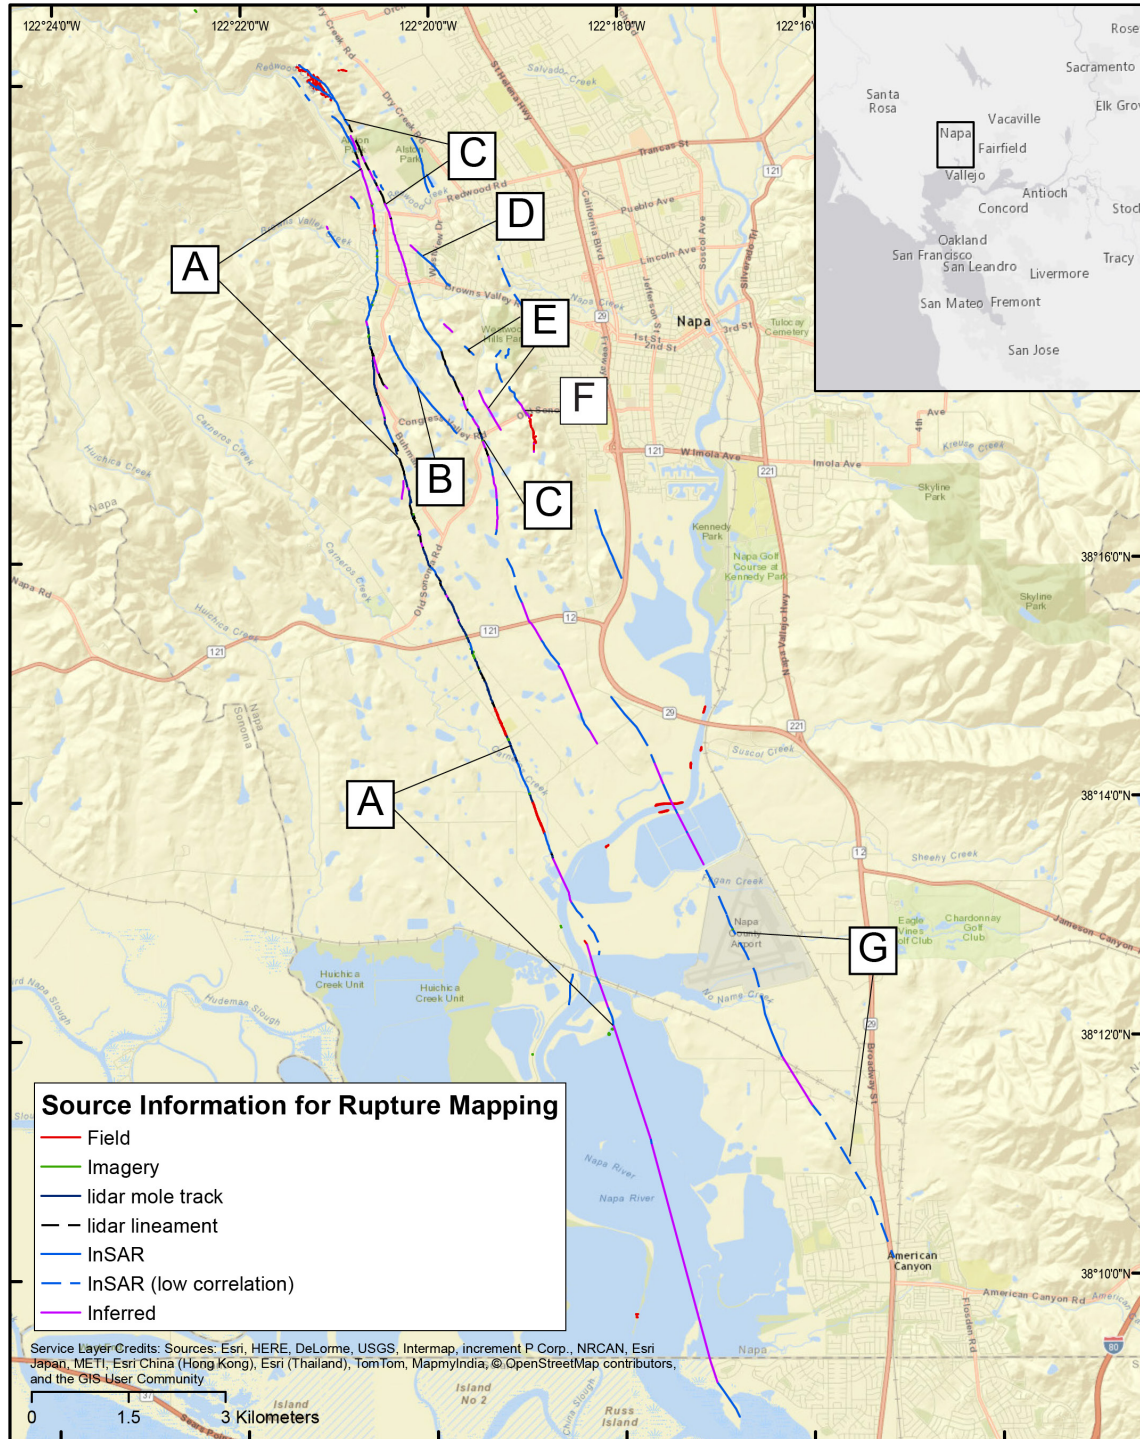
Figure 3. Map of ground deformation produced by the August 24, 2014, South Napa earthquake, showing the types of source information used for constructing the map. Categories shown in the legend are explained in table 3. A–G, principal tectonic traces discussed in this report. Inset shows location of map area relative to San Francisco (located ~50 km south) and other major northern California cities.

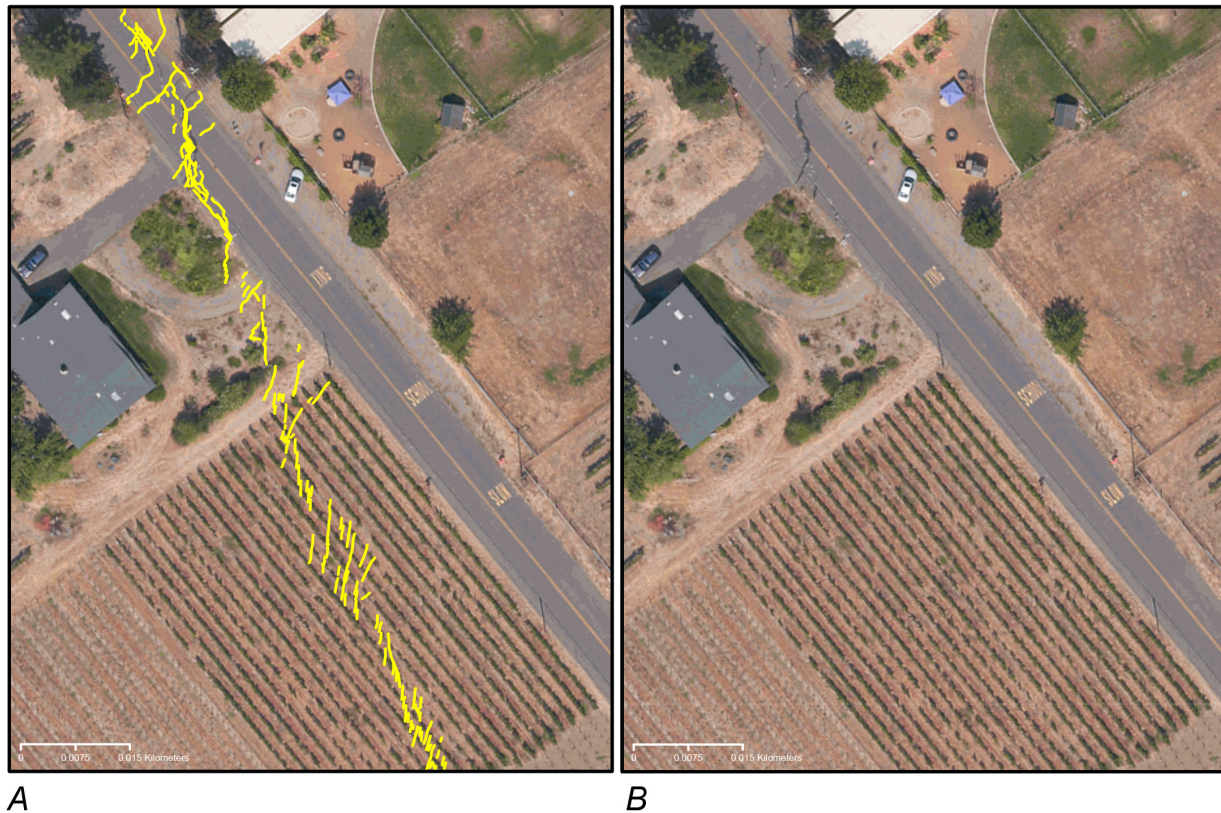
Figure 4. Map of a portion of the fault rupture produced by the August 24, 2014, South Napa earthquake, showing a representative example of rupture detail mapped in the field. *A*, Fine-scale details of fault rupture on Trace A near Stone Bridge School (near stations 66–75, appendix 2, fig. 2.2) from field mapping by A. Lutz and C. Hitchcock, included in our rupture compilation, superimposed onto USGS/Towill orthoimagery flown on September 9, 2014. *B*, USGS/Towill orthoimagery of the same area without the overlying linework.

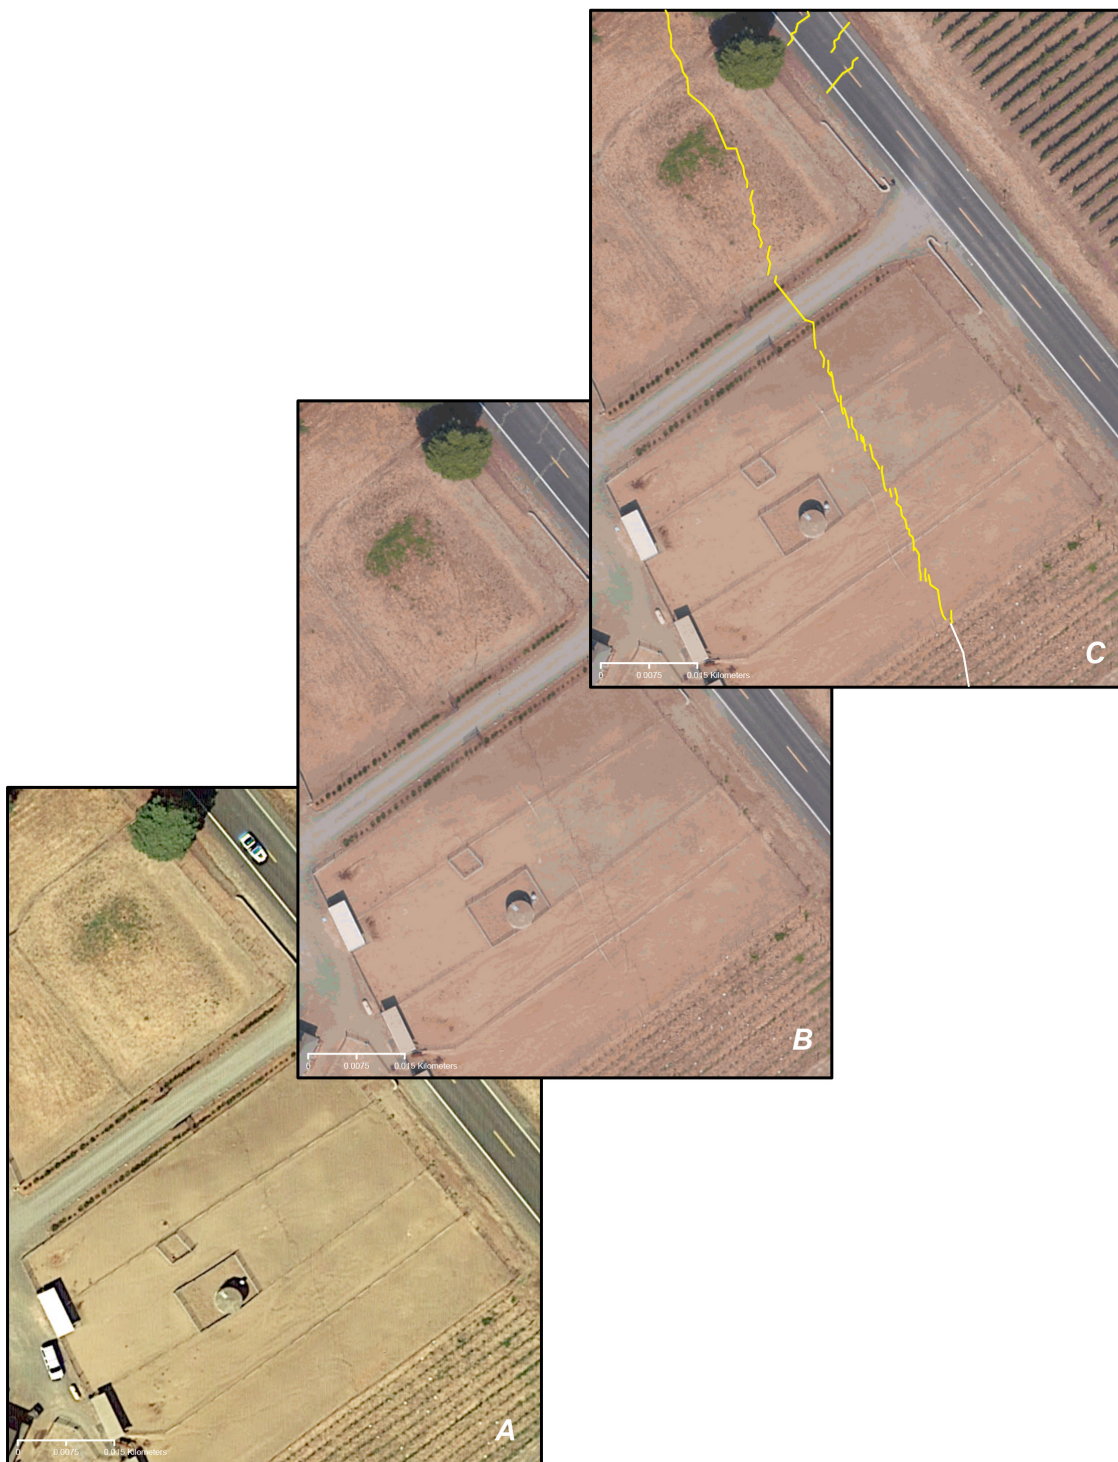
Figure 5. Examples of post-earthquake airborne imagery used for the rupture compilation, showing expression of fault rupture on Trace A of the West Napa Fault System from about 200 m south of State Route 12/121 (stations 135–152, appendix 2, fig. 2.3). *A*, Google orthoimagery (~15-cm pixel resolution) acquired in the afternoon on August 24, 2014, less than 12 hours after the earthquake; *B*, USGS/Towill orthoimagery (~15-cm pixel resolution) acquired September 9, 2014; *C*, rupture interpretation from our compilation derived from imagery (yellow) and lidar (white) superimposed on USGS/Towill orthoimagery.

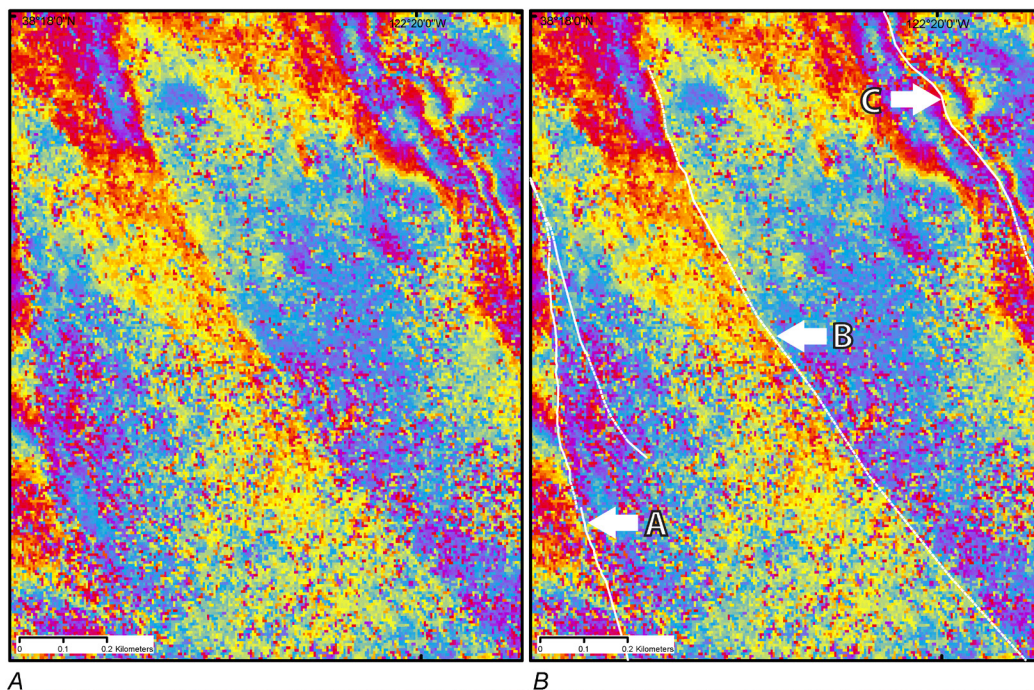
Shallow faulting or other ground deformation produced by the earthquake is expressed on Interval 2 and Interval 3 interferograms as lineaments produced by fringe dislocations or substantial changes in radar phase over a short distance (fig. 8). Most lineament mapping was performed on Interval 2 interferograms, although Interval 3 interferograms were used along Trace A where coseismic slip was high. Preseismic (Interval 1) interferograms were used as a check on the mapping to ensure that mapped lineaments were not associated with non-seismic causes.

Figure 8. UAVSAR wrapped phase interferogram (line 23511) for a portion of the West Napa Fault System that ruptured in the August 24, 2014, South Napa earthquake. The interferogram is derived from data collected on May 29 and August 29, 2014 (Interval 2), and was used to aid rupture mapping where rupture could not be detected on airborne imagery or lidar shaded relief images. *A*, Interferogram centered over the Trace B lineament (fig. 1); color spectrum from red to violet represents a 2π change in phase. *B*, Same image with interpreted traces A, B, and C (labeled with arrows).
