## **Appendix 4. Tabulated Observations and Photographs of Surface Faulting and Ground Deformation Produced by the $M_w$ 6.0 South Napa Earthquake of August 24, 2014—Trace C**

## Trace C

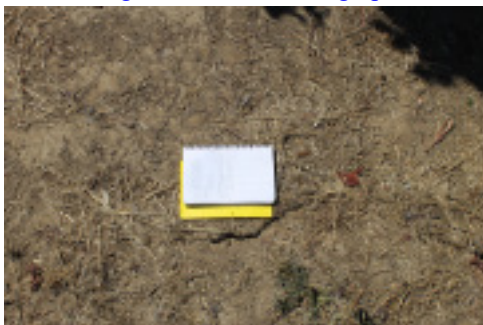
| Station ID: 547 | | | Observer: Pickering/Hecker | |

| Station ID: 547 | | | Observer: Pickering/Hecker | |
|---|---|---|---|---|
| Purely a tension crack, might be shaking related. Represents the south end of subsidiary alignment of fractures. | | | | |

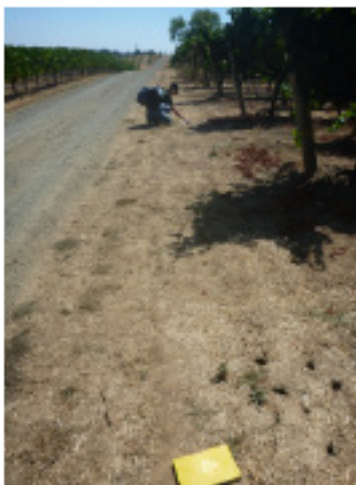
| Station ID: 548 | | | | Observer: Hecker | | |

| Station ID: 548 | | | | Observer: Hecker | | |
|---|---|---|---|---|---|---|
| >10-meter-long zone of cracks (including two left-stepping en echelon) along west side of road, subparallel to and east of "main" zone. | | | | | | |

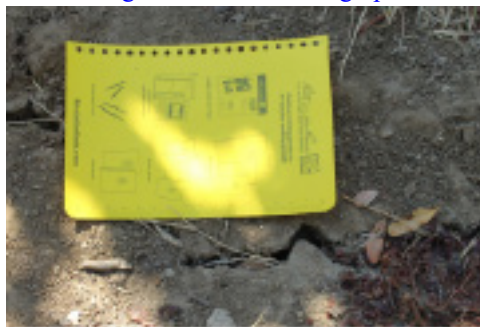
| Station ID: 550 | | | | Observer: Hecker/Pickering | | |
|---|---|---|---|---|---|---|
| Broad zone of north-south oriented fractures, small displacement (1-3 mm). Zone consists of 4-6 cracks over ~20-m-wide interval. | | | | | | |

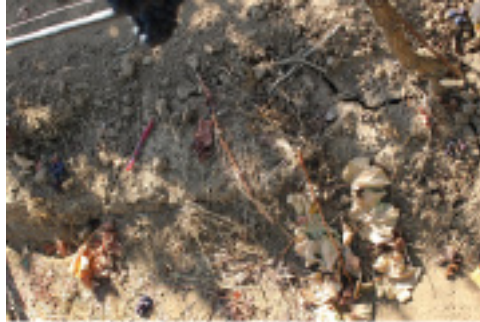
| Station ID: 553 | | | Observer: Pickering/Hecker | | | |
|---|---|---|---|---|---|---|
| Prominent, open fractures forming polygonal-type pattern through two vineyard rows. 0.5cm extension with some left-lateral. | | | | | | |

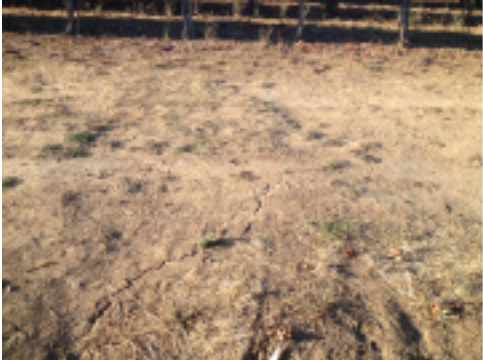
| Station ID: 556 | | | | | Observer: Seitz | |
|---|---|---|---|---|---|---|
| Minor ground cracking and en echelon break 1 m-long; left stepping; more poorly expressed than surface ruptures observations immediately to the north. | | | | | | |

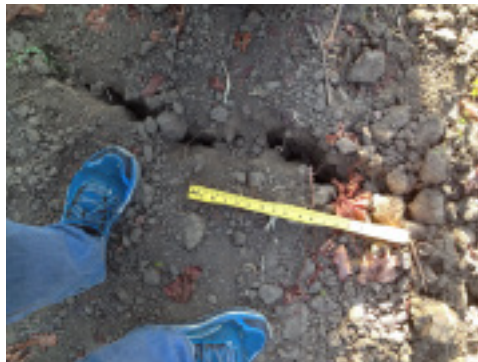
| Station ID: 559 | | | | | Observer: Seitz | |
|---|---|---|---|---|---|---|
| Surface rupture in vineyard. Deflection on the order of 5 to 10 cm but very difficult to measure. Compiler note: from photograph, possible RL offset of ~5 cm. | | | | | | |

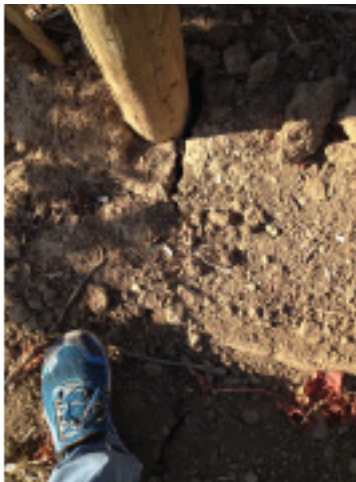
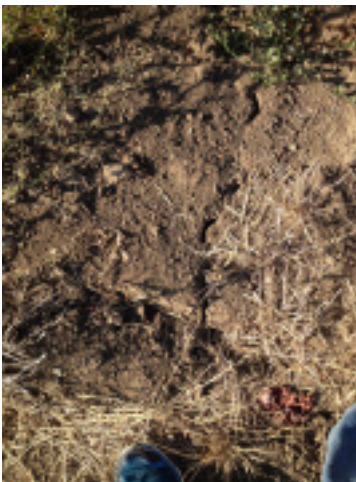
| Station ID: 560 | | | | | | Observer: Seitz |

| Station ID: 560 | | | | | | Observer: Seitz |
|---|---|---|---|---|---|---|
| Zone of distributed ground cracking; rough left-stepping pattern; difficult to measure offsets. | | | | | | |

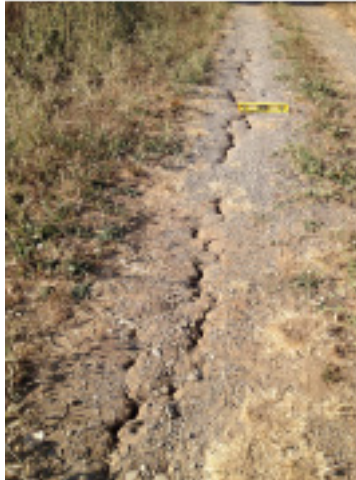
| Station ID: 563 | | | | Observer: Seitz |
|---|---|---|---|---|
| Possible surface rupture also possible cracking of pond levee. Compiler note: location is east of inferred fault location based on UAVSAR. | | | | |

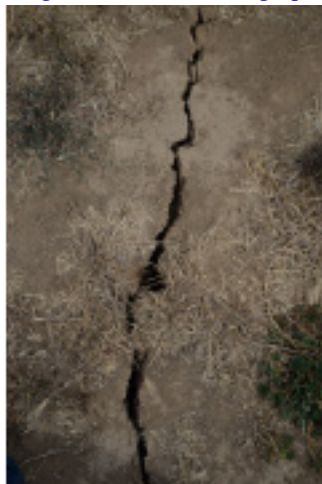
| Station ID: 567 | | | | | | Observer: Hudnut |
|---|---|---|---|---|---|---|
| Fractures in compacted soil; intersects fault trace; zone trends N40E. | | | | | | |

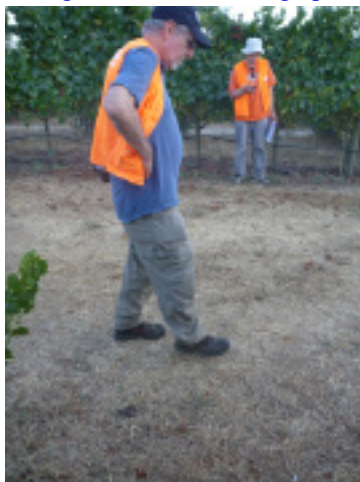
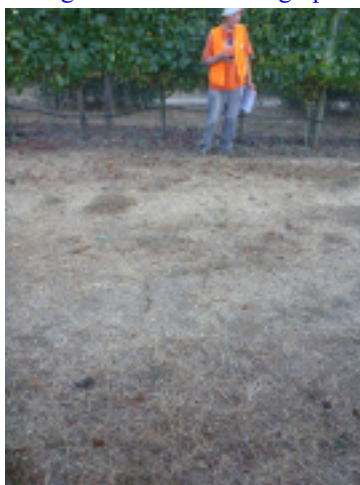
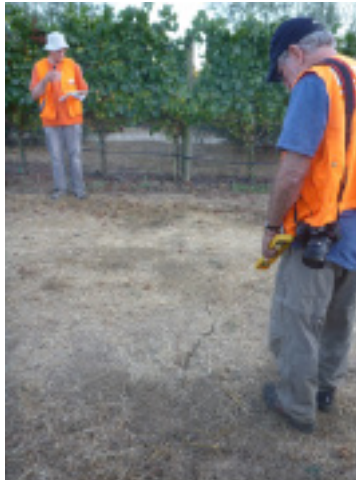
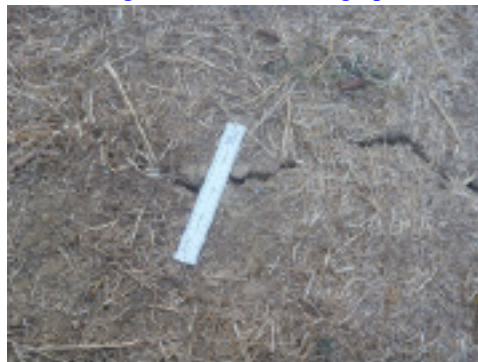
| Station ID: 568 | | | | Observer: Prentice/Hecker/Sickler | | |

| Station ID: 568 | | | | Observer: Prentice/Hecker/Sickler | | |
|---|---|---|---|---|---|---|
| Small left-stepping en echelon cracks, | | | | | | |

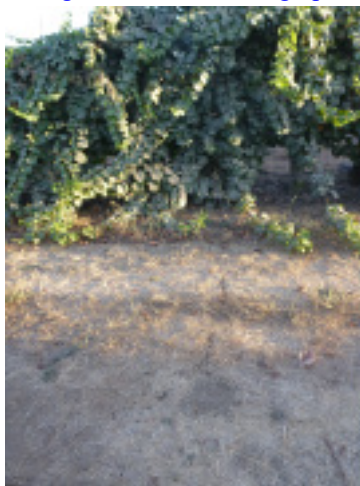
| Station ID: 569 | | | Observer: Prentice/Hecker/Sickler | |

| Station ID: 569 | | | Observer: Prentice/Hecker/Sickler | |
|---|---|---|---|---|
| Left-stepping en echelon cracks across road. | | | | |

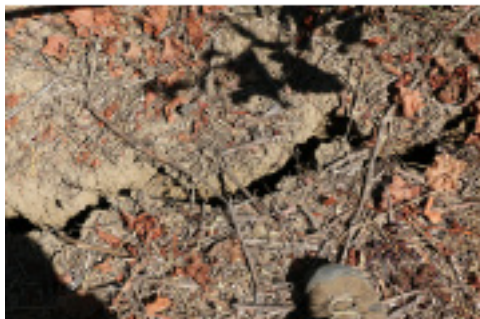
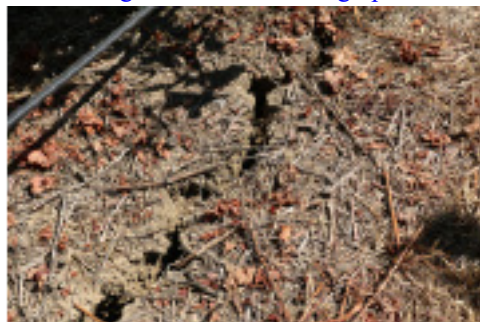
| Station ID: 570 | | | | Observer: Prentice/Hecker/Sickler | | |

| Station ID: 570 | | | | Observer: Prentice/Hecker/Sickler | | |
|---|---|---|---|---|---|---|
| Cracks in vineyard, small right-lateral slip ( | | | | | | |

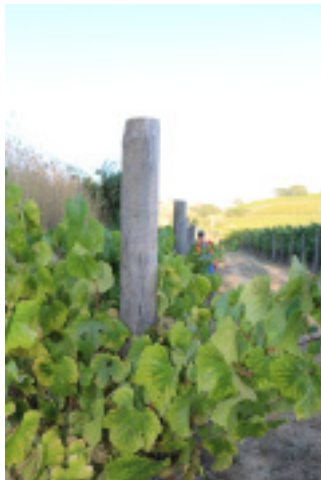
| Station ID: 571 | | | | Observer: Prentice/Hecker/Sickler | | |

| Station ID: 571 | | | | Observer: Prentice/Hecker/Sickler | | |
|---|---|---|---|---|---|---|
| Vineyard fence shows very small right-lateral, left-stepping en echelon cracks across road and through vineyard. | | | | | | |

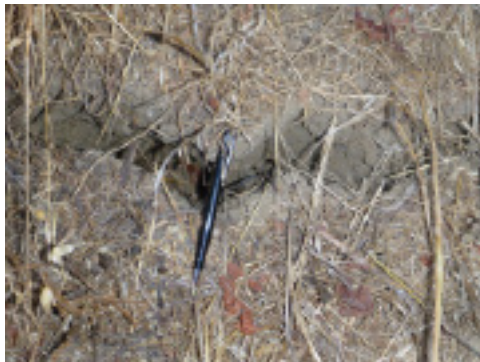
| Station ID: 572 | | | | | | | Observer: Prentice/Hecker/Sickler | | |

| Station ID: 572 | | | | | | | Observer: Prentice/Hecker/Sickler | | |
|---|--|---|---|---|---|---|---|---|---|
| Cracks across vineyard road, small right-lateral slip ( | | | | | | | | | |

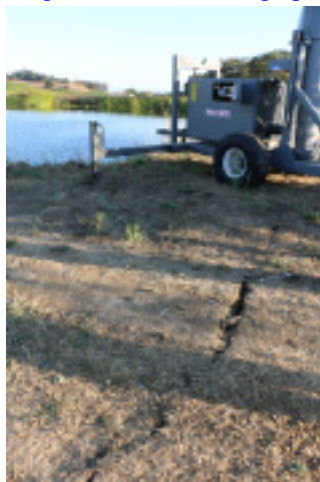
| Station ID: 573 | | | | Observer: Hecker | | |
|---|---|---|---|---|---|---|
| Fractures intersect north end of retention pond. Two primarily extensional cracks up to 3 cm opening. South side of pond (below embankment) - one main fracture, mainly extensional. Slight apparent right-lateral deflection of fence line. | | | | | | |

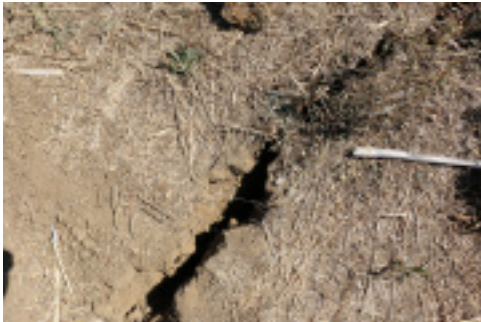
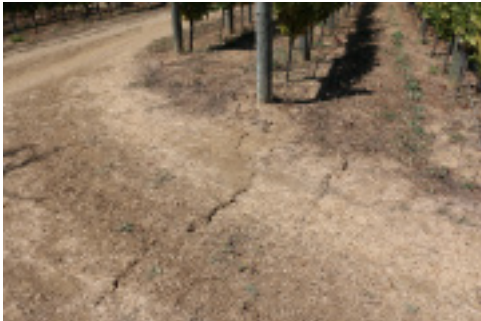
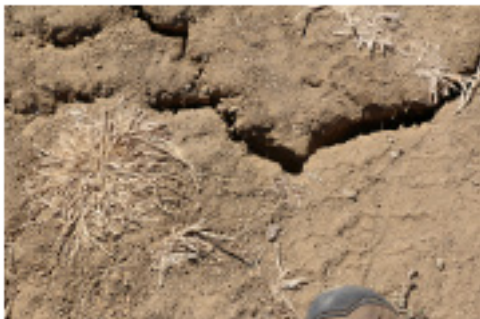
| Station ID: 574 | | | Observer: Prentice/Hecker/Sickler | |

| Station ID: 574 | | | Observer: Prentice/Hecker/Sickler | |
|---|---|---|---|---|
| Cracks across vineyard road. | | | | |

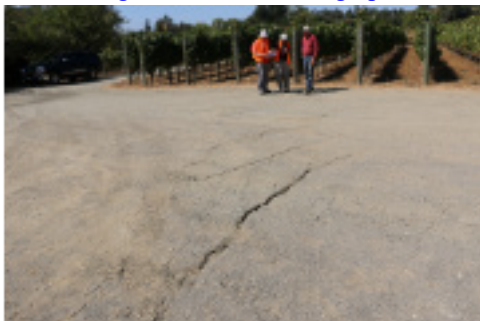
| Station ID: 575 | | | | Observer: Prentice/Hecker/Sickler | | |

| Station ID: 575 | | | | Observer: Prentice/Hecker/Sickler | | |
|---|---|---|---|---|---|---|
| Left-stepping en echelon cracks across vineyard road. | | | | | | |

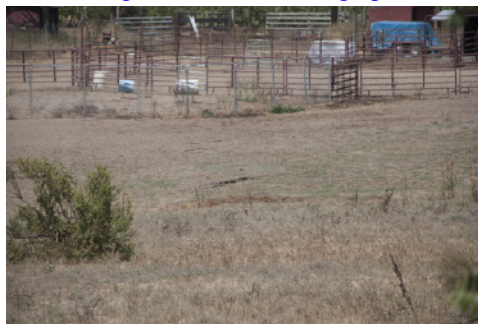
| Station ID: 593 | | | | Observer: Brossy |

| Station ID: 593 | | | | Observer: Brossy |
|---|---|---|---|---|
| Subtle ground cracks infilled with roto-tilled soil; coincident with trends of documented surface deformation to north and south. | | | | |

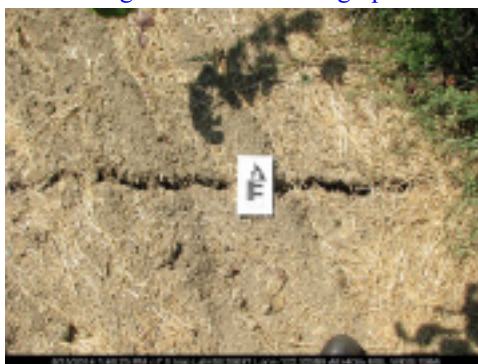
| Station ID: 595 | | | | Observer: Dawson |

| Station ID: 595 | | | | Observer: Dawson |
|---|---|---|---|---|
| Cracks in ground just south of driveway. | | | | |

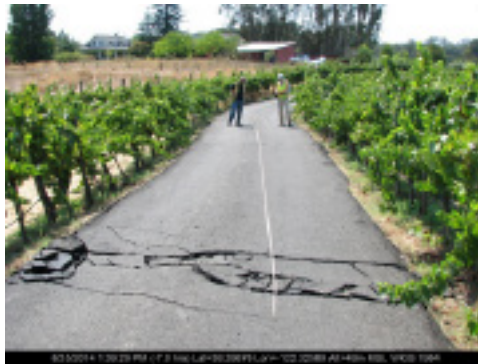
| Station ID: 597 | | | | | Observer: Dawson | |

| Station ID: 597 | | | | | Observer: Dawson | |
|---|---|---|---|---|---|---|
| Fault zone crossing driveway. 3 to 4 cracks, 53 feet wide, breaks asphalt. | | | | | | |

Shattering of asphalt along southern part of trace C on driveway near Thompson Road. Rupture was difficult to see in soil on either side of driveway, but obvious on asphalt. Right-lateral offsets were around 5 cm in this area, although difficult to measure at this location

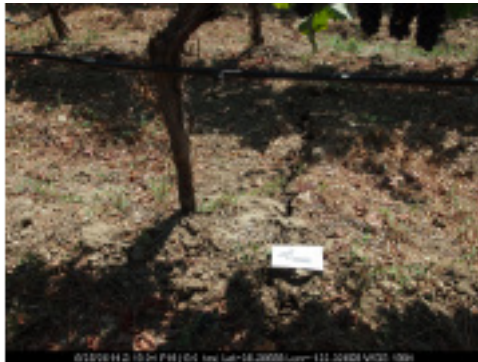
| Station ID: 599 | | | | | Observer: Brossy | |

| Station ID: 599 | | | | | Observer: Brossy | |
|---|---|---|---|---|---|---|
| Discontinuous ground cracks observed in vineyard; ~6 m long and ~2-4 cm wide. | | | | | | |

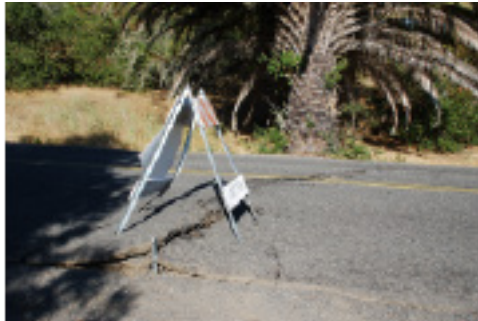
| Station ID: 602 | | | | | Observer: Brossy | |
|---|---|---|---|---|---|---|
| Cracking parallel and perpendicular to paved road surface, buckling of road surface as well. Apparent right-lateral separation of western margin of center line ~ 4cm; eastern margin of center line ~5 cm. | | | | | | |

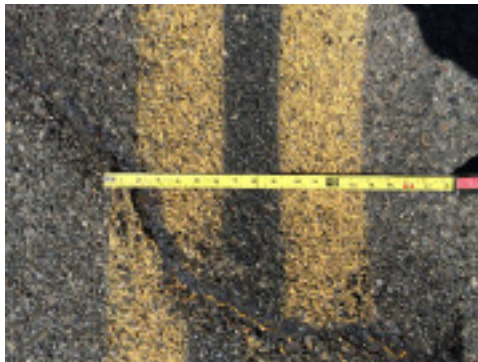
| Station ID: 606 | | | | Observer: Brossy | | |
|---|---|---|---|---|---|---|
| Pervasive, on-strike en echelon ground cracking, 3-5 cm lateral, 7-8 cm vertical. Overall strike of features is 345-350 degrees. azimuth, some variation among individual cracks between 345 and 15 degrees. Compiler note: Upthrown side inferred from photo. | | | | | | |

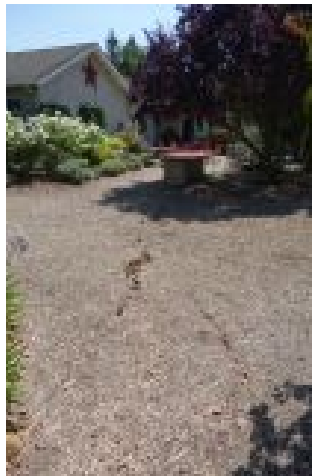
| Station ID: 607 | | | | Observer: Brossy | | |
|---|---|---|---|---|---|---|
| Pervasive, on-strike en echelon ground cracking, 3-5 cm lateral, 7-8 cm vertical. Overall strike of features is 345-350 degrees azimuth; some variation among individual cracks between 345 and 15 degrees. | | | | | | |

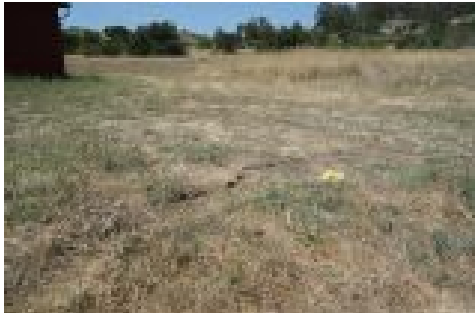
| Station ID: 609 | | | | Observer: Brossy | | |
|---|---|---|---|---|---|---|
| Left-stepping en echelon cracks, displacements measured an average of 3-5 cm +/- 1cm lateral, with up to 7-8 cm +/- 1 cm vertical. Overall strike of features is 345-350 degrees azimuth; some variation among individual cracks between 345 and 15 degrees. Cracks range from 3 - 12 meters in length Compiler note: Upthrown side inferred from photo. | | | | | | |

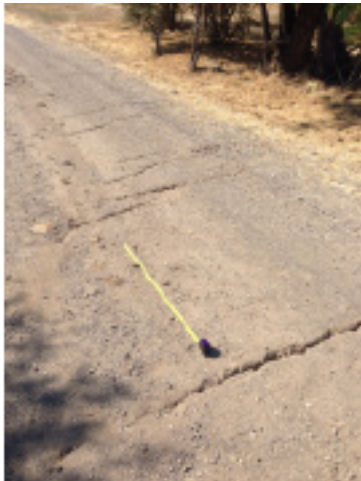
| Station ID: 611 | | | | Observer: Hecker | | |
|---|---|---|---|---|---|---|
| ~5-m-wide zone of three or more left-stepping extensional (1-3 cm opening) cracks crossing vineyard dirt road adjacent to property-line fence. Fractures appear to continue to the south. Fault trend 309. ~5 cm of vertical separation on one crack, down to east (upslope-side down). | | | | | | |

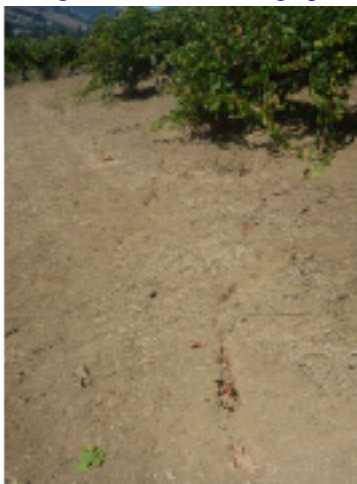
| Station ID: 612 | | | | | Observer: Hecker | |
|---|---|---|---|---|---|---|
| One main crack plus 1-2 minor cracks where it crosses transverse dirt road. Zone here appears to step left 5 m or so onto adjacent property where fracture is visible on other side of fence (limited view). Fault trend 323-325. | | | | | | |

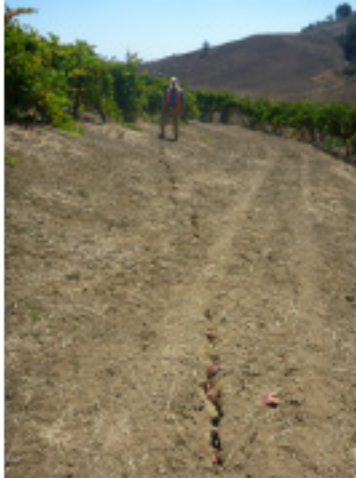
| <b>Station ID: 613</b> | | <b>Observer: Morelan/Trexler</b> | | |

| Site name: round_hill - Measurement: None - Measurement azimuth: None - Displacement sense: None; buckling and broken water main. | | | | |

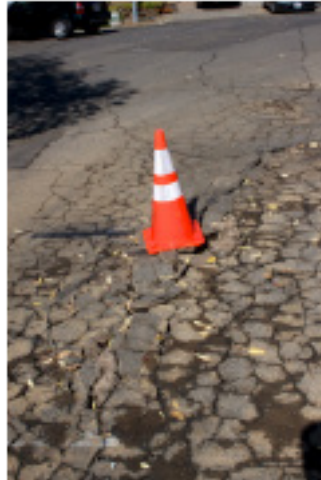
| Station ID: 614 | | | | Observer: Rubin |

| Station ID: 614 | | | | Observer: Rubin |
|---|---|---|---|---|
| Location of reported rupture. Many pre-existing cracks in street and curb. No obvious throughgoing pattern. No clear evidence of rupture here or elsewhere on Round Hill Circle. | | | | |

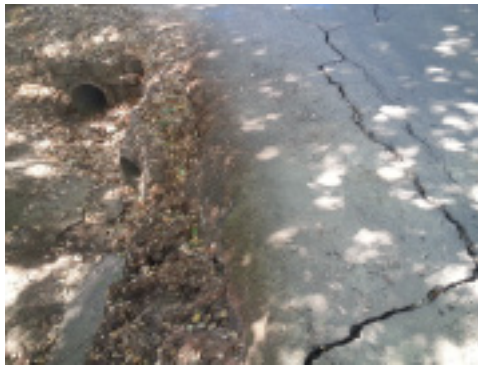
| Station ID: 616 | | | | Observer: Seitz |

| Station ID: 616 | | | | Observer: Seitz |
|---|---|---|---|---|
| Extensional cracks roughly along the trend of the fault zone to the north. | | | | |

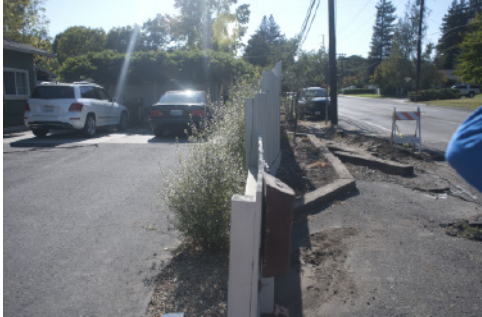
| Station ID: 619 | | | Observer: Lienkaemper/Schwartz | |

| Station ID: 619 | | | Observer: Lienkaemper/Schwartz | |
|---|---|---|---|---|
| Photo of RL rupture across Browns Valley Road. | | | | |

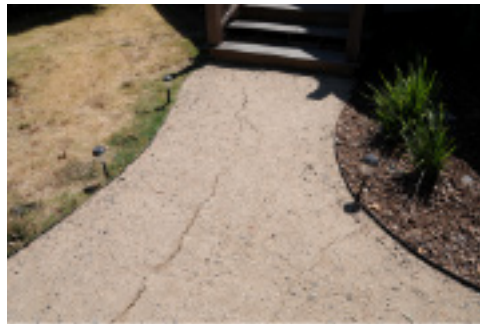
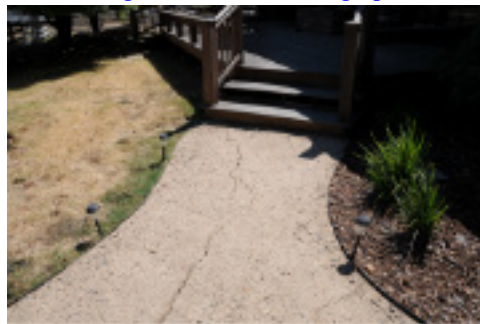
| Station ID: 635 | | | | Observer: Schwartz |

| Station ID: 635 | | | | Observer: Schwartz |
|---|---|---|---|---|
| Cracks in pathway. | | | | |

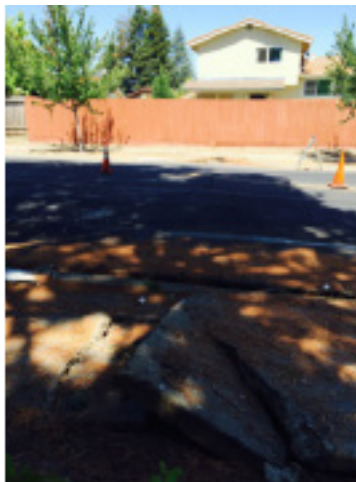
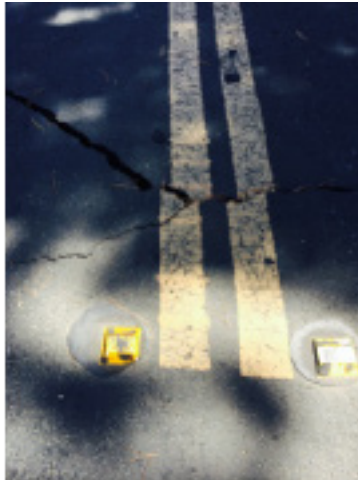
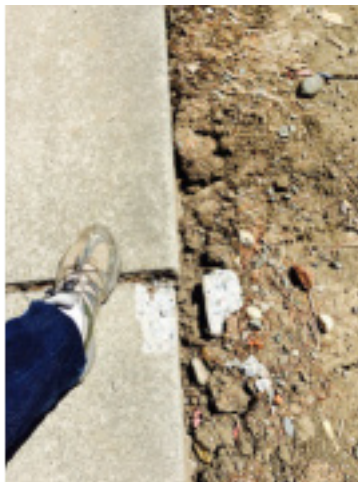
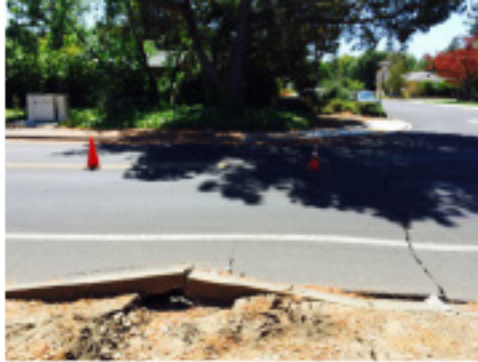
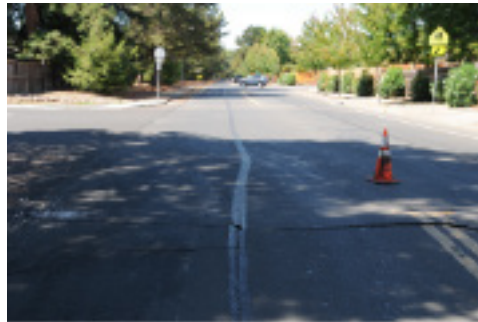
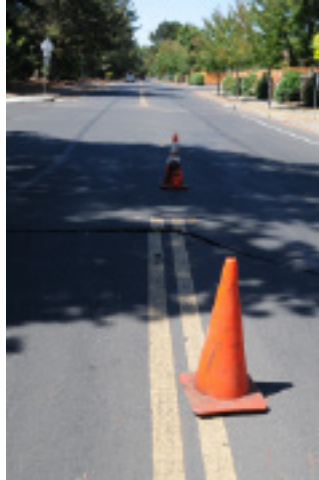
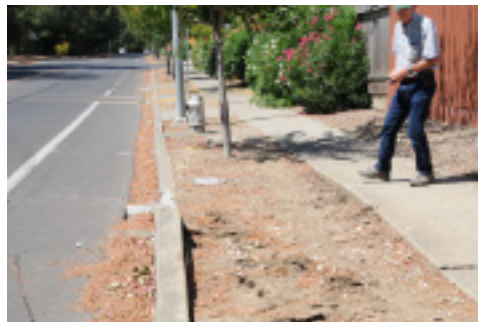
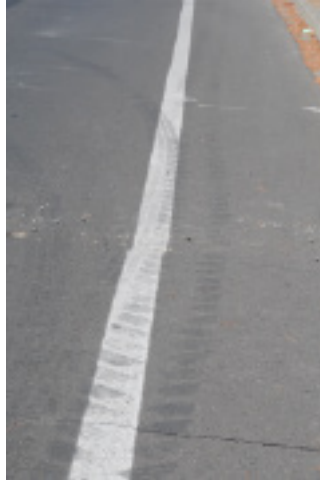
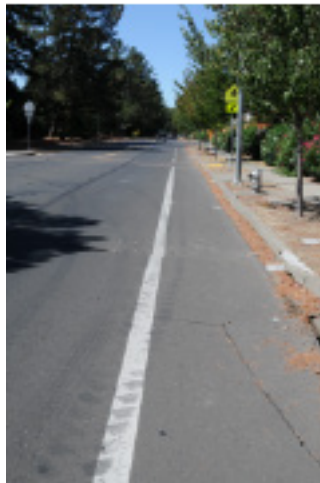
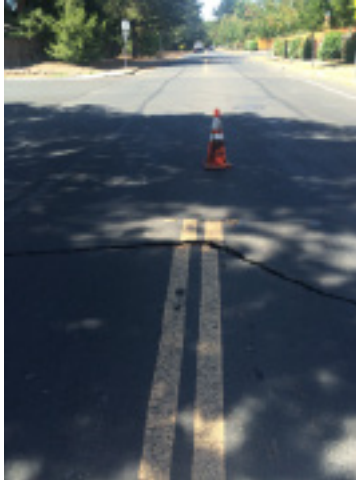
| <b>Station ID: 638</b> | | <b>Observer: Lienkaemper/Schwartz</b> | | |

| More rupture including popped up south sidewalk of Browns Valley Rd. curb. | | | | |

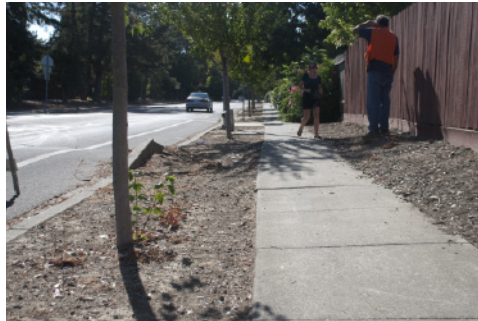
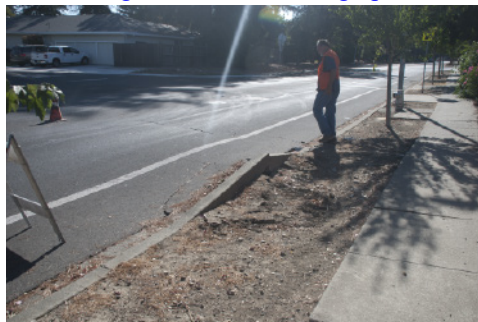
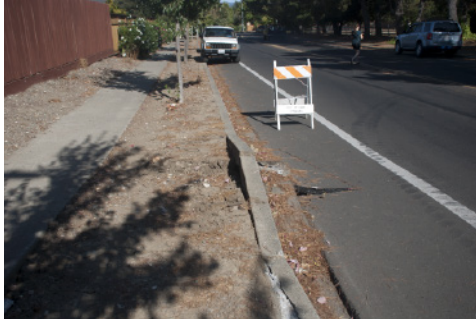
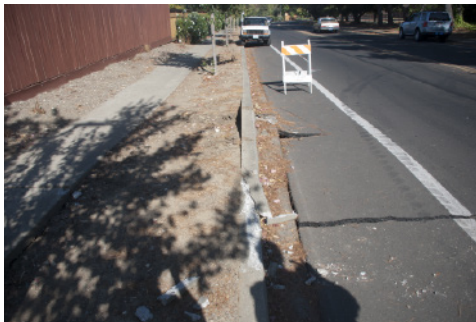
| Station ID: 642 | | | | Observer: Dawson/Davenport | | |
|---|---|---|---|---|---|---|
| Surface rupture forming mole track on asphalt road, tented concrete curb and displaced sidewalk in right-lateral sense on Partrick Road along eastern strand of the surface rupture. Right-lateral offset is on the order of between 5 - 10 cm. | | | | | | |

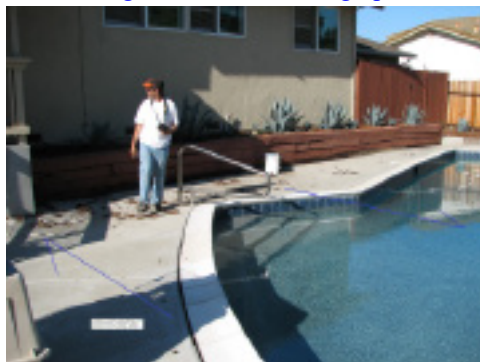
| Station ID: 646 | | | | Observer: Delattre |

| Station ID: 646 | | | | Observer: Delattre |
|---|---|---|---|---|
| Looking NE, new pool shell appeared undamaged, cracks & separations in new decking. | | | | |

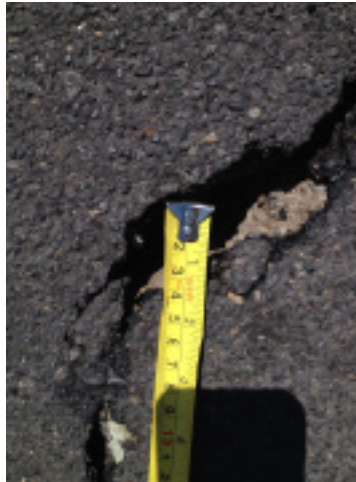
| Station ID: 651 | | | | Observer: Rubin/Seitz | | |
|---|---|---|---|---|---|---|
| Left-stepping en echelon cracks in street open 3.5 cm. Right-lateral separation on south curb 3 cm. Local left-lateral. Broad Right-lateral deflection of north curb over 5-6 m. Offset in south curb occurs 5.5 m east of crack in street. | | | | | | |

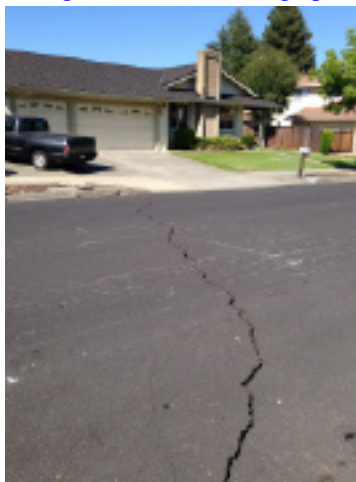
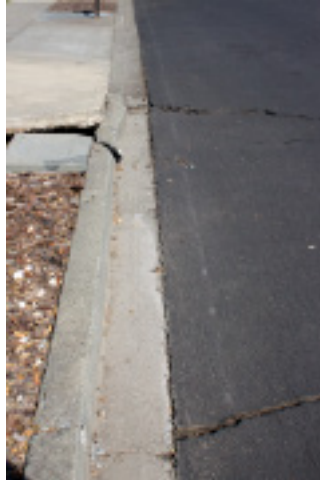
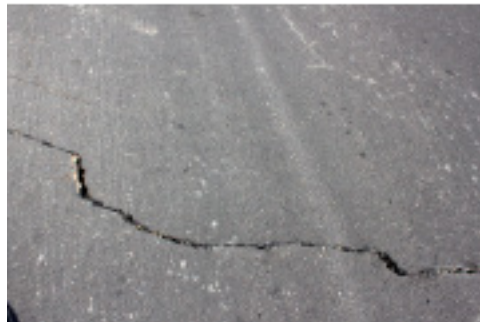
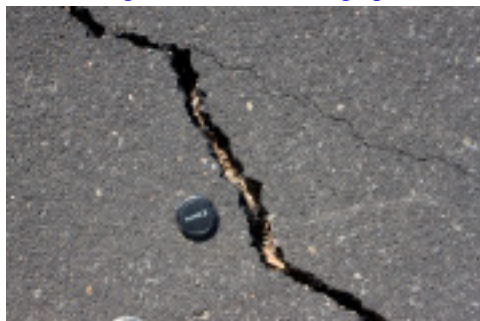
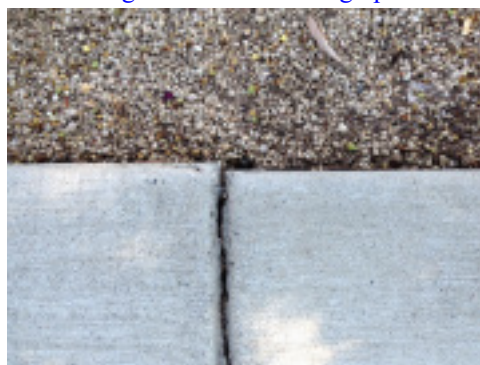
| Station ID: 652 | | | Observer: Morelan/Trexler | | | |
|---|---|---|---|---|---|---|
| Site name: covey - Measurement: 4 cm - Measurement azimuth: 10 - Feature azimuth: 30 - Displacement sense: RL. Crack across road. (Compiler note: Values above come from summary spreadsheet provided. Publication (Morelan and others, 2015) reports that no measurement was taken. | | | | | | |

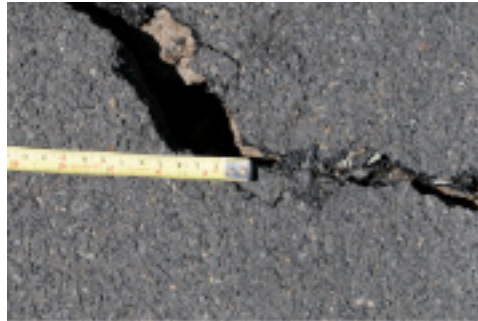
4 cm RL along exact pull-apart in asphalt concrete pavement

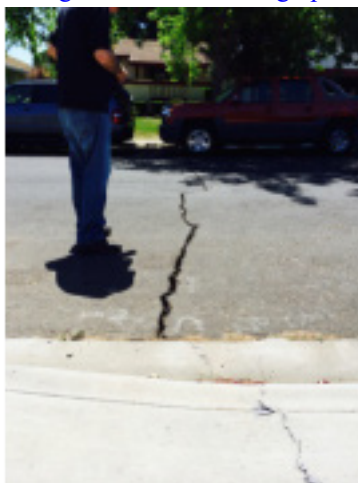
Photo of rupture crossing Ellen Way, view south.

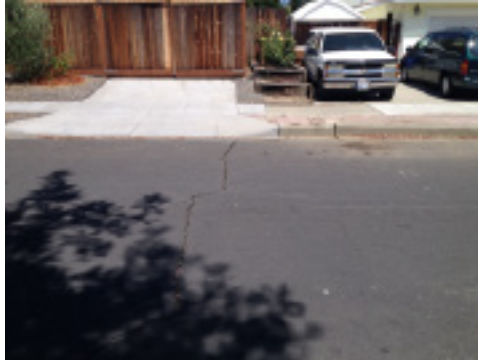
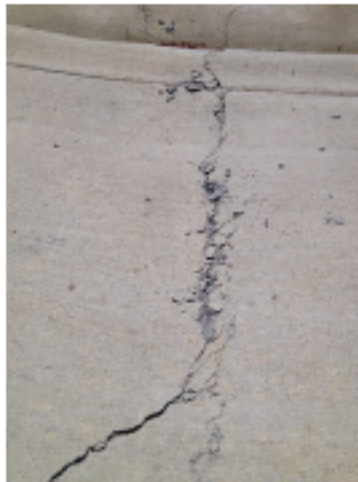
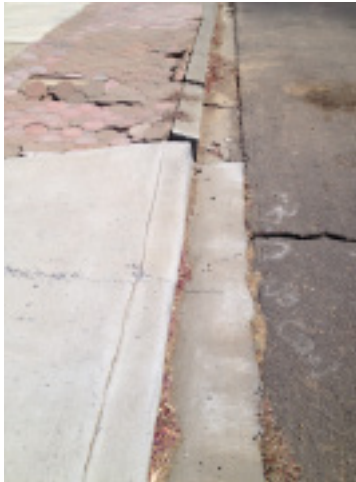
| Station ID: 660 | | | | Observer: Seitz/Rubin | | |
|---|---|---|---|---|---|---|
| Left-stepping cracks 5-6 m apart. No measurable or observed offsets. | | | | | | |

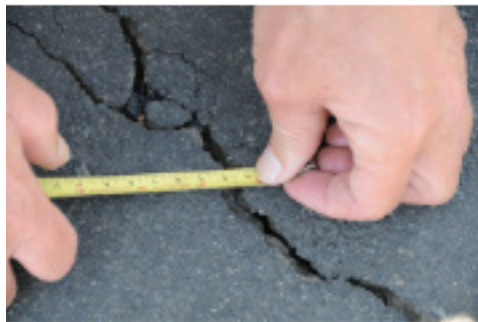
pull apart, true RL

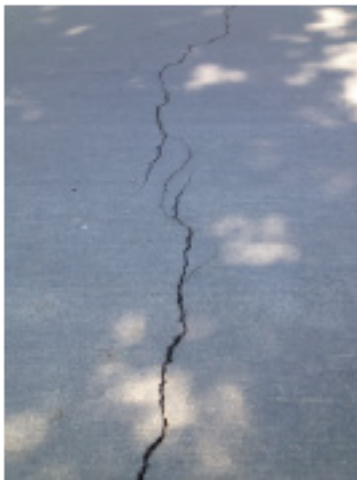
| Station ID: 664 | | | | Observer: Seitz/Rubin | | |

| Station ID: 664 | | | | Observer: Seitz/Rubin | | |
|---|---|---|---|---|---|---|
| Two open cracks in street, curb, and sidewalk. 4 mm right-lateral offset. | | | | | | |

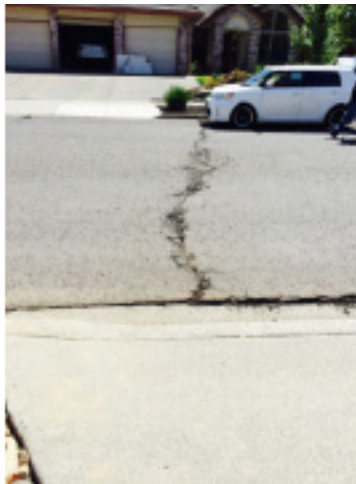
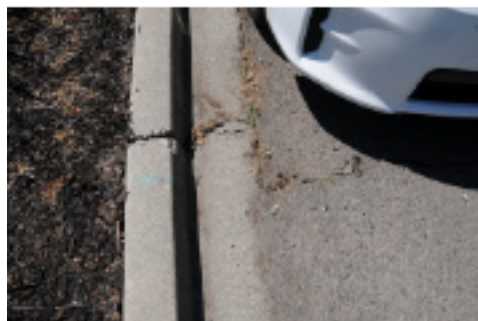
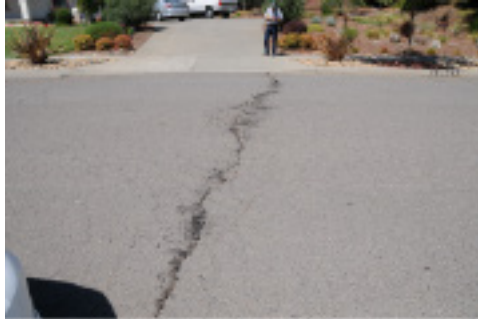
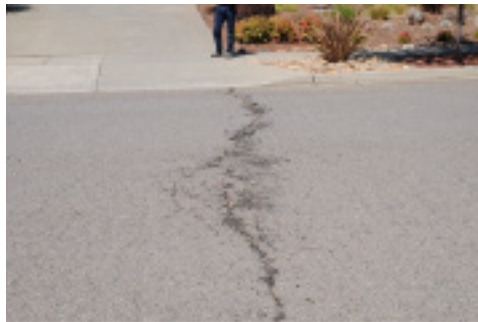
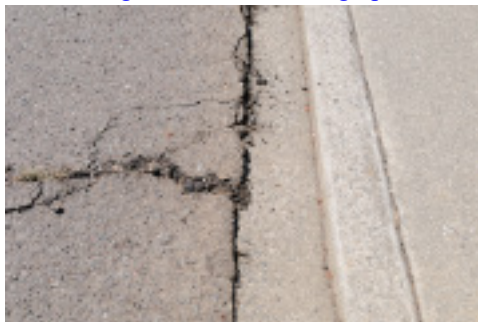
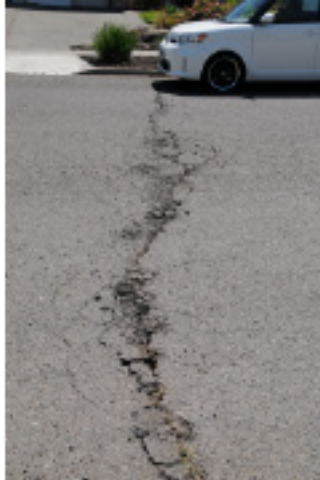
| <b>Station ID: 676</b> | | <b>Observer: Lienkaemper/Schwartz</b> |

| Station ID: 676 | | | Observer: Lienkaemper/Schwartz | |
|---|---|---|---|---|
| Rupture zone in A/C pavement Westminster Way. | | | | |

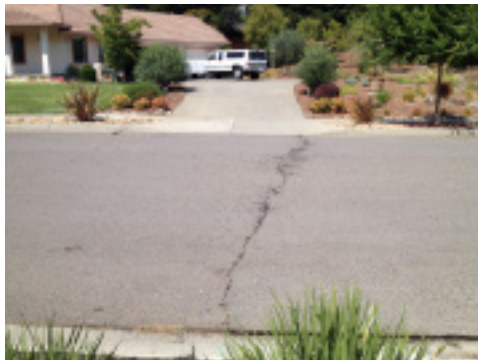
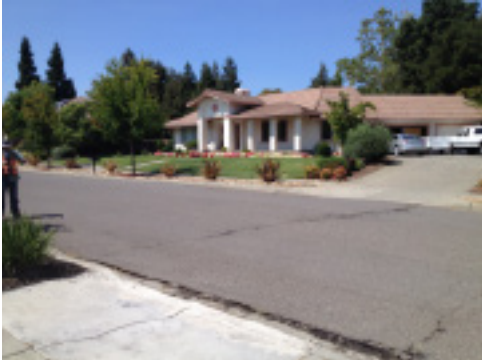
| Station ID: 677 | | Observer: Seitz/Rubin | |

| Station ID: 677 | | | | Observer: Seitz/Rubin | | |
|---|---|---|---|---|---|---|
| 5 cm right-lateral at north curb. 1.5 cm right-lateral offset at sidewalk. Street cracks not coincident with offsets. South curb has 2 right-lateral offsets 13.8m apart with total 6.5 cm. | | | | | | |

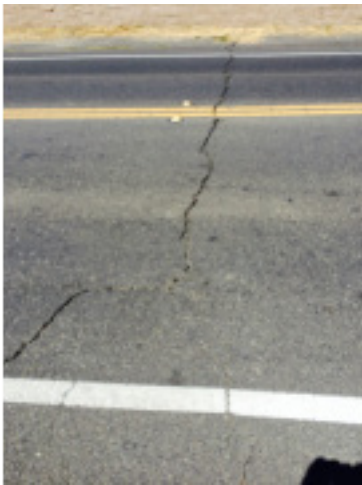
| Station ID: 681 | | | | Observer: Seitz/Rubin | |
|---|---|---|---|---|--|
| Cracked curb and damage to house but no visible offset. Many preexisting cracks in pavement, some open a few mm. | | | | | |

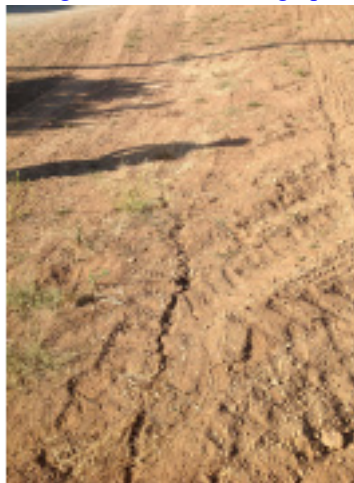
| Station ID: 696 | | | | Observer: Ponti | | |
|---|---|---|---|---|---|---|
| Small tension cracks in soil observable between vineyard rows (~1 cm opening). Pointed out by vineyard manager, who says these cracks run along a trend parallel to and east of fault trace that runs through corral; location approximate. Likely tectonic based on orientation and proximity to clear RL deformation to the west, but cannot be demonstrated directly. | | | | | | |

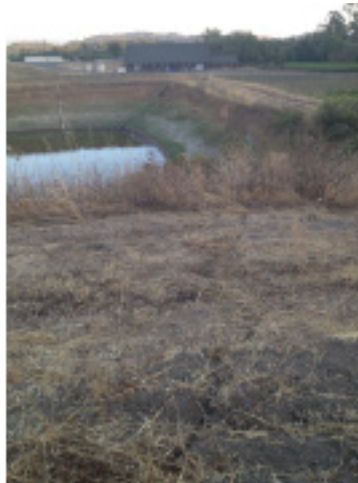
| Station ID: 700 | | | | | Observer: Ponti | |

| Station ID: 700 | | | | | Observer: Ponti | |
|---|---|---|---|---|---|--|
| Fractures here cross roadway by reservoir. | | | | | | |

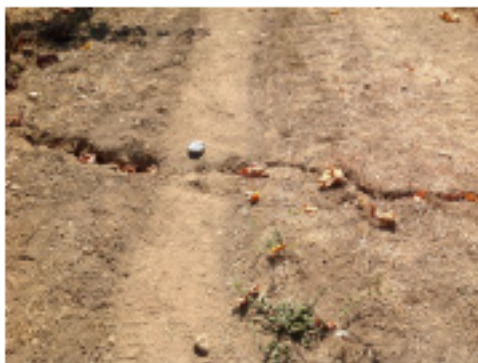
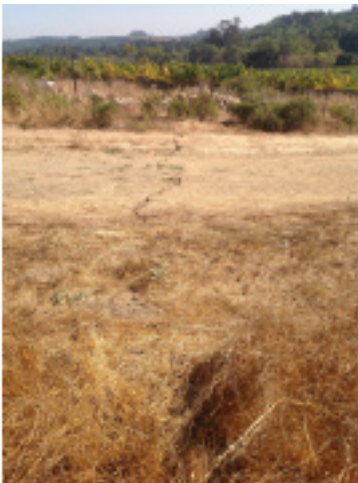
| Station ID: 704 | | | | Observer: Ponti | | |
|---|---|---|---|---|---|---|
| On InSAR lineament. Very distinct fracture crossing road with a trend of 342. Apparent left-stepping en echelon fracture. Fracture appears mostly tensional with some right-lateral movement. Best estimate for slip vector: 4 cm length; direction 310; plunge 32 to the west. Fracture zone is several meters below the crest of a broad, west facing gentle slope, perhaps an old scarp. The fracture zone can be traced to the south east into the adjoining vineyard, to the north however, it is difficult to follow owing to tall grass. Photos to the southeast and northwest. | | | | | | |

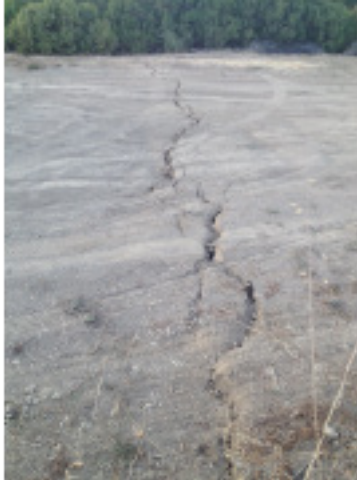
| Station ID: 710 | | | | Observer: Lienkaemper | | |

| Station ID: 710 | | | | Observer: Lienkaemper | | |
|---|---|---|---|---|---|---|
| N84W (az. 276) vector 2.5 cm opening; left-stepping EE cracks strike 345. | | | | | | |

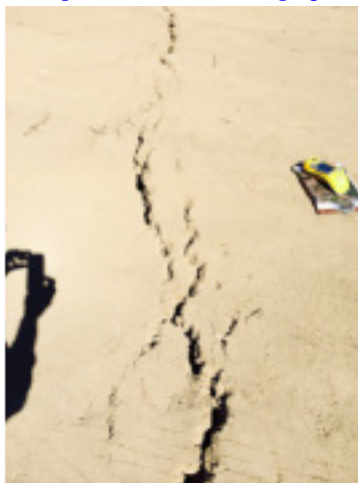
| Station ID: 711 | | | | Observer: Lienkaemper | | |

| Station ID: 711 | | | | Observer: Lienkaemper | | |
|---|---|---|---|---|---|---|
| Fracture azimuth 340; Offset ~5 cm on 24 deg. azimuth; line of vine row stakes. | | | | | | |

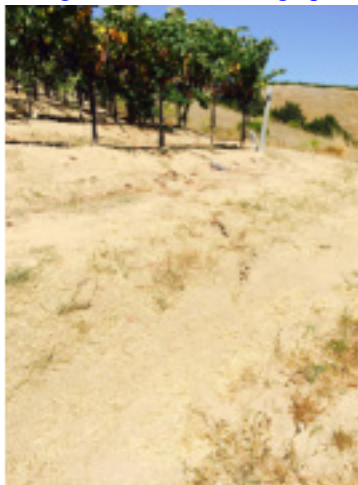
| Station ID: 712 | | | | Observer: Lienkaemper | | |

| Station ID: 712 | | | | Observer: Lienkaemper | | |
|---|---|---|---|---|---|---|
| Four parallel cracks N14W. This is the farthest north mapped point in rupture zone C with certain tectonic rupture. | | | | | | |

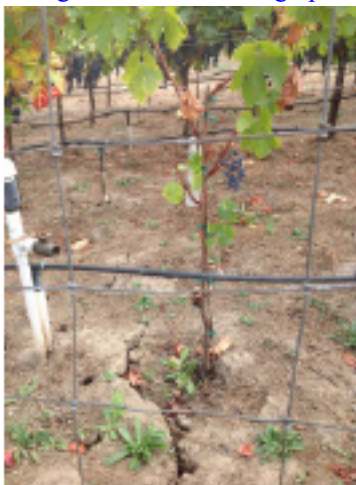
| Station ID: 713 | | | | Observer: Ponti | | |
|---|---|---|---|---|---|---|
| Photo view is to the northwest. Vector length=3; Vector azimuth=237; Vector plunge=0; Fracture azimuth=327; Fault zone azimuth=327. | | | | | | |

View is to the northwest.

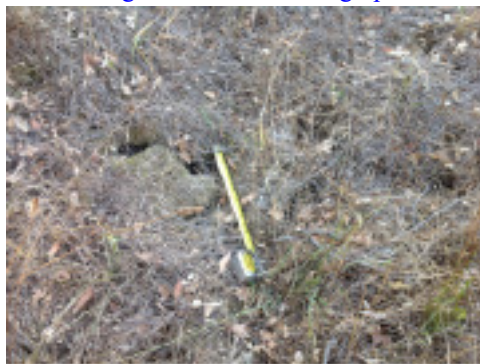
| Station ID: 716 | | | | Observer: Ponti |

| Station ID: 716 | | | | Observer: Ponti |
|---|---|---|---|---|
| Tension crack; intermittent along mapped trend. | | | | |

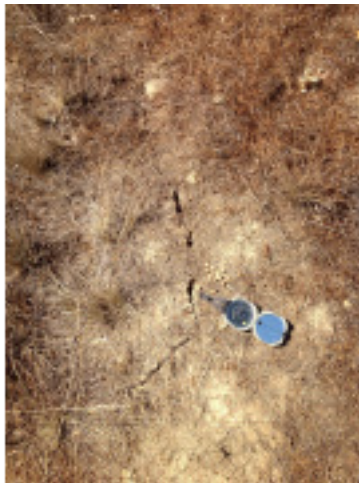
| Station ID: 723 | | | | | Observer: Ponti | |

| Station ID: 723 | | | | | Observer: Ponti | |
|---|---|---|---|---|---|---|
| Tension crack; continuous along mapped trend. No obvious lateral offset. | | | | | | |
