Appendix 5. Tabulated Observations and Photographs of Surface Faulting and Ground Deformation Produced by the M_w 6.0 South Napa Earthquake of August 24, 2014—Trace D

Trace D

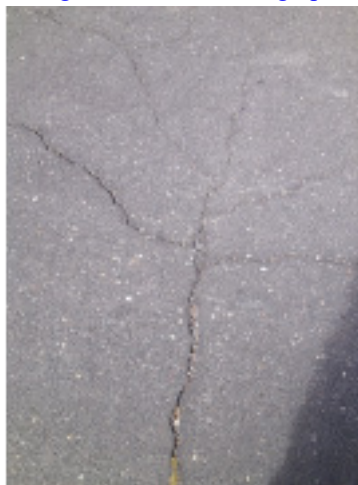
Station ID: 770		Observer: Seitz		
Observation Date	Latitude	Longitude	Offset Feature	Inferred Origin
2014:09:16	38.30916	122.33425	Pavement	Tectonic
Photographer	Camera Coordinates		Photograph Date	
Seitz	38.30918	122.33423	2014:09:16 15:04:59

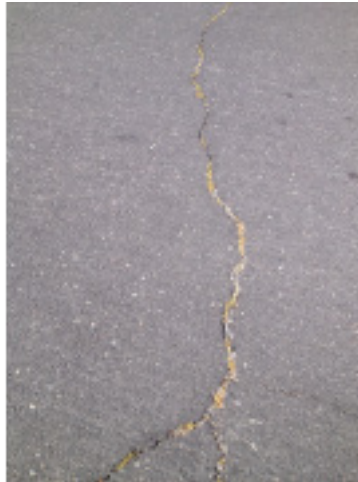
Station ID: 770 **Observer: Seitz**

Photographer	Camera Coordinates		Photograph Date
Seitz	38.30915	122.33427	2014:09:16 15:05:09

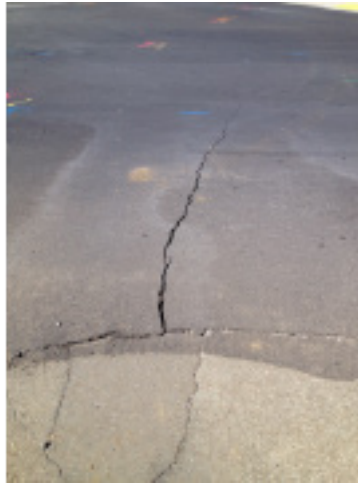
Station ID: 772				Observer: Seitz
Observation Date	Latitude	Longitude	Offset Feature	Inferred Origin
2014:09:16	38.30970	122.33525	Pavement	Tectonic
Photographer	Camera Coordinates		Photograph Date	
Seitz	38.30969	122.33531	2014:09:16 14:32:33

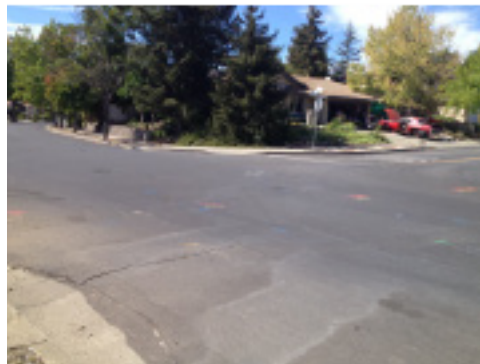
Photographer	Camera Coordinates		Photograph Date
Seitz	38.30966	122.33525	2014:09:16 14:32:47

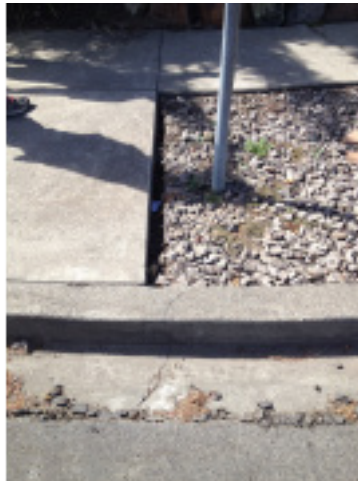
Station ID: 774		Observer: Seitz		
Observation Date	Latitude	Longitude	Offset Feature	Inferred Origin
2014:09:16	38.30983	122.33543	Curb/Sidewalk	Tectonic
Photographer	Camera Coordinates		Photograph Date	
Seitz	38.30978	122.33532	2014:09:16 14:41:35

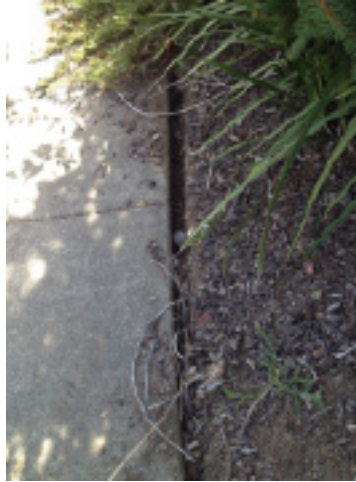
Station ID: 774**Observer: Seitz**

Photographer	Camera Coordinates		Photograph Date
Seitz	38.30984	122.33545	2014:09:16 14:41:49

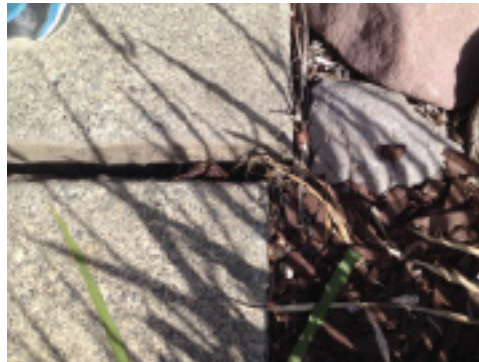
Station ID: 775**Observer: Seitz**

Observation Date	Latitude	Longitude	Offset Feature	Inferred Origin
2014:09:16	38.30990	122.33551	Curb/Sidewalk	Tectonic

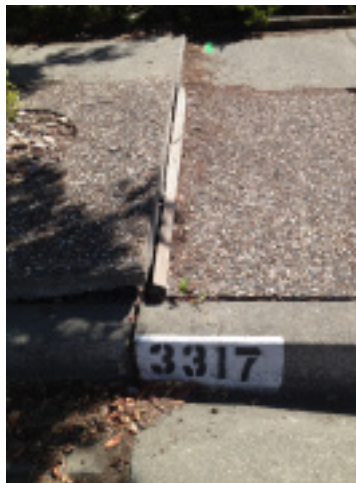
Station ID: 780				Observer: Seitz
Observation Date	Latitude	Longitude	Offset Feature	Inferred Origin
2014:09:16	38.31079	122.33702	Curb/Sidewalk	Uncertain
Photographer	Camera Coordinates		Photograph Date	
Seitz	38.31082	122.33701	2014:09:16 14:52:41

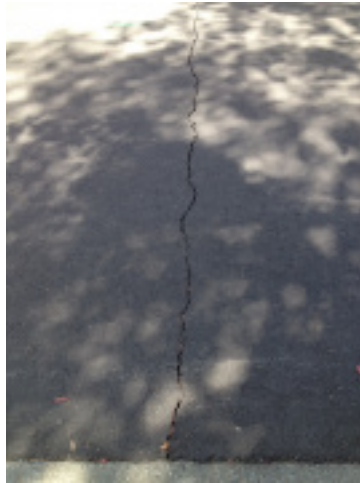
Station ID: 782				Observer: Seitz
Observation Date	Latitude	Longitude	Offset Feature	Inferred Origin
2014:09:16	38.31087	122.33605	Pavement	Uncertain
Photographer	Camera Coordinates		Photograph Date	
Seitz	38.31087	122.33605	2014:09:16 14:47:26
