Appendix 6. Tabulated Observations and Photographs of Surface Faulting and Ground Deformation Produced by the M_w 6.0 South Napa Earthquake of August 24, 2014—Trace E

Trace E

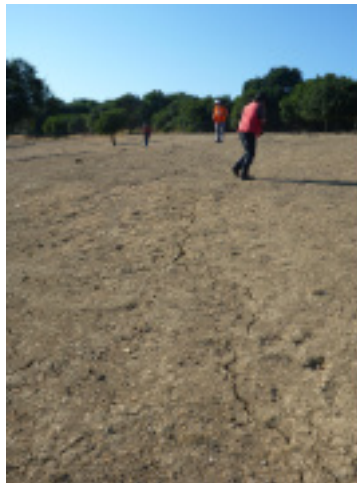
Station ID: 794				Observer: Hecker
Observation Date	Latitude	Longitude	Offset Feature	Inferred Origin
2014:08:27	38.29583	122.32615	Soil	Tectonic
Photographer	Camera Coordinates		Photograph Date	
Hecker			2014:08:27 18:09:11
