Appendix 12. Tabulated Observations and Photographs of Ground Deformation Produced by the M_w 6.0 South Napa Earthquake of August 24, 2014—Isolated Cracking on Slopes

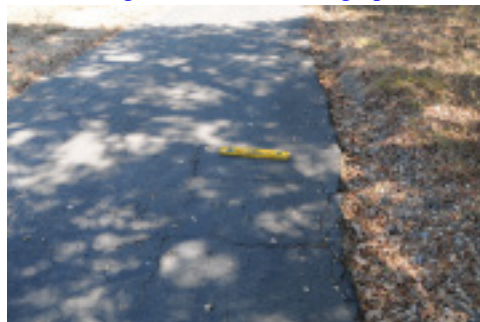
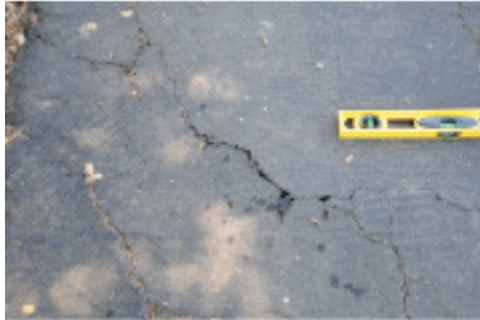
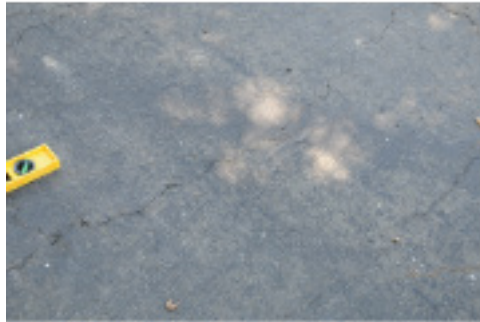
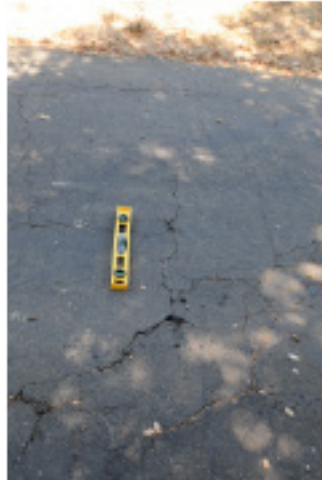
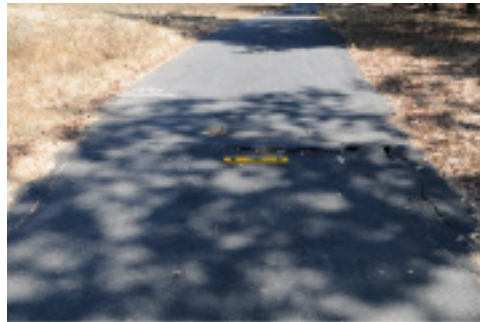
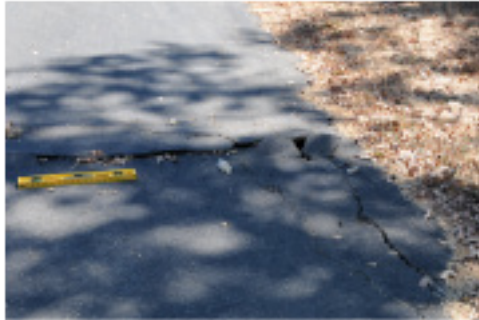
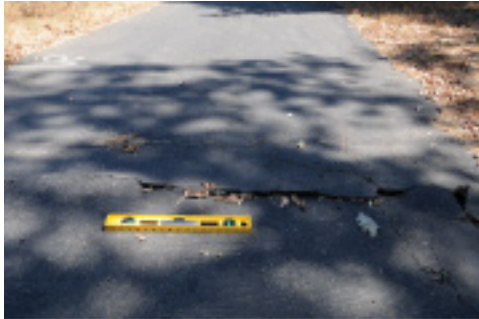
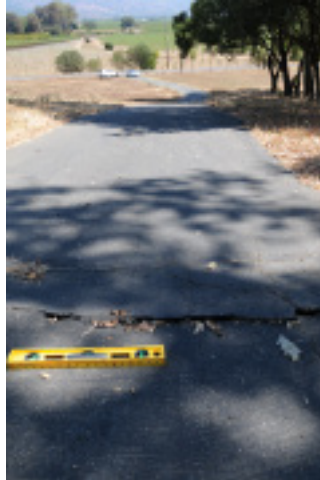
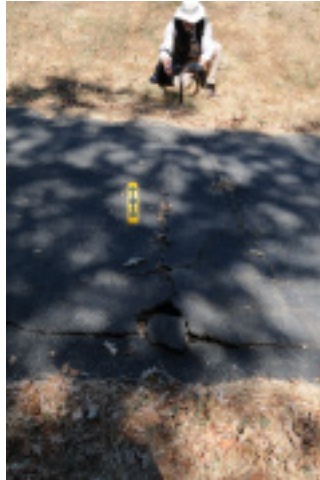
Station ID: 1165		Observer: Schwartz		
Observation Date	Latitude	Longitude	Offset Feature	Inferred Origin
2014:08:27	38.34533	122.35486	Pavement	Uncertain
Photographer	Camera Coordinates		Photograph Date	
Schwartz			2014:08:27 12:06:42

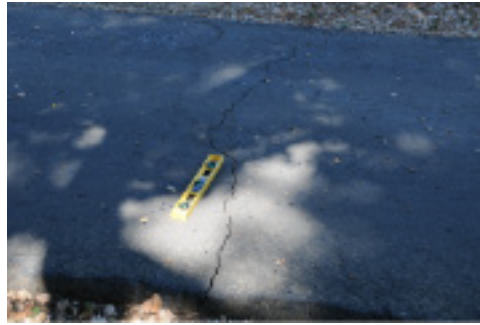
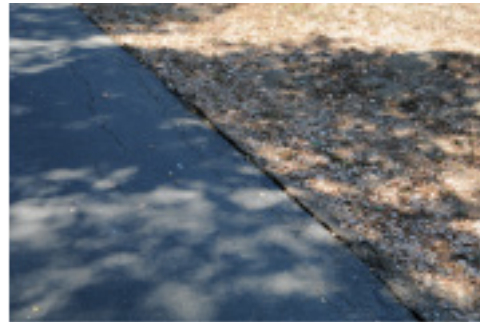
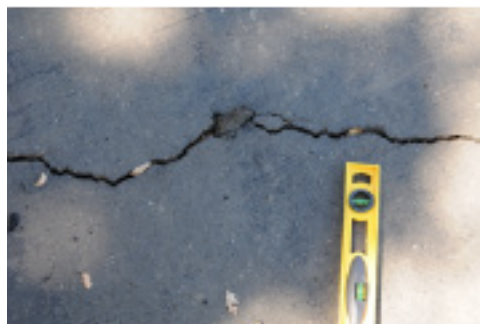
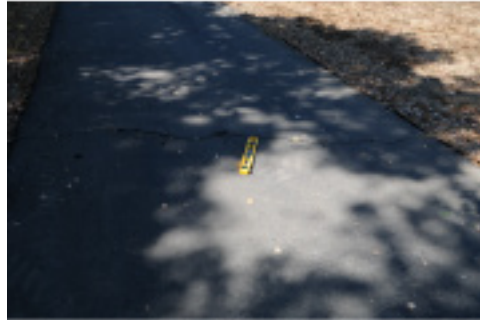
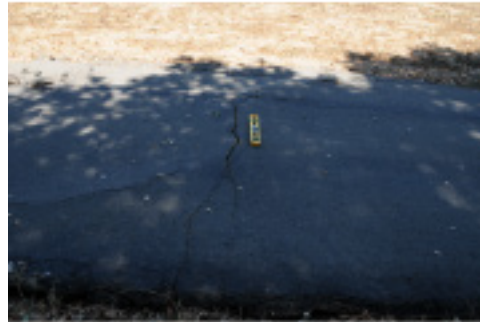
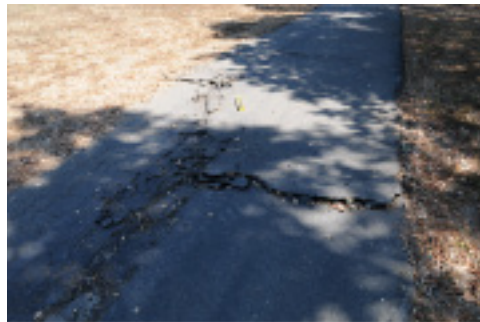
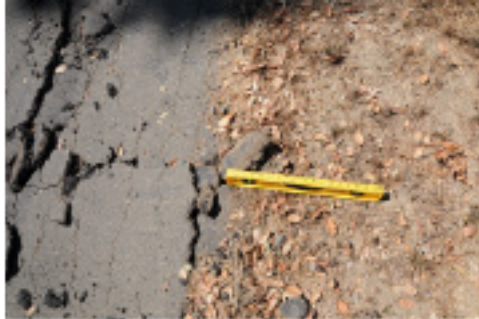
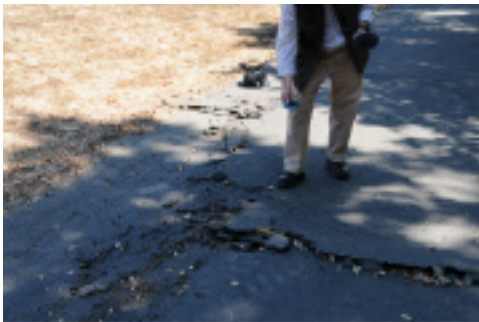
Station ID: 1166				Observer: Schwartz
Observation Date	Latitude	Longitude	Offset Feature	Inferred Origin
2014:08:27	38.34537	122.35472	Pavement	Uncertain
Photographer	Camera Coordinates		Photograph Date	
Schwartz			2014:08:27 12:03:44
