# Appendix 13. Tabulated Observations and Photographs of Ground Deformation Produced by the $M_w$ 6.0 South Napa Earthquake of August 24, 2014—Fractures Associated with UAVSAR Lineaments

## Introduction

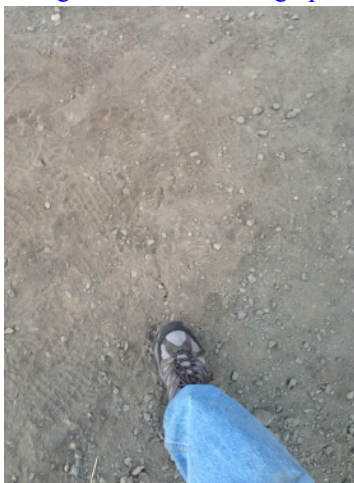
| Station ID: 1194 | | | Observer: Morelan/Trexler | |

| Station ID: 1194 | | | Observer: Morelan/Trexler | |
|---|---|---|---|---|
| Site name: alston_1 - Measurement: None - Measurement azimuth: None - Feature azimuth: None - Displacement sense: opening; halfway up scarp. | | | | |

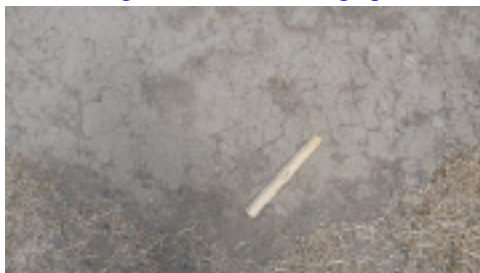
| Station ID: 1196 | | | | Observer: Seitz/Rubin | | |

| Station ID: 1196 | | | | Observer: Seitz/Rubin | | |
|---|---|---|---|---|---|---|
| Location of reported rupture. | | | | | | |

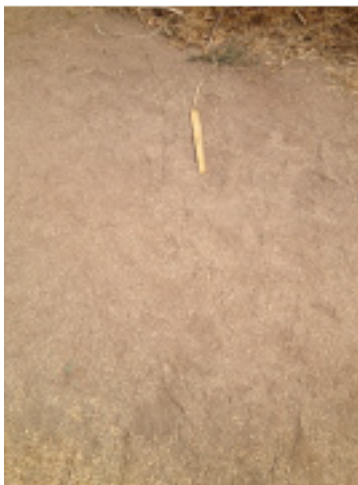
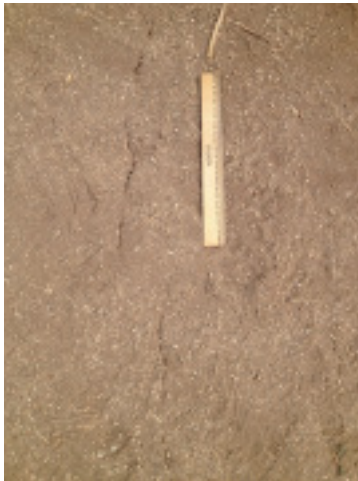
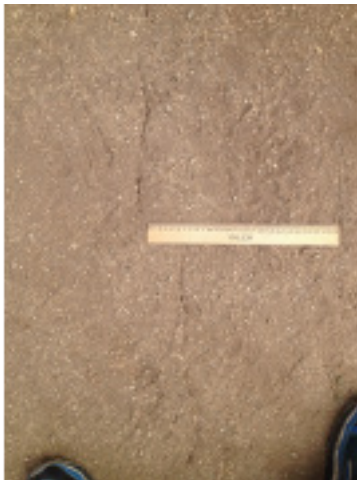
| Station ID: 1200 | | | | Observer: Seitz/Rubin |

| Station ID: 1200 | | | | Observer: Seitz/Rubin |
|---|---|---|---|---|
| Crack in trail. 2-3 mm open. Orientation nearly orthogonal to slope. Near transition between boulder and clayey material in trail cut. | | | | |

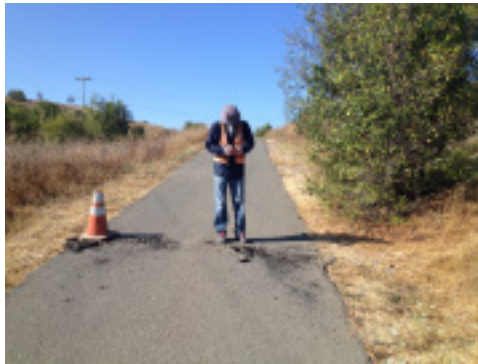
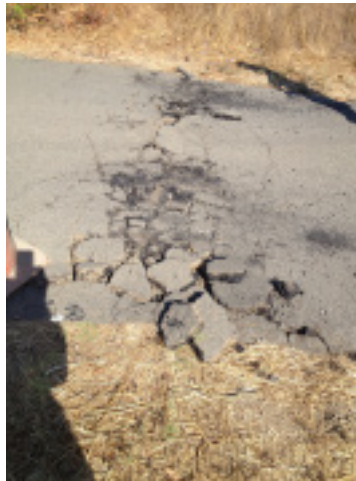
| Station ID: 1203 | | | | Observer: Seitz/Rubin |

| Station ID: 1203 | | | | Observer: Seitz/Rubin |
|---|---|---|---|---|
| Minor tenting across driveway along pre-existing cracks. Do not extend into soil. No lateral offset. Other similar features along this driveway. | | | | |

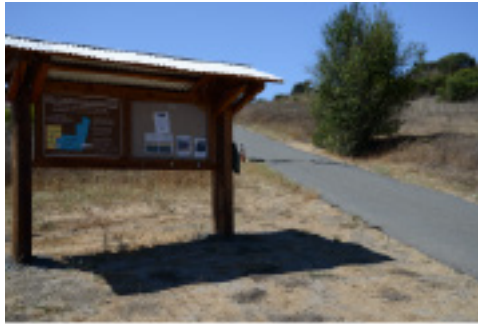
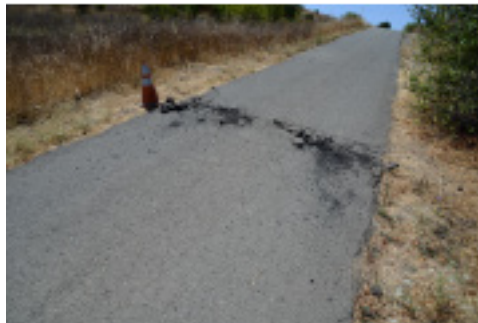
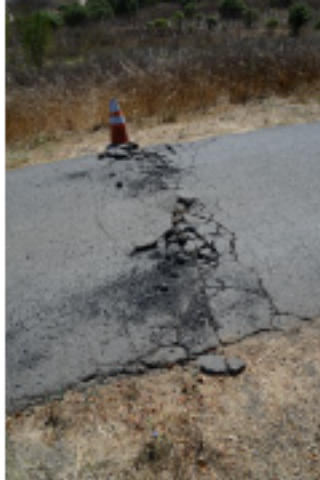
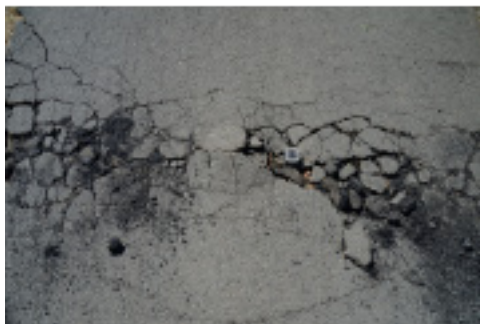
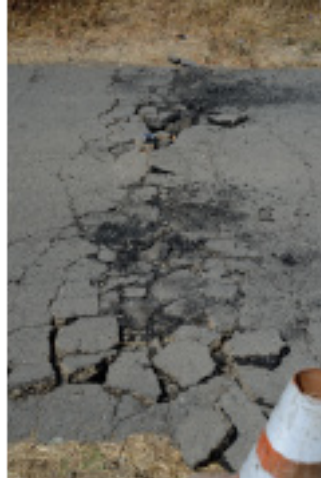
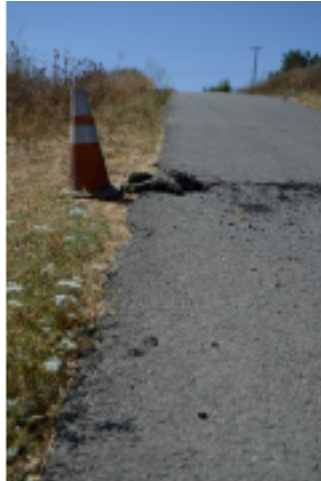
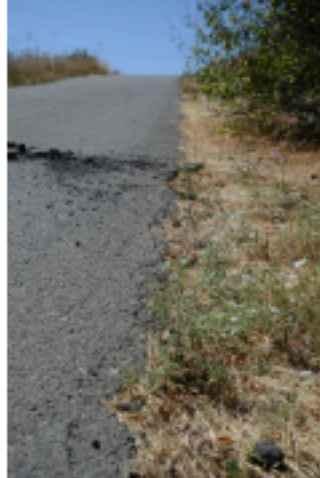
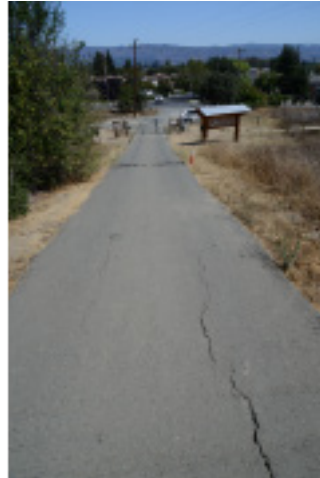
| Station ID: 1204 | | | | Observer: Hudnut |

| Station ID: 1204 | | | | Observer: Hudnut |
|---|---|---|---|---|
| Uplifted/fractured pavement. | | | | |

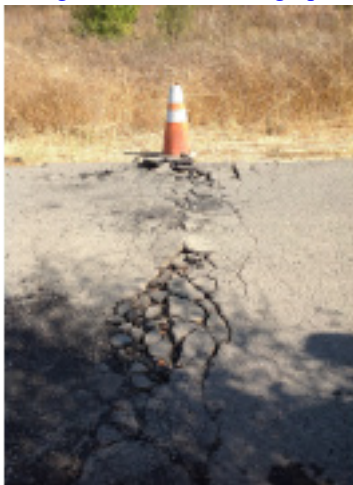
| Station ID: 1205 | | | | | | Observer: Ponti |

| Station ID: 1205 | | | | | | Observer: Ponti |
|---|---|---|---|---|---|---|
| Compressive fracture in pavement at Alston Park. Strike trend 310. Does not extend into soil. | | | | | | |

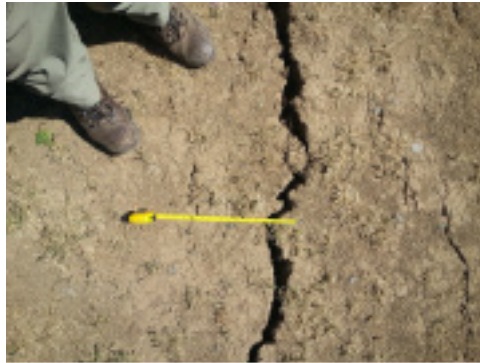
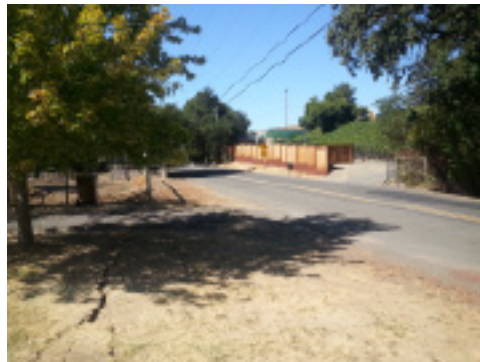
| Station ID: 1286 | | | | Observer: Seitz | | |
|---|---|---|---|---|---|---|
| Zone of cracks across asphalt seem to be related to slumping into adjacent drainage ditch. Quite extensive, about 50 m long, parallel to the roadway and it seems to be related to weak pavement. Direction roughly N45W. | | | | | | |

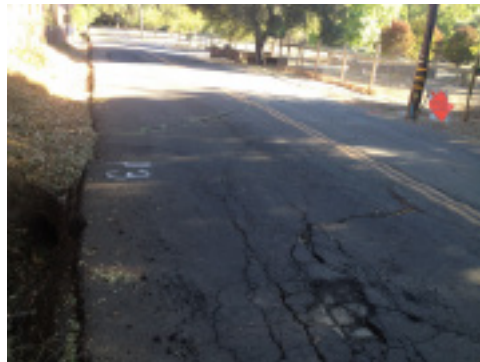
| Station ID: 1288 | | | Observer: Lancaster | |

| Station ID: 1288 | | | Observer: Lancaster | |
|---|---|---|---|---|
| Deformation on Partrick Rd. Cracks show predominantly horizontal separation. | | | | |

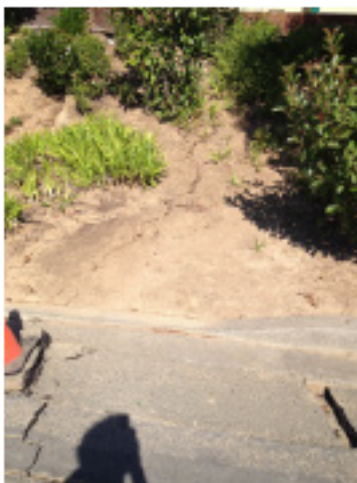
| Station ID: 1296 | | | | Observer: Wells |

| Station ID: 1298 | | | | Observer: Brossy | | |
|---|---|---|---|---|---|---|
| Cracking in the street that extended across the whole paved section and into the soil adjacent, projecting under the house along ~335 degrees. No cracking or deformation of the property to the south was apparent. | | | | | | |

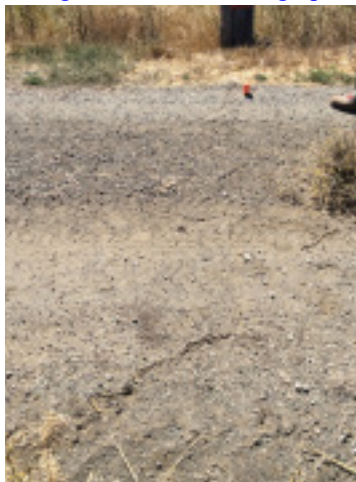
| Station ID: 1113 | | | | Observer: Hitchcock/Lutz | |
|---|---|---|---|---|--|
| Fresh cracks in dirt road, both parallel and normal to the road alignment. | | | | | |

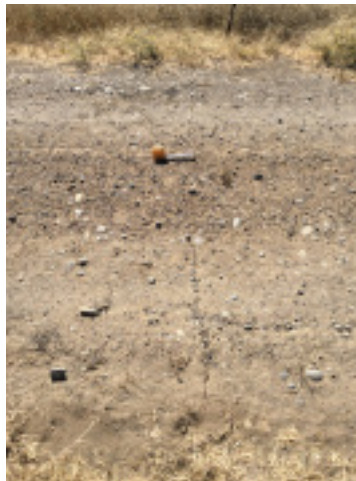
| <b>Station ID: 1114</b> | | <b>Observer: Hitchcock/Lutz</b> | | |

Fresh cracks in dirt road, both parallel and normal to the road alignment.

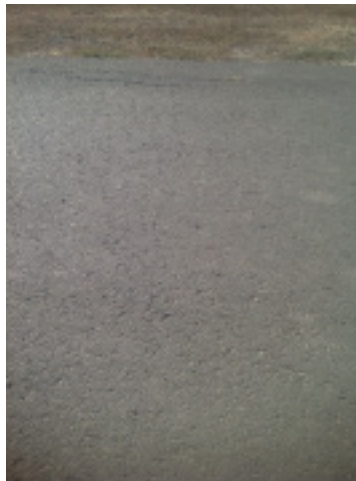
| Station ID: 1119 | | | Observer: Hitchcock/Lutz | |

| Station ID: 1119 | | | Observer: Hitchcock/Lutz | |
|---|---|---|---|---|
| Fresh hairline crack in asphalt, oriented roughly normal to road alignment. | | | | |

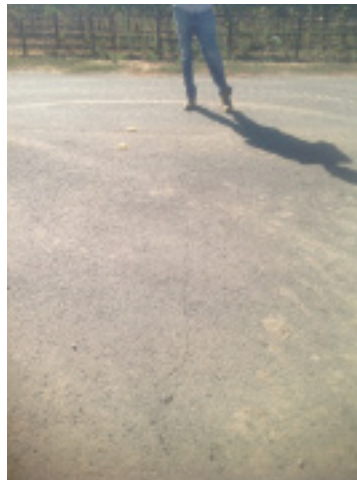
| Station ID: 1123 | | | Observer: Hitchcock/Lutz | |

| Station ID: 1123 | | | Observer: Hitchcock/Lutz | |
|---|---|---|---|---|
| Fresh hairline crack in asphalt, oriented roughly subparallel to road alignment. | | | | |

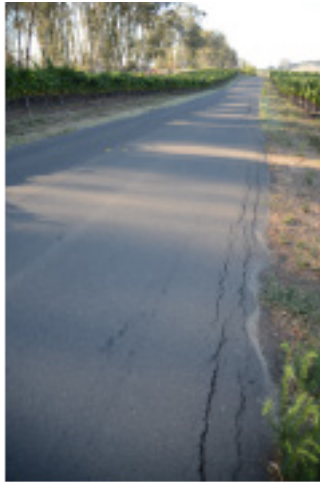
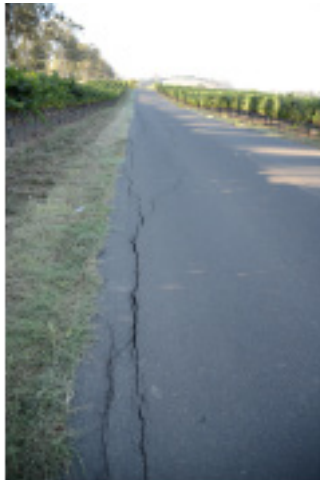
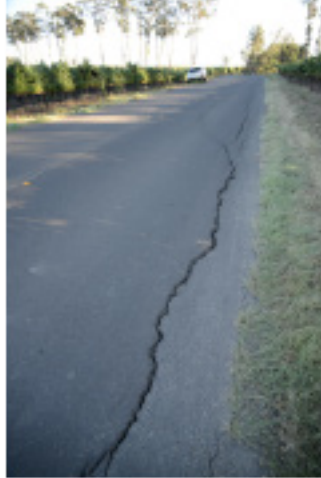
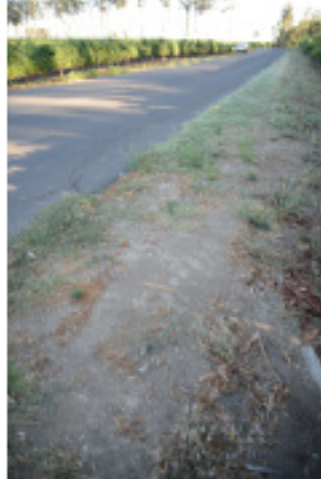
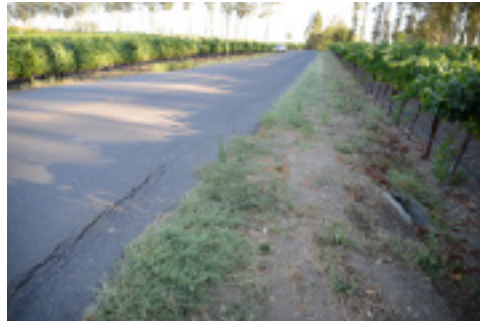
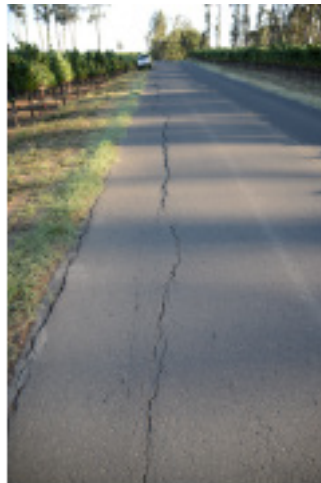
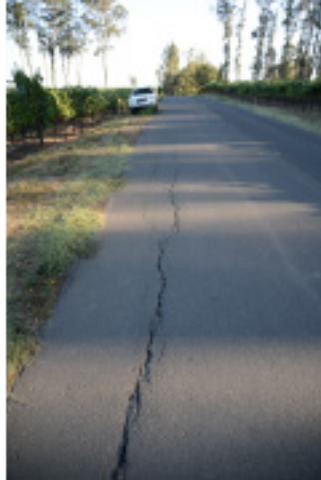
| <b>Station ID: 1124</b> | | <b>Observer: Hudnut</b> |

| Station ID: 1124 | | | | Observer: Hudnut |
|---|---|---|---|---|
| Fracture in pavement. All cracks are parallel to road; no indication of displacement at all. | | | | |

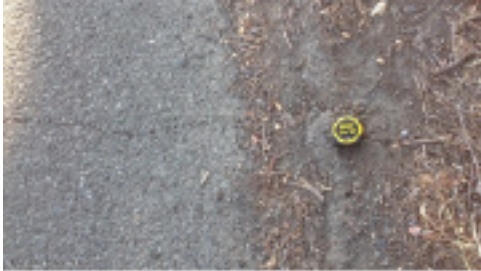
| Station ID: 1126 | | | | Observer: DeLong |
|---|---|---|---|---|
| Tiny crack from pavement through dirt. No offset. No other apparent surface rupture in this area. | | | | |
