# Appendix 14. Tabulated Observations and Photographs of Ground Deformation Produced by the $M_w$ 6.0 South Napa Earthquake of August 24, 2014—Areas of Extensive Curb and Sidewalk Damage

## Introduction

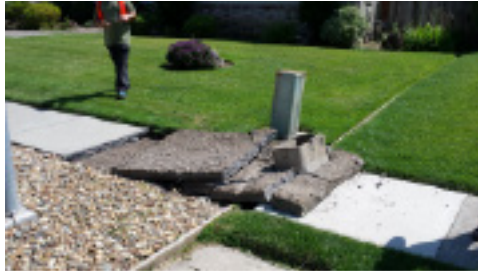
Two sidewalk panels upside down. Possibly shaking related. Does not appear to be related to rupture based on distance from observed rupture locations.

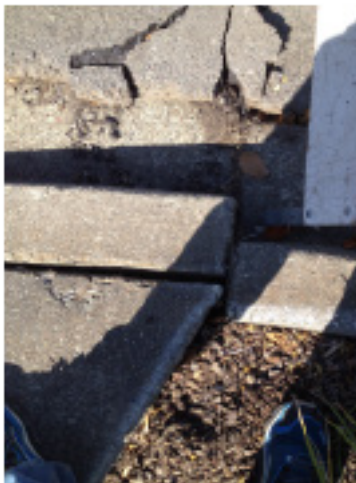
| Station ID: 1229 | | | | Observer: Rubin/Seitz |
|---|---|---|---|---|
| Irregular cracks in road and shifted sidewalk slabs. No obvious throughgoing pattern. | | | | |

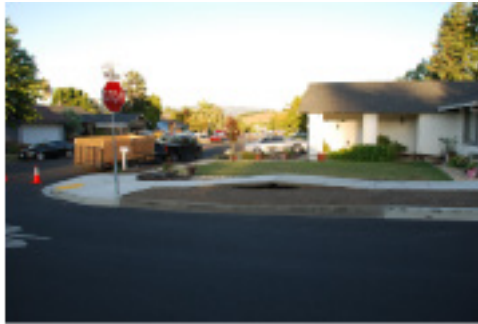
| Station ID: 1233 | | | | | | Observer: Rubin |
|---|---|---|---|---|---|---|
| Left-lateral separations on both curbs on pre-existing breaks. Breaks in road in between curbs along pre-existing cracks. Large trees next to both curbs. | | | | | | |

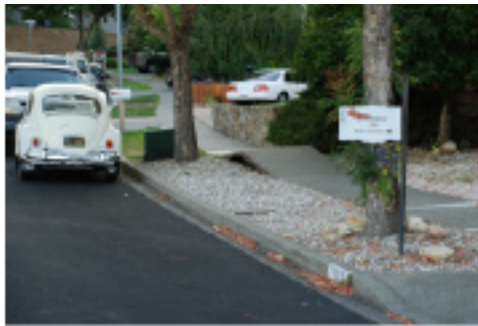
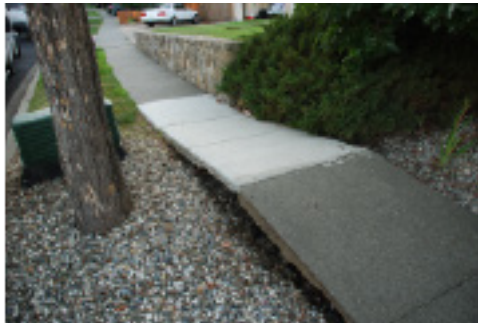
| Station ID: 1242 | | | | Observer: Holzer |

| Station ID: 1242 | | | | Observer: Holzer |
|---|---|---|---|---|
| Stonybrook Dr.: tented sidewalk west side, north-side compression. | | | | |

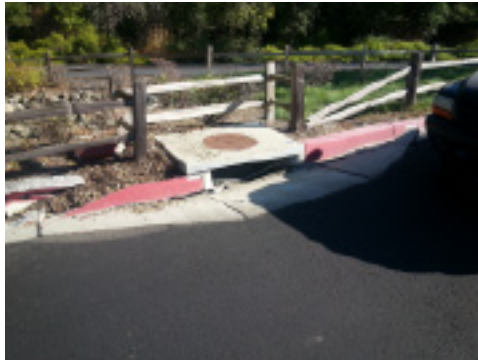
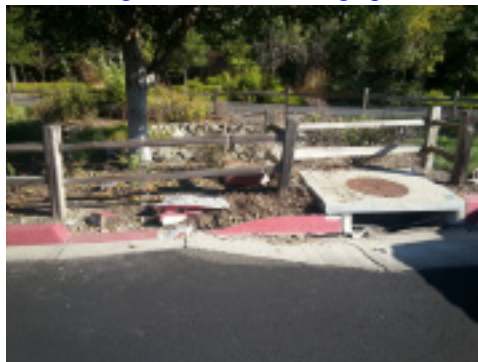
| Station ID: 1245 | | | | Observer: Lancaster |

| Station ID: 1245 | | | | Observer: Lancaster |
|---|---|---|---|---|
| Tall Grass Drive Subdivision, compressional features in sidewalk comprised of tented and heaved sidewalks, and exploded curbs. | | | | |

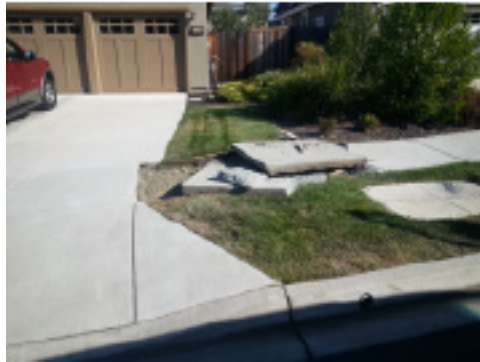
| Station ID: 1251 | | | | Observer: Lancaster |

| Station ID: 1251 | | | | Observer: Lancaster |
|---|---|---|---|---|
| Tall Grass Drive Subdivision, compressional features in sidewalk comprised of tented and heaved sidewalks, and exploded curbs. | | | | |
