Landscape Change Associated with the Upper Scenic Drive Landslide, La Honda, California, January 10–June 28, 2017

By Alexandra J. Pickering, Carol S. Prentice, and Stephen B. DeLong

Open-File Report 2019–1024

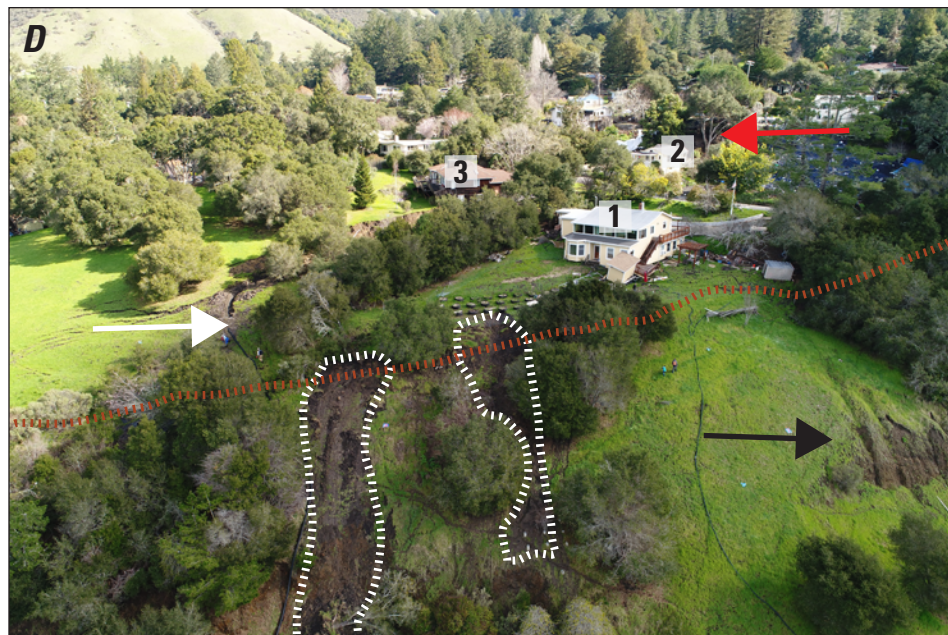
(figs. 10, 11; see also, table 1). Total horizontal movement between January 28 and February 23 was at least 5 cm (station BLUE15) and no more than 28 cm (BLUE13). No measurable landslide motion occurred after February 23, and none of the monuments outside of the current 2017 USDL

Figure 10. Schematic map showing boundaries of previous (1998, 2005, 2006) Scenic Drive landslides, compared to that of 2017 upper Scenic Drive landslide (USDL; see fig. 1 for location). USDL, which is located above headscarps of previous Scenic Drive landslides, encompasses about 8,000 m². Black dots indicate locations of 58 survey points and one local base station (labeled LHBASE2) used to monitor landslide activity: points labeled PK01–05 are survey nails embedded in Scenic Drive roadway used for 2016 and 2017 real-time kinematic global positioning system and terrestrial laser scanner surveys; points labeled ROADPK17–27, survey nails placed in pavement on January 27, 2018, to monitor ongoing 2017 landslide activity; points labeled ROAD01–12, reflective lane markers along Scenic Drive; points labeled BLUE05–17, other survey markers placed throughout study area.
