Measurement of Long-Term Channel Change Through Repeated Cross-Section Surveys at Bridge Crossings in Alaska

Open-File Report 2019–1028

By Karenth L. Dworsky and Jeffrey S. Conaway

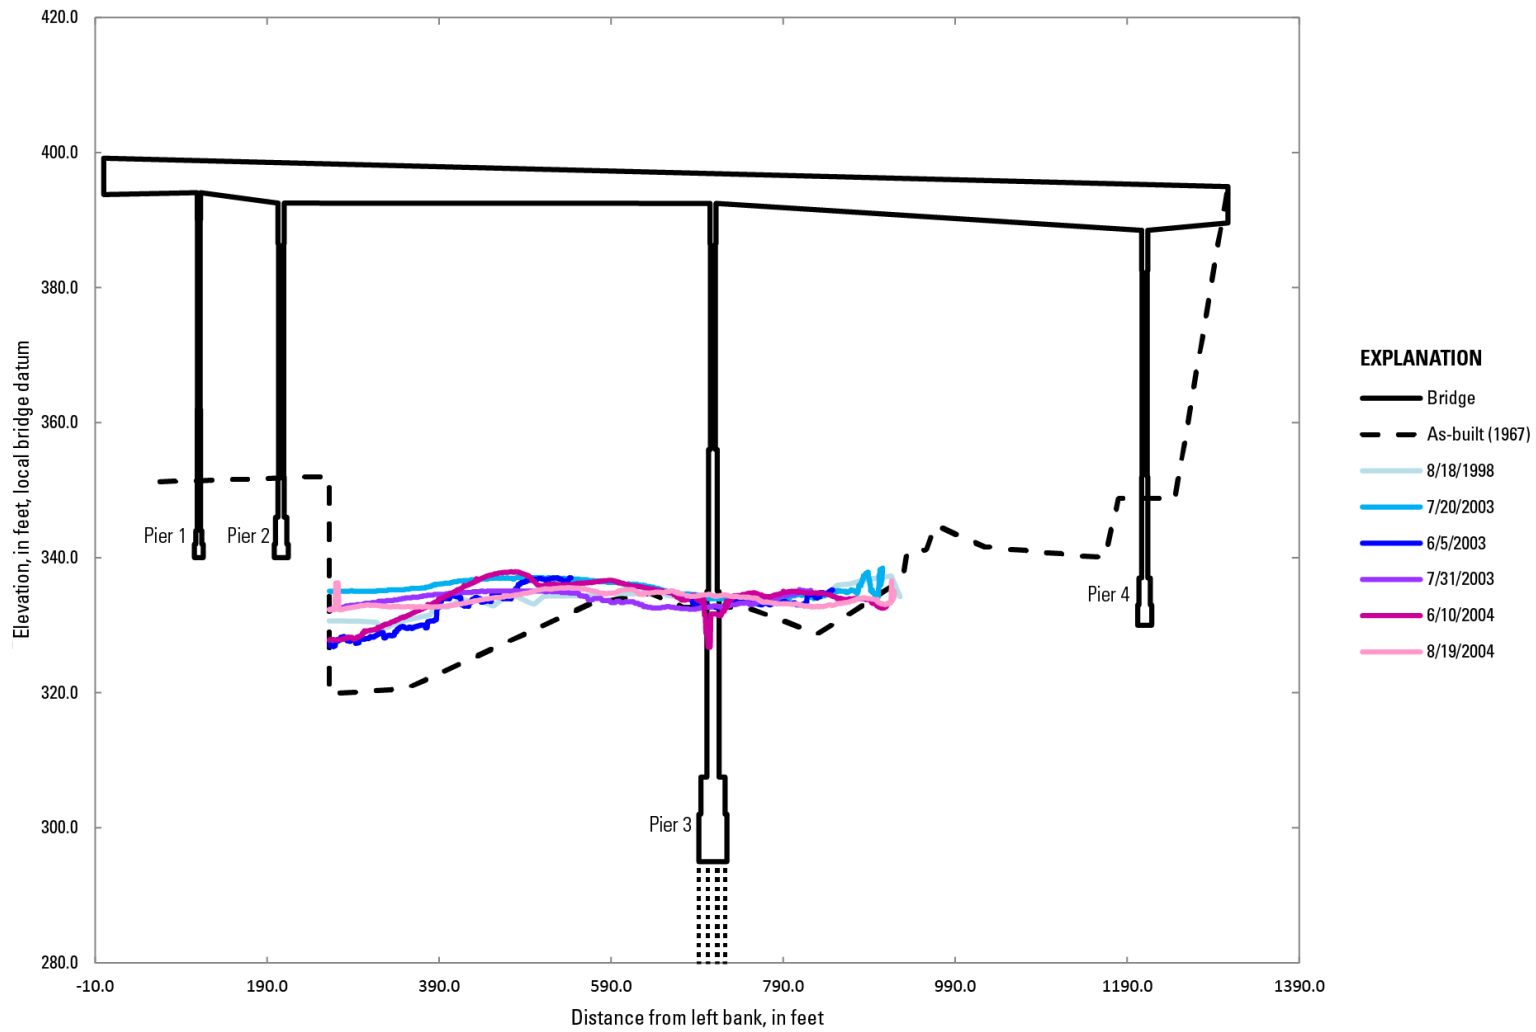
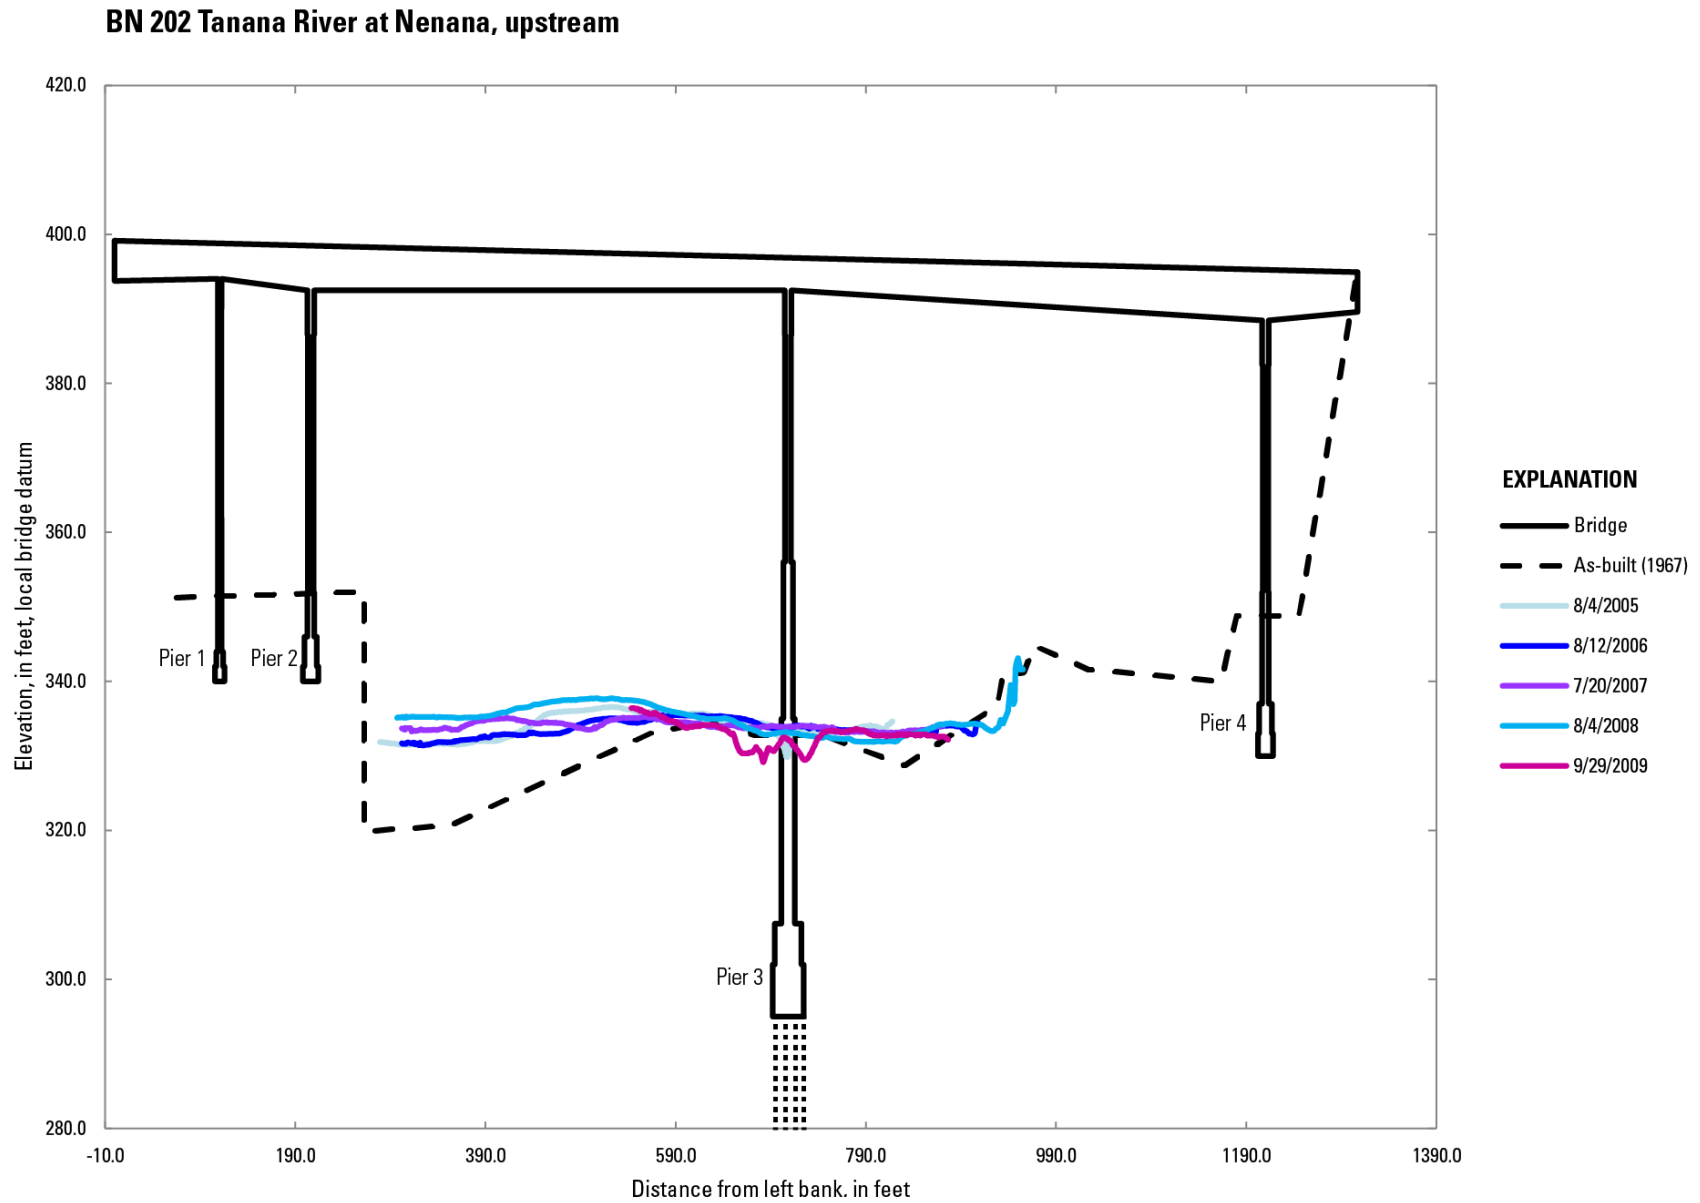
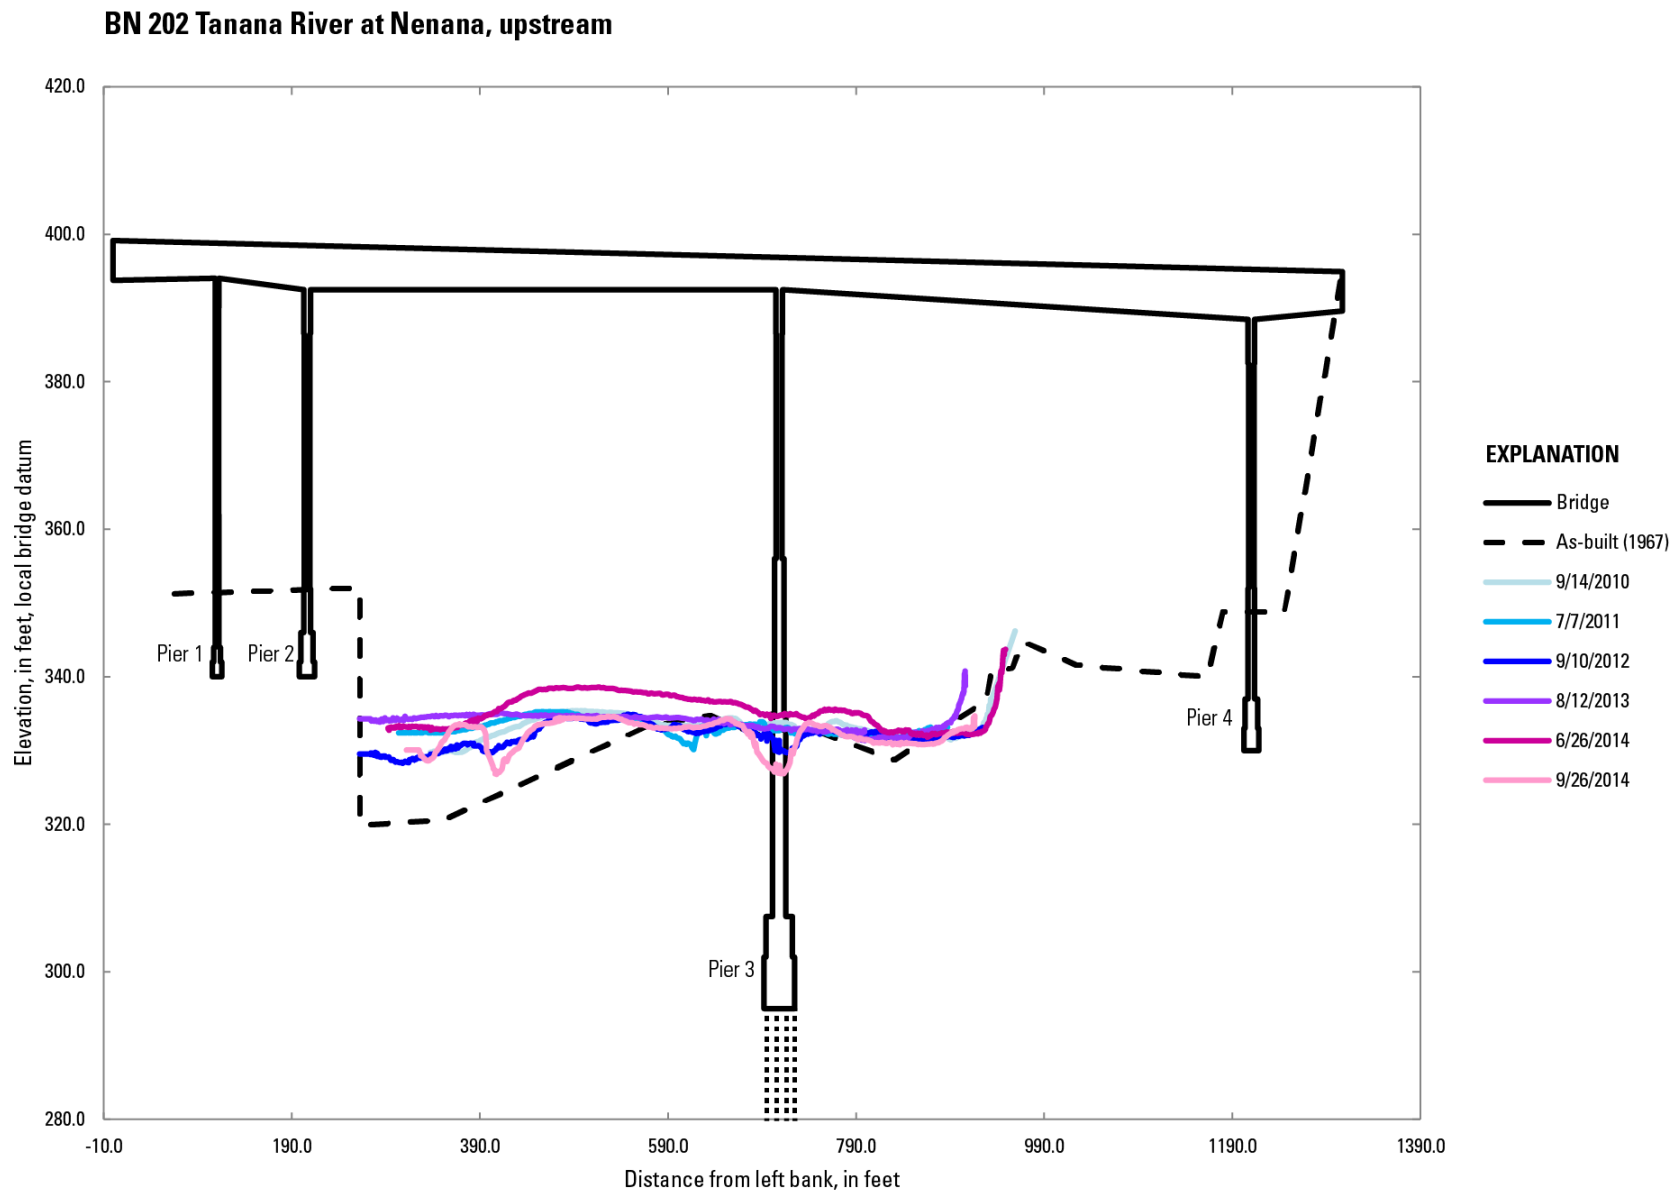
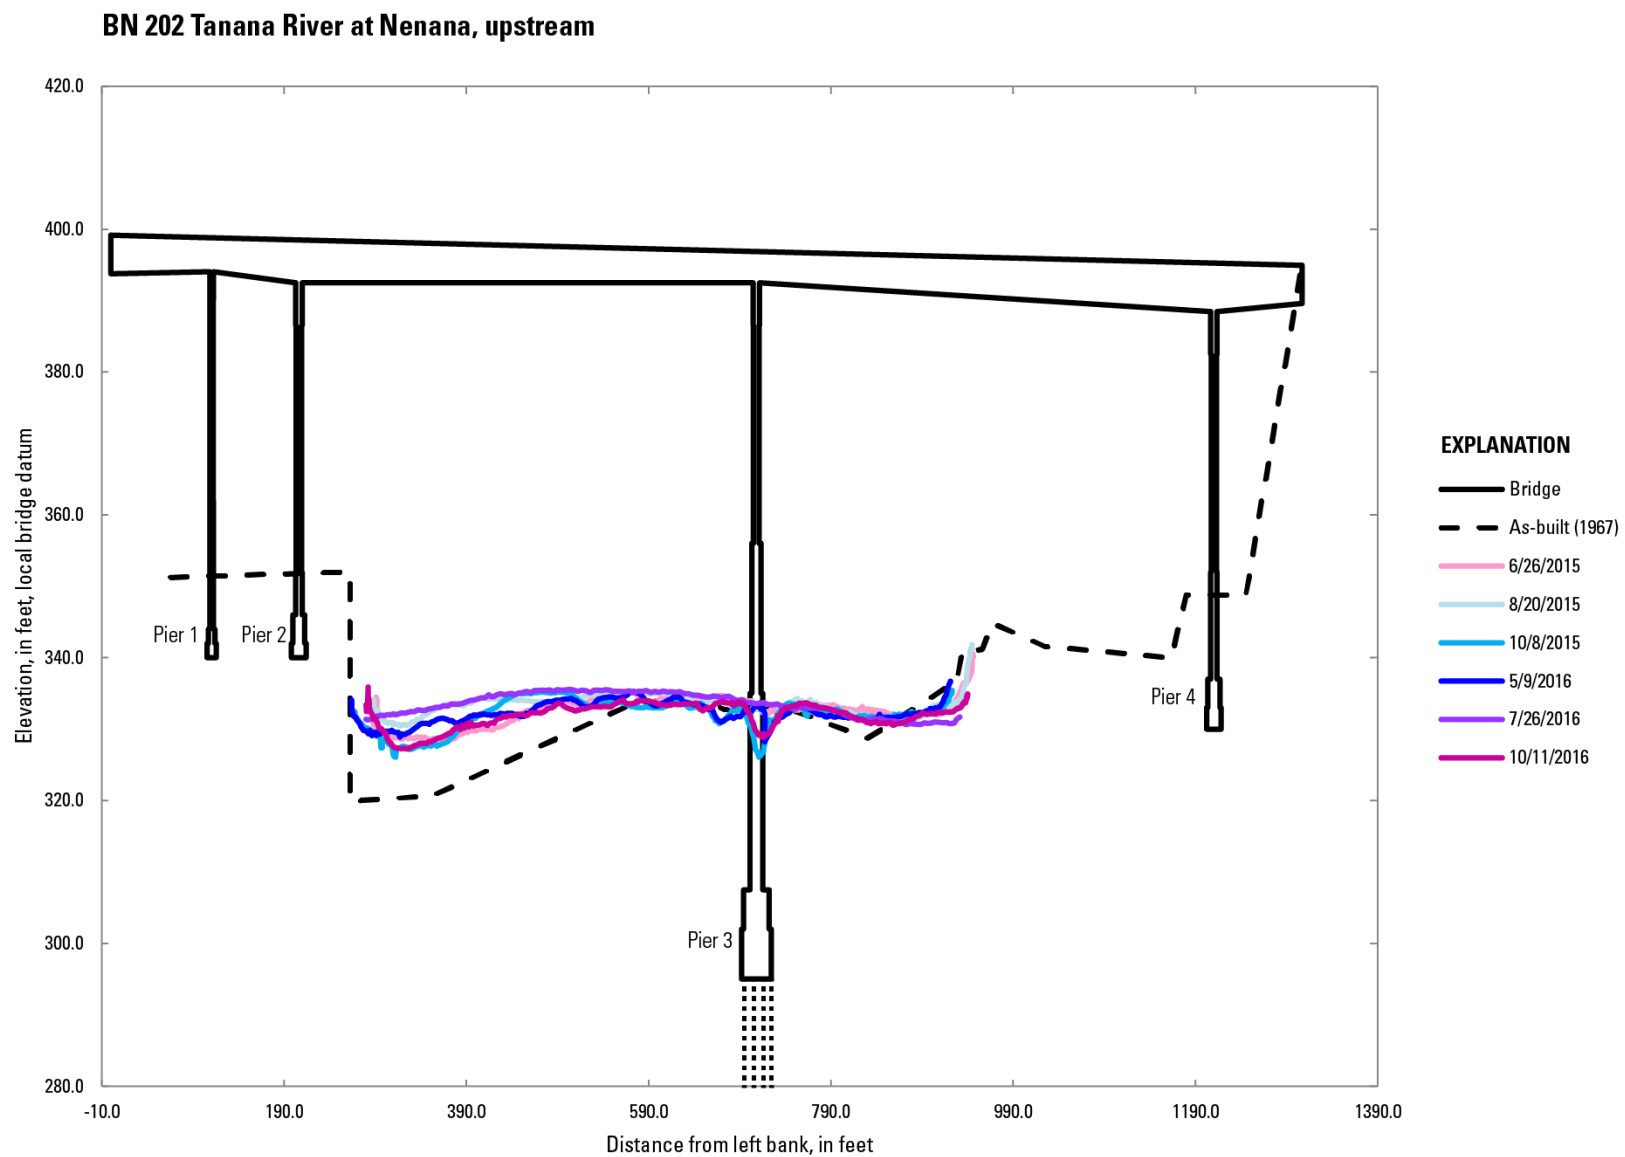
BN 202 Tanana River at Nenana, upstream

Tanana River is a glacially fed river with headwaters in the Alaska Range. The river crossing at Nenana is hydraulically complex owing to the confluence of the Nenana River downstream of the bridge and the division of the main channel by an island into a main flow and an adjacent slough (Langley, 2006). The main pier on the bridge also is oriented about 15 degrees to flow. The river is relatively straight for many channel widths upstream of the bridge. Cross sections were collected along the upstream side of the bridge during 1998 and 2003–16 (figs. 4–7). Although the soundings indicate a relatively stable streambed across most of the channel, maximum observed scour around the pier was 8 ft, and maximum aggradation along the left bank also was 8 ft.

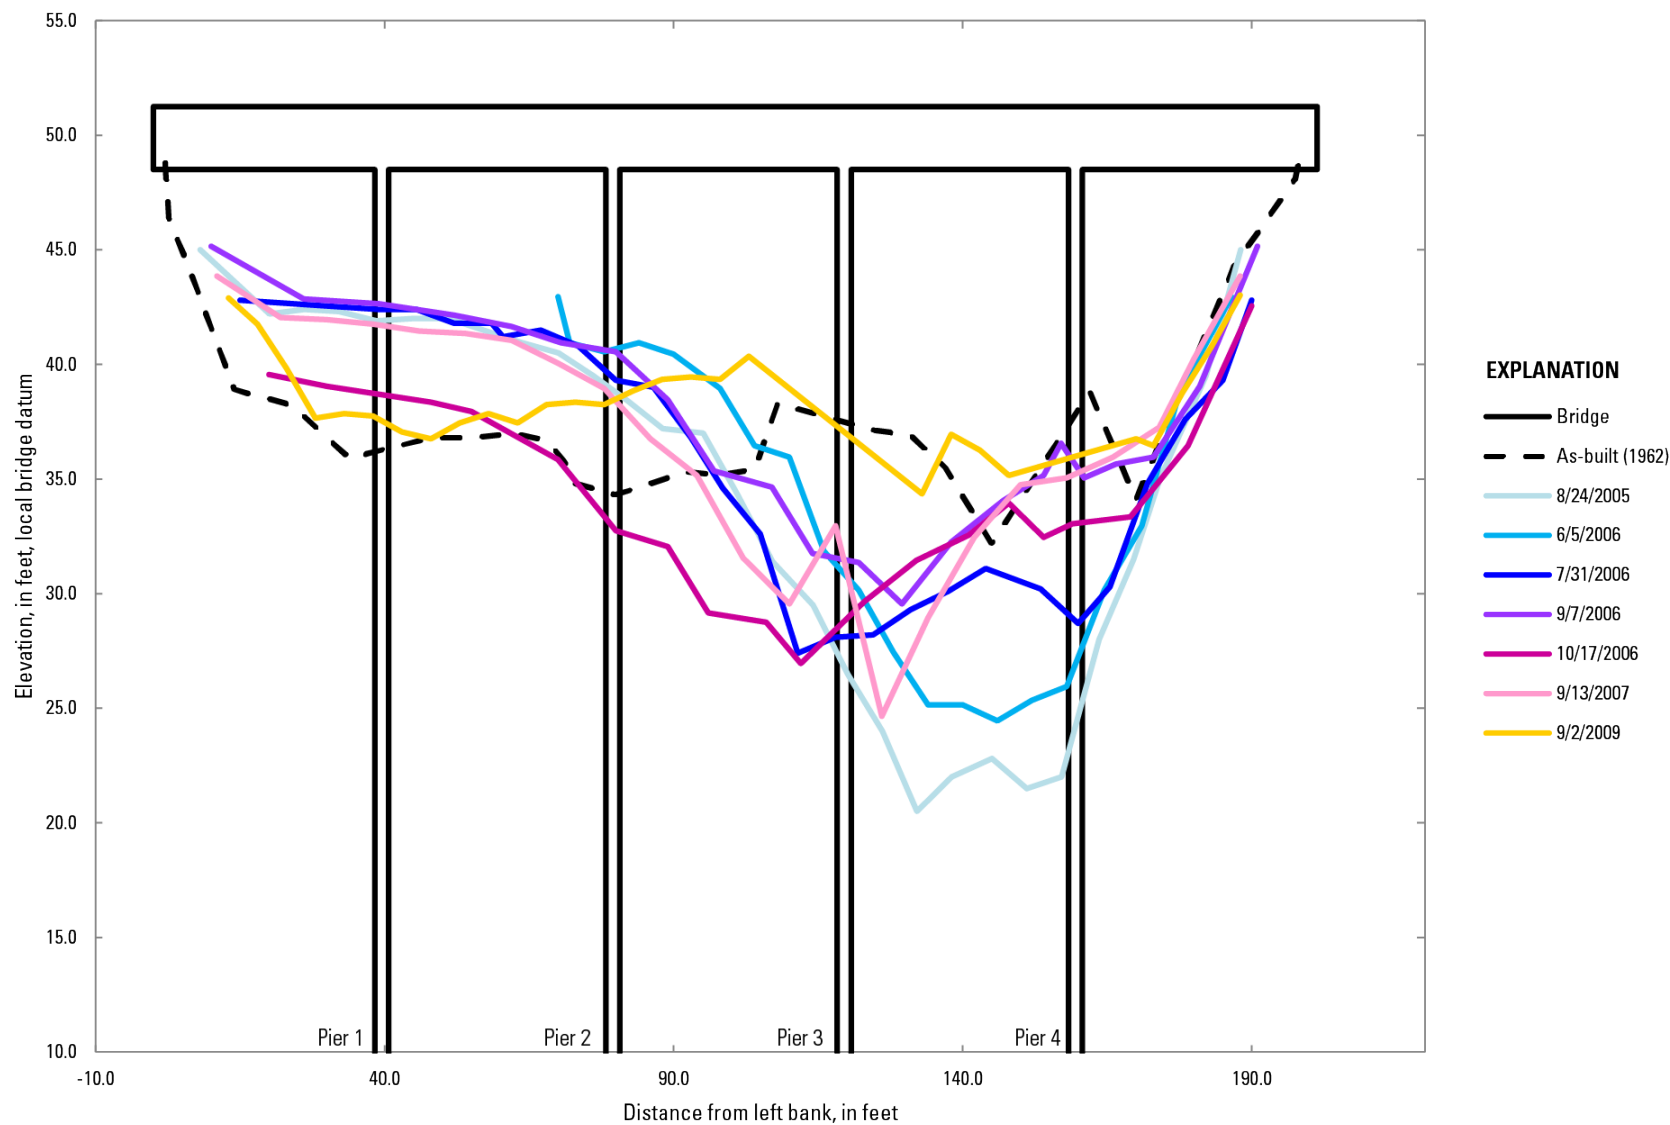
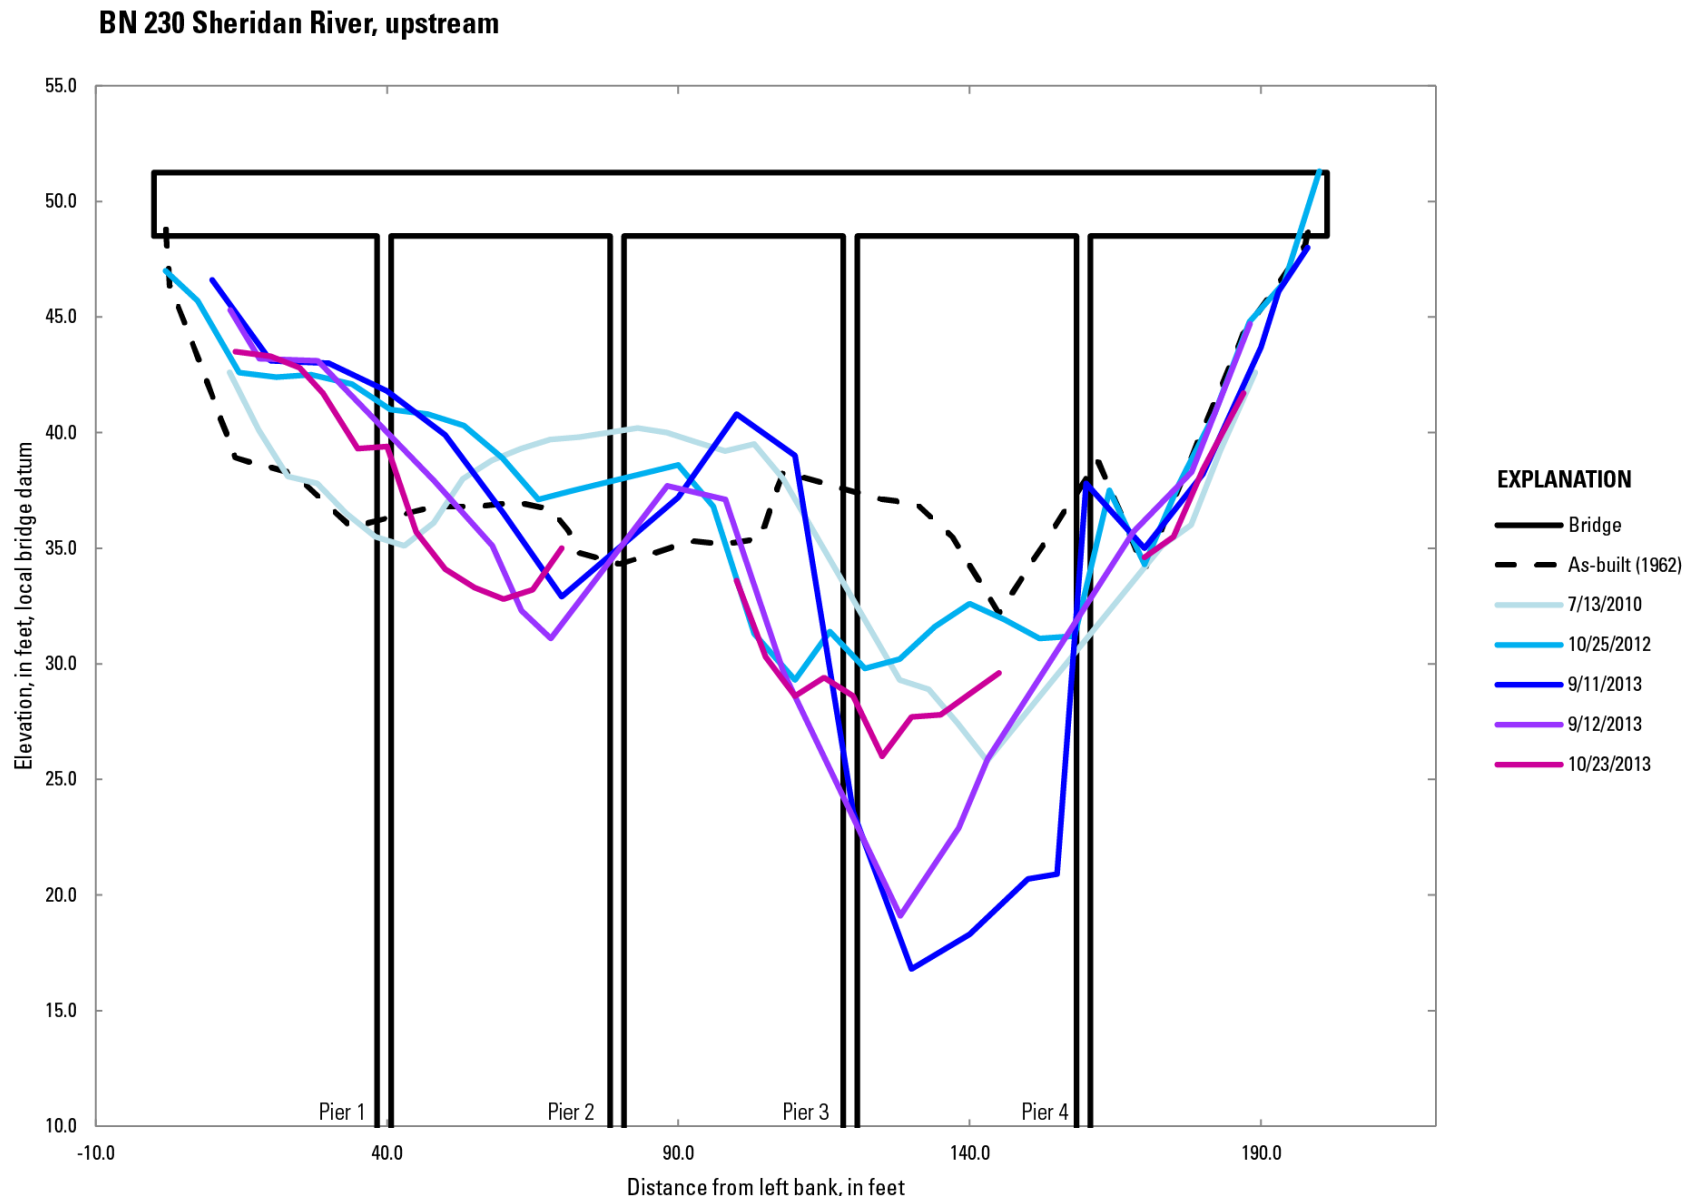
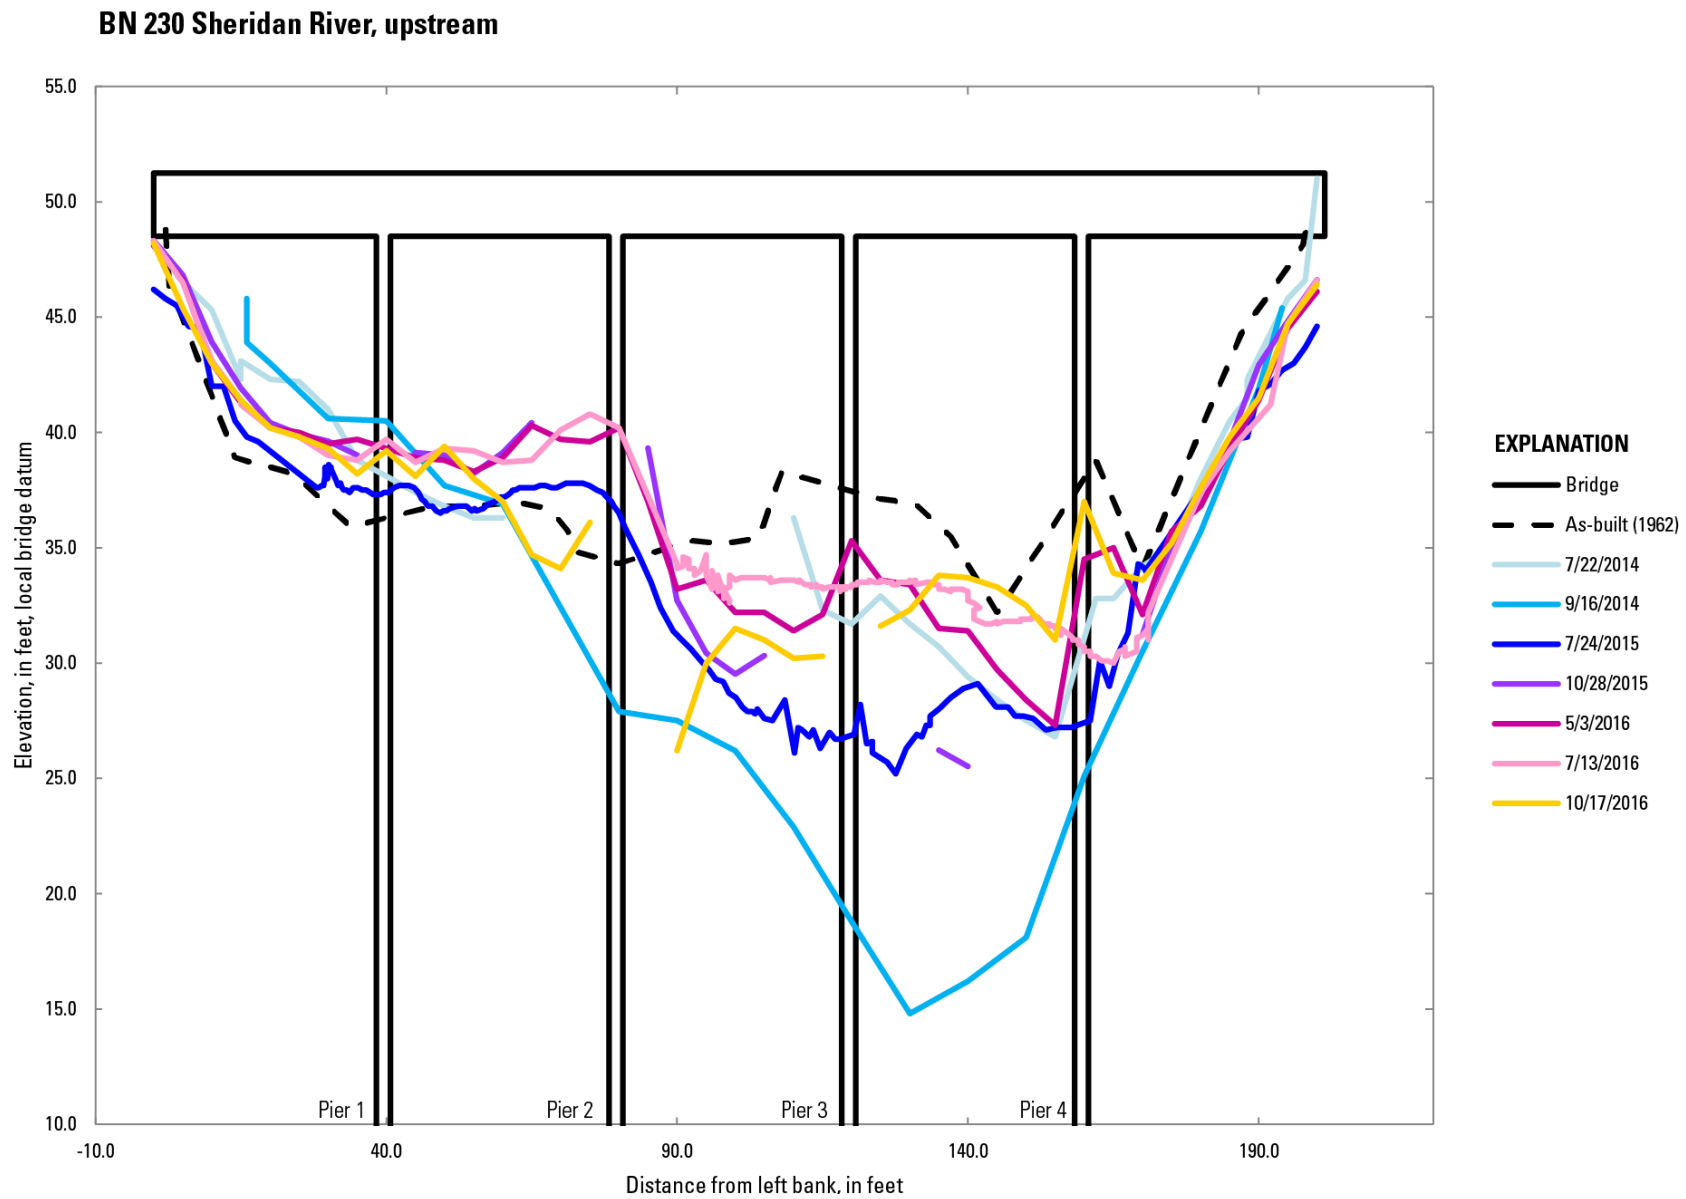
BN 230 Sheridan River, upstream

Sheridan River originates in a proglacial lake in front of the Sheridan Glacier 3 mi upstream of the bridge. Heavy rainfall and rain on snow result in rapid increases in discharge at this site. Multiple discharges greater than the previously estimated 1-percent annual exceedance probability flow have occurred at this site over the course of this monitoring (2005–16) (Conaway, 2007). A riprap dike extends upstream of the bridge on the right bank to prevent overbank flow that has previously overtopped and closed the Copper River Highway on several occasions. Additionally, a guide bank directs flow into the bridge on the left bank. The channel is constricted by the bridge opening and approaches the bridge at a 20–35-degree angle. During floods, it is not uncommon for the road and low-lying areas around the bridge to be submerged under water. The bridge is prone to collecting large woody debris at the piers and between spans, which reduces the conveyance of flow. Cross-sectional surveys were done at the Sheridan River from 2004 to 2016 (figs. 14–17). Scour is concentrated at the two piers closest to the right bank. Maximum scour observed at these piers is 20 ft. Aggradation between the abutment and the left bank pier of about 3 ft also has been observed.

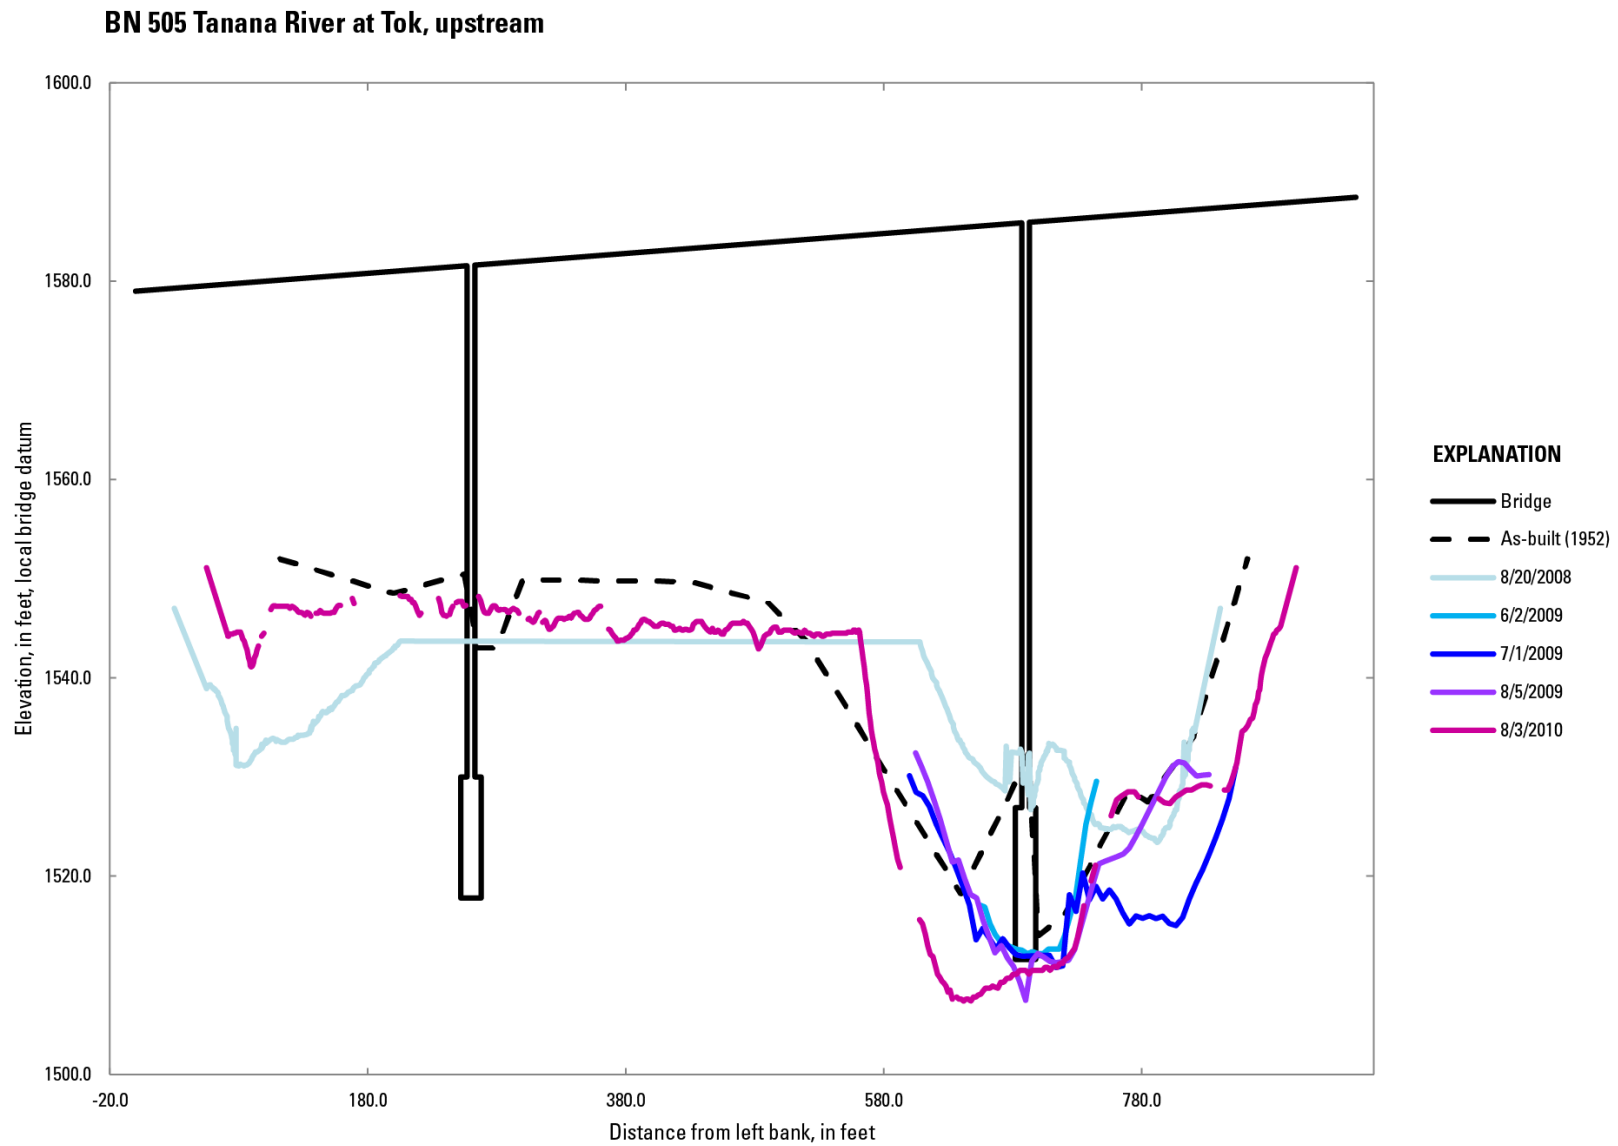
The bridge is located where the Tanana River enters a natural constriction that is controlled by bedrock along the right bank and is a single channel at all but low flows. The river has migrated in the direction of the right bank since the bridge was built and is directed by the bedrock into the bridge reach at an angle. This flow angle of attack on the pier was observed to be about 40–45 degrees (Conaway and Moran, 2004). The high angle of attack on the pier and position of the bridge at the head of a natural constriction, where flow velocities and sediment transport capacity are the highest, made this structure particularly susceptible to streambed scour (Conaway and Moran, 2004). An extensive bathymetric survey was done at Bridge 505 in 2003 (Conaway and Moran, 2004) to build a two-dimensional hydrodynamic model. Annual cross-sectional surveys were done from 2002 to 2010 (figs. 44 and 45). Scour of as much as 22 ft was concentrated at the right-bank pier. Some lesser contraction scour of 9 ft also was noticed at this crossing. The bridge was ultimately replaced in 2010, 250 ft downstream of the original bridge (Conaway, 2010).

Figure 45. Cross sections showing upstream soundings at bridge 505, Tanana River at Tok, Alaska, 2008–10.

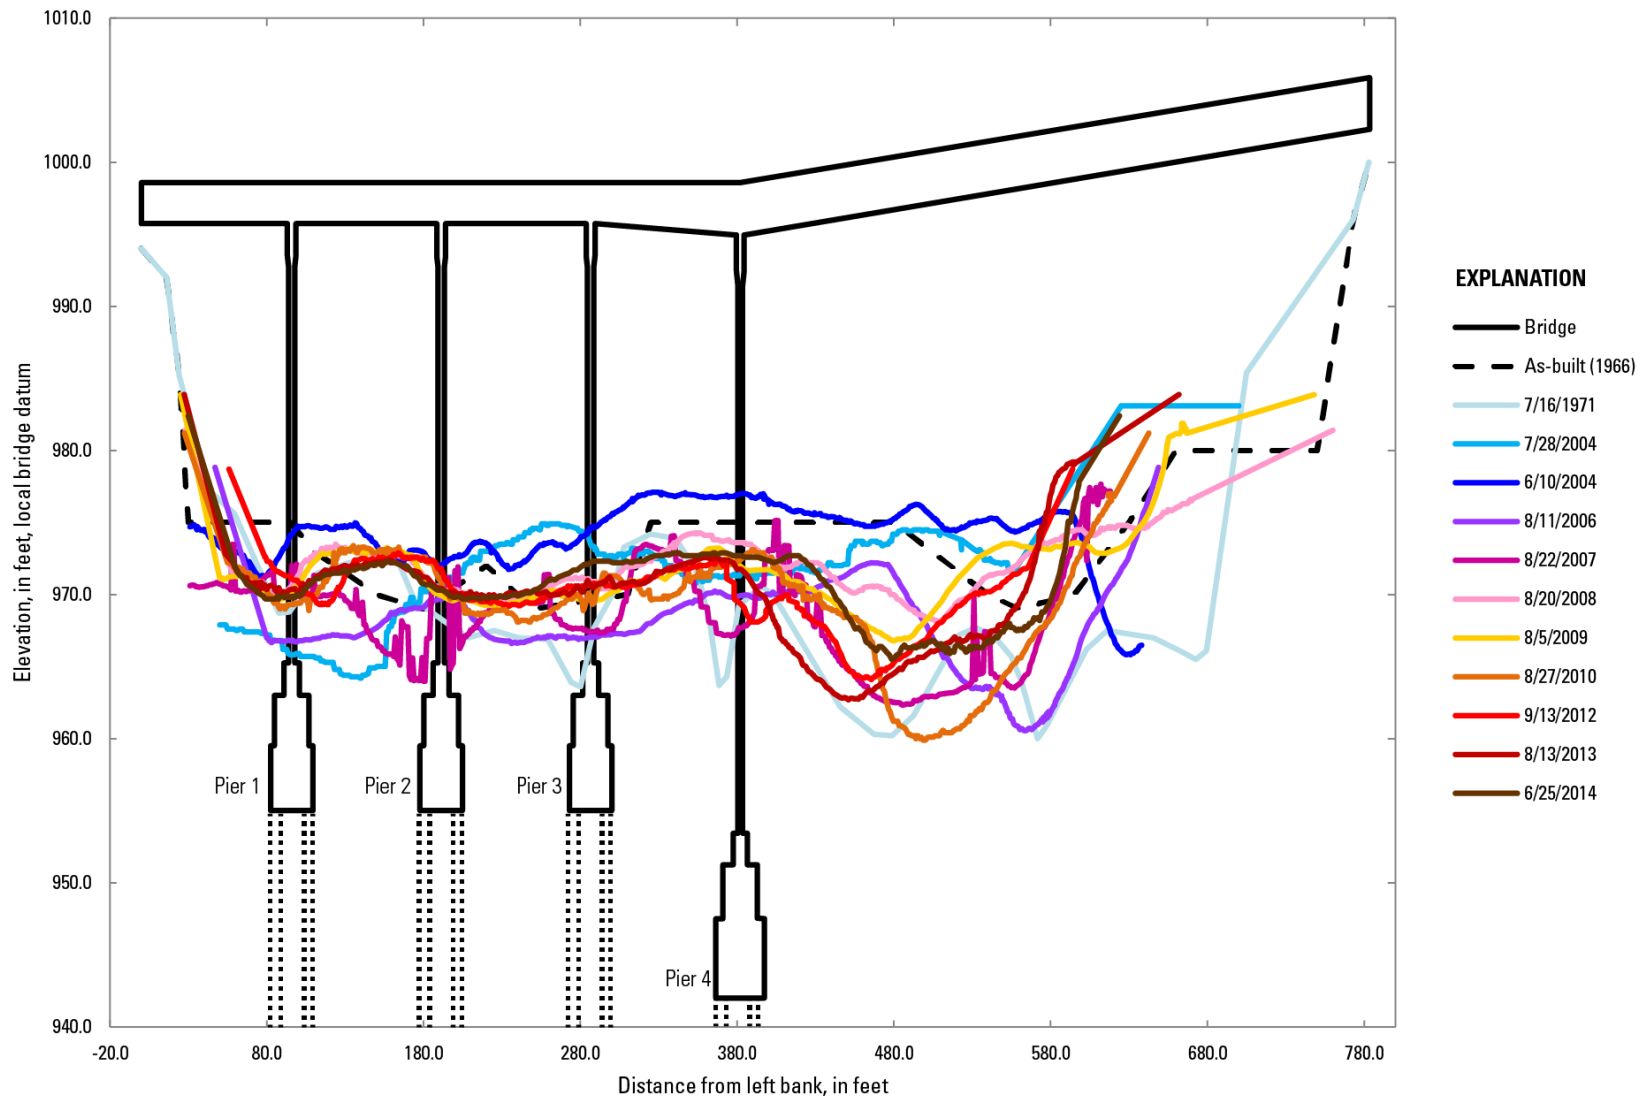
BN 524 Tanana River at Big Delta, upstream

The Tanana River is in a single channel at the bridge 524 crossing and is joined by the Delta River immediately downstream of the bridge. The USGS initially identified the potential for streambed scour at the bridge in 1975 (Norman, 1975). A detailed hydraulic survey and scour investigation in 1996 quantified the effects of the downstream confluence of the Delta River on scour at bridge 524 and described the processes responsible for channel erosion (Heinrichs and others, 2006). The angle of approaching flow on the piers is partially controlled by the Delta River and a maximum value of 35 degrees has been observed (Norman, 1975). Cross-sectional surveys were done in 1971 and during 2004–10 and 2012–14 (figs. 46 and 47) and indicate that contraction scour and pier scour occur at this bridge. Erosion along the right bank has been attributed to the complex hydraulics associated with a slough that enters the Tanana River immediately upstream of the bridge and backwater from the Delta River entering immediately downstream of the bridge (Heinrichs and others, 2006). Local scour at the piers is evident in several of the cross sections during years 1971, 2007 and 2010. Pier footings were exposed during 2004 and 2007 soundings. Scour was deepest on the downstream edge of the bridge piers, a finding that is consistent with Norman (1975) who also reported that the minimum streambed elevation at all piers occurred slightly downstream at Big Delta. Channel degradation in more recent years has been confined to the right section of the channel. Between the last pier and the right bank, a maximum of 16 ft of scour was observed. The left section of the channel has some aggradation and degradation over the years but is relatively the same as the as-built plan. Maximum localized scour of 11 ft occurred around the piers.

Figure 46. Cross sections showing upstream soundings at bridge 524, Tanana River at Big Delta, Alaska, 1971–2014.

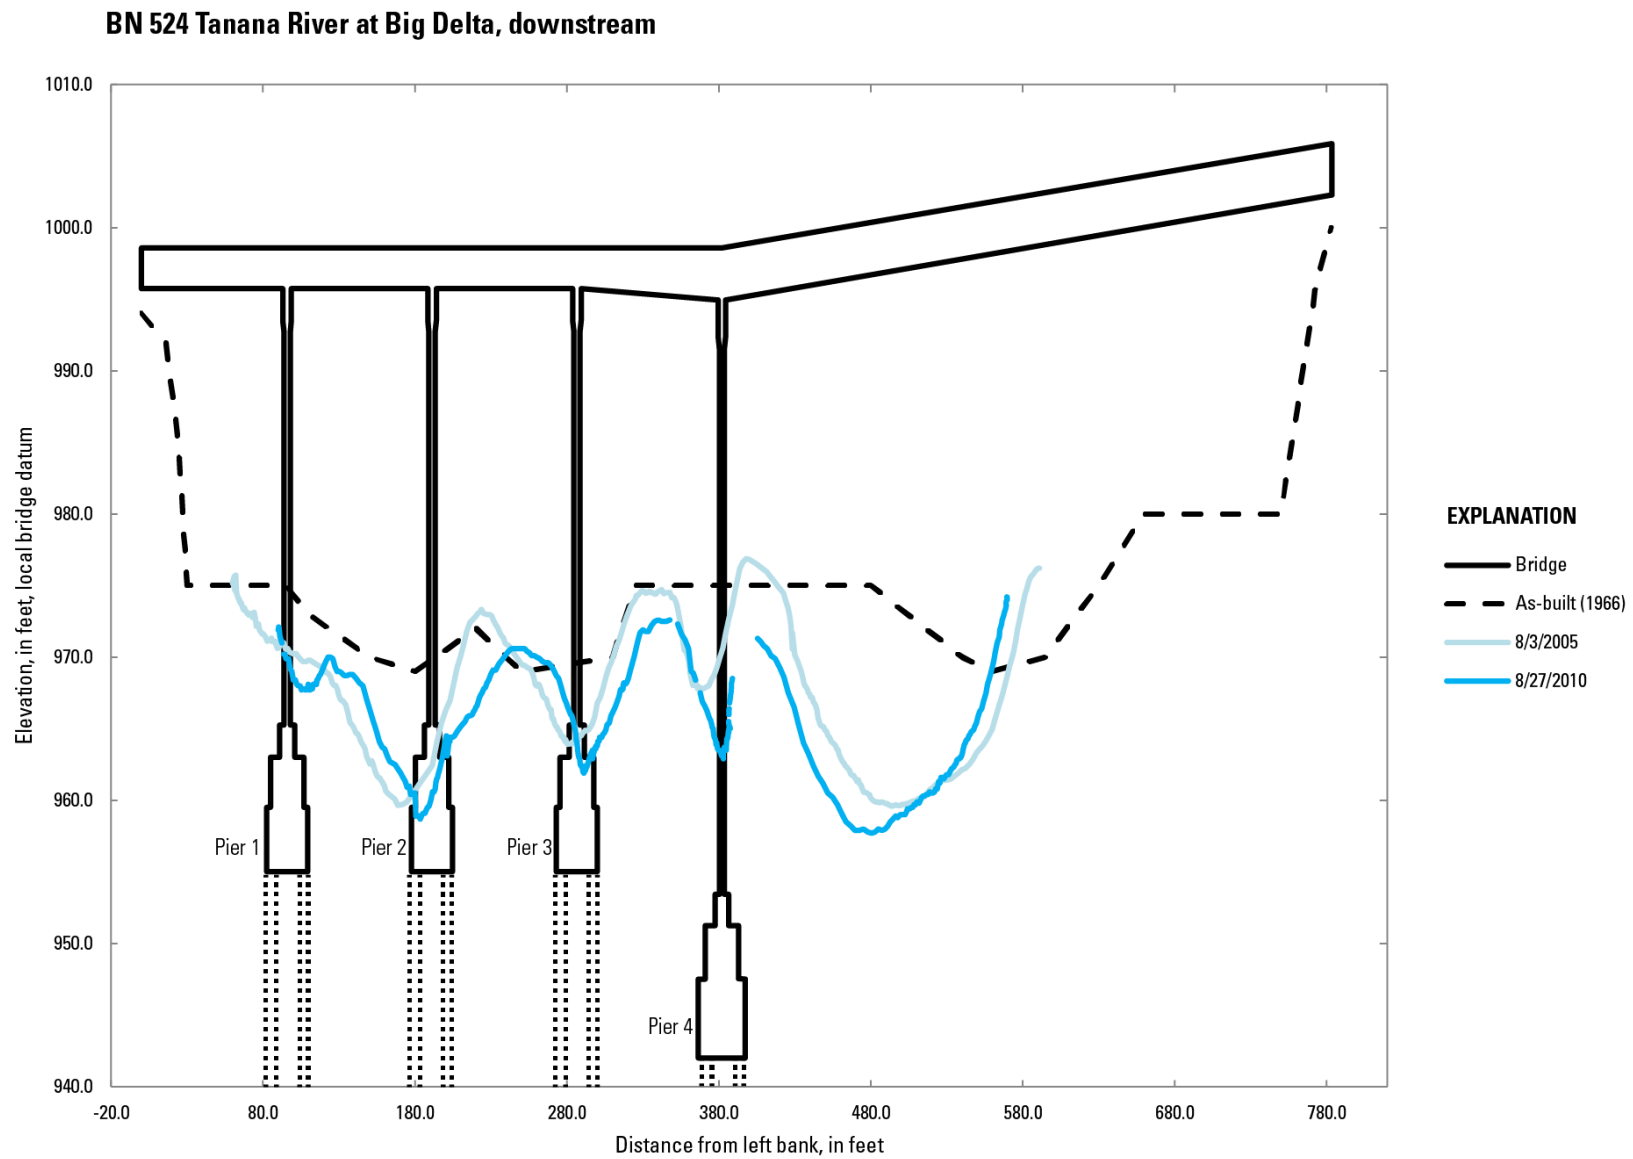
Figure 47. Cross sections showing downstream soundings at bridge 524, Tanana River at Big Delta, Alaska, 2005–10.

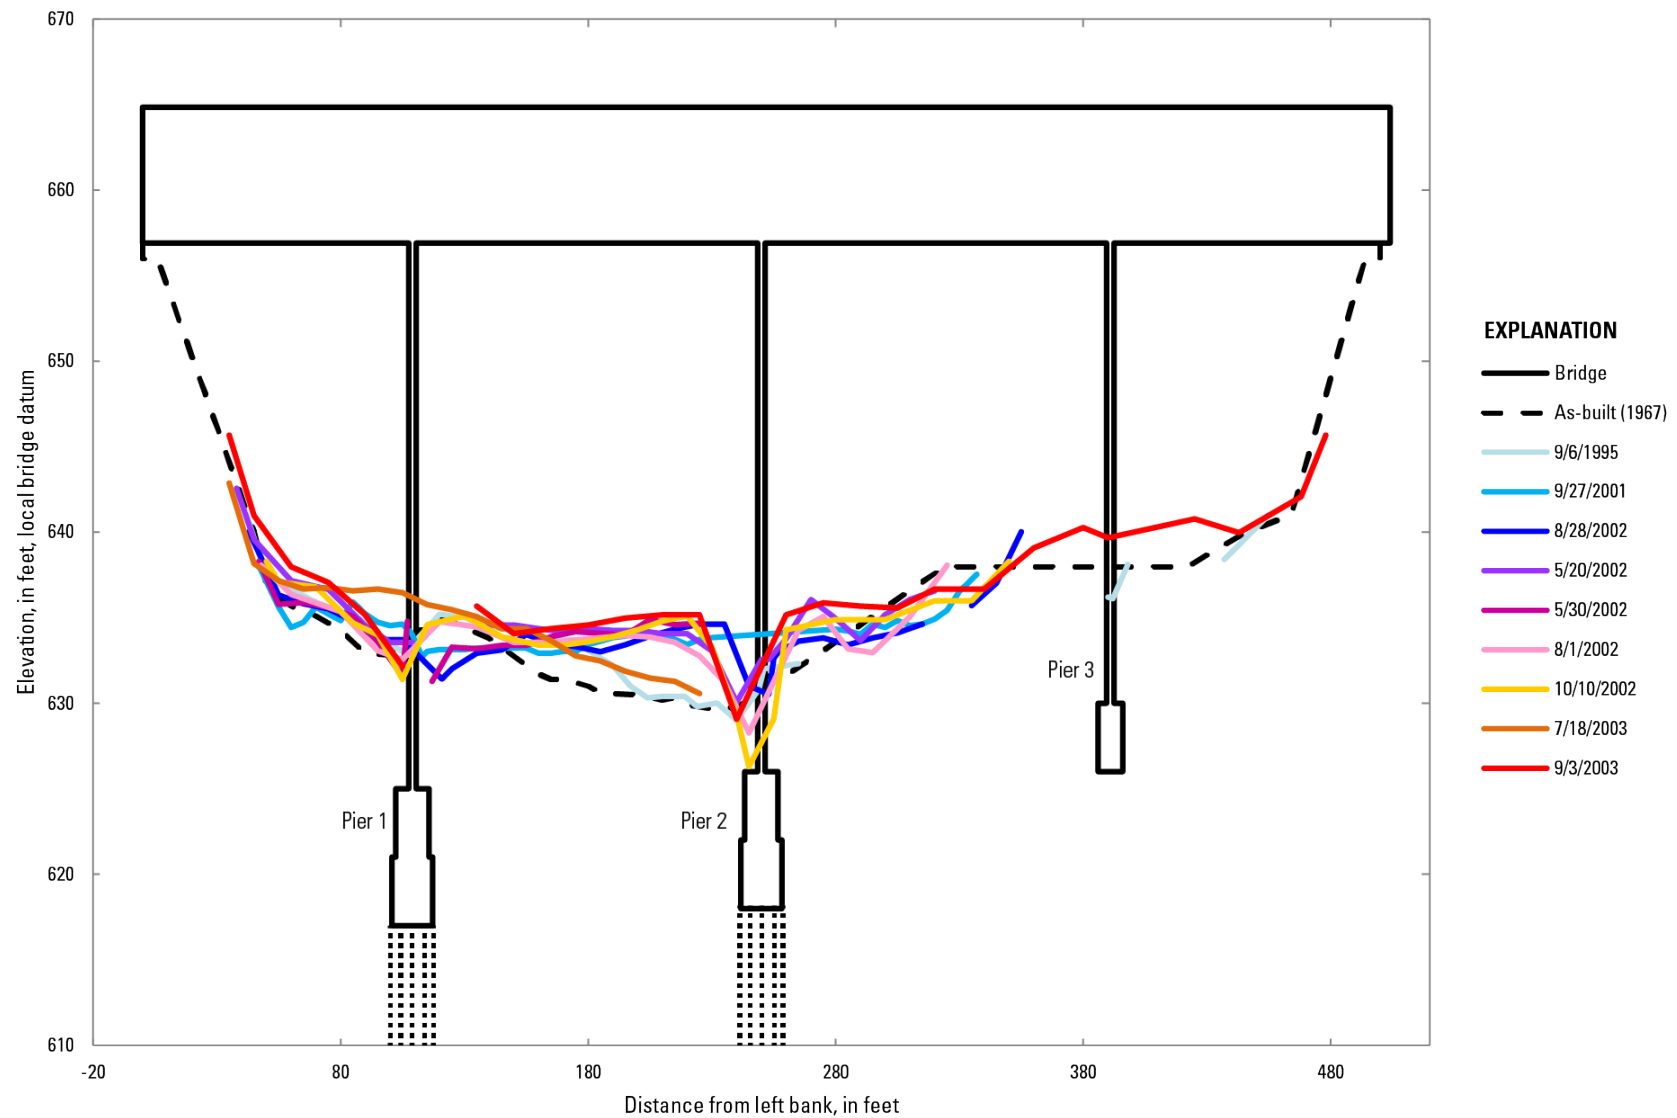
BN 527 Salcha River, upstream

The Salcha River is a major tributary of the Tanana River. It is a single strand through the bridge reach, with slight bends both upstream and downstream of the bridge. The main flow typically is confined to the left side of the channel and the right side of the channel is composed of brushy lowlands that are exposed during low-to-moderate flow but flooded during high flow. There is no substantial angle of attack on the piers; however, the piers tend to collect large amounts of debris during high flows that contribute to the localized scour around the piers (Norman, 1975). Cross-sectional surveys were done during 1995 and 2001–16 (figs. 48–52). The soundings across the channel generally indicate very little long-term aggradation or degradation. Maximum localized scour around the piers of as much as 8 ft has occurred, and a pier footing was exposed during a channel survey in 2002.

Figure 48. Cross sections showing upstream soundings at bridge 527, Salcha River, Alaska, 1995–2003.
