Measurement of Long-Term Channel Change Through Repeated Cross-Section Surveys at Bridge Crossings in Alaska

Open-File Report 2019–1028

By Karenth L. Dworsky and Jeffrey S. Conaway

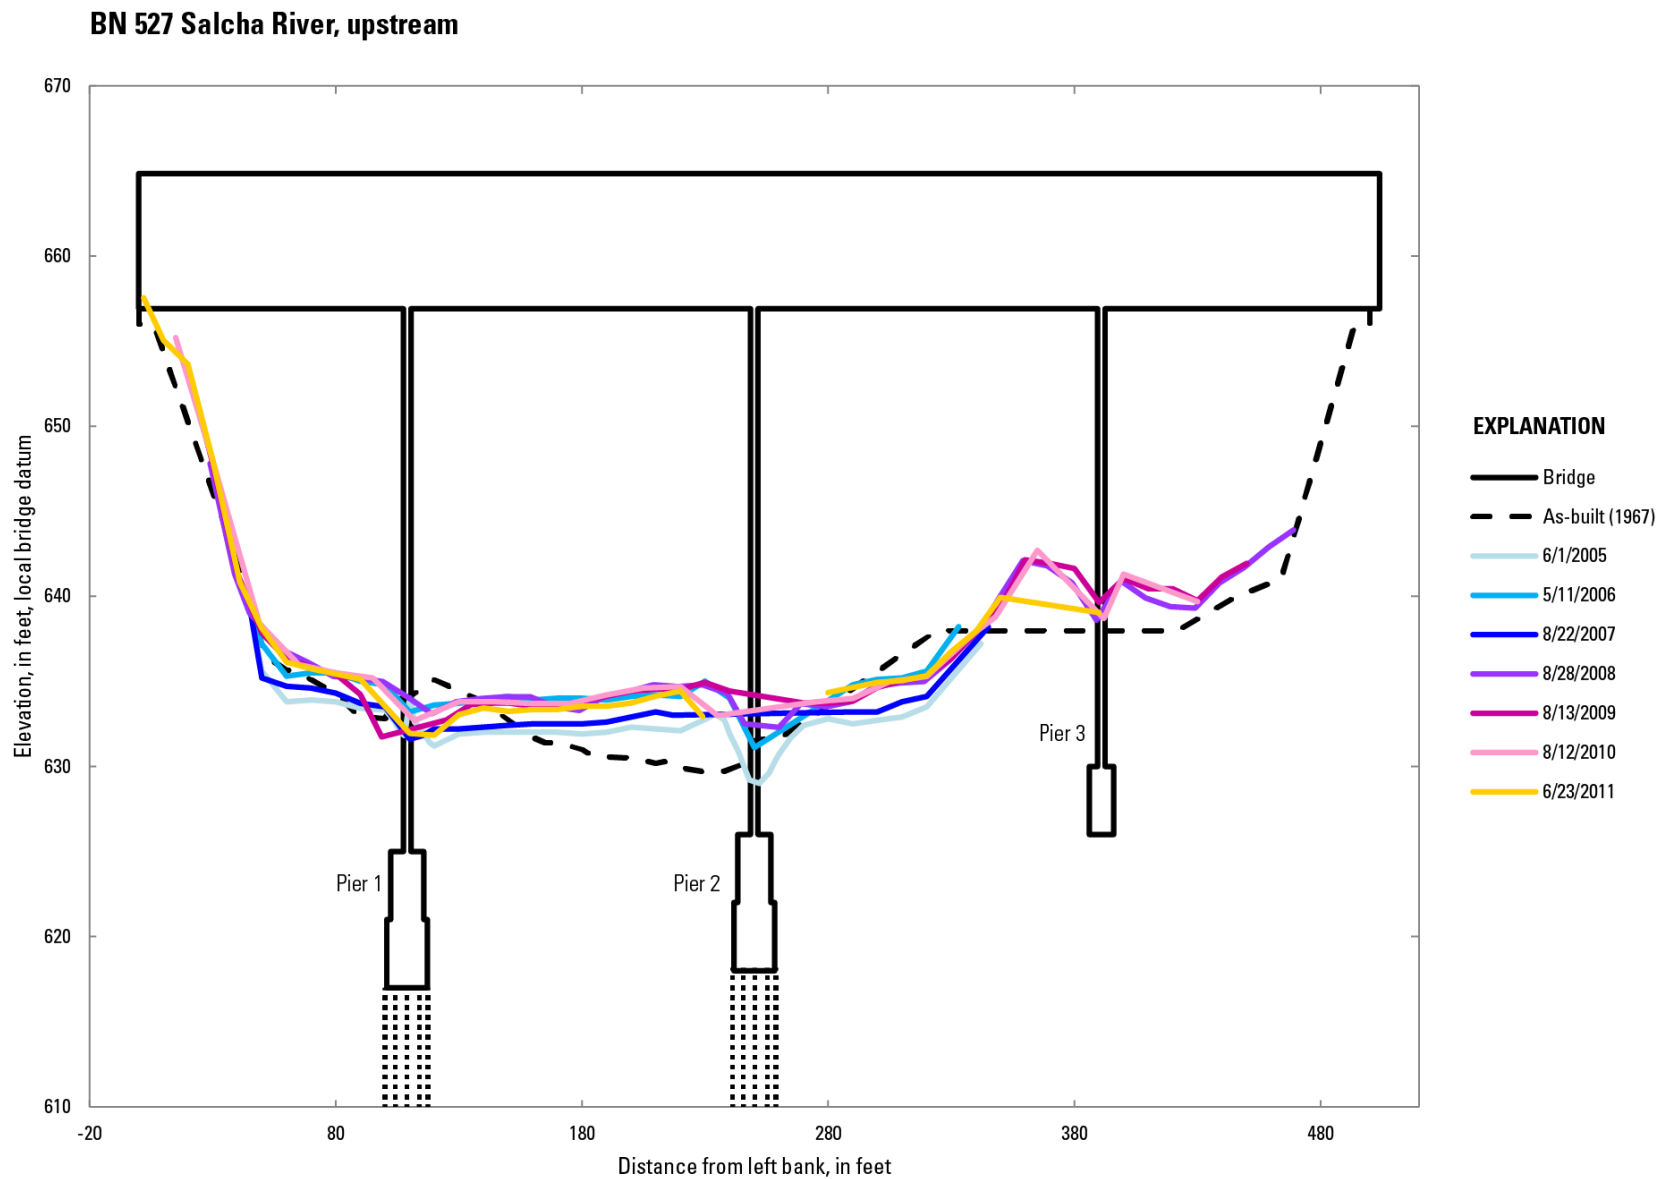
The Salcha River is a major tributary of the Tanana River. It is a single strand through the bridge reach, with slight bends both upstream and downstream of the bridge. The main flow typically is confined to the left side of the channel and the right side of the channel is composed of brushy lowlands that are exposed during low-to-moderate flow but flooded during high flow. There is no substantial angle of attack on the piers; however, the piers tend to collect large amounts of debris during high flows that contribute to the localized scour around the piers (Norman, 1975). Cross-sectional surveys were done during 1995 and 2001–16 (figs. 48–52). The soundings across the channel generally indicate very little long-term aggradation or degradation. Maximum localized scour around the piers of as much as 8 ft has occurred, and a pier footing was exposed during a channel survey in 2002.

Figure 49. Cross sections showing upstream soundings at bridge 527, Salcha River, Alaska, 2005–11.

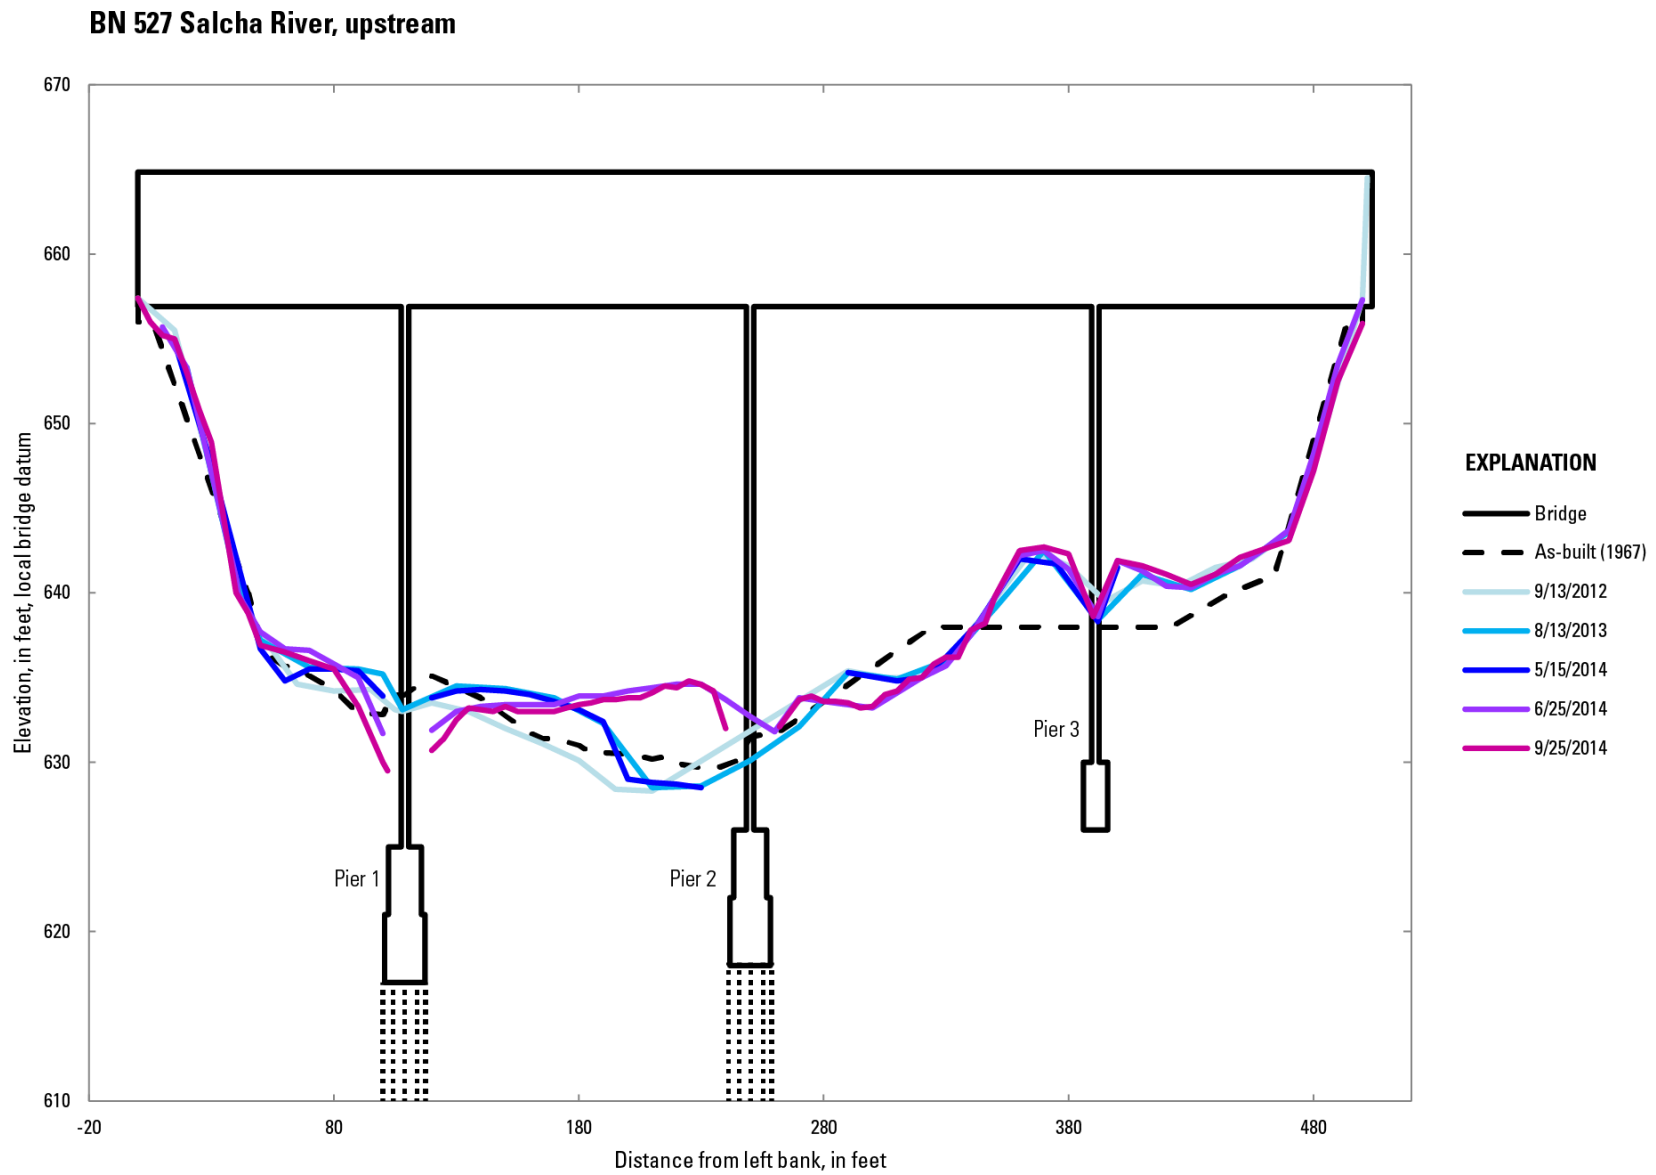
Figure 50. Cross sections showing upstream soundings at bridge 527, Salcha River, Alaska, 2012–14.

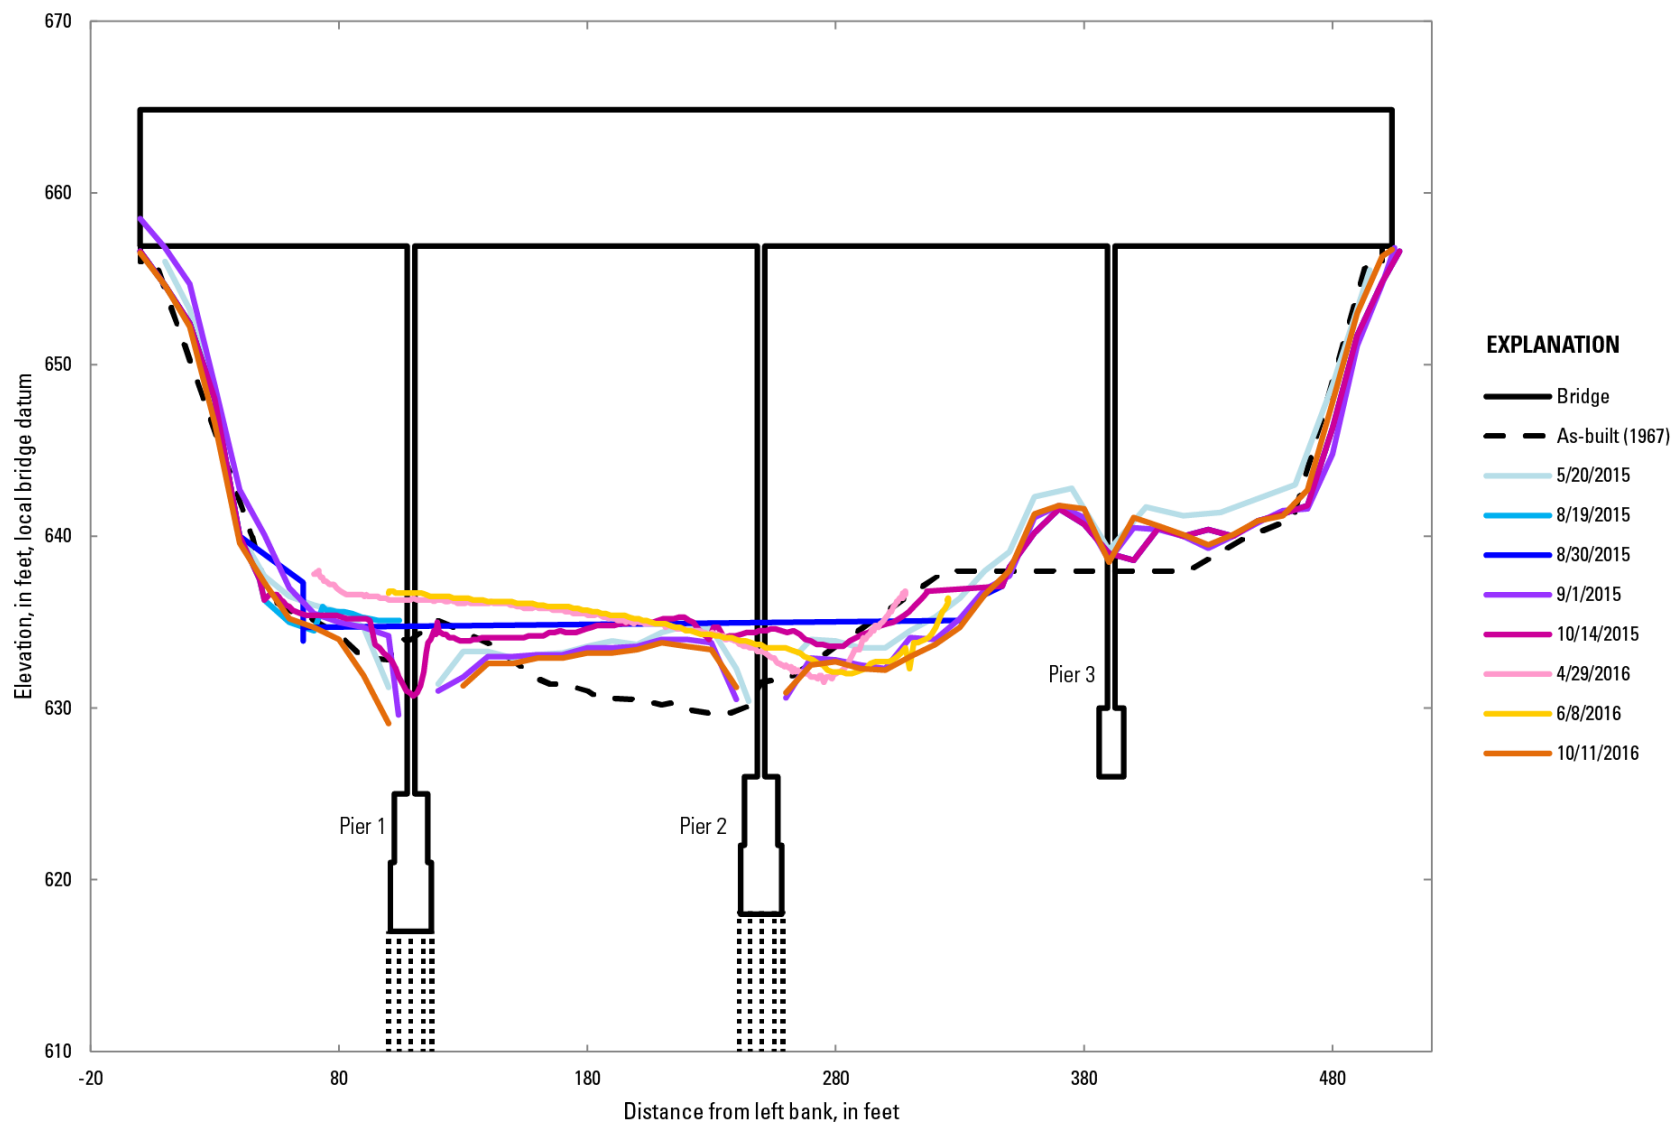
BN 527 Salcha River, upstream

Figure 51. Cross sections showing upstream soundings at bridge 527, Salcha River, Alaska, 2015–16.

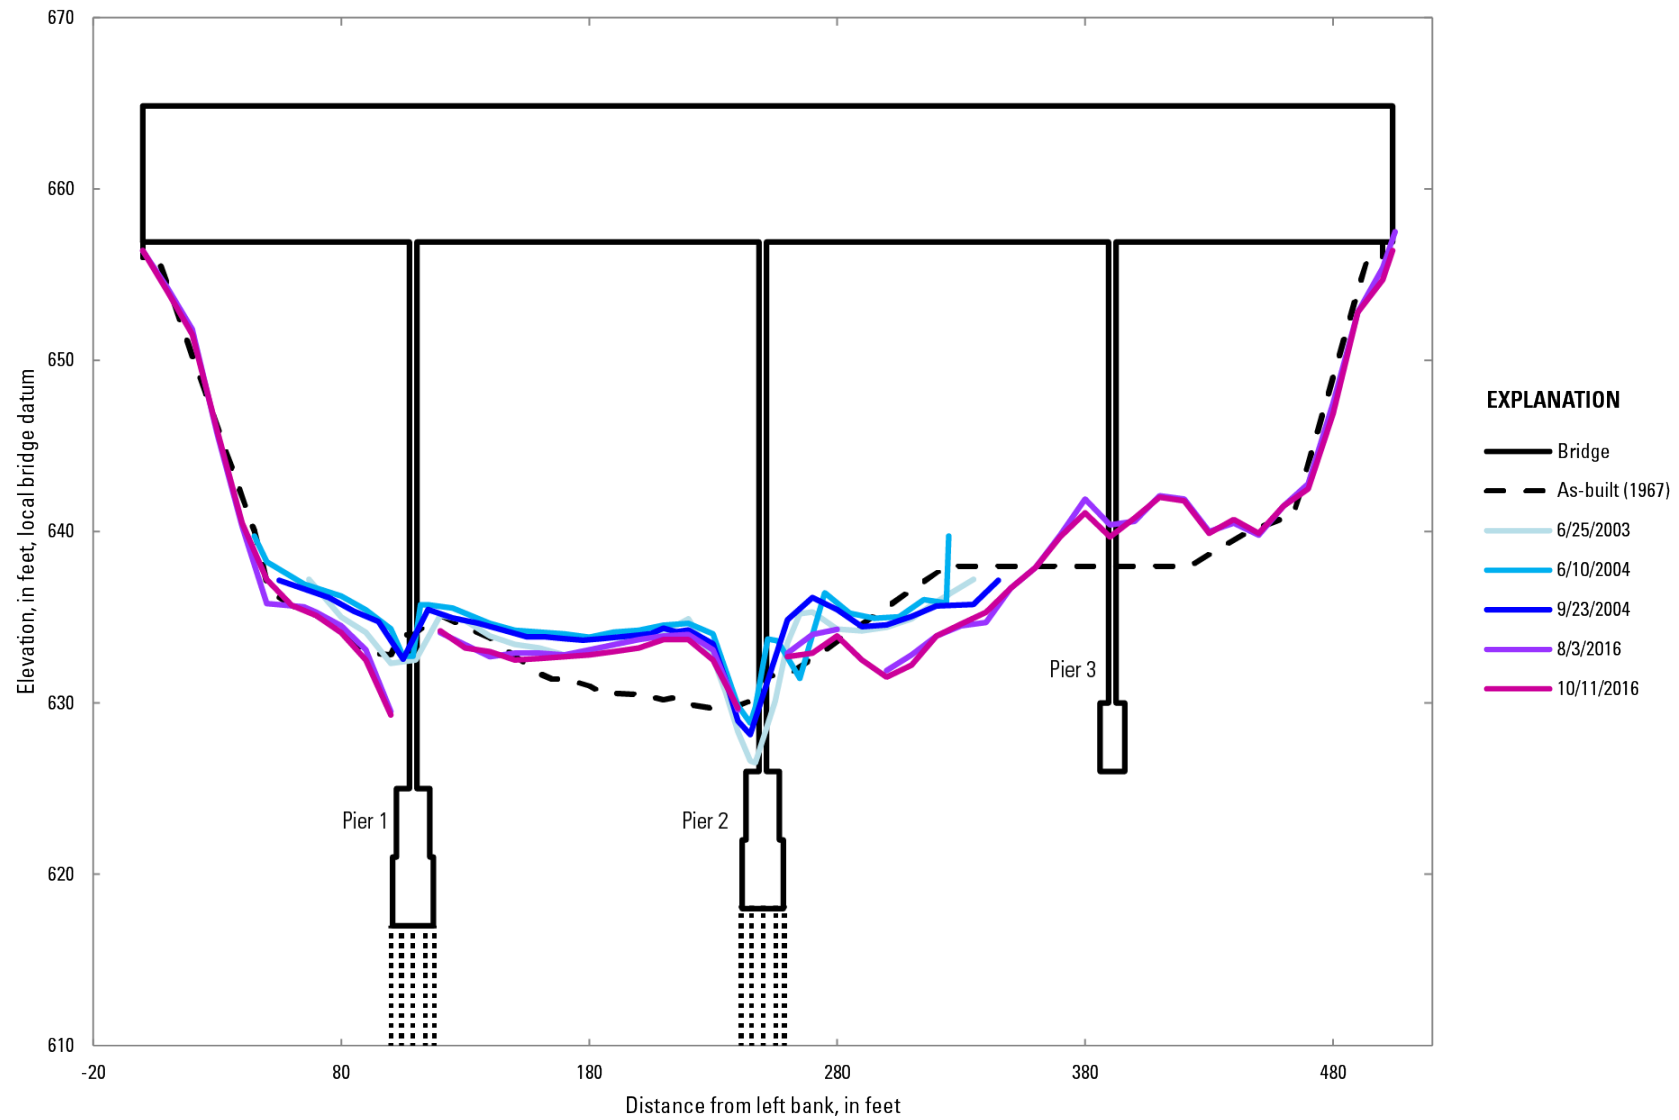
BN 527 Salcha River, downstream

Figure 52. Cross sections showing downstream soundings at bridge 527, Salcha River, Alaska, 2003–16.

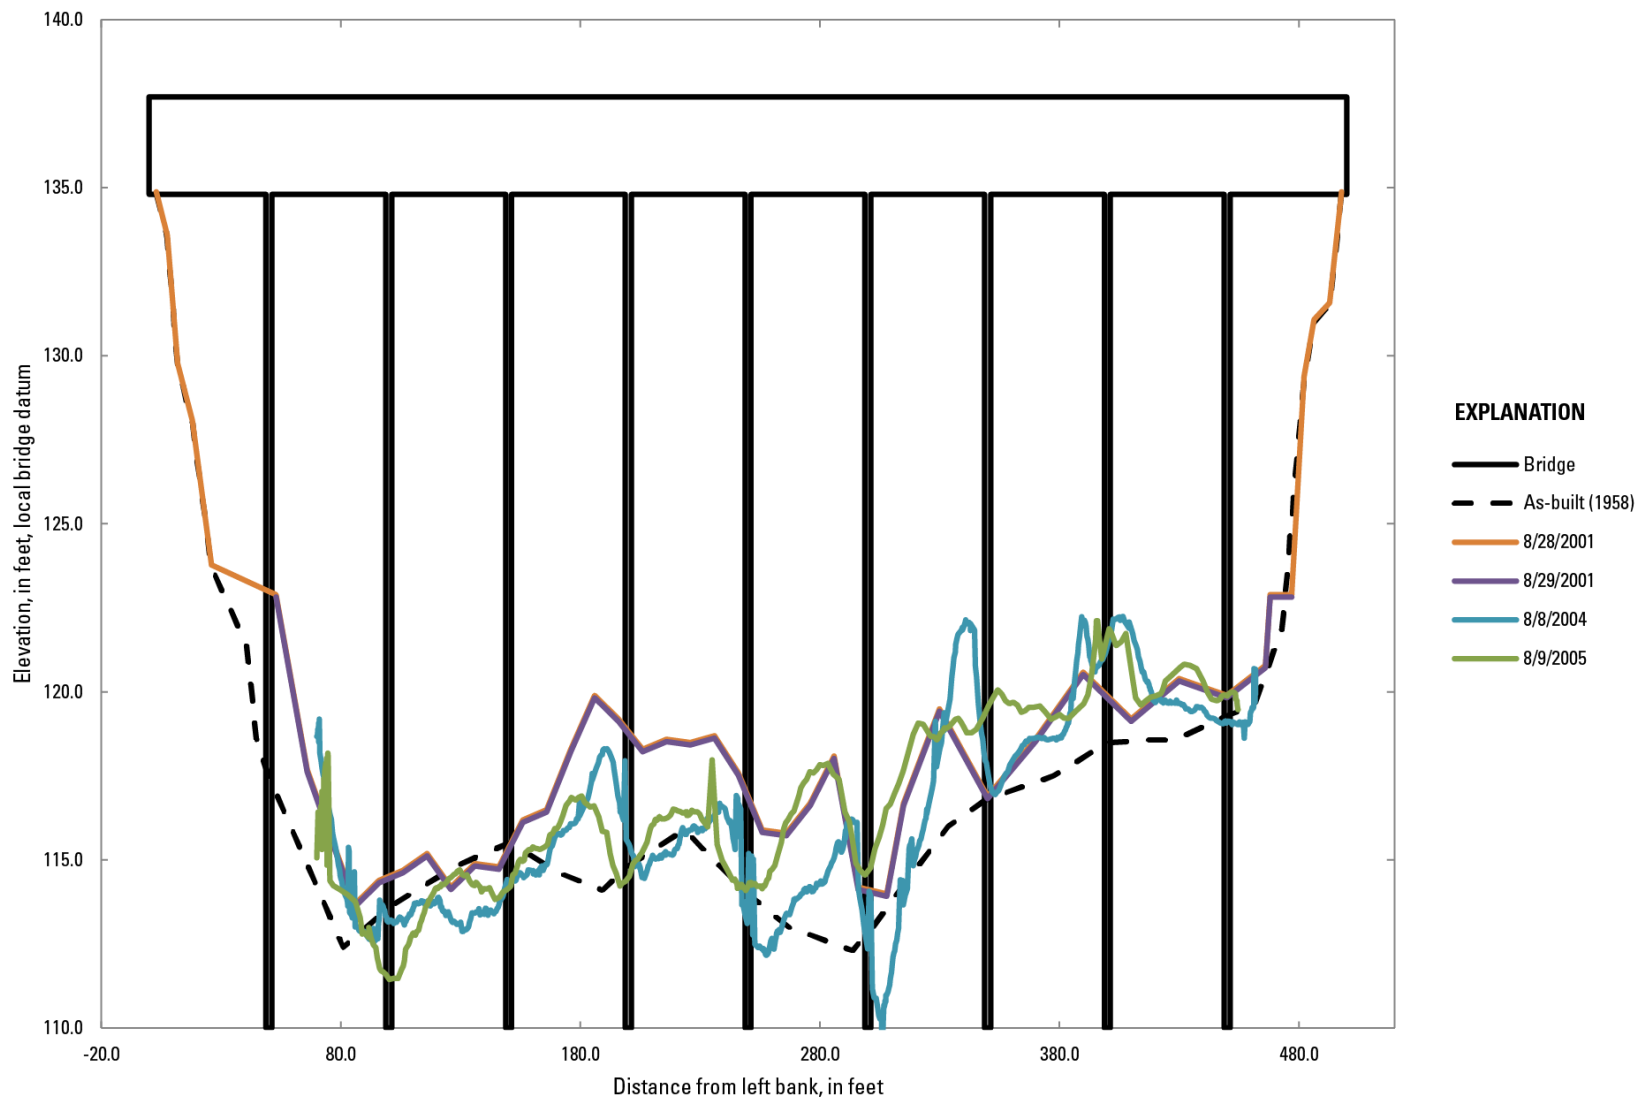
BN 742 Chilkat River, downstream

The Chilkat River originates at Chilkat Glacier in the Coast Range on the border of Alaska and British Columbia. The river flows in a single channel through the bridge, which crosses about 1 mi upstream of the Klehini River confluence. Cross sections were measured during 2001, 2004–11, and 2013–16 (figs. 68–70). Since the as-built survey, 7 ft of aggradation occurred on the left bank with little to no degradation on the right bank. From 2006 to 2010, the Chilkat River scoured as much as 7 feet locally around piers 2, 5, and 6 (pier numbering starts from the left side). From 2013 to 2016, as much as 8 ft of scour occurred between piers 2 and 4, and aggradation of as much as 6 ft occurred around the other piers.

Figure 70. Cross sections showing downstream soundings at bridge 742, Chilkat River, Alaska, 2001–05.

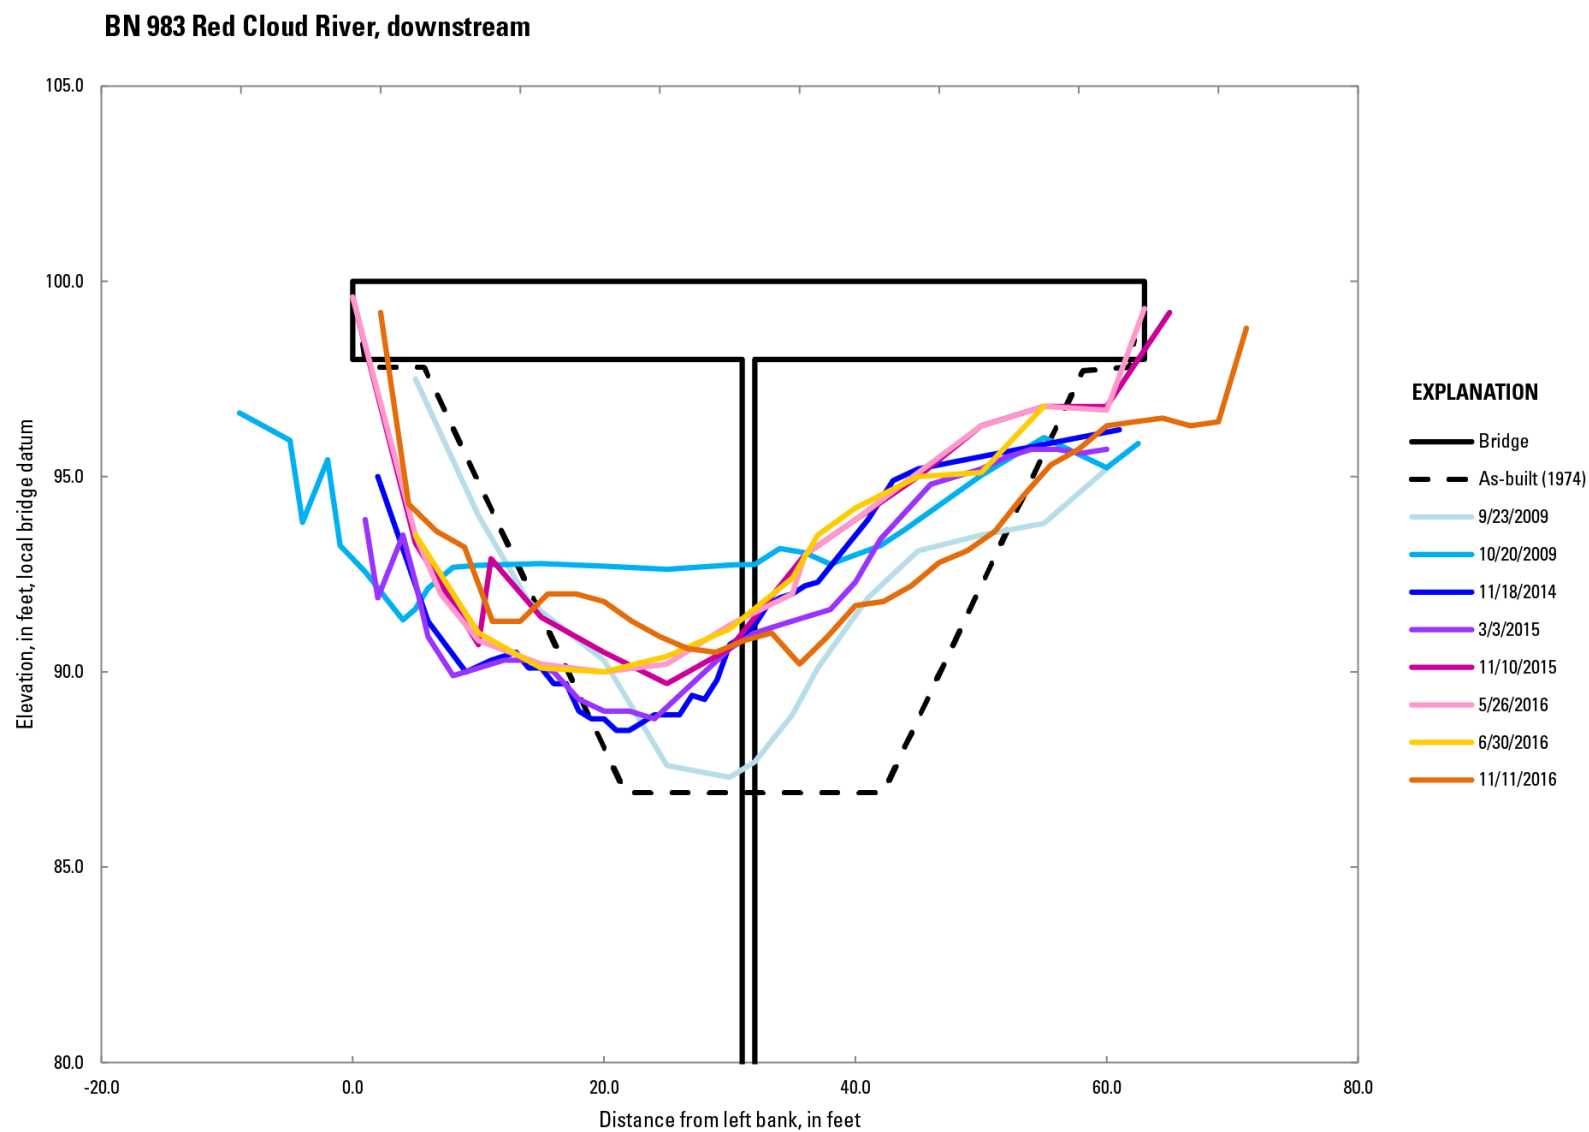
Figure 78. Cross sections showing downstream soundings at bridge 983, Red Cloud River, Alaska, 2009–16.

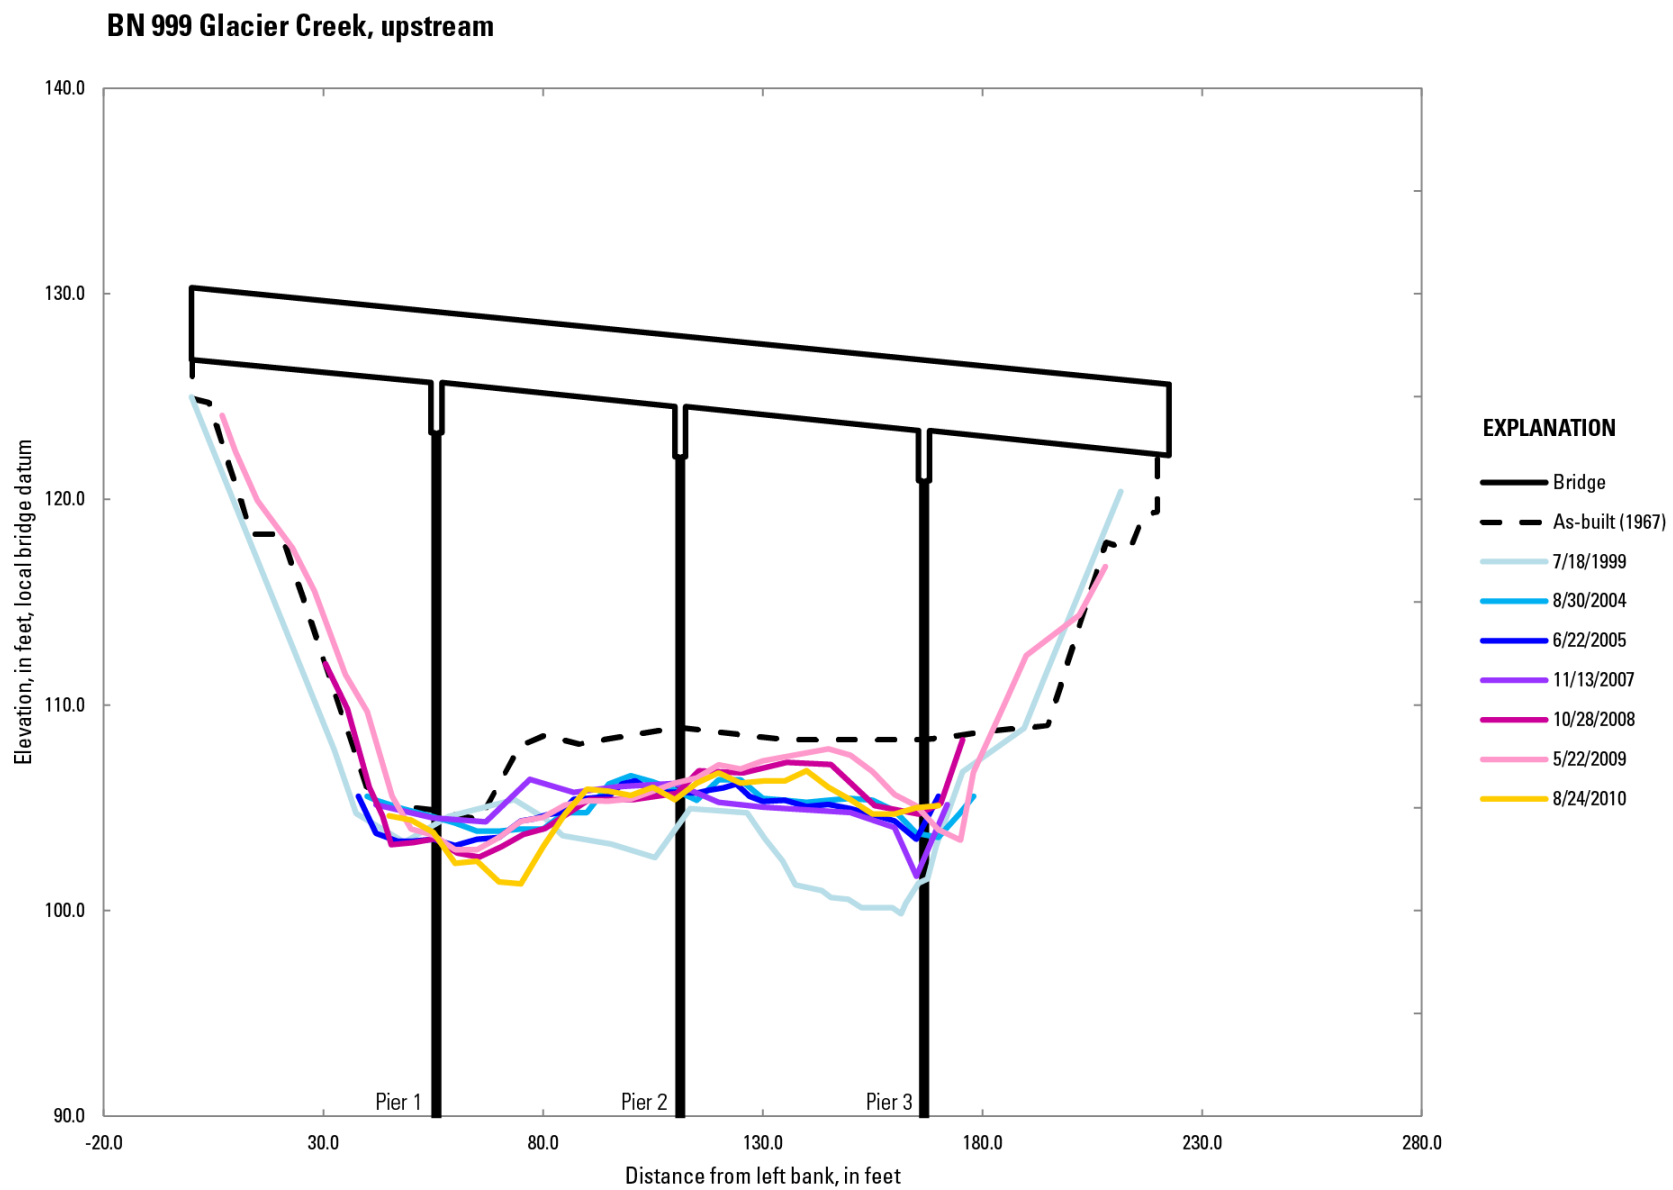
Glacier Creek is a glacially fed creek originating in the Chugach Range. The channel is braided through the bridge reach at all but the highest flows. The middle piers of the upstream pedestrian bridge and the highway bridge are connected and divide the creek through the bridge. During low-to-moderate flows, the channel is a contained river left of the center pier, where the angle of attack is 25–35 degrees. The channel to the right of the pier has no flow during low flows, but often has ponded water. During moderate-to-high flows, most of the channel is still concentrated on the river left, but the angle of attack on the pier is reduced (0–15 degrees). Cross sections were measured during 1999, 2004, 2005, and 2007–16 (figs. 79 and 80). An overall degradation of 3 ft occurred across the entire channel compared to the as-built cross section, and as much as 6 ft of scour occurred at the right bank pier.

Figure 79. Cross sections showing upstream soundings at bridge 999, Glacier Creek, Alaska, 1999–2010.

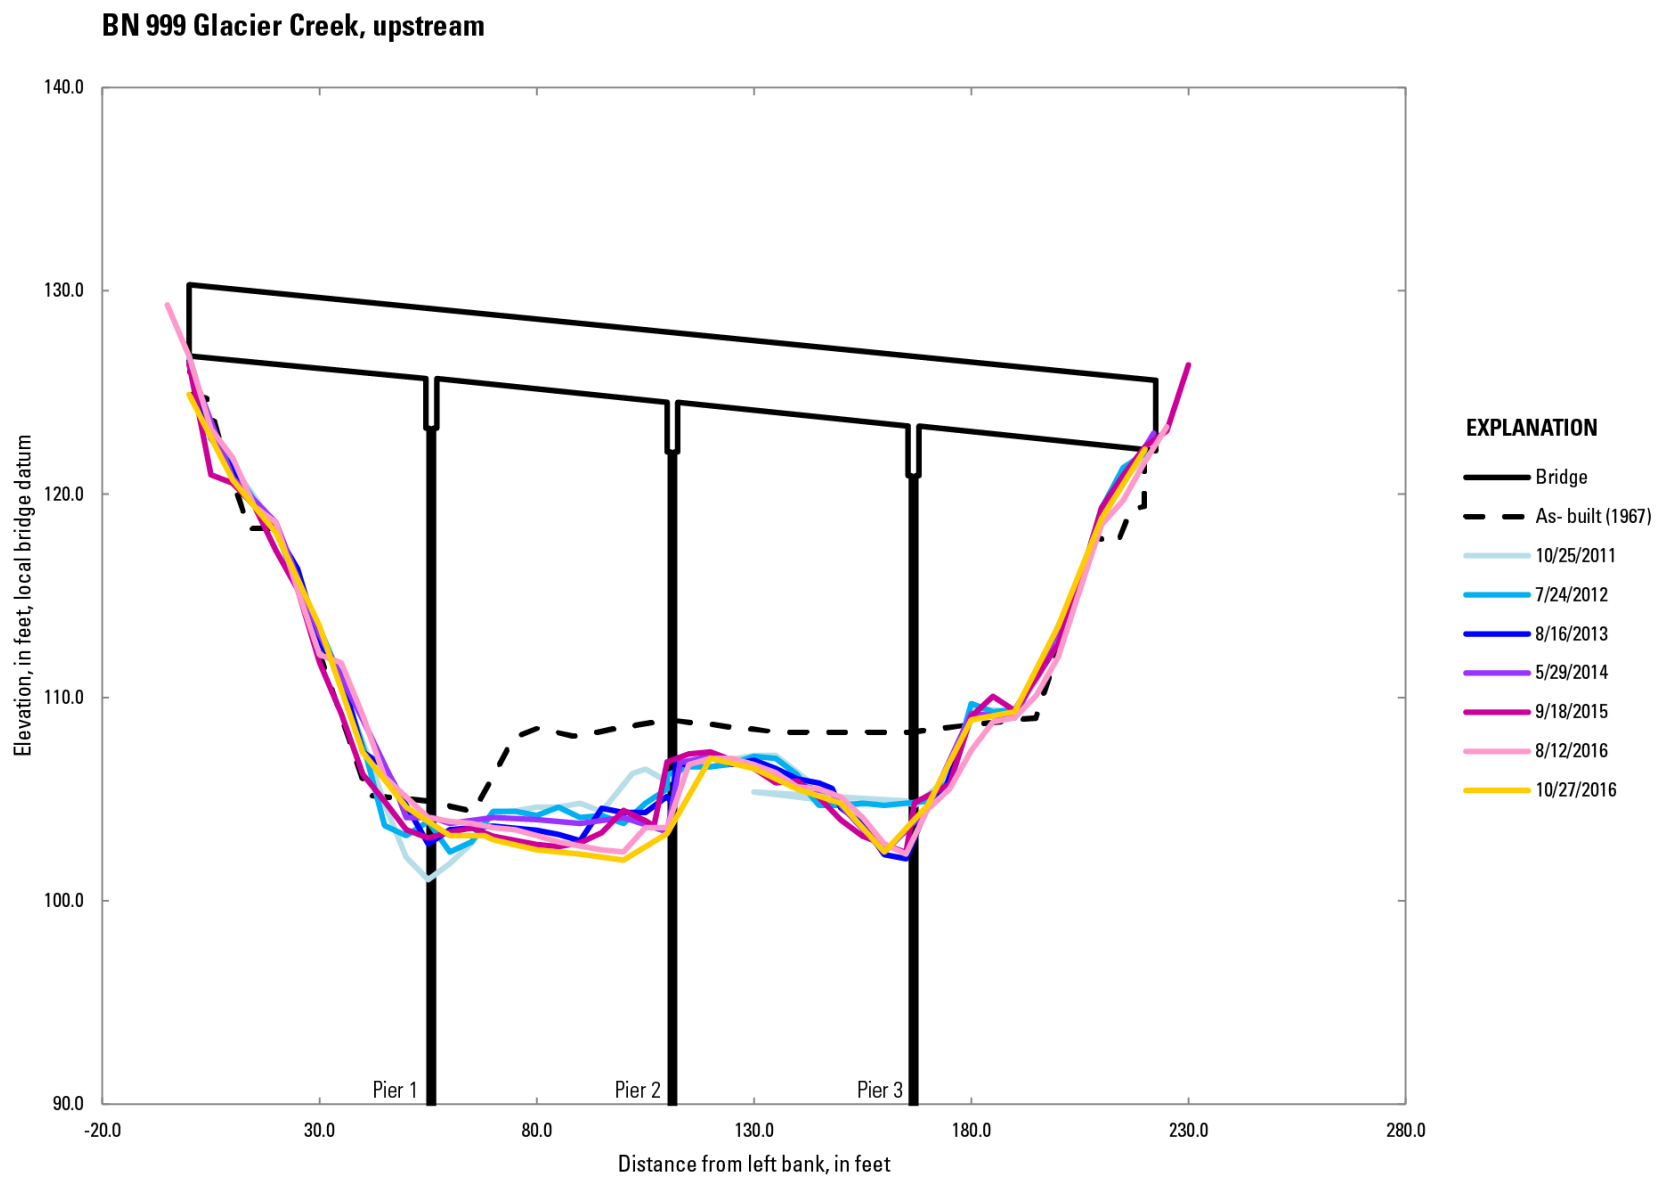
Figure 80. Cross sections showing upstream soundings at bridge 999, Glacier Creek, Alaska, 2011–16.

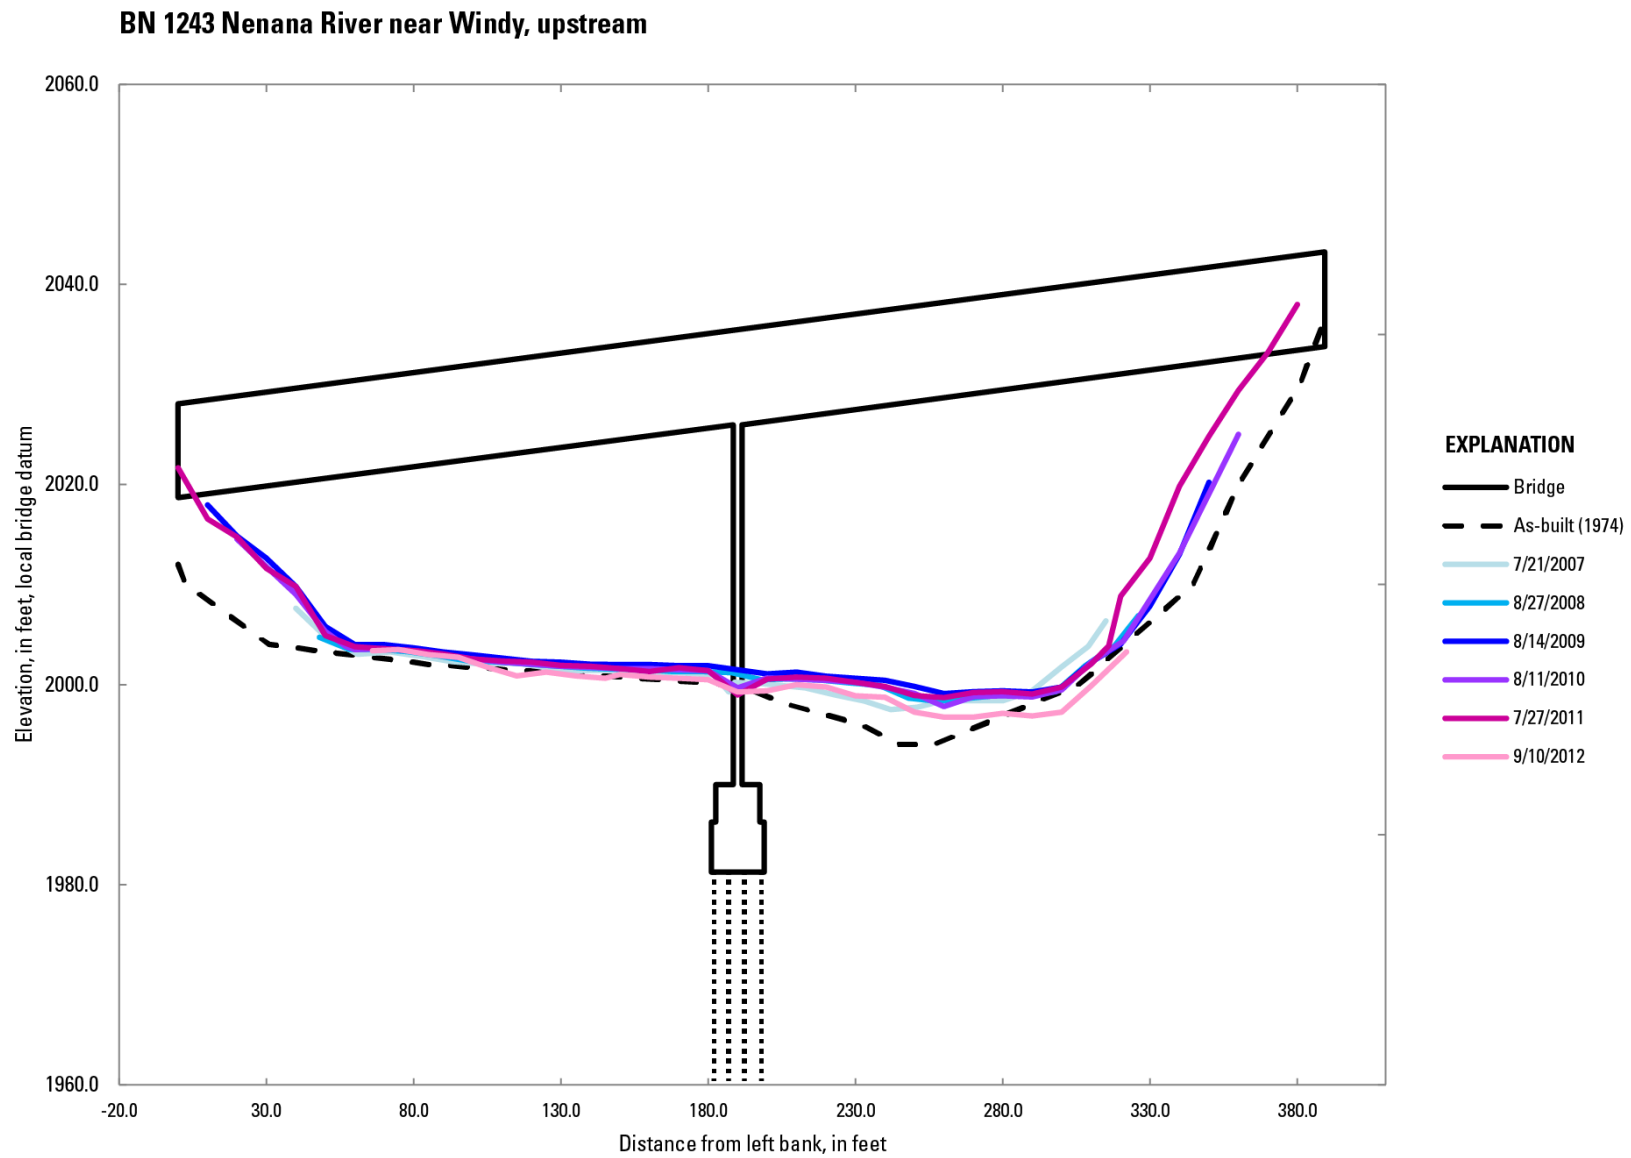
The Nenana River is a meandering single channel that is crossed at a 45-degree angle by bridge 1243. The bridge is supported by a single pier and the angle of attack on this pier is 10 degrees. The left bank of the channel under the bridge is armored with riprap and the right bank is a steep sandy bank. Cross sections were measured annually from 2007 to 2016 (figs. 81 and 82). The channel has been stable and relatively unchanged during the years in which soundings were measured, with a maximum of 2 ft of localized scour around the pier.

Figure 81. Cross sections showing upstream soundings at bridge 1243, Nenana River near Windy, Alaska, 2007–12.

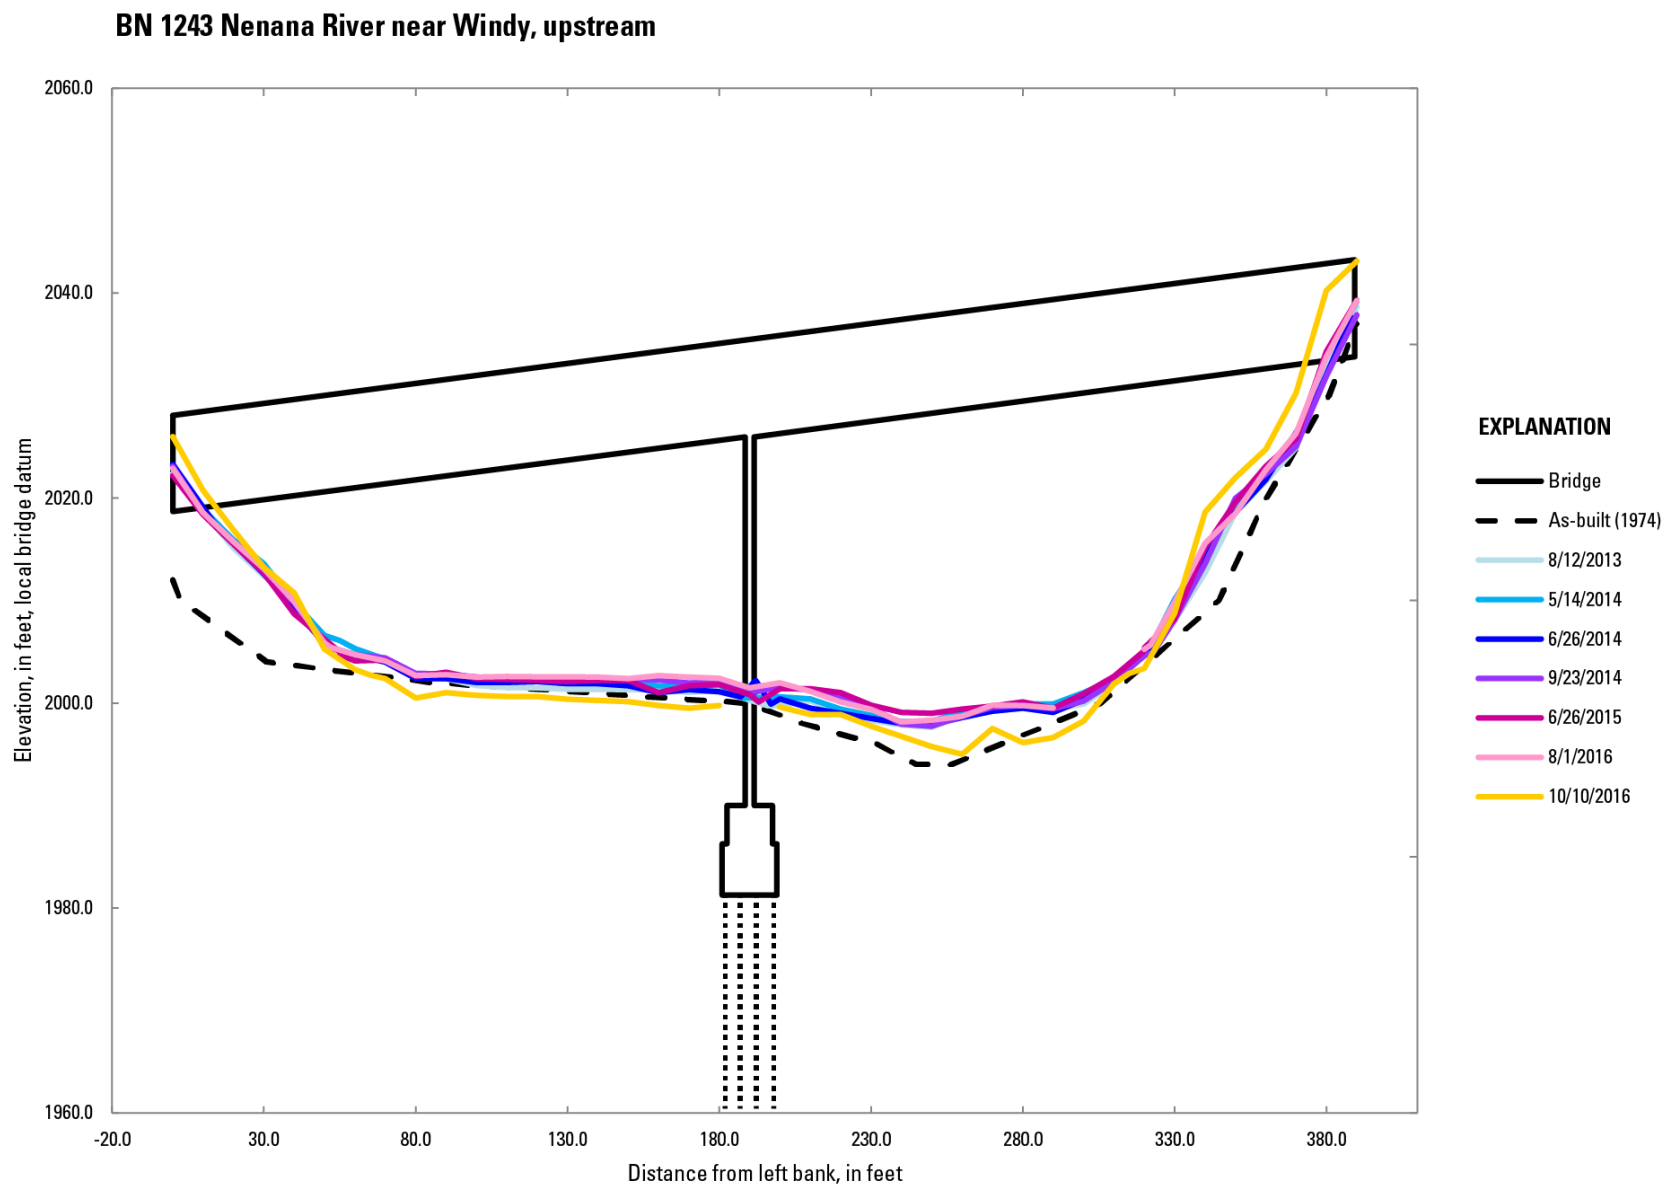
Figure 82. Cross sections showing upstream soundings at bridge 1243, Nenana River near Windy, Alaska, 2013–16.

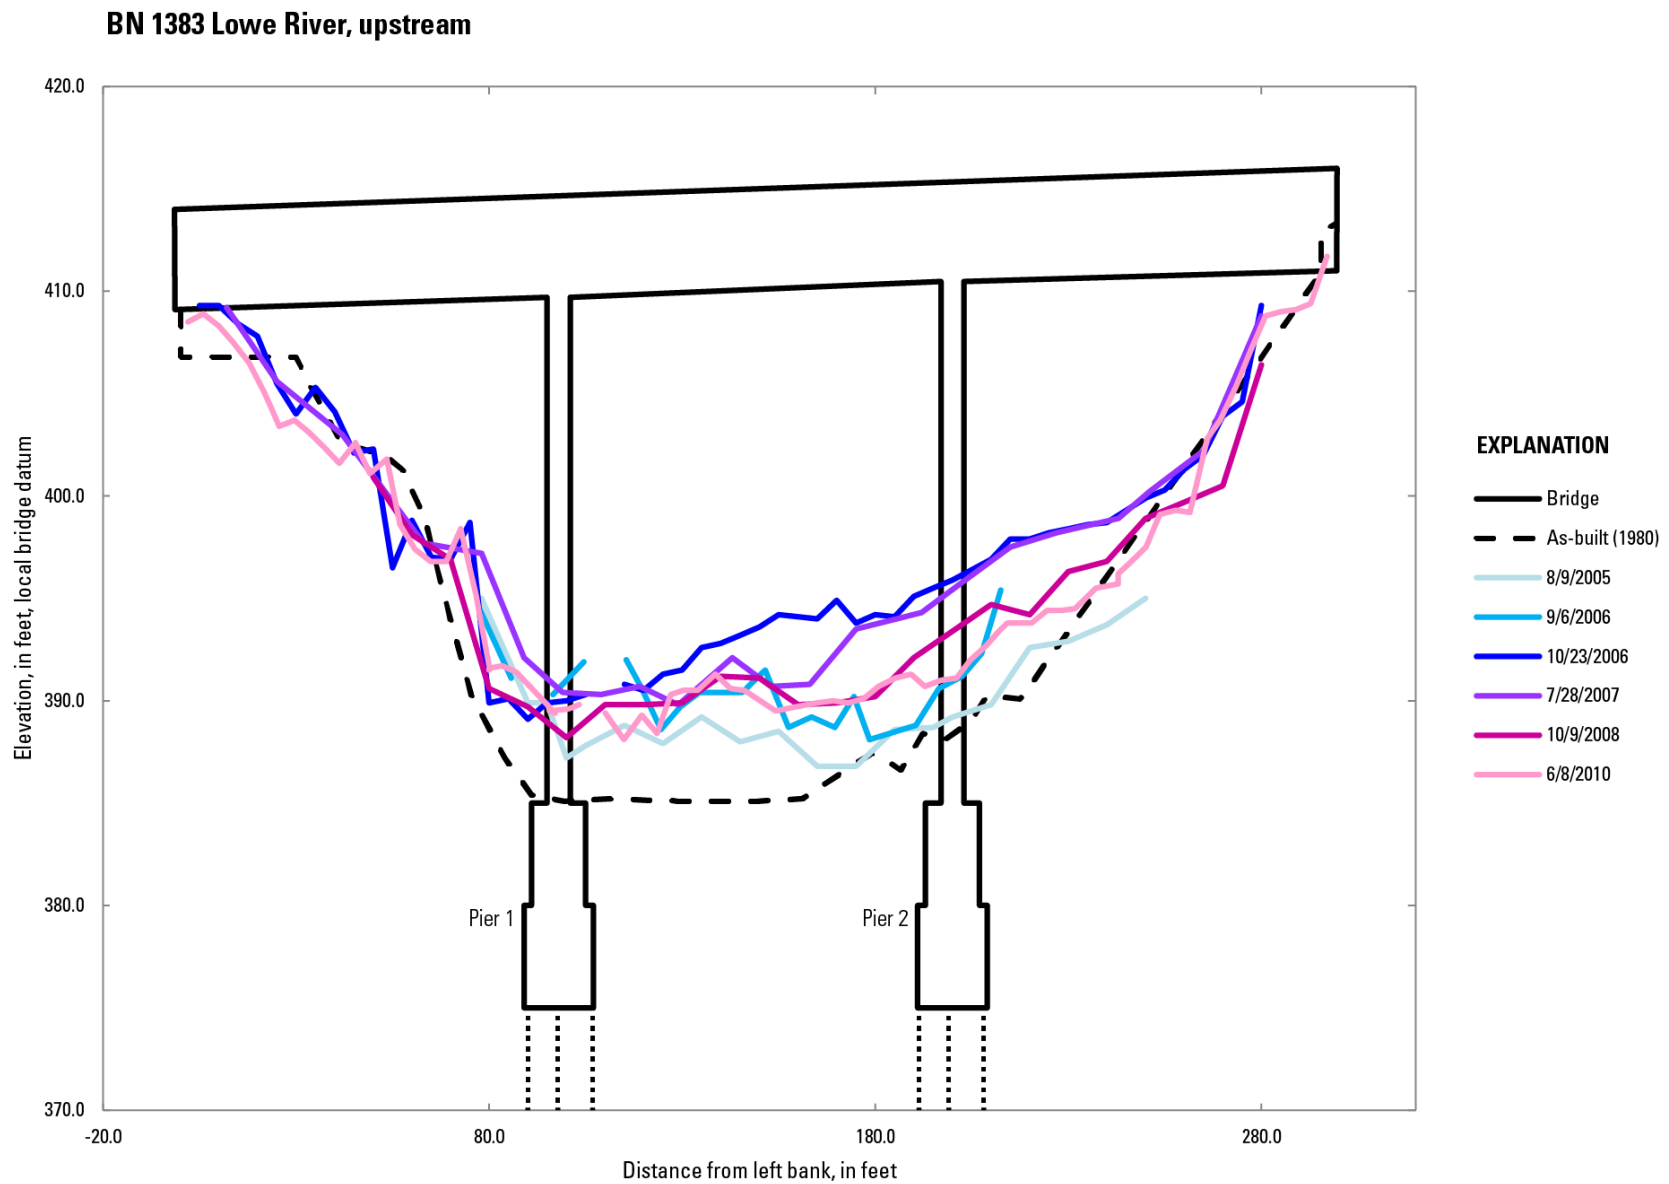
The Lowe River is a high-gradient, boulder-strewn channel that originates in the Chugach Mountains from Deserted Glacier before traversing Keystone Canyon where bridge 1383 is located. The right pier typically is out of the water except during floods. The left side of the channel is on bedrock, whereas the road approach is heavily armored with riprap. Flow increases and decreases relatively quickly during heavy rain owing to the steep gradient of the river and its drainage basin. Cross sections were measured during 2005–08 and 2010–16 (figs. 83–85). About 5 ft of aggradation occurred overall across the entire channel compared to the as-built cross section. Between 2005 and 2006, streambed elevation fluctuated 6 ft around the pier, but never decreased below the as-built elevation. Since 2006, the right side of the channel has been relatively stable.

Figure 83. Cross sections showing upstream soundings at bridge 1383, Lowe River, Alaska, 2005–10.
