Measurement of Long-Term Channel Change Through Repeated Cross-Section Surveys at Bridge Crossings in Alaska

Open-File Report 2019–1028

By Karenth L. Dworsky and Jeffrey S. Conaway

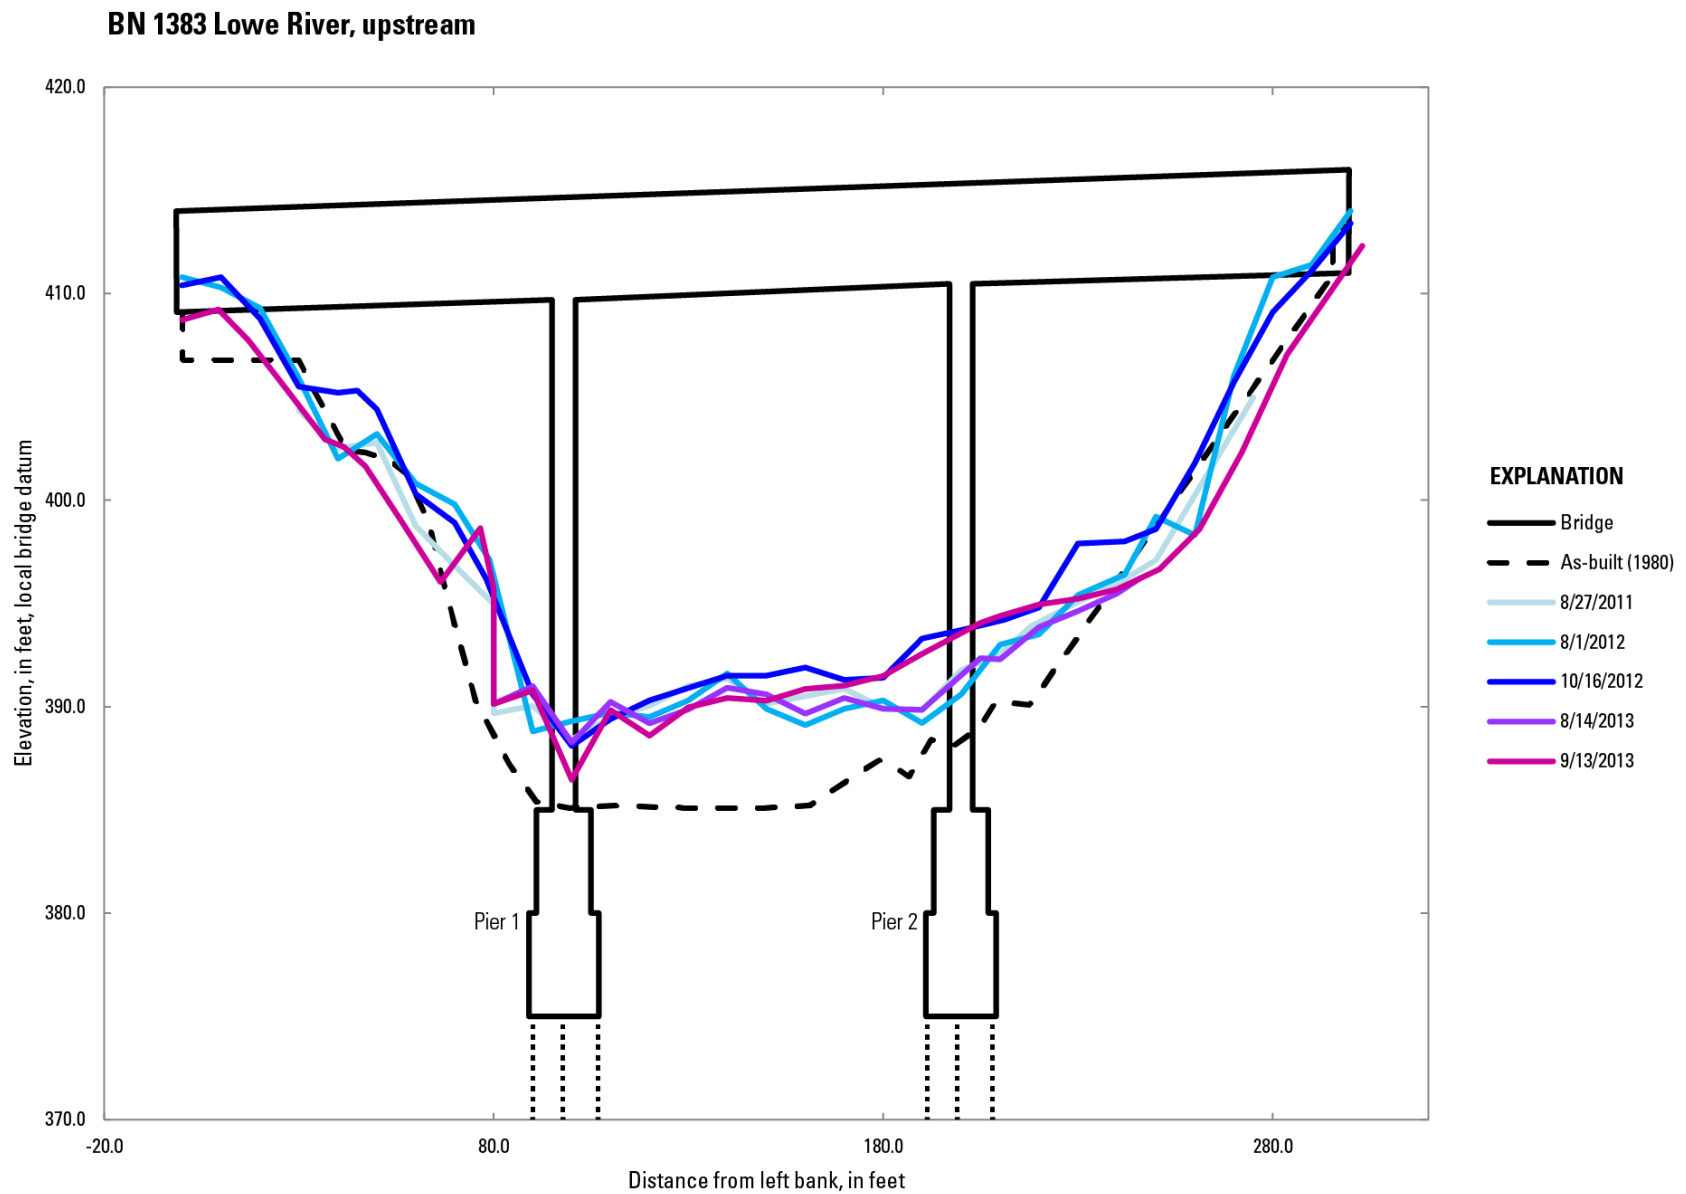
The Lowe River is a high-gradient, boulder-strewn channel that originates in the Chugach Mountains from Deserted Glacier before traversing Keystone Canyon where bridge 1383 is located. The right pier typically is out of the water except during floods. The left side of the channel is on bedrock, whereas the road approach is heavily armored with riprap. Flow increases and decreases relatively quickly during heavy rain owing to the steep gradient of the river and its drainage basin. Cross sections were measured during 2005–08 and 2010–16 (figs. 83–85). About 5 ft of aggradation occurred overall across the entire channel compared to the as-built cross section. Between 2005 and 2006, streambed elevation fluctuated 6 ft around the pier, but never decreased below the as-built elevation. Since 2006, the right side of the channel has been relatively stable.

Figure 84. Cross sections showing upstream soundings at bridge 1383, Lowe River, Alaska, 2011–13.

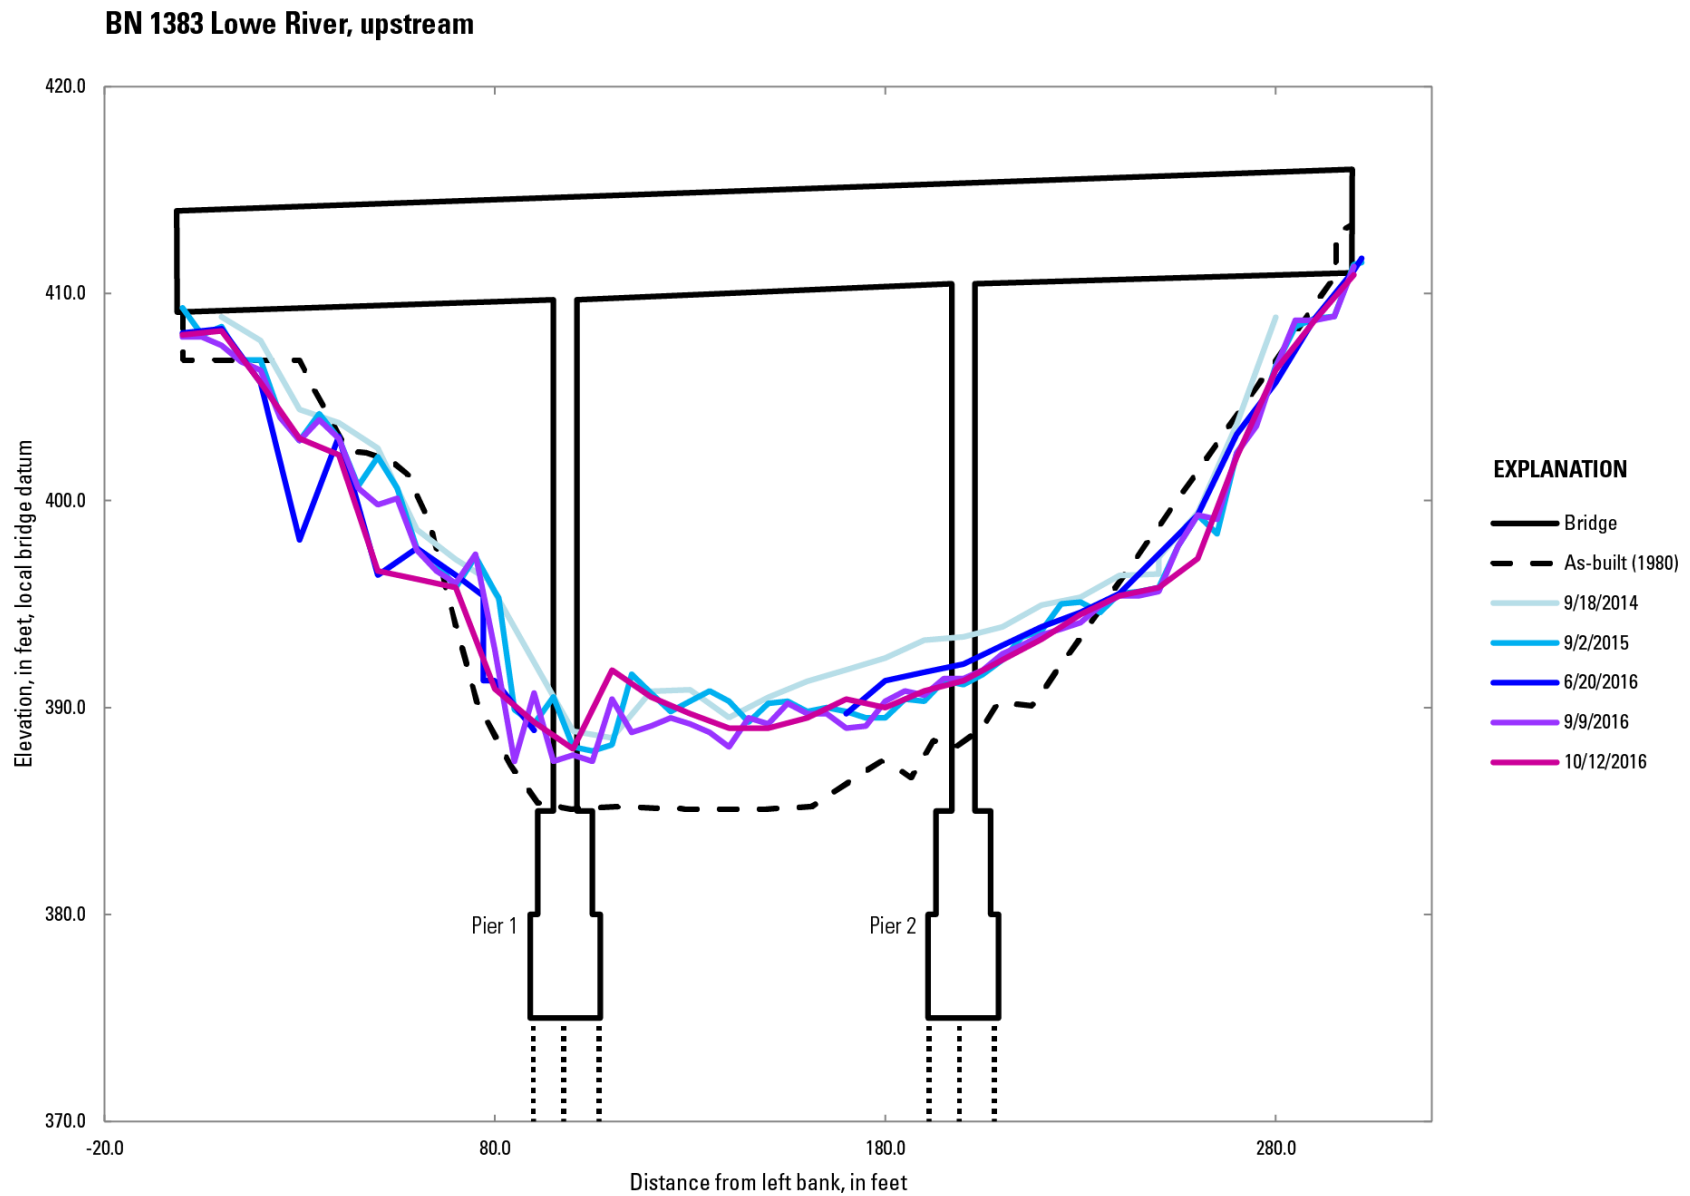
Figure 85. Cross sections showing upstream soundings at bridge 1383, Lowe River, Alaska, 2014–16.
