## **Ground Failure Triggered by Shaking during the November 30, 2018, Magnitude 7.1 Anchorage, Alaska, Earthquake**

Open-File Report 2020–1043

By Alex R.R. Grant, Randall W. Jibson, Robert C. Witter, Kate E. Allstadt, Eric M. Thompson,  
and Adrian M. Bender

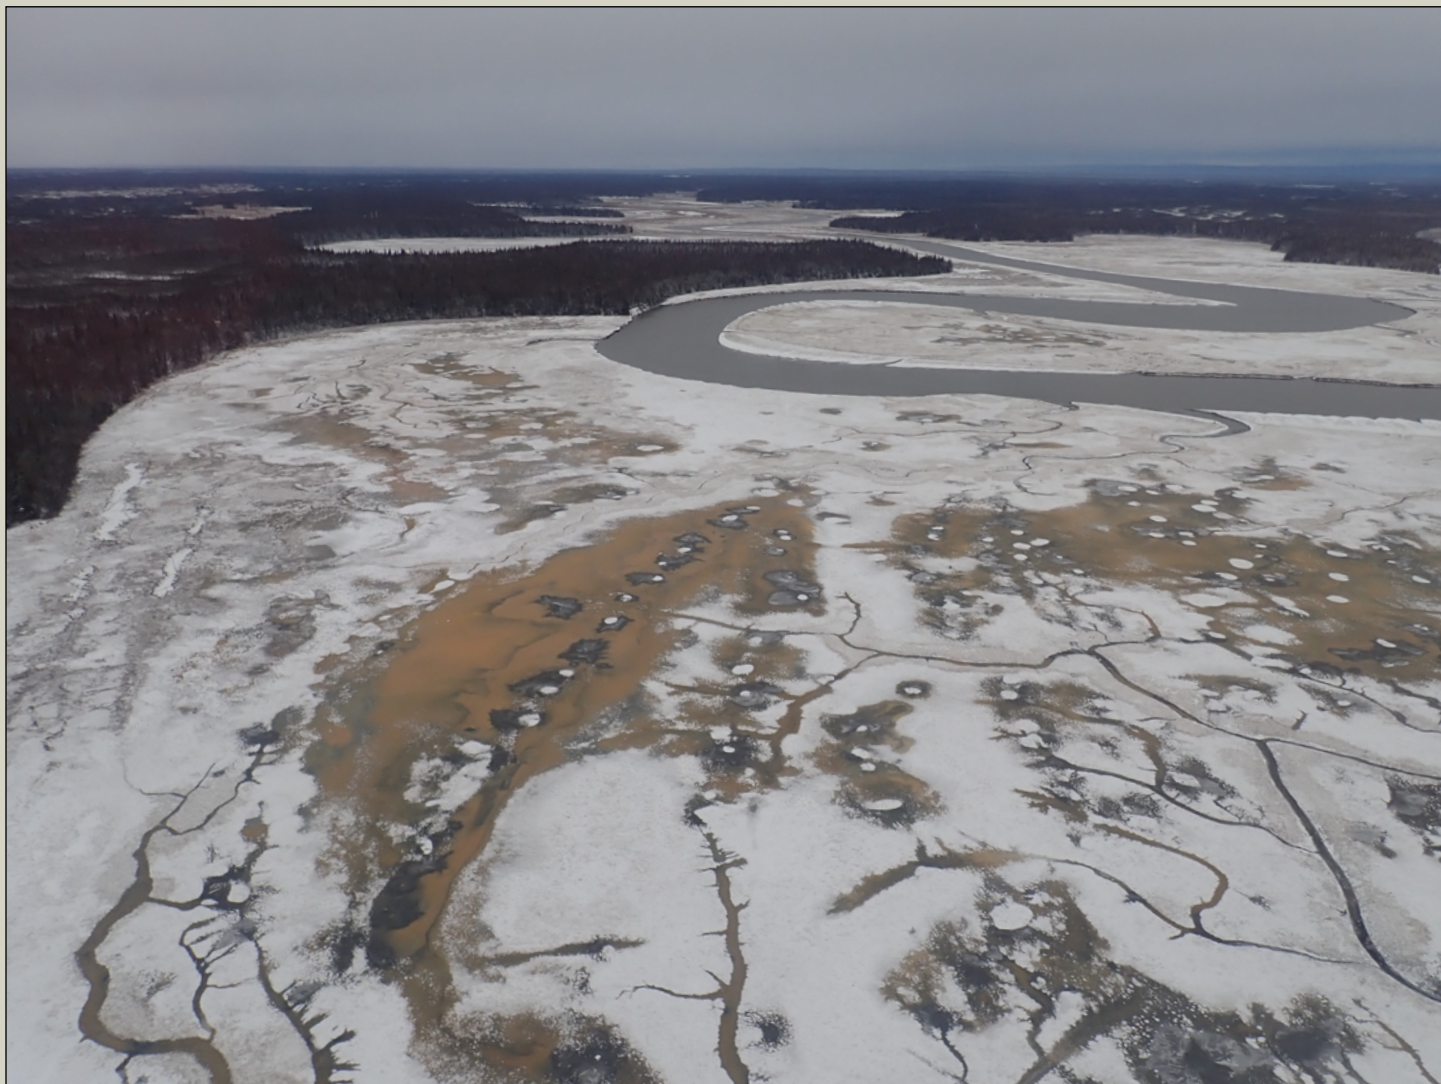
**Cover.** Photograph of a complex of sand boils along the mouth of the Little Susitna River, north of Anchorage, Alaska.
