# Characterization of the Bathymetry, Hydrodynamics, Water Quality, Infrastructure, and Channel Condition of the Old Erie Canal from DeWitt to its Junction with the Current Erie Canal in Verona, near Rome, New York, 2018–19

Open-File Report 2021–1125

U.S. Department of the Interior  
U.S. Geological Survey

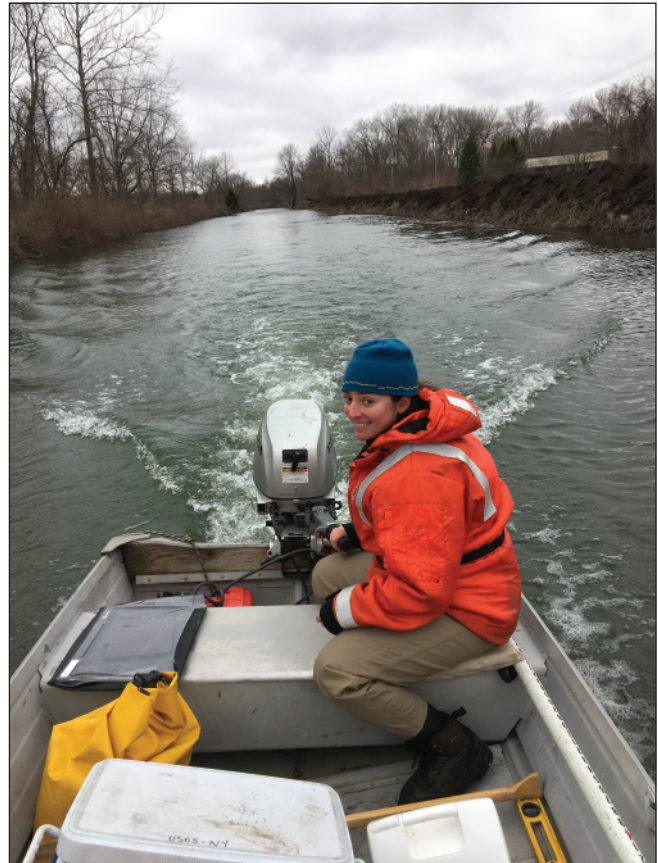
From DeWitt to Manlius Center Road, the channel is open and generally clear of trees or vegetation. Between Manlius Center Road and Kirkville Road there are a few downed trees, but navigation remained relatively easy. At the time of the survey (April 2018), a large beaver dam at Kirkville Road was obstructing the eastward flow. From Kirkville Road to Chittenango feeder, a few downed trees were also observed, but they were causing minimal disturbance to flow, and the channel was still open with navigation remaining relatively easy (fig. 19). From Chittenango feeder to Durhamville aqueduct, the number and size of trees increased,

**Figure 19.** Photograph of an open channel on the Old Erie Canal, easily navigable by boat, near the Chittenango aqueduct, New York.

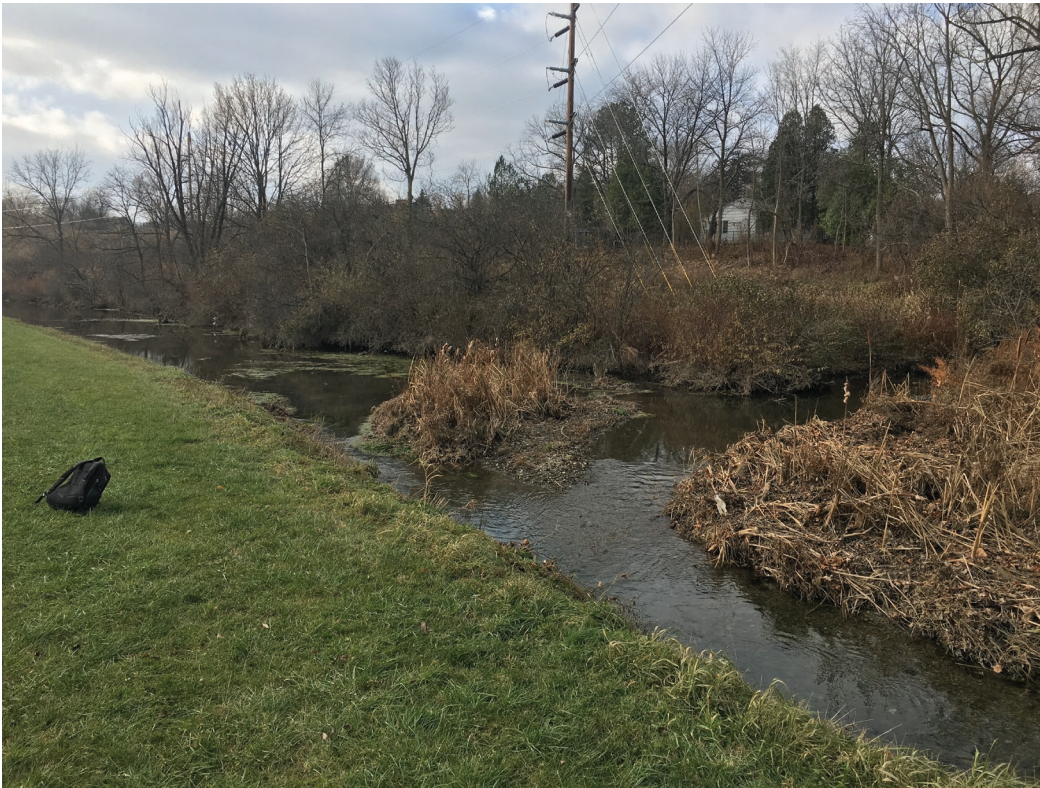
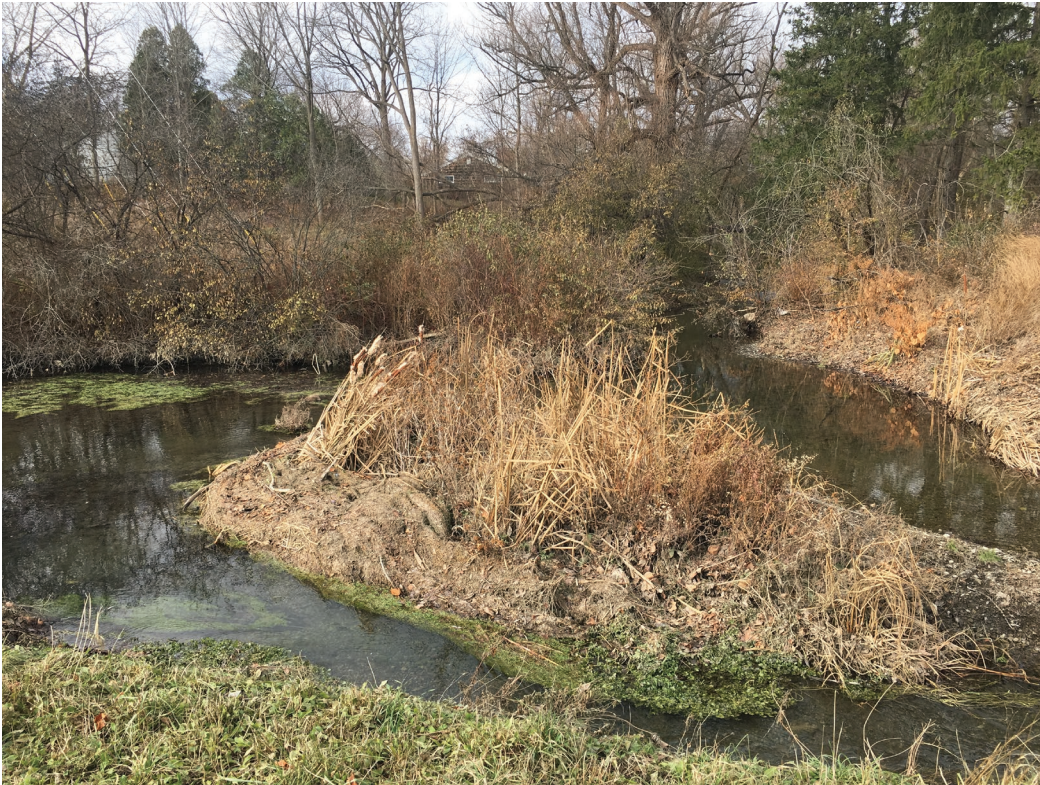
Butternut feeder ([fig. 3.2A](#)) currently receives no flow inputs from the sluice-gate openings, and yet flow visibly increased from zero flow at the sluice gate to a small stream by the time it passed under Andrews Road. The increase in flow likely is attributed to groundwater seepage into the feeder ([fig. 3.2B](#)). Evidence of flow overtopping the feeder levee walls during times of high flow in Butternut Creek was noted in two areas: a small area of backwater just to the west of the sluice gate, and a short distance downstream over the levee wall. Drift lines of leaves and debris in the feeder channel itself indicate that the water level can increase by several feet when it receives overbank flow from Butternut Creek over the levee walls. The feeder is narrow near the sluice gate ([figs. 3.2A](#), [3.2B](#), and [3.2C](#)) but widens downstream from Andrews Road ([figs. 3.2D](#) and [3.2E](#)). The feeder has been affected by sedimentation over time but is also open along its entire length except for an area of dense phragmites, an aggressive wetland grass, immediately downstream from Andrews Road ([fig. 3.2D](#)). Meadow Brook ([figs. 3.3A](#) and [3.3B](#)) is a natural stream that supplies additional unregulated flow through the Butternut feeder before it enters the canal through a culvert near DeWitt, N.Y.

**Figure 3.2.** Photographs of Butternut feeder. *A*, Butternut feeder immediately downstream from sluice gates; *B*, Butternut feeder upstream from Andrews Road showing groundwater contribution to flow; *C*, Butternut feeder viewed from Andrews road looking upstream; *D*, Butternut feeder viewed from Andrews Road looking downstream, with dense phragmites; and *E*, Butternut feeder upstream from Butternut culvert looking upstream.

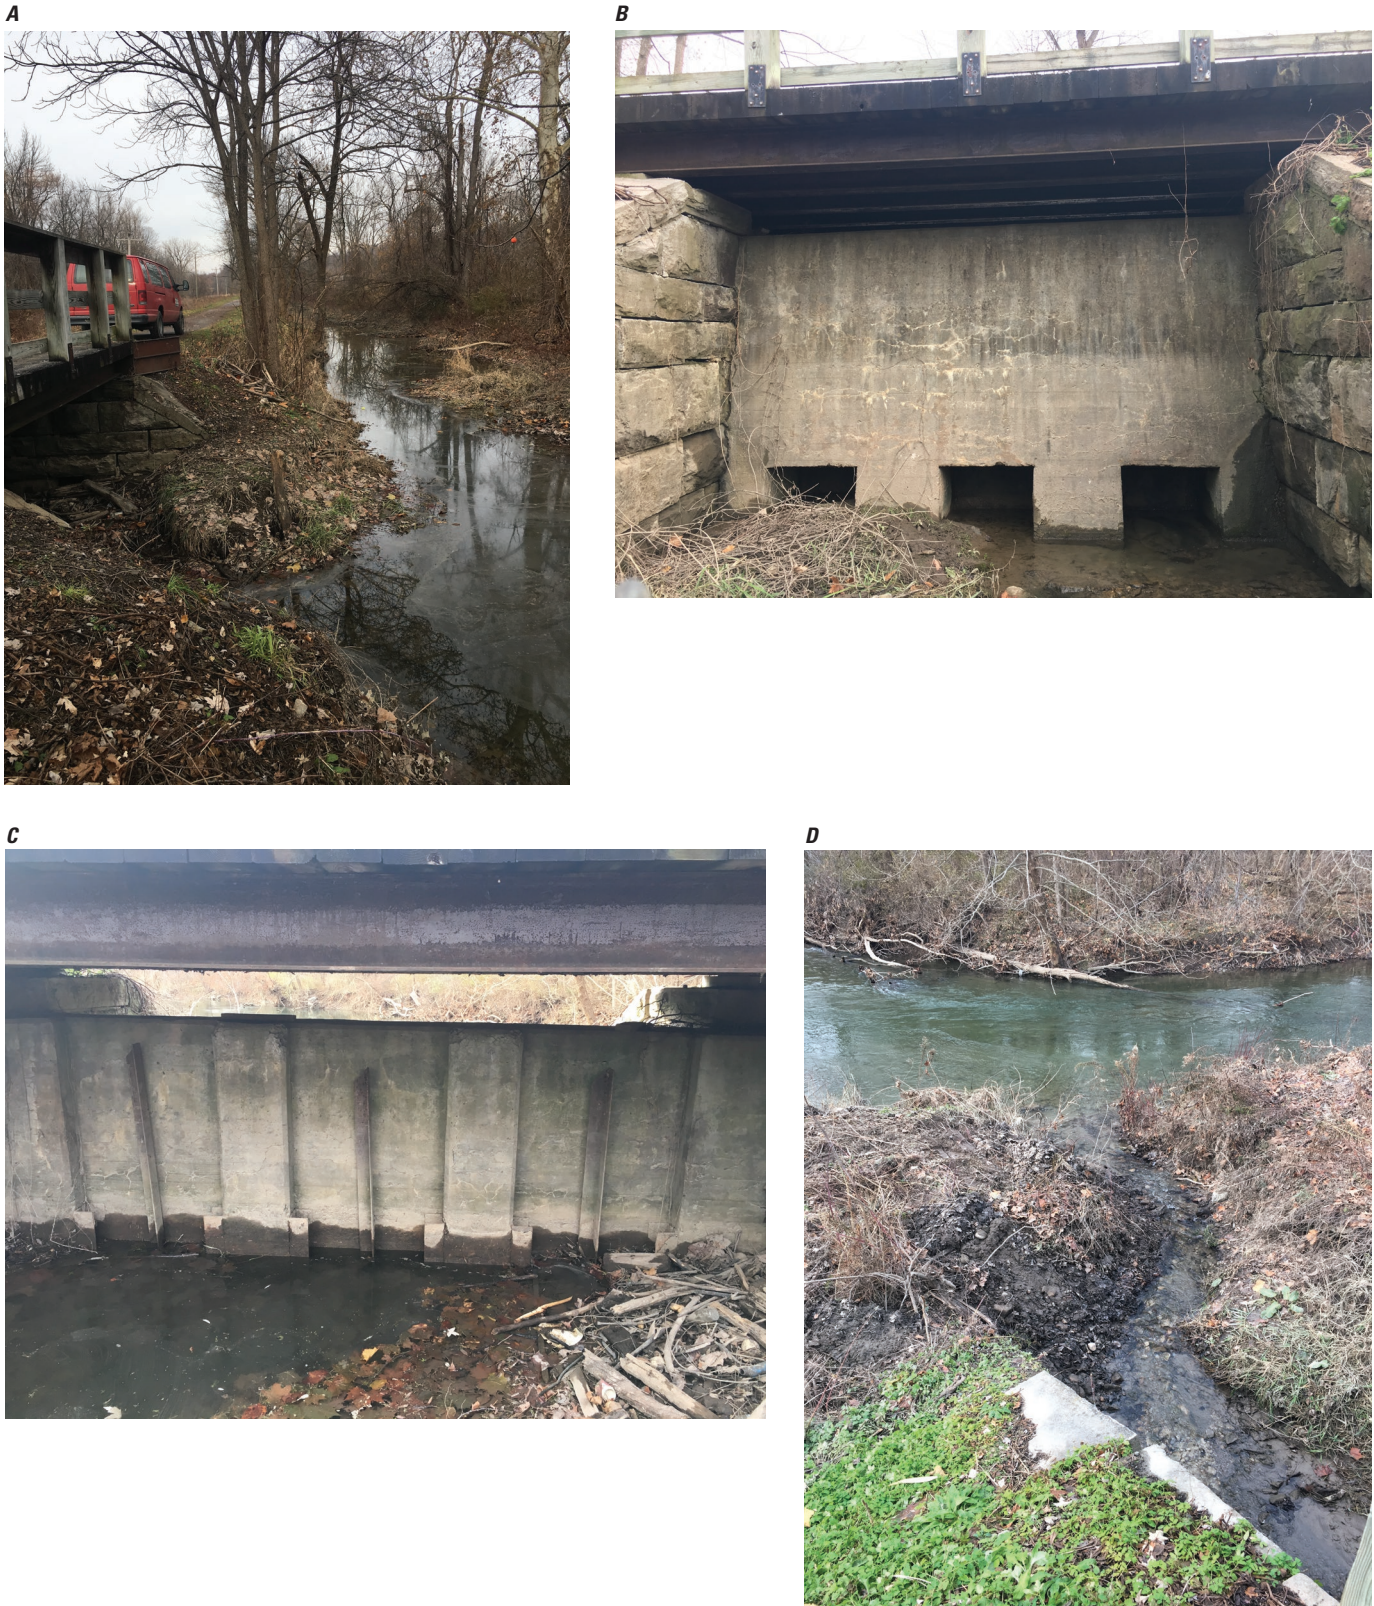
There is an unnamed control structure underneath the bridge located on Feeder Street which parallels Limestone feeder (fig. 4.3A) with three 2.5 by 2.5 ft concrete outfalls (fig. 4.3B) that are capable of discharging into Limestone Creek. The outfall gates are made of metal and recessed into the concrete with metal guides on either side (fig. 4.3C). Metal lifting bars to raise and lower the gates are rusted but in fair condition. Two of the three gates are closed; one of them has been raised 4.5–5.0 inches by debris that is stuck underneath it. At the time of inspection, water in the Limestone feeder was backwater from the canal with flow moving slowly upstream from the mouth of the feeder to the control structure, where it was discharged into Limestone Creek (fig. 4.3D) from the partially raised metal outfall gate.

**Figure 4.3.** Photographs of an unnamed flow control structure underneath the bridge on Feeder Street. *A*, Limestone feeder on right. Unnamed control structure underneath the bridge on Feeder Street on left; *B*, Western face of the unnamed control structure, facing towards Limestone Creek, with three outfall openings; *C*, Eastern face of the unnamed control structure, facing towards the Limestone feeder, with three outfall gates with lifting bars recessed into concrete structure with metal guides; and *D*, Water discharging from the Limestone feeder into Limestone Creek from the partially opened outfall gate.

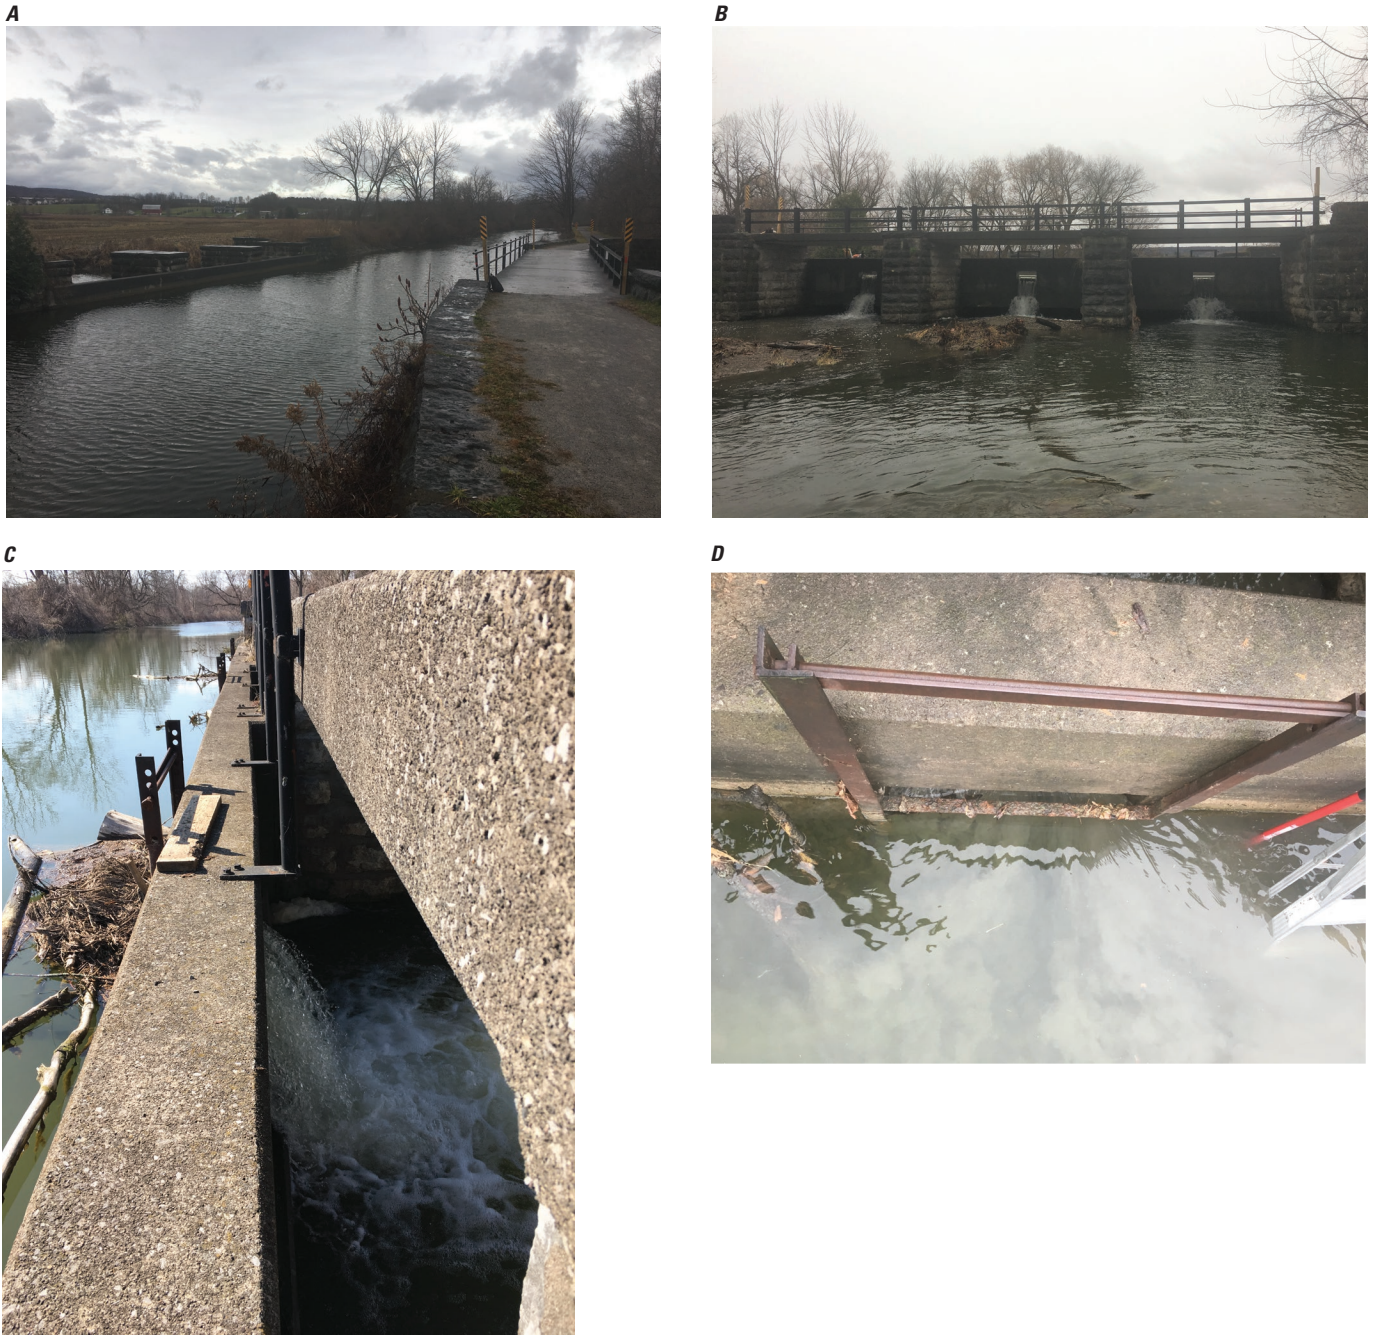
Chittenango aqueduct conveys water over Chittenango Creek in a 47-ft-wide channel (fig. 4.4A). The aqueduct itself is in fair condition and conveys water very well. Three concrete outfalls (fig. 4.4B) that average 3.0 ft wide and 4.0 ft high are located on the north side of the aqueduct and capable of discharging into Chittenango Creek (fig. 4.4C). The three outfalls are partially closed with a series of stacked flashboards in metal guides on either side, with metal lifting bars to raise and lower the flashboards (fig. 4.4D). The wood boards and metal infrastructure were found in good condition, and because they were partially open, allowed water to discharge into Chittenango Creek. Drift lines of leaves and debris on top of the aqueduct indicate that the water has flowed over the top of the aqueduct (426.47 ft elevation, NAVD 88). Tables 7 and 8 lists the dimensions for the individual outfall openings and their associated elevations. These dimensions include the elevations at the bottom of the openings; the point at which discharge would occur if no flashboards were in place; the elevations of the tops of the openings; and the elevations of the tops of the flashboards currently installed. These elevations are based on measurements from the top of the water surface at the time of inspection. The elevation of the water surface was determined using the closest installed staff gages with the appropriate offset (table 2).

**Figure 4.4.** Photographs of structures at Chittenago aqueduct. *A*, The wide channel at the Chittenago aqueduct conveys the flow of the canal over Chittenango Creek; *B*, Downstream view of the three outfall openings of Chittenago aqueduct discharging into Chittenango Creek; *C*, Outfall gate partially closed with flashboards. Flow is seen discharging into Chittenango Creek; and *D*, Outfall gate with metal lifting bar and metal guides viewed from the canal side.

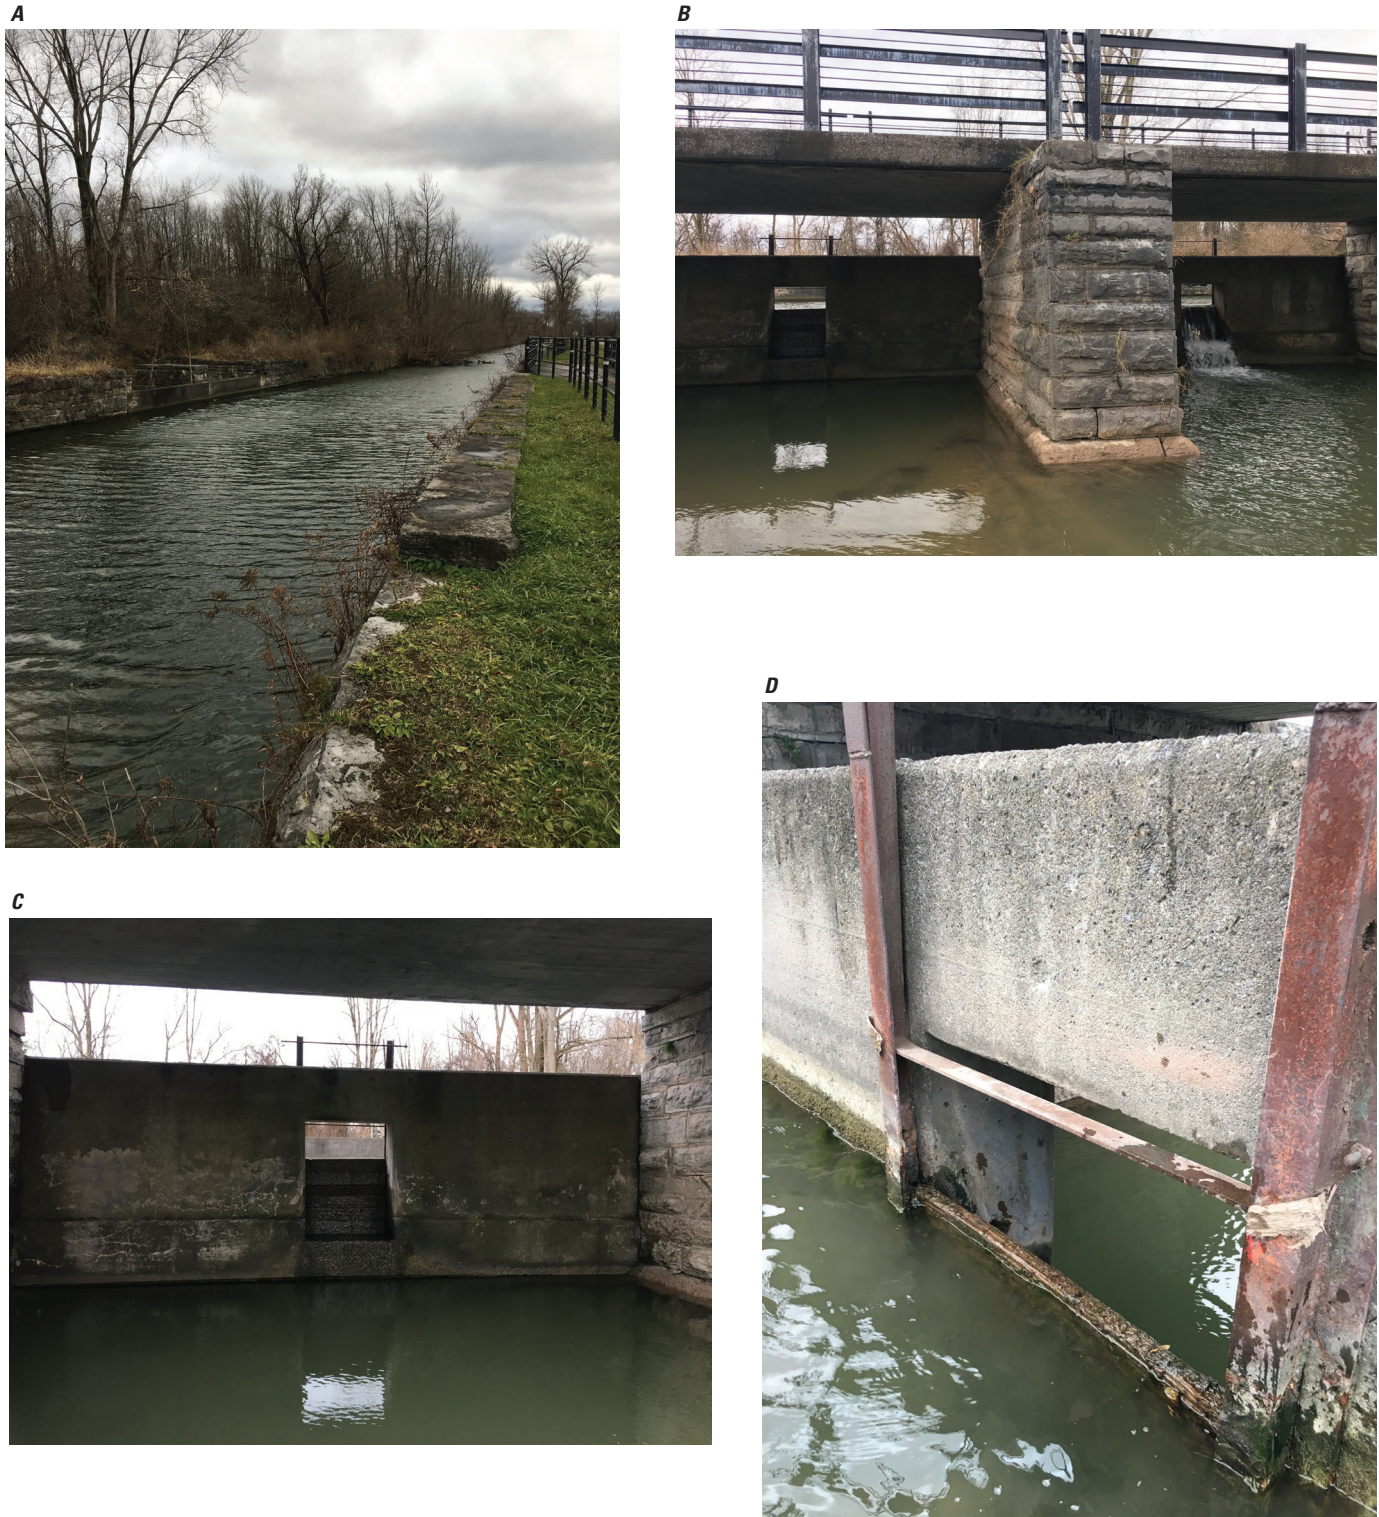
Cowaselon aqueduct conveys water over Cowaselon Creek in a 50-ft wide channel (fig. 4.5A). The aqueduct itself is in fair condition and conveys water very well. Two concrete outfalls that average 3.0 ft wide and 4.0 ft high are located on the north side of the aqueduct and capable of discharging into Cowaselon Creek (fig. 4.5B). The two outfalls are partially closed by a series of stacked flashboards (fig. 4.5C) with metal guides on either side and metal lifting bars to raise and lower them (fig. 4.5D). The wood boards and metal infrastructure were found in fair to poor condition, rusted and bent, but nonetheless functional. The outfalls were partially open with one discharging water into Cowaselon Creek and the other

**Figure 4.5.** Photographs of structures at Cowaselon aqueduct. *A*, The wide channel at the Cowaselon aqueduct conveys flow of the canal over Cowaselon Creek; *B*, Downstream view of the two outfall openings of the Cowaselon aqueduct. Outfall on right shows flow discharging into Cowaselon Creek; *C*, Downstream view of outfall gate with installed wood flashboards functioning to hold back canal water from discharging into Cowaselon Creek (foreground); and *D*, Outfall gate with metal lifting bar and metal guides viewed from the canal side.

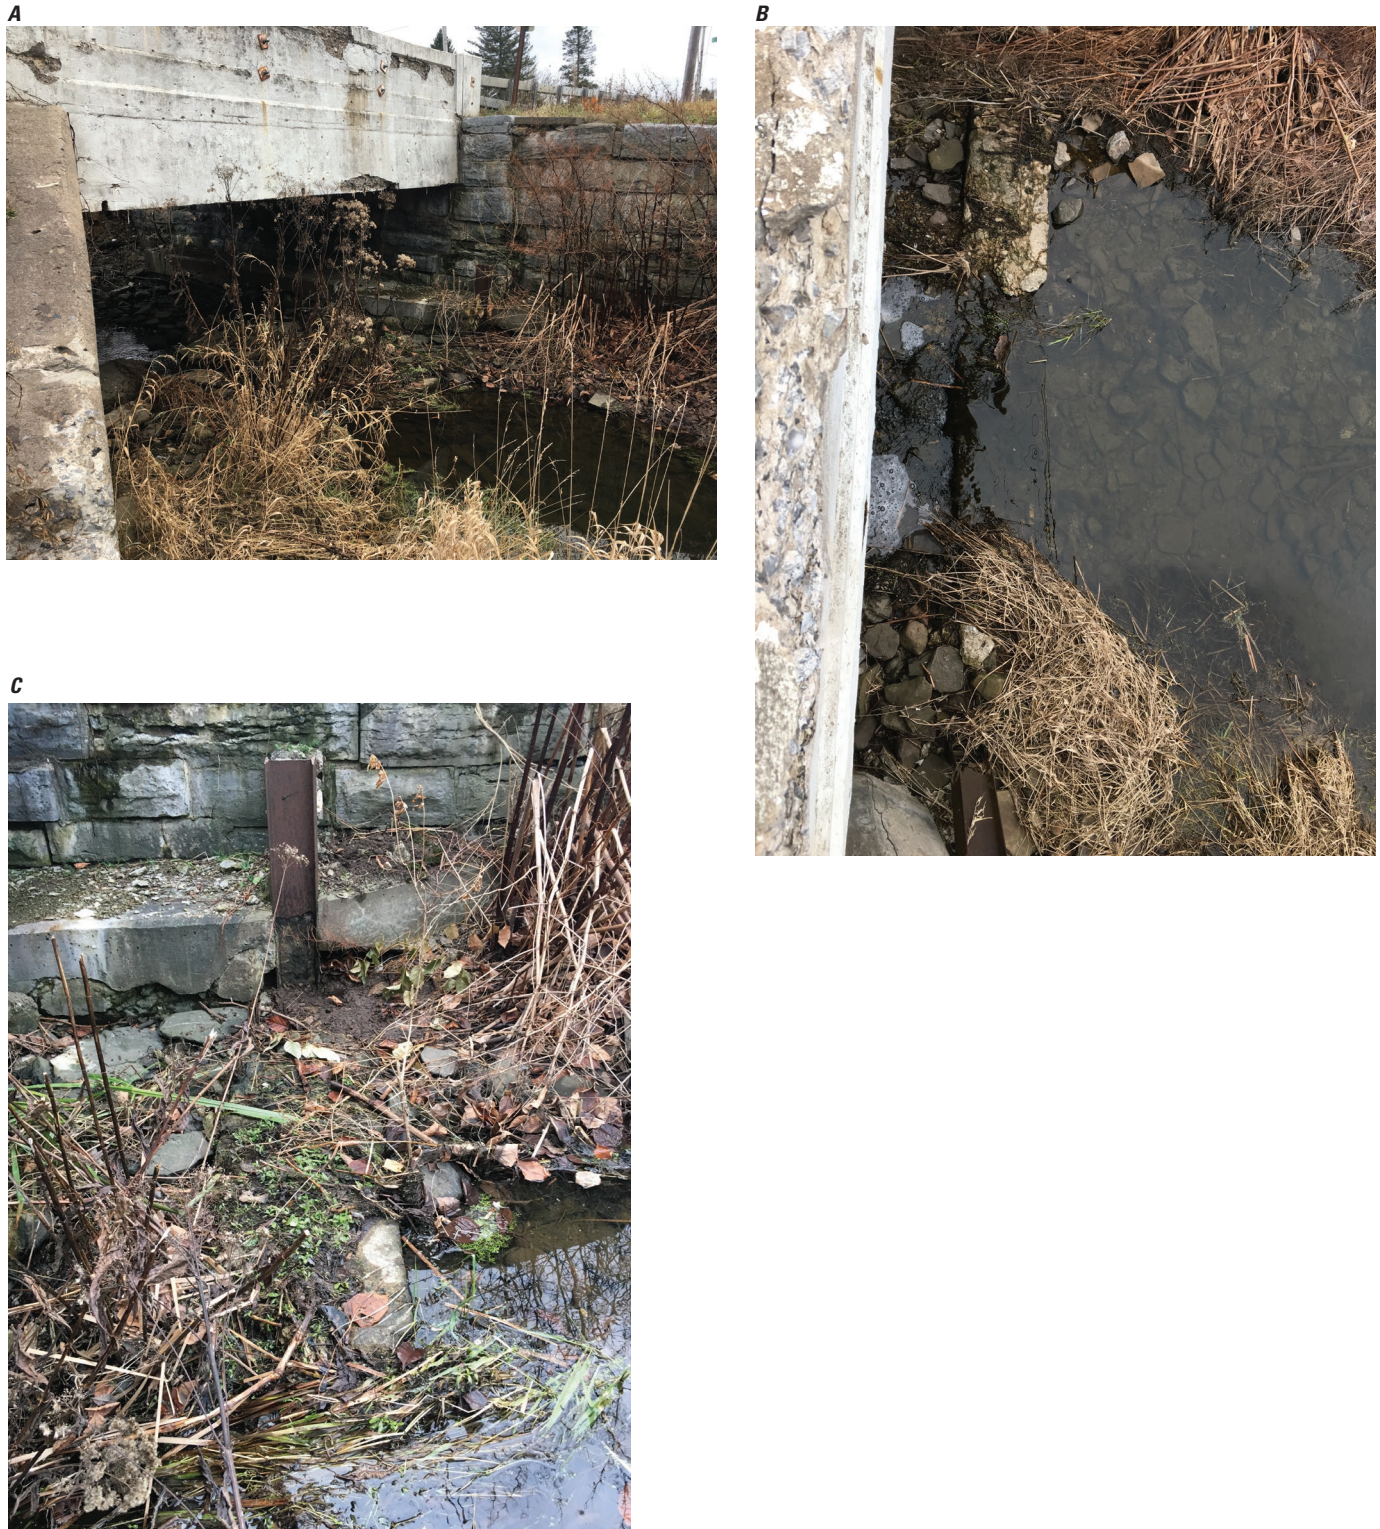
Large flashboards could potentially be installed to raise the water level in the canal upstream from the New London Road Bridge ([fig. 4.7A](#)). Remnants of a concrete base and two I-beams on which the flashboards could rest are visible but crumbling ([fig. 4.7B](#)). The I-beam on the south side of the

canal is intact and 3.4 ft high, whereas the northern I-beam is severely rusted and mostly deteriorated (fig. 4.7C). No flashboards were observed, and the water level in this most downstream reach of the canal was low.

**Figure 4.7.** Photographs of structures in the Old Erie Canal near New London Road bridge. *A*, Structure found underneath New London Road Bridge could potentially be used to raise the water level in the Old Erie Canal; *B*, Remnants of a concrete base pad underneath New London Road to support flashboards; and *C*, Steel I-beam designed to accept flashboards to raise water level in the canal upstream from New London Road bridge.

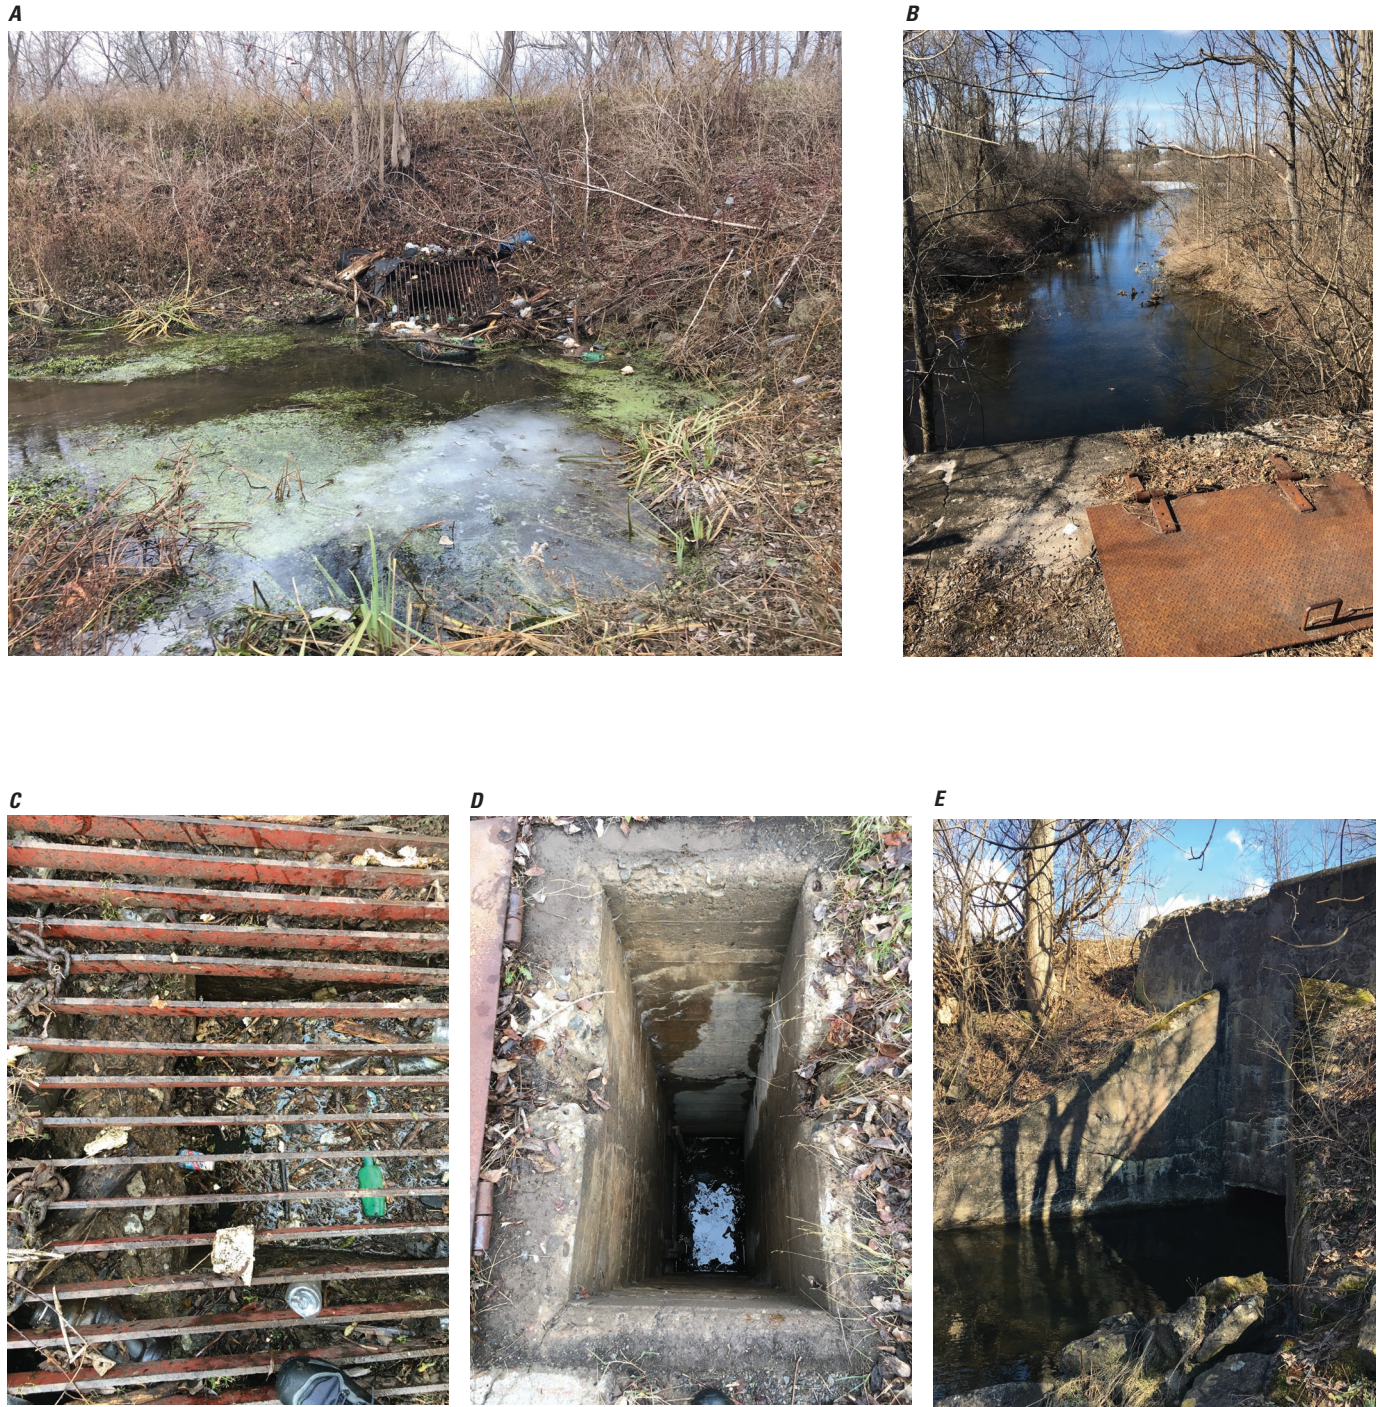
The New London sluice gate and culvert (fig. 4.8A) mark the end of the surveyed reach of the canal. The remaining flow of the Old Erie Canal discharges through these structures into the Erie Canal (fig. 4.8B). The sluice gate is set in a concrete outfall measuring 2.5 ft wide and 3.5 ft high with a metal grate to block debris from entering (fig. 4.8C). The grate was found clogged with tree and trash debris. An access port cover on top of the culvert near the towpath is functional; at the bottom of the port is a set of metal guides that can accept flashboards to prevent water from discharging into the Erie Canal (fig. 4.8D). The culvert was found open, except for debris on the gate, with flow discharging into the Erie Canal (fig. 4.8E).

**Figure 4.8.** Photographs of structures at the New London sluice gate/culvert where the Old Erie Canal enters the Erie Canal. *A*, New London sluice gate/culvert viewed from the Old Erie Canal side; *B*, All flow remaining in the Old Erie Canal enters the Erie Canal; *C*, Concrete outfall opening and metal screen viewed from the canal side; *D*, View from access panel. Metal guides at the bottom allow for installation of flashboards; and *E*, New London sluice gate/culvert exit where all remaining flow discharges into the Erie Canal.
