# The Alaska Earthquake

# Effects of the Earthquake Of March 27, 1964 At Anchorage, Alaska

*A description and analysis of the damage resulting from seismic vibration, ground cracks, and especially landslides in Alaska's largest city*

GEOLOGICAL SURVEY PROFESSIONAL PAPER 542-A

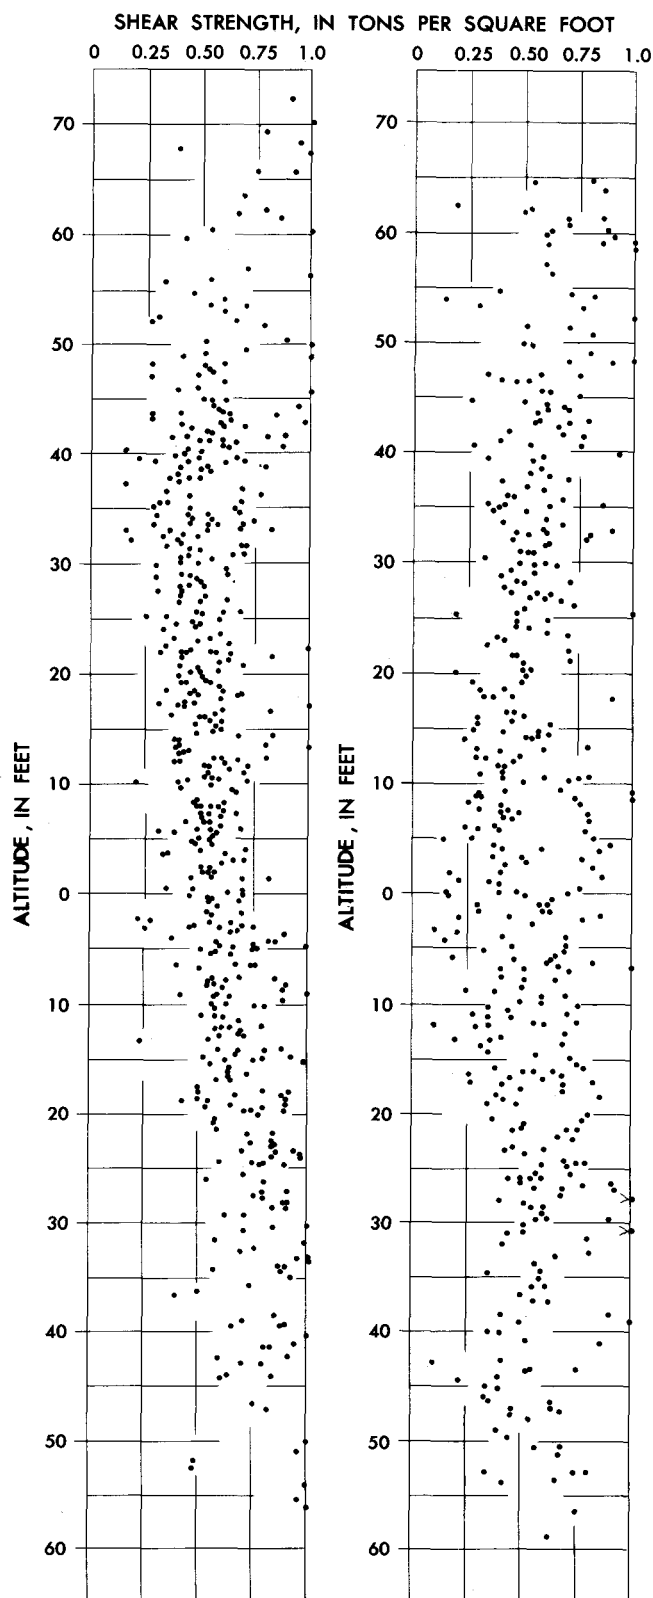
Shear strength was measured in torsional-vane-shear tests, undrained triaxial tests, consolidated-undrained triaxial tests, and consolidated-drained triaxial tests; strain, stress, volume change, and pore-water pressure were recorded throughout the tests (Shannon and Wilson, Inc., 1964, p. 28). The results of vane-shear tests for the Fourth Avenue and Turnagain Heights slide areas are shown in figure 8. Triaxial tests performed on the clay generally correlated well with the vane-shear tests within the ranges of strengths at which failure was prevalent. Tests correlated well in the range 0.4 to 0.5 tsf (tons per square foot), but for clays of higher strength, the triaxial tests generally yielded somewhat higher values than the vane tests. Most of the samples of clay from critical depths in the landslides had initial shear strengths between 0.2 and 0.7 tsf, and in this range the ratio of torsional-vane-shear-test results to triaxial-compression-test results is generally between 0.7 and 1.5 (Shannon and Wilson, Inc., 1964, p. B8). This ratio indicates a fairly good correlation between test methods. In any event, the vane-shear-test results shown by the graphs of figure 8 clearly demonstrate the generally lower shear strength of the clay at intermediate depths as compared with shallower and deeper layers.

8.—Summary of torsional-vane-shear strengths of selected borings, Bootlegger Cove Clay, from Fourth Avenue slide area (left) and Turnagain Heights slide area (right). Simplified from Shannon and Wilson, Inc. (1964, pl. B15).

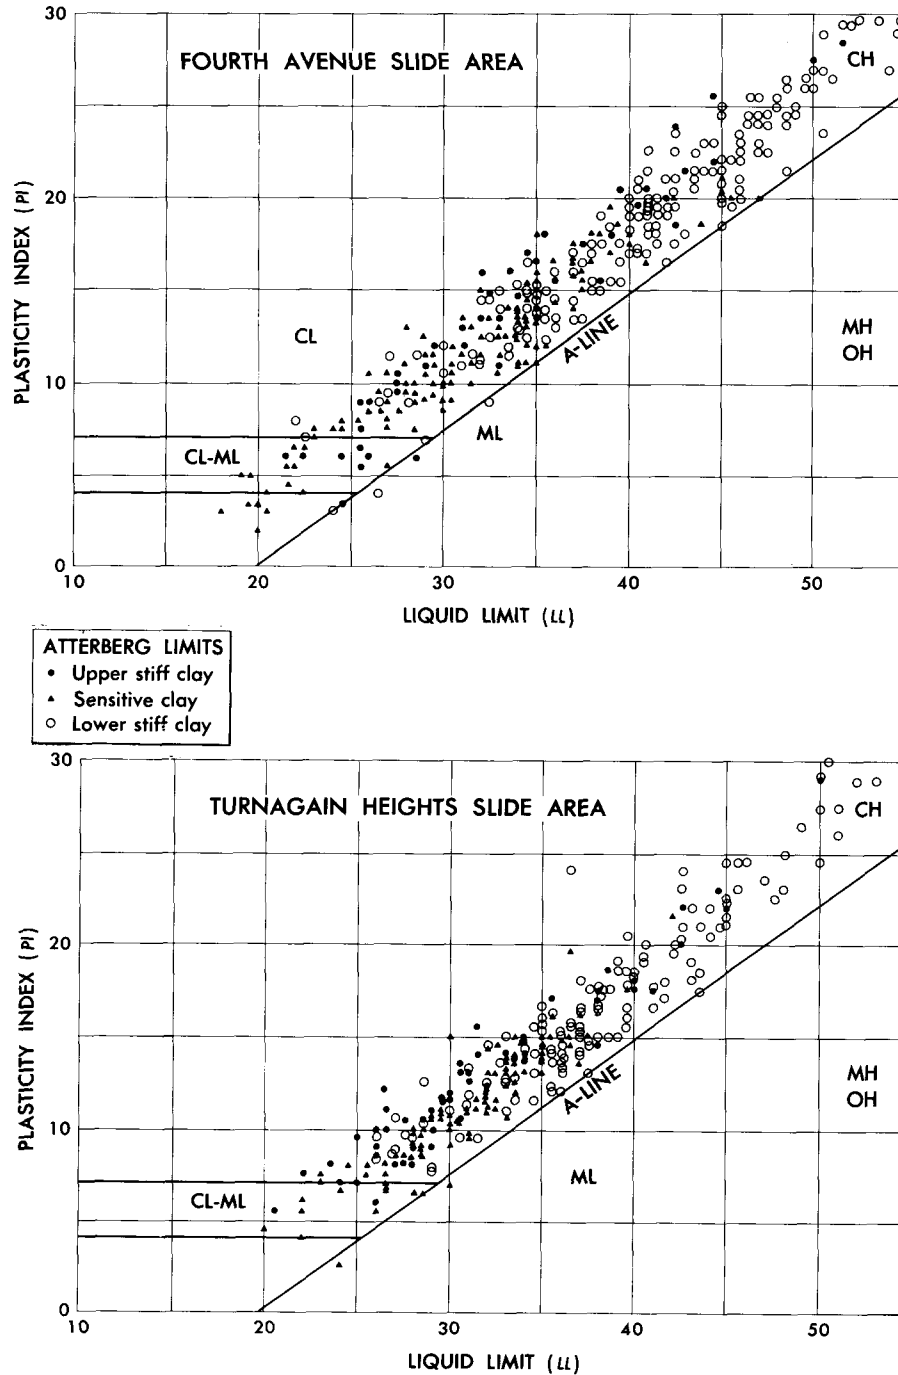
The plasticity charts (fig. 9) show the statistical relationship of liquid limit to plasticity index of the Bootlegger Cove Clay in the Fourth Avenue and Turnagain Heights slide areas, as measured for the Corps of Engineers by

9.—Plasticity charts from selected borings, Bootlegger Cove Clay, Fourth Avenue and Turnagain Heights slide area. Reprinted from Shannon and Wilson, Inc. (1964, pl. B16). CL, inorganic clay of low to medium plasticity; ML, inorganic silts and very fine sand; CH, inorganic clay of high plasticity; MH, inorganic silt; OH, organic clay.

Shannon and Wilson, Inc. (1964). These charts show generally higher plasticity indices and liquid limits for the lower stiff clay than for the upper stiff clay or the sen-

bution curves (fig. 10). Nearly all points plotted on the plasticity charts lie above the "A" line—the line which separates soils of high cohesion and low permeability above from soils of low cohesion and high permeability below (Casagrande, 1947, p. 801).

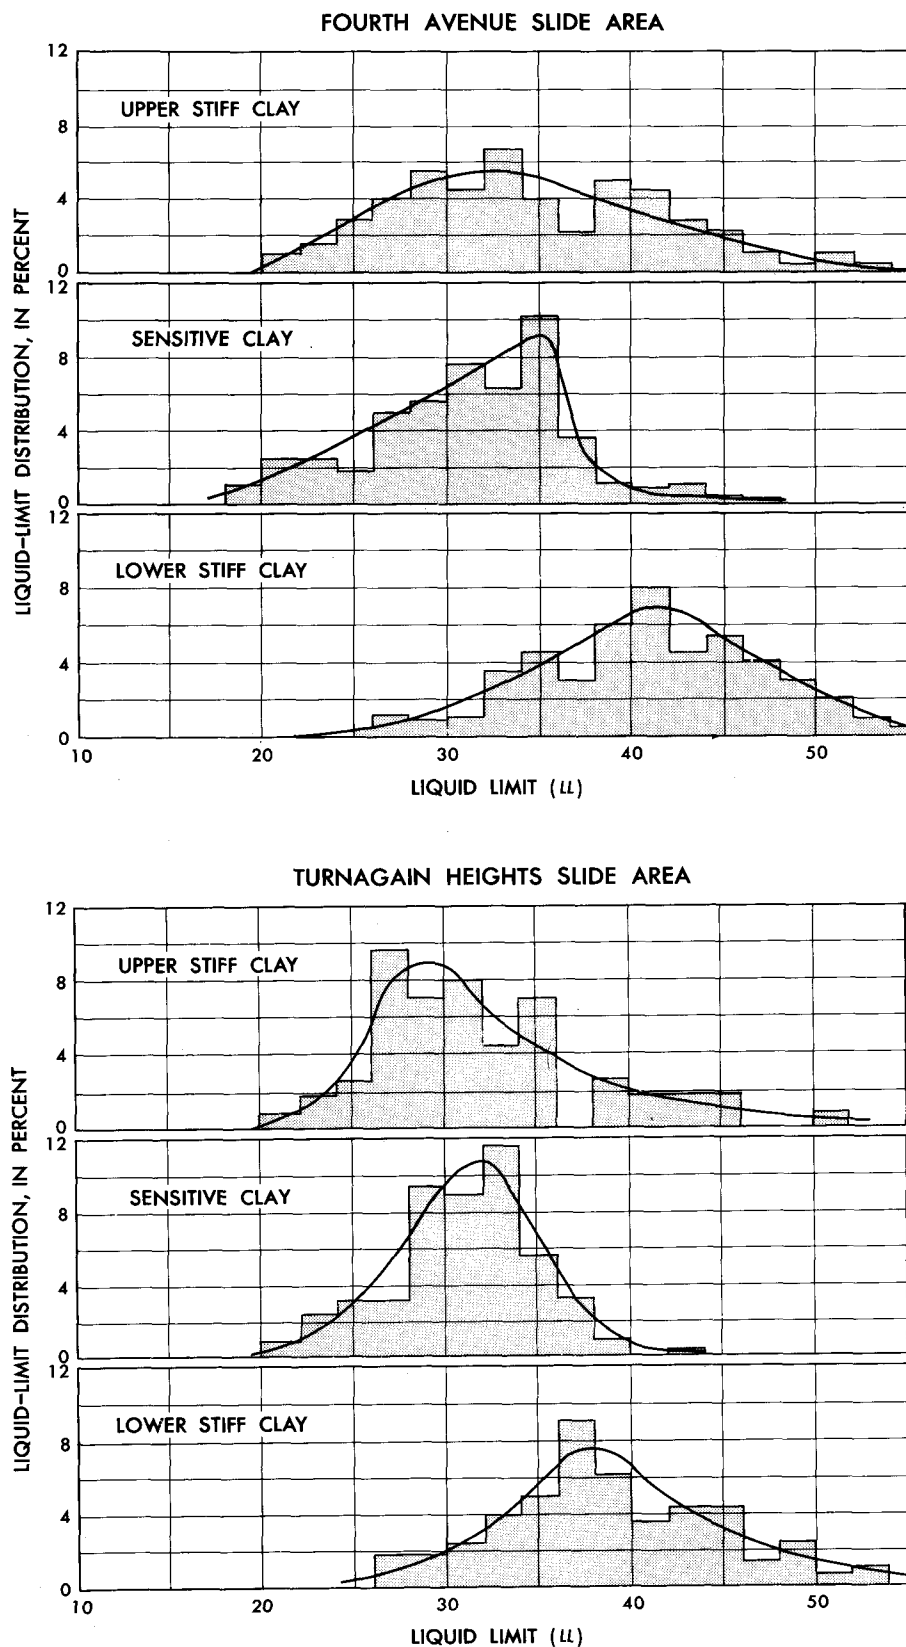
The statistical liquid-limit distribution curves (fig. 10) show the distinctions between the three zones of the Bootlegger Cove Clay in the Fourth Avenue and Turnagain Heights areas. These curves bring out the differences between the upper stiff zone and the sensitive zone, and also the higher liquid limit of the lower stiff zone. The statistical relationship of sensitivity to liquid limit is shown by figure 11. In general, about 80 percent of the soil samples tested had liquid limits within the range of 22 to 48 percent, regardless of their vertical position in the formation. About 80 percent of the liquid limits of the sensitive clay range from 22 to 38 percent, and about 80 percent from the lower stiff clay range from 32 to 50 percent. As sensitivity increases, the upper limit of the liquid limit decreases. Most clay samples of sensitivities greater than 10 had liquid limits in the range of 20 to 40 percent, and no sensitive-clay sample had a liquid limit above 45 percent. For sensitivities greater than 40, the range of liquid limits was only 22 to 28 percent (Shannon and Wilson, Inc., 1964, p. B11). Several samples analyzed had a natural-water content greater than their liquid limits.

10.—Statistical liquid-limit distribution curves from selected borings, Bootlegger Cove Clay. Reprinted from Shannon and Wilson, Inc. (1964, pl. B16).

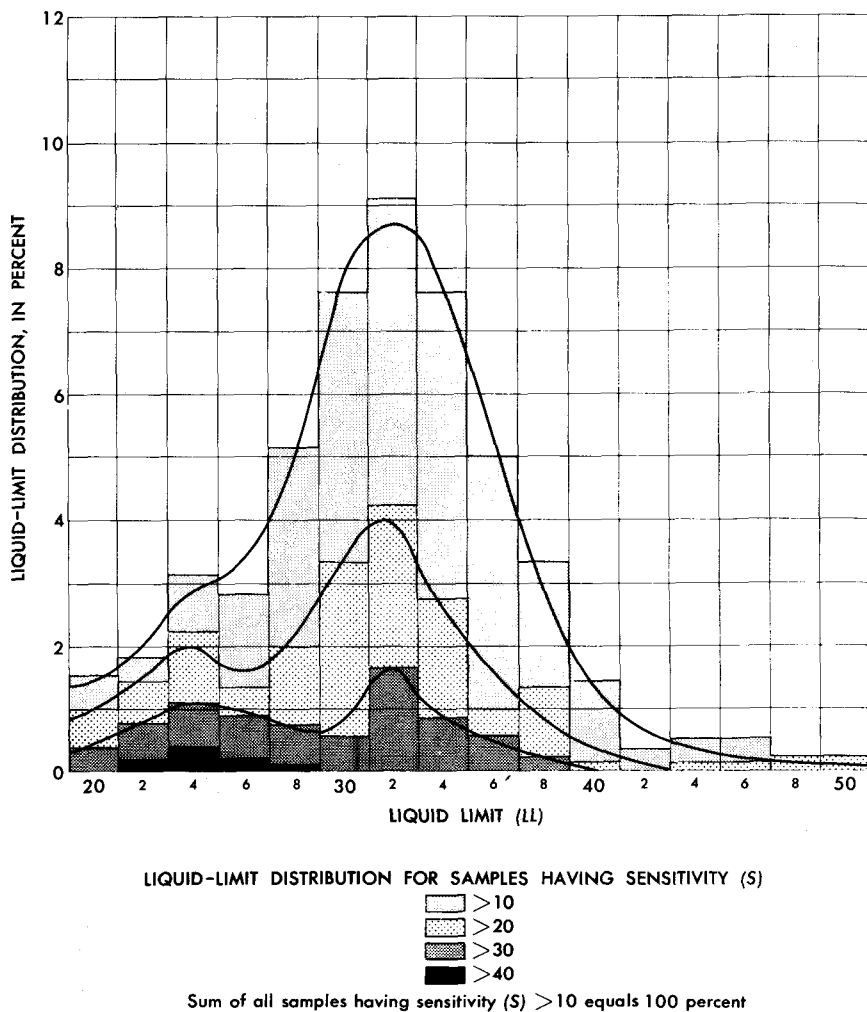
11.—Liquid-limit sensitivity distribution curves, Bootlegger Cove Clay. Reprinted from Shannon and Wilson, Inc. (1965, pl. B17).

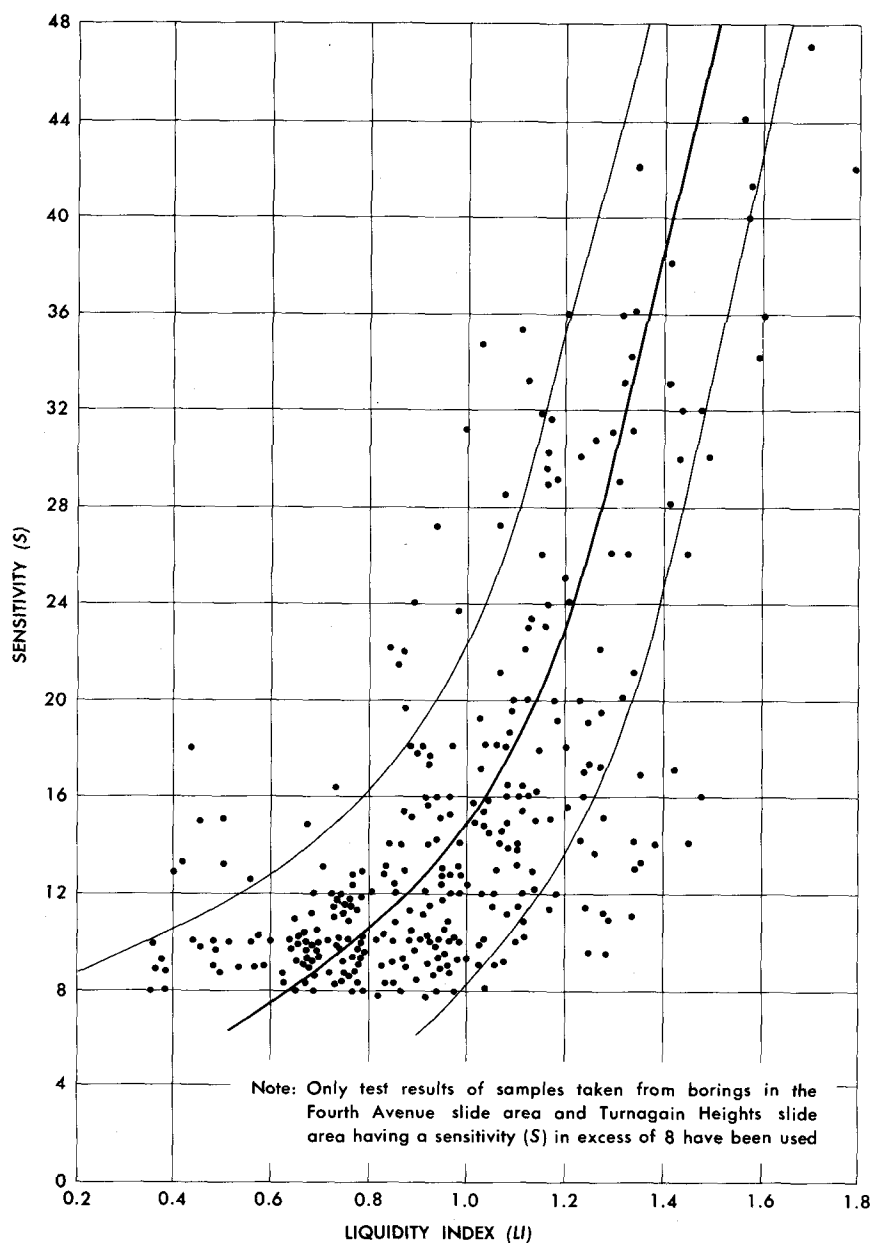
the liquid limit minus the plastic limit; that is  $(W_n - PL)/(LL - PL)$ . For the Bootlegger Cove Clay, it was found that in most soils having a water-plasticity ratio greater than 1.0 the liquid limit ranged from 20 to 40 percent, and in soils having a water-plasticity ratio greater than 2.0 the liquid limit lay in the range 19 to 27 percent. A direct correlation also was found between sensitivity and the water-plasticity ratio (Shannon and Wilson, Inc., 1964, p. B11, pl. B17; see fig. 12, next page). Thus in the Bootlegger Cove Clay a high water-plasticity ratio is related to low shear strength, high

sensitivity, and high susceptibility to failure.

12.—Relation between sensitivity and liquidity index (water-plasticity ratio), Bootlegger Cove Clay. Reprinted from Shannon and Wilson, Inc. (1964, pl. B17).

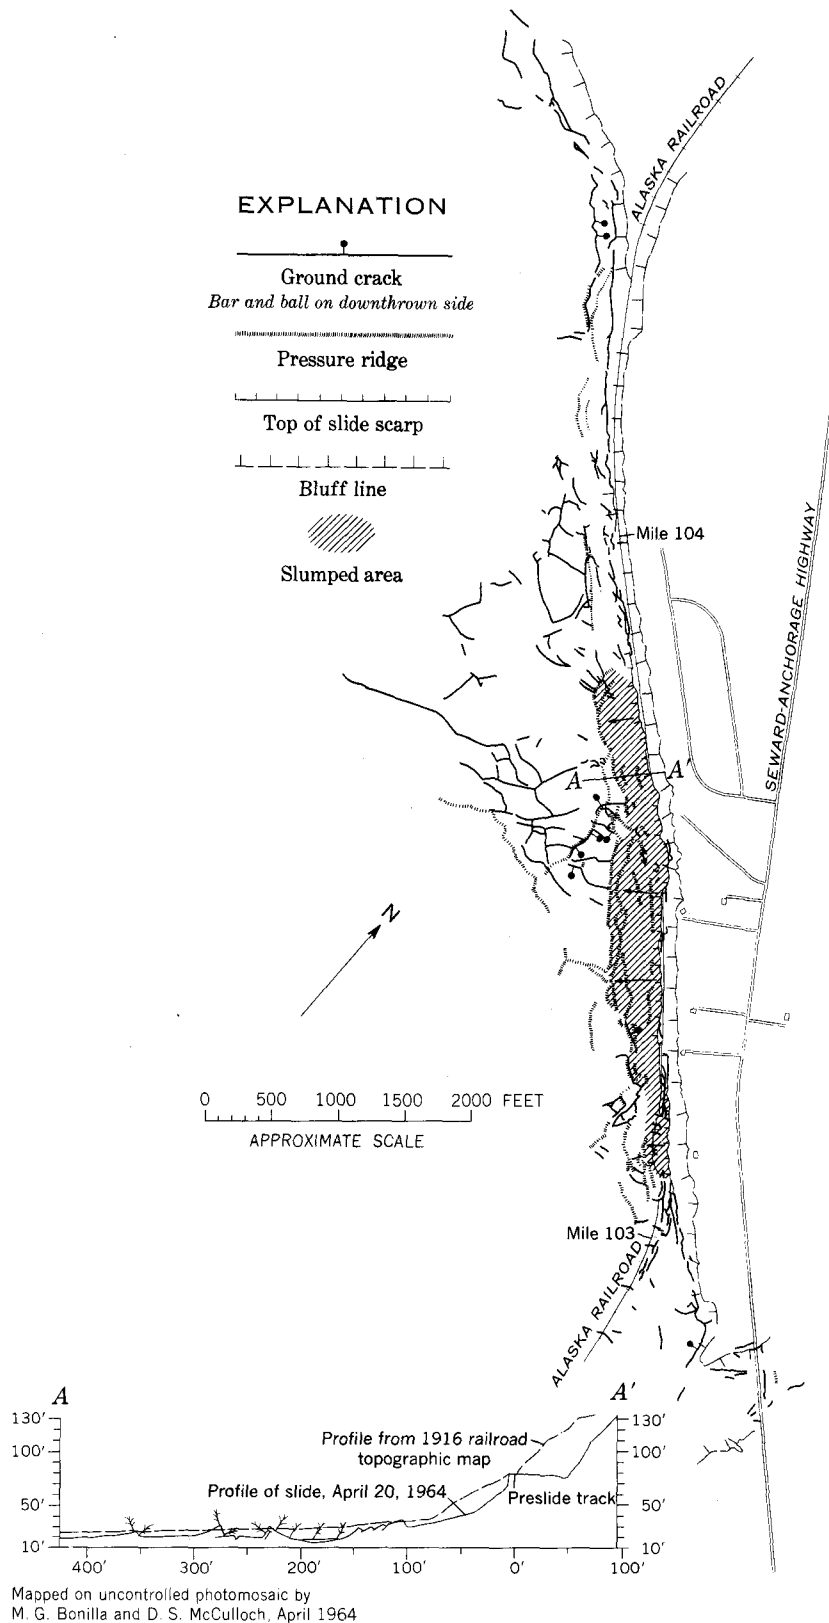
17.—Map and profile of Potter Hill landslide area near Anchorage, Alaska.

sisted of elongate fragmented slump blocks rotated backward and broken into many pieces toward the base of the slope. In places at the toe, they turned into earth and mudflows derived partly from the intertidal silt of Turnagain Arm and partly, perhaps, from the clay-silt-sand sequence in the lower part of the bluff.

Marginal fractures bounded the slides roughly parallel to the face of the bluff. They cut across natural bank material and fill alike as high as the level of the tracks, in the roadbed itself, and in the drainage ditch beside the tracks. Near Rabbit Creek, where the tracks turn southward across the flats, cracks reached nearly to the top of the bluff. At one point they extended as far back as 400 feet from the edge of the bluff. Sand that was ejected from these cracks during the quake spread out onto the surface of the snow. But in general, cracking was confined to the face of the bluff itself.

The mechanics of sliding has been investigated by D. S. McCulloch and M. G. Bonilla (written commun., 1964). They concluded that sliding was initiated by failure and flowage of material from the base of the slope. Higher parts of the slope slumped and disintegrated as a consequence. Flowage may have occurred in the modern estuarine silt at the base

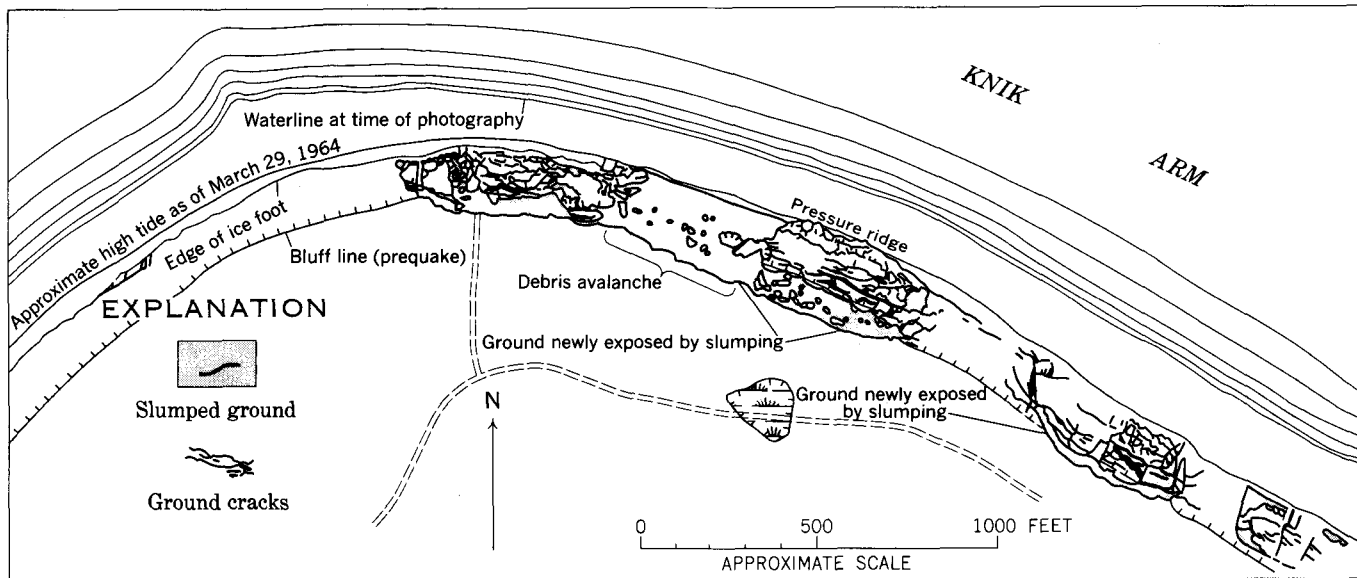
18.—Photogeologic sketch map of Point Woronzof landslide area, Alaska.

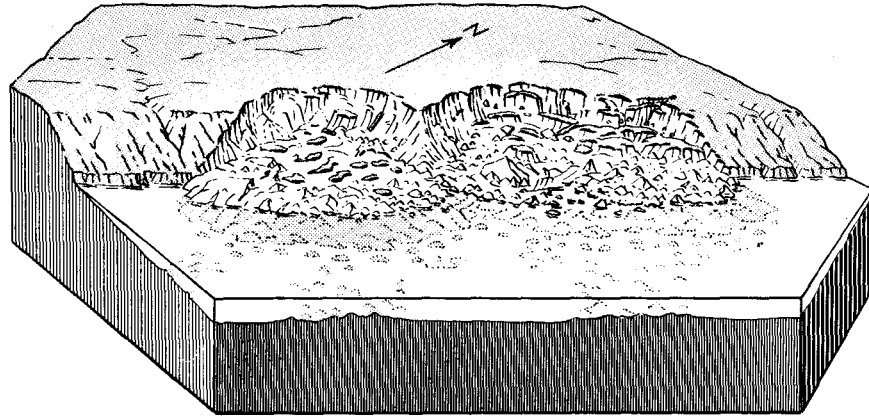
Detailed land measurements have not been made of either slide. Estimates based on air and ground reconnaissance and on photographs indicate that the larger slide was about 700 feet wide along the bluff line. It worked headward about 200 feet into the bluff, and it surged out perhaps 500 feet onto the mudflat for a total length of at least 700 feet from crown to

20.—Block diagram of compound slump near Sleeper landing strip. Two lobes of slide surged out onto mudflat below high tide.

toe. It was a compound slide in that it extended back into the bluff in two large joined arcuate alcoves (fig. 20). The slide was complex in that the slumped mass broke into several slices below the crown and into countless jumbled blocks toward the foot, where it passed into an earthflow. Its main scarp had a pronounced concave-outward profile and a maximum height of about 80 feet from the crown to the jumbled blocks below.

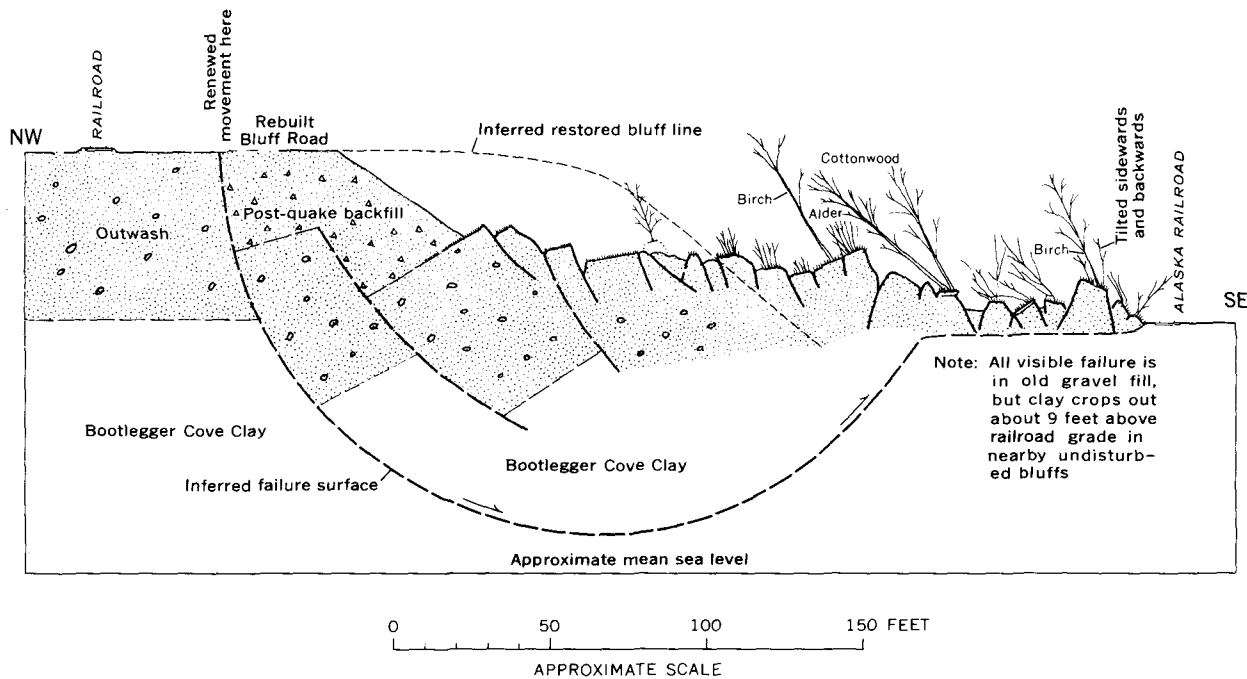
into the bluff as much as 120 feet. An additional 400 feet of bluff line east and west of the main slide mass cracked and began to slump. Altogether, about 650 feet of Bluff Road was destroyed, dropping as much as 40 feet below the prequake gradeline and rotating backward  $15^{\circ}$  to  $30^{\circ}$ .

22.—Sketch section through rotational slide at Bluff Road.

All four slumps were modified by multiple cracking, internal breakup, and flowage. None moved as a simple block. Within each slump, slices rotated on individual slip surfaces, their motions modified by interference or shoving of one slice against another. There was evidence, moreover, of flowage beneath each slump, as well as of extrusion of material at the toe.

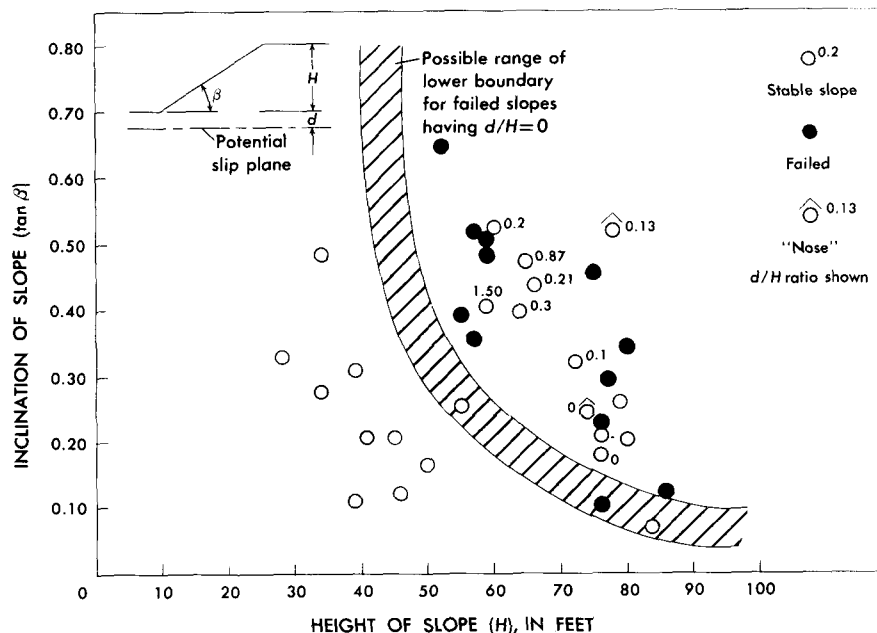
23.—Slope stability chart. Reprinted from Shannon and Wilson, Inc. (1964, pl. 7.1).

slope-to-height ratios within the same area of the chart as slopes that failed seems to point up the modifying influences of other factors such as soil-strength profile and water content. A low slope underlain by soil having a high water-plasticity ratio, for example, may be more susceptible to failure—may have a lower safety factor—than a high slope underlain by soil having a low water-plasticity ratio. In a unit of time, other factors being equal, a salient should drain and desiccate more rapidly than a recess; hence it should be more stable.

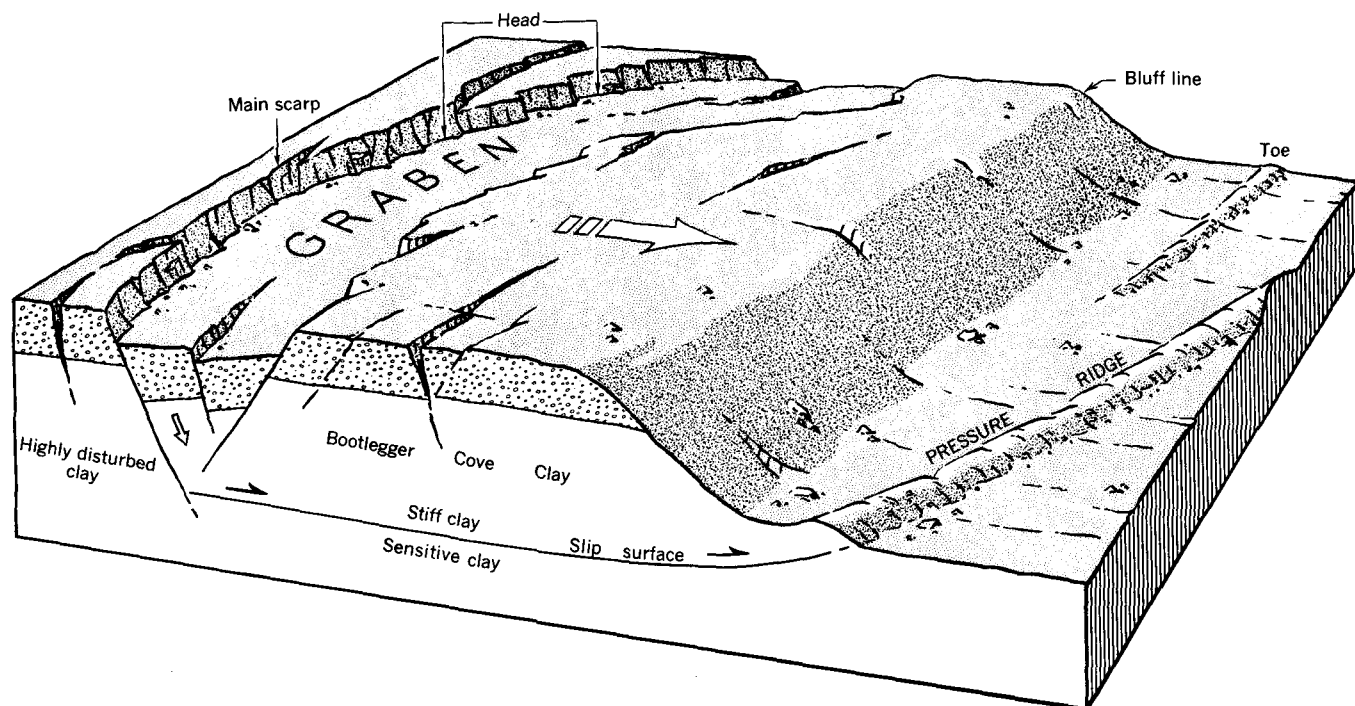
24.—Block diagram of a translatory slide.

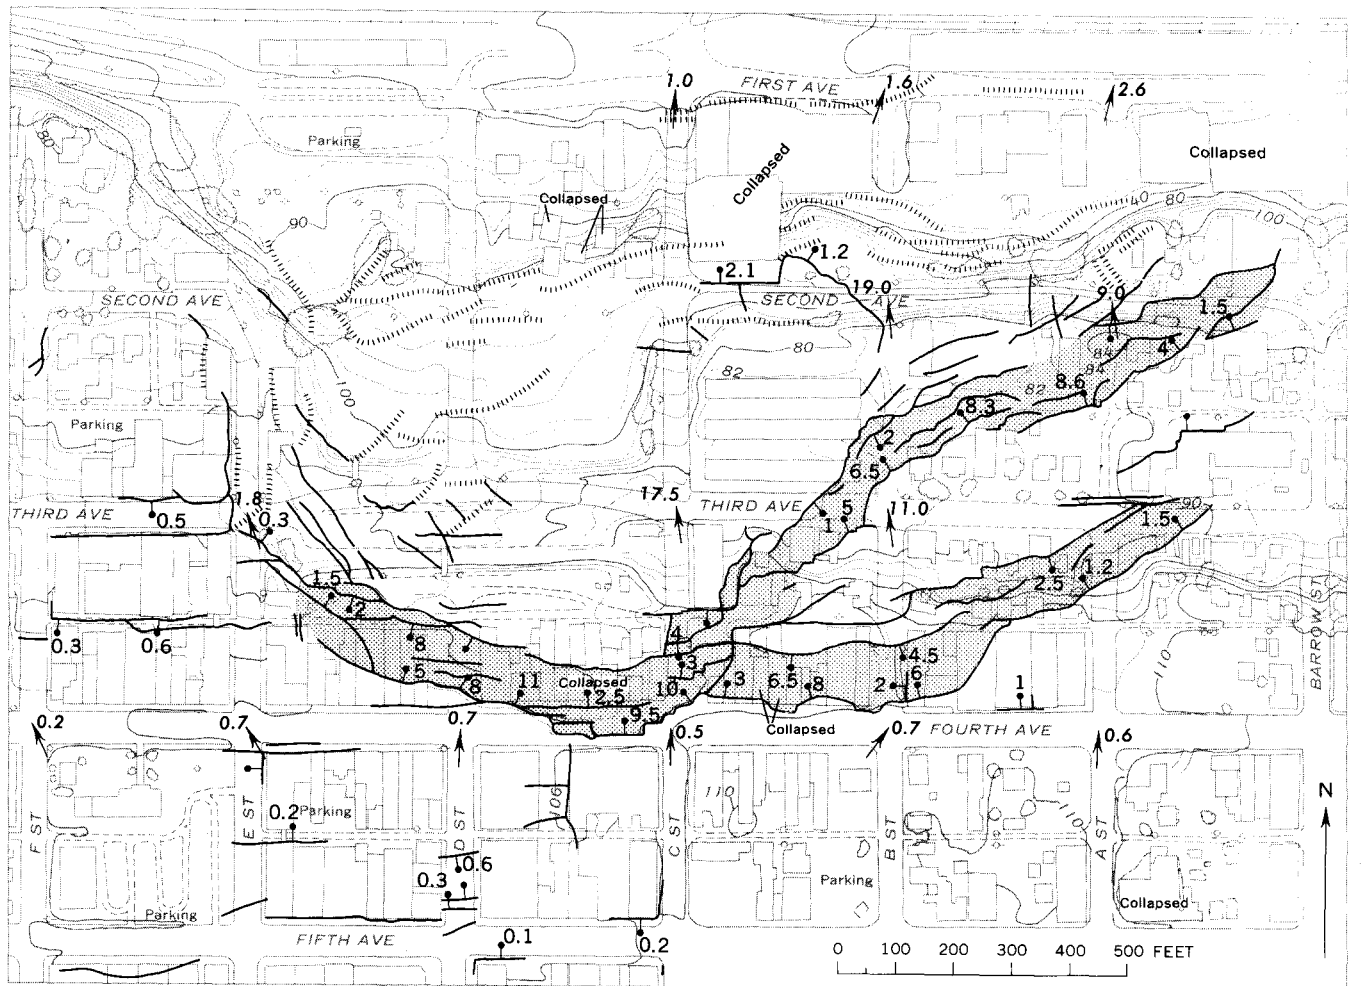
The Fourth Avenue slide involved all or parts of 14 city blocks in a roughly oval area of about 36 acres, containing perhaps 2 million cubic yards of earth, centered at the north side of downtown Anchorage (fig. 25). It was bounded headward on the south by Fourth Avenue, on the west by E Street, on the north approximately by First Avenue, and on the east somewhat indefinitely by Barrow Street. Its length north to south in the direction of slippage was about 1,050 feet; east to west it was about 1,800 feet across. Strong fracturing and related ground displacements extended  $1\frac{1}{2}$  blocks (about 450 feet) or so south of the slide proper, where considerable damage was inflicted on buildings,

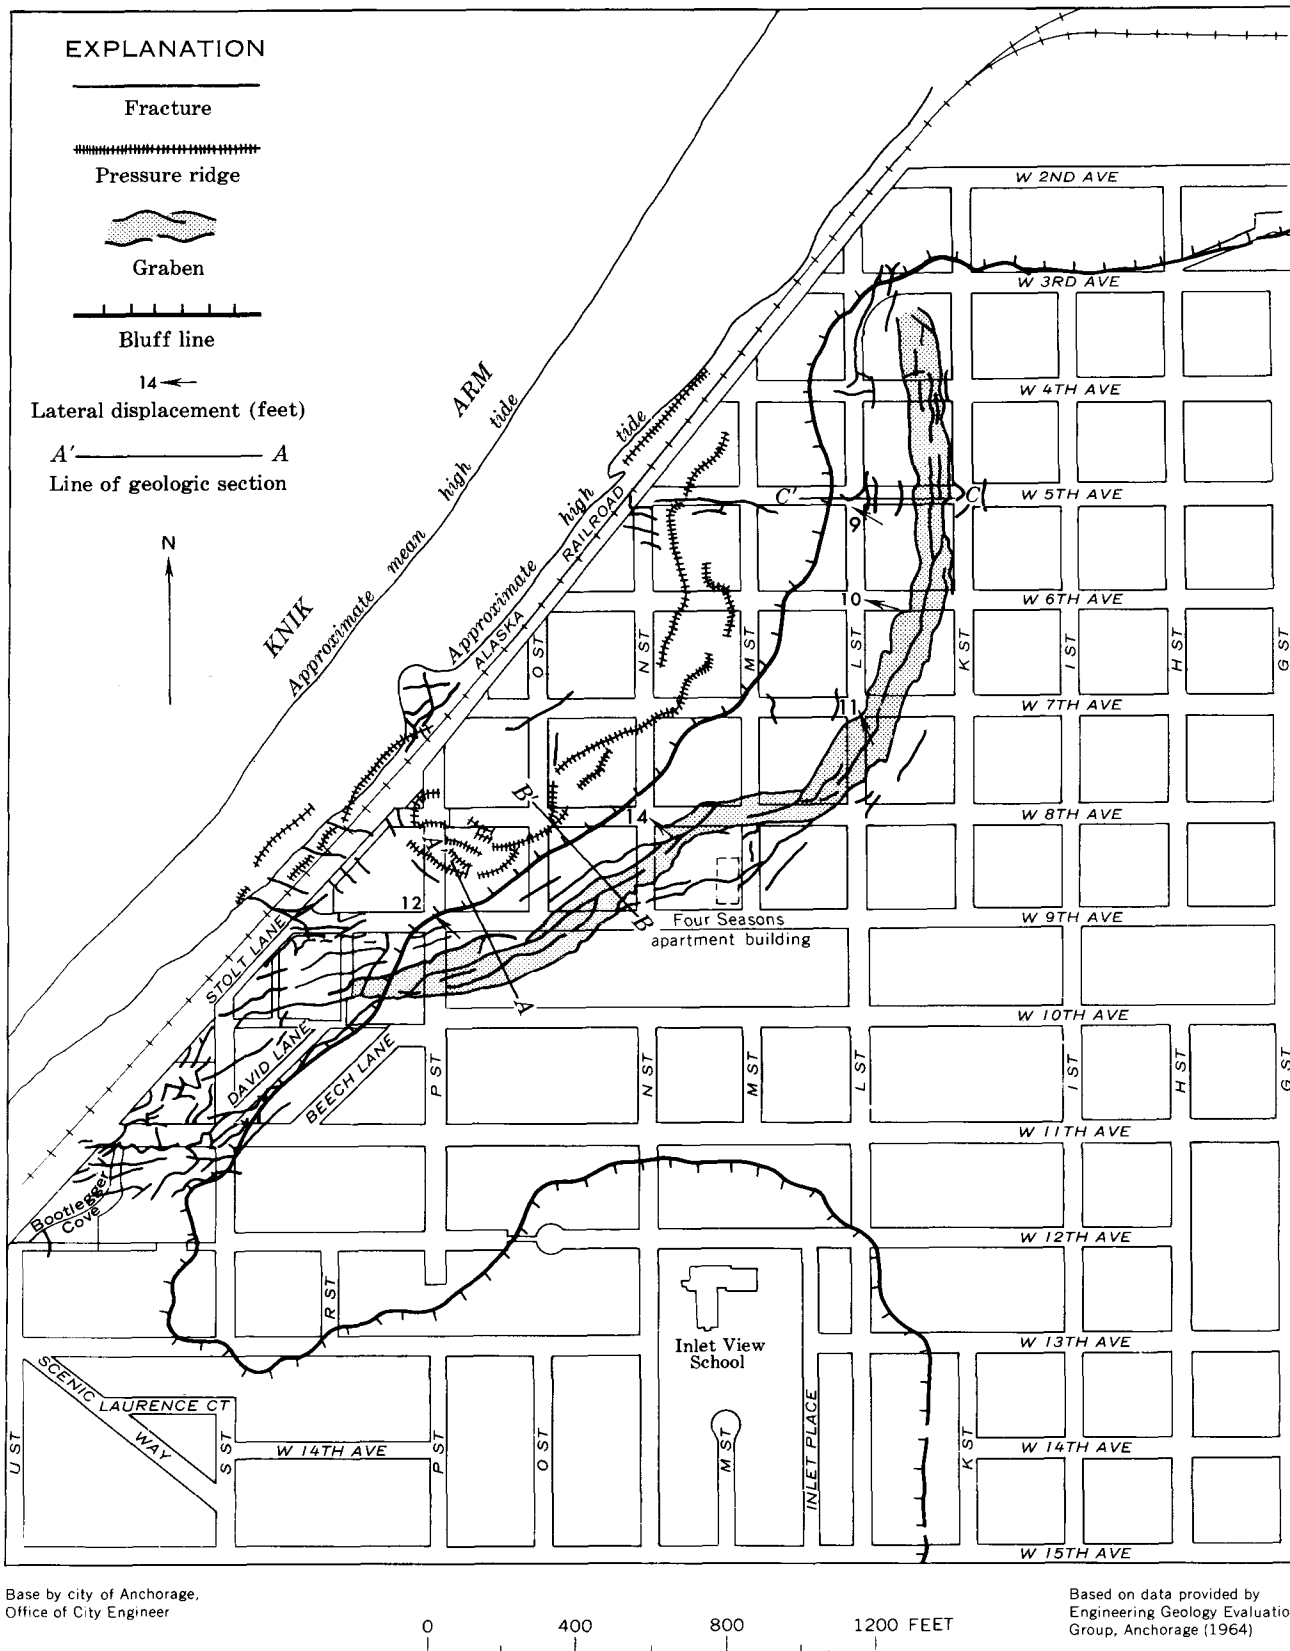
The graben itself formed a broad arc in plan, concave toward the slide block. It extended south from West Third Avenue between K and L Streets and curved westward to R Street between Ninth and Tenth Avenues. It was about 3,600 feet long and had a maximum width of about 250 feet; generally, its width was between 150 and 200 feet (fig. 30). Its depth—that is, the displacement of the down-dropped block—reached a maximum of about 10 feet; the displacement was greater south of Sixth Avenue than north. Overall, the graben looked like a dry canal or a streambed, and, when contrasted with the lack of damage on either side, it stirred considerable speculation in the minds of early viewers. One popular magazine account stated that it resulted from collapse of an old

27.—L Street slide area, Anchorage, Alaska. Geologic cross sections are shown in figure 30.

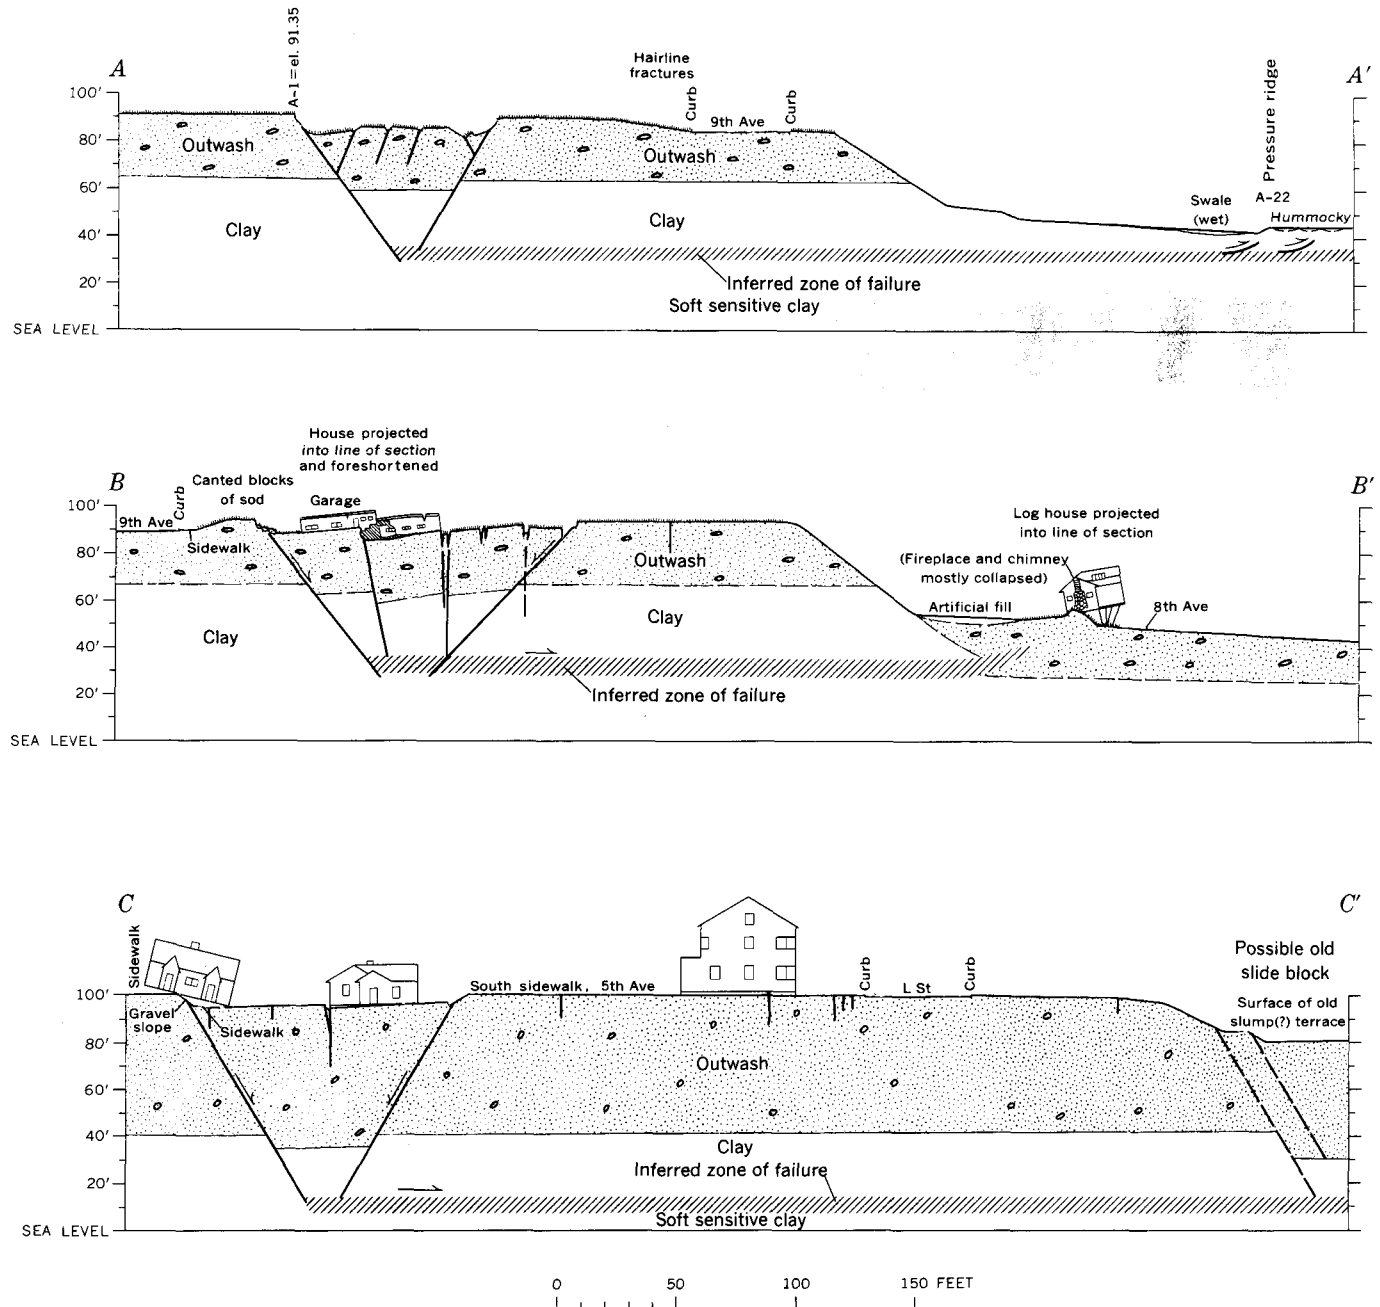
The available evidence, both surface and subsurface, favors the view that the pressure ridges were caused chiefly by shallow compressional translations of the frozen superficial soil mantle, which in turn was shoved laterally by the sliding block behind. This mantle was only a few feet thick, but it was highly competent in its frozen state. Some indication of its strength was provided at one point where a small chunk of partly buried concrete caught in a surface fracture was so firmly held in place that it parted in half instead of breaking free from the frozen soil. In further support of the shallow depth concept, the altitude of the

30.—Geologic section through the L Street slide. In section C-C' the toe of the slide is to the right of C'.

pressure ridges above sea level was very close to the inferred altitude of failure beneath the main slide block.

Despite numerous borings, the position of the zone of failure in the L Street slide was not definitely established, although zones of very low strength and high sensitivity were clearly indicated. Presumably, slippage occurred at the top of the sensitive zone, where the strength was lowest and the shearing stress was highest (Shannon and Wilson, Inc., 1964, p. 55). This position varied appreciably—from about 55 to 85 feet below ground surface (45 to 15 feet above sea level)—in different drilling locations. Estimates based on the graben rule place the zone of failure within that range also. Pres-

sure ridges at the foot of the slide lie within the same range of altitudes. Therefore, if failure beneath the block was within that range, the pressure ridges—as noted above—must have been caused by shallow translations of the relatively thin frozen surface layer—a sort of shove effect—rather than by deeper surfaceward shear. If so, some of the remedial buttresses proposed by the Corps of Engineers (Shannon and Wilson, Inc., 1964, pl. 9.6) would require design changes to be effective in the event of future movement.

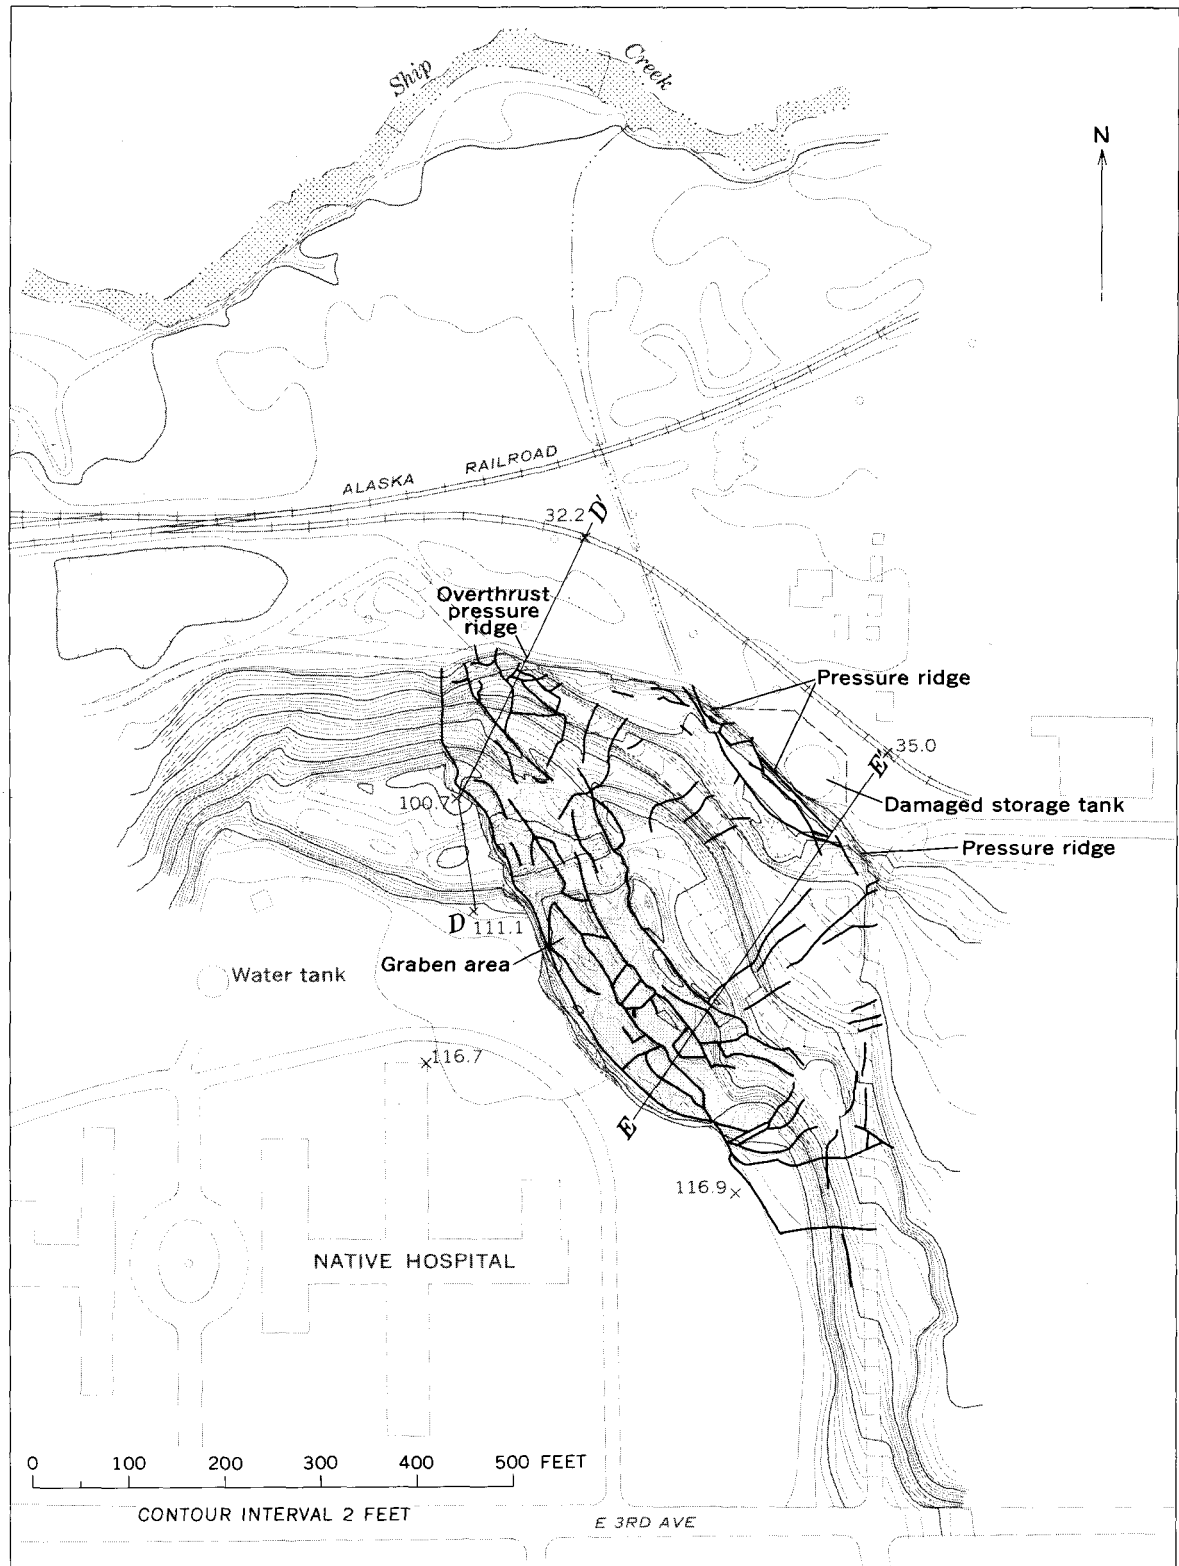
The graben was exceptionally large for the size of the slide. Its disproportionate size is attributed to the large apparent lateral slippage of the slide. Arcuate in plan, it was about 600 feet long; it had a mean width of about 120 feet and a downthrow (depth) of as much as 25 feet which averaged about 20 feet. Its depth diminished rapidly toward the south, where horizontal slippage died out also.

Near the center of the slide, the downdropped graben wedge broke off precisely at the bluff line and tilted headward as it collapsed, so that the displacement at the headwall of the graben was greater than at the front wall and gave

the slide a pseudorotational appearance; however, the causative failure and dominant movements were horizontal, as verified by the perfectly upright attitude of trees in the main slide block. Longitudinally, the graben wedge was rent by great gaping tension cracks. The total relations are well illustrated by the aerial view (fig. 32) and by the cross sections (fig. 33).

confined laterally. Accordingly, it spread as it moved outward, and tension cracks opened in a fanlike arrangement at the periphery. Some of these tension cracks are visible in figure 32. They have been plotted in figure 31.
