# The Alaska Earthquake

# Effects of the Earthquake Of March 27, 1964 At Anchorage, Alaska

*A description and analysis of the damage resulting from seismic vibration, ground cracks, and especially landslides in Alaska's largest city*

GEOLOGICAL SURVEY PROFESSIONAL PAPER 542-A

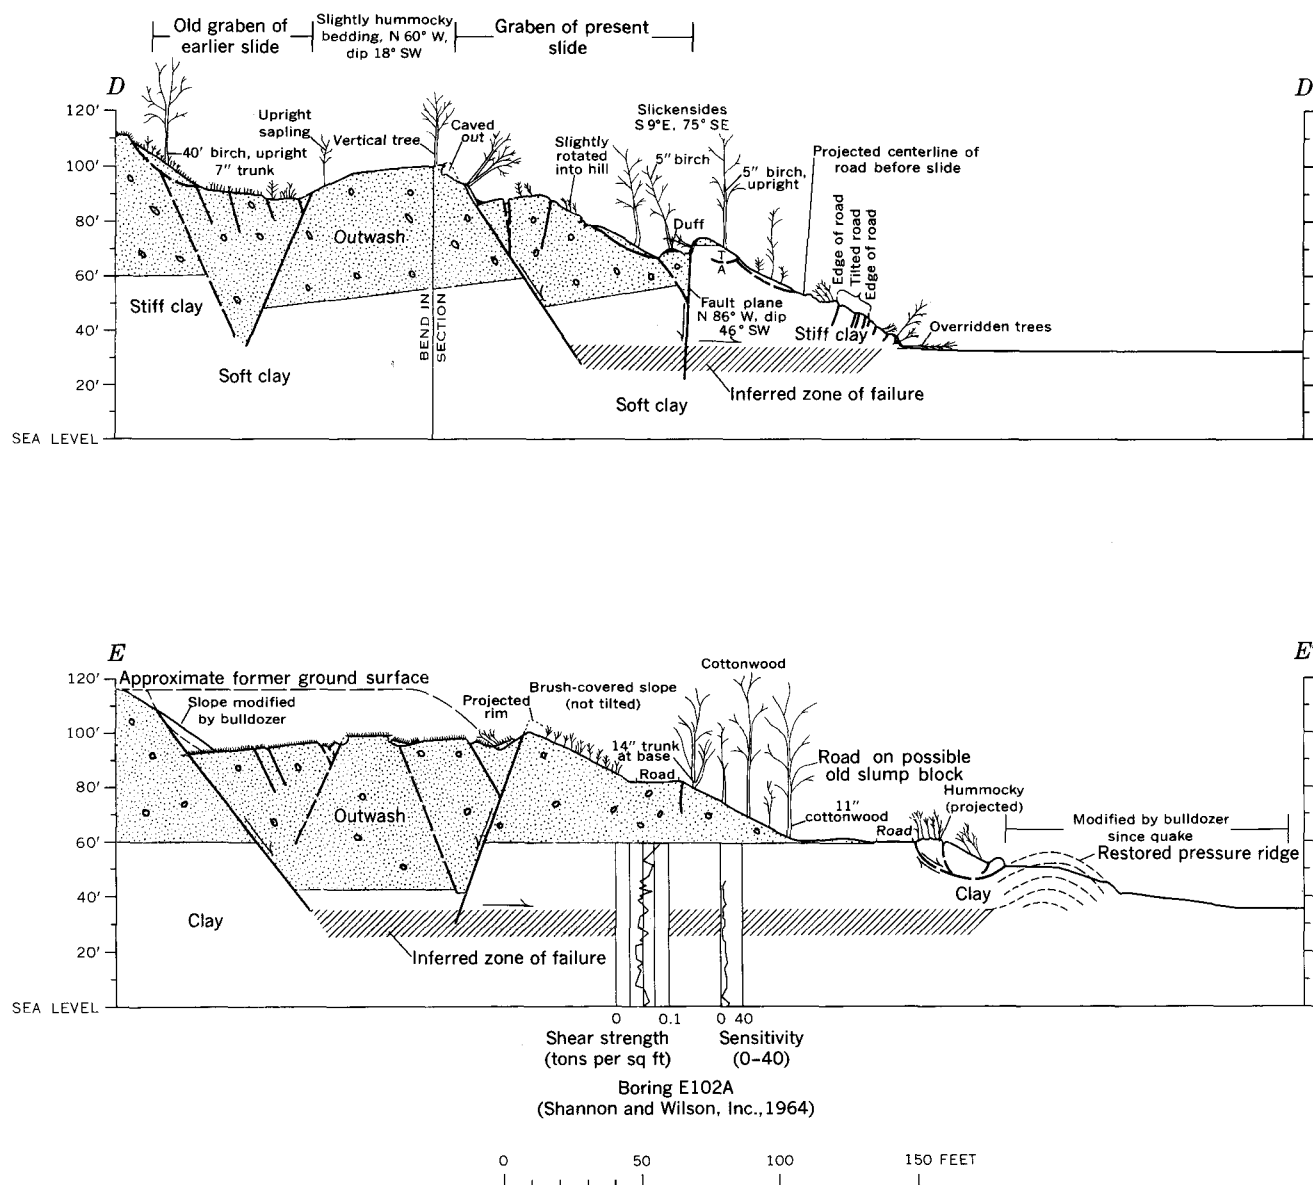
33.—Geologic sections through the Native Hospital slide, Anchorage, Alaska. Section D-D' transects the graben of an earlier landslide (upper left). Boring data from Shannon and Wilson, Inc. (1964).

the slide a pseudorotational appearance; however, the causative failure and dominant movements were horizontal, as verified by the perfectly upright attitude of trees in the main slide block. Longitudinally, the graben wedge was rent by great gaping tension cracks. The total relations are well illustrated by the aerial view (fig. 32) and by the cross sections (fig. 33).

Figure 33 shows cross-sectional reconstructions of the Native Hospital slide based on both surface and subsurface data. Although subsurface exploration by the Corps of Engineers did not disclose the surface of rupture, it did clearly define zones of stiff clay above and below a zone of weaker clay. Most of the clay sampled had sensitivities below 10, but the

sensitivity of some of it exceeded 30. Several thin sand layers may have contributed to failure by liquefaction.

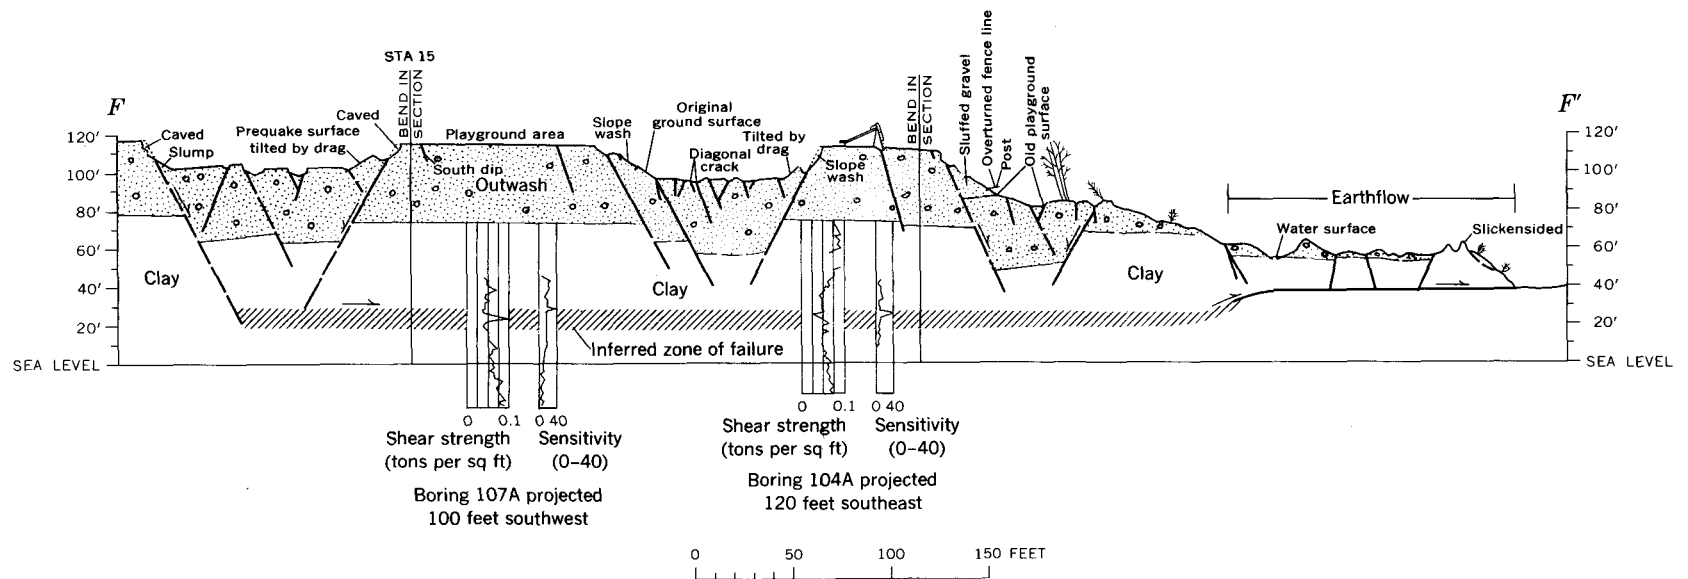
37.—Geologic section through Government Hill slide. Boring data from Shannon and Wilson, Inc. (1964).

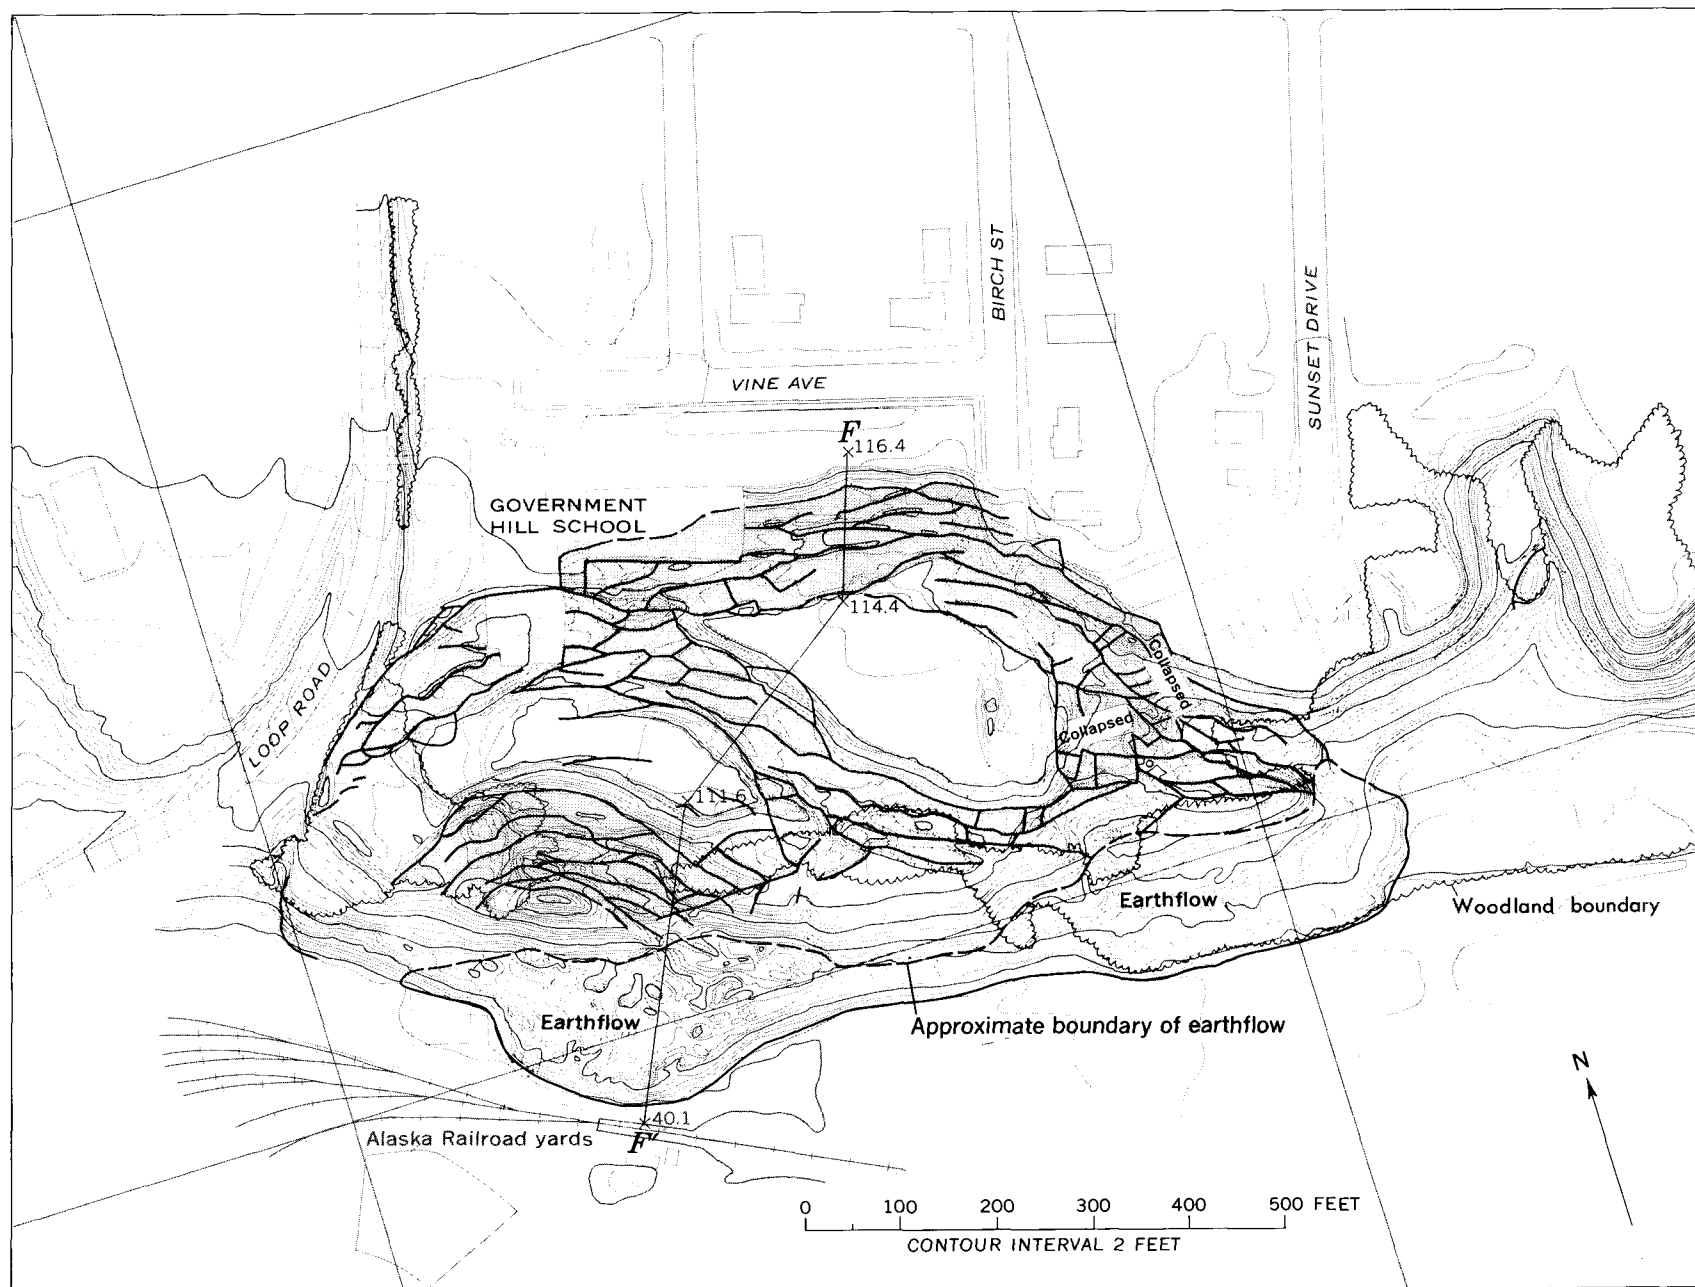
ward as the slide pulled away from the bluff. Two or three partly integrated grabens formed side by side along the crown of the bluff; these were complicated by internal collapses, cracking, and slumping along the face of the bluff. Two additional grabens formed behind the crown on the upland surface. The head of the slide broke away clean; back from the head there was very little cracking and virtually no damage to property.

38.—Map of Government Hill slide, Anchorage, Alaska. Many small fractures have been omitted. Graben areas indicated by shading. Compare with aerial photograph, figure 35.

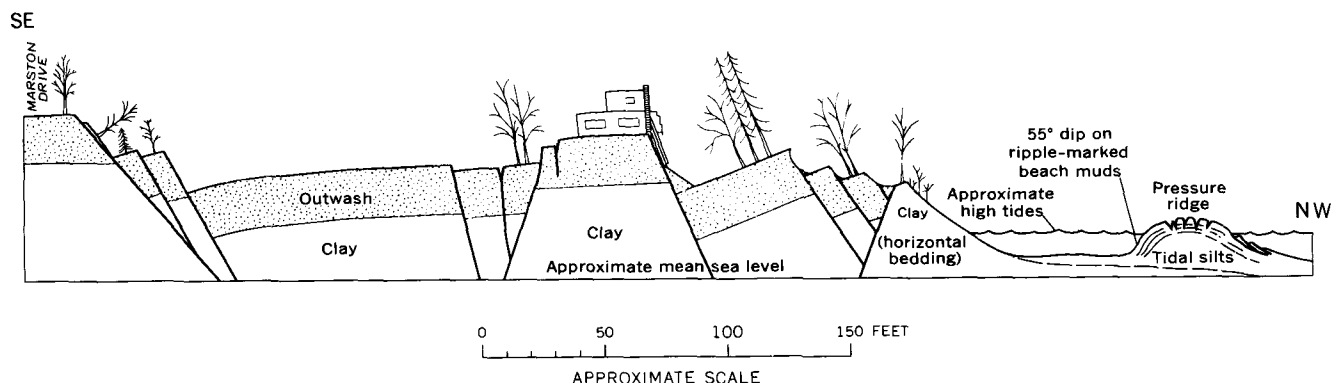
44.—Sketch section through eastern part of Turnagain Heights slide. Note pressure ridge, upright blocks at center and to left of pressure ridge, and tilted collapsed blocks between.
