The Alaska Earthquake

Effects of the Earthquake Of March 27, 1964 At Whittier, Alaska

By REUBEN KACHADOORIAN

GEOLOGICAL SURVEY PROFESSIONAL PAPER 542-B

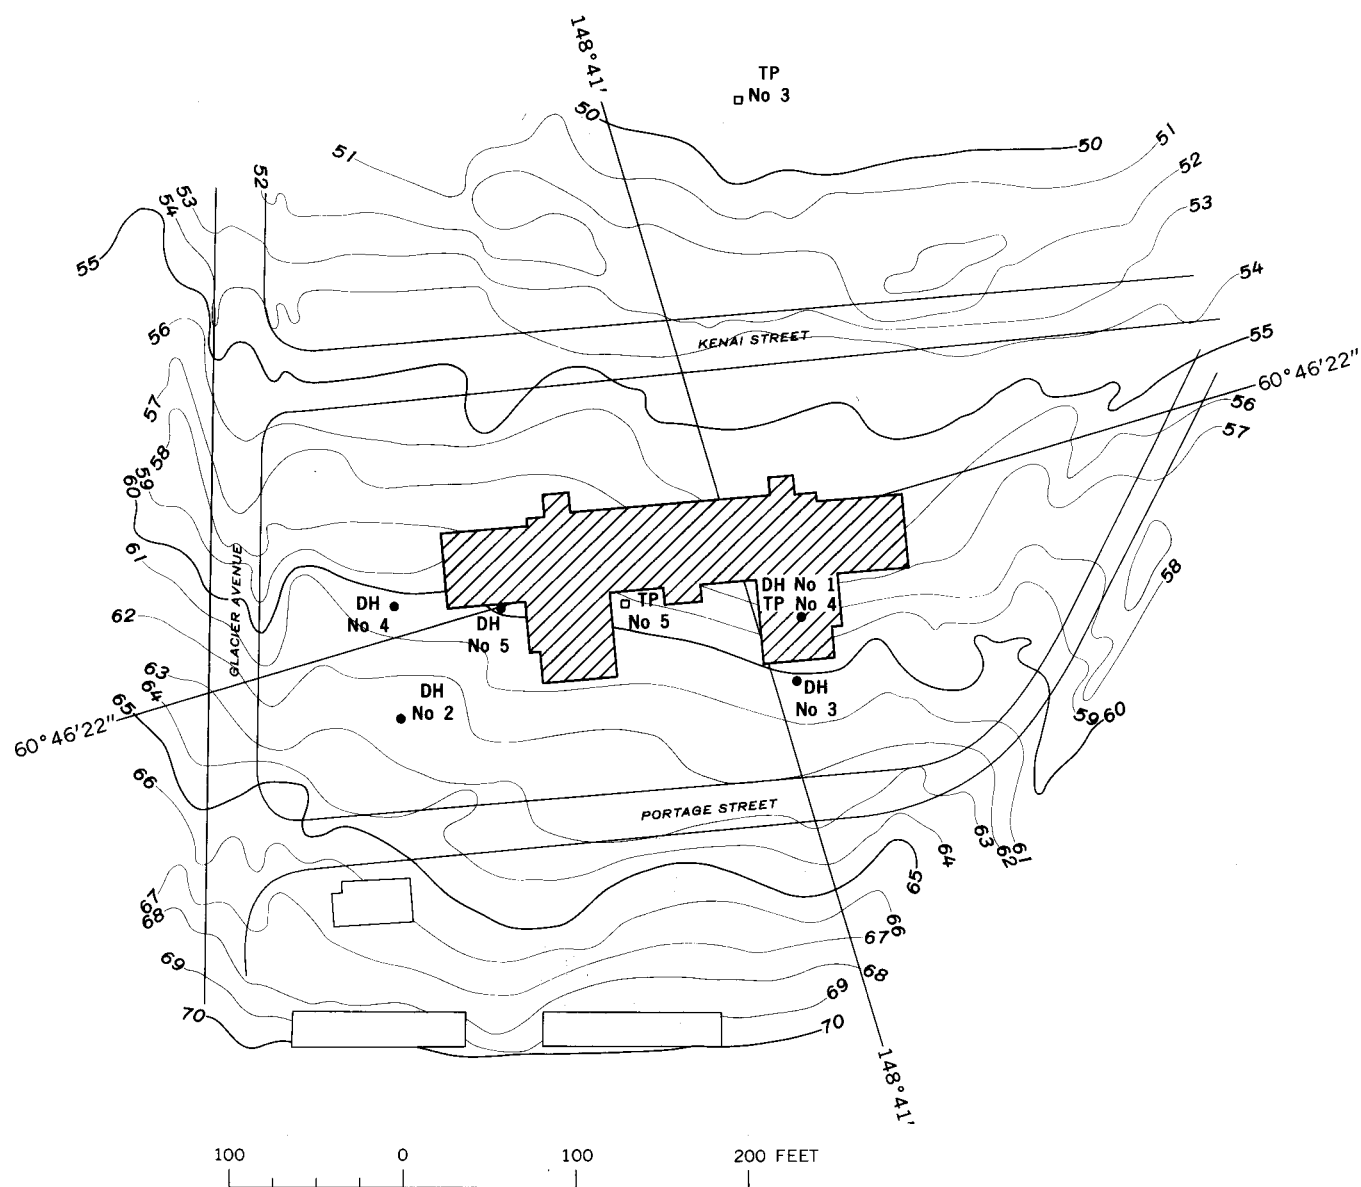
The Whittier delta is composed predominantly of coarse, subangular to subrounded gravel in a matrix of coarse sand. The maximum thickness of the gravel is unknown but is at least 44 feet beneath the Hodge Building (figs. 2 and 3).

2.—Map showing Hodge Building, surrounding area, and location of drill holes. Graphic logs of these holes are shown in figure 3.

The Hodge Building, a reinforced-concrete 14-story structure 265 feet long and 50 and 110 feet wide (figs. 2 and 3), rests on at least 44 feet of unconsolidated sand and gravel. The building was constructed as three structural monolithic units connected by 8-inch expansion joints. In the corridors, metal jumper plates spanned the 8-inch joints; on the exterior, the joints were secured by a weather seal. The long dimension of the building was parallel to the predominant east-west direction of the seismic motion;

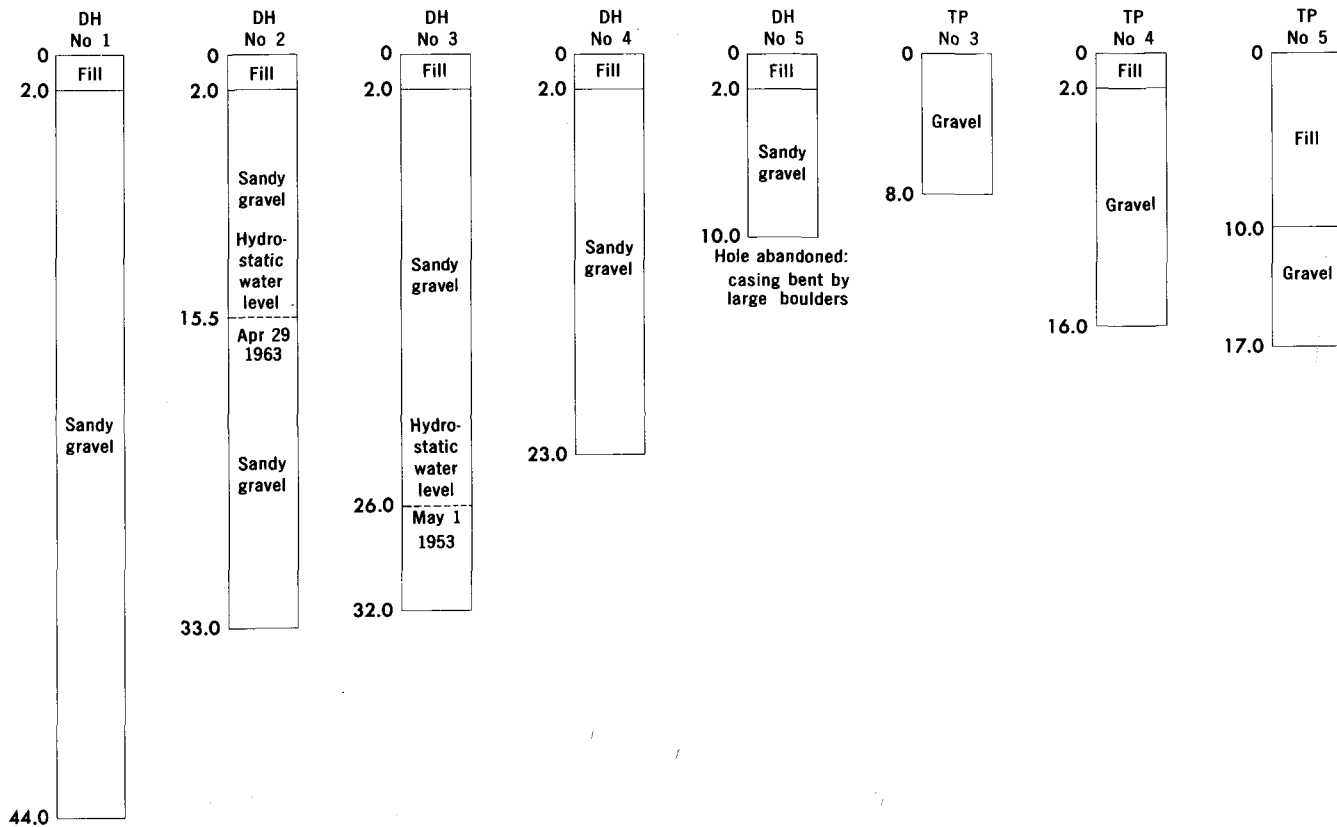
3.—Graphic logs of drill holes (DH) and test pits (TP) in the Hodges Building area. Location of holes and pits are shown in figure 2.

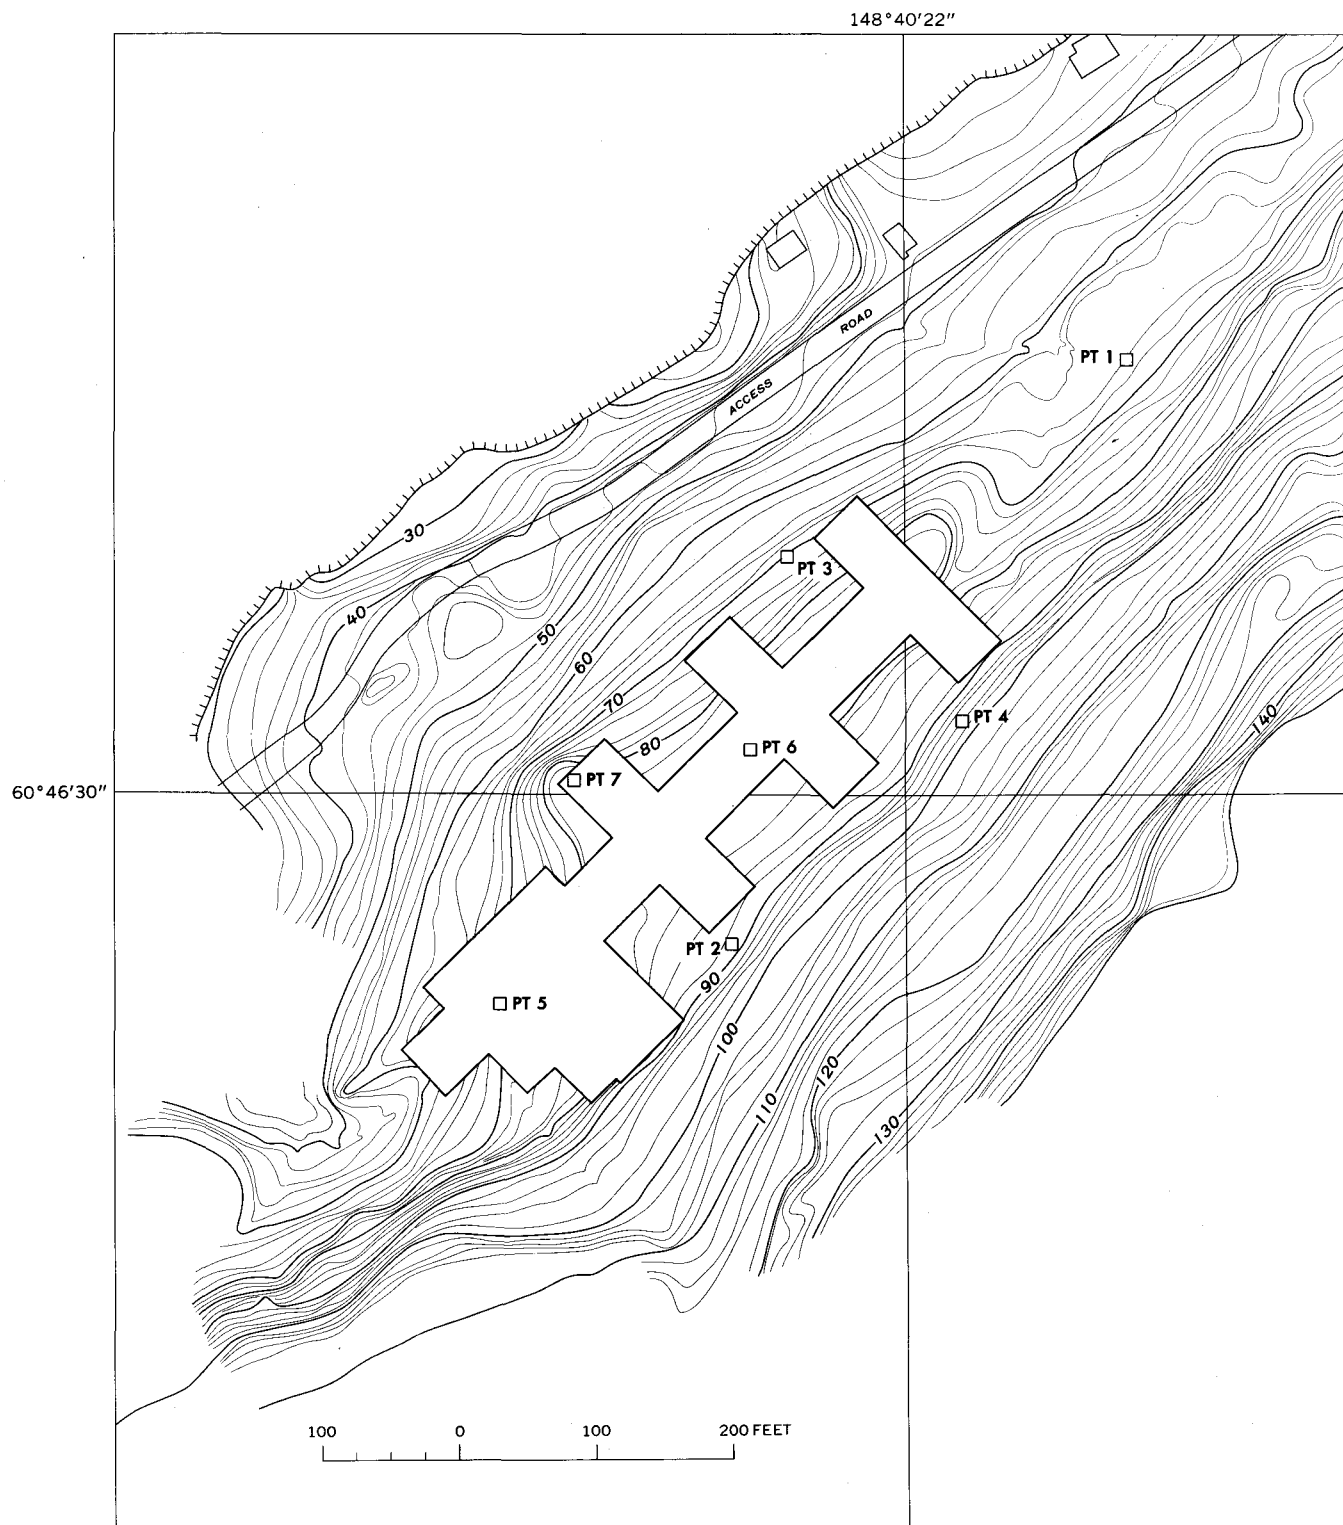
15.—Map showing Buckner Building, surrounding area, and location of test pits (Pt). Graphic logs of these pits are shown in fig. 16.

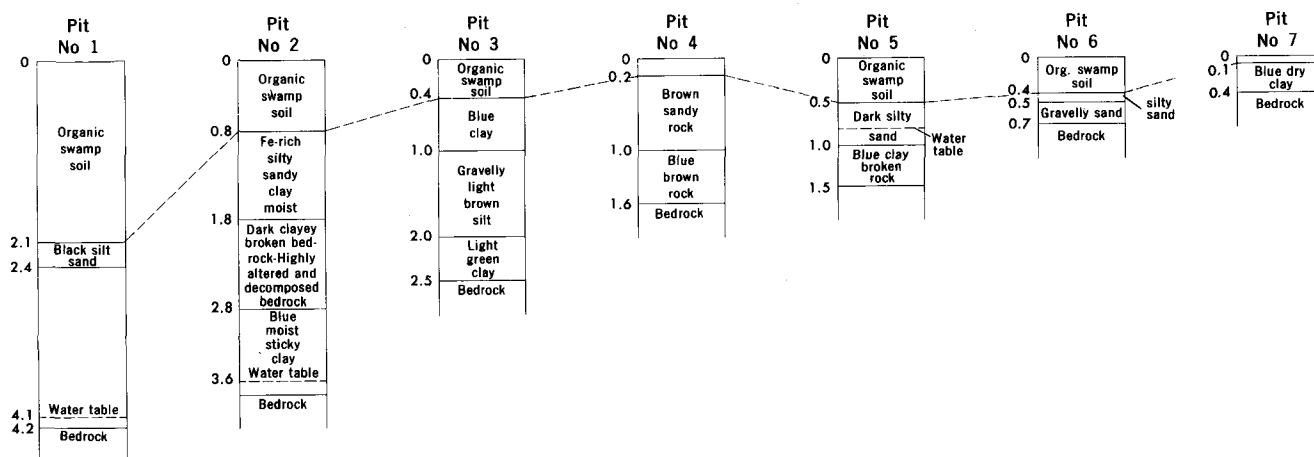
16.—Graphic logs of test pits (Pit) in the Buckner Building area. Locations of the pits are shown in figure 15.

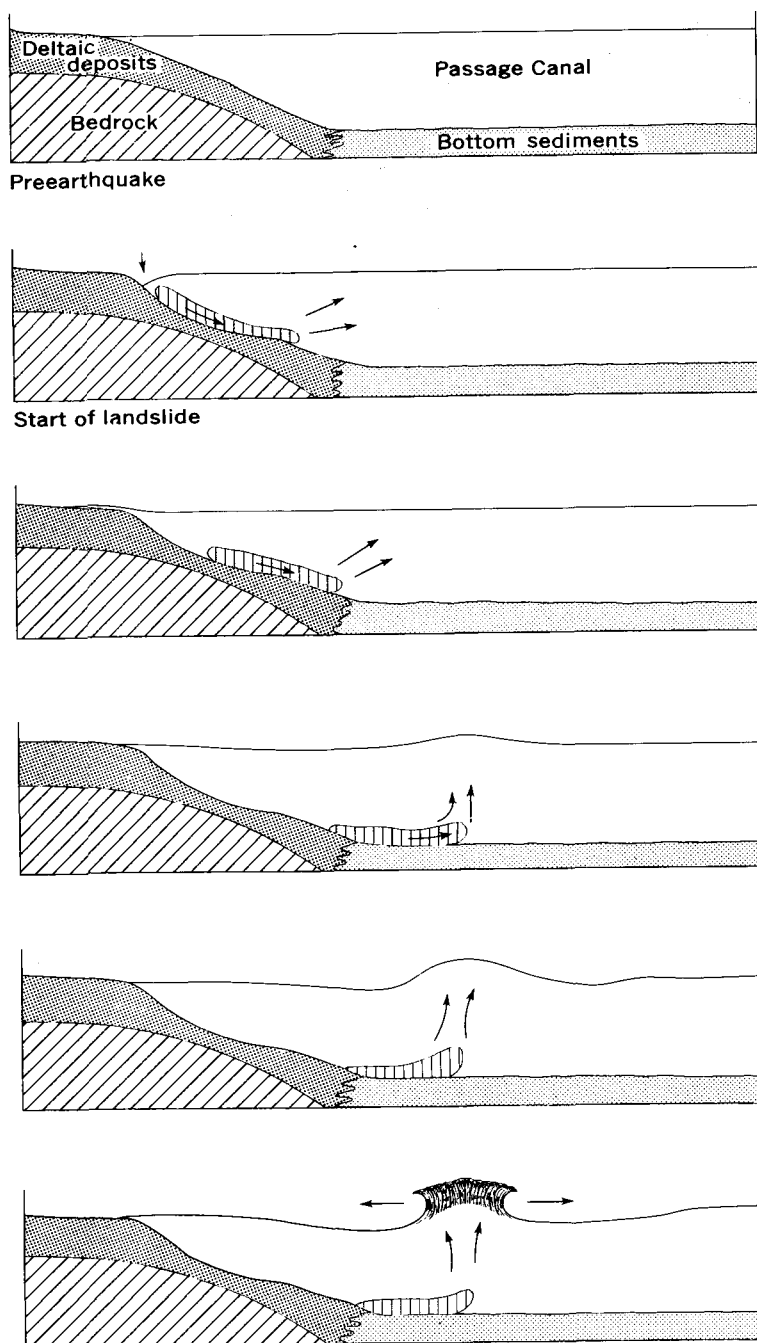
There are several possible explanations of the glassy wave reported by witnesses. If the sliding mass moved with sufficient velocity, the

volume of drawdown could be large enough to form a wave that would reach an altitude of 25 to 26 feet when water rushed into the vacated area yet which probably would not be highly turbulent.

18.—Schematic sections showing generation of waves associated with submarine landslides.
