# The Alaska Earthquake

# Effects of the Earthquake Of March 27, 1964 At Valdez, Alaska

By HENRY W. COULTER and RALPH R. MIGLIACCIO

GEOLOGICAL SURVEY PROFESSIONAL PAPER 542-C

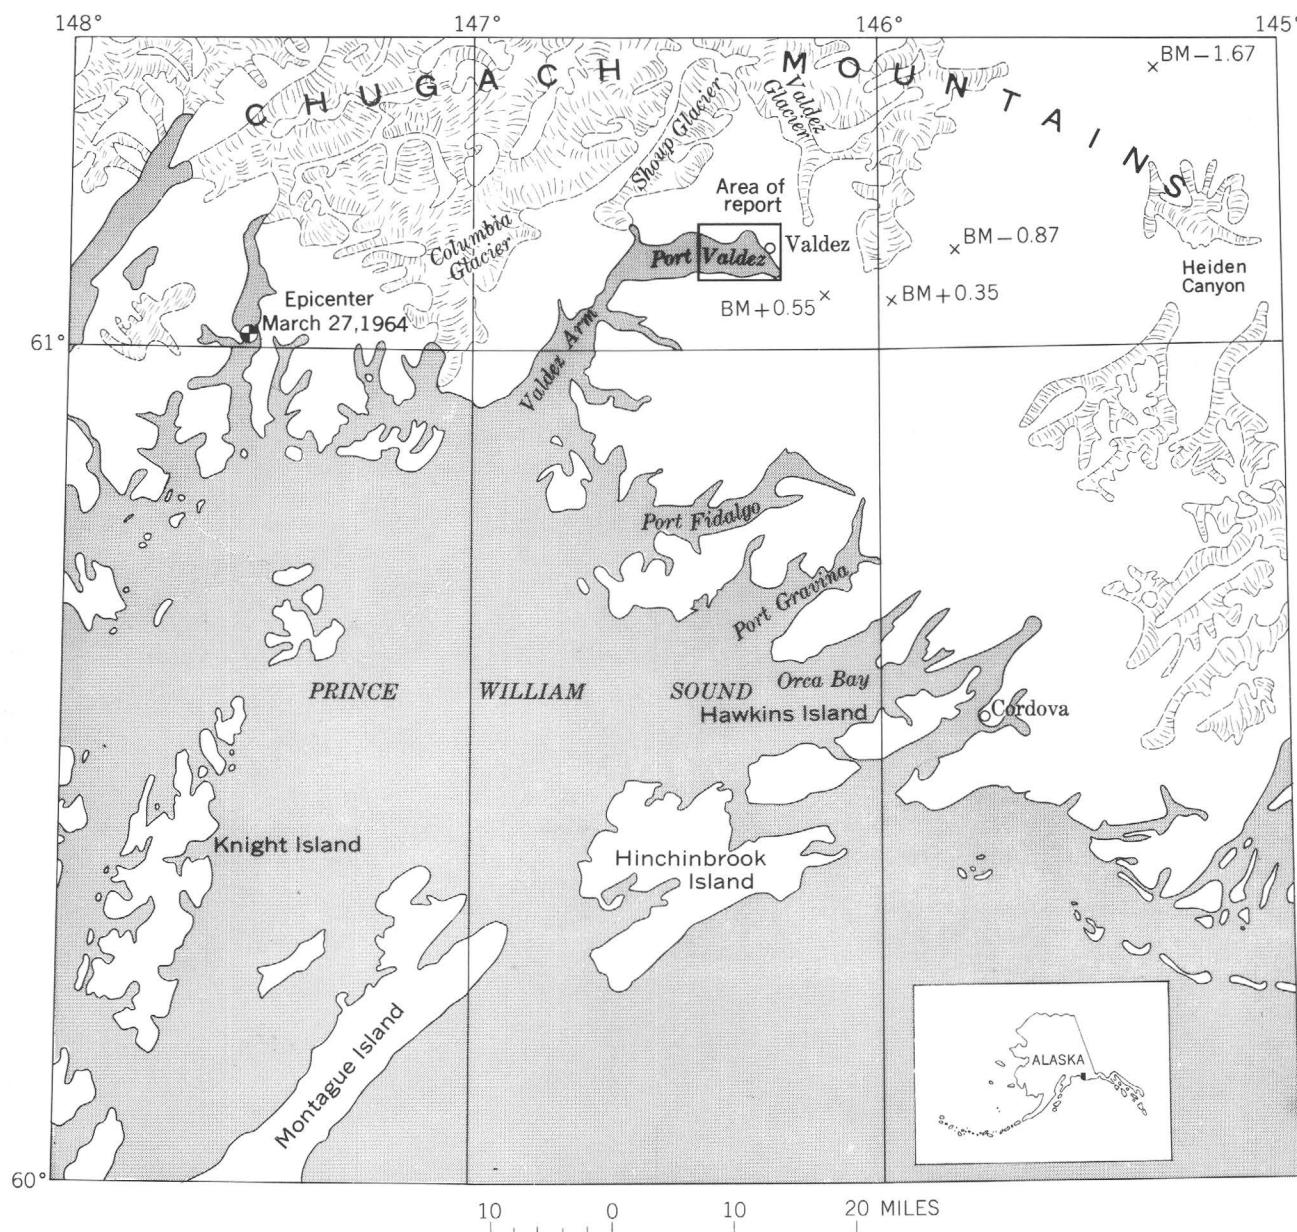
1.—Index map, Valdez area. Bench marks show change in altitude, in feet.

distribution of these changes in altitude strongly suggests that the Port Valdez valley—and its continuation into Heiden Canyon—lies on the dividing line between the area of tectonic uplift and subsidence (see fig. 1).

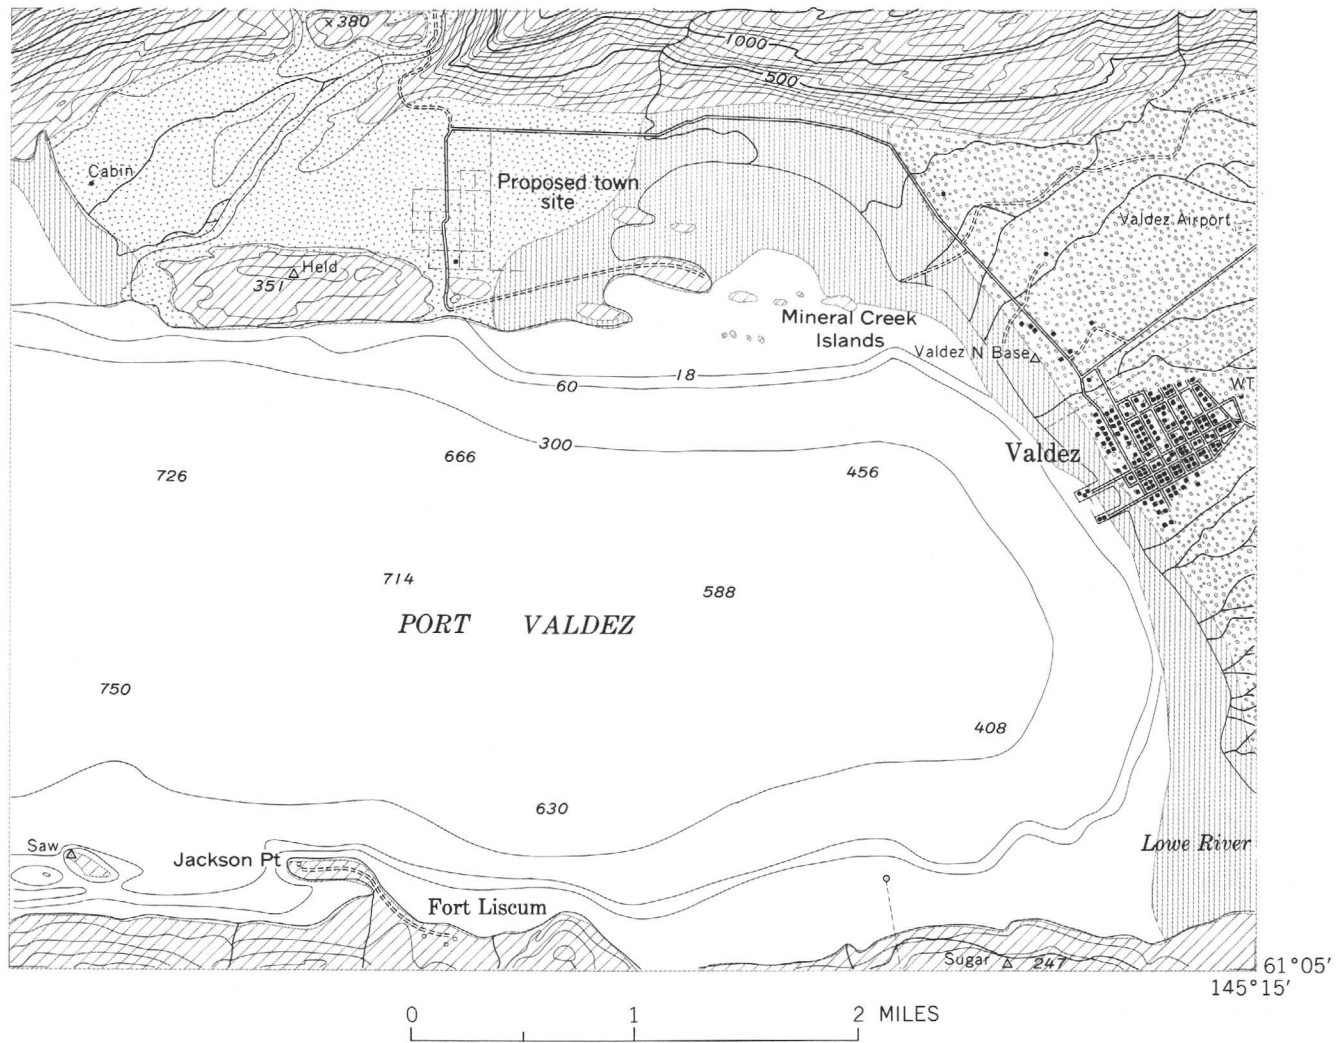
2.—Ground conditions at Valdez.

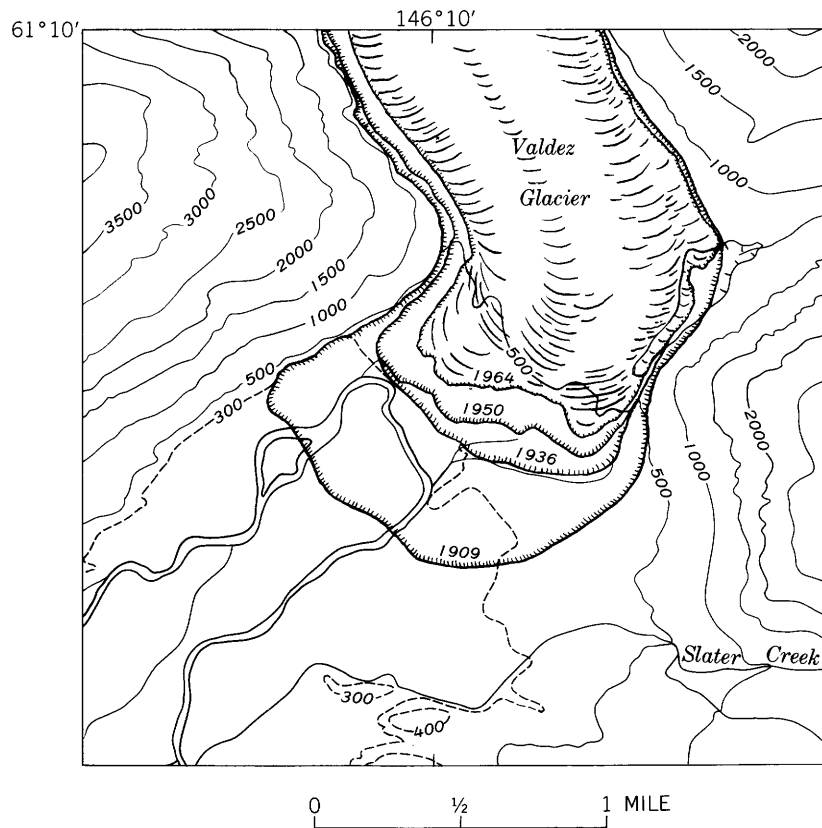
3.—Recorded positions of the terminus of Valdez Glacier since 1909.

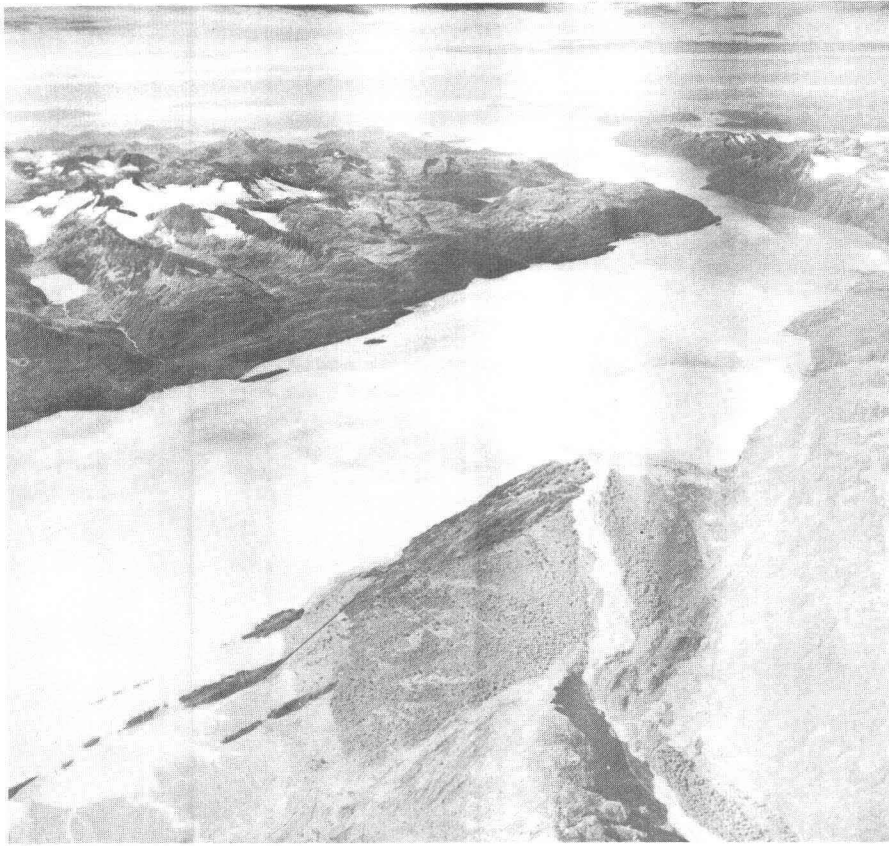
20 (above).—Oblique aerial photograph showing Mineral Creek fan and Mineral Creek islands (foreground), the western end of Port Valdez, Shoup Spit, and Valdez Narrows (background). Photograph by U.S. Air Force.

The absence of evidence of wave damage, of ground breakage and fissures, and of vibration damage to the single dwelling on the Mineral Creek Fan (figs. 20 and 21) indicates a more stable environment there under seismic conditions than exists on the Valdez Delta.

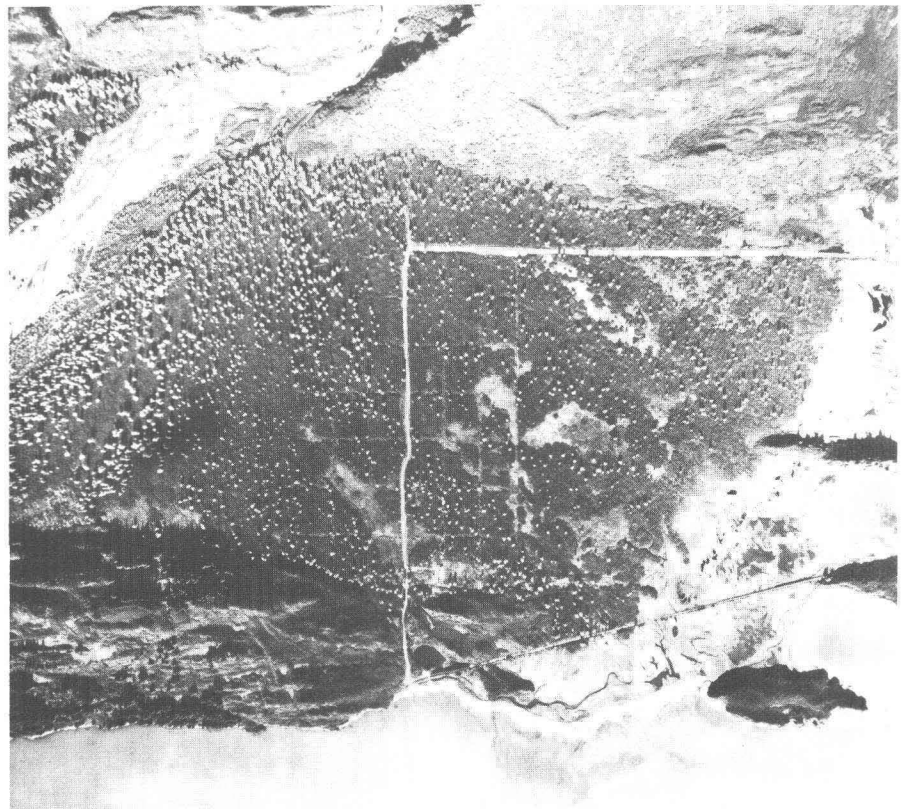
21 (below).—Vertical aerial photograph showing the new location for Valdez on the Mineral Creek fan. Photograph by U.S. Bureau of Land Management.
