# The Alaska Earthquake

# Effects of the Earthquake Of March 27, 1964 In the Homer Area, Alaska

By ROGER M. WALLER

GEOLOGICAL SURVEY PROFESSIONAL PAPER 542-D

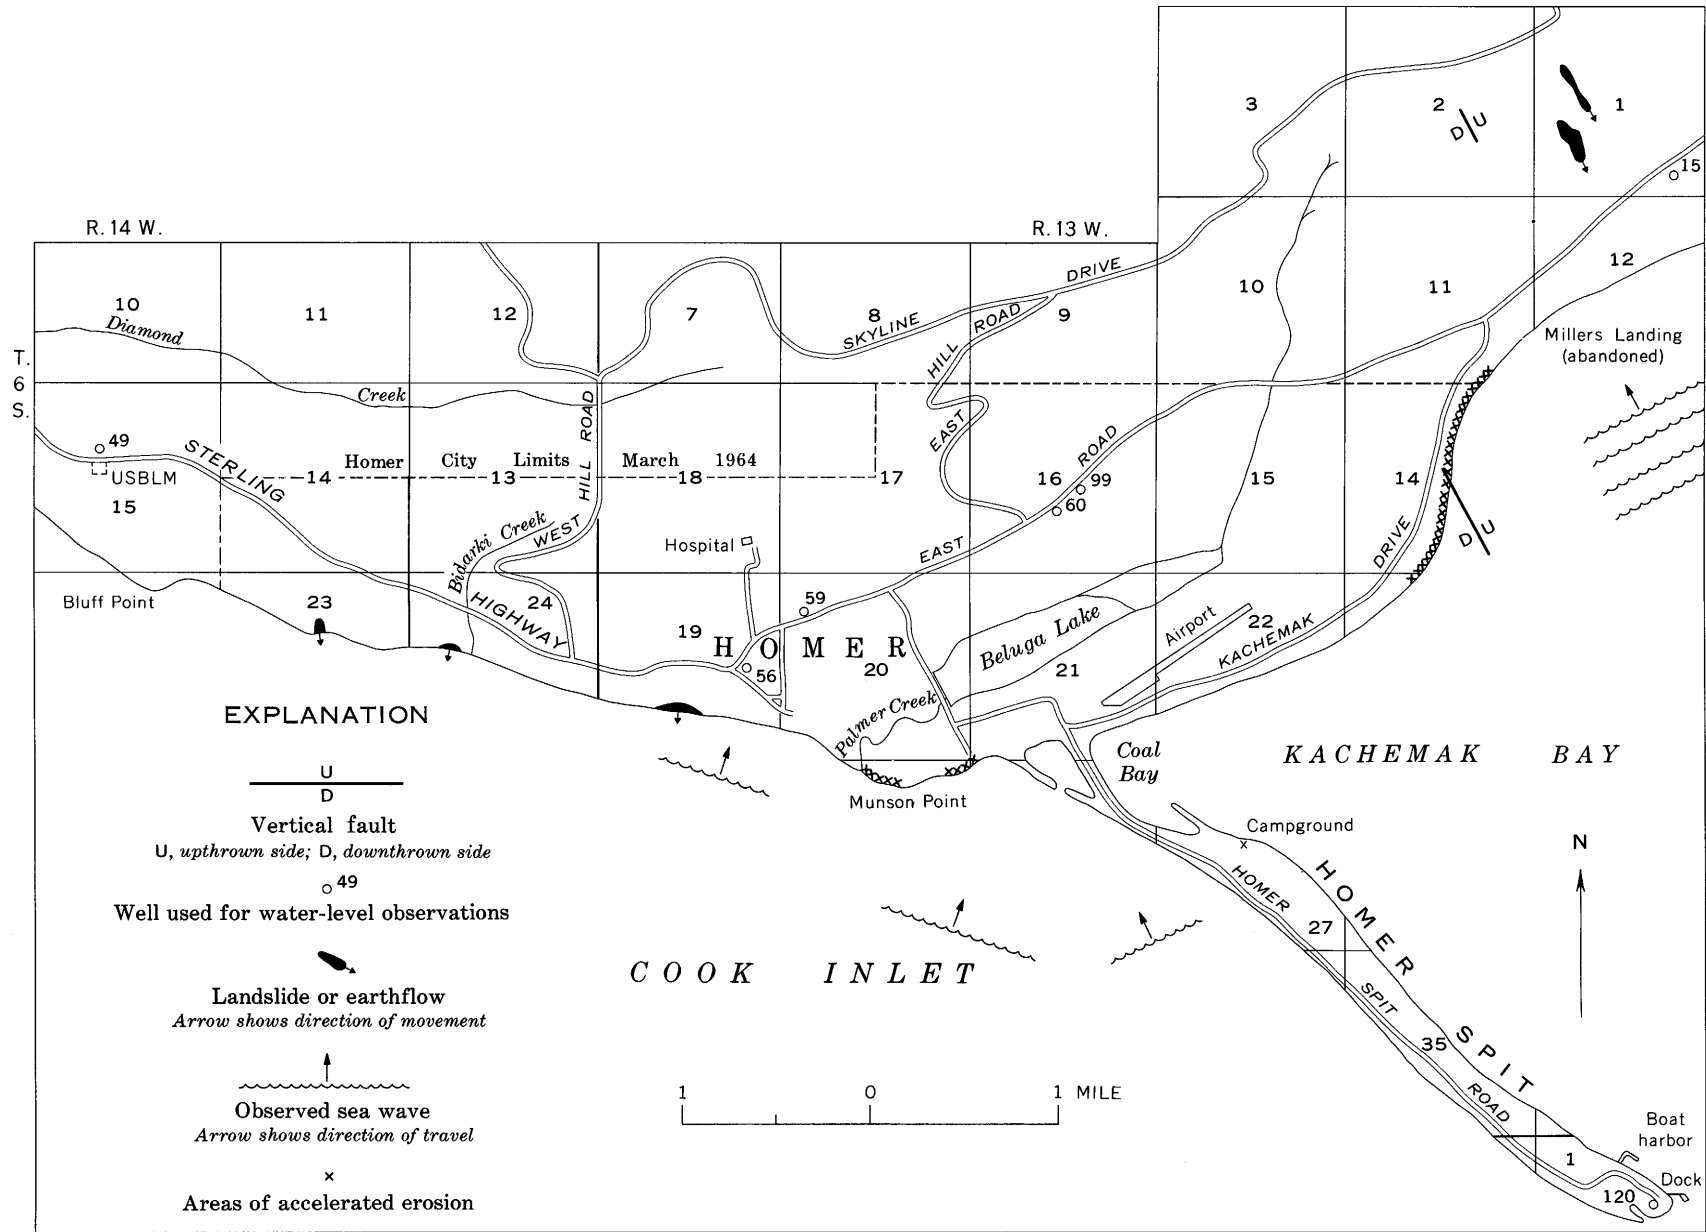
2.—Map of the Homer area showing slide areas, beach erosion points, and locations of wells.

scale slumping or landsliding, or both, in uninhabited parts of Cook Inlet cannot be disregarded; however, there is no direct evidence that such sliding and slumping occurred to cause the sea waves. In short, the origin of the waves remains unexplained. The reported wave patterns are shown diagrammatically on figure 2.

Eyewitnesses reported that wave heights and patterns were markedly different in Cook Inlet and in Kachemak Bay. For example, while returning to Homer from the spit, shortly after the earthquake, Mr. Glen Sewell noticed a wave "rolling in from the ocean" about a mile offshore. Mr. and Mrs. D. P. Lowcock also saw a wave which probably was the same one seen by Mr. Sewell. After the ground motion stopped, the Lowcocks looked offshore and saw a wave "rolling in from Seldovia." It was perhaps a mile long, cresting, and aligned approximately northwest to southeast. They also observed another wave coming directly northwestward toward them. It was shorter and did not appear as high, but it was cresting also. The two waves gave the appearance of an "inverted V," but they were not joined (fig. 2).

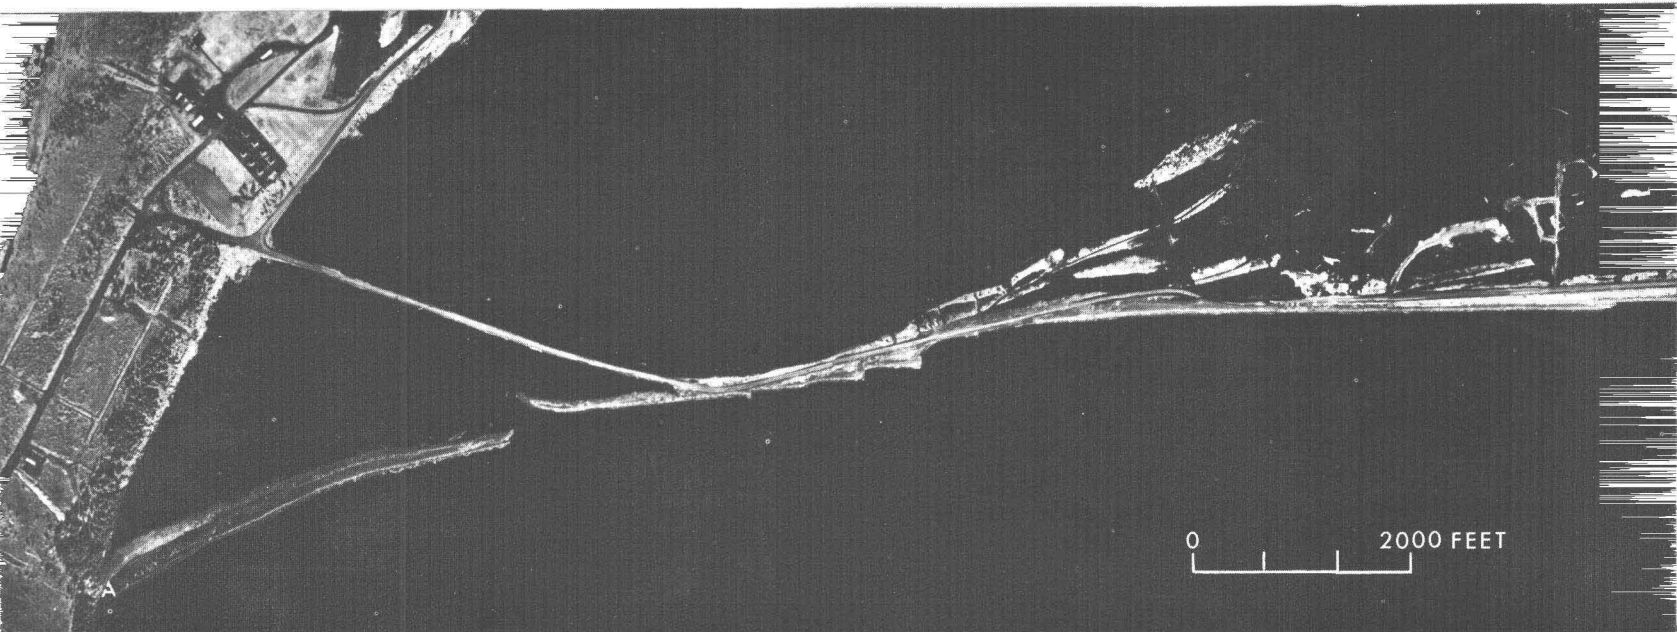
In addition to damage to man-made structures, the subsidence caused a change in the physical relations between the spit and the water surrounding it. As a result, the shape of the spit changed and beach stability was disrupted. The phenomena relating to beach changes on Homer Spit are the subject of the section by K. M. Stanley (p. D20). The extent of high-tide flooding of the spit is shown by Stanley (see fig. 15) in a pair of maps that contrast dry-land exposure on the spit before and after the earthquake. The devastating flooding on the spit immediately after the quake is further illustrated by figures 6 and 7 (on next page), aerial photographs of the spit taken before and after the earthquake.

6—Photomosaic of Homer Spit at high tide on August 8,

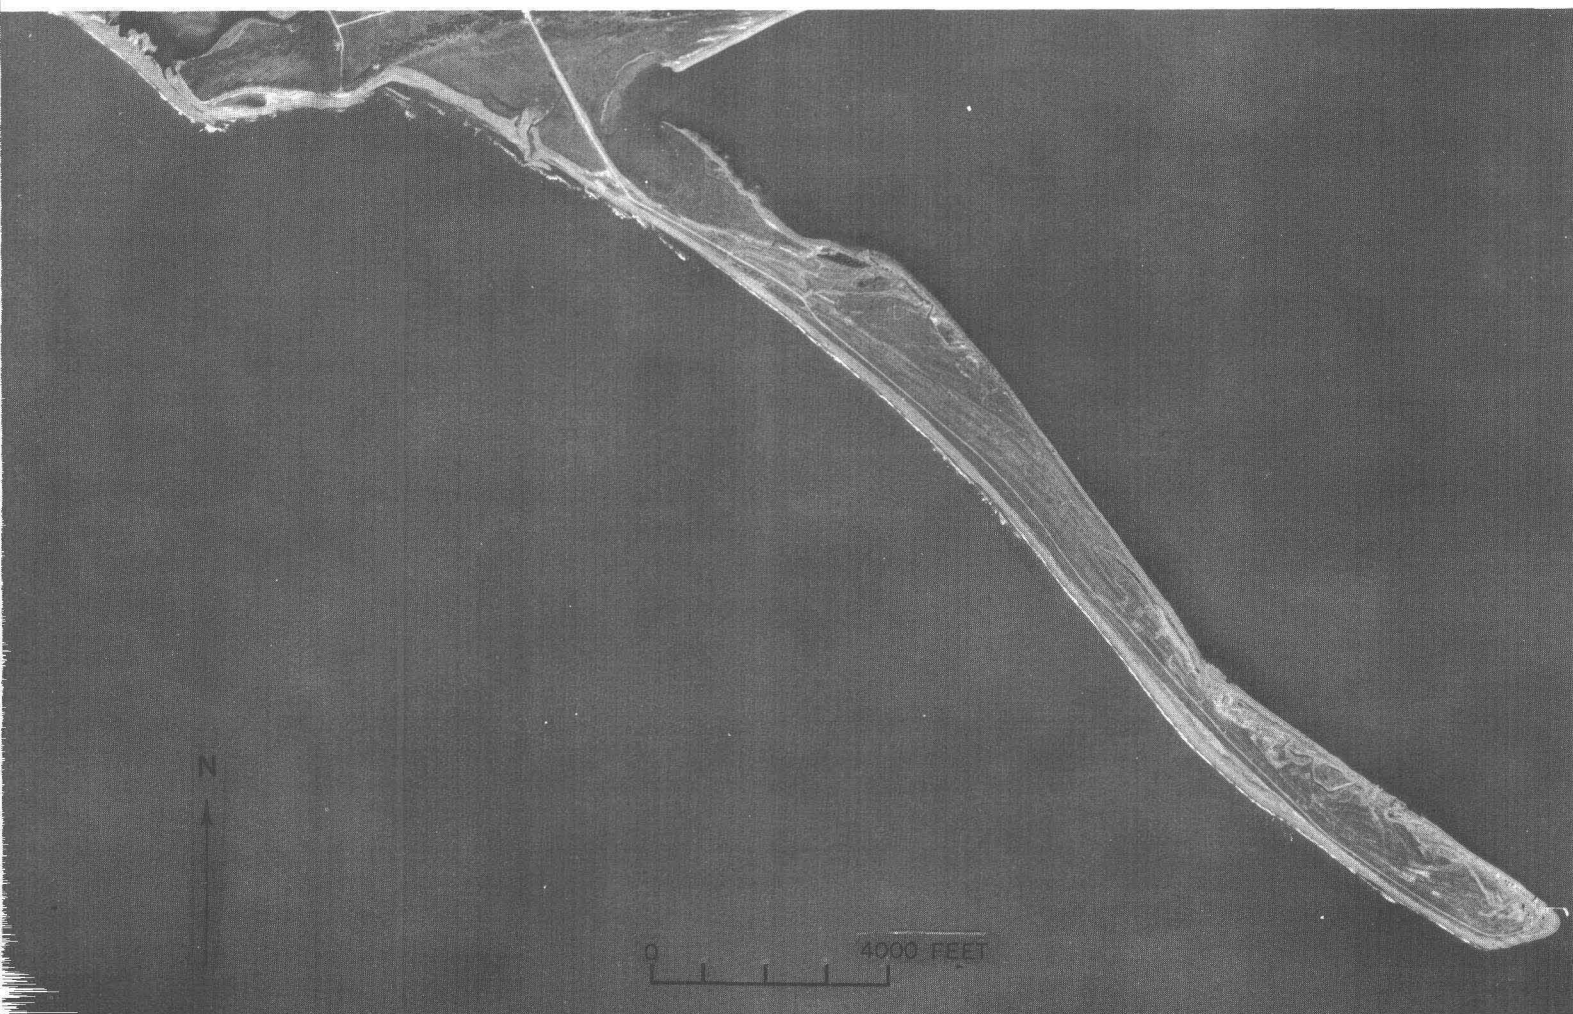
7.—Preearthquake aerial photograph of Homer Spit.

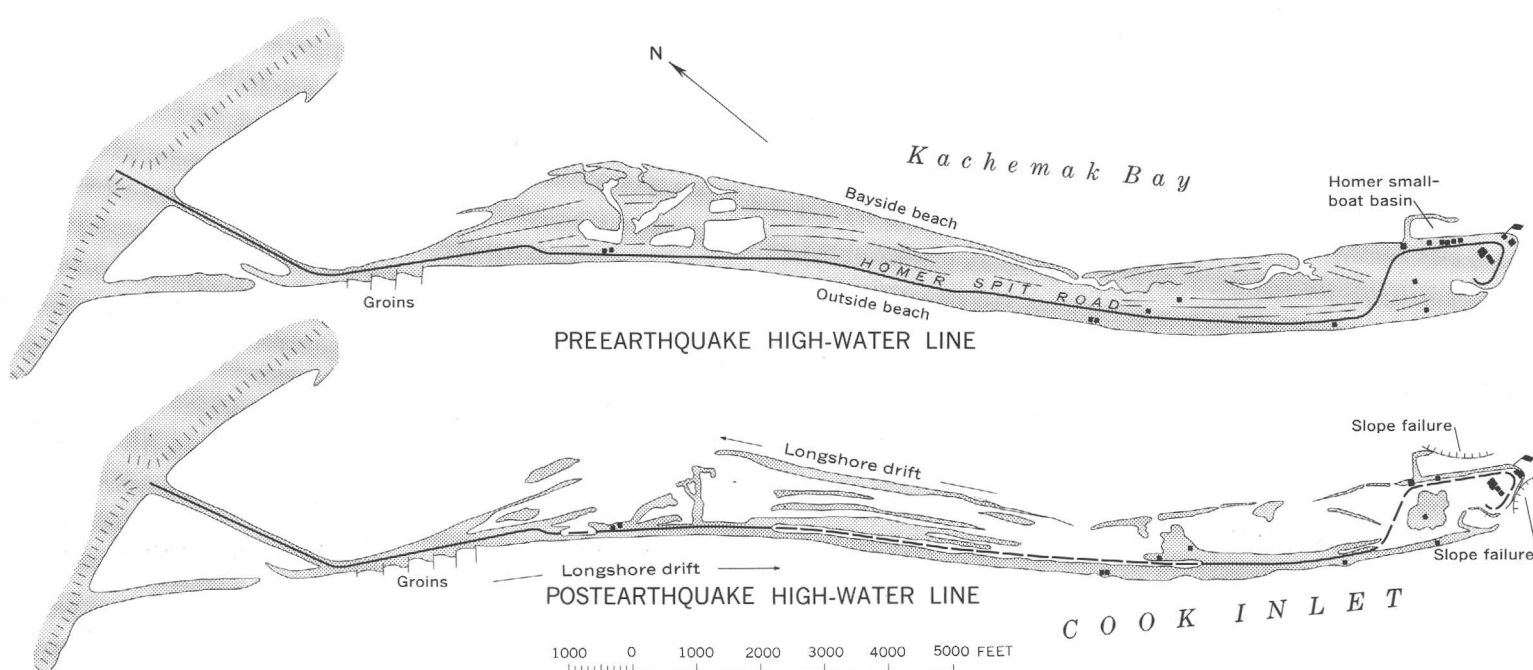
15. Comparison of the high-water line along Homer Spit before and after the earthquake and submergence of March 27, 1964. Light lines on Spit represent old beach berms. High-water line traced from U.S. Army Corps of Engineers aerial photographs, September 1959, and from U.S. Bureau of Land Management infrared photographs, August 1964.

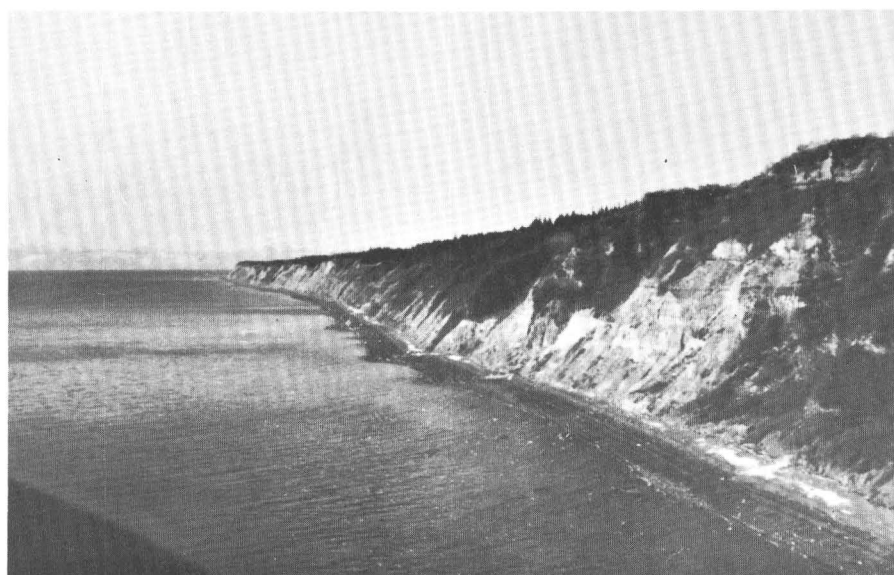
Subsidence of the mainland has caused accelerated erosion of the beaches and headlands that have been—and are—source areas for the material deposited on Homer Spit. The resulting increased supply of gravel and sand probably will cause the spit to widen gradually on the Cook Inlet side. Similarly, the new frontal berm will probably grow to a height sufficient to prevent overtopping by all but the larger storm swashes. The nature of shore processes on the spit has not been materially altered by subsidence, but the rates of erosion and deposition have been accelerated. The lasting effect of subsidence (excluding flooding) will be enlargement of the beach on the Cook Inlet side and gradual wasting of the beach on the bay side of the spit.

16.—Shoreline west of Homer Spit, probably the source area of material composing the spit.
